SITE NUMBER AND NAME: C065-1, -2, -3, -4, and -5 East of Trochu Slide		HIGHWAY & KM: 585:02, 16.136	PREVIOUS INSPECTION DATE: August 10, 2022 (warranty inspection)	INSPECTION DATE: June 19, 2024
LEGAL DESCRIPTION: 15-22-33-22 W4M	NAD 83 COORDINATES: UTM Northing Easting 12 5746228 359147		RISK ASSESSMENT: C065-1: PF: 1 CF: 5 TOTAL: 5 C065-3: PF: 3 CF: 5 TOTAL: 15 C065-4: PF: 3 CF: 4 TOTAL: 14 C065-5: PF: 3 CF: 4 TOTAL: 14	
AVERAGE ANNUAL DAILY TRAFFIC (AADT): 380 (east) (Ref No. 105290)			CONTRACT MAINTENANCE AREA (CMA): 517

PRIMARY SITE ISSUE: Several geohazards along an approximate 1 km long section of H585:02, on the west valley slope of the Red Deer River valley, that are causing pavement distress. C065-1: Slope failure affecting both lanes of H585:02. C065-2: Series of linear and shallow depressions, or troughs, in the pavement surface near the middle of C065. C065-3: Slope failure affecting both lanes of H585:02. C065-4 and -5: Slope failure on the north side of H585:02 and extends into the westbound lane.

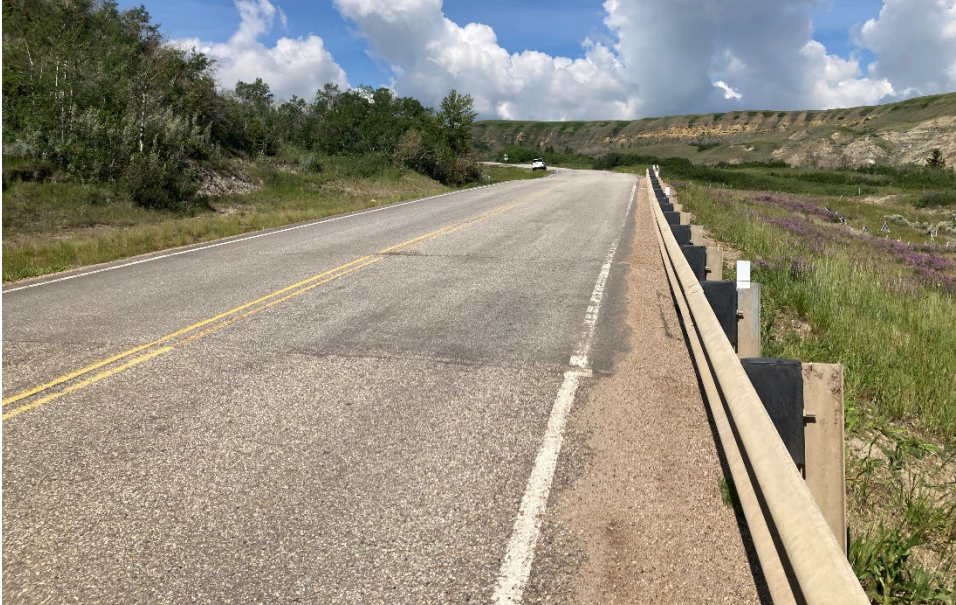
- The pavement surface along the site is in good condition (Photo 1) indicating the repair is performing well. A pavement dip was observed at the west extent of C065-1 repair and the existing highway subgrade (Photo 2) which may be attributed to differential settlement.

Photo 1 **The pavement at the C065-1 site is in good condition and no pavement distress was observed. Photo taken June 19, 2024, facing northwest.**

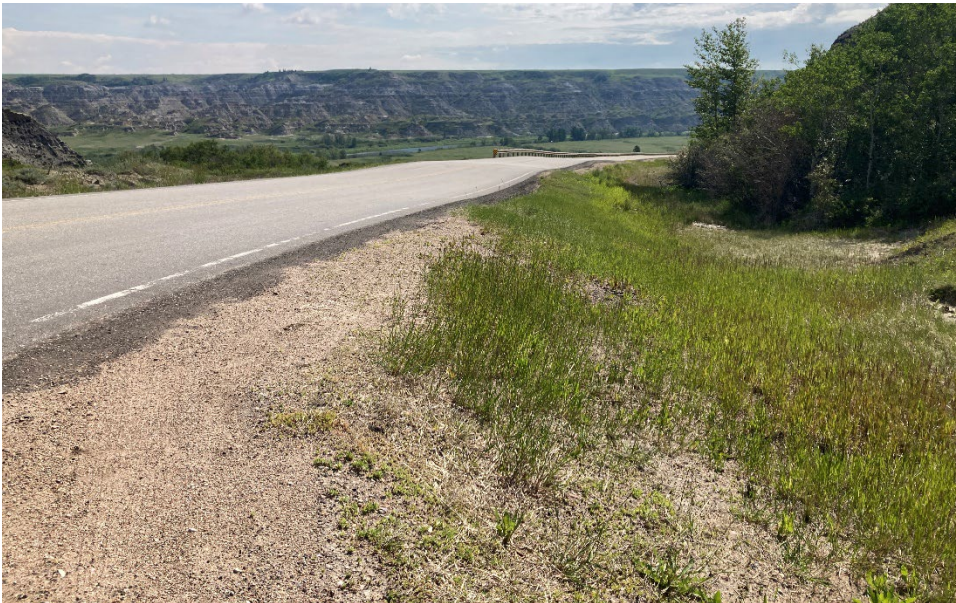
Photo 2 **A dip in the pavement is west (uphill) of the C065-1 site at the repair-existing highway contact. Photo taken June 19, 2024, facing east.**

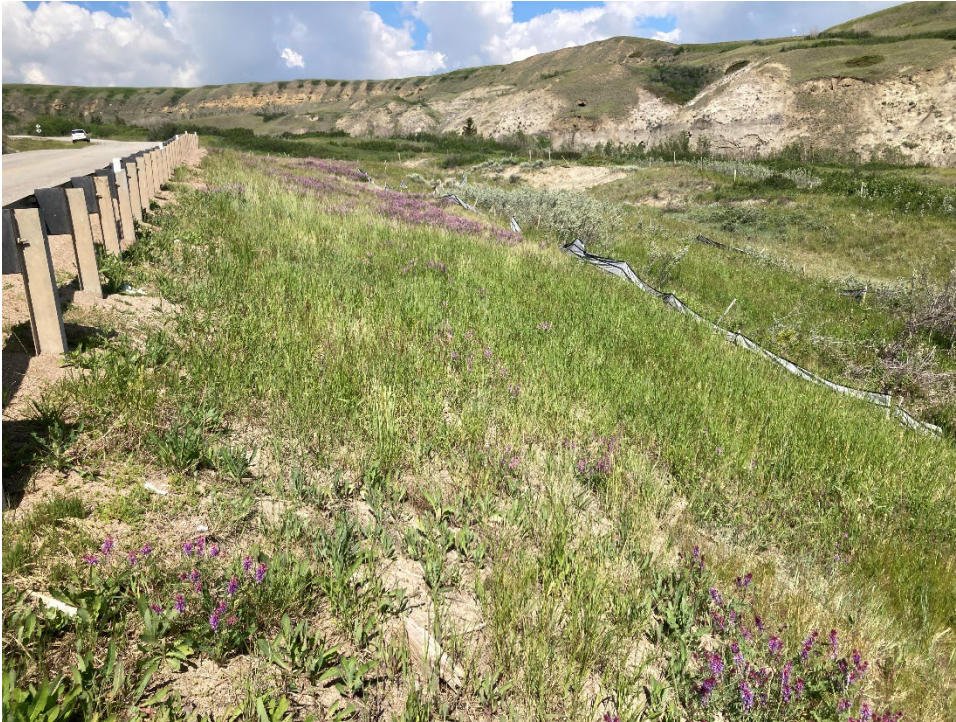
- The highway embankment slope is in good condition and is relatively well vegetated for sites within the Red Deer River valley (Photo 3).
- The drain outlet at the toe of the slope is in good condition (Photo 4). Although no flow was observed during the inspection, there was evidence that the drain is flowing (i.e., ponded water and wet ground at and downstream of the drain outlet, respectively).

Photo 3 The slope at the highway embankment repair is in good condition and relatively well vegetated. Photo taken June 19, 2024, facing northwest.

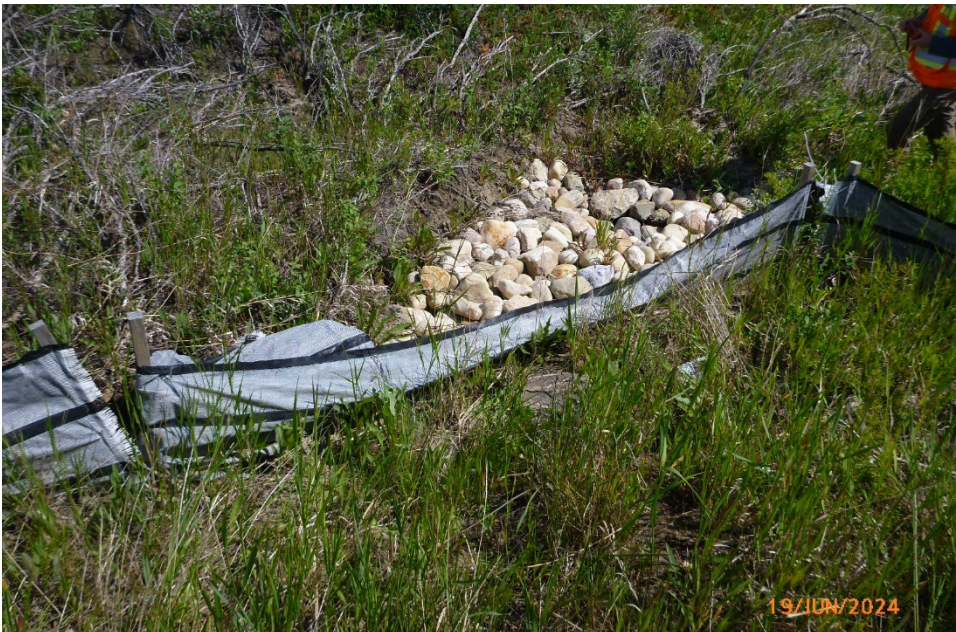
Photo 4 The drain outlet is in good condition. No flow was observed, but there was evidence of recent flow observed at and downstream of the drain outlet. Photo taken June 19, 2024, facing northeast.

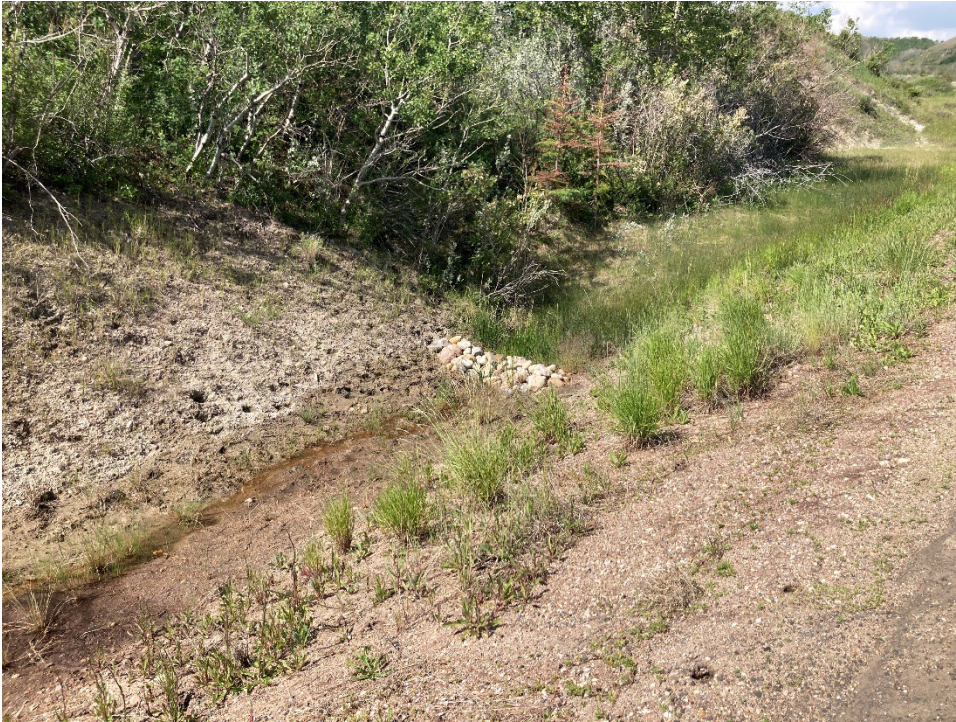
- Minimal flow was observed from an existing spring located in the upslope (south) ditch near the west extent of the repair (Photo 5).
- There is ongoing ditch erosion downhill (east) of the C065-1 site (Photo 6). The degree of erosion appears similar as during the August 2022 warranty inspection.

Photo 5 Minor flow was observed at a spring located in the south (eastbound) ditch.
Photo taken June 19, 2024, facing west.

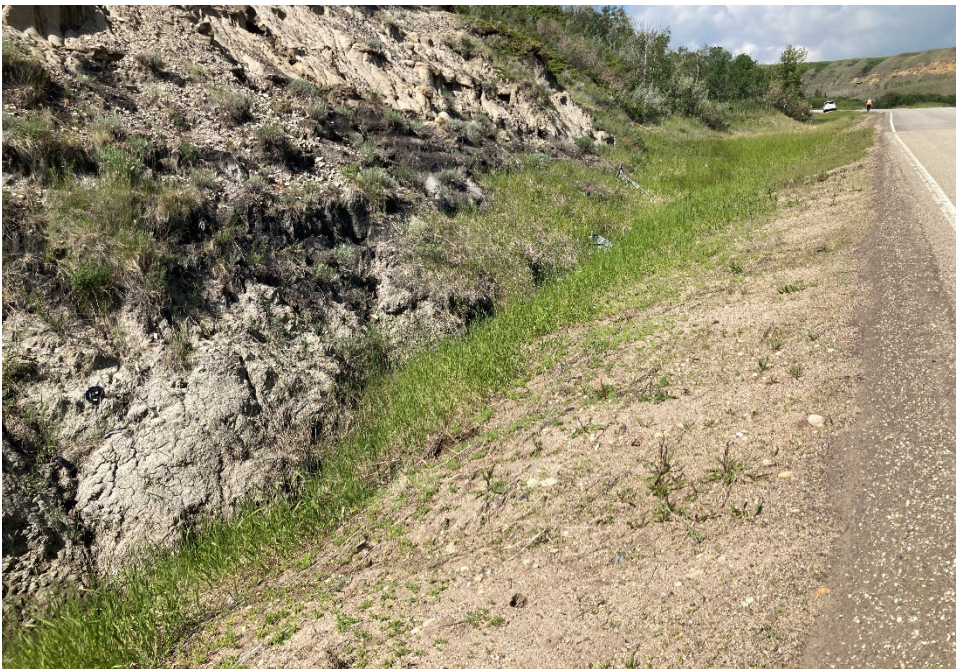
Photo 6 There is ongoing ditch erosion in the south (eastbound) ditch east of the C065-1
subsite (east of the 2021 repair). Photo taken June 19, 2024, facing west.

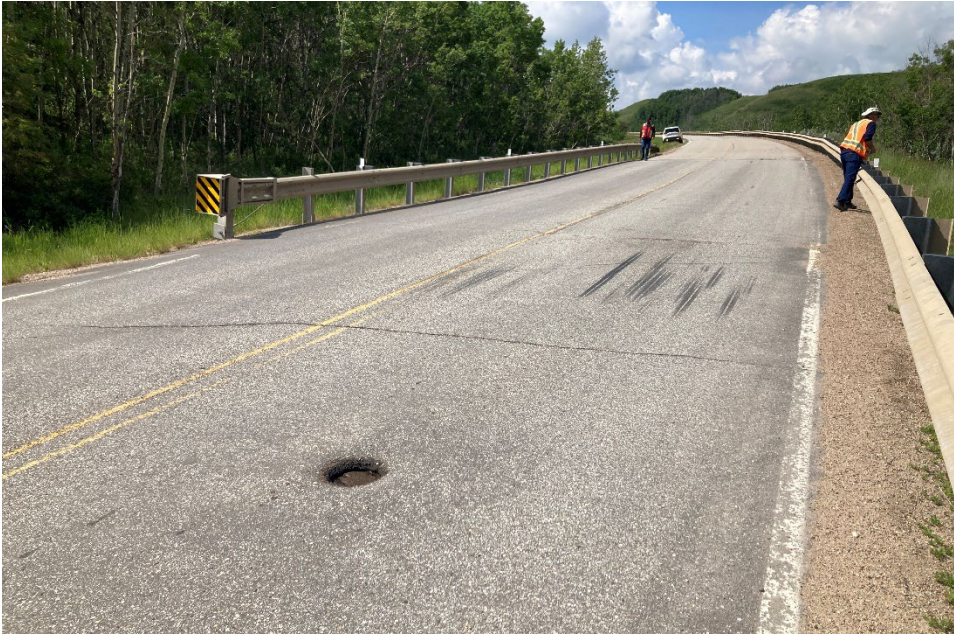
- The pavement surface above the slide appears to be in similar condition as during the August 2022 warranty inspection (Photo 7).
- The highway embankment slope upslope and east of the riprap-lined channel is well vegetated and appears to be in good condition (Photo 8).
- The culvert outlet and riprap-lined channel appears to be in good condition (Photo 9).
- The gabion basket inlet structure appears to be in good condition (Photo 10).
- There guardrail impact attenuator for the south guardrail is damaged (Photo 11). KCB suspects the guardrail was likely damaged during snow clearing activities.

Photo 7 Pavement surface at the C065-3 site is in fair condition. Headbox containing two piezometers and one slope inclinometer is in good condition but is covered by a thin layer of sand and gravel. Photo taken June 19, 2024, facing west.

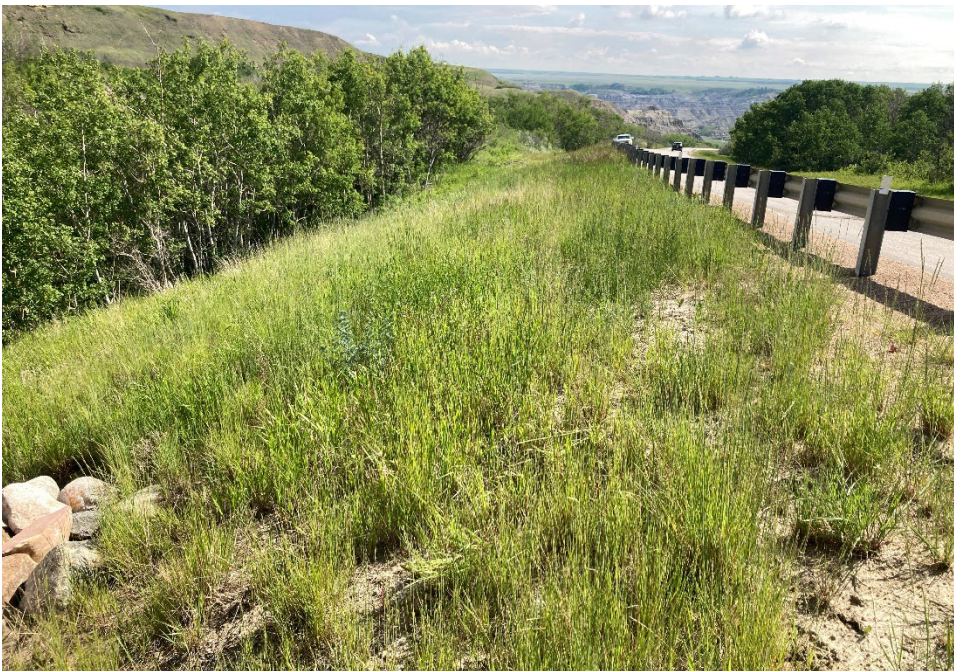
Photo 8 Slope upslope and east of the 1 m diameter CSP culvert and riprap lined outlet channel is in good condition. Photo taken June 19, 2024, facing east.

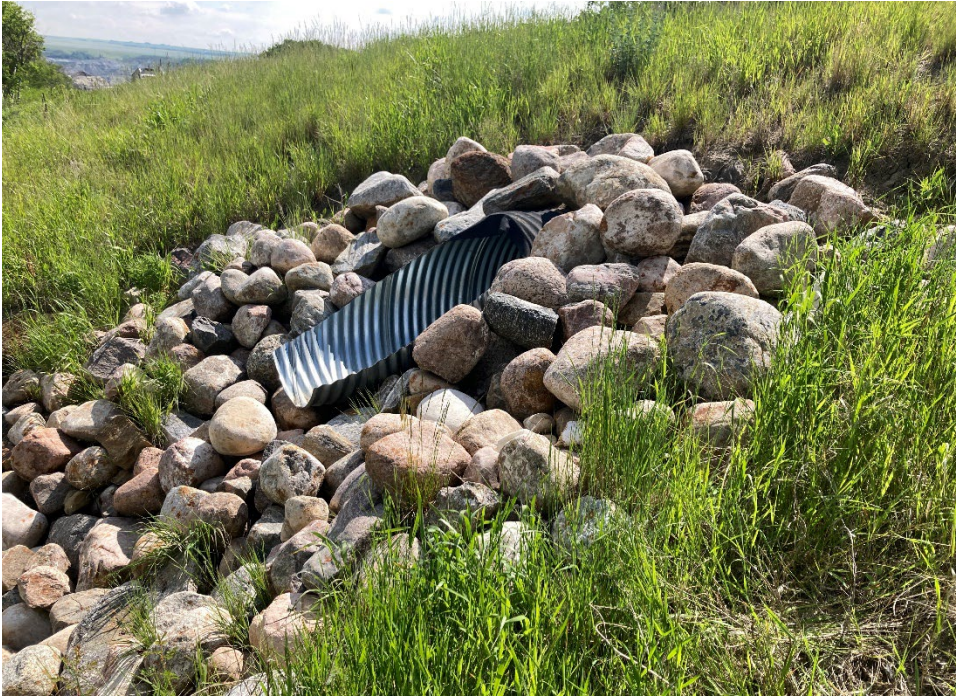
Photo 9 The riprap lined outlet channel downstream of the 1 m diameter CSP culvert appears to be in good condition. Photo taken June 19, 2024, facing east.

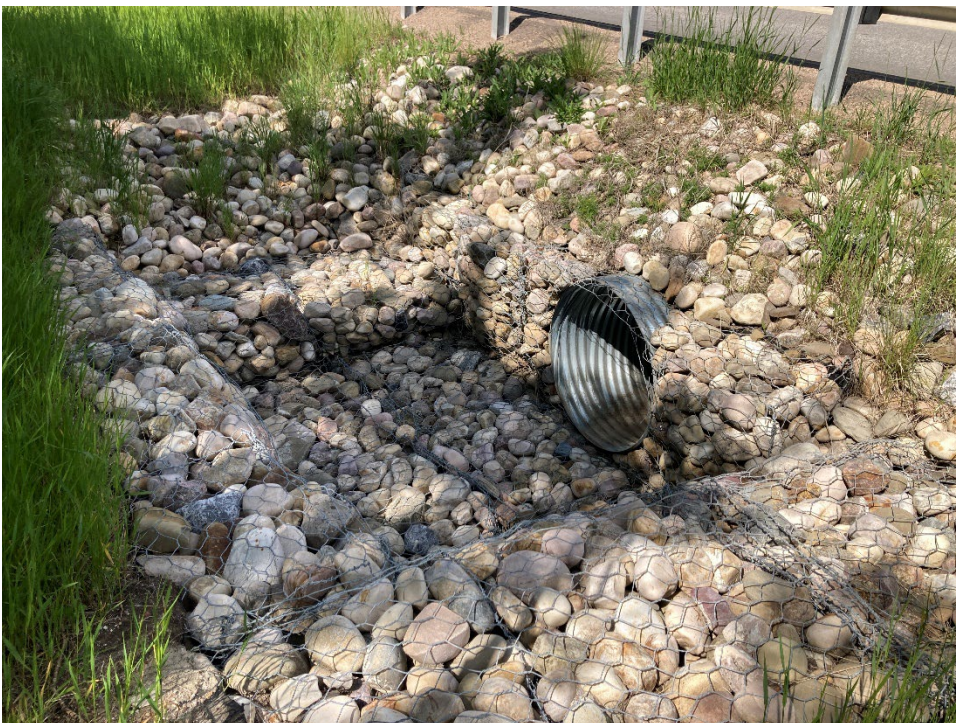
Photo 10 Gabion basket inlet structure appears to be in good condition. Photo taken June 19, 2024, facing northwest.

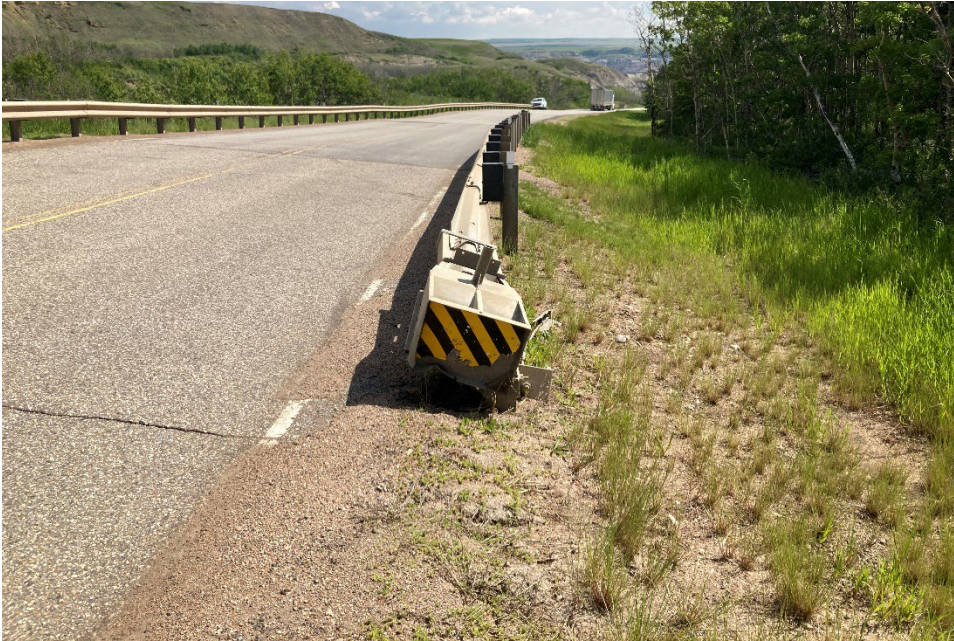
Photo 11 Impact attenuator for the south (eastbound) guardrail is damaged and was likely damaged during snow clearing activities. Photo taken June 19, 2024, facing east.

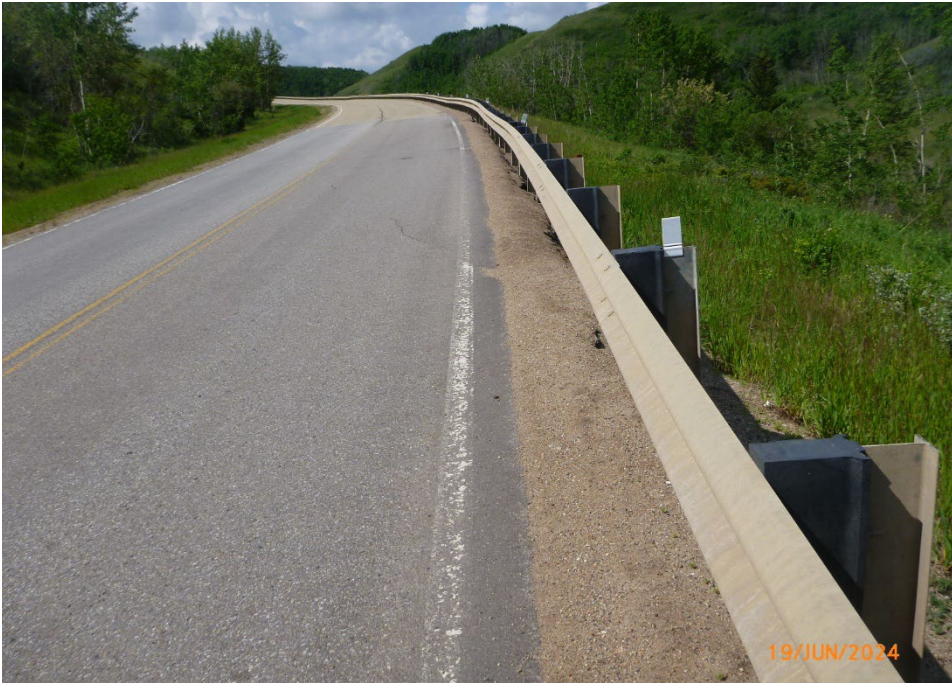
- The pavement surface above the slide appears to be in similar condition as the last inspection (Photo 12). The pavement cracking and settlement is isolated to the north (westbound) lane and does not appear to have expanded laterally.
- There is minor settlement above the 2021 H-pile wall where backfill material has settled between the piles (Photo 14).

Photo 12 Pavement patch above the C065-4 slide appears in similar condition as during previous inspections. Photo taken June 19, 2024, facing west.

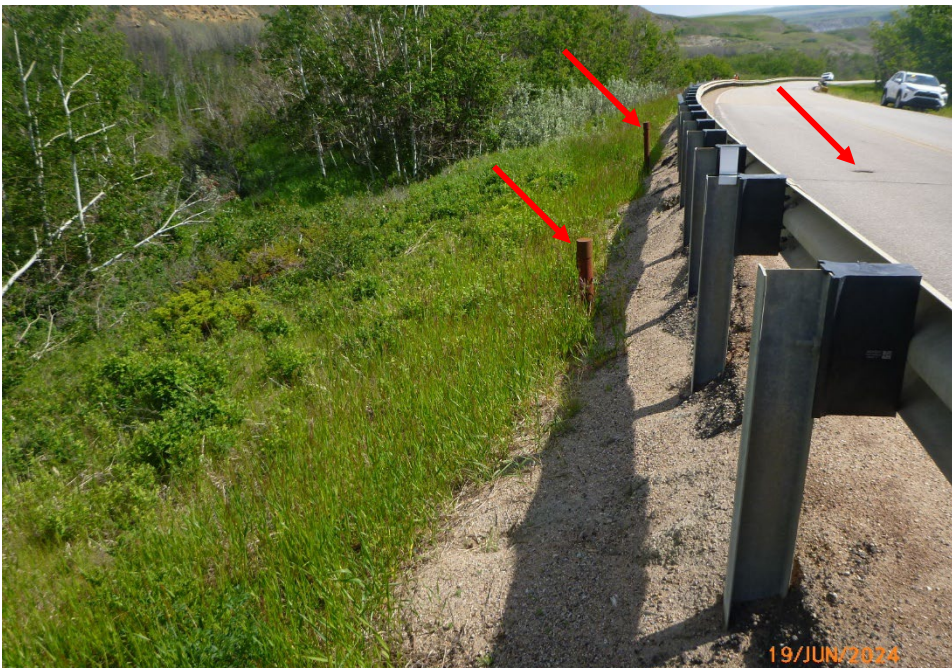
Photo 13 The three slope inclinometers (2017 and 2021) installed at the C065-4 site. Locations indicated by red arrows. Photo taken June 19, 2024, facing east.

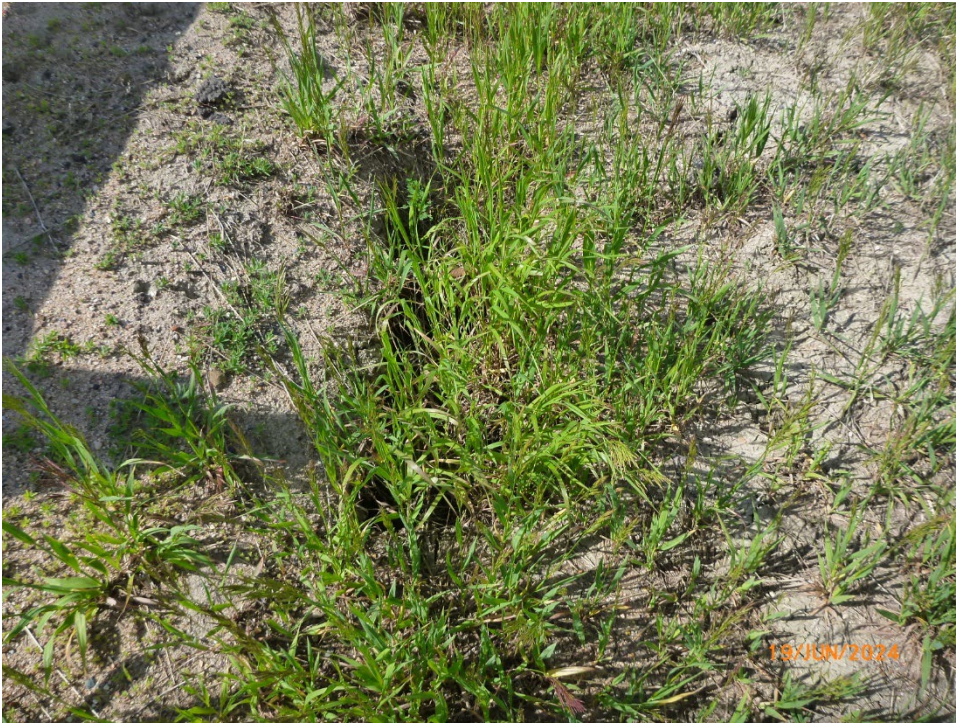
Photo 14 **Settlement of fill above the 2021 H-pile wall. Photo taken June 19, 2024, facing west.**

- The inspection frequency should be reduced from annually to once per contract as part of the Central Region Section B Inspections. The site should continue to be read in the spring and fall as part of the Section C Instrumentation Monitoring program.
- The following should be completed by TEC's Highway Maintenance Contractor (HMC):
 - The impact attenuator at the C065-3 site should be repaired.
 - Speed reduction and grooved pavement ahead signs on either side of the site should be removed.
 - The settlement/voids above the H-pile walls should be backfilled with sand and gravel.
