Alberta Transportation and Economic Corridors  
4<sup>th</sup> Floor, Provincial Building  
4920 – 51<sup>st</sup> Street  
Red Deer, Alberta  
T4N 6K8

**CON0022160 Central Region GRMP Instrumentation Monitoring  
Site C065; H585:02, km 16.136 East of Trochu Slides  
Section C – 2024 Spring Readings**

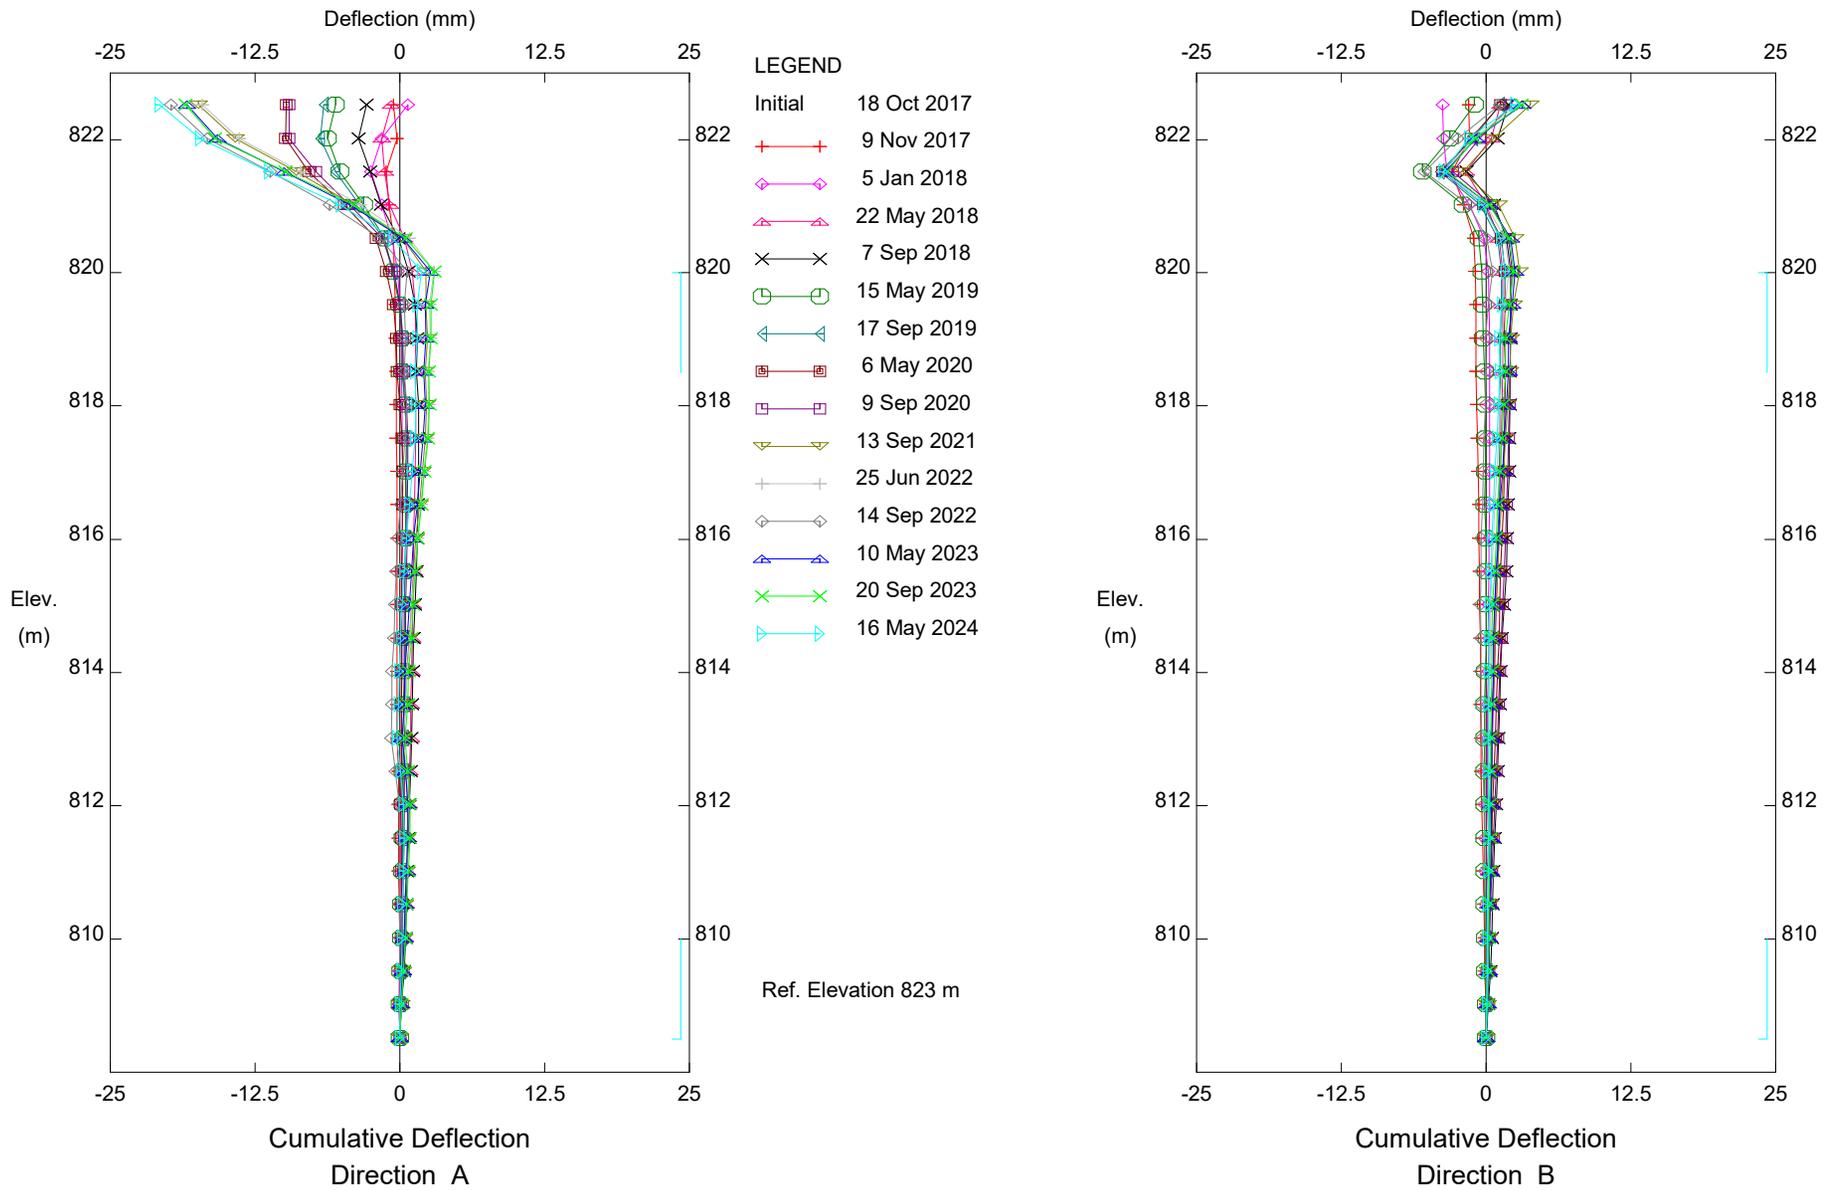
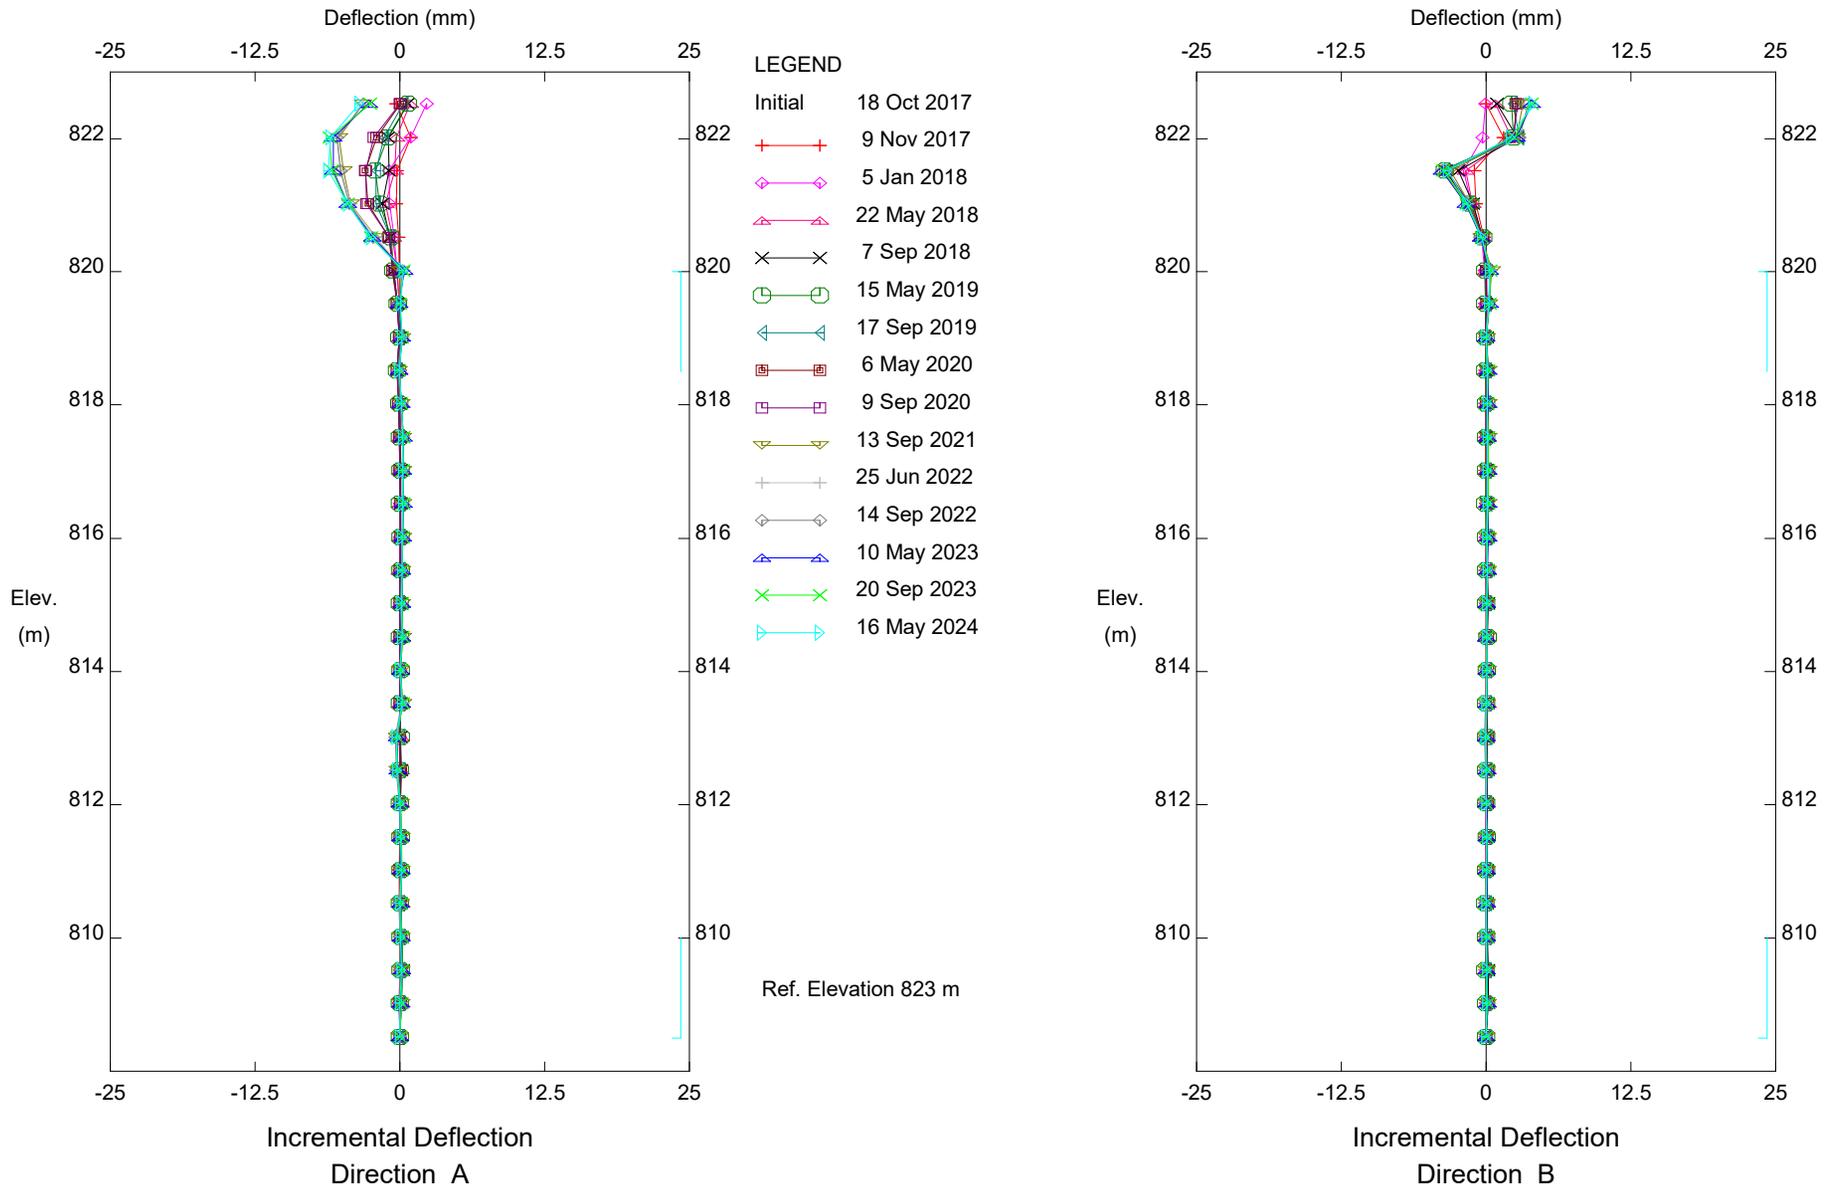
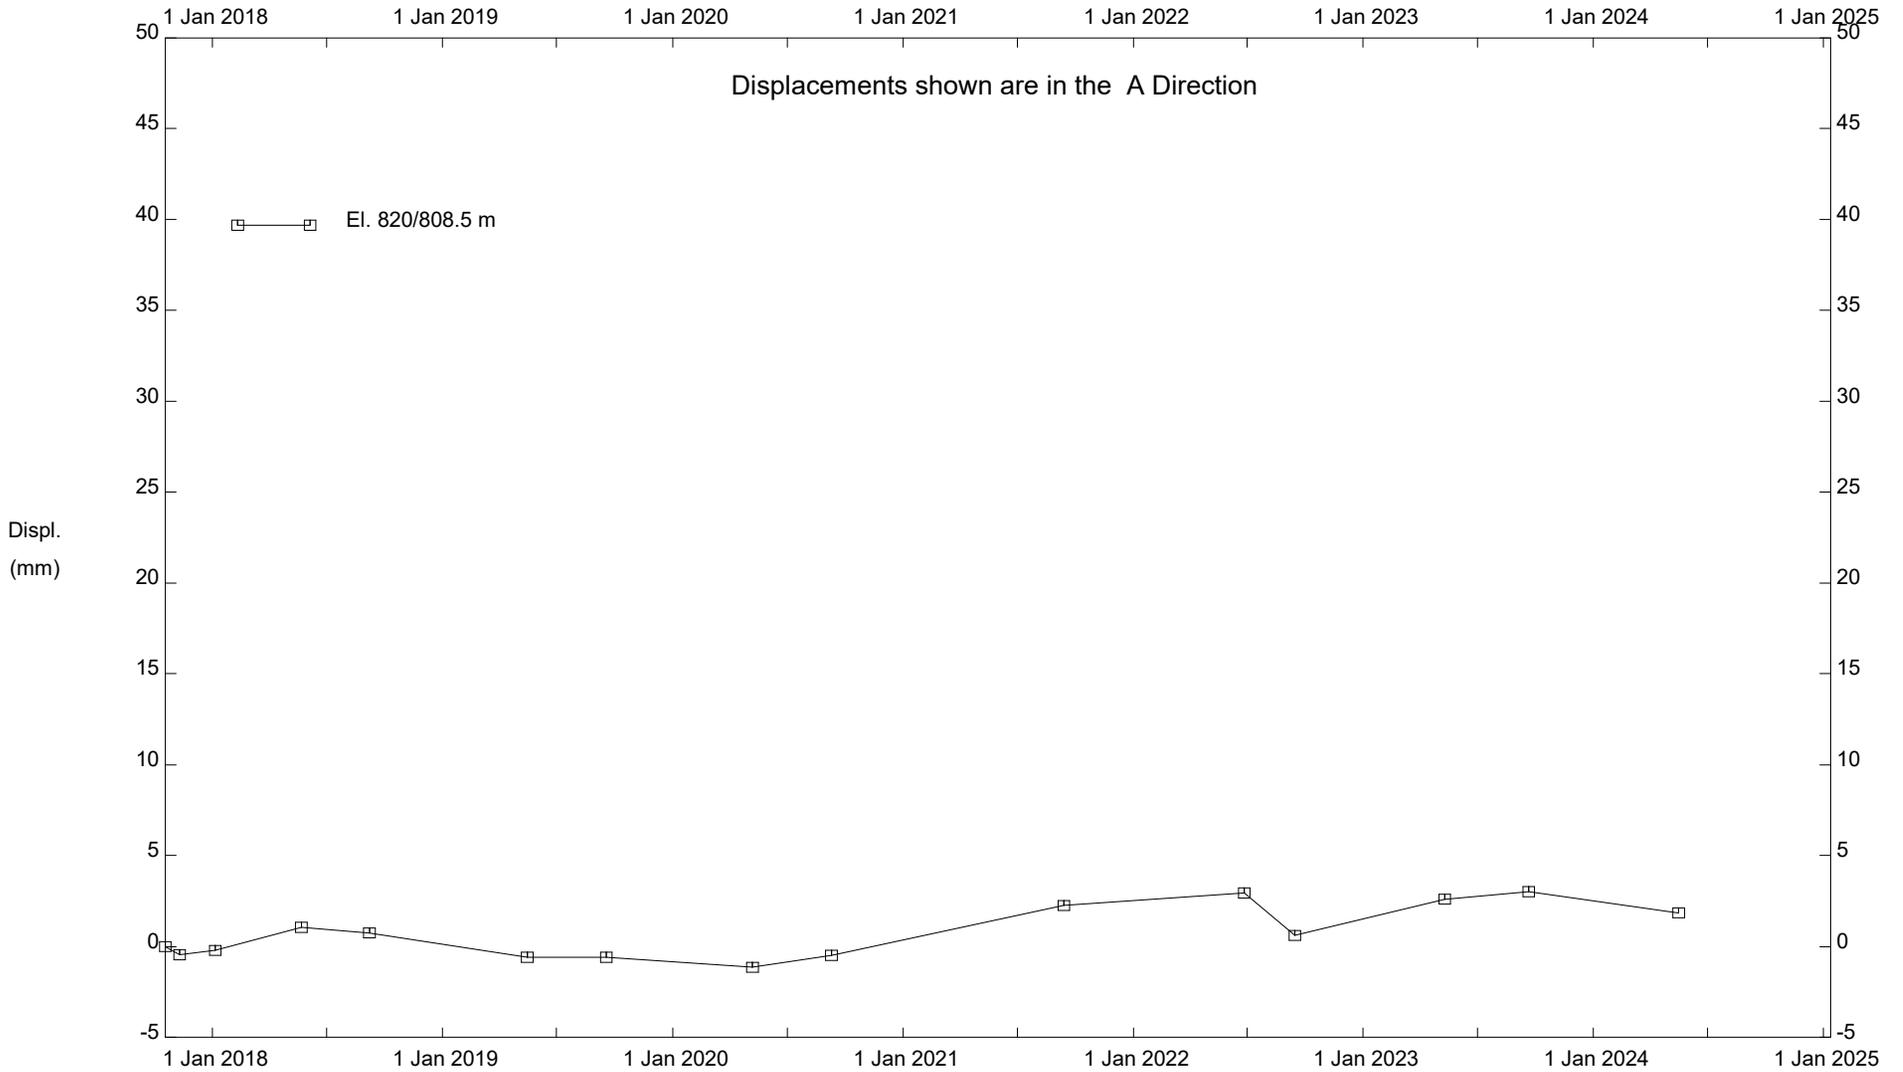
C065-IV; H585:02, East of Trochu, Inclinometer SI17-C65-01

No discernible movement has been recorded in SI17-C65-01 since installation, excluding shallow deflection in the upper 3 m of the instrument. No discernible movement has been recorded in SI21-C65-01.

No discernible movement has been recorded in SI17-C65-01 since installation, which indicates the slide is either inactive or moving at a very slow rate of movement (i.e., within the readings accuracy of the SI equipment).

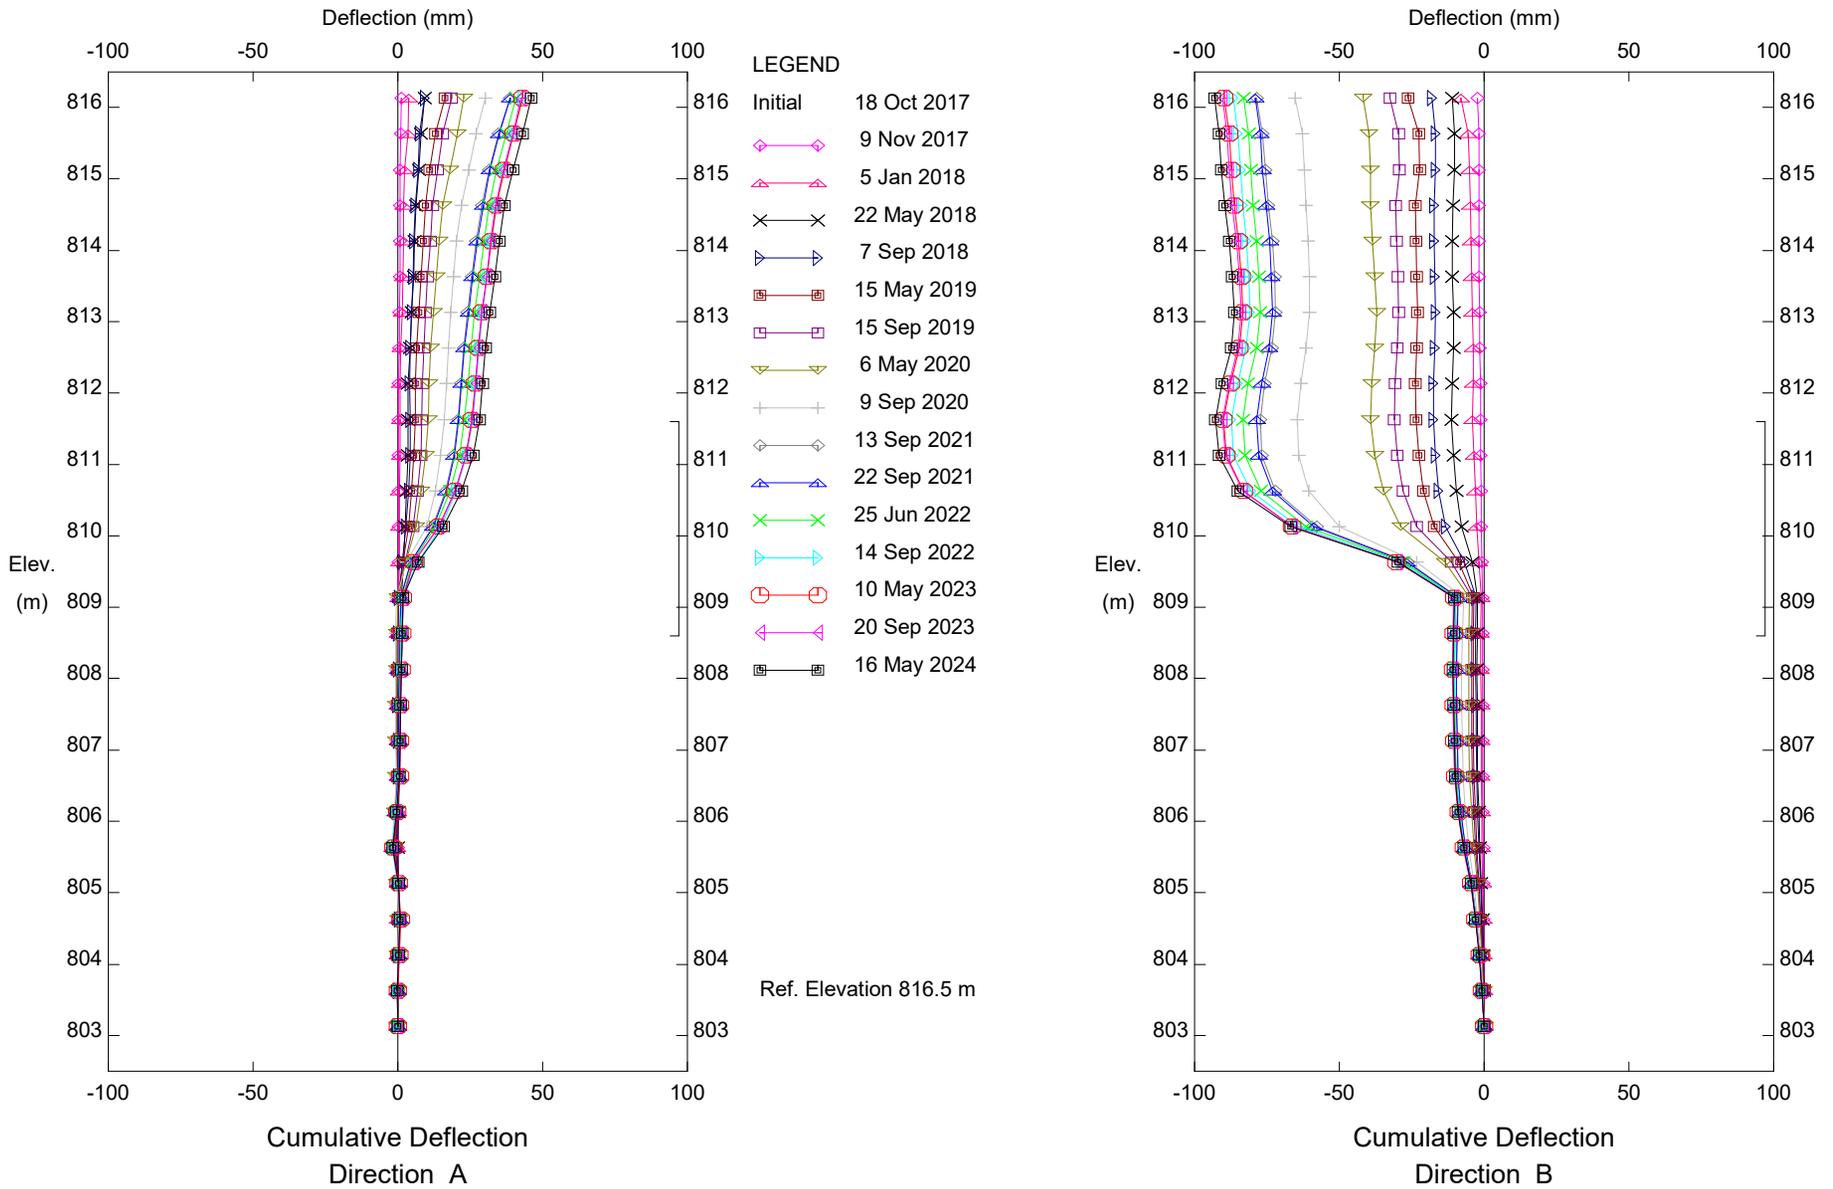
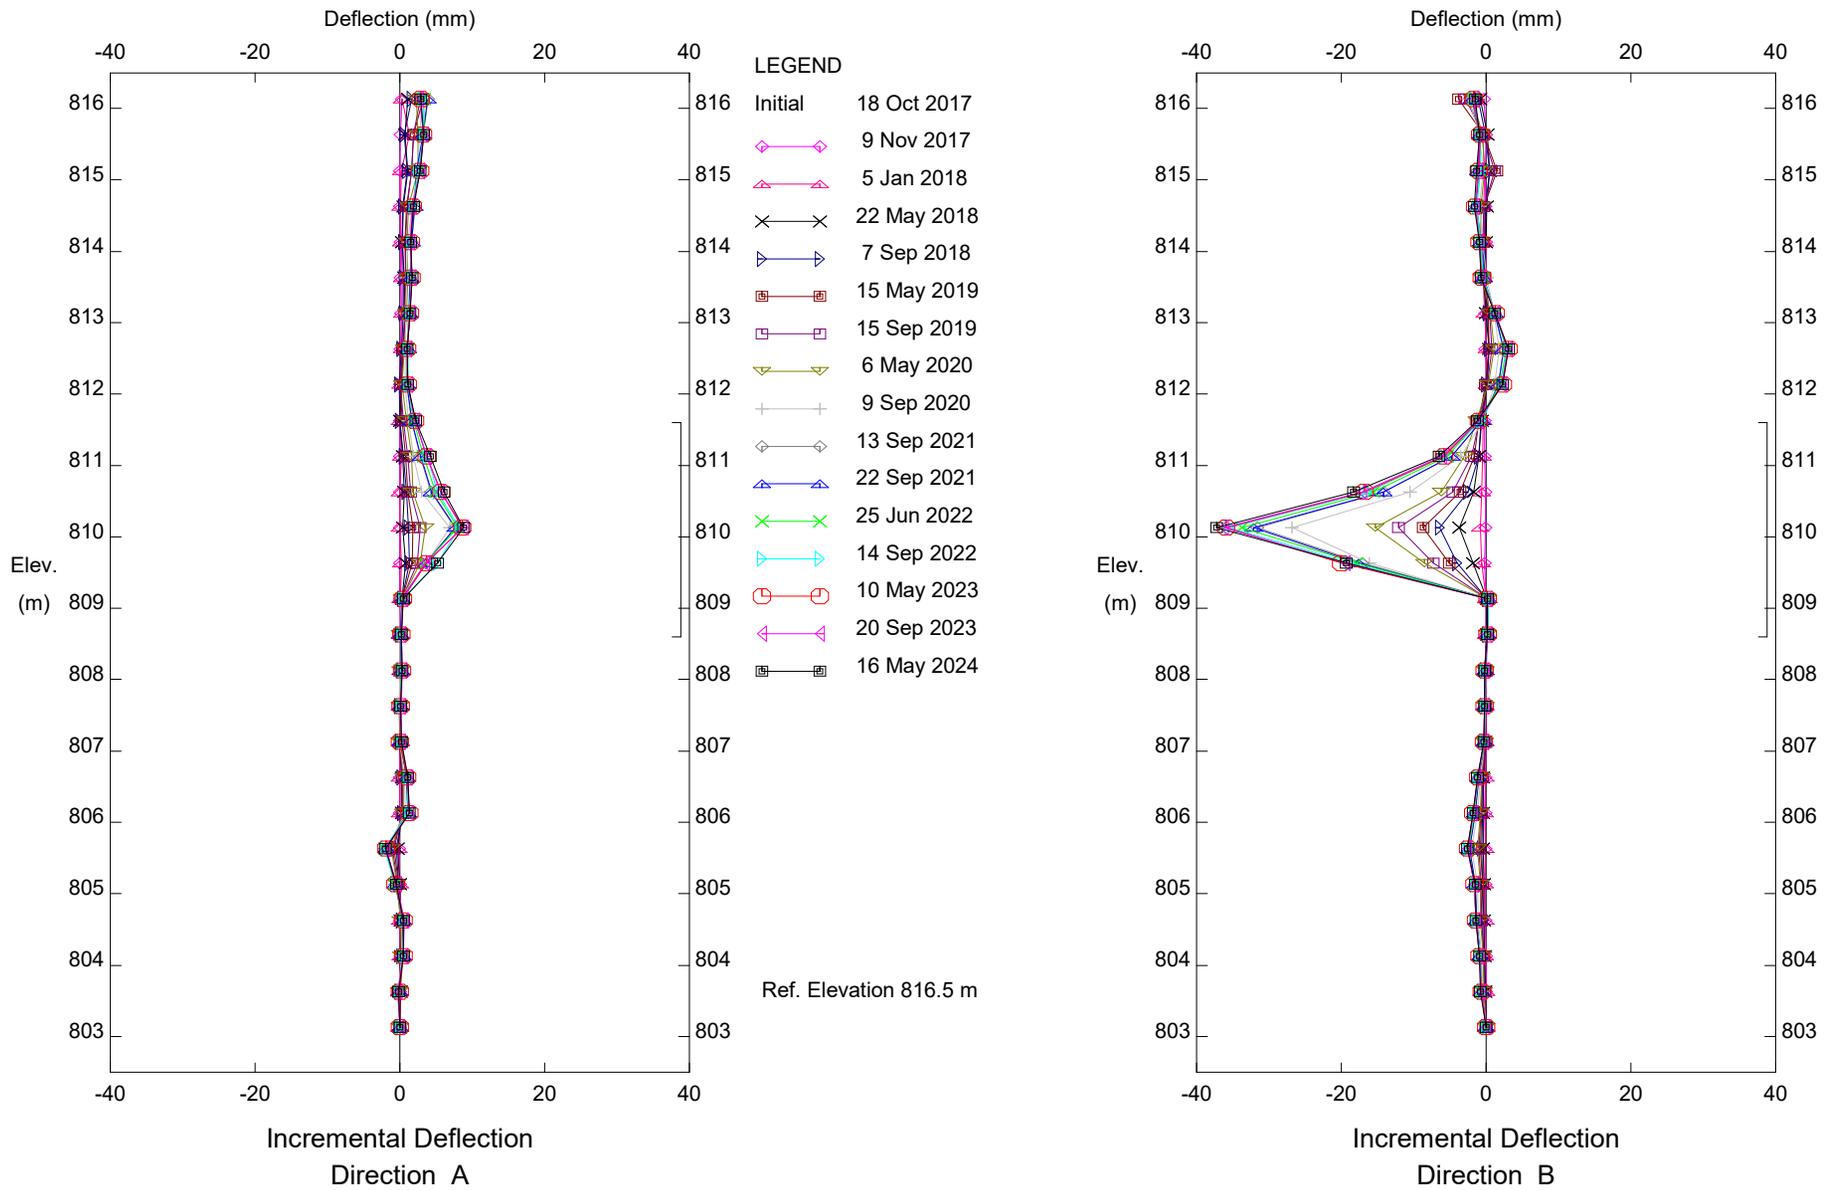
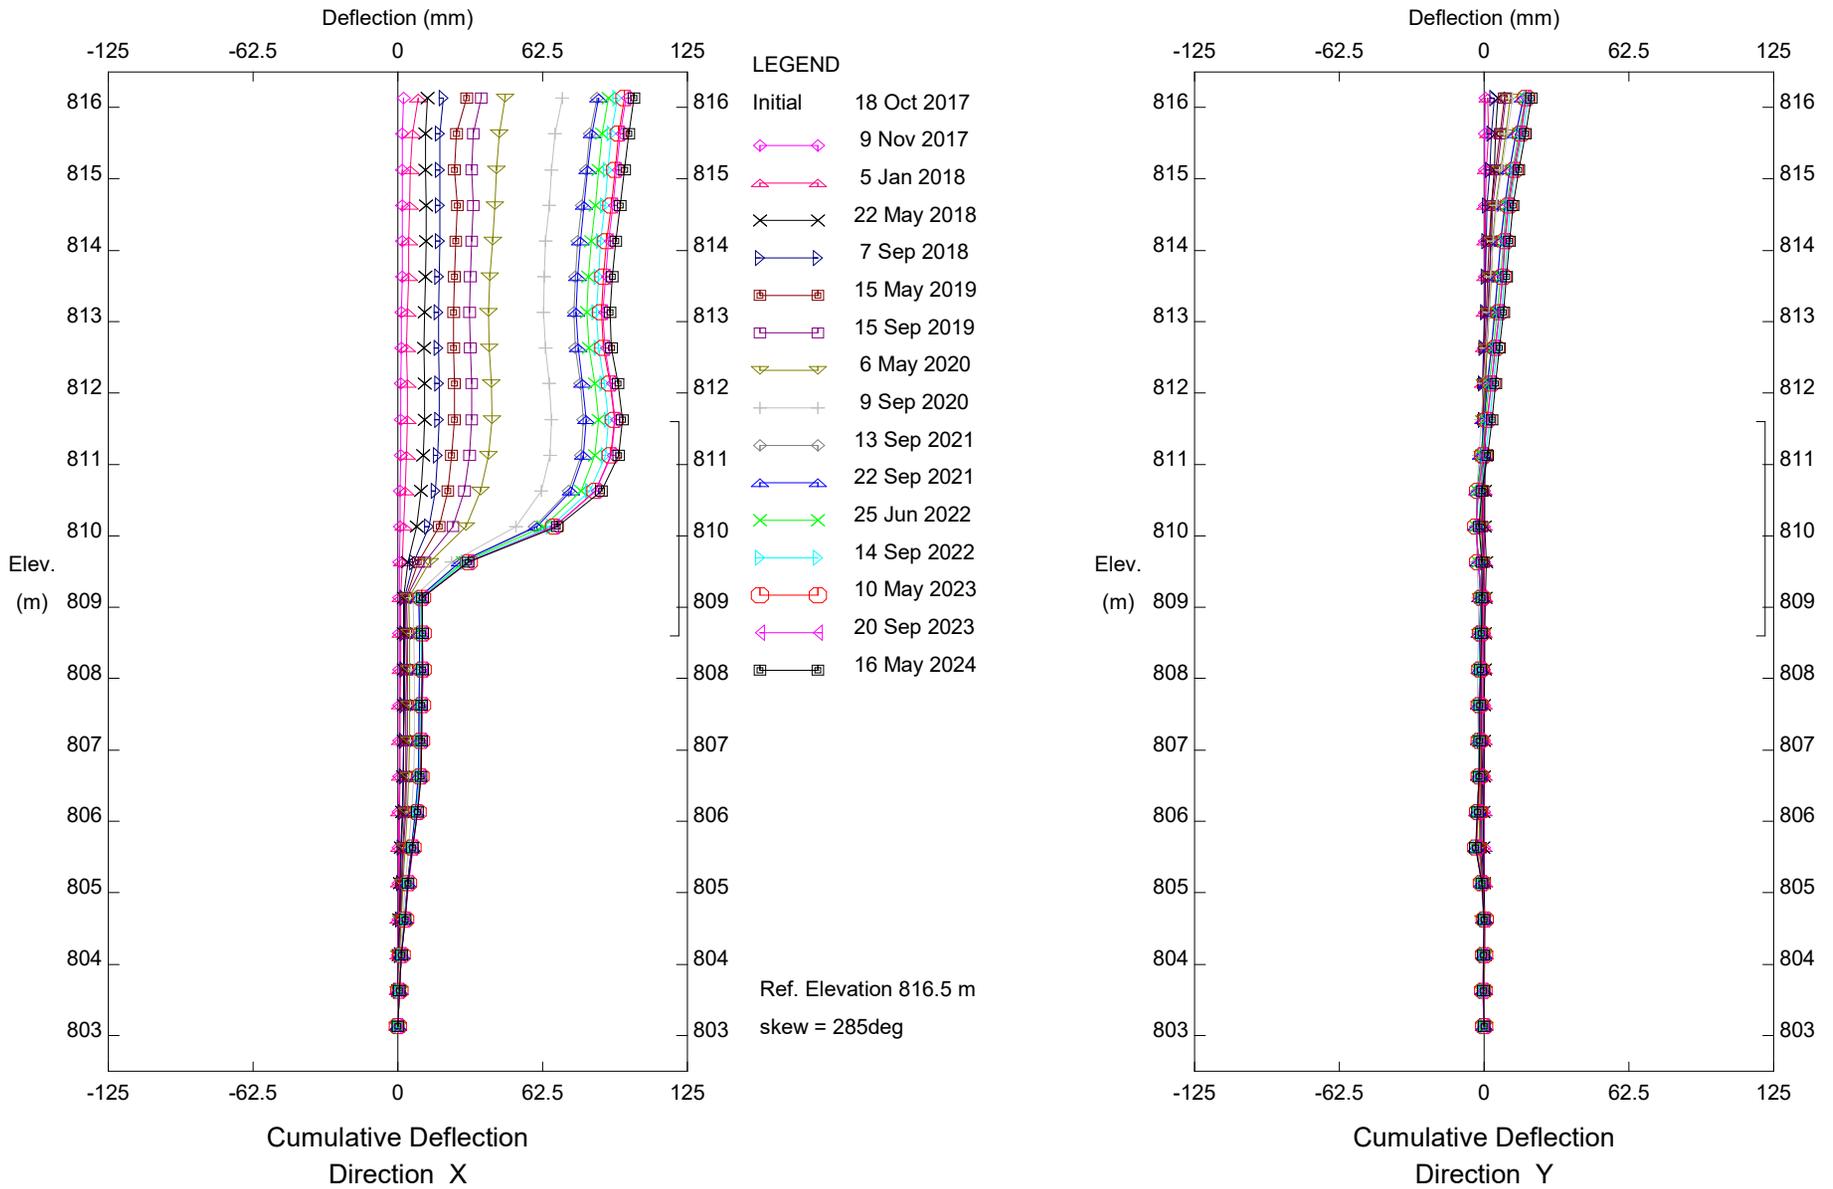
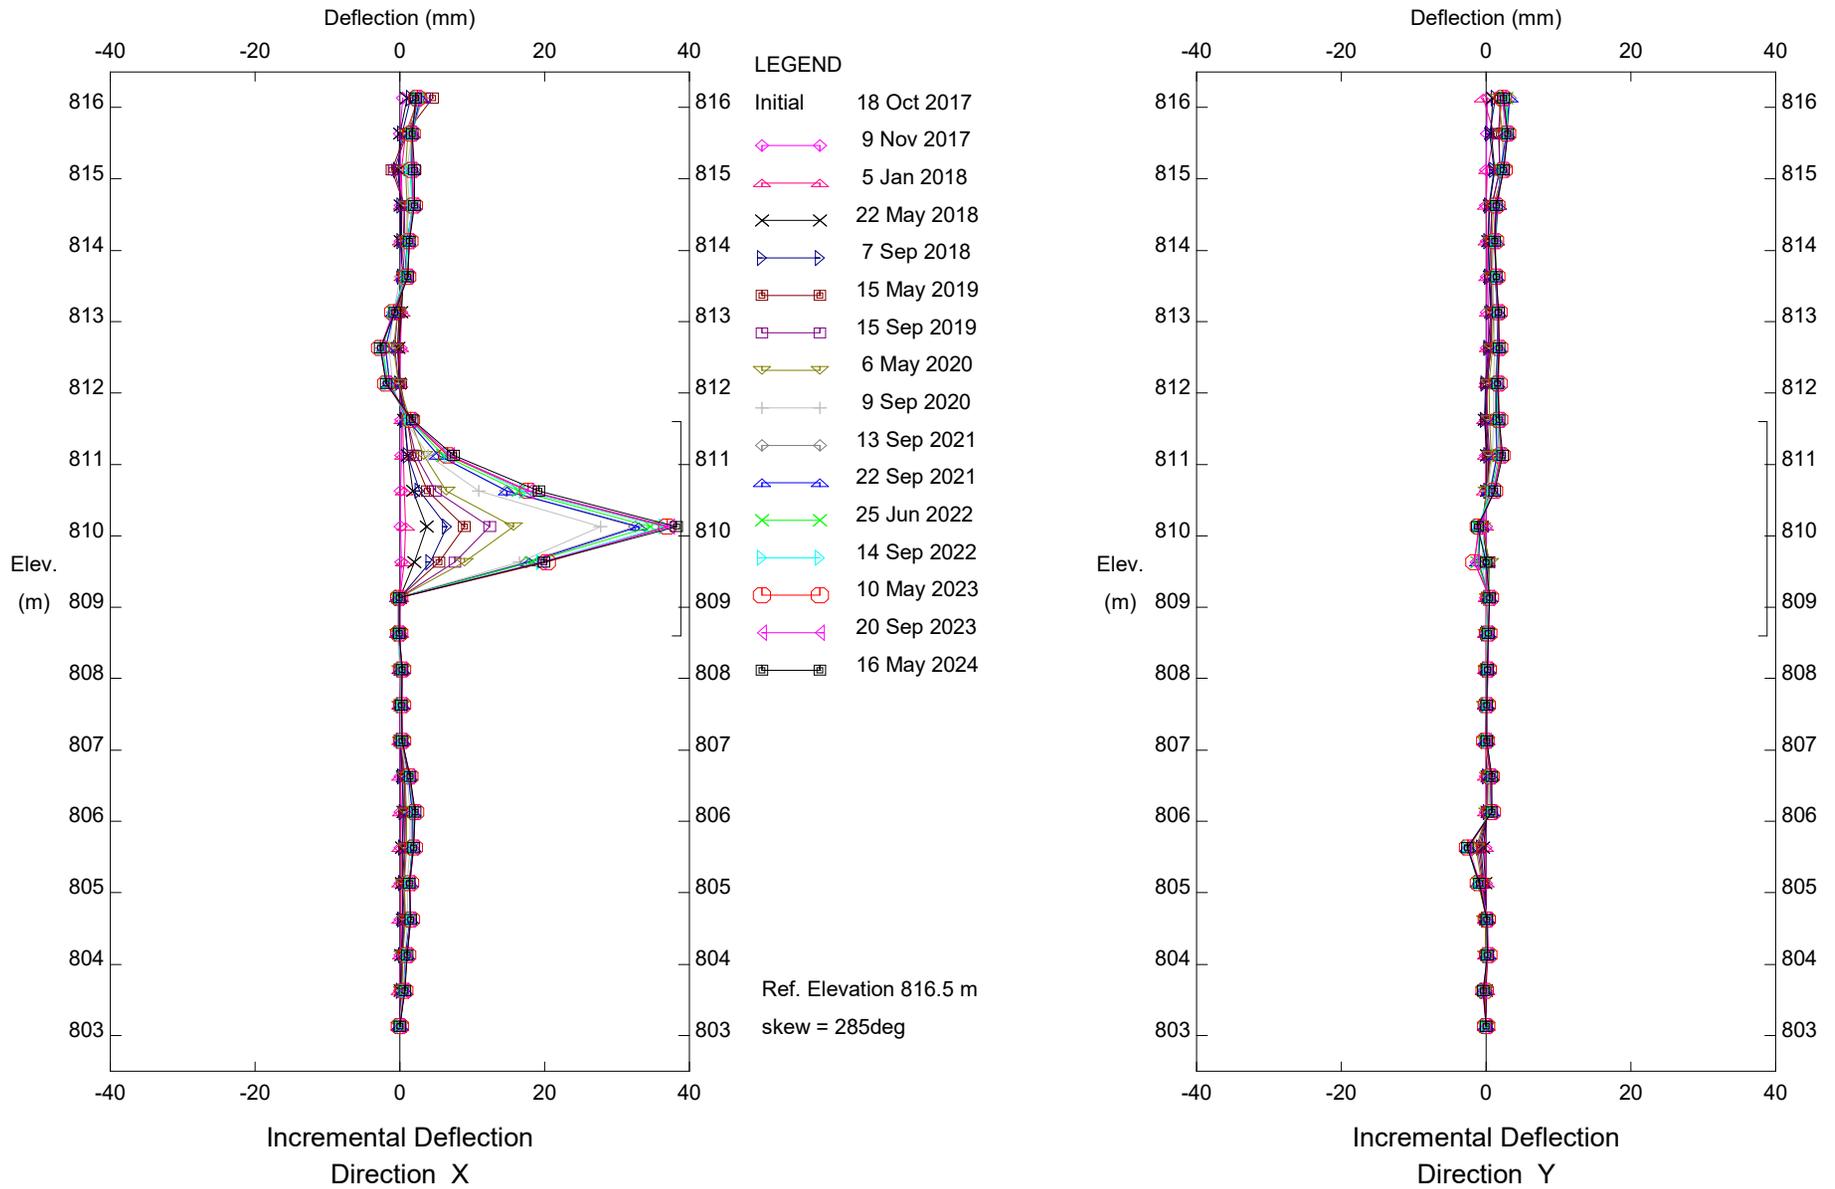
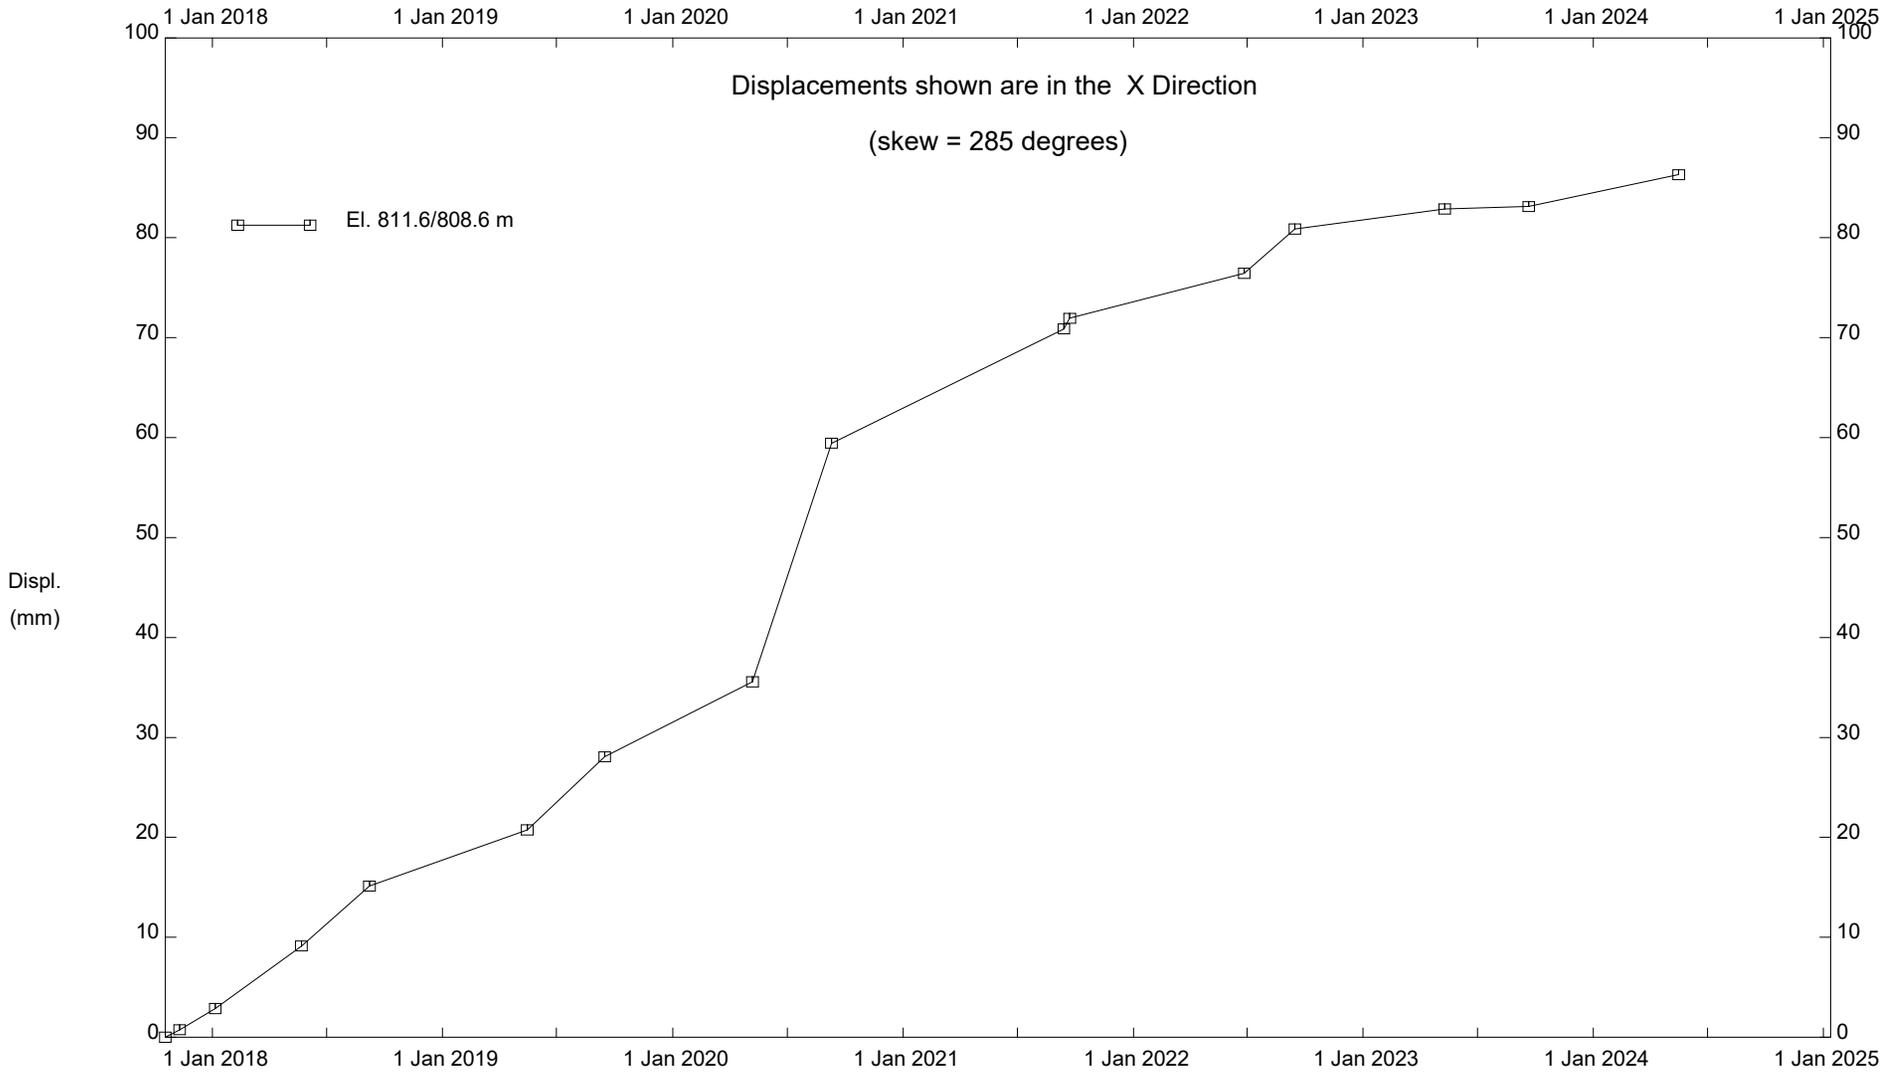
C065-III; H585:02, East of Trochu, Inclinometer SI17-C65-02

Discrete movement (i.e., movement occurring on a defined failure plane) is being recorded in SI17-C65-02 between an approximate depth of 5.0 m to 7.5 m below ground surface, at the interface between clay colluvium and bedrock. Since June 2021, a pinch has been felt in the SI casing at this depth when reading the instrument.

In September 2020 and 2021, an increased rate of movement (approximately 69 mm/year and 45 mm/year, respectively) was recorded in SI17-C65-02. The increase in 2020 was most likely attributed to wet weather, while the 2021 increase was likely due to construction activities at the C065 site (e.g., heavy truck traffic, increased traffic in the north (westbound) lane during south (eastbound) lane closures, and channel excavation at the C065-3 site).

Since 2021 construction, the rate of movement has decreased (excluding an increased rate of movement recorded in September 2022 of approximately 20 mm/year) and is currently less than approximately 5 mm/year. The increased rate of movement recorded in September 2022 was most likely attributed to wet weather in June and July 2022. Movement rates may increase, or additional displacements may occur in response to periods of heavy or prolonged rainfall, resulting in higher groundwater conditions.

Approximately 86 mm of movement has been recorded in SI17-C65-02 since installation. Since the spring of 2021, a zone of tightness (i.e., pinch) has been felt during readings of this instrument from approximately 5.0 m to 7.5 m below ground surface. This instrument may shear as overall displacement at this depth increases over time.

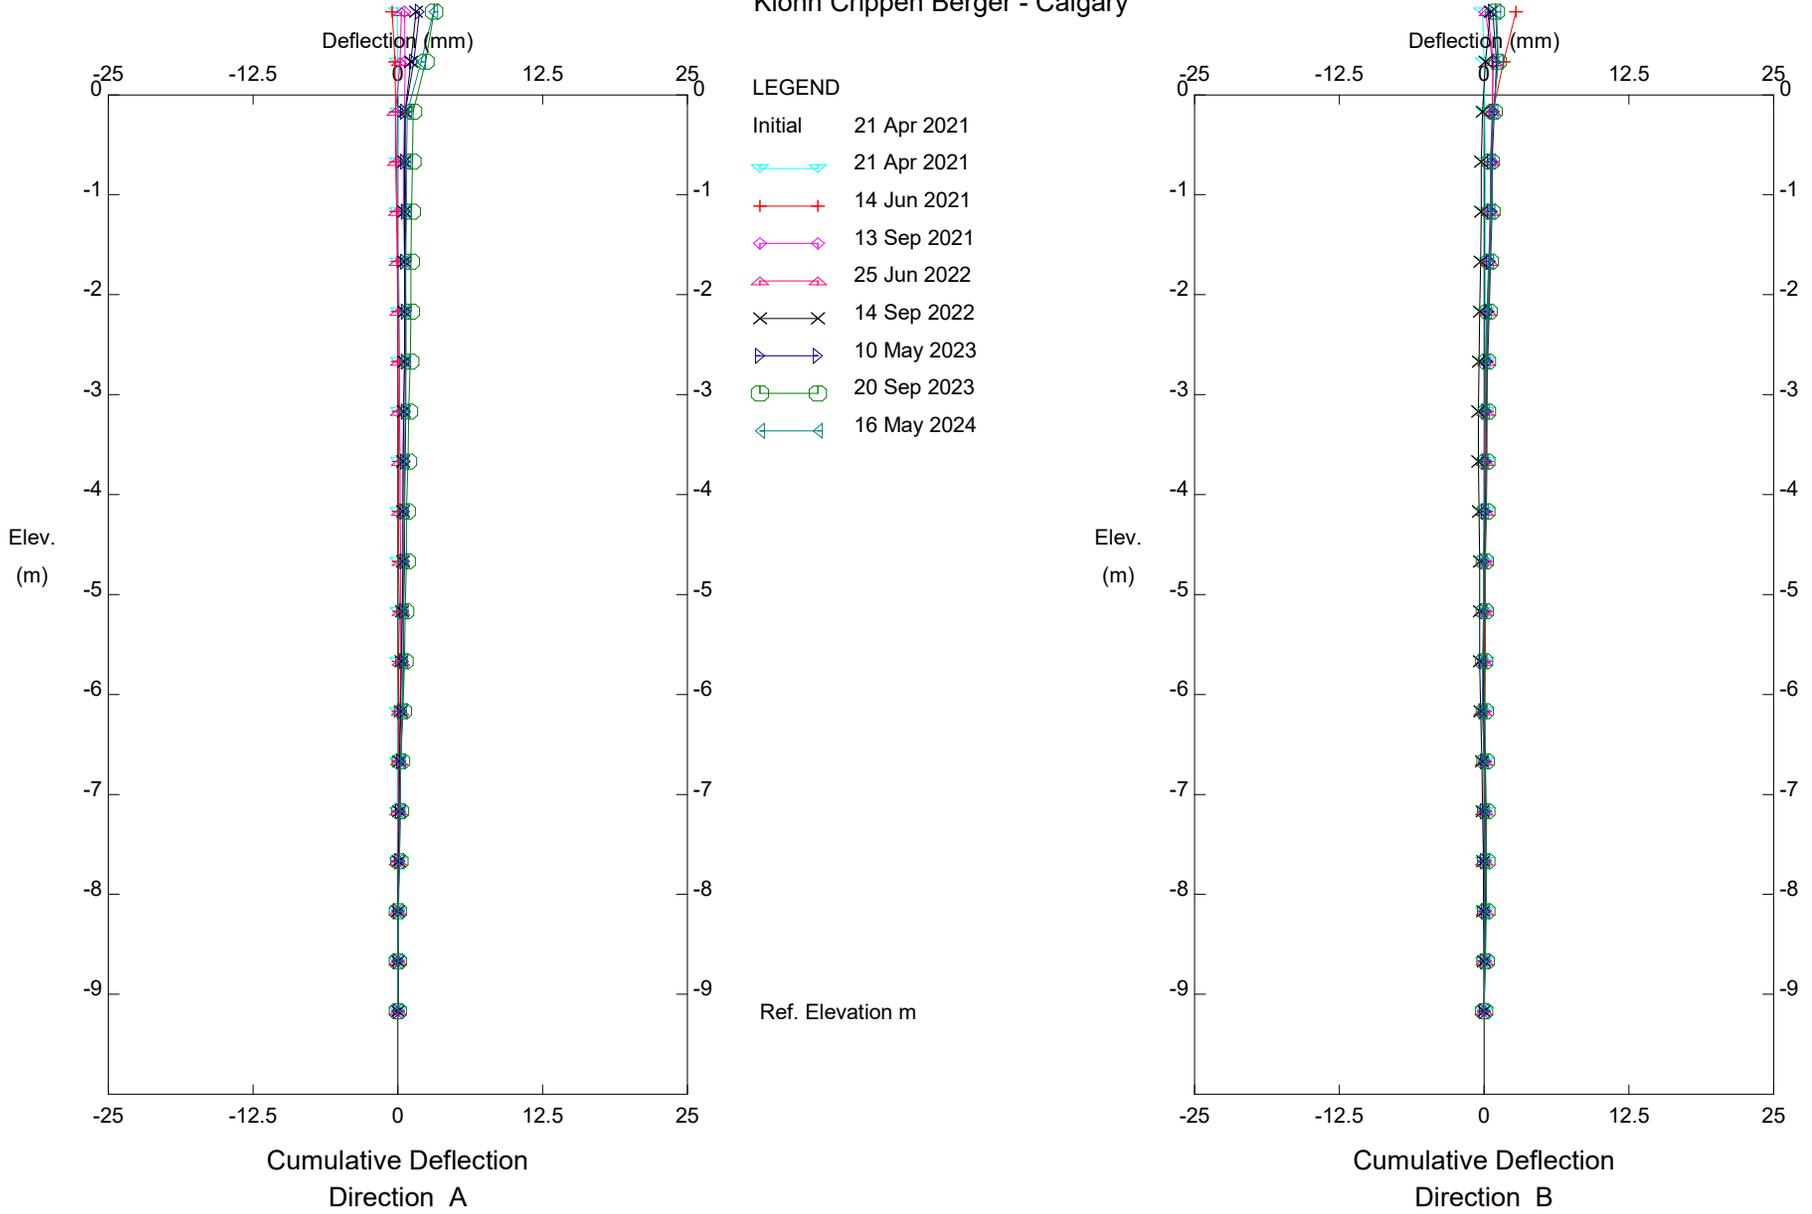
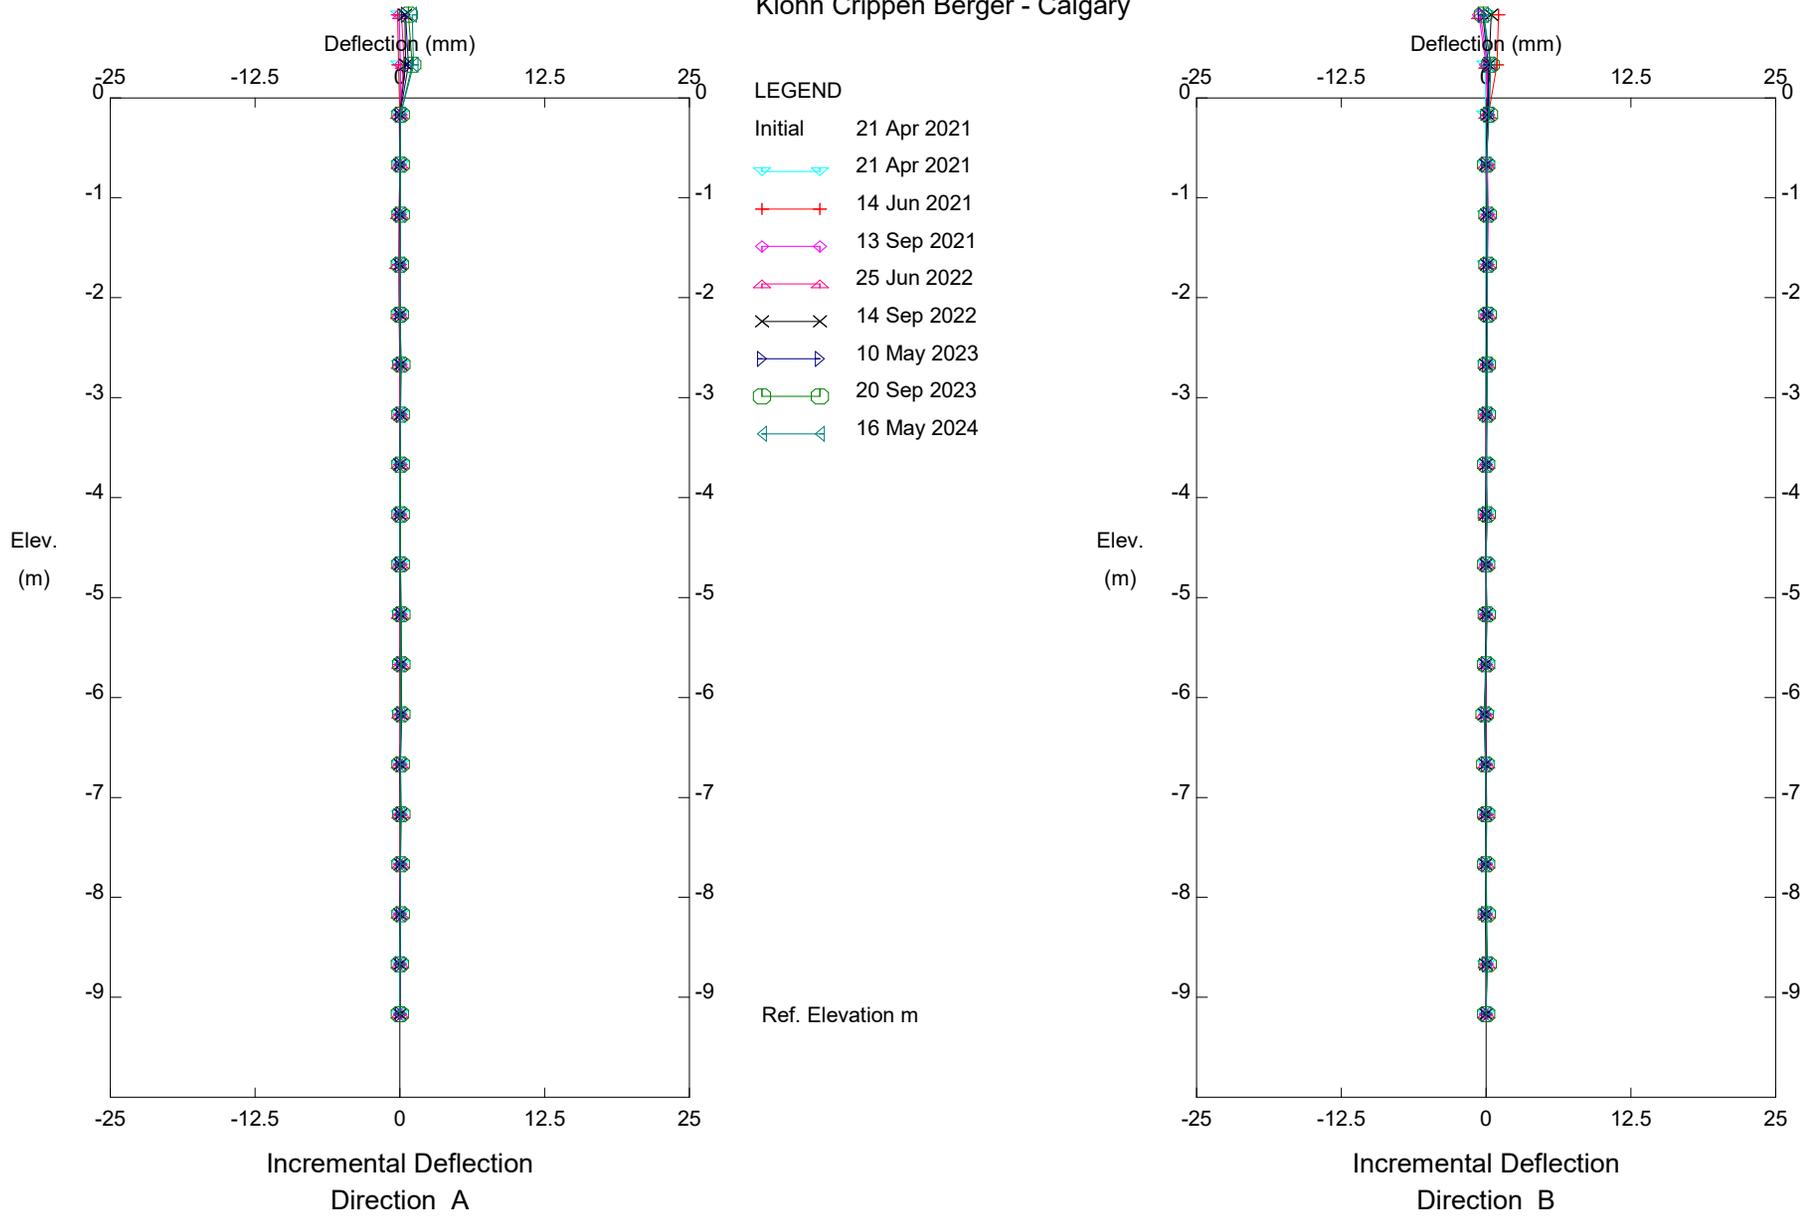
C065-IV; H585:02, East of Trochu, Inclinator SI21-C65-01  
 Alberta Transportation

No discernible movement has been recorded in SI21-C65-01, and distributed movement has been recorded in SI21-C65-02 from ground surface to near the base of the instrument. This indicates that the H-pile wall has intercepted the failure surface and is continuing to deflect, transferring load to depths below the failure plane as the piles stabilize the slide mass. As movement continues in the H-pile wall, it will be eventually reflected in SI21-C65-01.
