Alberta Transportation and Economic Corridors  
4<sup>th</sup> Floor, Provincial Building  
4920 – 51<sup>st</sup> Street  
Red Deer, Alberta  
T4N 6K8

**CON0022160 Central Region GRMP Instrumentation Monitoring  
Site C065; H585:02, km 16.136 East of Trochu Slides  
Section C – 2024 Spring Readings**

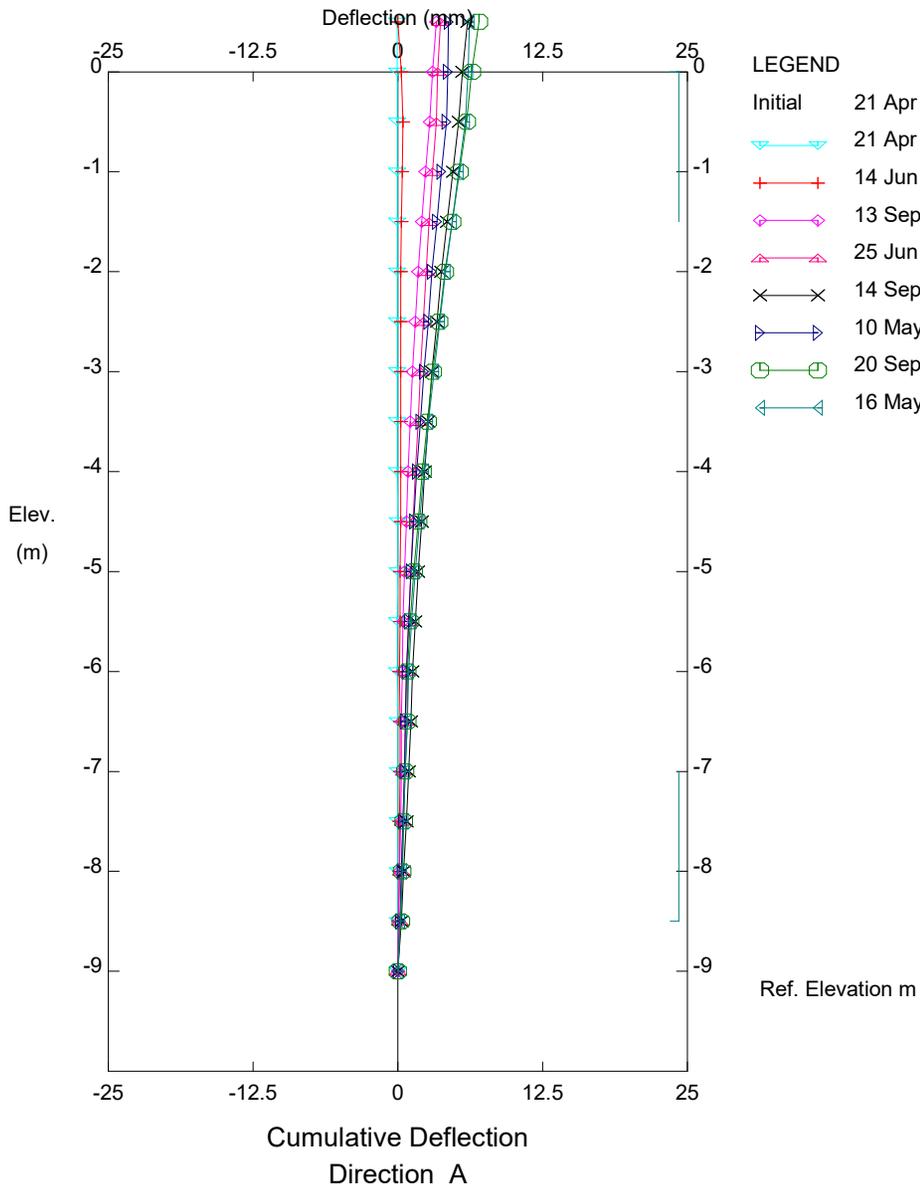
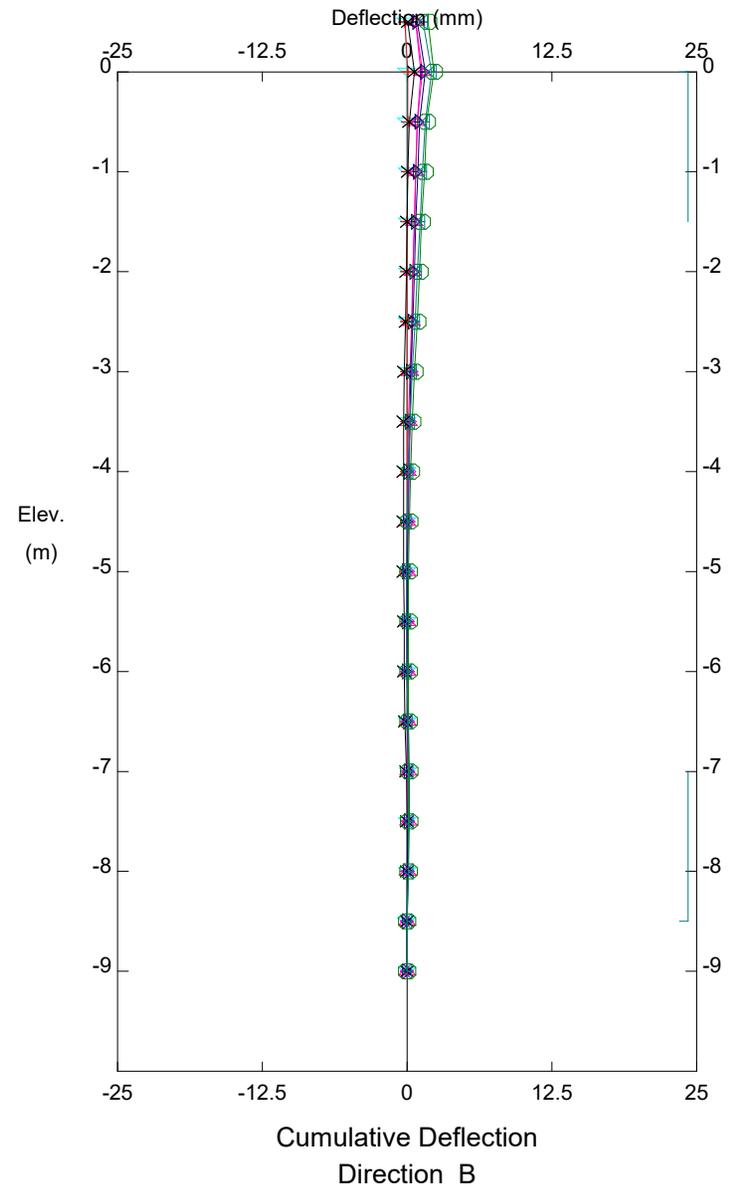
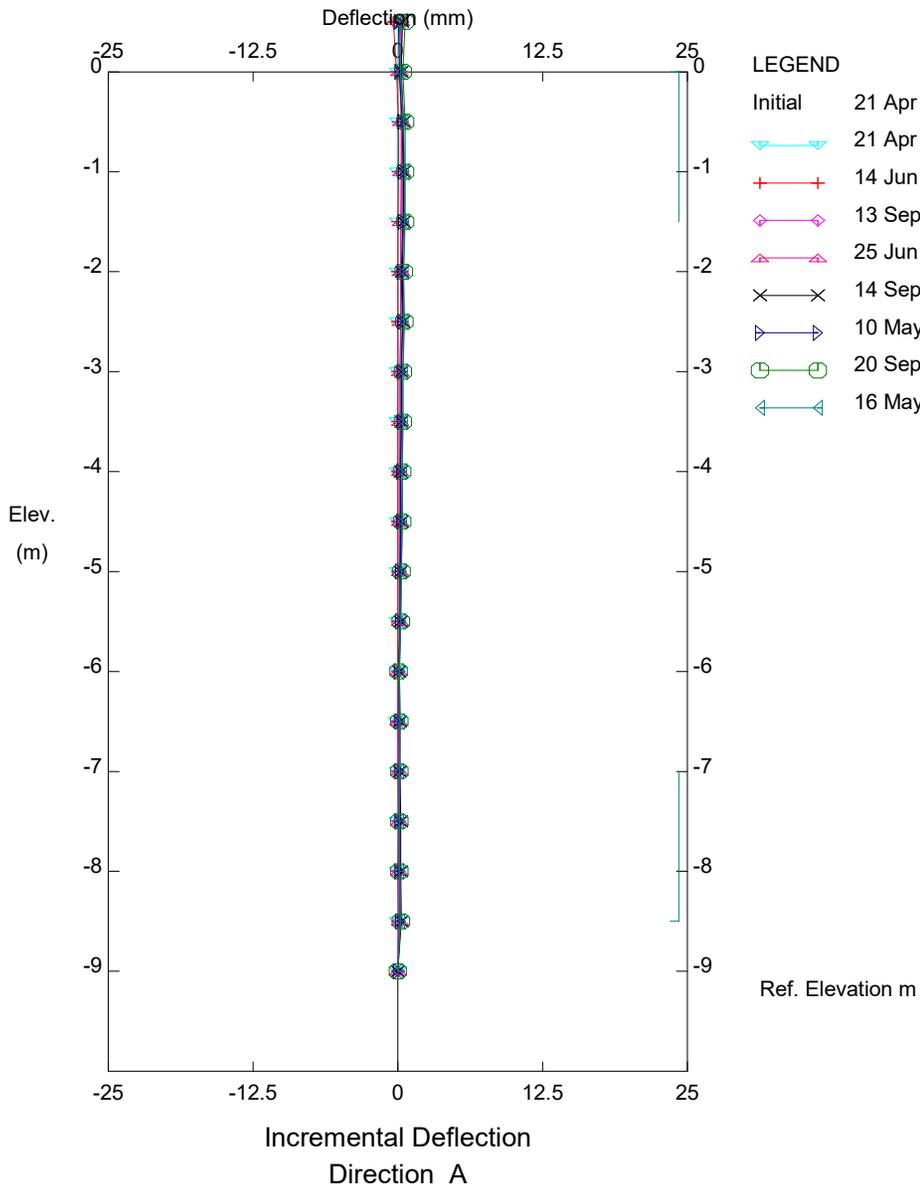
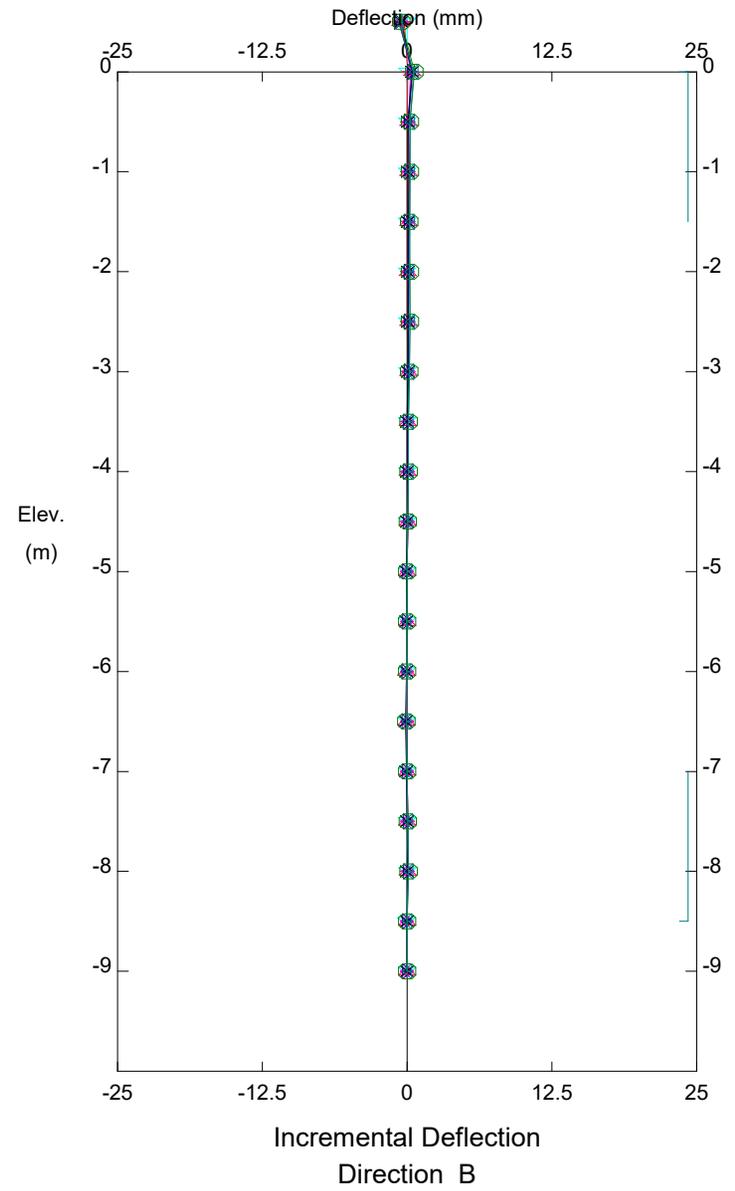
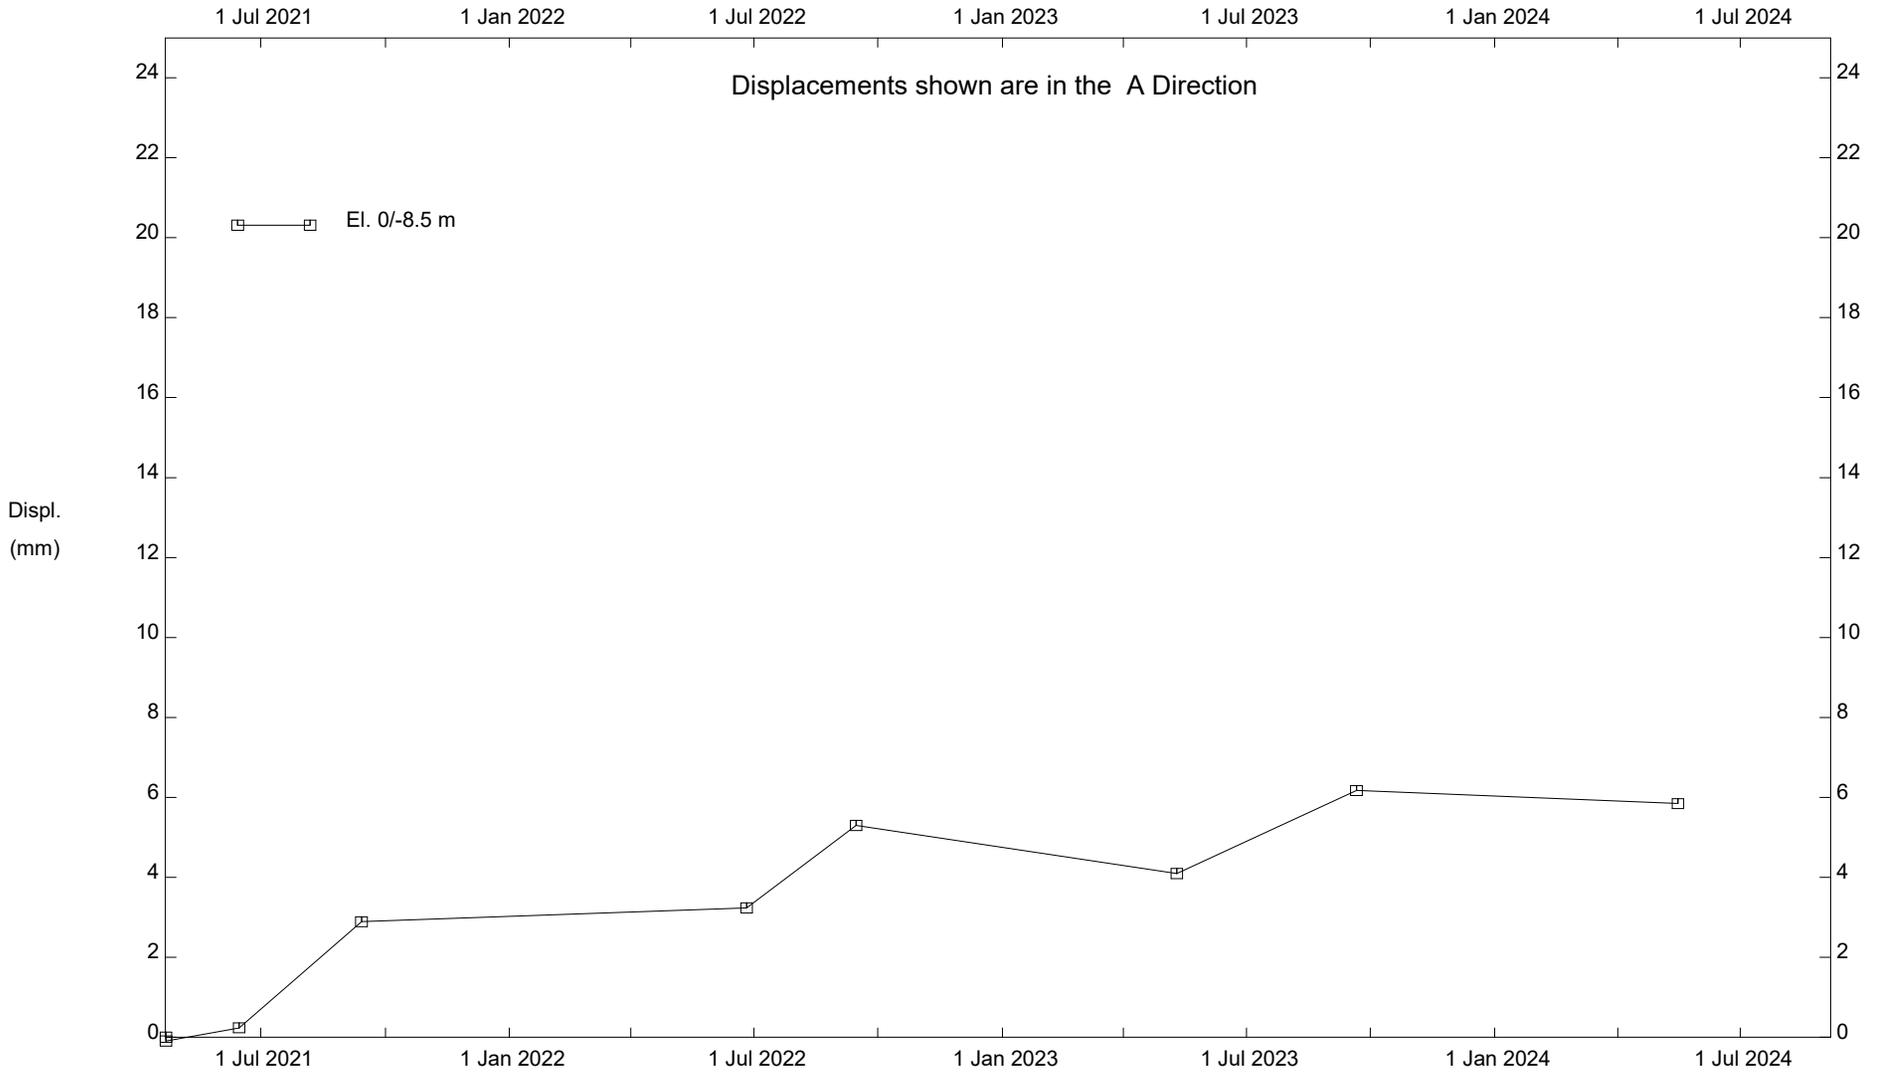
C065-IV; H585:02, East of Trochu, Inclinator SI21-C65-02  
 Alberta Transportation

Distributed movement has been recorded in SI21-C65-02 from ground surface approximately 1 m above the base of the instrument.

No discernible movement has been recorded in SI21-C65-01, and distributed movement has been recorded in SI21-C65-02 from ground surface to near the base of the instrument. This indicates that the H-pile wall has intercepted the failure surface and is continuing to deflect, transferring load to depths below the failure plane as the piles stabilize the slide mass. As movement continues in the H-pile wall, it will be eventually reflected in SI21-C65-01.

The May 2024 data obtained from the pile-wall SIs indicates that the top of the H-pile wall has deflected up to approximately 6 mm since installation. Since installation, the overall rate of movement recorded in SI21-C65-02 has been slow (less than 3 mm/year) with minimal movement being recorded over the winter months (less than approximately 1 mm/year) and increased rates of movement recorded between spring and fall (up to approximately 11 mm/year). The May 2024 readings are consistent with historical trends for the instrument.

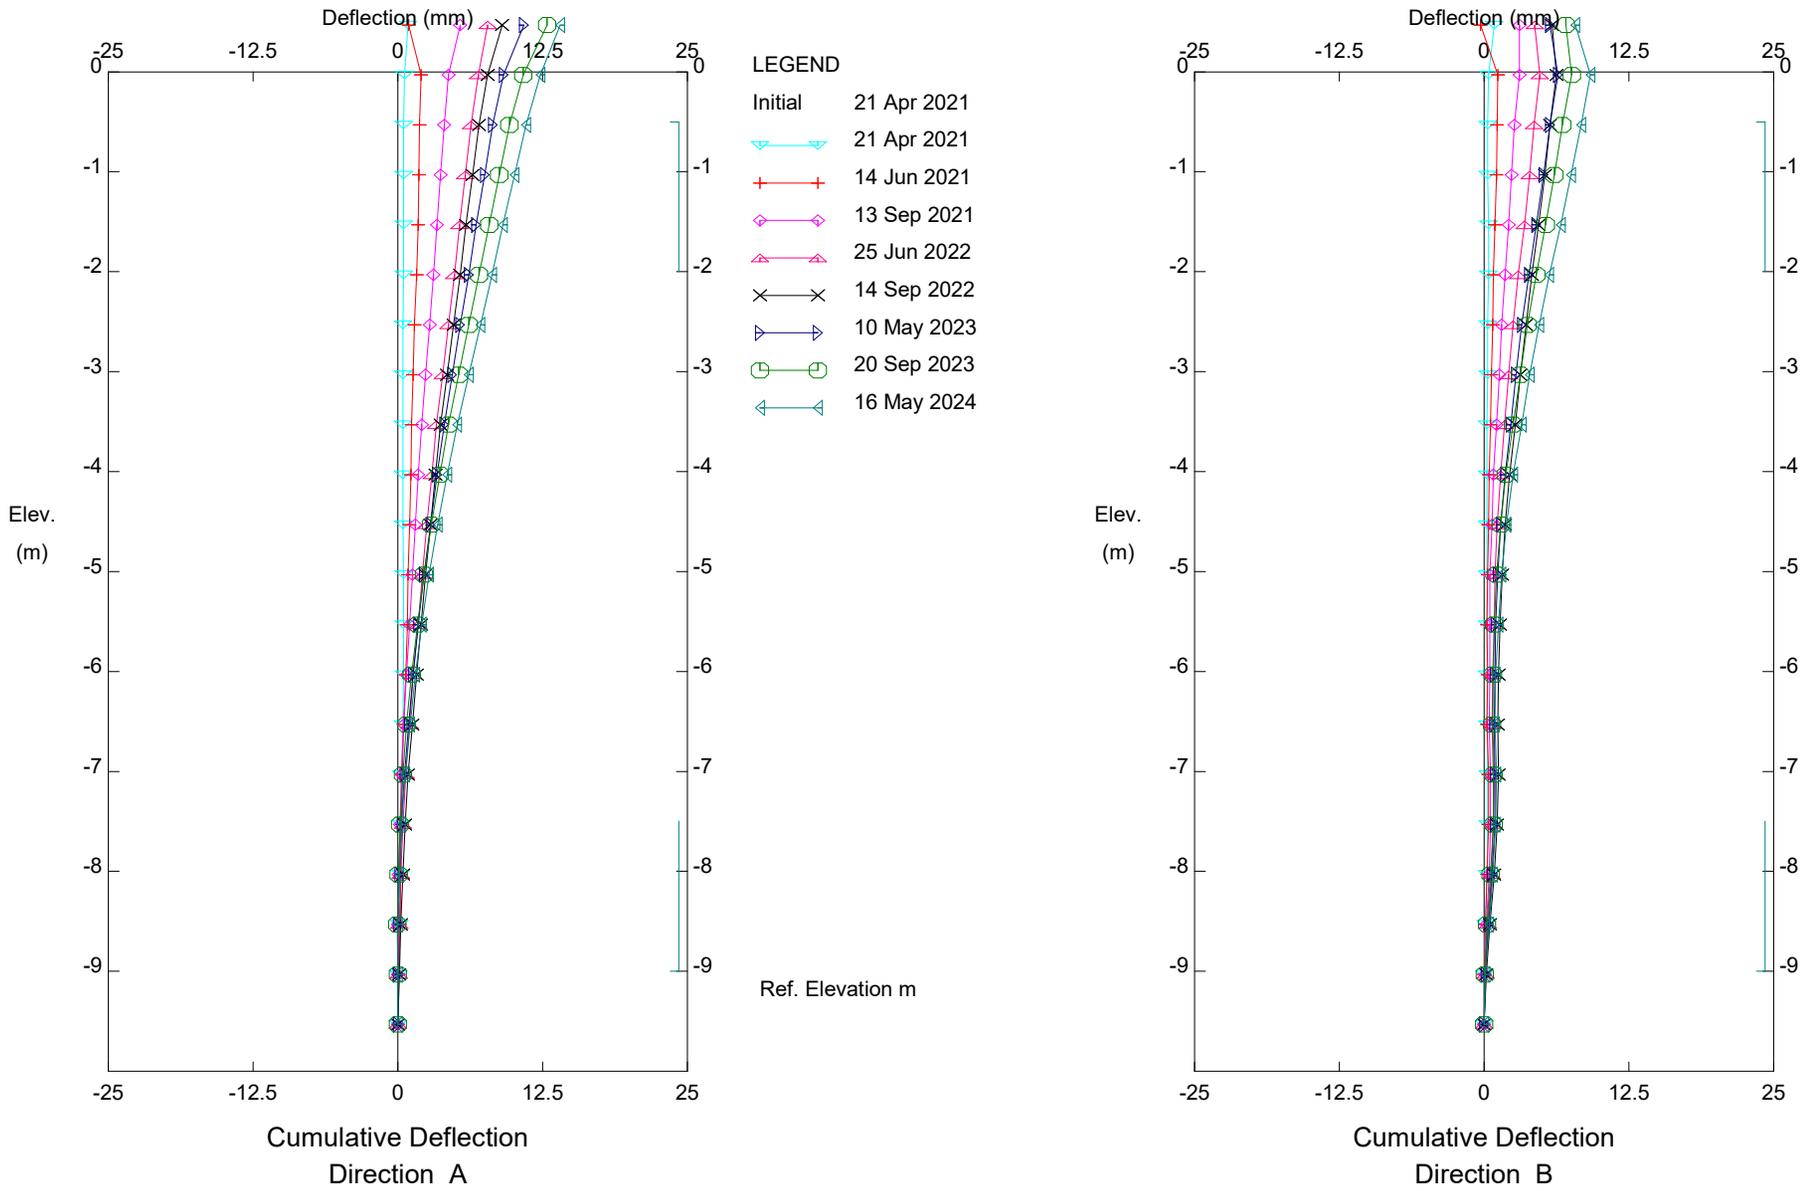
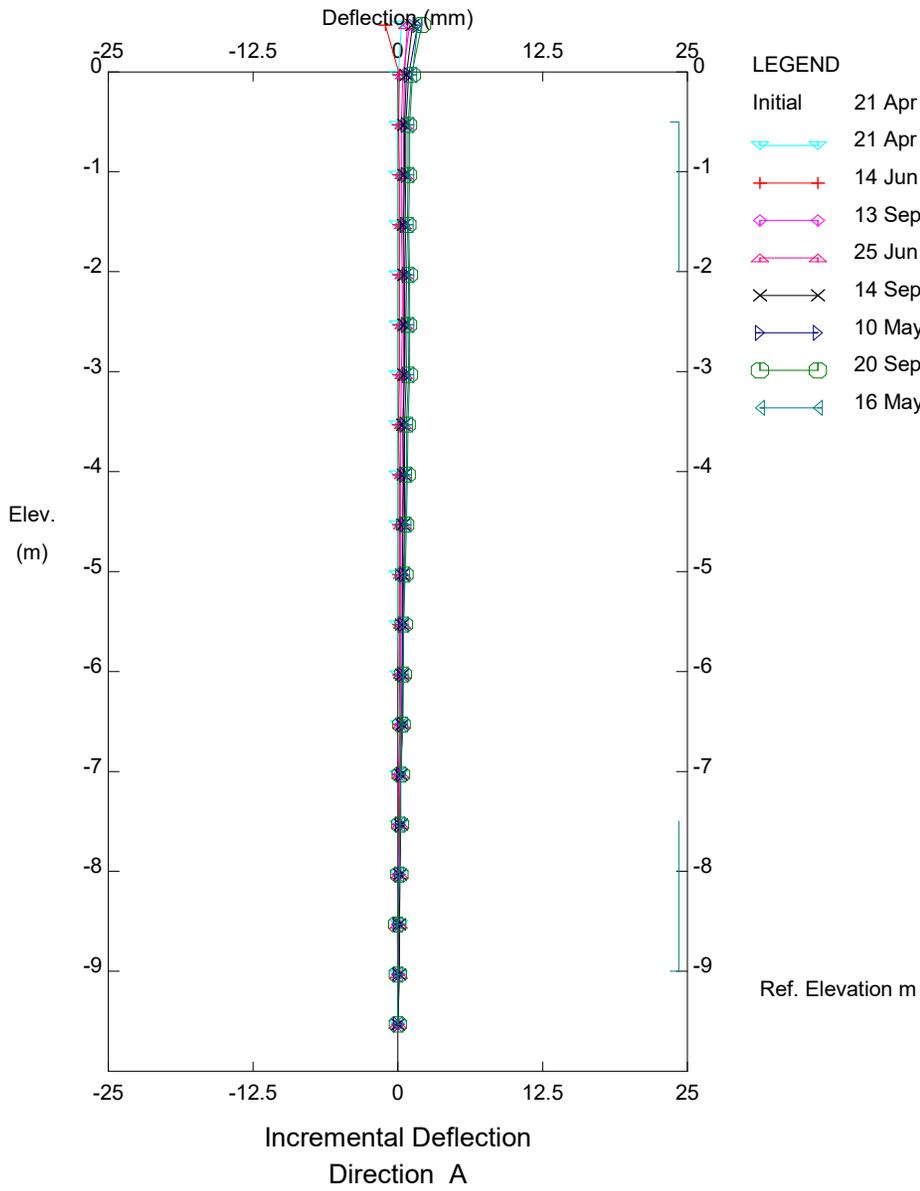
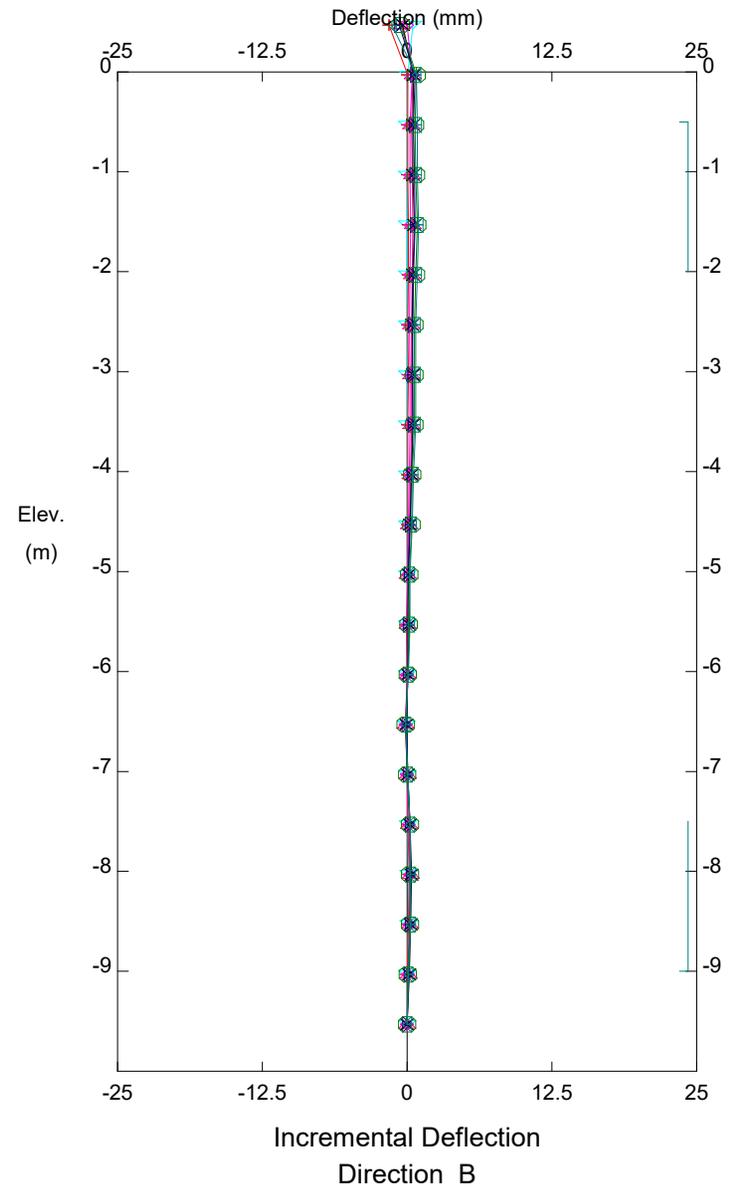
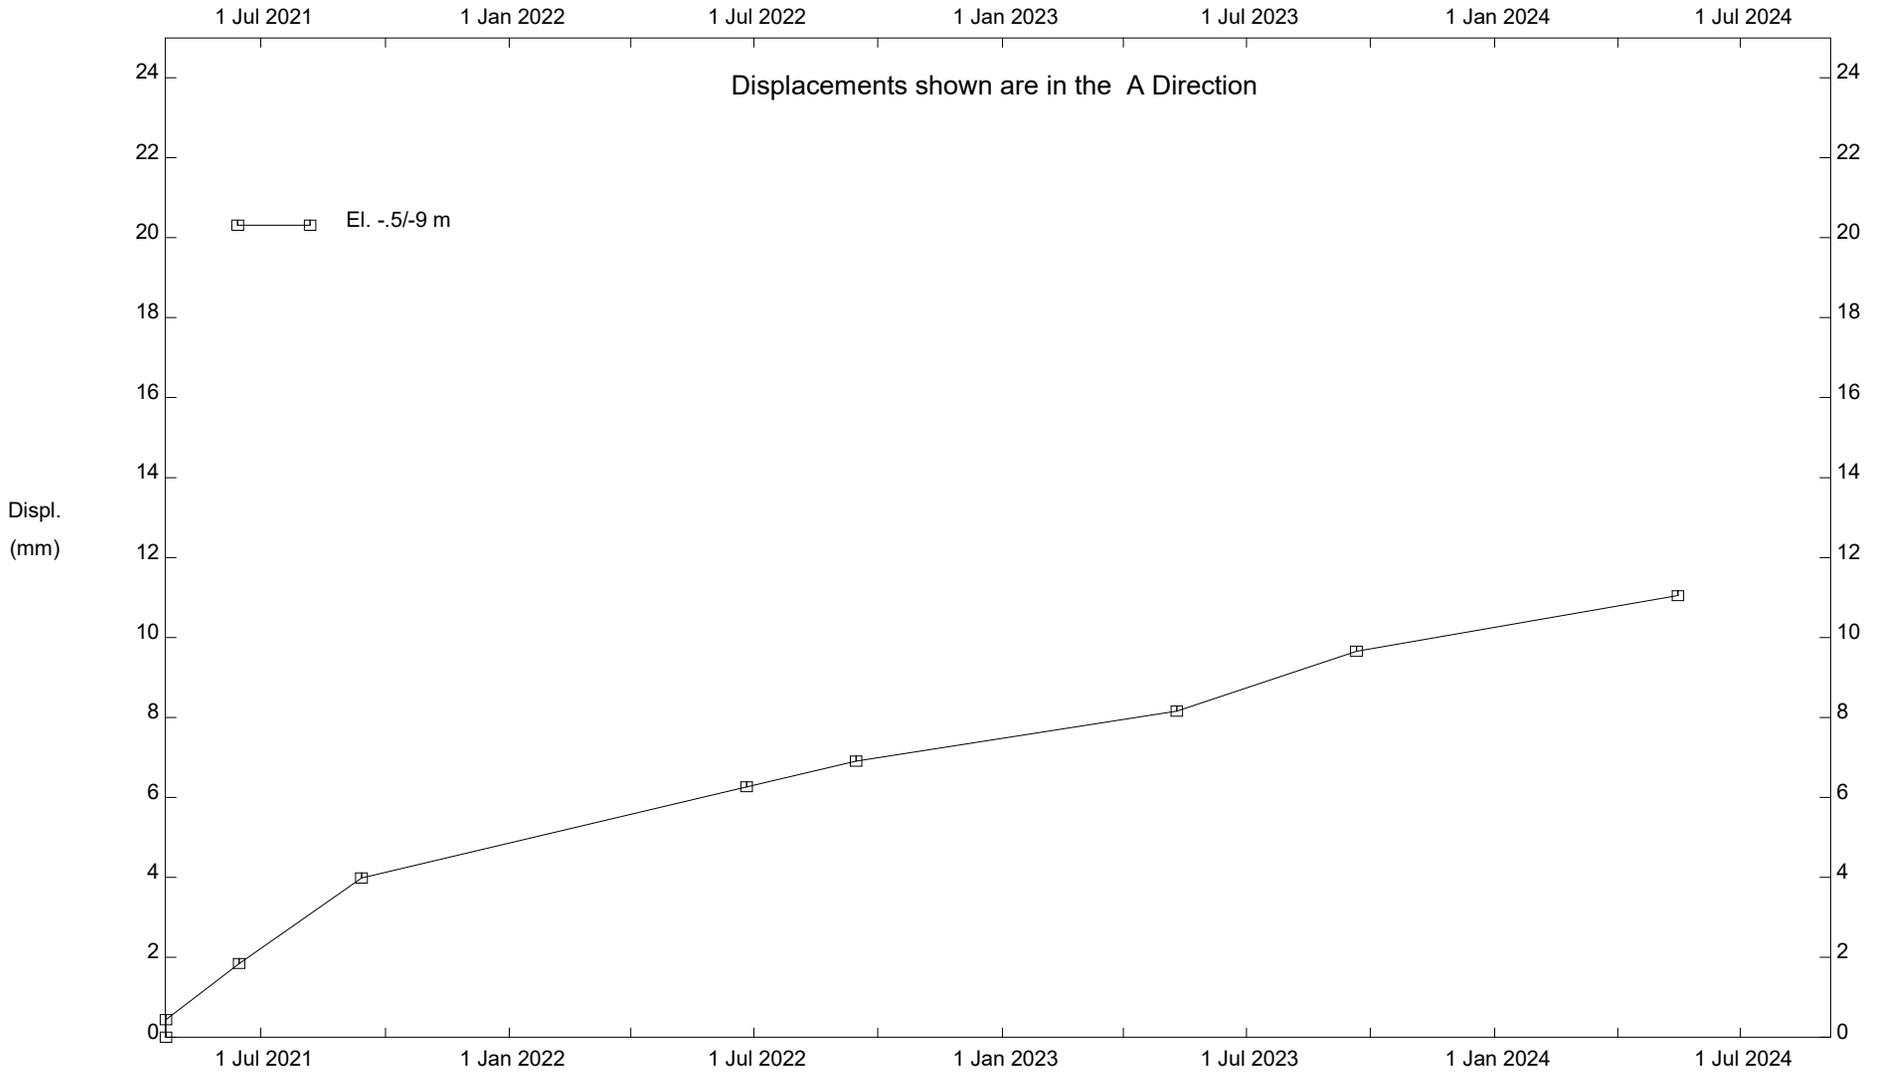
C065-V; H585:02, East of Trochu, Inclinator SI21-C65-03  
 Alberta Transportation

Distributed movement has been recorded in SI21-C65-03 from ground surface to approximately 2 m above the base of the instrument.

Distributed movement has been recorded in the pile-wall SI (SI21-C65-03) and appears to be from ground surface to near the base of the instrument. This indicates that the H-pile wall has intercepted the failure surface and is continuing to deflect, transferring load to depths below the failure plane as the piles stabilize the slide mass.

The May 2024 data obtained from the pile-wall SI indicates that the top of the H-pile wall has deflected up to approximately 11 mm since installation.

In the spring of 2021, shortly after construction of the H-pile wall, the maximum rate of movement recorded in this SI was approximately 10 mm/year. Since fall of 2021, the rate of movement has been relatively steady and is currently approximately 2 mm/year. KCB anticipated that the rate of movement shortly after installation would be highest and would decrease as the H-pile wall picked up load stabilizing the sliding mass.

Distributed movement (i.e., from top to bottom of casing) up to 8 mm has also been recorded in the B-direction of SI21-C65-03. It is unknown if this movement is due to post installation SI casing flexure, shifting in the steel pocket the SIs are installed in, or flexure/twist of the H-piles that is occurring due to the H-pile wall picking up load from the sliding mass. The rate of movement being recorded in the B-direction is slow (less than 5 mm/year).

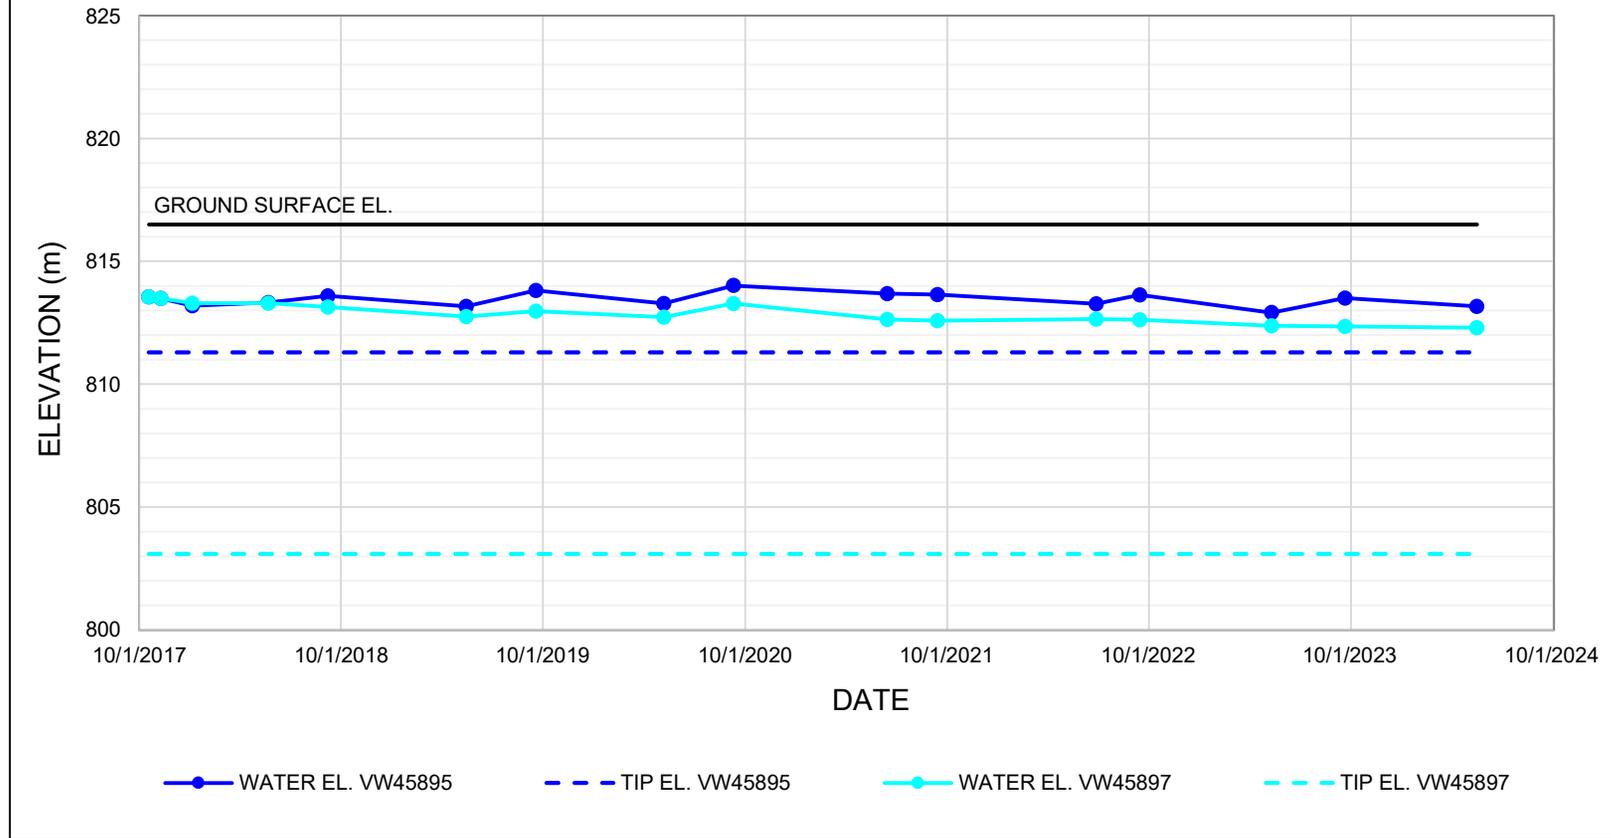
### VW45895 AND VW45897

Since installation in October 2017, water levels recorded in VW45895 and VW45897 have been relatively steady varying from 2.5 m to 3.6 m below ground surface and 2.9 m to 4.2 m below ground surface, respectively. The May 2024 readings of VW45895 and VW45897 were consistent with historical trends observed in these instruments. During the 2024 Section B inspection, no additional pavement distress (settlement and/or cracking) was observed.

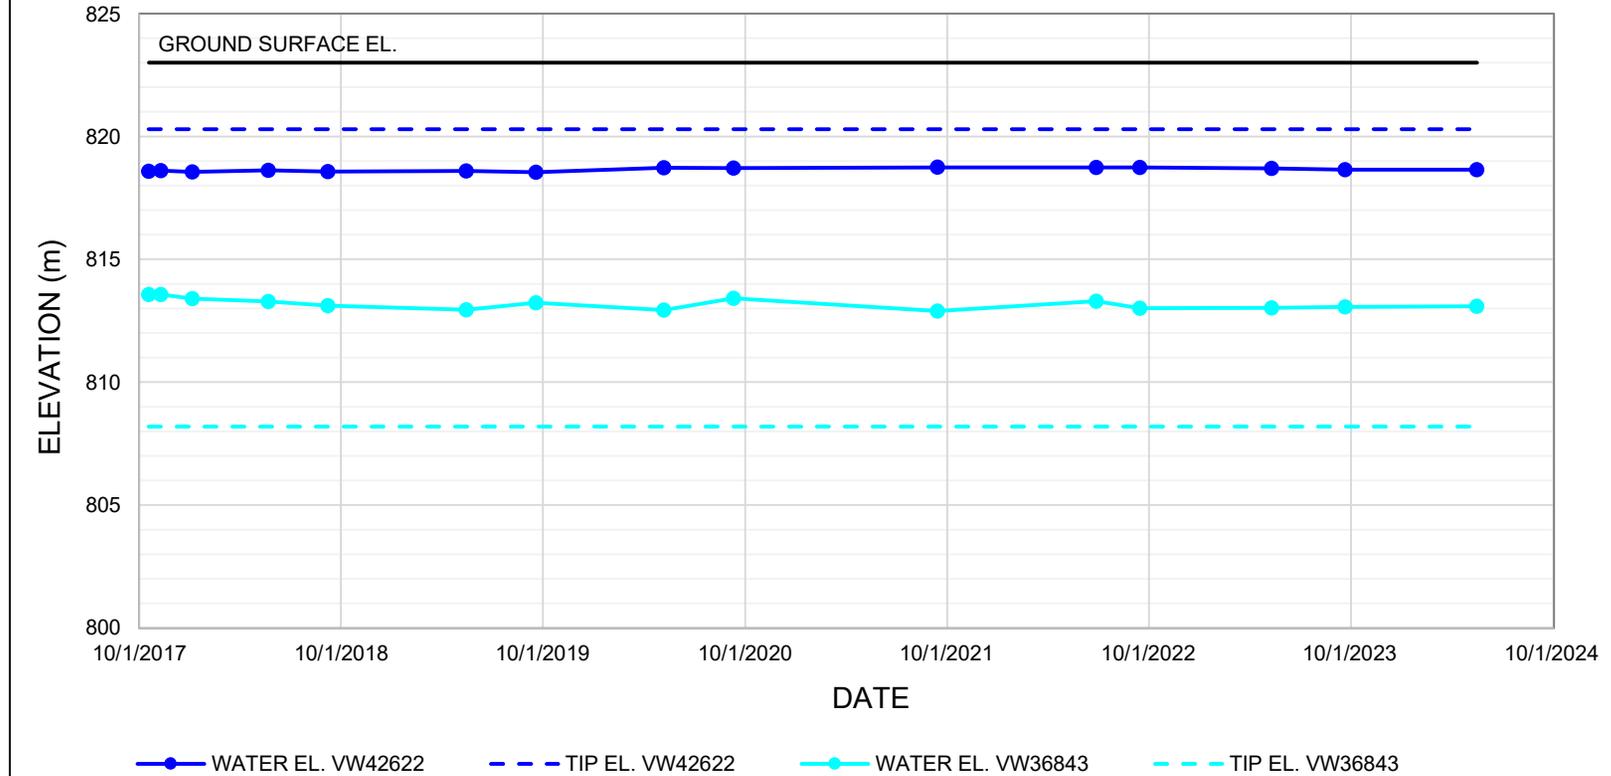
### VW42622 AND VW36843

Since installation in October 2017, water levels recorded in VW36843 have been relatively steady varying from 9.4 m to 10.1 m below ground surface. VW42622 has been dry since October 2017. The May 2024 readings of VW42622 and VW36843 were consistent with historical trends observed in these instruments.
