| SITE NUMBER AND NAME: C035 H590 Ditch Erosion | | HIGHWAY & KM: 590:04, 20.104 | PREVIOUS INSPECTION DATE: June 24, 2021 | INSPECTION DATE: June 18, 2024 |

PRIMARY SITE ISSUE: Numerous erosion features located along Hwy 590, primarily in the ditches, on either side of the Red Deer River.

| PROJECT CENTRAL REGION GEOHAZARD RISK MANAGEMENT PROGRAM | | |
| TITLE Site Plan C035 - Ditch Erosion Hwy 590:04, km 20.104 | | |

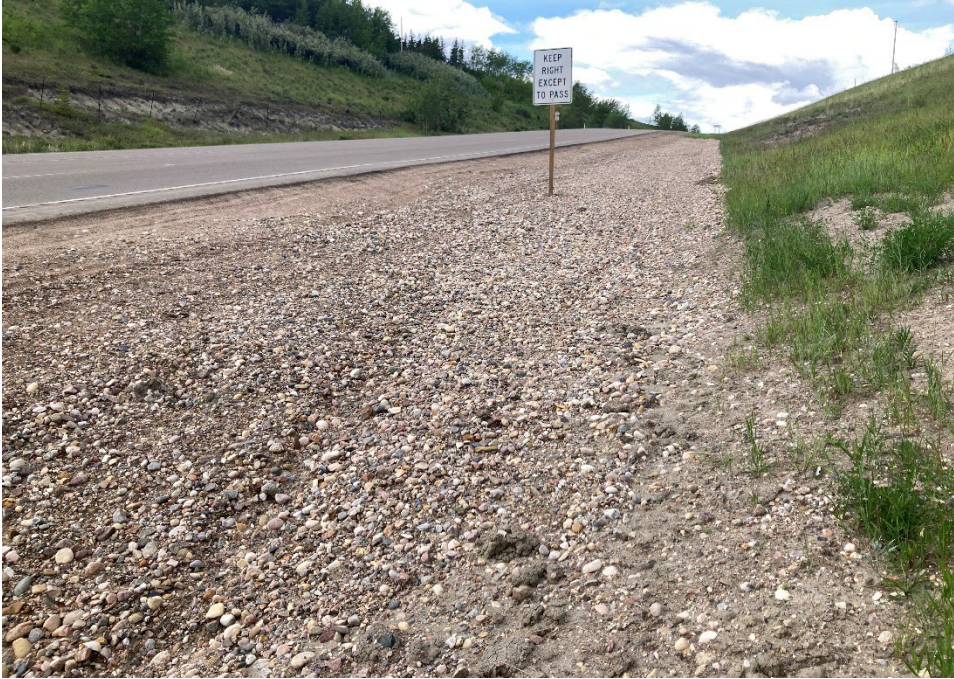
- The erosion gullies along the north and south ditches west of the bridge were backfilled with compacted pit run gravel and the repair is in good condition (Photos 1 through 7). Very little erosion was observed during the 2024 inspection.

Photo 1 West extent of the where the north (westbound) ditch was repaired in late-2023. Photo taken June 19, 2024, facing west.

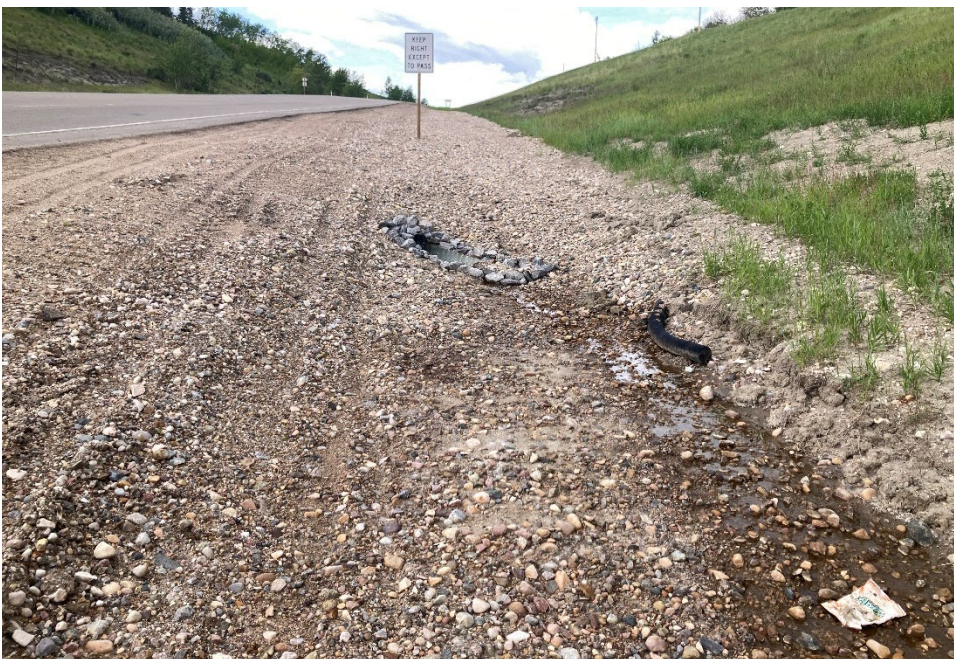
- A small amount of seepage was observed to be flowing from the perforated drainpipe installed along the west extent of the north ditch repair (not part of KCB's scope during the 2023 repair work) (Photo 2). The drainpipe was installed in a trench along the ditch bottom upstream (west) of the new centerline 600 mm diameter CSP culvert (Photo 2) which was conveying flow from the south ditch during the 2024 inspection.

Photo 2 Downstream (east) of a new 600 mm diameter CSP culvert and perforated drainpipe outlet. Photo taken on June 19, 2024, facing west.

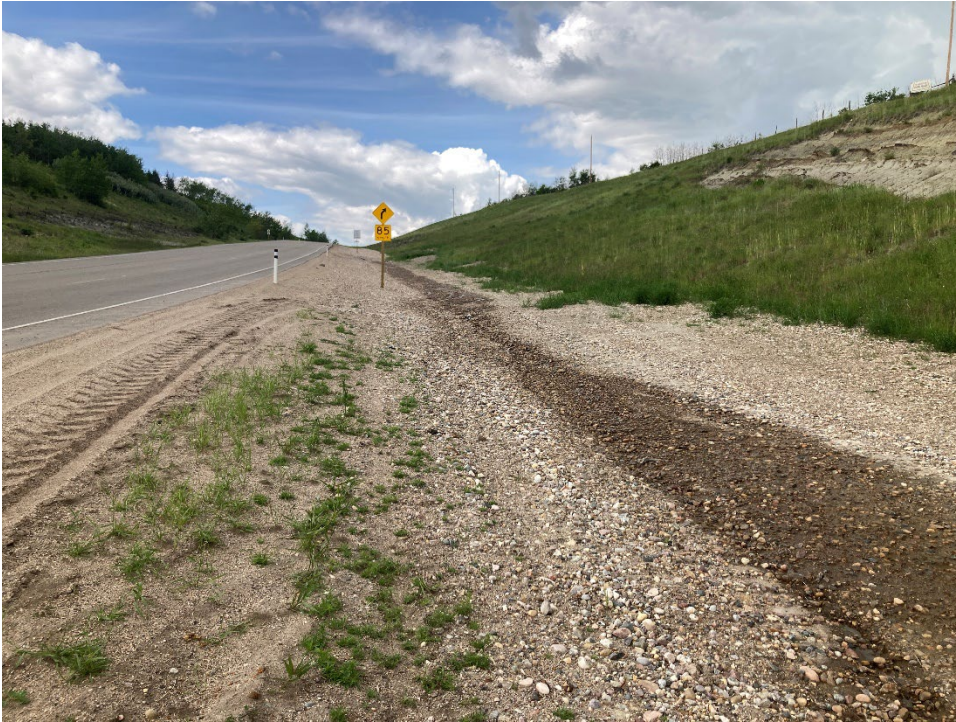
Photo 3 Downstream (east) portion of the north (westbound) ditch repair. Photo taken June 19, 2024, facing west.

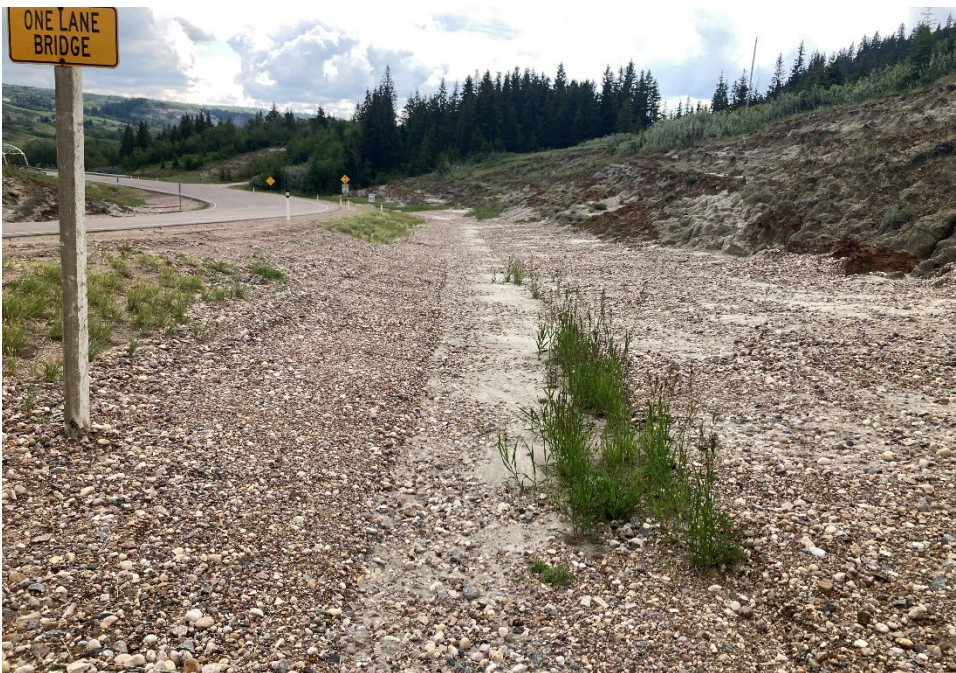
- A small amount of grass was growing in the north and south ditches (Photo 4 and 5). Generally, the vegetative cover along the repair is poor.
- Sediment is accumulating behind the straw waddles installed along the north ditch, upstream (west) of the centerline culvert (Photo 7). If the sediment is not regularly removed, flows will flow overtop the straw waddles, completely negating their ability to slow down flows through the ditch. The installation of straw waddles was not part of KCB's design and was done independently by the contractor when KCB was not on site. The straw waddles installed at the edge of riprap (Photo 8) may redirect flow away from the riprap, resulting in gully formation beside the repair.

Photo 4 Upstream (west) extent of the south ditch repair. Photo taken June 19, 2024, facing east-southeast.

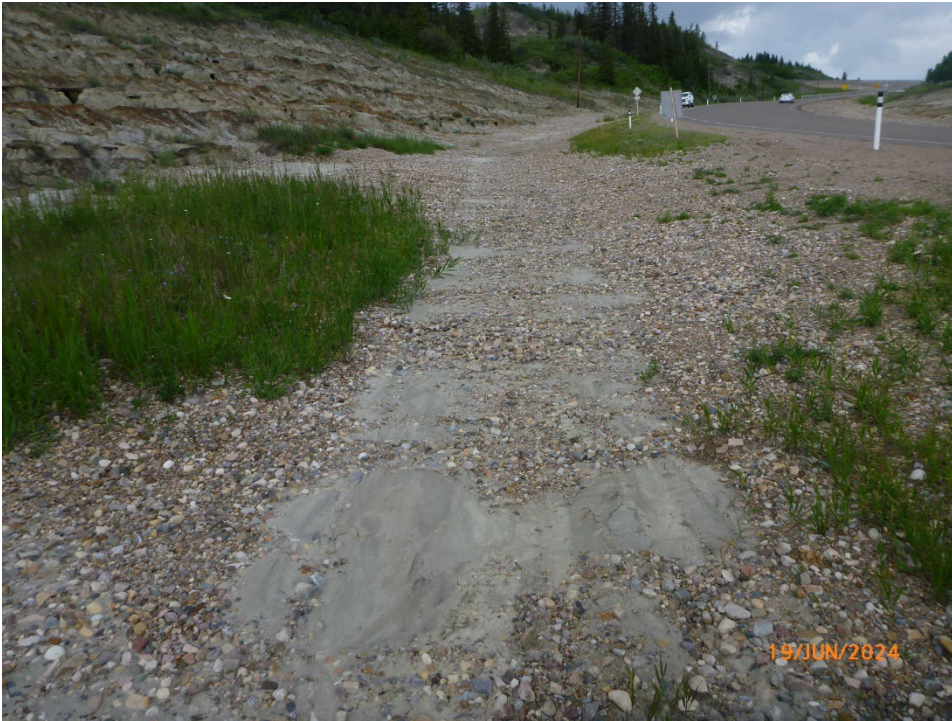
Photo 5 Portion of the south (eastbound) ditch repair. Photo taken June 19, 2024, facing west.

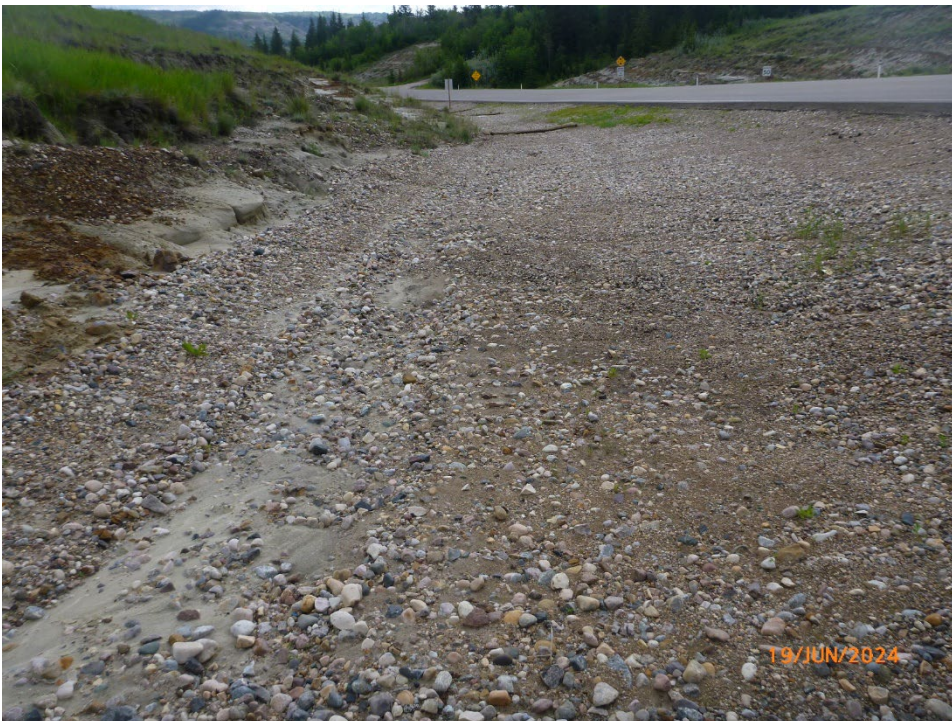
Photo 6 West extent of the north (westbound) ditch repair just west of the Red Deer River bridge crossing. Photo taken June 19, 2024, facing east.

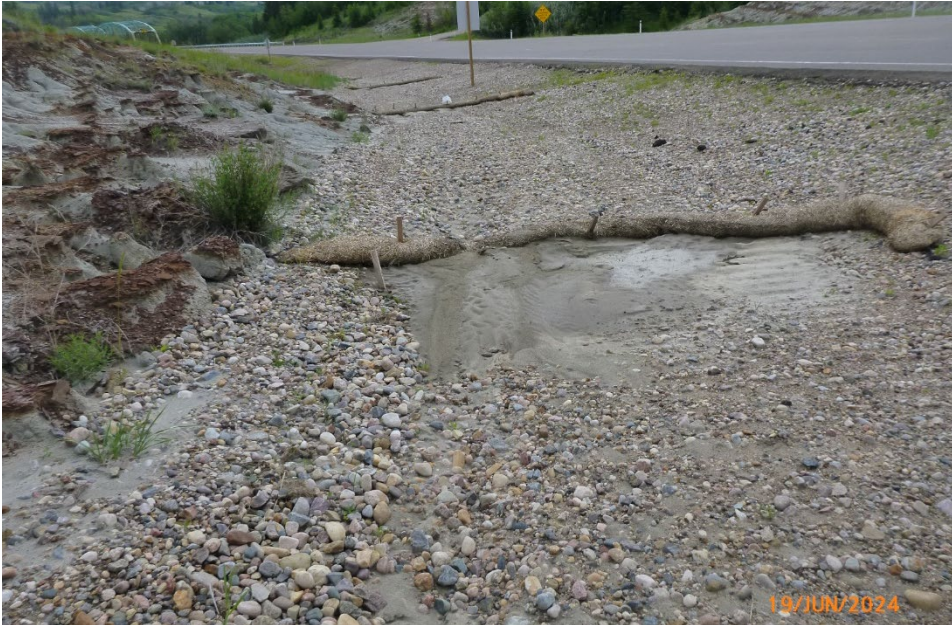
Photo 7 Sediment captured by a straw wattle installed perpendicular to the ditch.
Photo taken June 19, 2024, facing southeast.

- The sediment accumulating behind the straw waddles installed along the north ditch west of the bridge should be regularly removed by TEC's HMC. The straw waddles are a temporary erosion control measure and should be replaced by riprap check dams for a more permanent method of slowing down flows through the ditch.

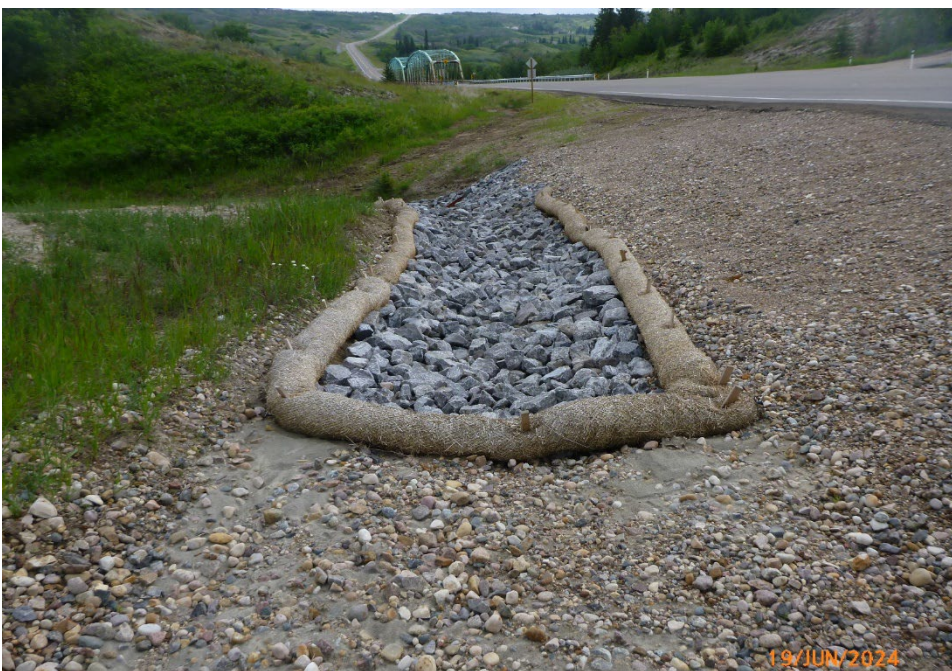
Photo 8 Riprap armoring in the ditch bottom, where the grade of the ditch steepens just west of the culvert outlet underlying Hwy 590. Straw wattles installed along the edge of riprap could direct flows away from riprap and lead to erosion gully formation.
Photo taken June 19, 2024, facing east.

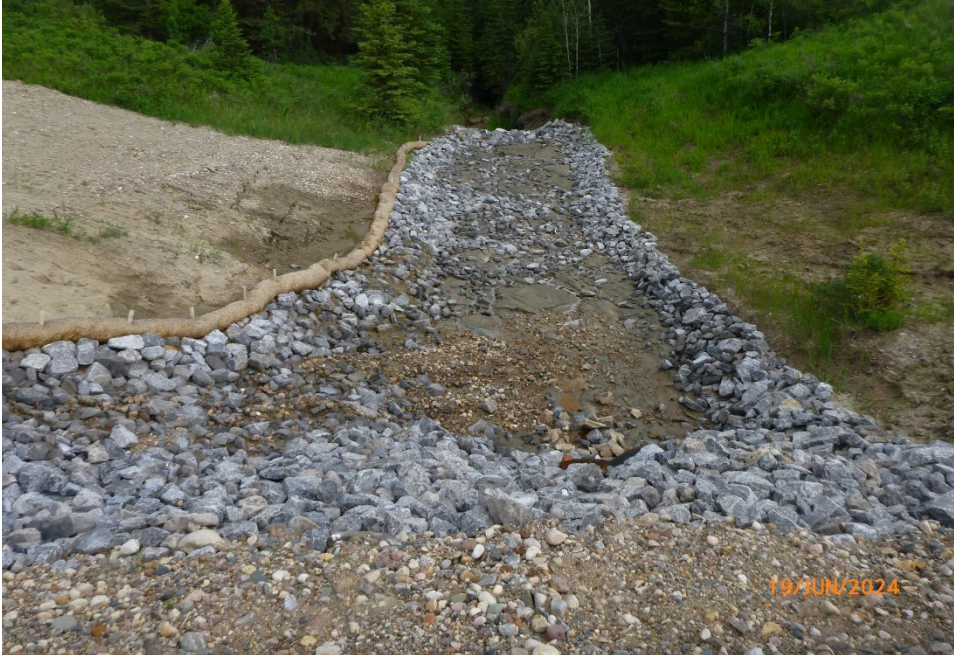
- The riprap-lined outlet channel installed downstream of the centerline culvert appears to be performing well (Photos 9 and 10). Sediment has been deposited in the channel since the post construction inspection completed in October 2023.

Photo 9 Riprap-lined outlet channel downstream of the culvert underlying Hwy 590. Sediment has been deposited along the channel since late-2023 construction. Photo taken June 19, 2024, facing north.

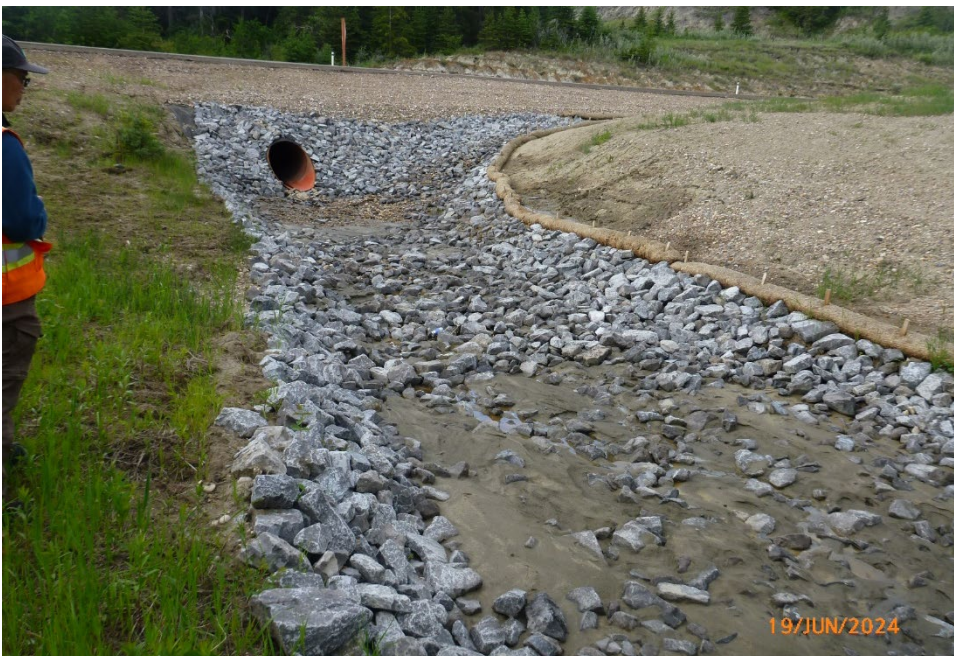
Photo 10 Riprap-lined outlet channel downstream of the culvert underlying Hwy 590. Sediment has been deposited along the channel since late-2023 construction. Photo taken June 19, 2024, facing southwest.

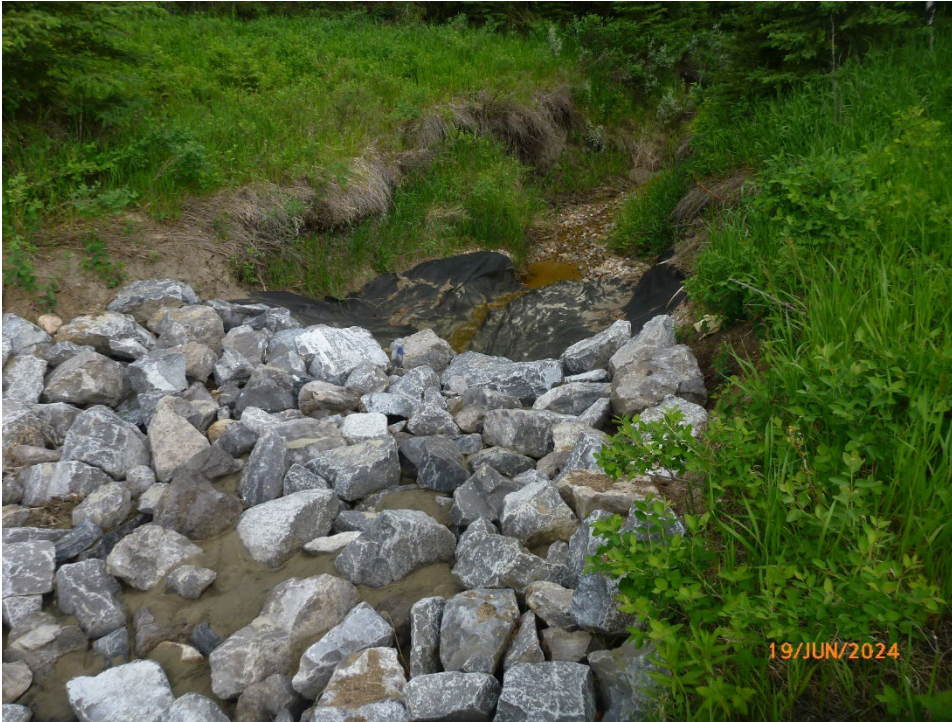
- At the riprap-lined outlet channel, the non-woven geotextile was extending past where the riprap was terminated (Photo 11).

Photo 11 Downstream limit of the riprap-lined channel. The non-woven geotextile extends past where the Class 1 riprap was placed. Photo taken June 19, 2024, facing north.

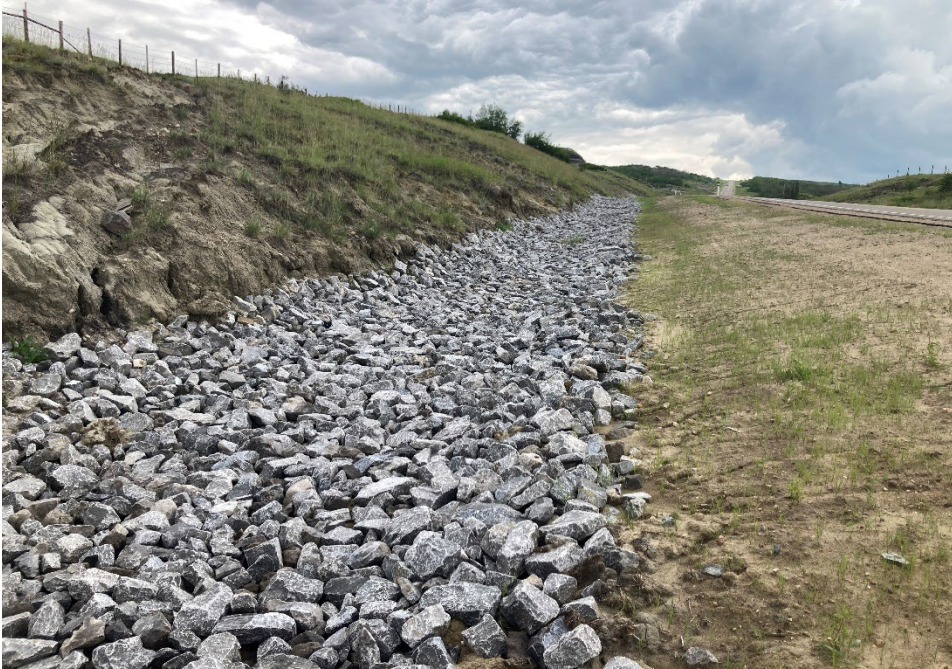
- The riprap armoured length of the north ditch is performing well (Photo 12 and 13).
- Some grass was observed to be growing on the north highway embankment slope along the repair (Photo 12 through 15).

**Photo 12 Riprap armouring in the north (westbound) ditch constructed in late-2023.
Photo taken June 19, 2024, facing east.**

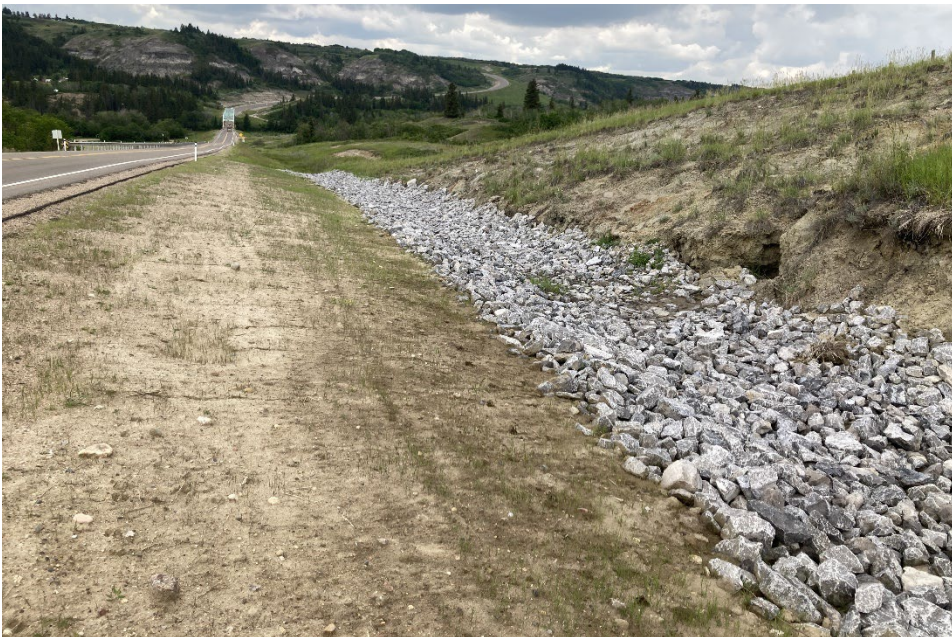
Photo 13 Riprap armouring in the north (westbound) ditch. Photo taken June 19, 2024, facing west.

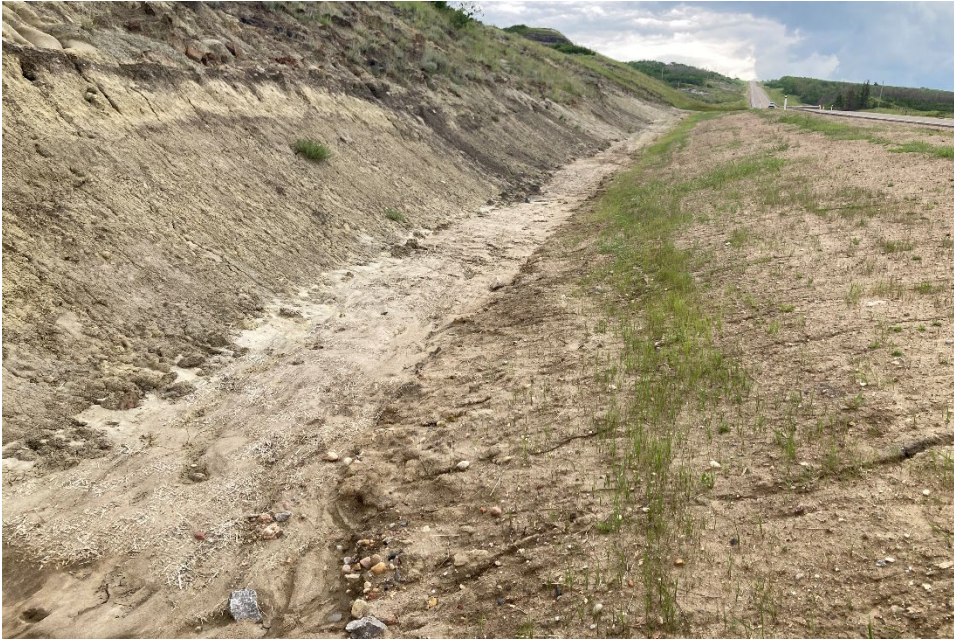
- The length of ditch armoured with RECP is performing poorly. Sections of the RECP are already becoming undermined due to erosion of the in-situ material used to backfill the erosion gullies (Photo 14 and 15).

Photo 14 Length of north (westbound) ditch armoured with rolled erosion control product (RECP). Photo taken June 19, 2024, facing east.

- The RECP installed east of the bridge should be replaced by TEC's HMC. The RECP should be installed properly, with RECP placed along the ditch side slopes (with at least 0.5 m cover) and keyed in according to TEC's Erosion and Sediment Control Manual.

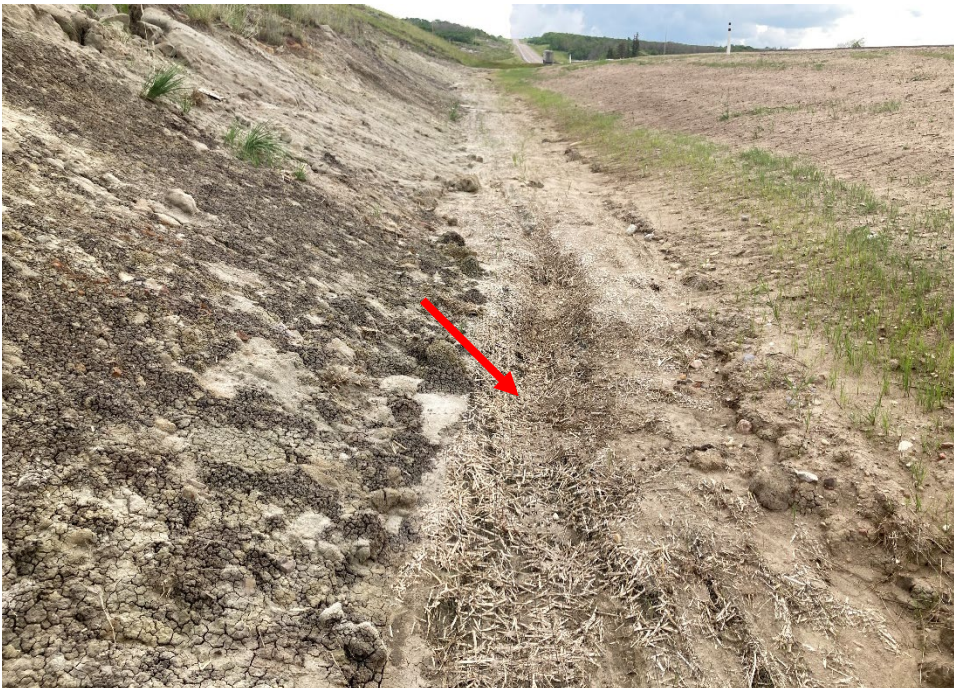
Photo 15 Length of north (westbound) ditch armoured with RECP in late-2023. The RECP is being undermined along the ditch bottom (indicated by red arrow). Photo taken June 19, 2024, facing east.

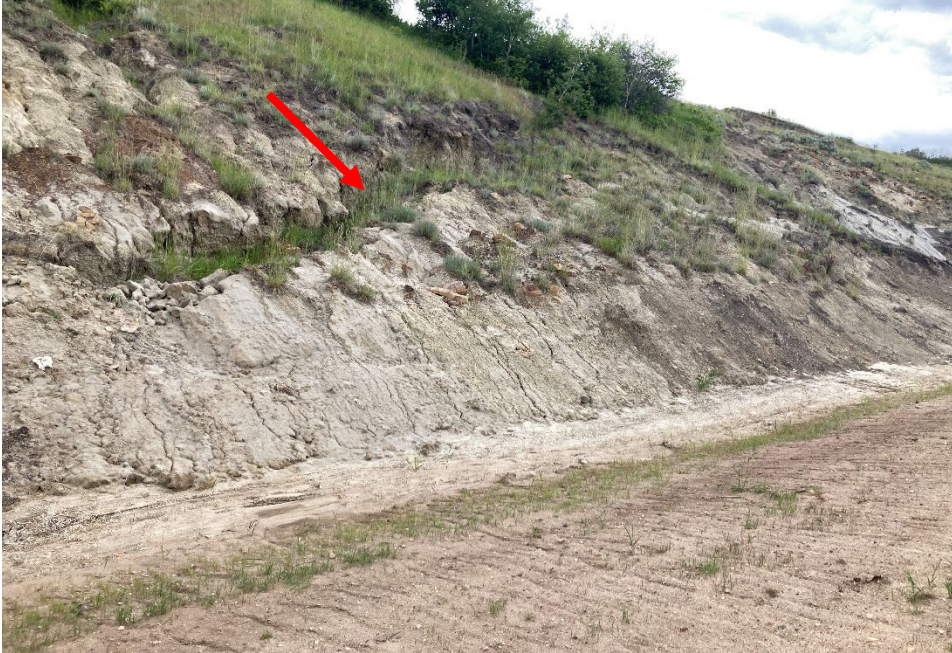
- Slope instability was observed on the north cutslope above the length of ditch armoured with RECP (Photo 16). There is a large crack in the slope, approximately one third up the slope, likely exacerbated by rainfall events causing surface runoff upslope of the crack.

Photo 16 Area of instability along the north (westbound) cut slope above where the ditch was armoured with RECP (ground crack indicated by red arrow). Photo taken June 19, 2024, facing northeast.

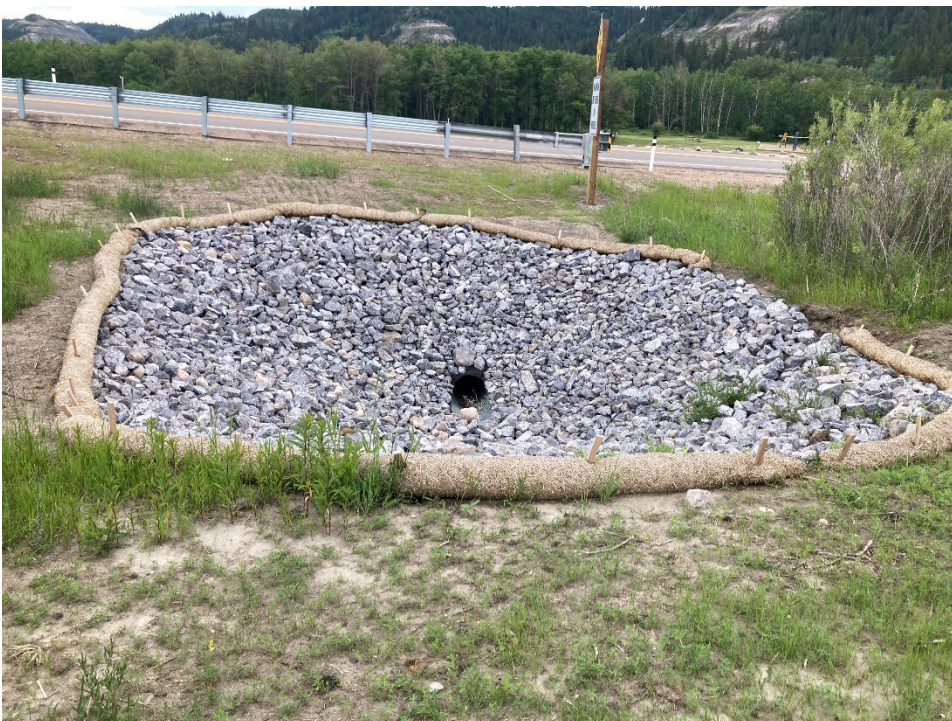
- The armouring at the older and new culvert inlets are performing well (Photo 17 and 18). Straw waddles were installed to reduce sediment from flowing into the culverts.

Photo 17 Riprap armoured culvert inlet in the north (westbound) ditch just east of the Red Deer River bridge crossing. Photo taken June 19, 2024, facing southwest.

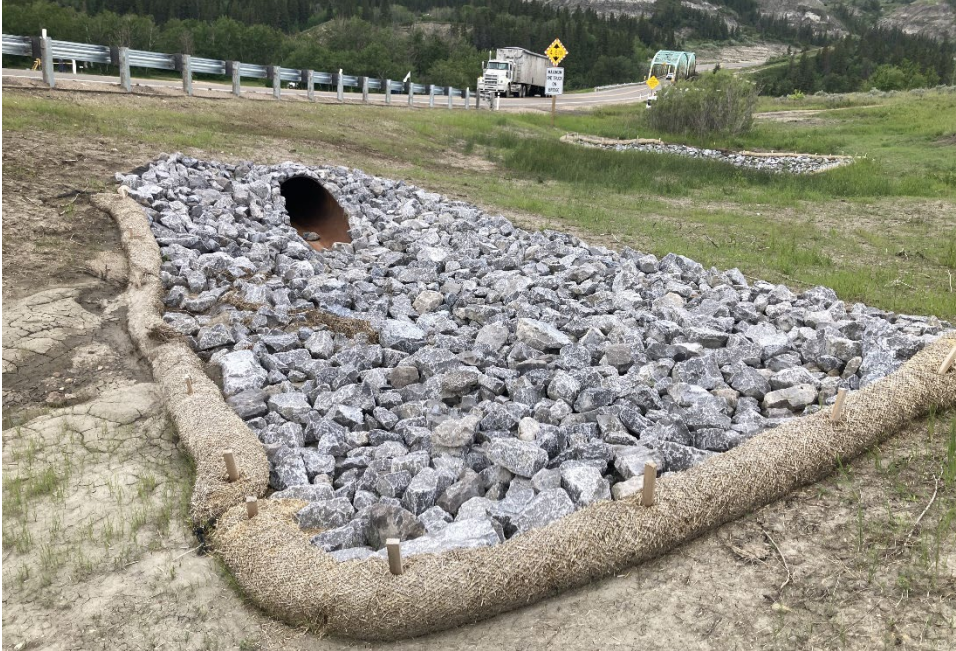
Photo 18 Riprap armouring of new centerline culvert installed below Hwy 590 in 2023, east of the existing culvert (shown in Photo 17). Photo taken June 19, 2024, facing southwest.

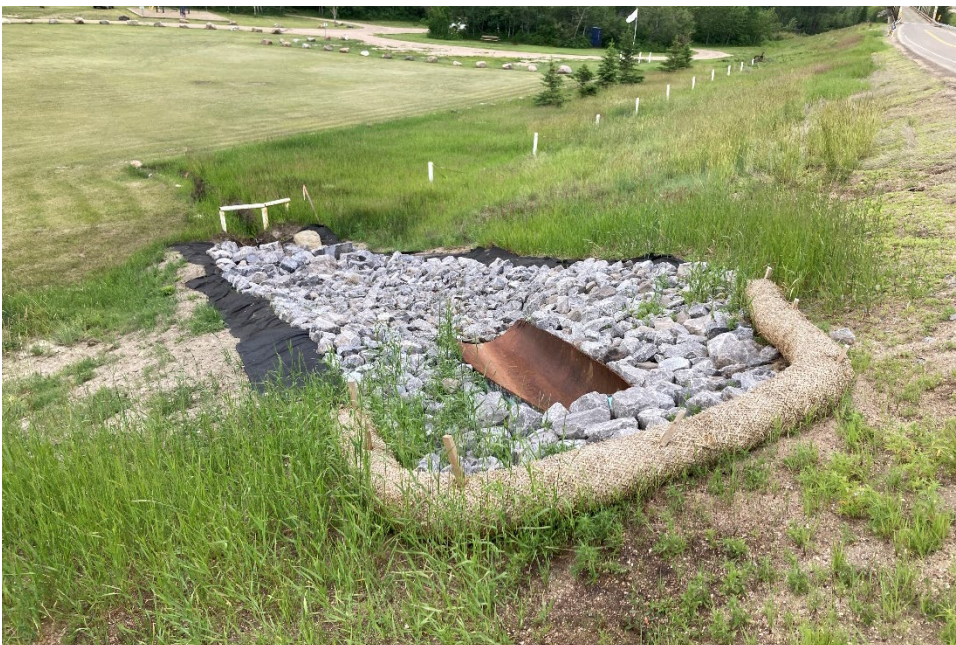
- The riprap-lined outlet (overlying non-woven geotextile) of the new smooth walled steel culvert appears to be in good condition (Photo 19). The existing CSP culvert outlet is at the downstream limit of the outlet channel, is buried by riprap, and was not observed during the 2024 inspection.

Photo 19 Culvert outlet of new centerline culvert installed in late-2023. Photo taken June 19, 2024, facing southwest.

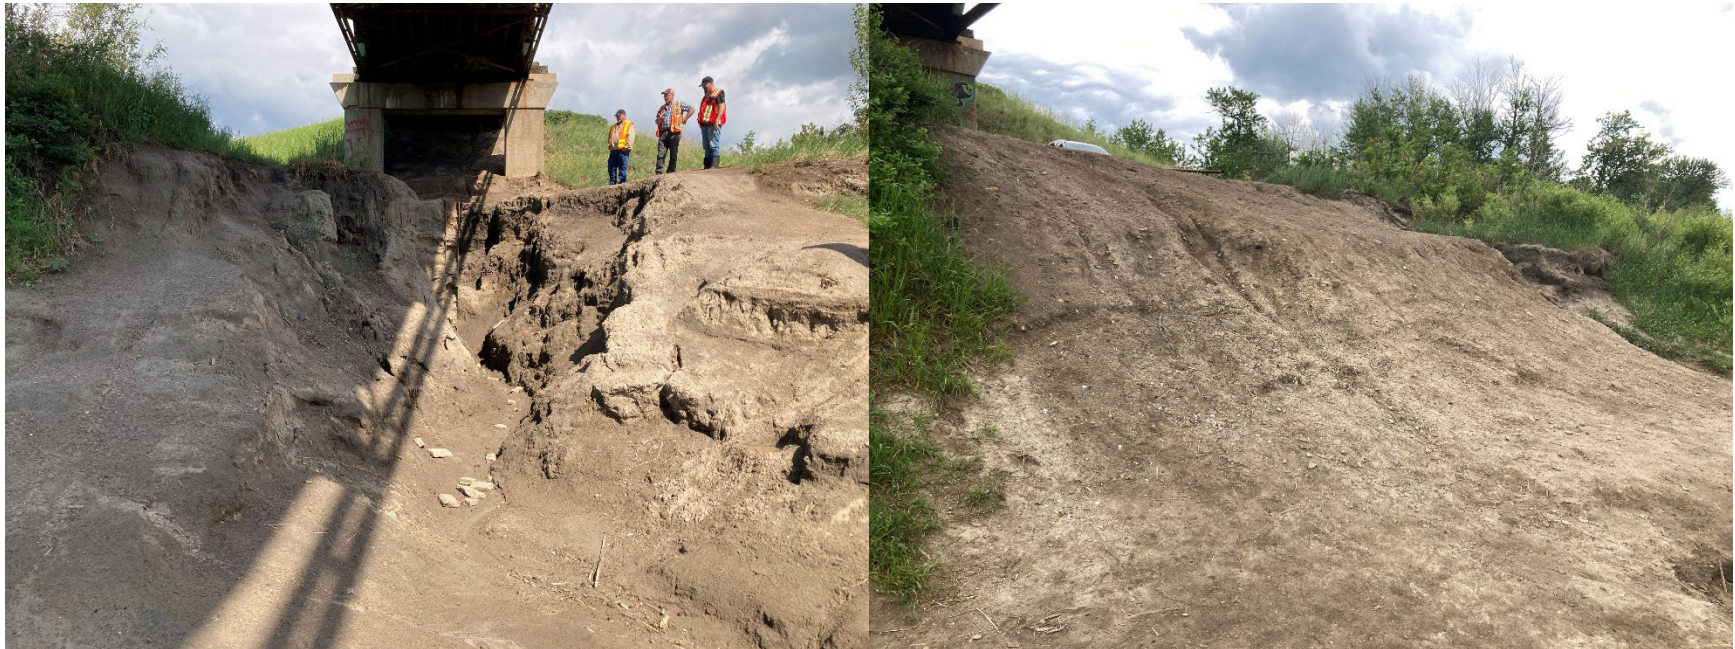
- The large erosion gully on the east riverbank slope, below the bridge, was backfilled between the 2021 and 2024 inspections and is in good conditions (Photo 20).

Photo 20 Large erosion gully on the east riverbank below the bridge was backfilled between the 2021 and 2024 inspections. Left and right photos taken June 24, 2021, and June 19, 2024, respectively.
