July 15, 2024

Alberta Transportation and Economic Corridors
4th Floor, Provincial Building
4920 51 Street
Red Deer, Alberta
T4N 6K8

**CON0022160 Central Region GRMP Instrumentation Monitoring
Site C060; H597:02, km 11.299 Slide East of Blackfalds
Section C – 2024 Spring Readings**

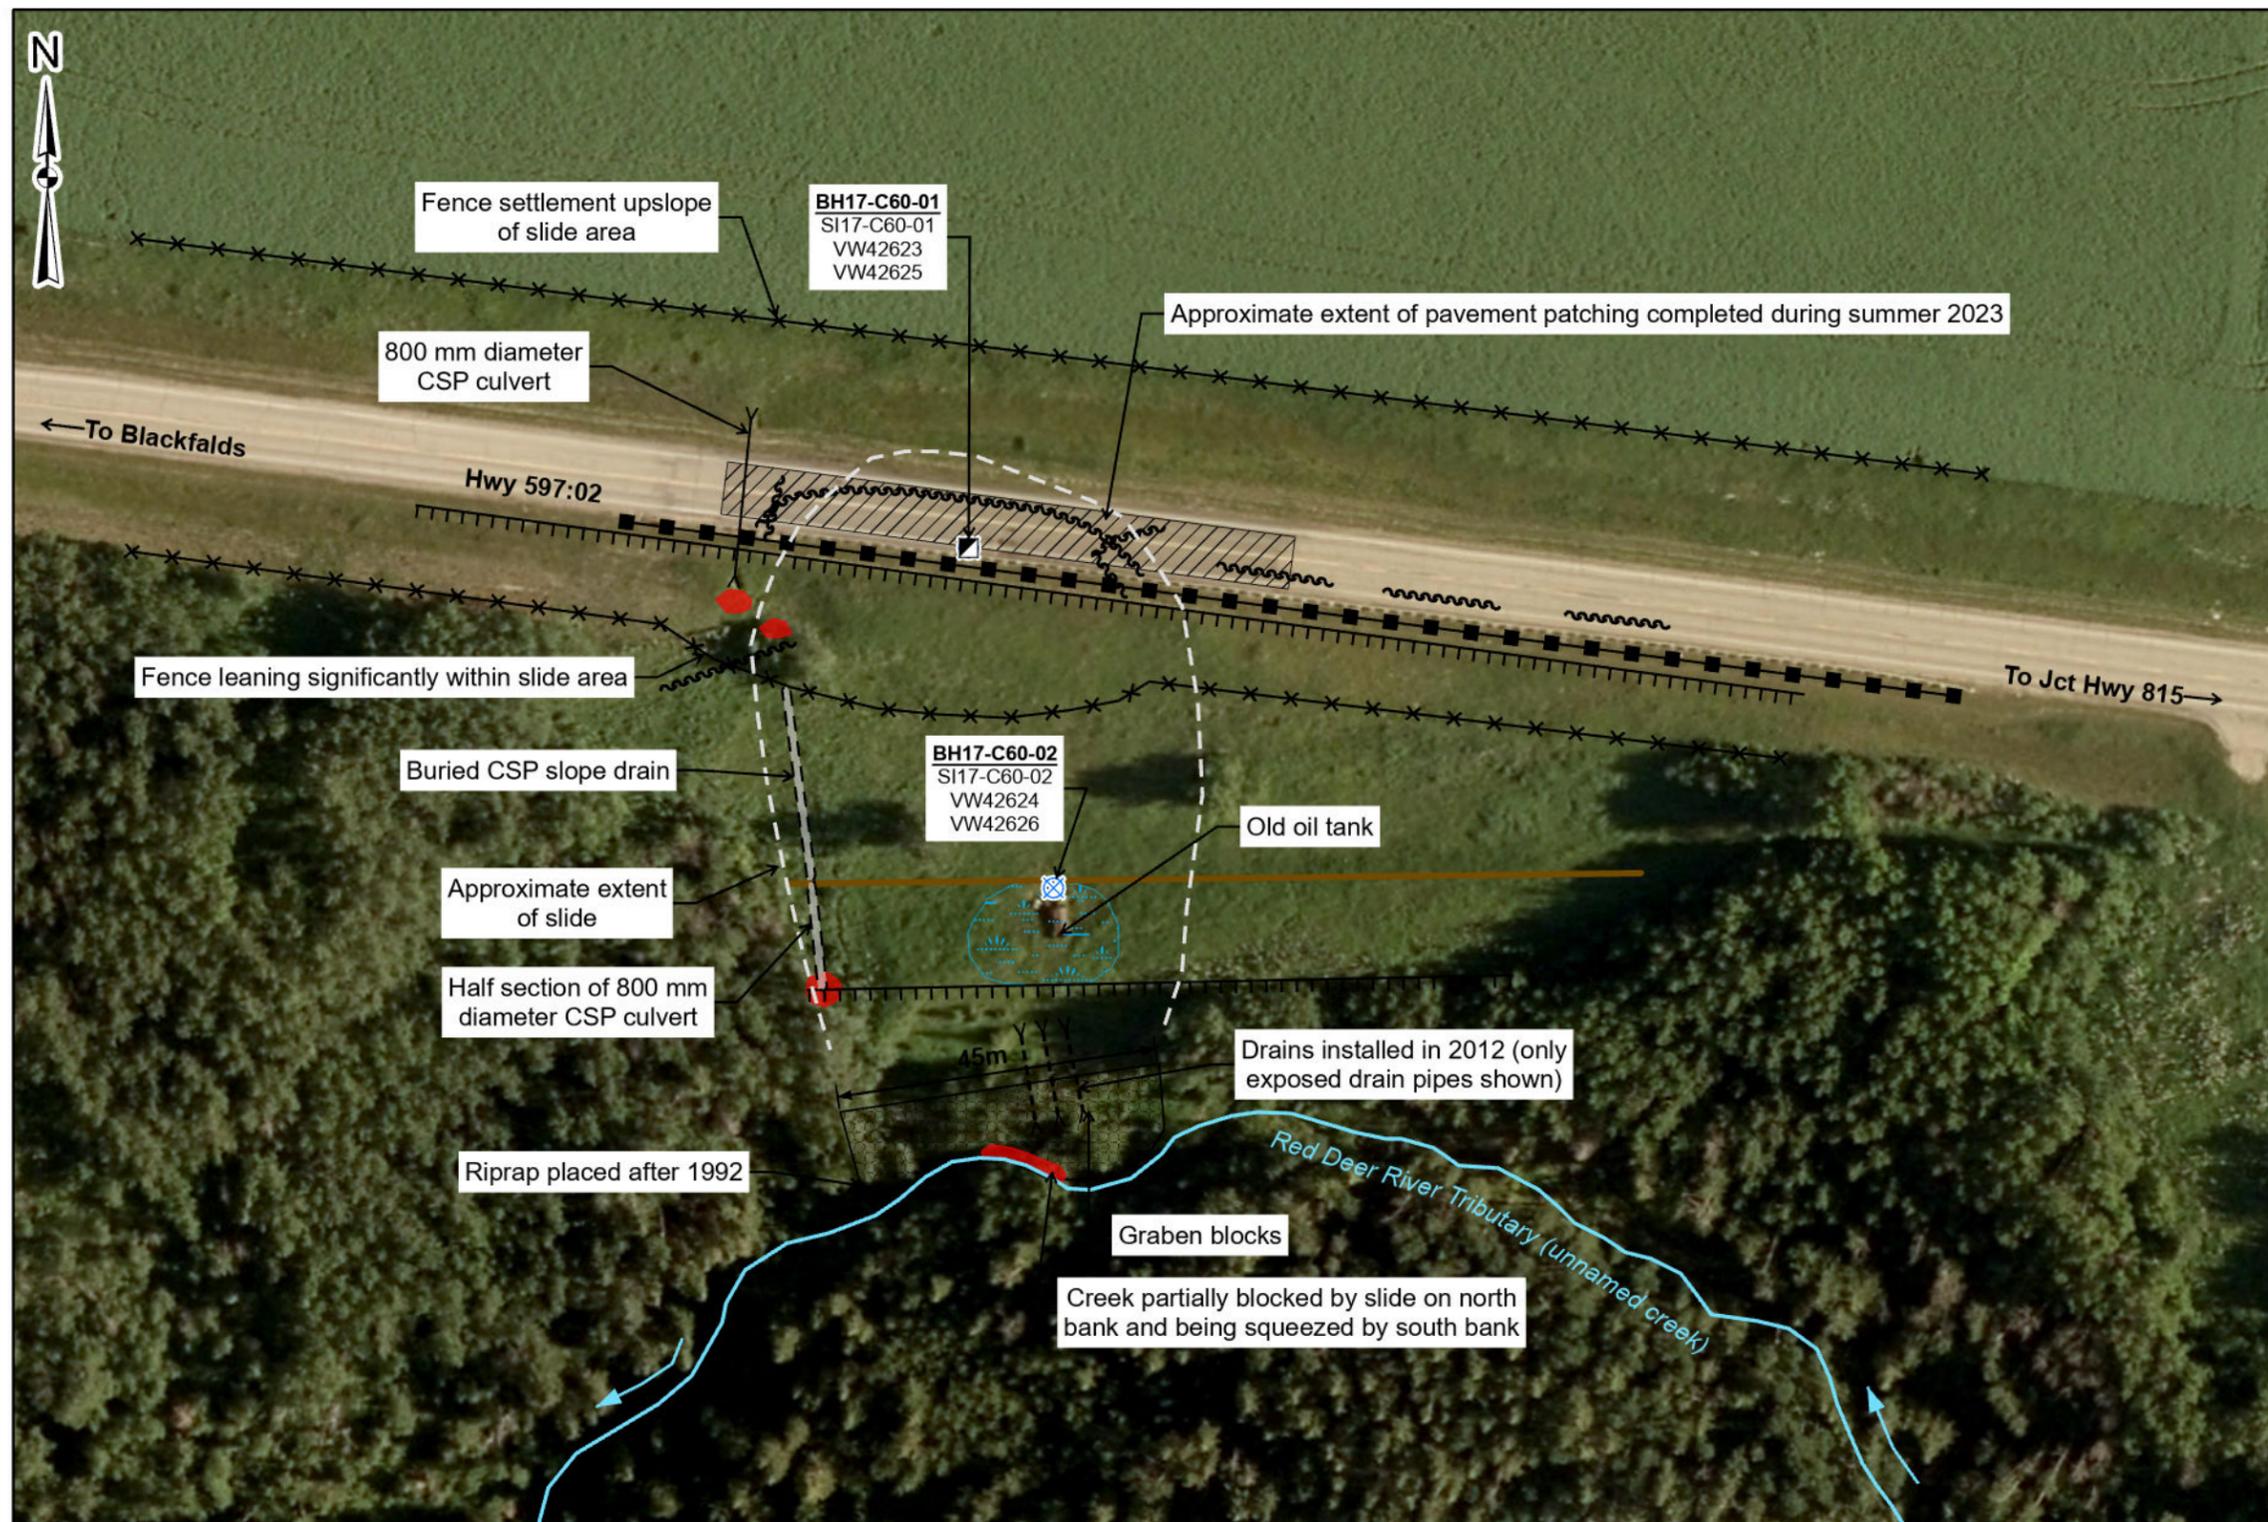
TITLE
Site Plan
C060 - Slide East of Blackfalds
Hwy 597:02, km 11.299

The geohazard at the C060 site consists of a slide through the foundation of the highway embankment. The slide is located on the south side (eastbound lane) of Hwy 597:02. Issues at this site developed shortly after construction of the highway was completed in 1976. Previous remedial actions at this site include installation of horizontal drains in November 1983 to lower the groundwater table, construction of a toe berm with a shear key in 1983, construction of a riprap toe berm sometime after 1992, installation of deep horizontal drains in February 2012, and removal of a dip in the highway surface in summer 2012.

Current instrumentation data indicates movement is occurring below the crest of the highway embankment and below the crest of the toe berm. As the upper portion of the slide continues to move, load will be placed on the lower portion of the slide below the toe berm causing movement of the embankment toe and slope.

- extending the corrugated-steel-pipe (CSP) slope drain to discharge surface water runoff into the creek and not the toe berm surface;
- installing a drainage system on the west abutment to intercept any groundwater that may be entering the embankment from the original valley slope;
- enlarging the toe berm and passing creek flows with a culvert;
- placing additional riprap at the toe of the slope; and
- installing a pile wall or a double row of pile walls at the head of the slide.

Currently, unless movements accelerate and impact the highway surface, TEC has no plans of repairing this site. Since SI17-C60-01 is recording movement below the highway surface, TEC should inspect the road surface regularly for signs of pavement distress (e.g., cracking and/or settlement).

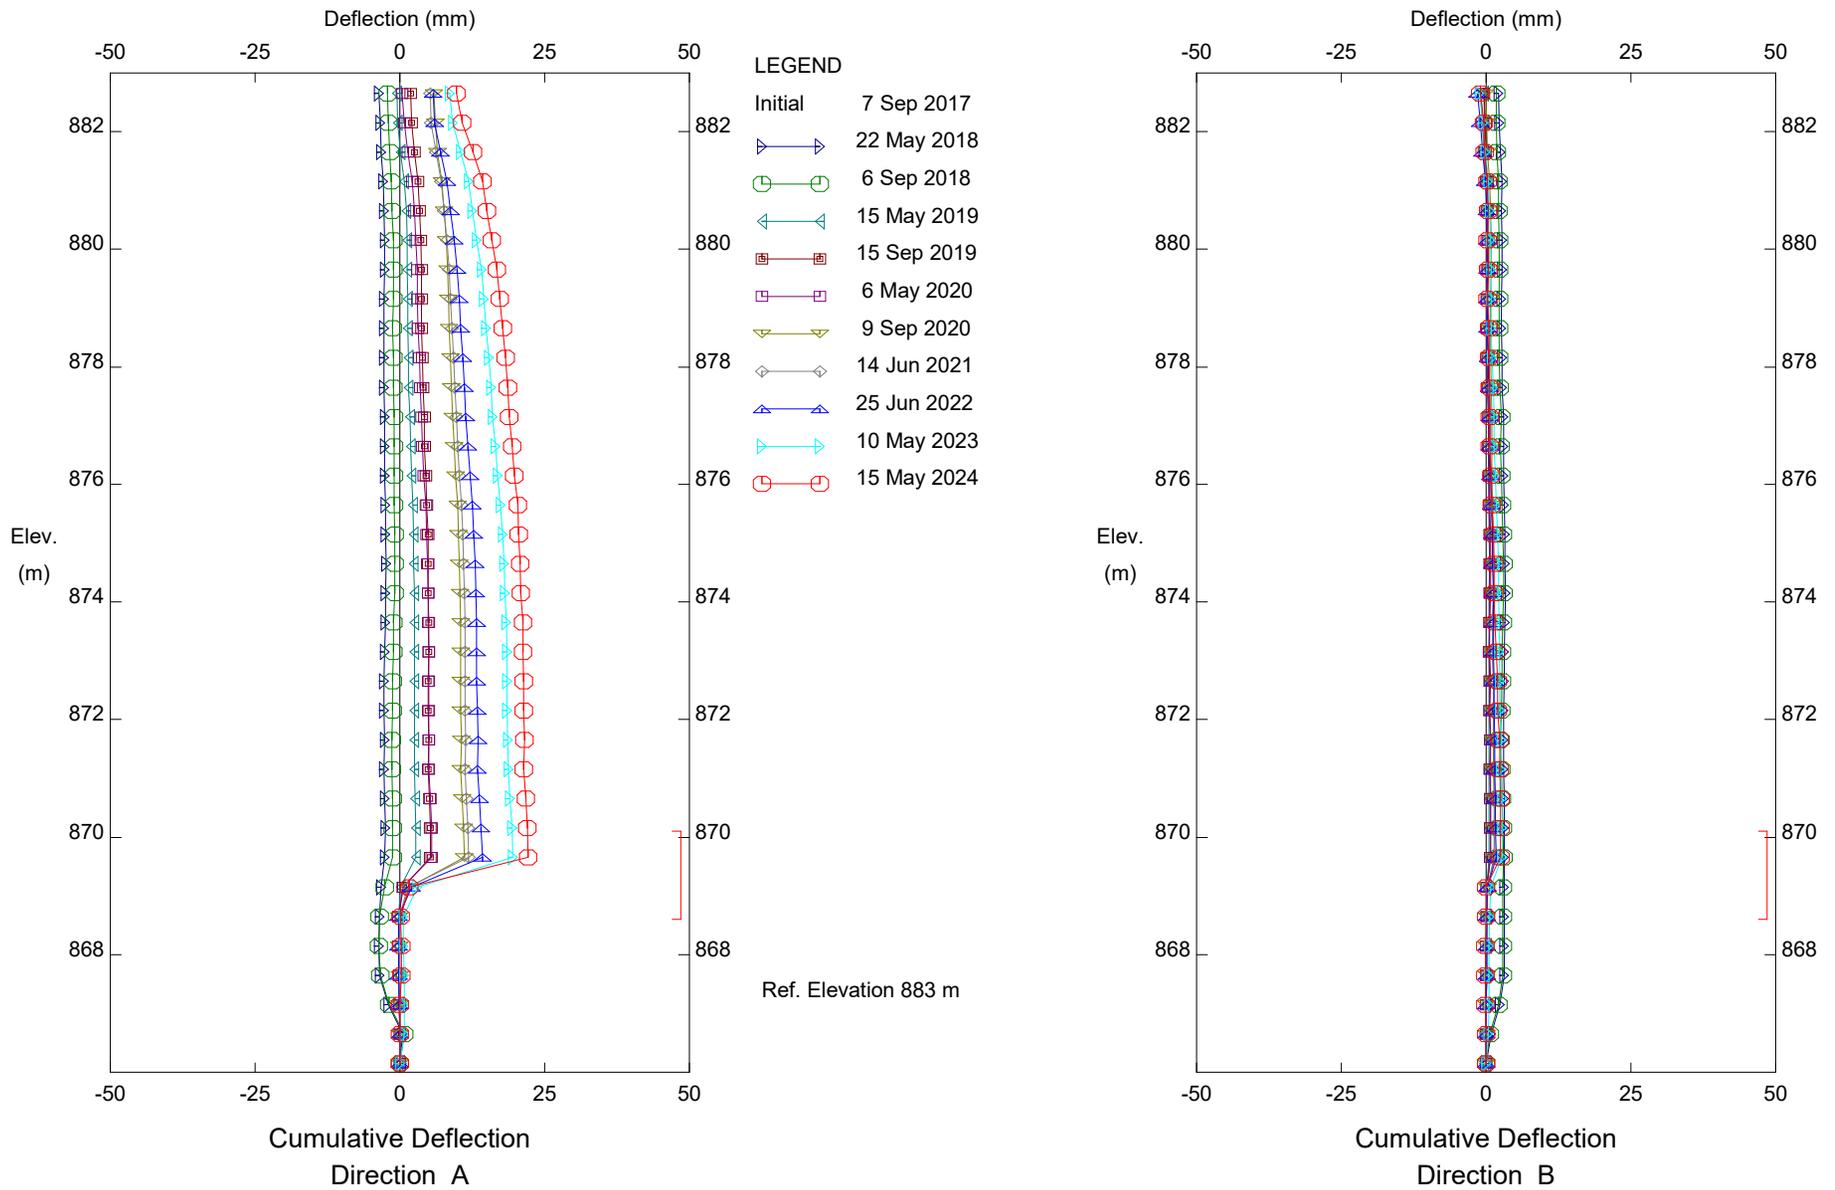
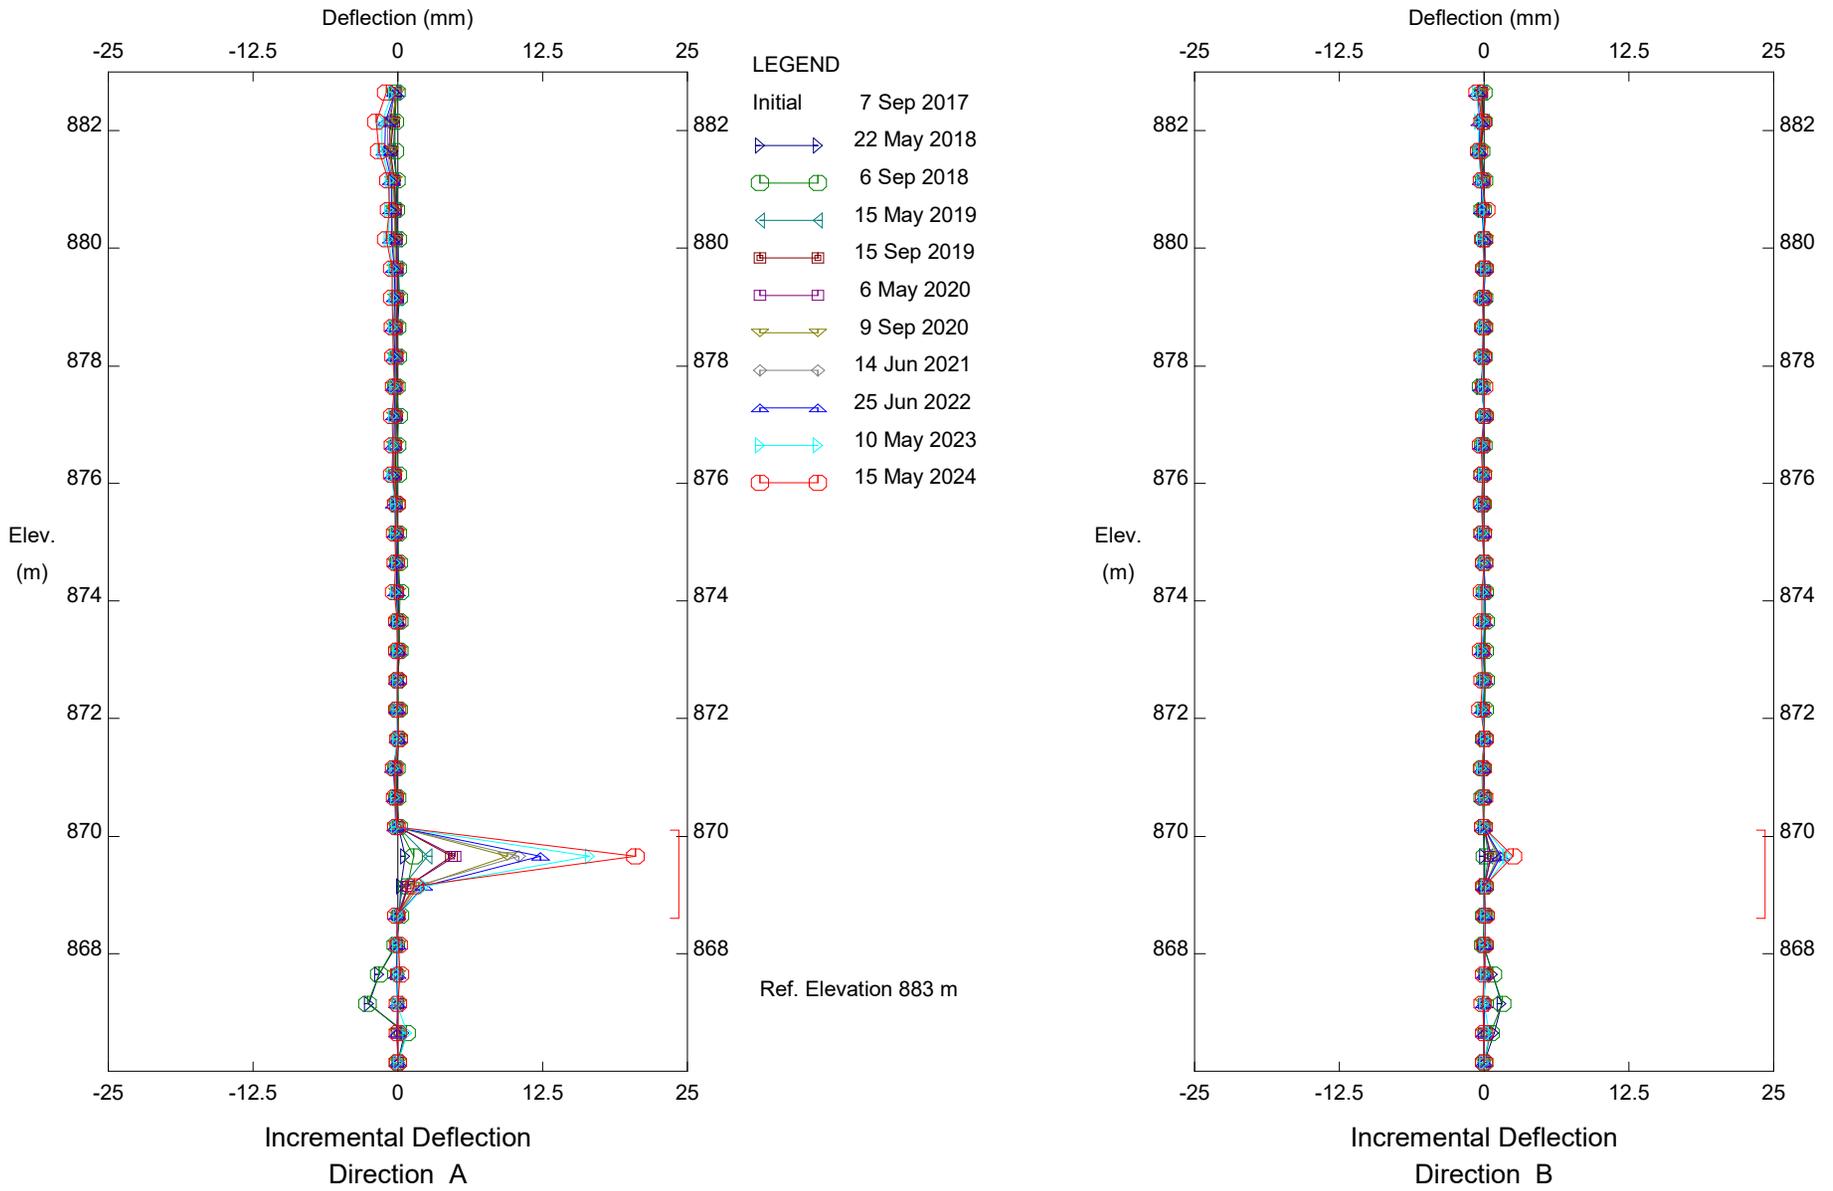
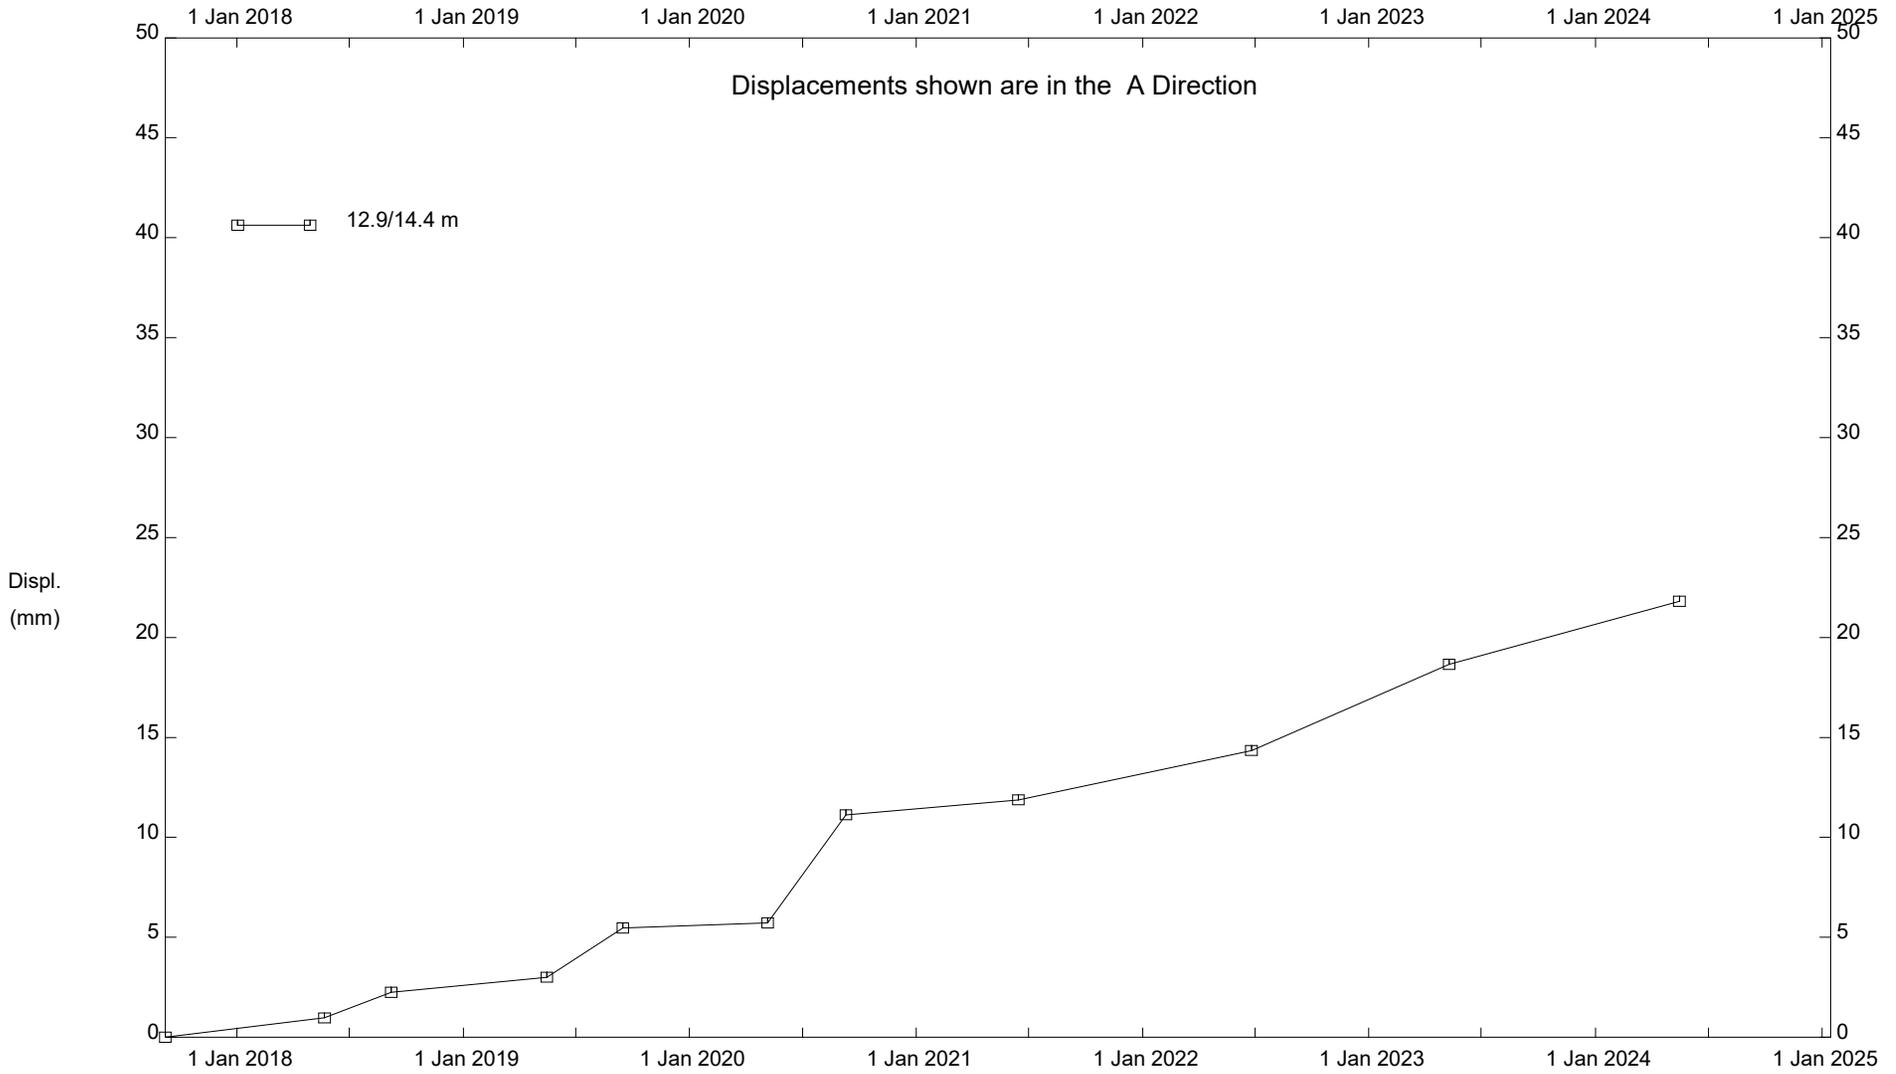
C060; H597:02, Slide East of Blackfalds, Inclinator SI17-C60-01

Discrete movement is being recorded in SI17-C60-01 at an approximate depth of 13.9 m below ground surface (approximately elevation 869.2 m). Prior to being re-initialized in 2017, distributed movement was being recorded at an approximate depth of 2.3 m (approximately elevation 880.7 m).

- the movement recorded in SI10-01 and SI12-01 (mid-slope) appears to have occurred at the interface between the clay and rafted bedrock.
- the upper and lower zones of movement recorded in SI17-C60-01 appear to be occurring in the embankment fill and at the interface between clay and bedrock. The magnitude and rate of movement being recorded in SI17-C60-01 tends to fluctuate, especially near the bottom of the casing. Based on the stratigraphy encountered during the 2010 drilling investigation, we suspect SI17-C60-01 was terminated in rafted bedrock and the toe of the SI could be moving. Although SI17-C60-01 extends below the suspected failure surface, it may not extend deep enough and the recorded movement, especially near the bottom of the casing, are likely caused by movement of the rafted bedrock in the underlying till.

The rate of movement in SI17-C60-01 has been relatively steady (less than 7 mm/year) since installation, except for between May 2020 and September 2020 when the rate of movement increased to approximately 16 mm/year before decreasing to 1 mm/year in June 2021. A steady rate of movement (less than 6 mm/year) has also been recorded in SI17-C60-02 since installation apart from an increase to approximately 14 mm/year between May and September 2020. The increased rate of movement recorded in both slope inclinometers between May and September 2020 is likely attributed to wet weather during the summer months. The May 2024 readings for both SI17-C60-01 and SI17-C60-02 are consistent with their historical trends.

Some minor movement has been recorded in the B-direction of SI17-C60-01 and SI17-C60-02, which has been attributed to poor grout backfill and casing settlement, respectively.

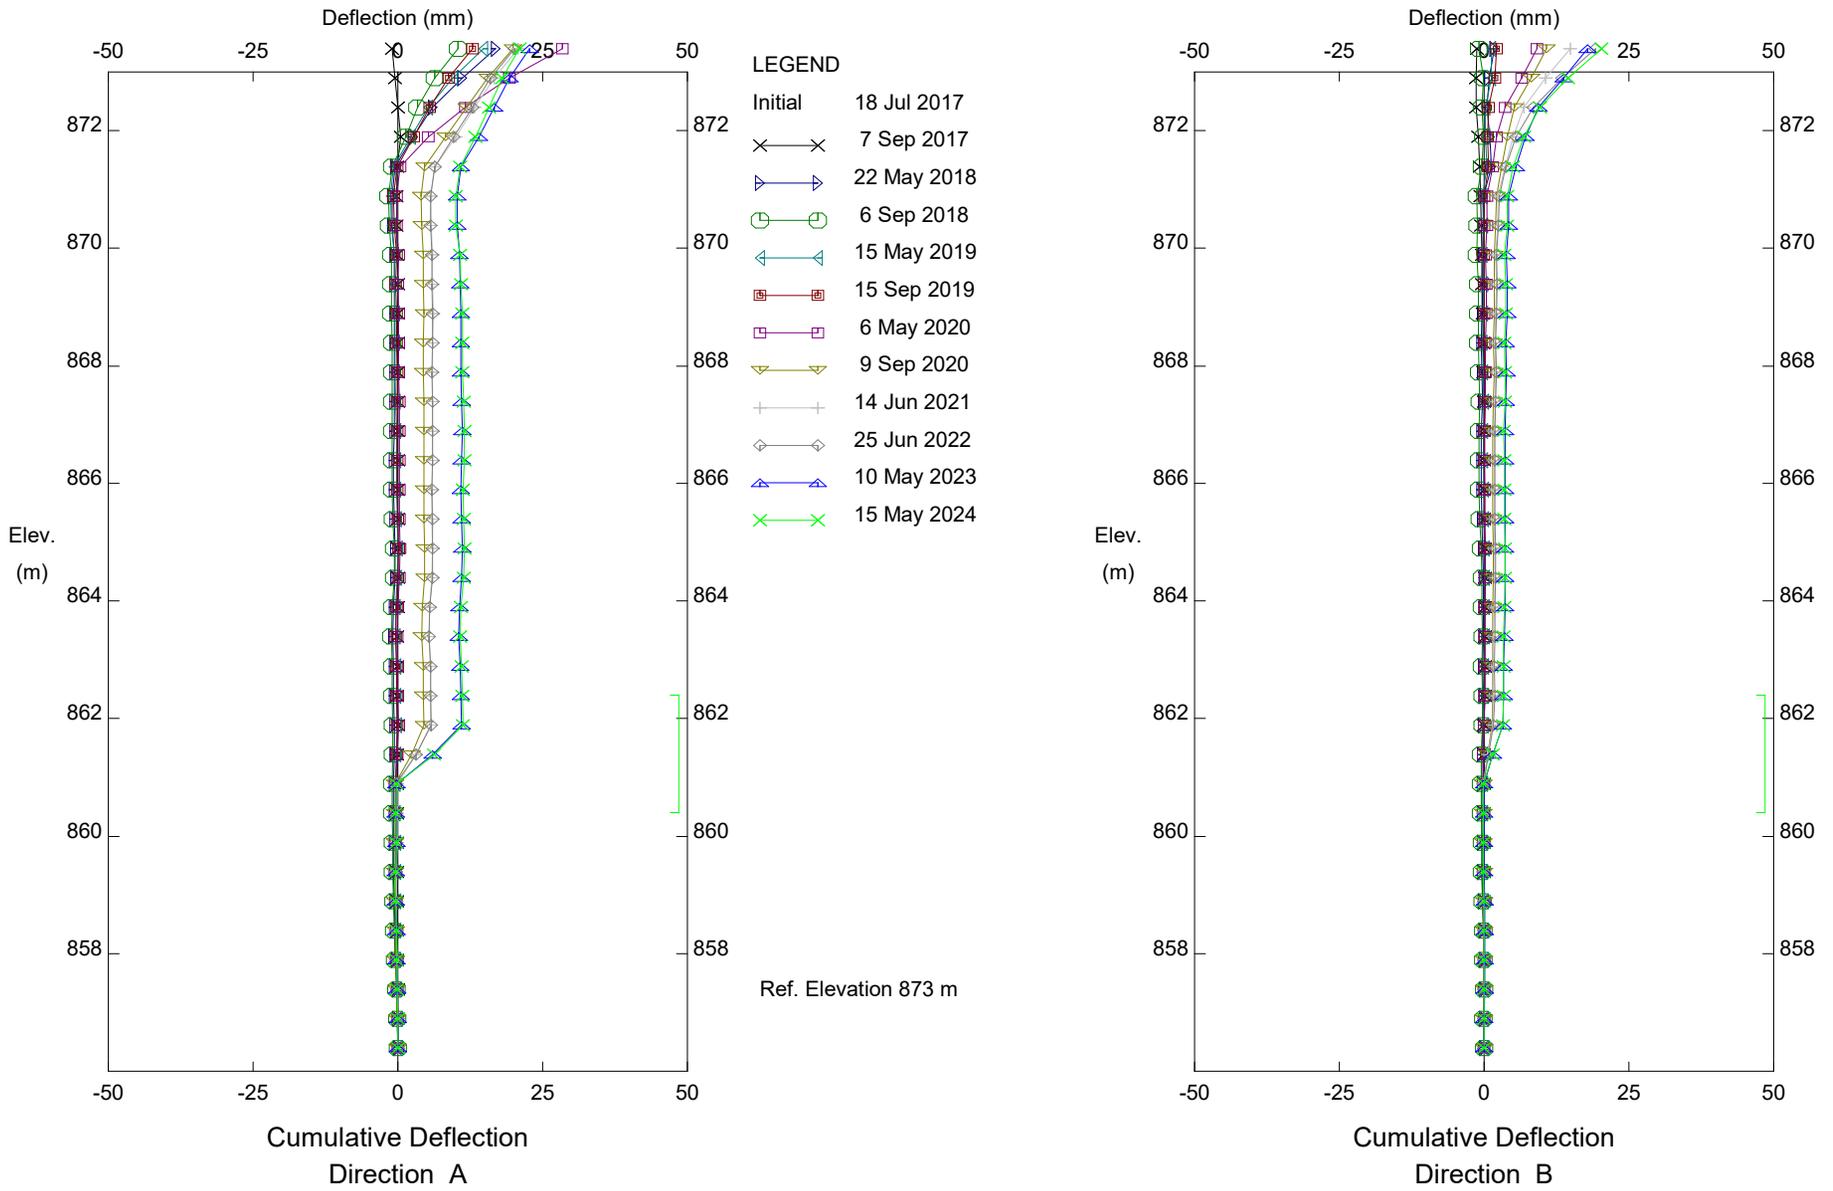
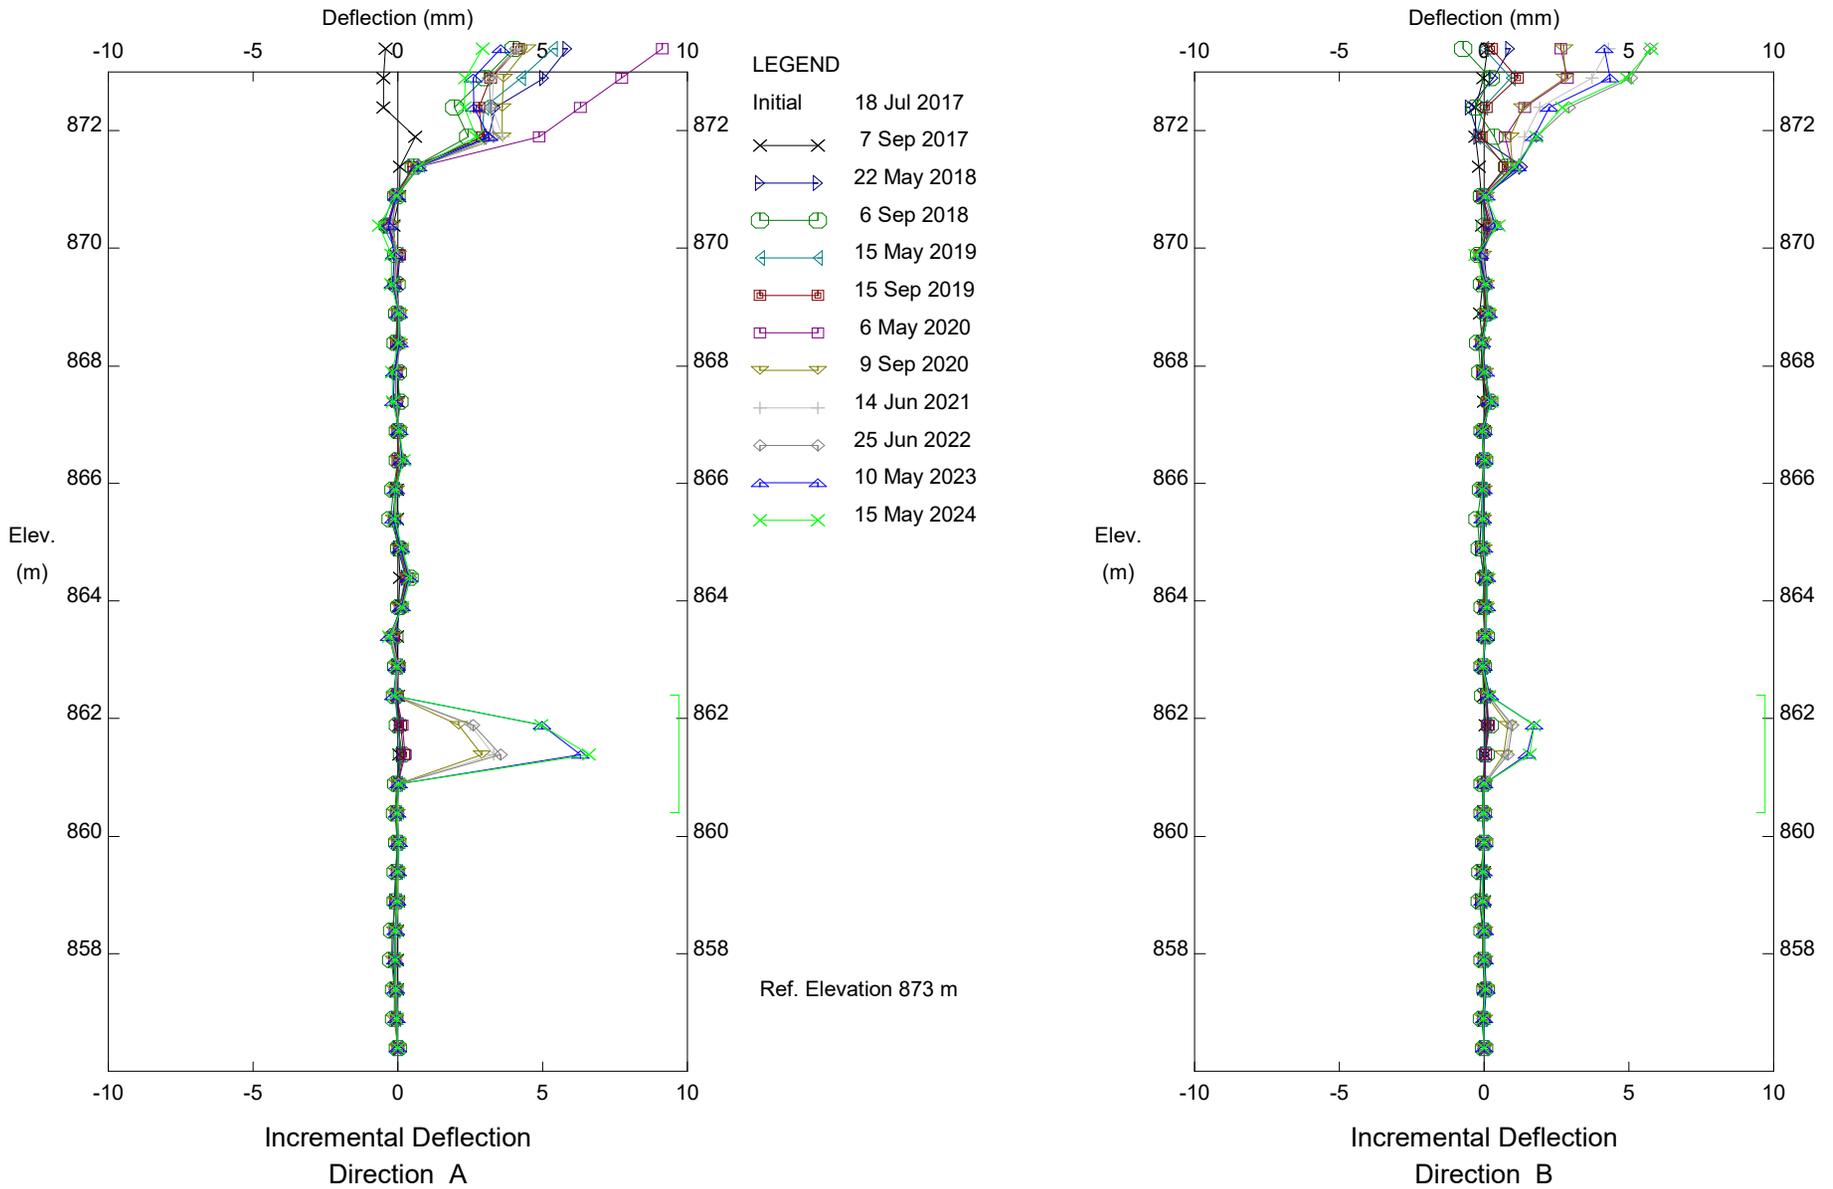
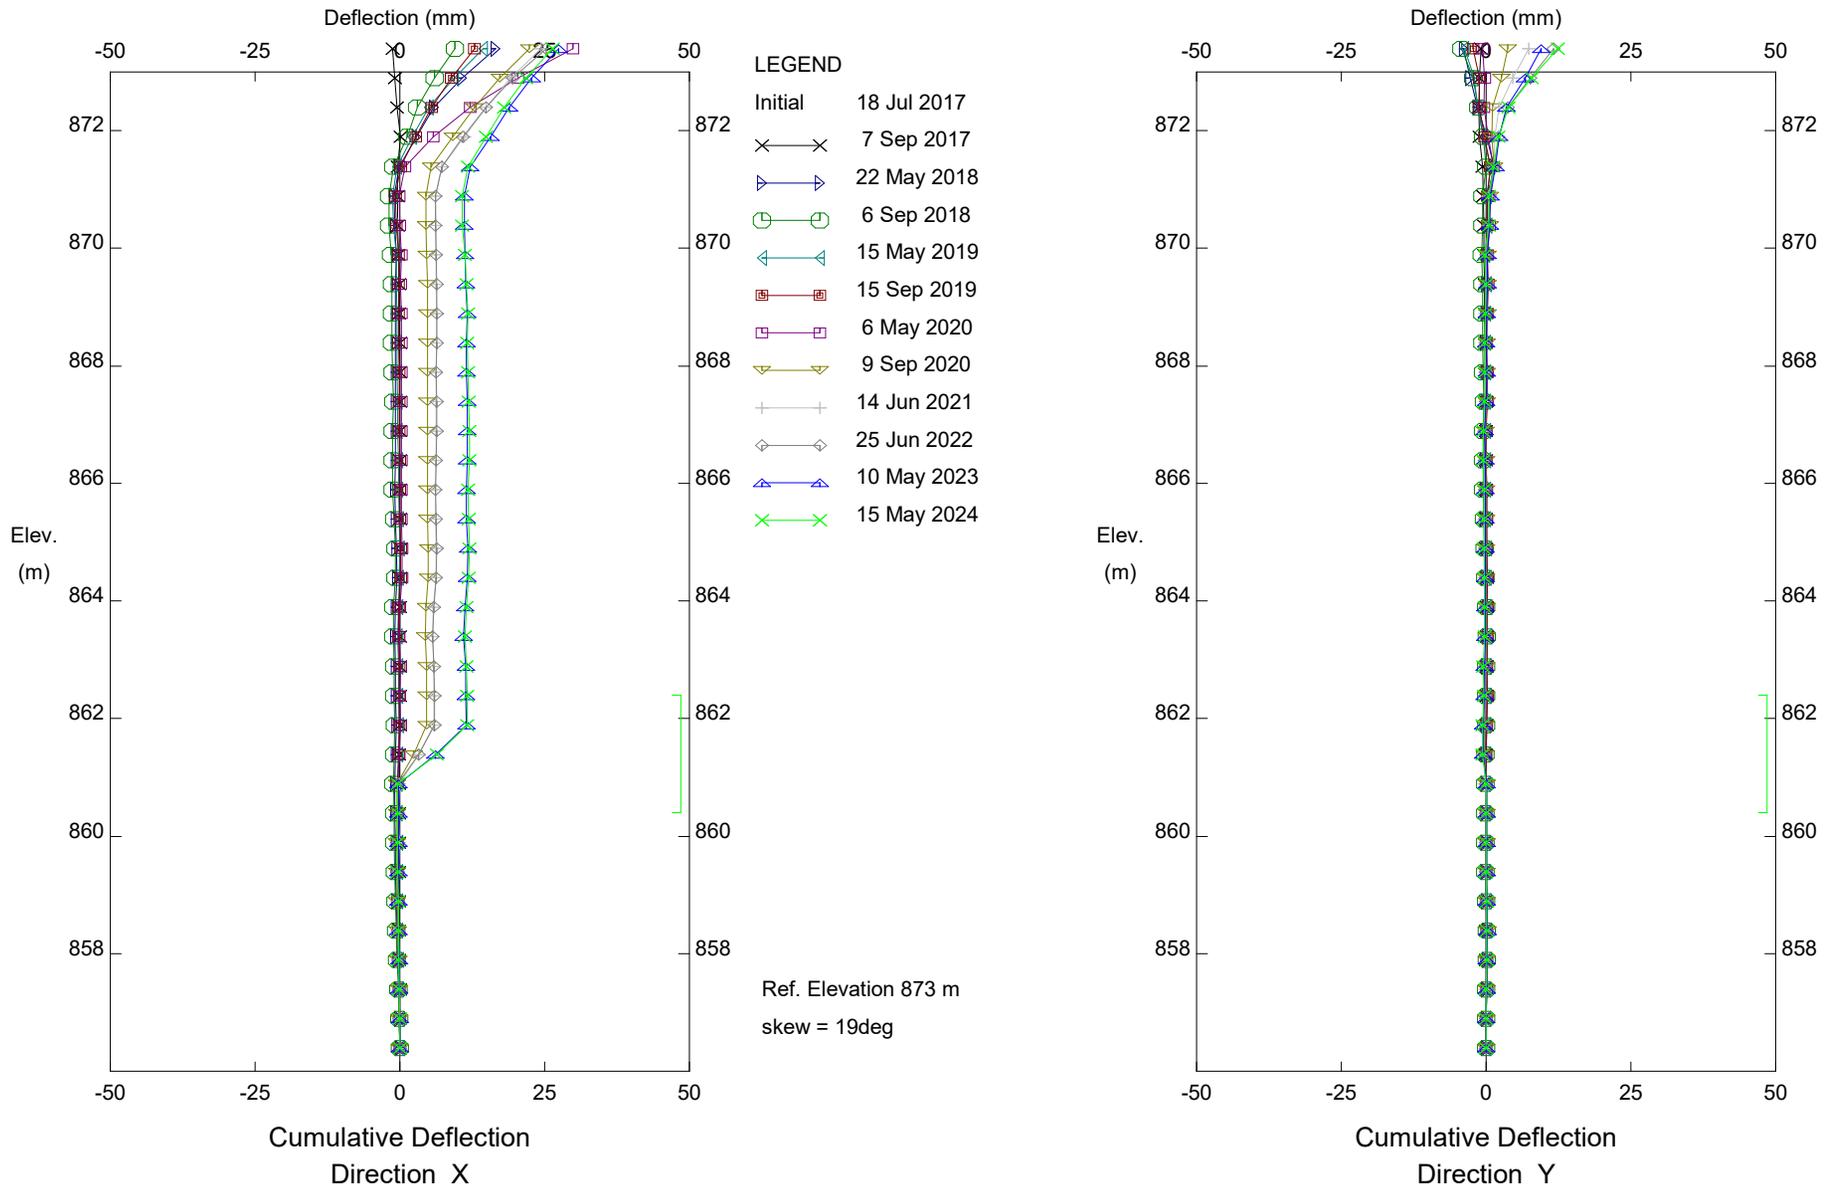
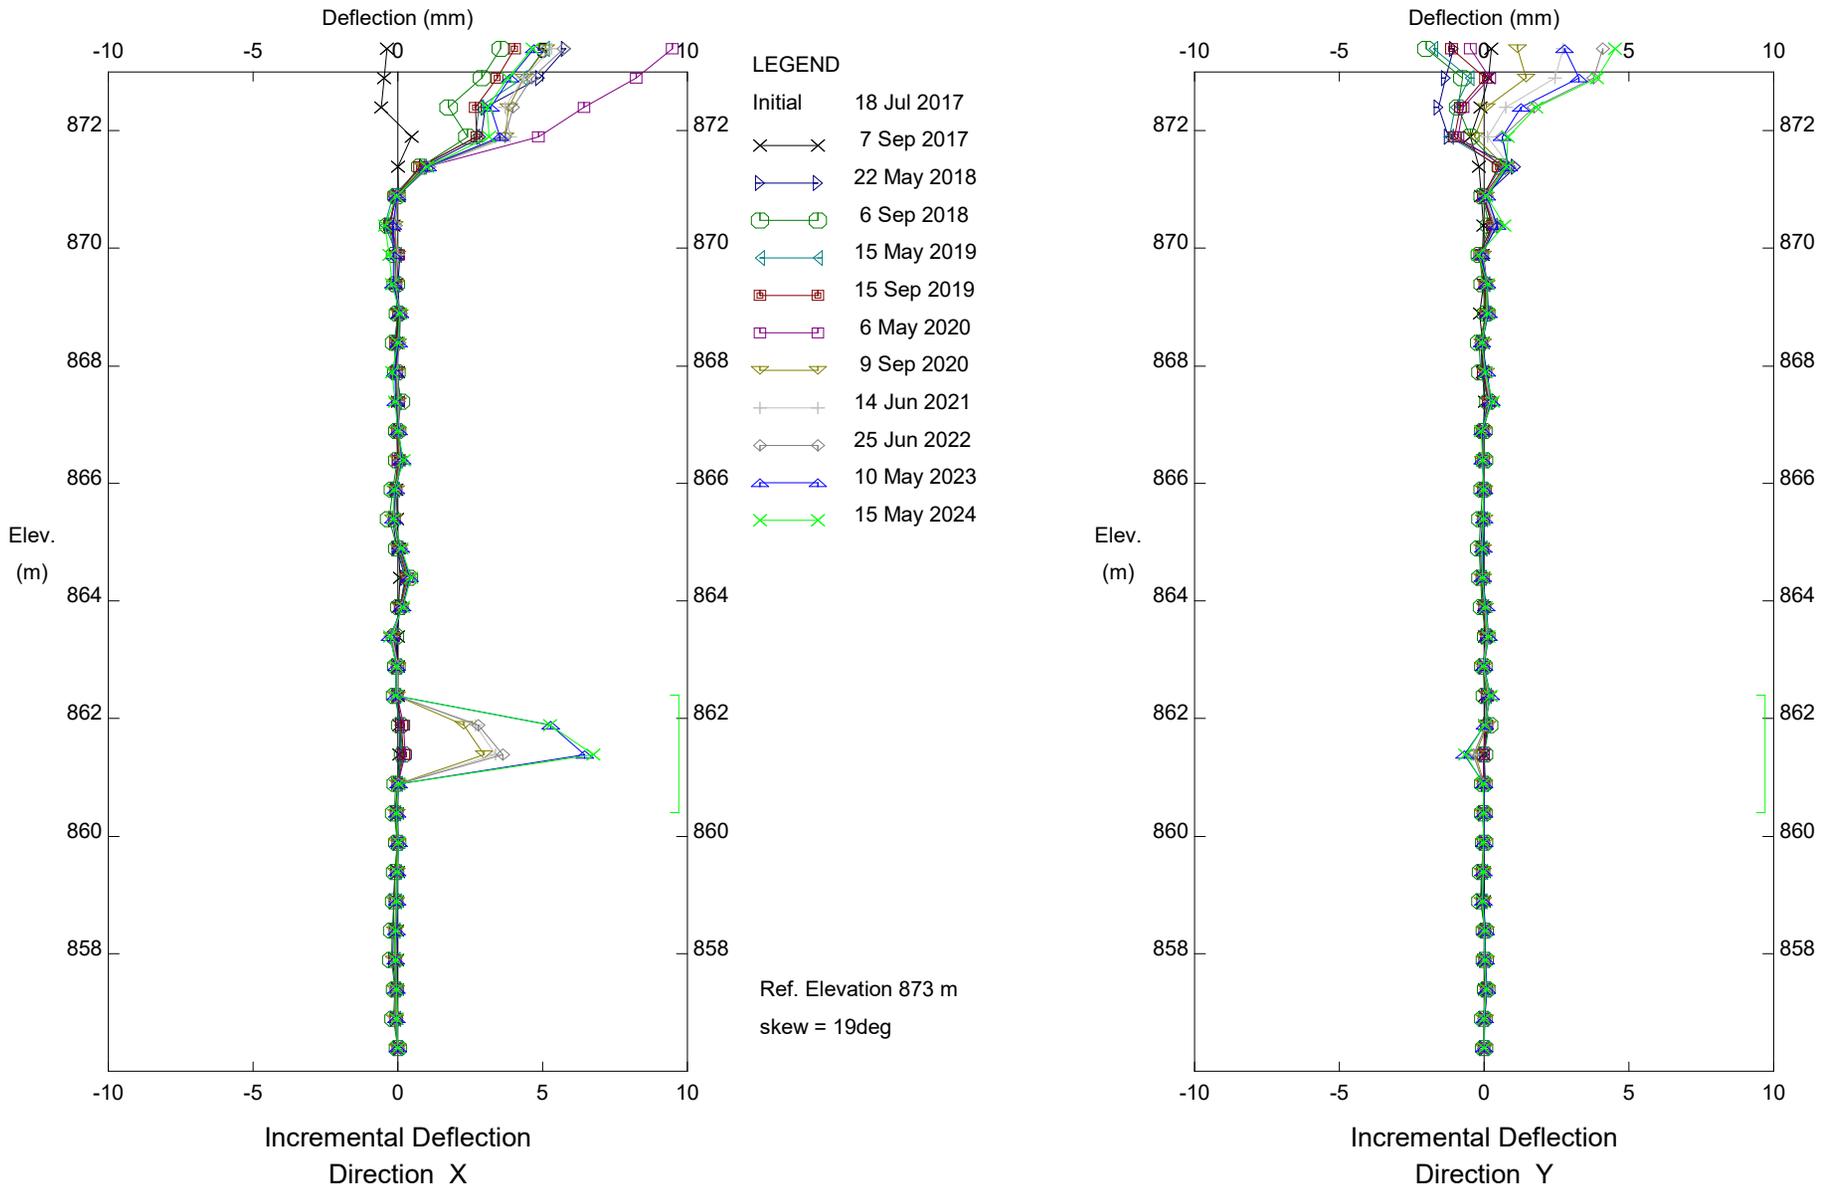
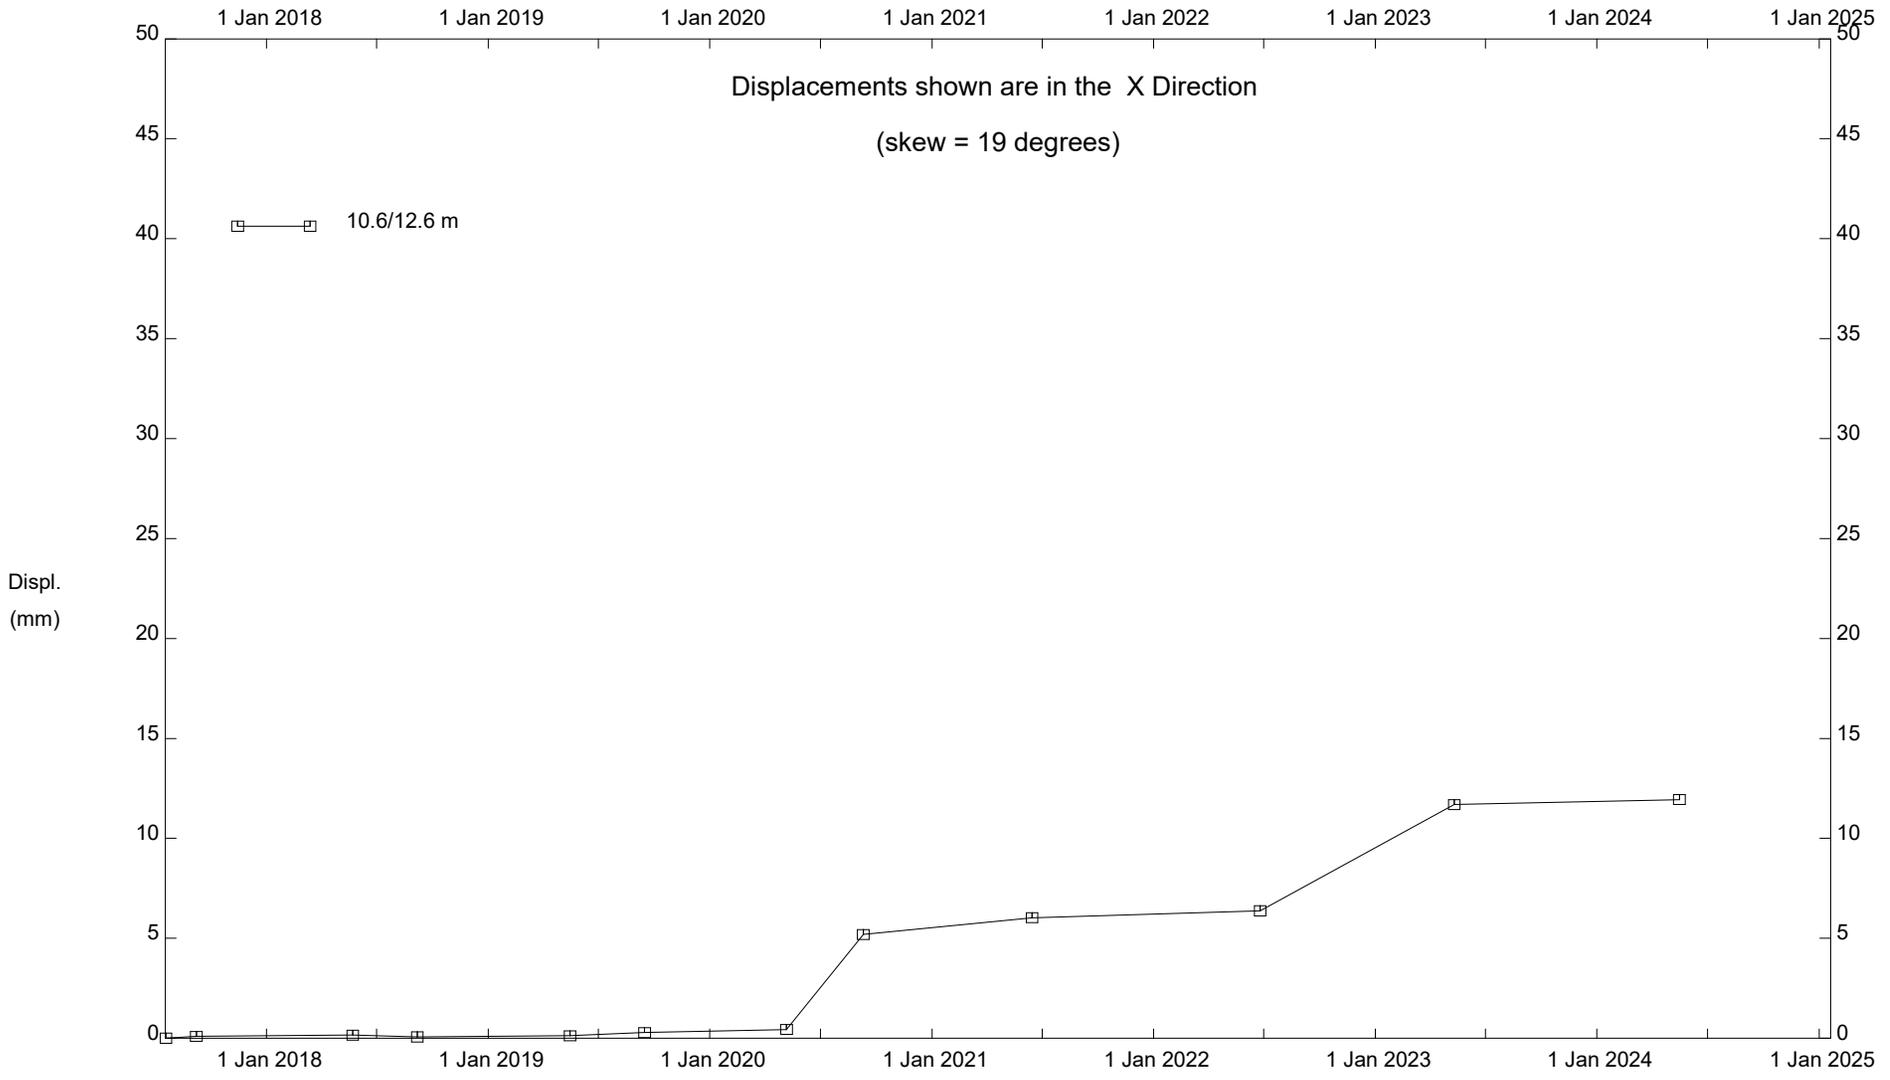
C060; H597:02, Slide East of Blackfalds, Inclinator SI17-C60-02

Discrete movement is being recorded in SI17-C60-02 at an approximate depth of 12.1 m below ground surface (approximately elevation 860.9 m).

- the movement recorded in SI17-C60-02 appears to be occurring near the interface between the toe berm fill and underlying foundation materials.
