July 15, 2024

Alberta Transportation and Economic Corridors
4th Floor, Provincial Building
4920 51 Street
Red Deer, Alberta
T4N 6K8

**CON0022160 Central Region GRMP Instrumentation Monitoring
Site C060; H597:02, km 11.299 Slide East of Blackfalds
Section C – 2024 Spring Readings**

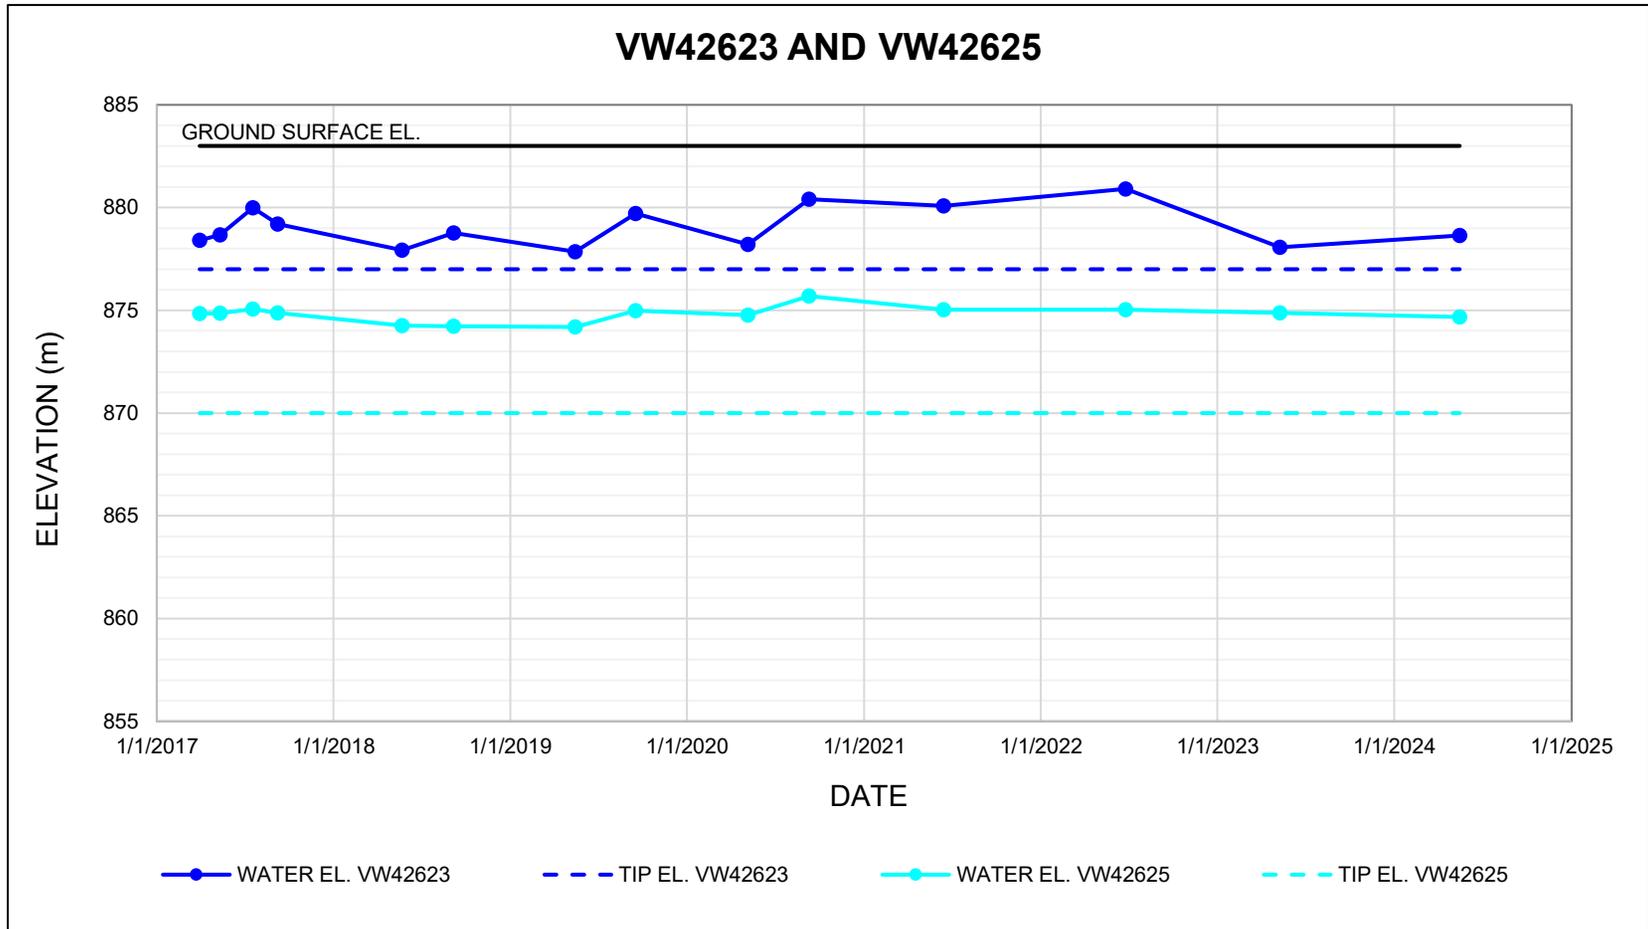
| | TITLE Piezometer Data C060 - Slide East of Blackfalds Hwy 597:02, km 11.299 | | |

Water levels recorded in VW42625, VW42624, and VW42626 (lower piezometer below highway, and piezometers below toe berm crest) have been relatively steady (typically ± 0.5 m) since they instruments were installed in 2017, excluding higher-than-typical water levels recorded in September 2020 after wet weather during the summer months. Water levels recorded in VW42623 (upper piezometer below highway) appear to fluctuate seasonally with the spring readings being lower than fall readings. However, since the reading frequency was reduced to spring readings only in 2021, fluctuations between seasons are no longer captured.
