<b>SITE NUMBER AND NAME:</b> C075-I and -II Hwy 609 and Hwy 56 Ditch Erosion		<b>HIGHWAY &amp; KM:</b> 609:02, 16.42	<b>PREVIOUS INSPECTION DATE:</b> May 31, 2022	<b>INSPECTION DATE:</b> <b>June 17, 2024</b>
<b>LEGAL DESCRIPTION:</b> NW 08-44-19-W4M & SW 17-44-19-W4M	<b>NAD 83 COORDINATES:</b> UTM    Northing    Easting 12      5849463    383508		<b>RISK ASSESSMENT:</b> C075-I: PF: 9    CF: 2    TOTAL: 18 C075-II: PF: 11    CF: 2    TOTAL: 22	
<b>AVERAGE ANNUAL DAILY TRAFFIC (AADT):</b> 540 (east) & 440 (west) (Reference No. 107370 & 110370)			<b>CONTRACT MAINTENANCE AREA (CMA):</b> 517

PROJECT  
CENTRAL REGION GEOHAZARD RISK MANAGEMENT PROGRAM

TITLE  
 Site Plan  
 C075 - Hwy 609 Ditch Erosion  
 Hwy 609:02, km 16.420

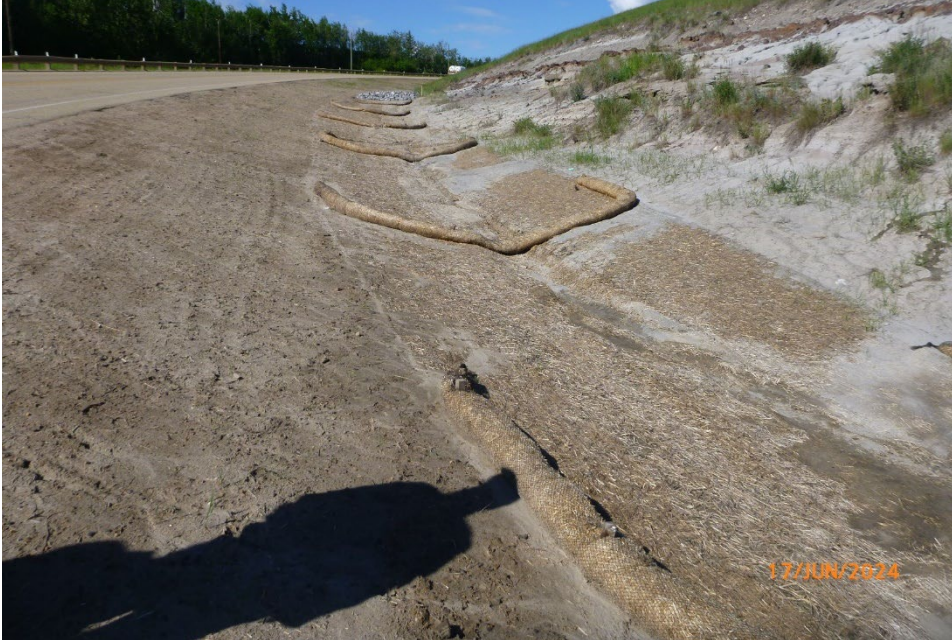
- In 2023, most of the north (westbound) ditch was backfilled with well graded material, armoured with a rolled erosion control product (RECP), and straw wattle and riprap check dams were installed regularly along the repair (Photos 1 through 5). At the culvert outlet, additional riprap (angular, estimated to be Class 1M) was placed upstream and downstream of the culvert outlet (overtop of the rounded riprap placed in 2021) (Photo 7 and 8). TEC informed KCB that the repair work was completed by Inline.

**Photo 1** The ditch erosion along the north (westbound) ditch of Hwy 609 was backfilled, armoured with RECP, and riprap check dams and straw wattles were installed in 2023. Photo taken June 17, 2024, facing west-northwest.

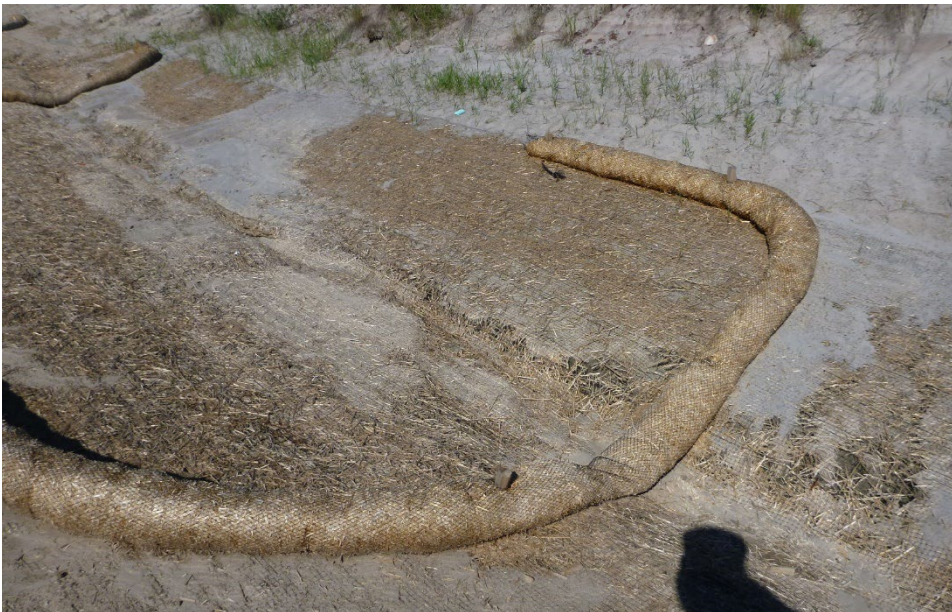
- There was some undermining of the RECP along the repair in the ditch center (Photo 1 and 2). KCB confirmed with TEC's MCI that no check trenches were completed during the repair. The undermined areas are worse the further downstream (east) towards the culvert outlet.

**Photo 2** The RECP along portions of the repair is being undermined. Photo taken June 17, 2024, facing north.

- The riprap check dams should be expanded laterally to span the entire width of the ditch. The side slopes of the check dams (i.e., parallel with the ditch orientation) should be flattened from approximately 2H:1V to 4H:1V.
- Where the RECP is being undermined, the RECP should be cut, erosion backfilled with compacted granular fill, and new RECP placed.
- In areas where there is insufficient freeboard (particularly near the east extent of the repair, upstream of the culvert outlet) the RECP should be removed and replaced to have at least 0.5 m of freeboard on both ditch side slopes.

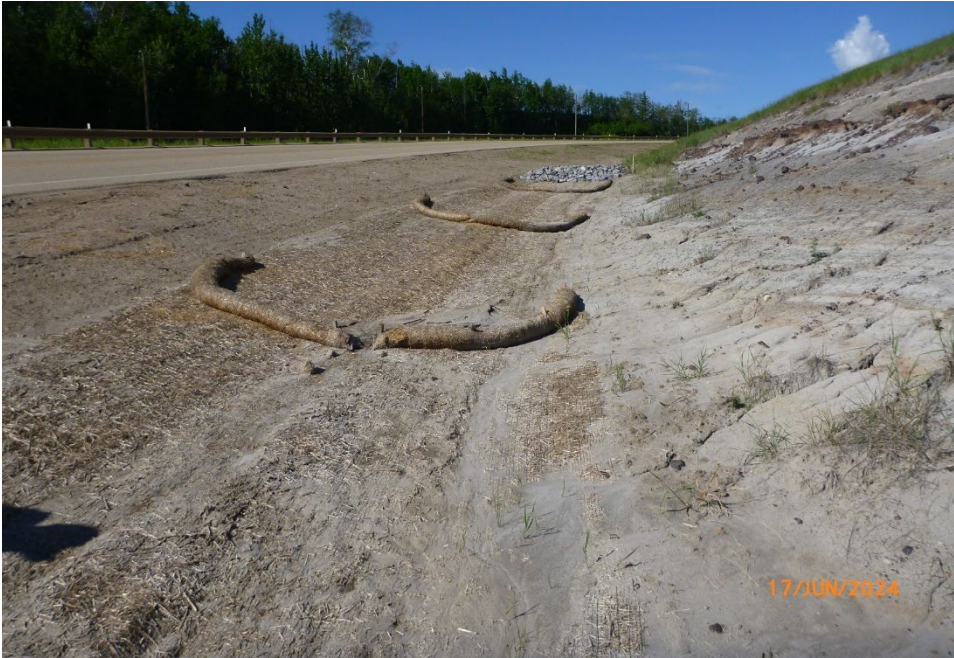
- Straw wattles were installed regularly along the repair. During the 2024 inspection, some of the straw wattles were breached, likely during high flow events, reducing their effectiveness (Photo 3). Sediment is also accumulating behind the straw wattles (Photo 4)

**Photo 3** Several of the straw wattles were breached after installation, reducing their effectiveness. Photo taken June 17, 2024, facing west.

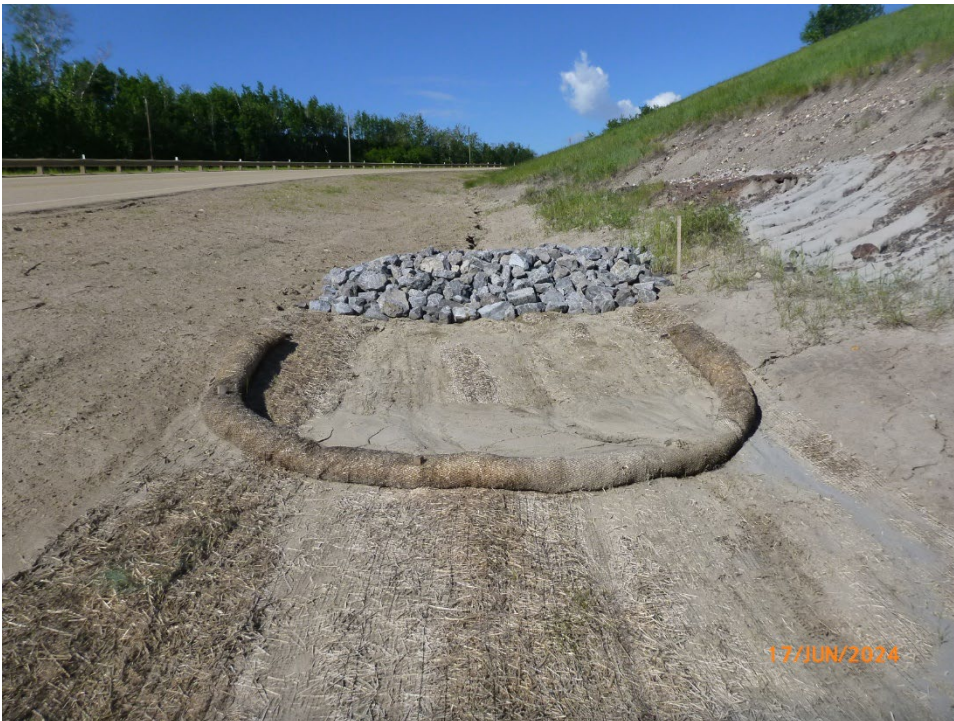
**Photo 4** Sediment is accumulating behind the straw wattles. Photo taken June 17, 2024, facing west.

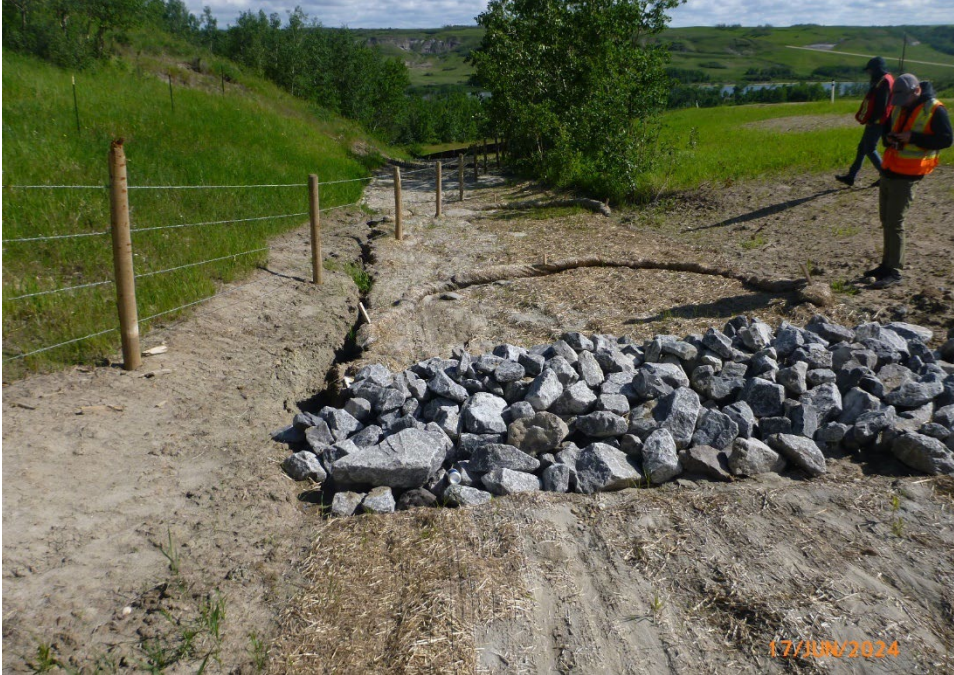
- The riprap check dams are approximately 0.5 m in height, 1.5 m long, and 3 m wide (Photo 4 and 5). The riprap is angular, appears to be Class 1M, and likely sourced from near Nordegg, Alberta. The check dams are quite steep and do not span the full width of the ditch. KCB suspects they were not placed closer to the edge of the north (westbound) lane since then they may be within the highway clearance zone. Flows are likely bypassing the check dams since they do not provide sufficient height during heavy precipitation events (Photo 5).

**Photo 5** Due to some of the riprap check dams not spanning the entire width of the ditch with adequate freeboard, flows have bypassed the check dams and are causing erosion gullies to reform. Photo taken June 17, 2024, facing east.

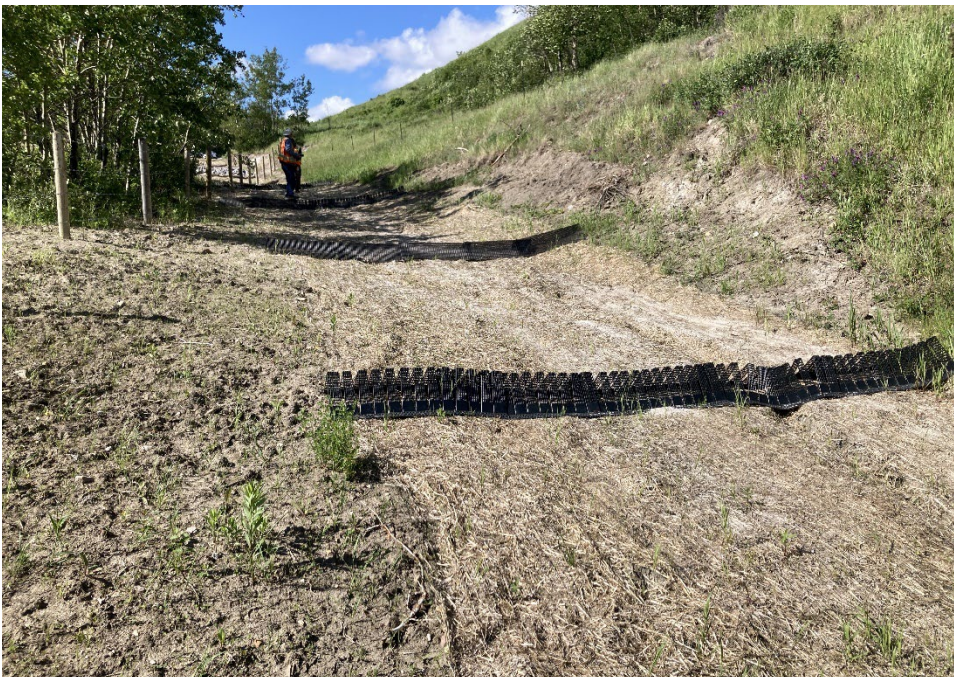
**Photo 6** Plastic check dams were installed along the ditch repair, upstream (west) of the culvert outlet. Photo taken June 17, 2024, facing west.

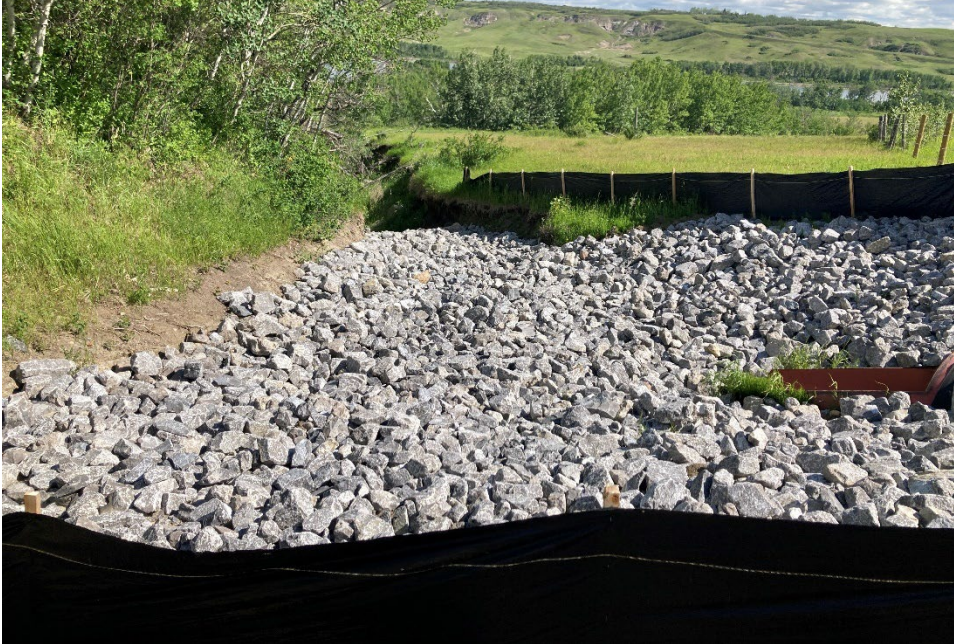
**Photo 7** A large riprap apron (Class 1M) was installed in 2023. The riprap apron was built over the previous apron and filled the large erosion gully downstream of the culvert outlet. Photo taken June 17, 2024, facing east.

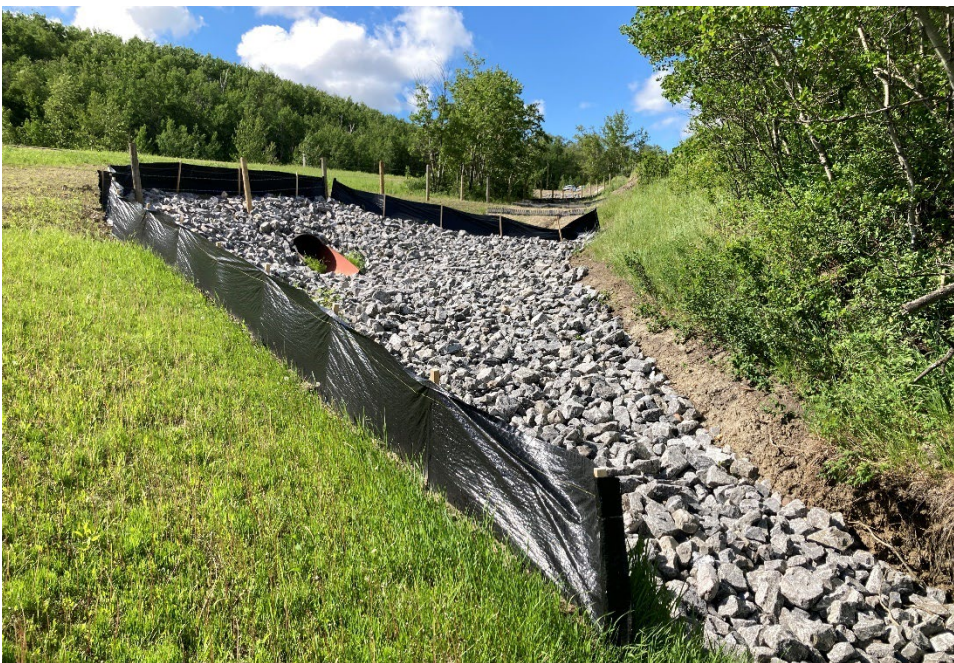
**Photo 8** A large riprap apron (Class 1M) was installed in 2023. The riprap apron is over the previous apron and filled the large erosion gully downstream of the culvert outlet. Photo taken June 17, 2024, facing west.

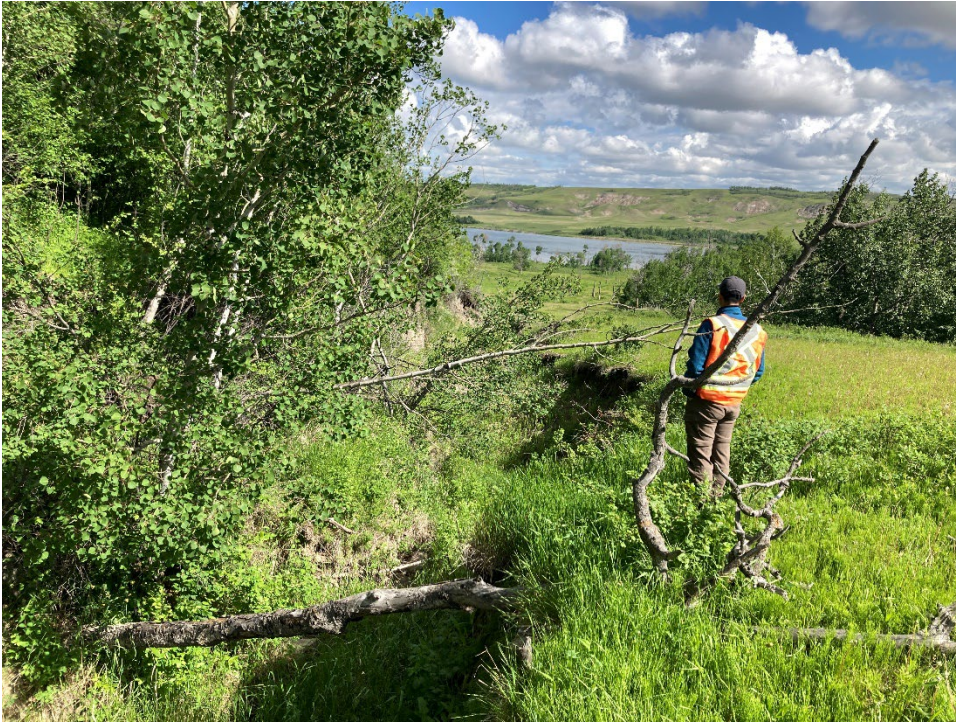
- The erosion gullies downstream (northeast) of the culvert outlet and north of the barbed wire fence appear similar as during the 2022 inspection. Trees along the erosion gully walls are leaning and/or have fallen into the erosion gully, and there is vegetation (grass and shrubs) growing at the base of the erosion gully (Photo 9).

**Photo 9** Erosion gully downstream of the culvert outlet appears to be in similar condition as during the 2022 inspection. Photo taken June 17, 2024, facing northeast.

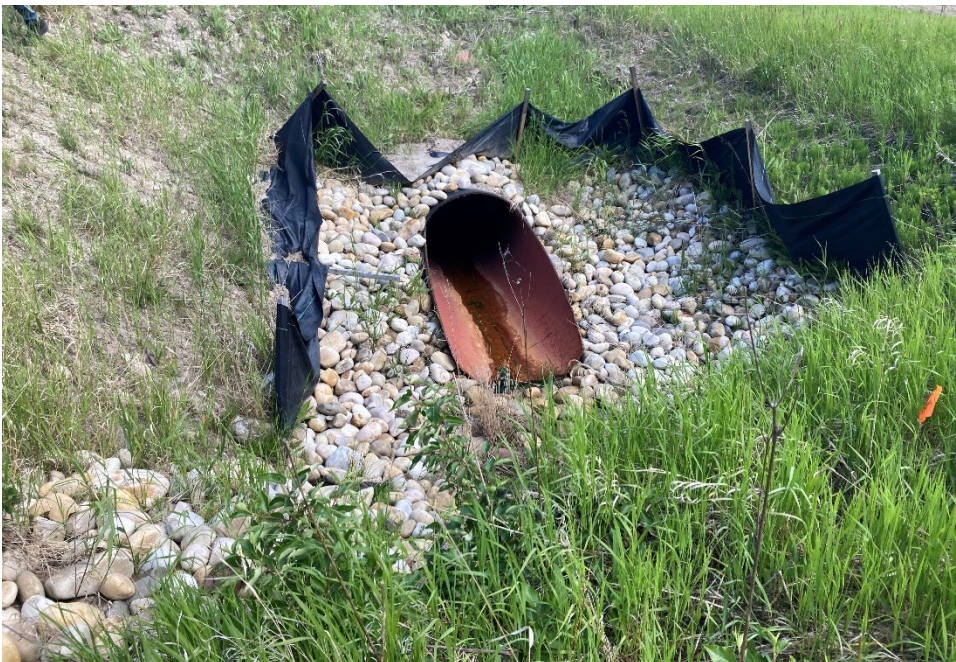
- In 2022, a soft and wet area was observed in the ditch upstream of the CSP culvert inlet. This area appeared drier during the 2024 inspection (likely attributed to improved vegetation cover). The culvert inlet appears to be in good condition (Photo 10).
- There's minor ditch erosion along the south (westbound) ditch (0.5 m to 1.0 m deep and not impacting the highway embankment) (Photo 11 and 12). The ditch is well vegetated, and the degree of erosion does not appear to have noticeably changes since the 2022 inspection.
- There is an exposed fibre-optic line (first observed during the 2020 call-out inspection) near the west extent of the site.
- A fence is being impacted by the ditch erosion.

**Photo 10** The culvert inlet appears to be in good condition. Photo taken June 17, 2024, facing northeast.

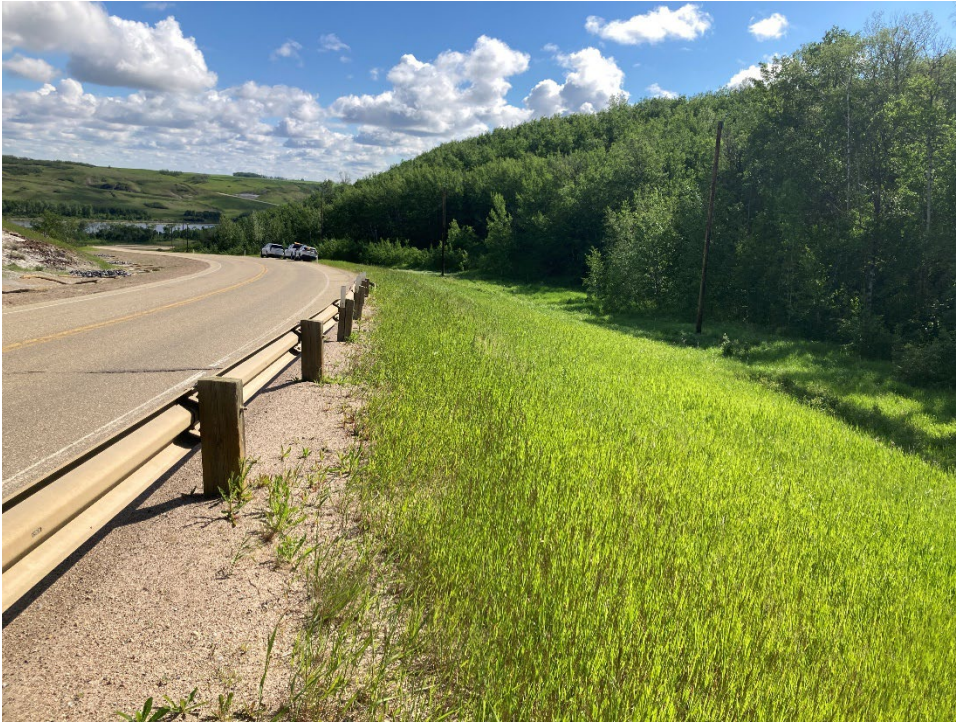
**Photo 11** The south highway embankment slope and ditch are well vegetated and appears to be in good condition. Photo taken June 17, 2024, facing east-southeast.

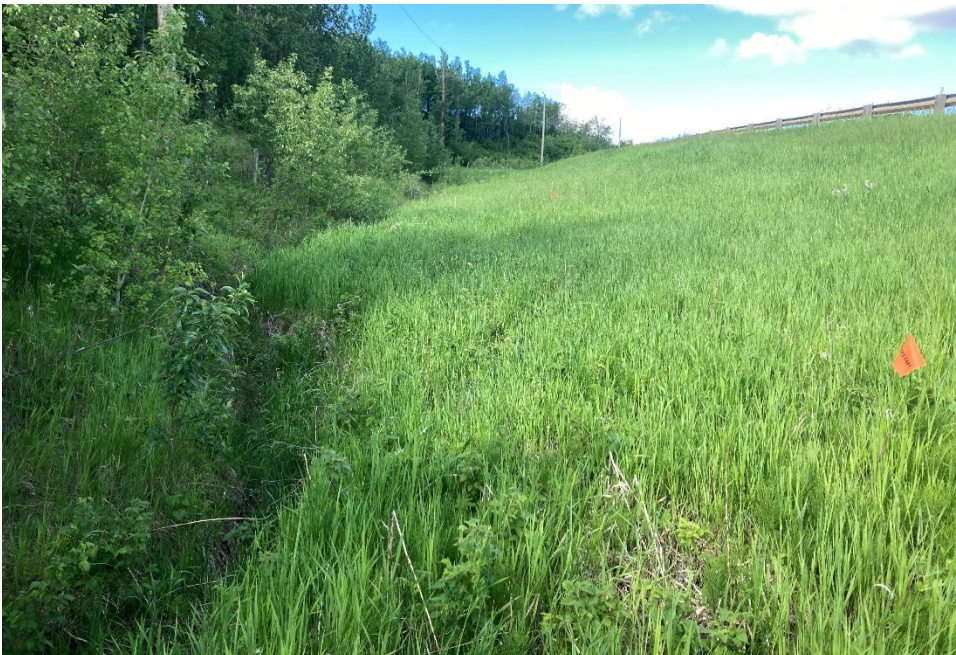
**Photo 12** The south highway embankment slope and ditch is well vegetated and appears to be in good condition. Minor ditch erosion in ongoing but is not impacting the highway embankment. Photo taken June 17, 2024, facing west.

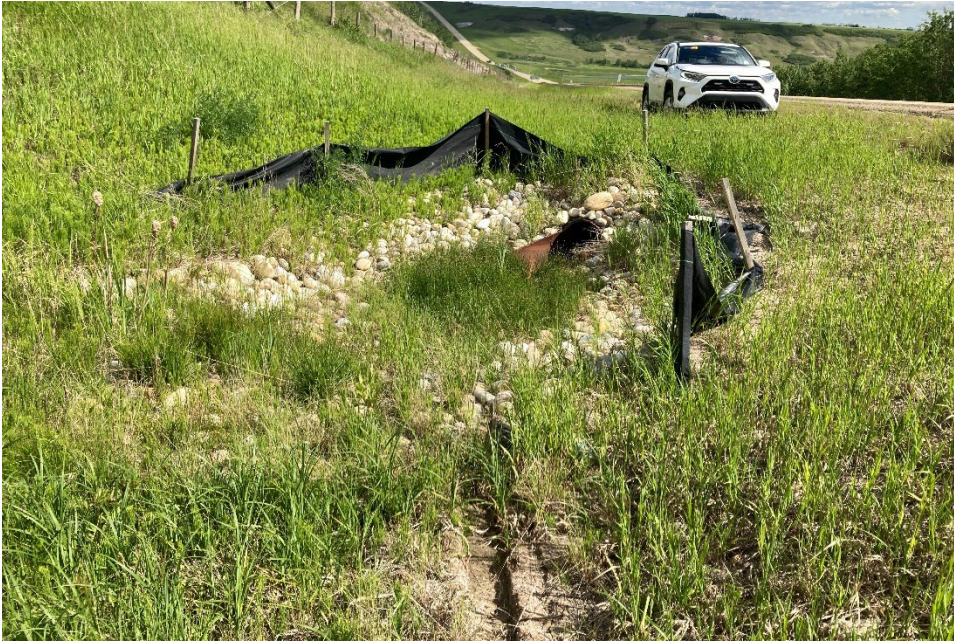
- In March 2021, the CSP culvert underlying Hwy 56:16 (oriented east to west) was sleeved with a steel smooth walled culvert and riprap aprons were built at the culvert inlet and outlet (Photo 13 and 14). TEC informed KCB the work was completed by Inline.
- The repair appears to be in good condition and no discernible erosion/movement was observed between the 2022 and 2024 inspections.
- The base of the smooth walled steel culvert appears to be corroding (Photo 15).

**Photo 13** Inlet of culvert and riprap apron at the C075-2 site appears to be in good condition.  
Photo taken June 17, 2024, facing north.

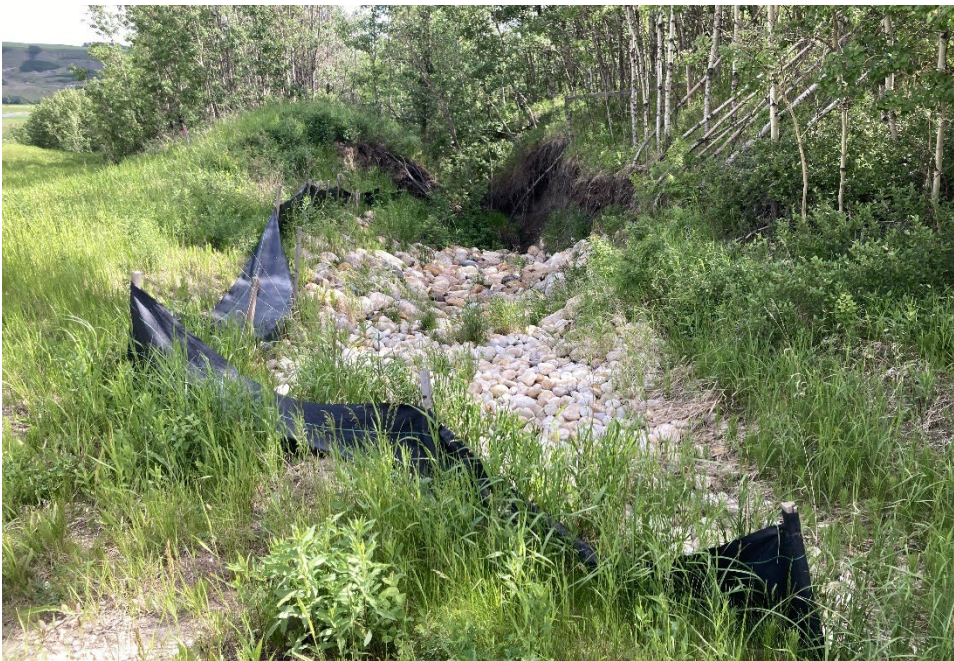
**Photo 14** Outlet of culvert and riprap apron at the C075-2 site appears to be in good condition.  
Photo taken June 17, 2024, facing north.

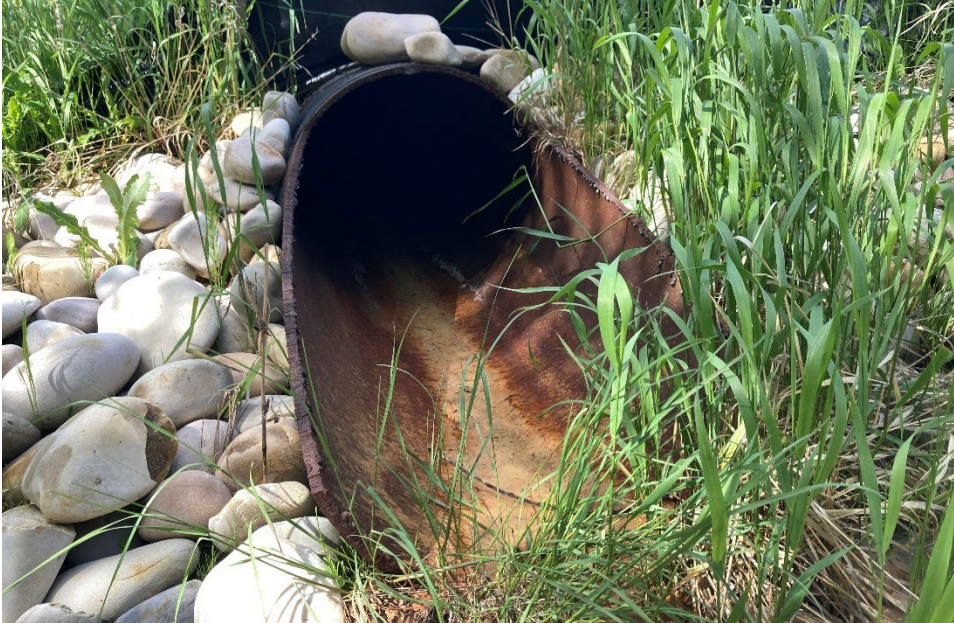
**Photo 15** Corrosion was observed along the base of the smooth walled steel culvert. Erosion appears to be ongoing since the 2022 inspection. Photo taken June 17, 2024, facing southeast.

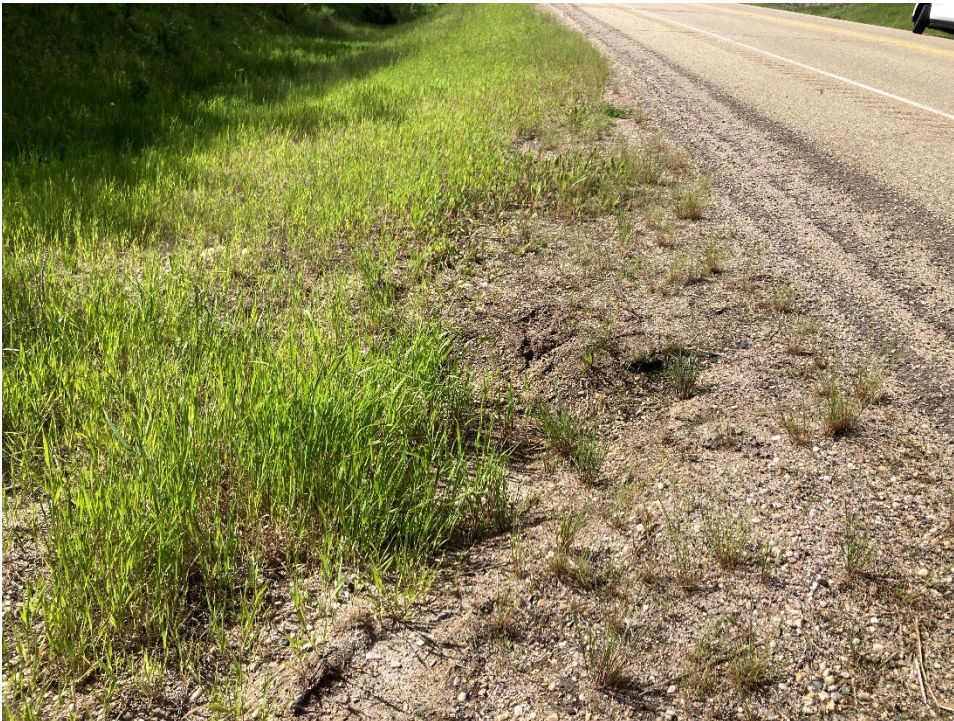
- The sinkhole (approximately 0.5 m to 1.0 m in diameter and 0.3 m deep) was observed above the culvert, on the east side of the highway near the culvert outlet (Photo 16). The sinkhole has not expanded since the 2022 inspection but should be backfilled with sand and gravel.

**Photo 16** Sinkhole above the culvert in the should of the east (northbound) lane appears similar as during the 2022 inspection. Photo taken June 17, 2024, facing south.

- The sinkhole near the culvert outlet should be backfilled with sand and gravel by TEC's HMC.
- KCB should prepare a proposal for the repair of the erosion gully along the west (southbound) ditch. The repair should be completed by TEC's HMC and could include:

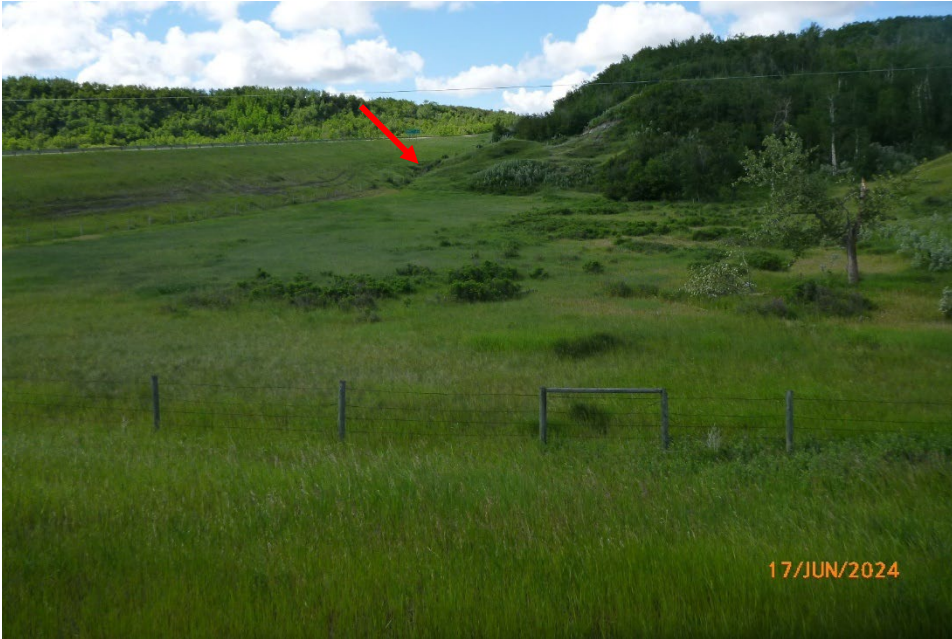
- An erosion feature was inspected in the west (southbound) ditch of Hwy 56, north of the C075-II site (approximately 200 south of the Hwy 609-Hwy 56 intersection) (Photos 17 through 20).

- The erosion gully is up to approximately 5 m wide, 5 m deep, and 40 m to 50 m long. There is a short section near the midpoint of the erosion gully that flatter, relatively intact, and well vegetated. The erosion gully is impacting the toe of the highway embankment and a private fence.

**Photo 17** Erosion gully in the west (southbound) ditch along Hwy 56 (indicated by red arrow) as viewed from Hwy 609. Photo taken June 17, 2024, facing south.

- A repair similar to the C073-II site (riprap armoured channel) could be completed at the site. An alternative repair could be a gabion basket drop structure if the grade of the ditch is too steep for a riprap repair. Repair options will be assessed by KCB as part of our engineering scope.

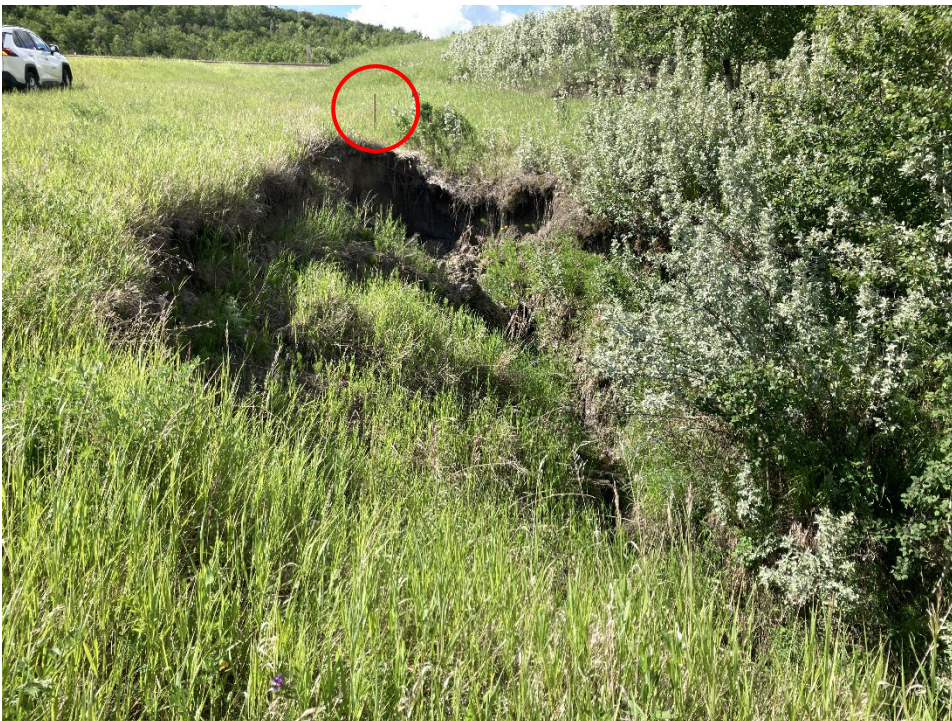
- Two stakes were installed (one at the upstream end of the erosion gully and one further downstream along the east edge) to monitor the rate of gully expansion. Both stakes were installed approximately 1 m from the eroding face (Photo 18).

**Photo 18** Erosion gully in the west (southbound) ditch along Hwy 56, north of the C075-2 site. Stake installed at upstream end indicated by red circle. Photo taken June 17, 2024, facing south.

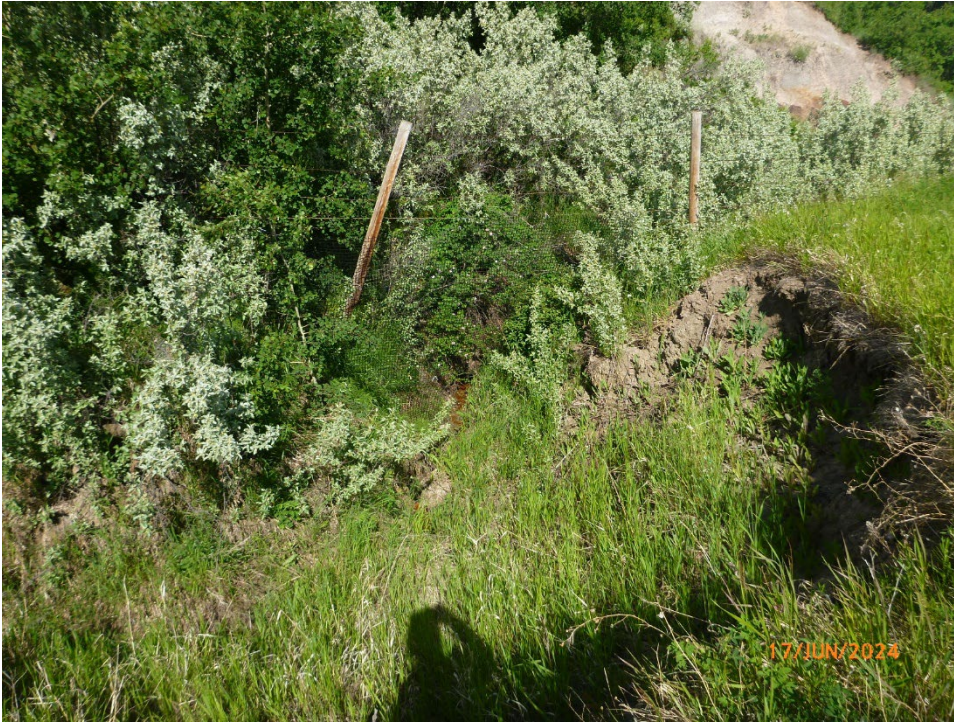
- Geogrid was installed by the private landowner perpendicular to the erosion gully, at the location of the private fence crossing, likely to stop cattle passing through the erosion gully off private land (Photo 19).

**Photo 19** Geogrid below hanging fence installed by private landowner to stop cattle from crossing the highway. Photo taken June 17, 2024, facing northwest.

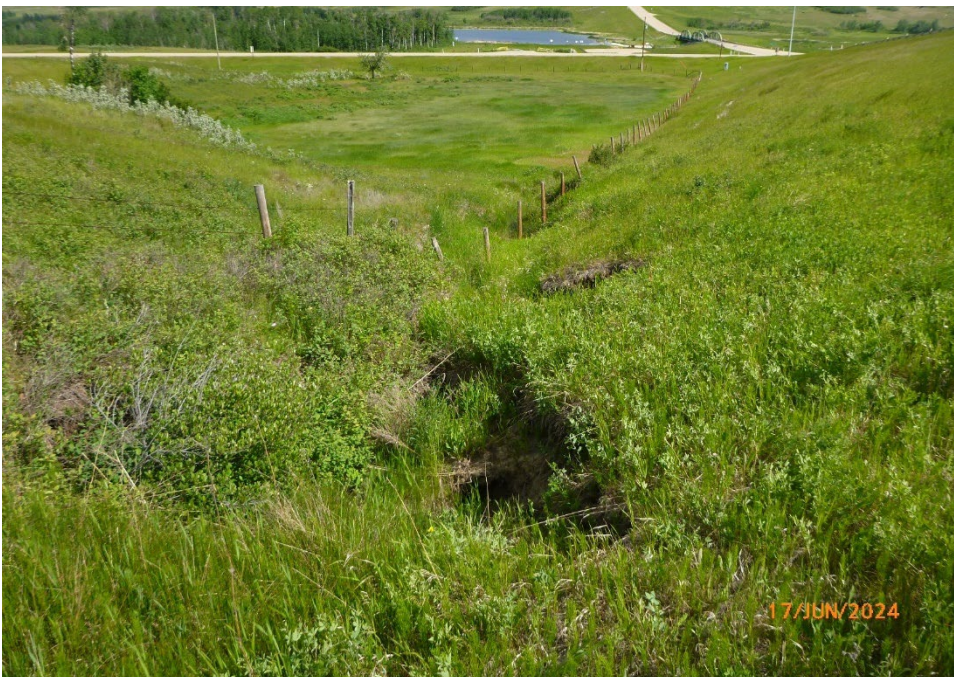
**Photo 20** Erosion gully along the toe of the highway embankment (Hwy 609 and Driedmeat Lake in the background). Photo taken June 17, 2024, facing north.

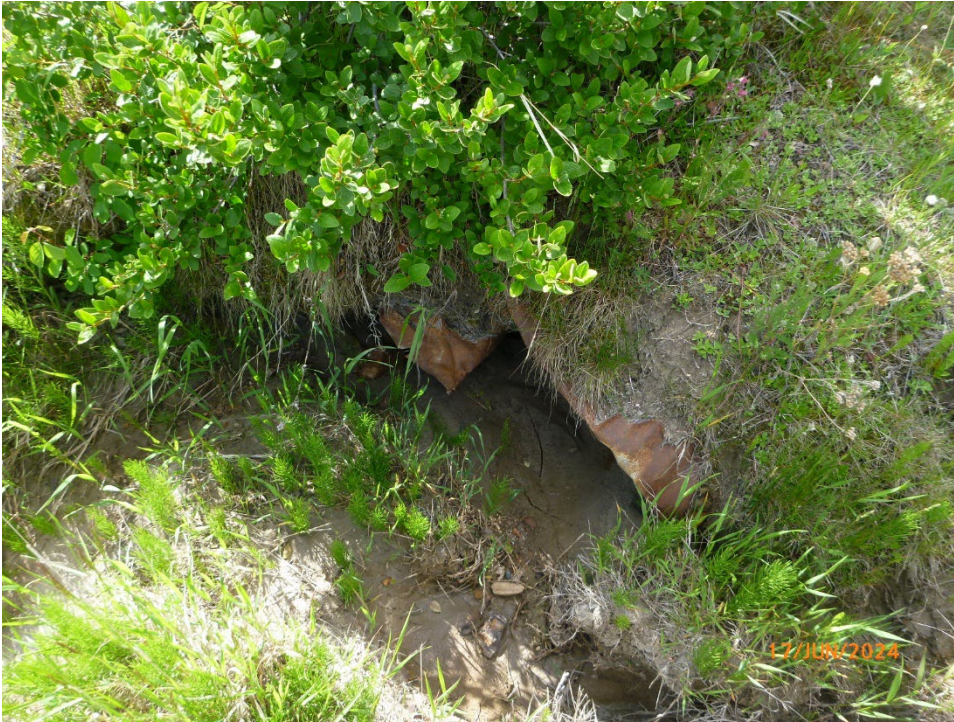
- Pieces of a CSP culvert were observed at the base of the erosion gully. There may be a damaged CSP culvert underlying the highway that requires repair (Photo 21).

**Photo 21**      **Damaged culvert or metal debris observed at the base of the erosion gully.**  
**Photo taken June 17, 2024.**
