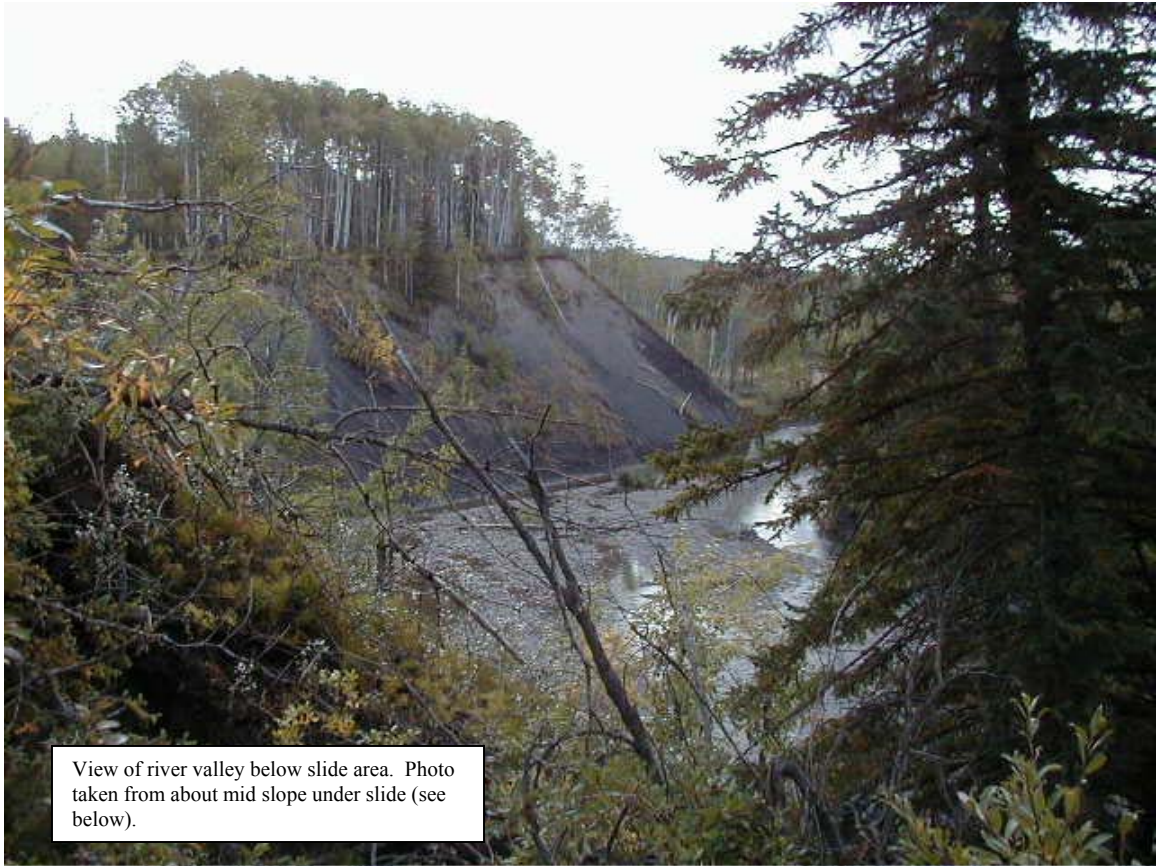
View of river valley below slide area. Photo taken from about mid slope under slide (see below).

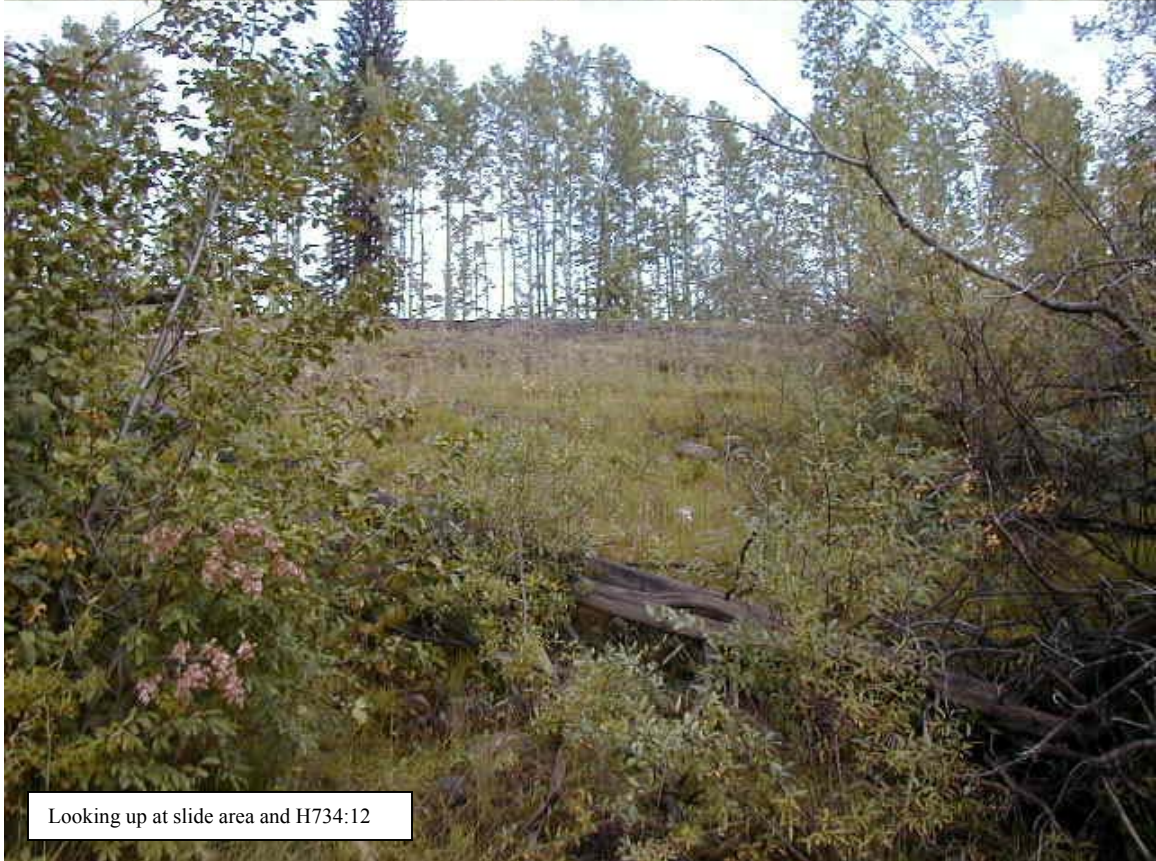
Looking up at slide area and H734:12

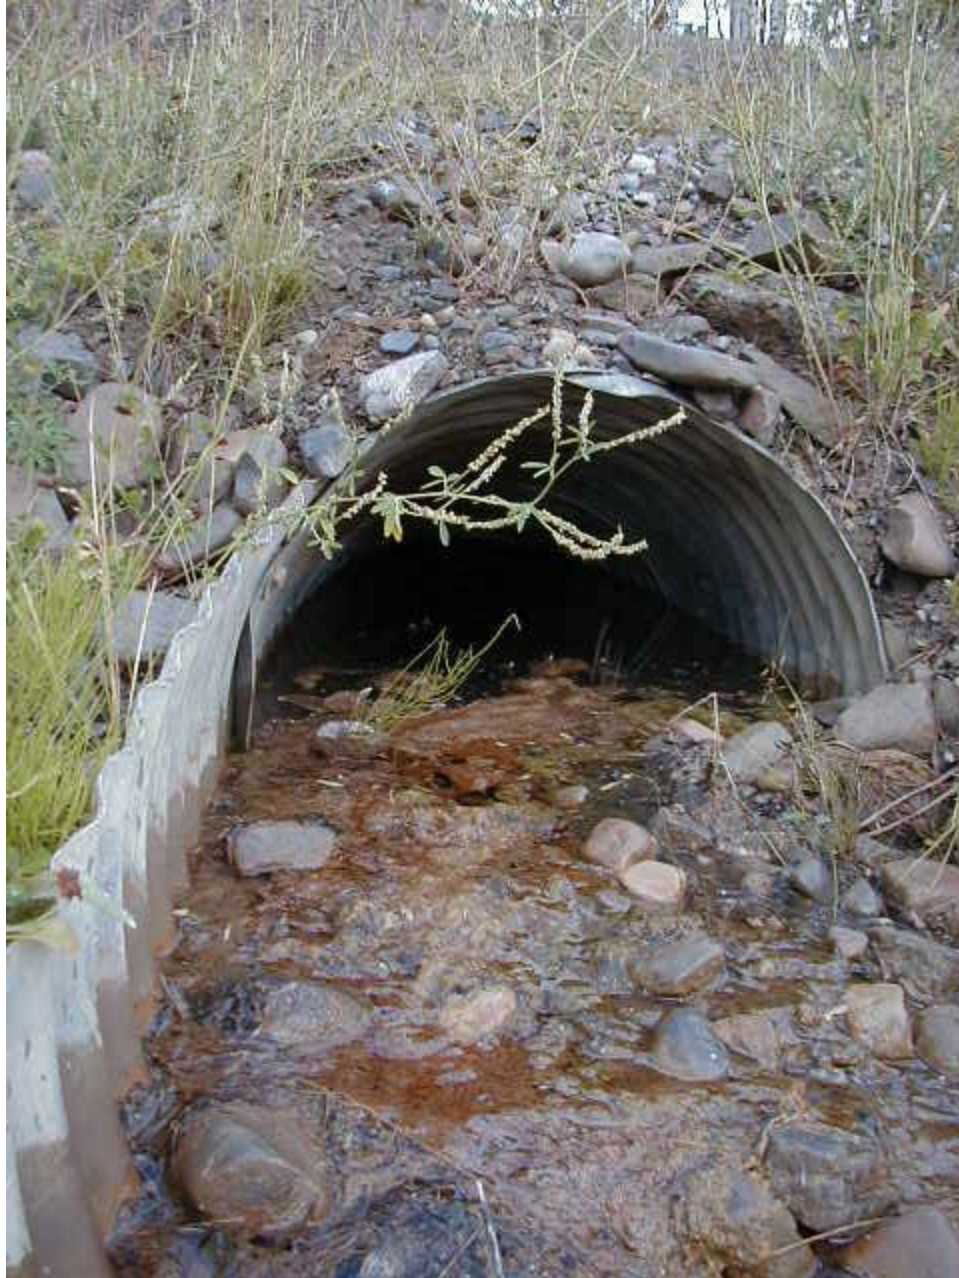
Outlet of 600 mm diameter CSP culvert damaged by slide. Water flow is from inside highway embankment (no inflow at upstream end).

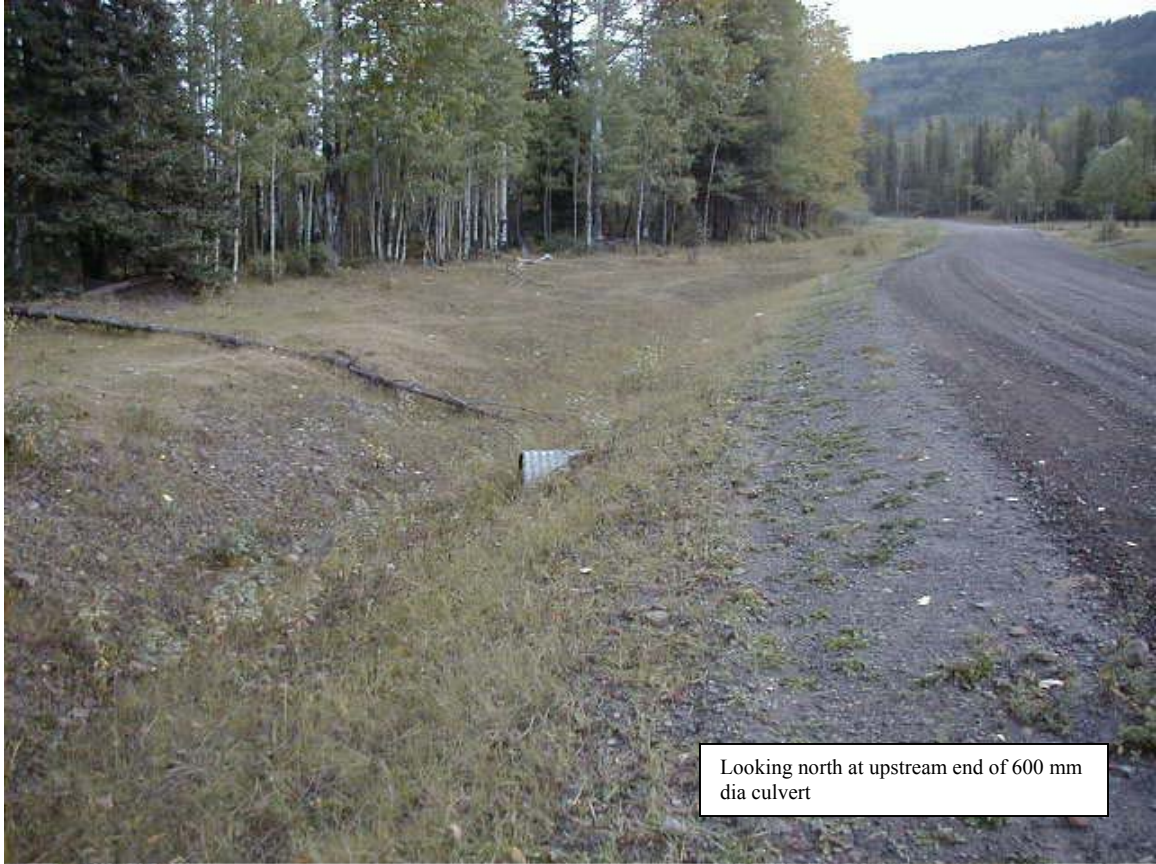
Looking north at upstream end of 600 mm dia culvert

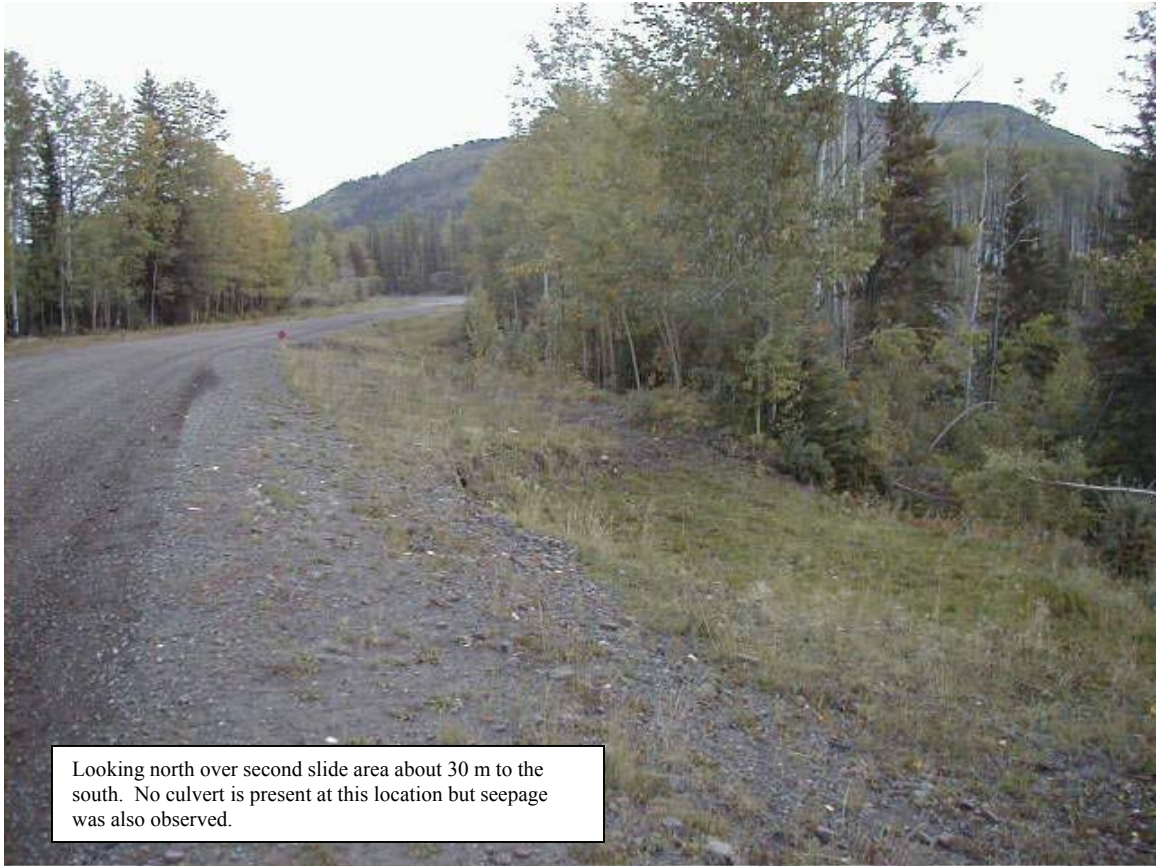
Looking north over second slide area about 30 m to the south. No culvert is present at this location but seepage was also observed.

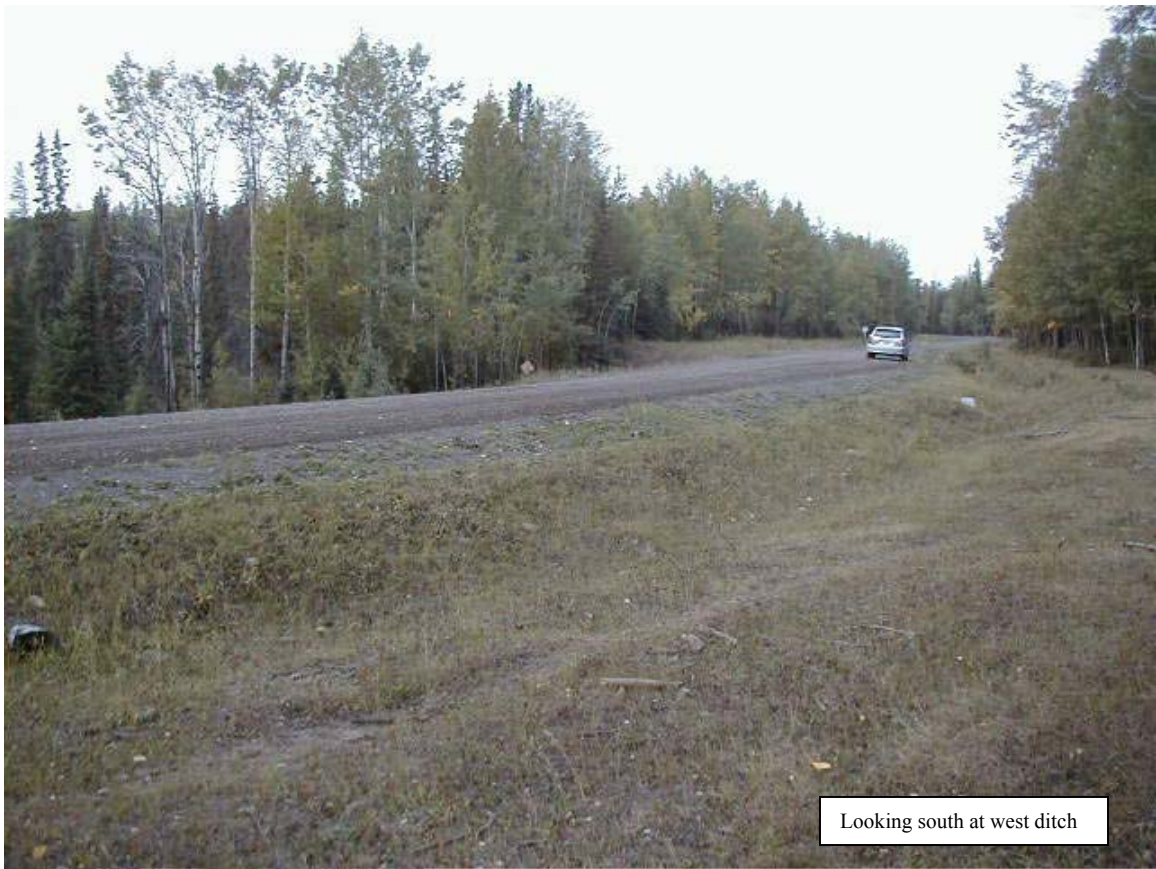
Looking south at west ditch
