Central Region GeoHazard Assessment
Site C30 H734:12 Slide
Geotechnical Callout Report

This geotechnical callout report was prepared by Klohn Crippen Consultants Ltd. (Klohn Crippen) for Alberta Transportation Central Region under the Geohazard Assessment Agreement CE 045/2004. The site inspection was undertaken on June 29, 2005 by Mr. Darren Ratcliffe, P.Eng., of Klohn Crippen Consultants Ltd. Mr. Ratcliffe was accompanied by Mr. Alain Momed and Mr. Fred Cheng of Alberta Infrastructure & Transportation. A second inspection was conducted on July 12, 2005 following remedial work to re-open the highway.

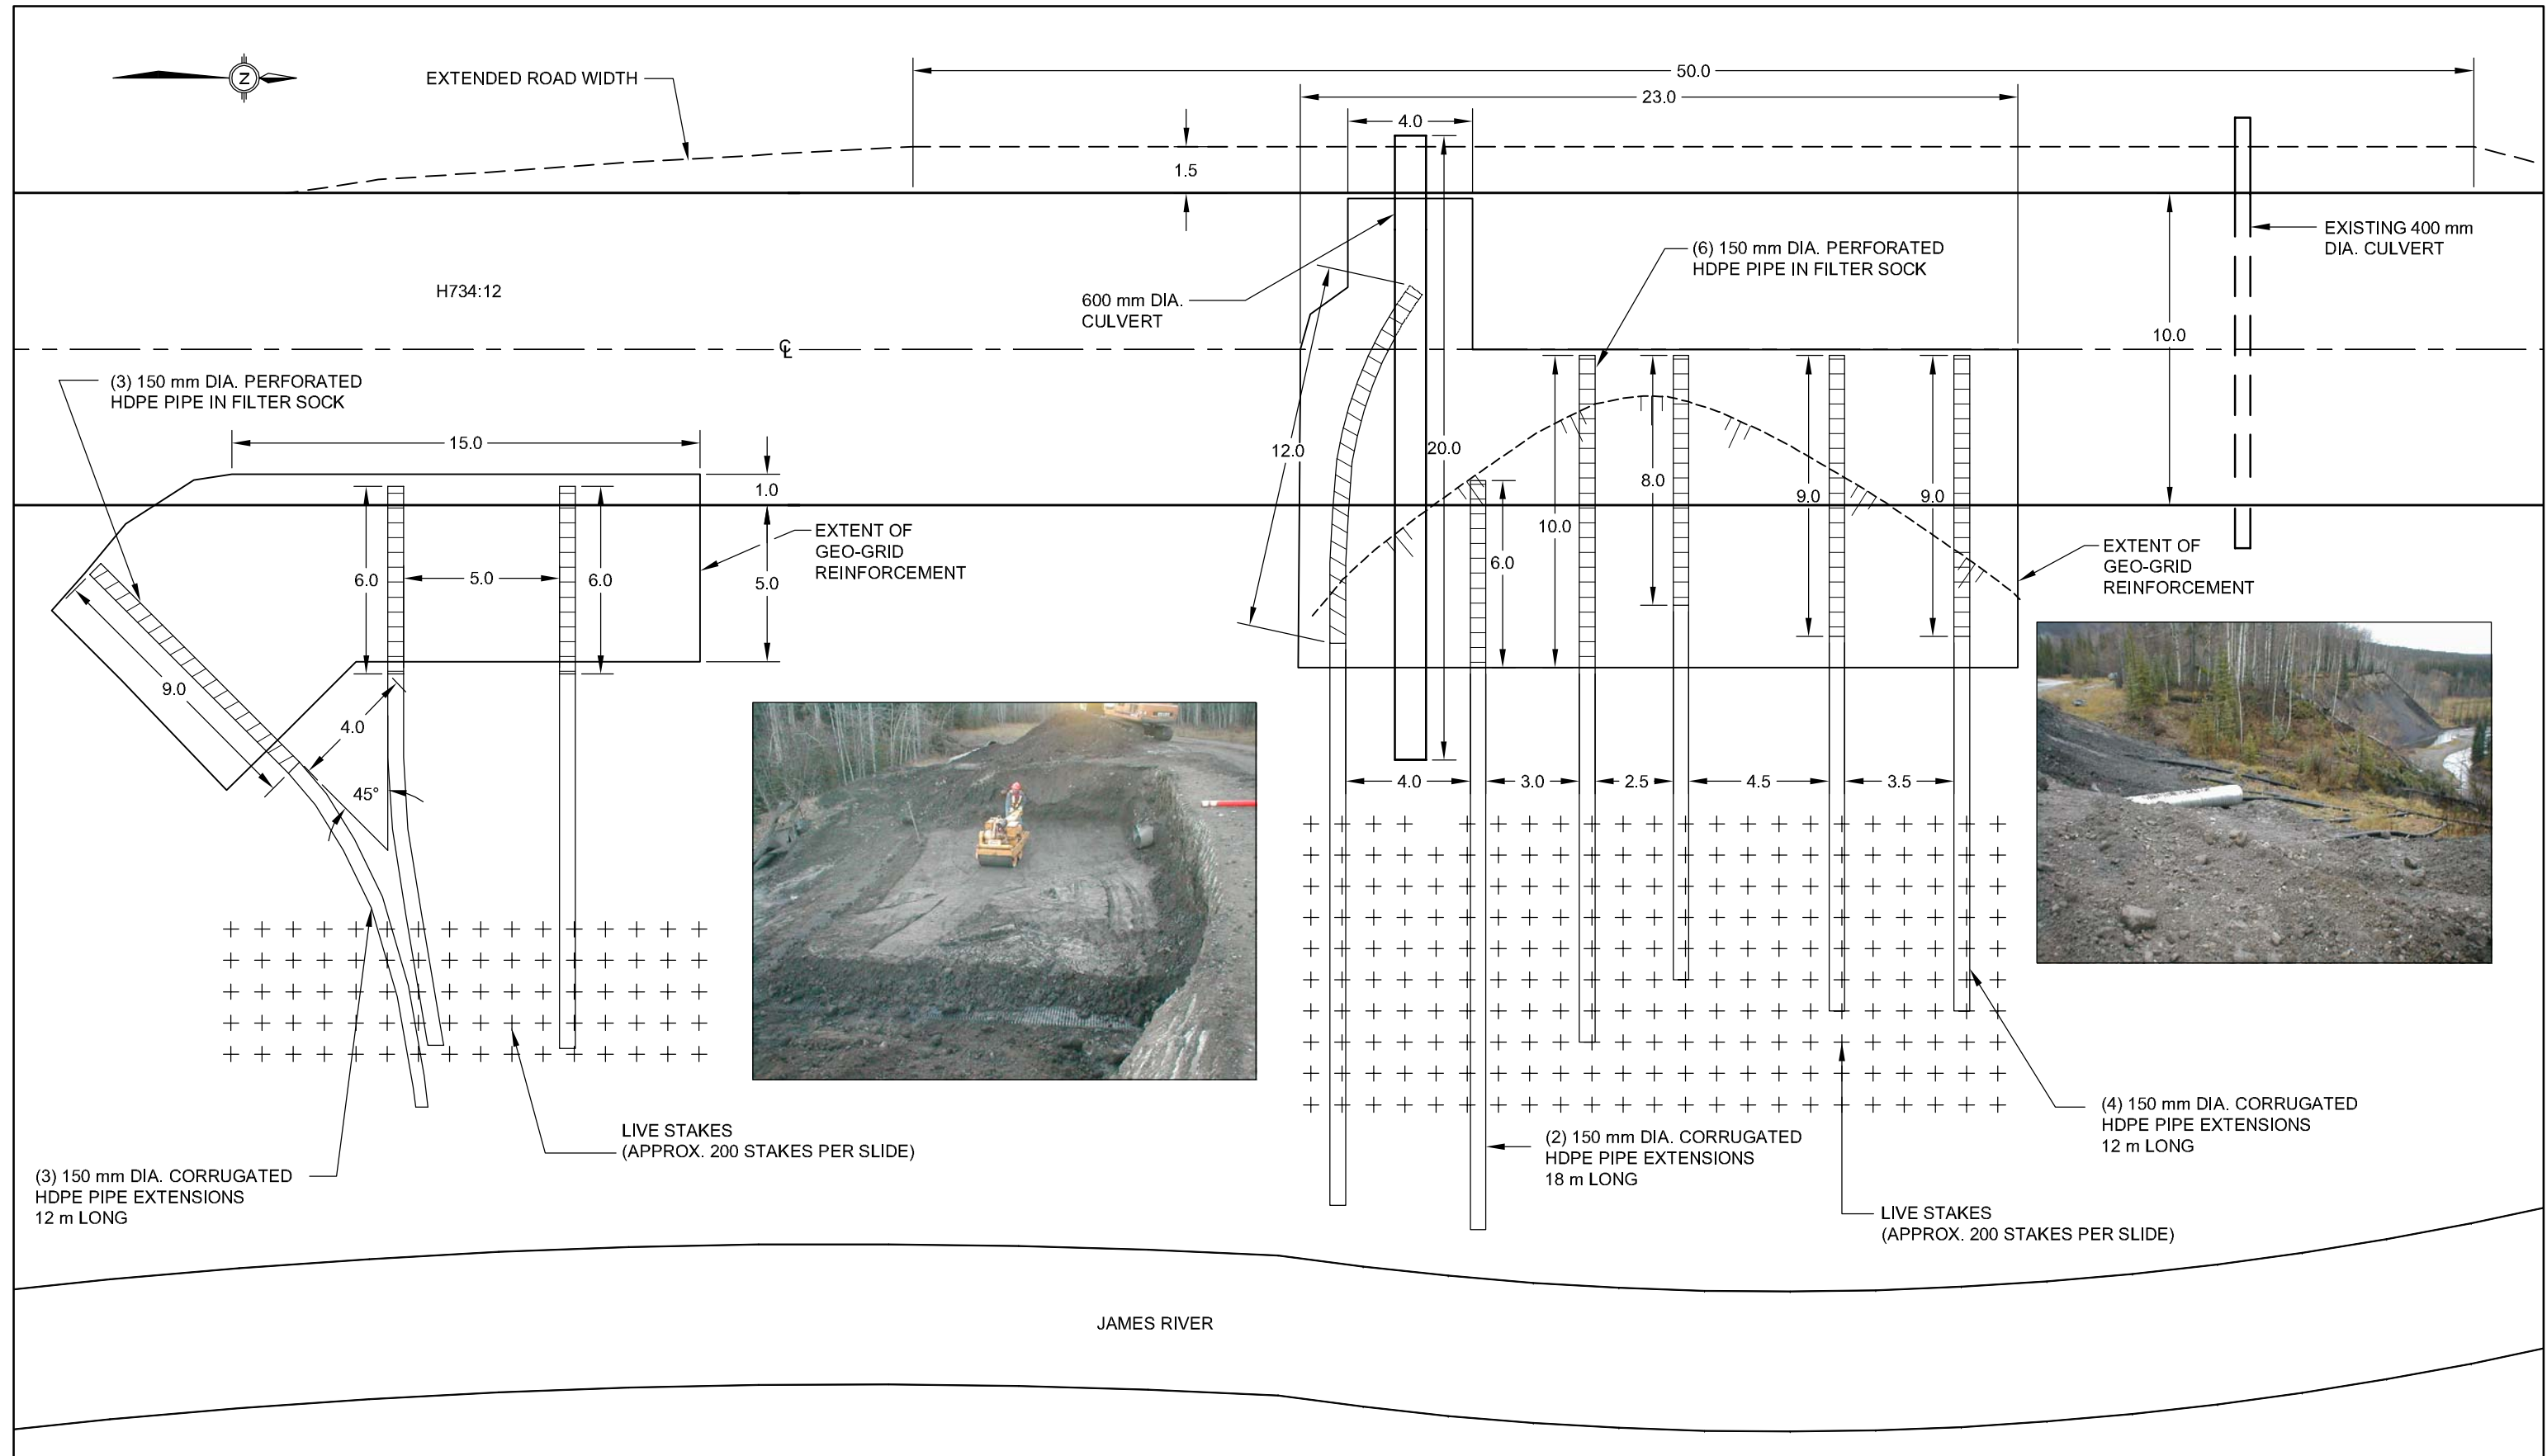
Due to the slide encroaching well into the road and creating a significant hazard, it was considered that this site warranted remedial action. The October 2004 remedial work comprised the following and is shown on Figure 1:

- (1) Replacement of the damaged culvert and controlling groundwater flows with pipes carrying the flow further down the slope.
- (2) Rebuilding the edge of the highway using reinforced gravel, limiting the load placed at the crest of the slide.

- (3) Extending the highway width away from the valley edge for a length of about 50 m.
- (4) Vegetating the downslope area.

For Slide 1, the damaged 600 mm diameter culvert was replaced with a new 600 mm diameter CSP culvert over the full width of the highway. Equally spaced across the slide area, five 150 mm diameter perforated HDPE (“Big-O”) pipes in filter socks were provided at a depth of about 2 m below the highway surface and extending to the centerline of the highway. The discharge ends of the HDPE pipes were to be connected to flexible corrugated HDPE pipes placed on the surface of the slope to discharge water away from the crest. For Slide 2, three similar perforated pipe drains were installed. Slide 1 was excavated to a depth of about 2 m below road level (about 0.5 m below invert of culvert on the east side of road). At this depth, the base material was dry, and so the proposed drains were installed at a lower elevation. Five drains were installed by digging trenches about 0.5 m below the base of the excavation.

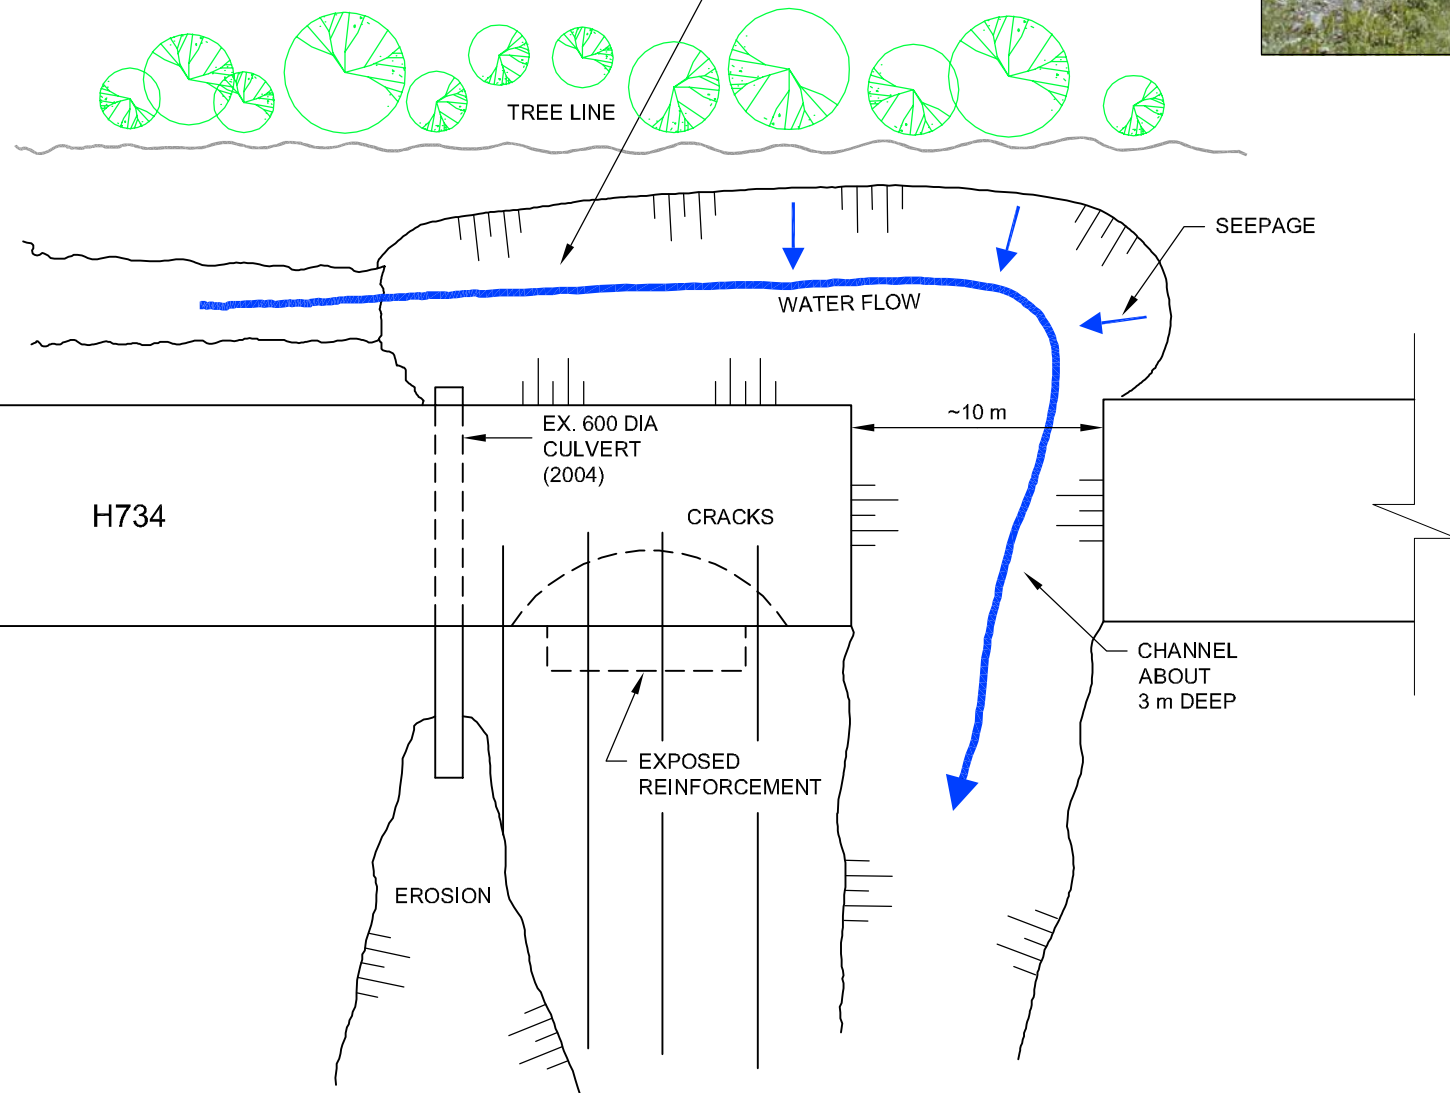
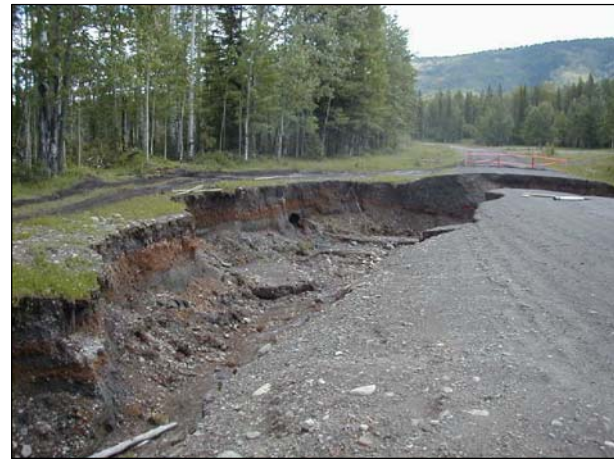
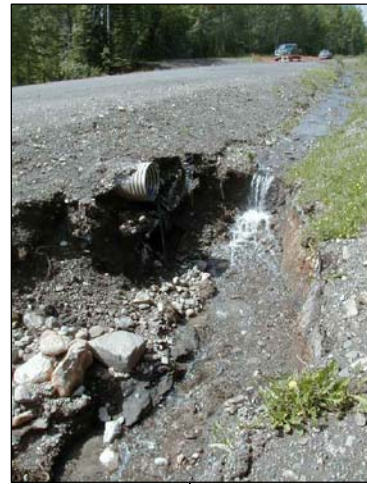
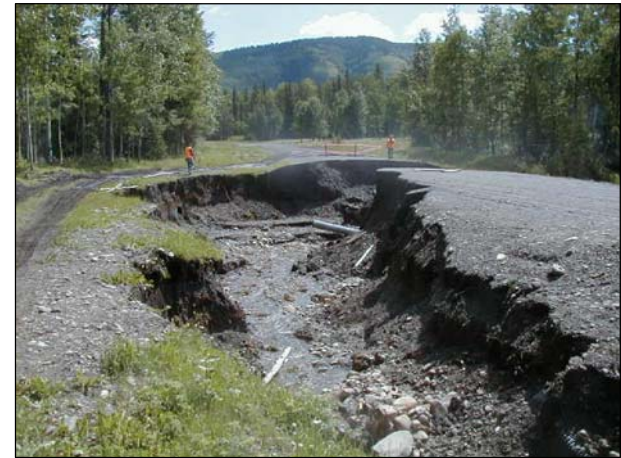
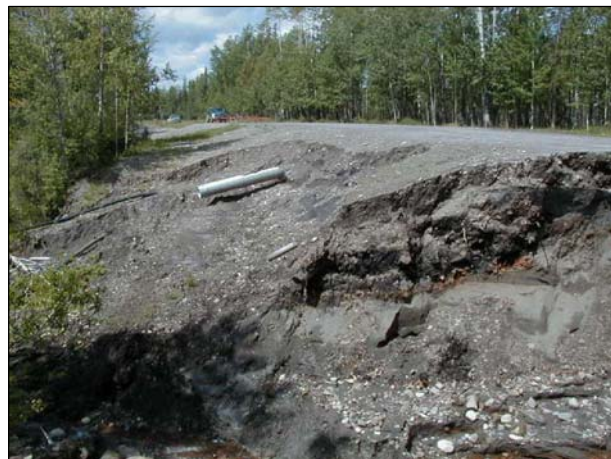
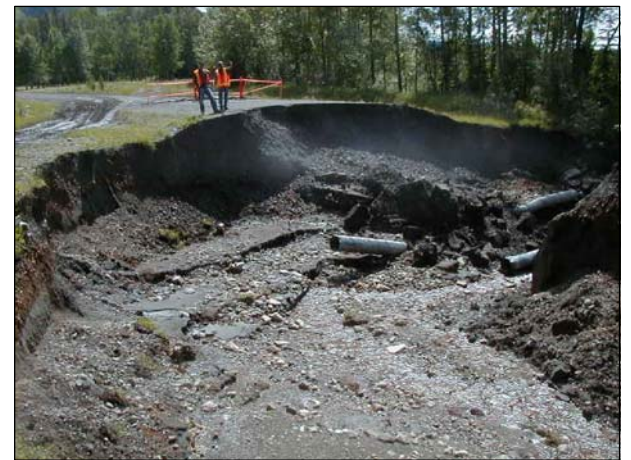
DATE	SHEET	DRAWING No.	REV.					
												JULY 2005	2 OF 5	FIGURE 2

Heavy rain in Southern Alberta in June 2005 caused significant flood events and subsequent damage to infrastructure. Flooding and erosion occurred at the H734:12 slide site closing the highway as shown on the attached photographs and illustrated on

Figure 2. An erosion channel about 10 m wide by about 3 m deep was formed at the east end of the “Slide 1” repaired area as ditch flows bypassed the culvert and flowed around the reinforced gravel area and down the slope. At the time of the inspection, the ditch was still flowing. A temporary vehicle access had been developed to the north of the erosion site.

- Seepage was observed from the steep north side of the erosion channel at a number of locations.
- Old culverts and previously buried perforated pipes were exposed by the flood and erosion. The 400 mm diameter CSP at the east end of the site has been washed away.

- The downstream end of the new 600 mm diameter CSP has been eroded leaving about 5 m of pipe exposed. The erosion of the slope area has also exposed the geo-grid reinforcement. It was noted that the reinforcement was not extended a sufficient distance downslope. However, it was also noted that the majority of the reinforced gravel section is remaining and erosion occurred to the east.

- Due to the loss of ground downslope, cracks in the highway surface have reappeared in a similar location to those observed previously.
- The HDPE off-take drain pipes have been displaced downslope by the flows.

- Most of the planted live stakes were washed away in the central part of the slope.

The observed damage to the site in June 2005 can be directly attributed to erosion from flood flows. The area of reinforced fill was largely undamaged and the flood eroded a section of highway to the east due to road overtopping due to the inadequate capacity of the culverts. For this reason, it is considered that the required repair work should be funded based on damage caused by the flood.

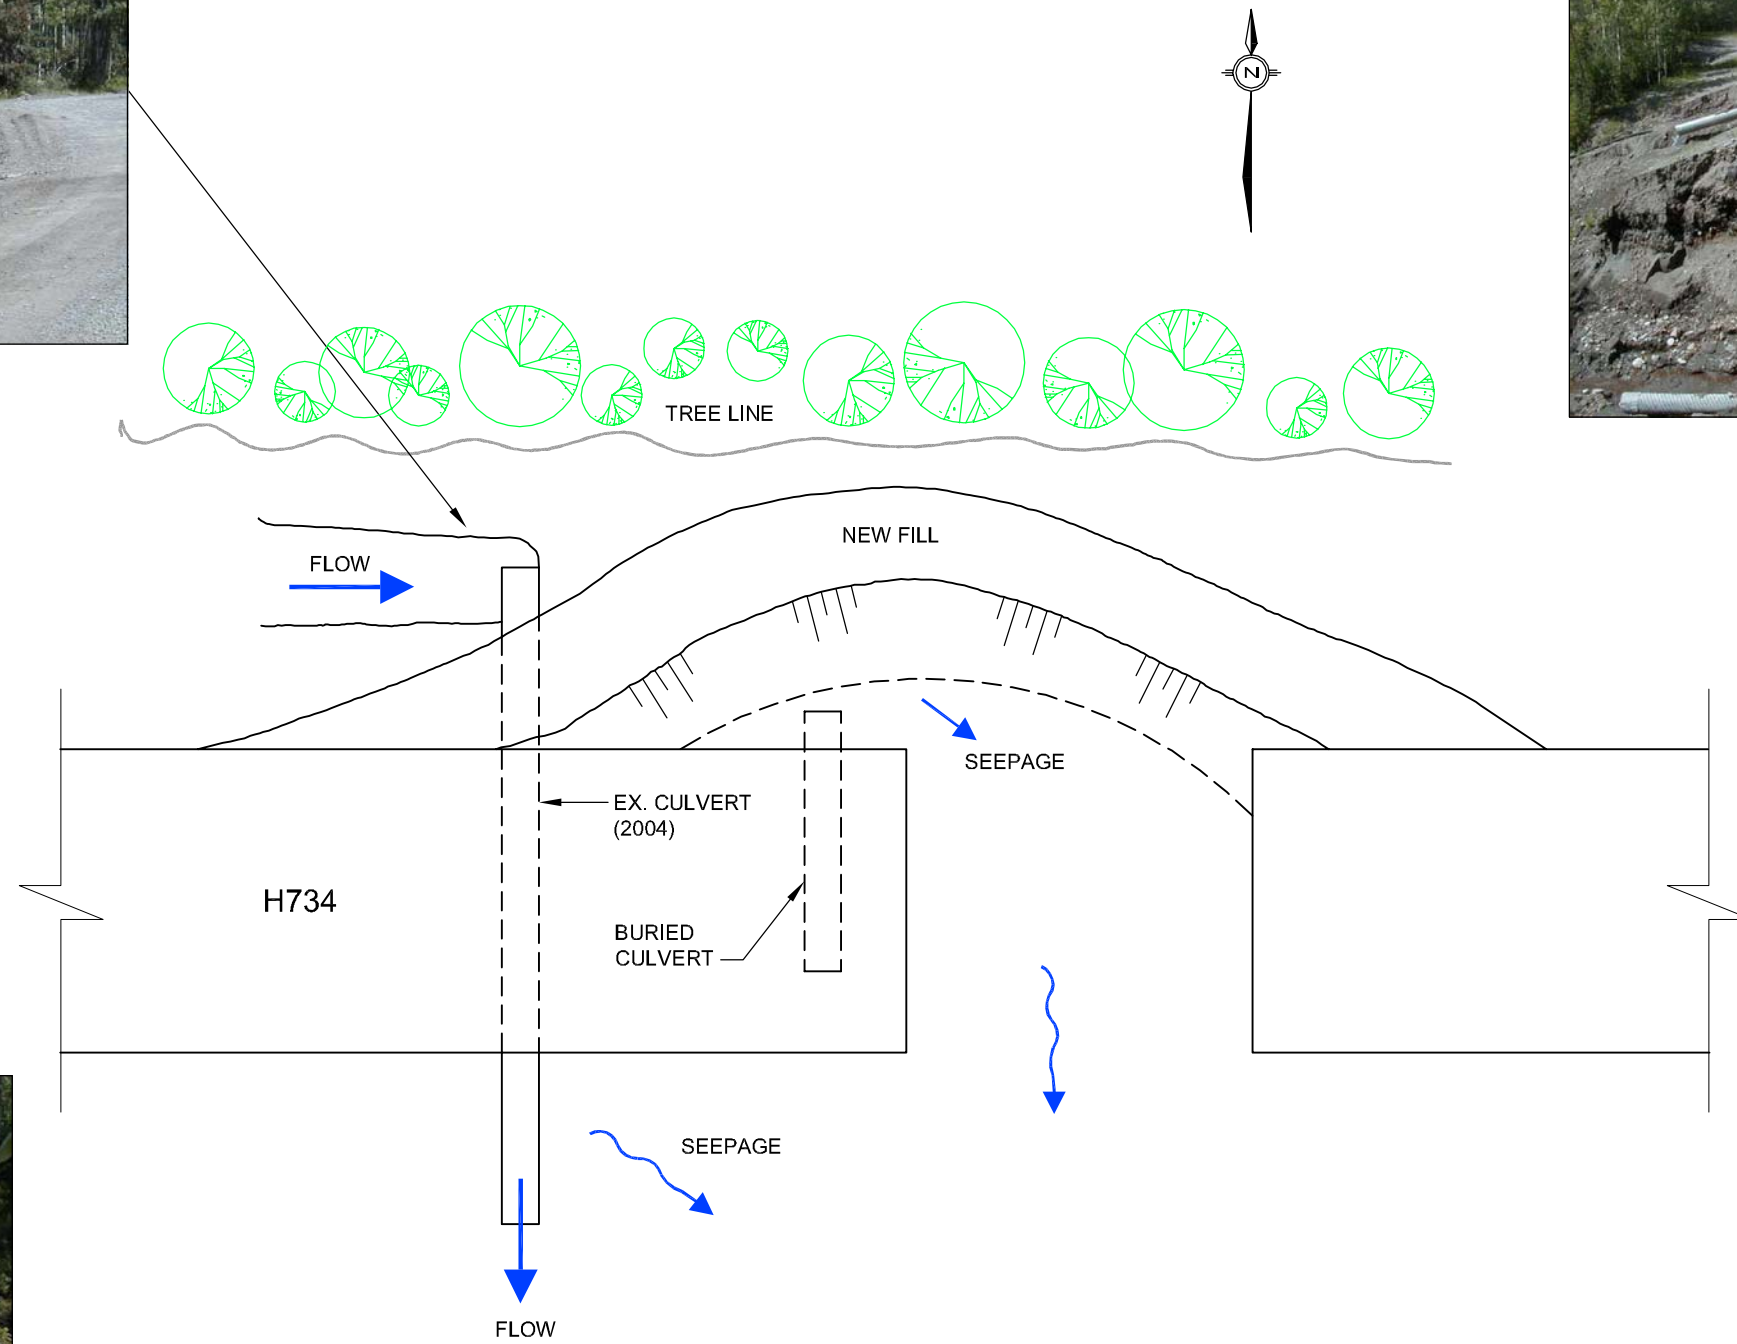
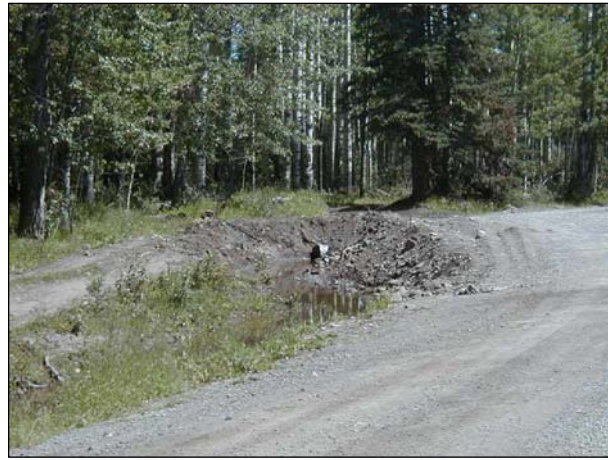
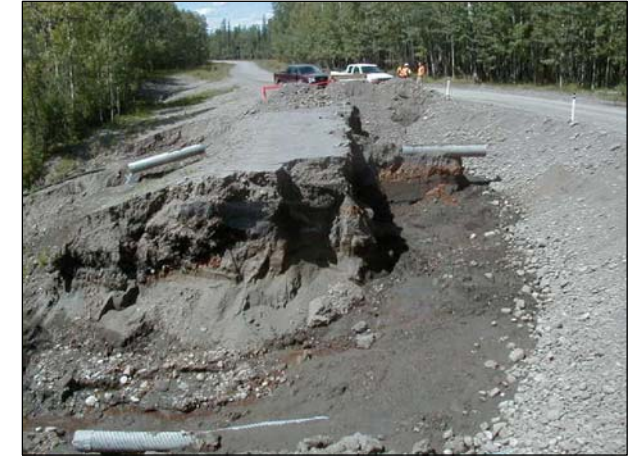
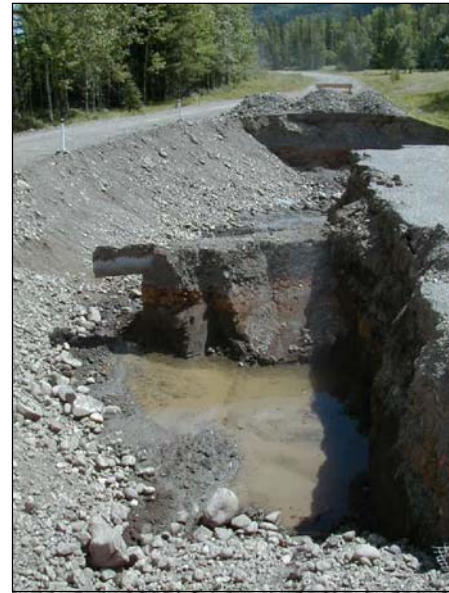
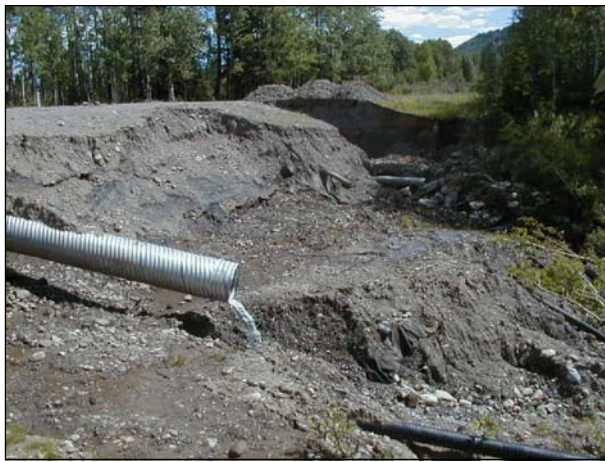
A second inspection of the site was undertaken on July 12, 2005 following the placement of gravel fill around the north section of the site to reopen the road as shown on Figure 3 and in the attached photographs. In general, there was no significant change or deterioration in the site conditions from the previous inspection. The following observations were noted:

- Ditch flows (slightly reduced from the previous inspection) were directed into the new 600 mm diameter CSP and the culvert is discharging onto the slope face. Some seepage was observed under the culvert.
- Some seepage was observed at the base of the new fill. Due to the new fill placement some upward seepage flow and ponding was observed in the base of the erosion channel.
- An old buried culvert was exposed by the excavation work to obtain material for the new highway fill.
