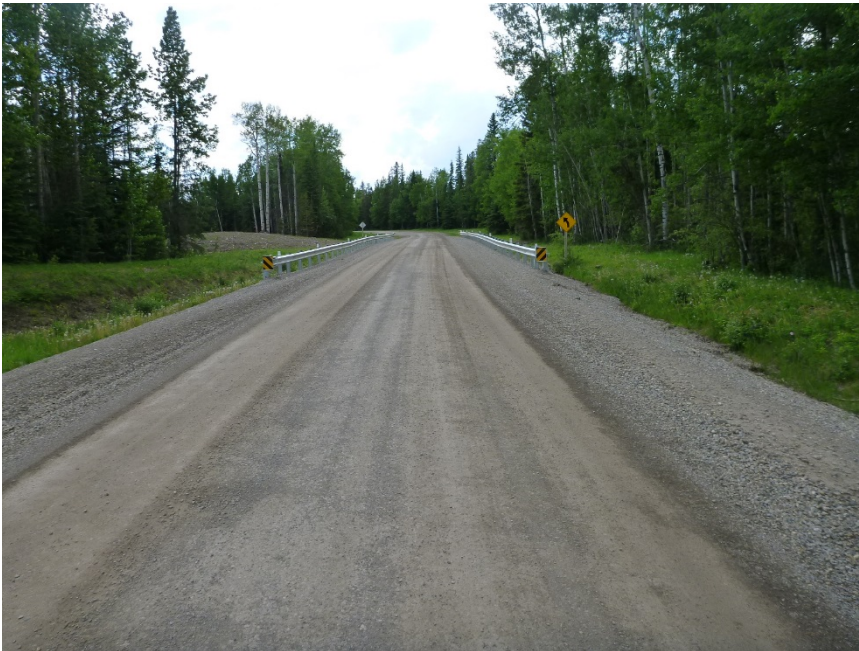
Photo 1 **The C030 high-water-mitigation site. Photo taken June 12, 2017 looking southwest.**

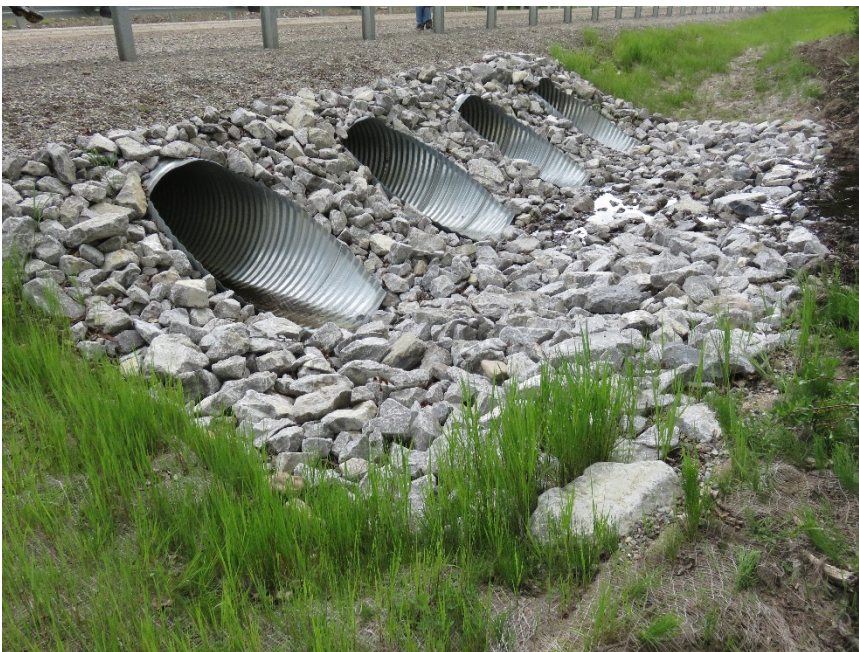
Photo 2 **The inlets of the four 1000-mm culverts that were installed in June 2016. Vegetation is growing through the erosion control cloth that was placed around the culverts and in the ditch in June 2016. Photo taken June 12, 2017 looking southwest.**

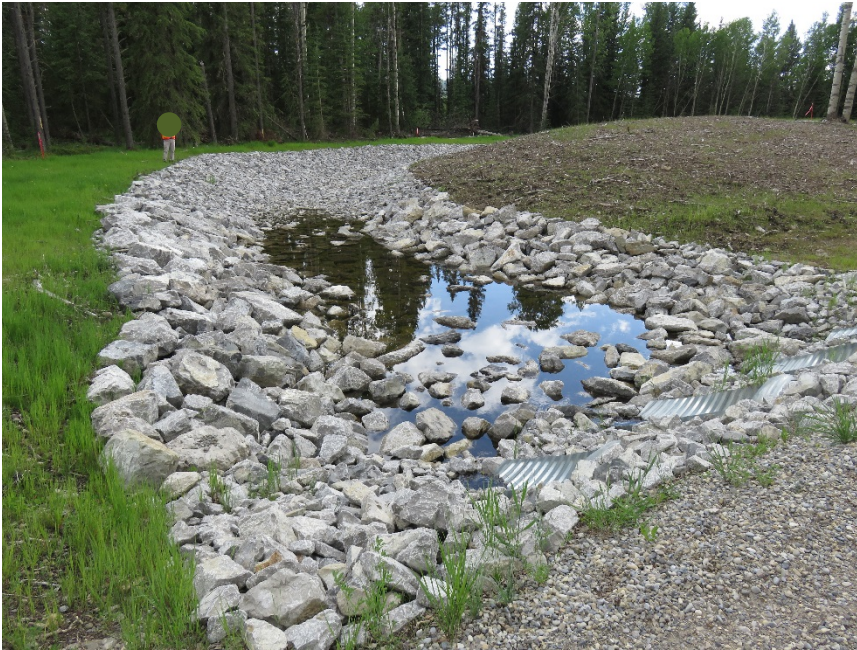
Photo 3 The outlet of the 1000-mm culverts, and the riprap armoured channel that were installed/constructed in June 2016. Vegetation is establishing itself on the east bank of the riprap armoured channel; however, the stockpile on the west bank remains poorly vegetated. Photo taken June 12, 2017 looking south.

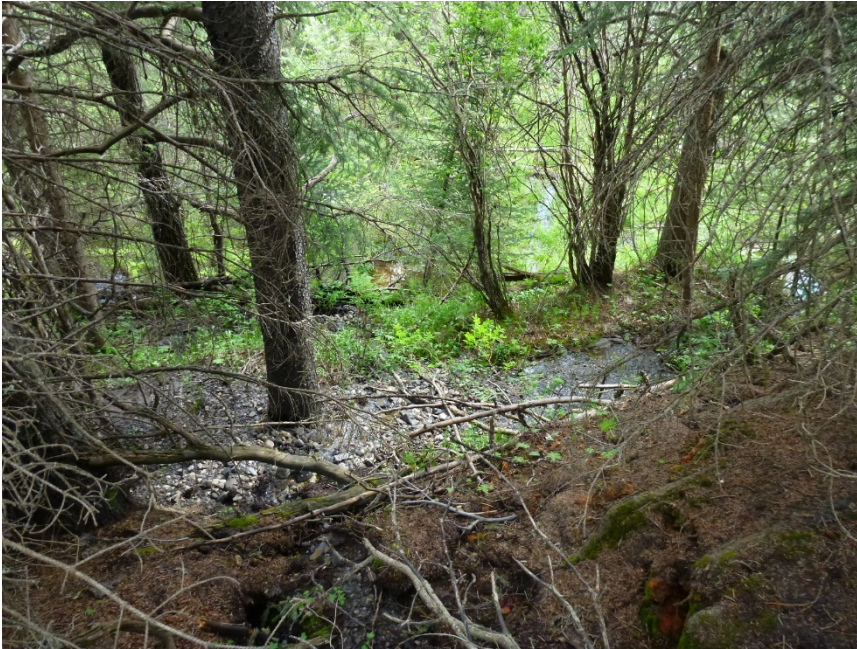
Photo 5 **Drainage from the riprap armored channel is exacerbating a historic slide on the north slope (outside bend) of the James River Valley. Photo taken June 12 2017 looking south to southwest.**
