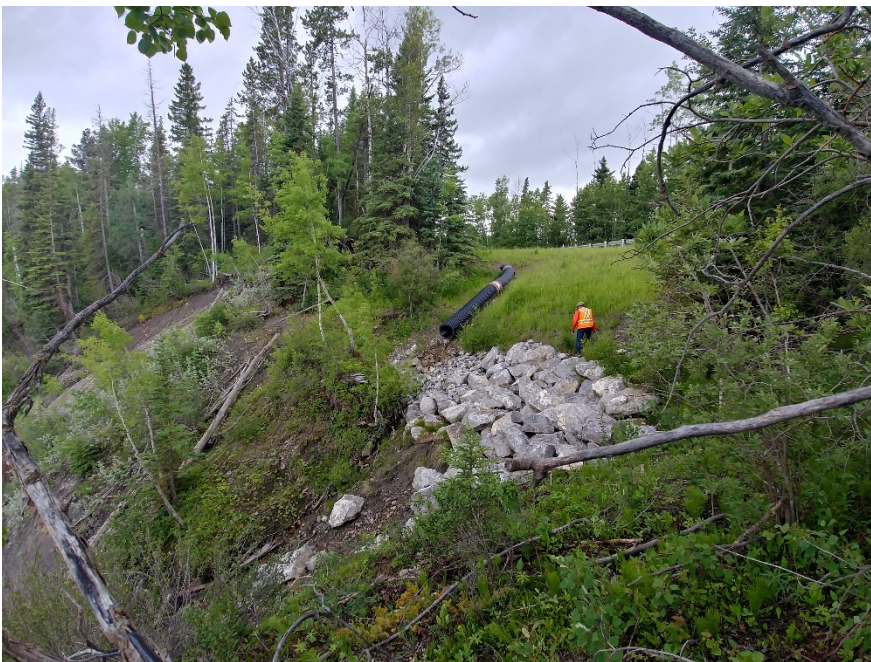
**Photo 2** Condition of western slope drain and riprap armouring. Photo taken July 9, 2019 looking northwest.
