| SITE NUMBER AND NAME: C071 Black Snake Slide | | HIGHWAY & KM: 836:04, 15.016 | PREVIOUS INSPECTION DATE: June 13, 2018 | INSPECTION DATE: June 19, 2024 |

| PRIMARY SITE ISSUE: Slope instability in the east (northbound) highway embankment slope resulting in ground cracks and a toe roll which impacted an existing fence. | | |

| TITLE | Site Plan C071 - Black Snake Slide Hwy 836:04, km 15.016 | |

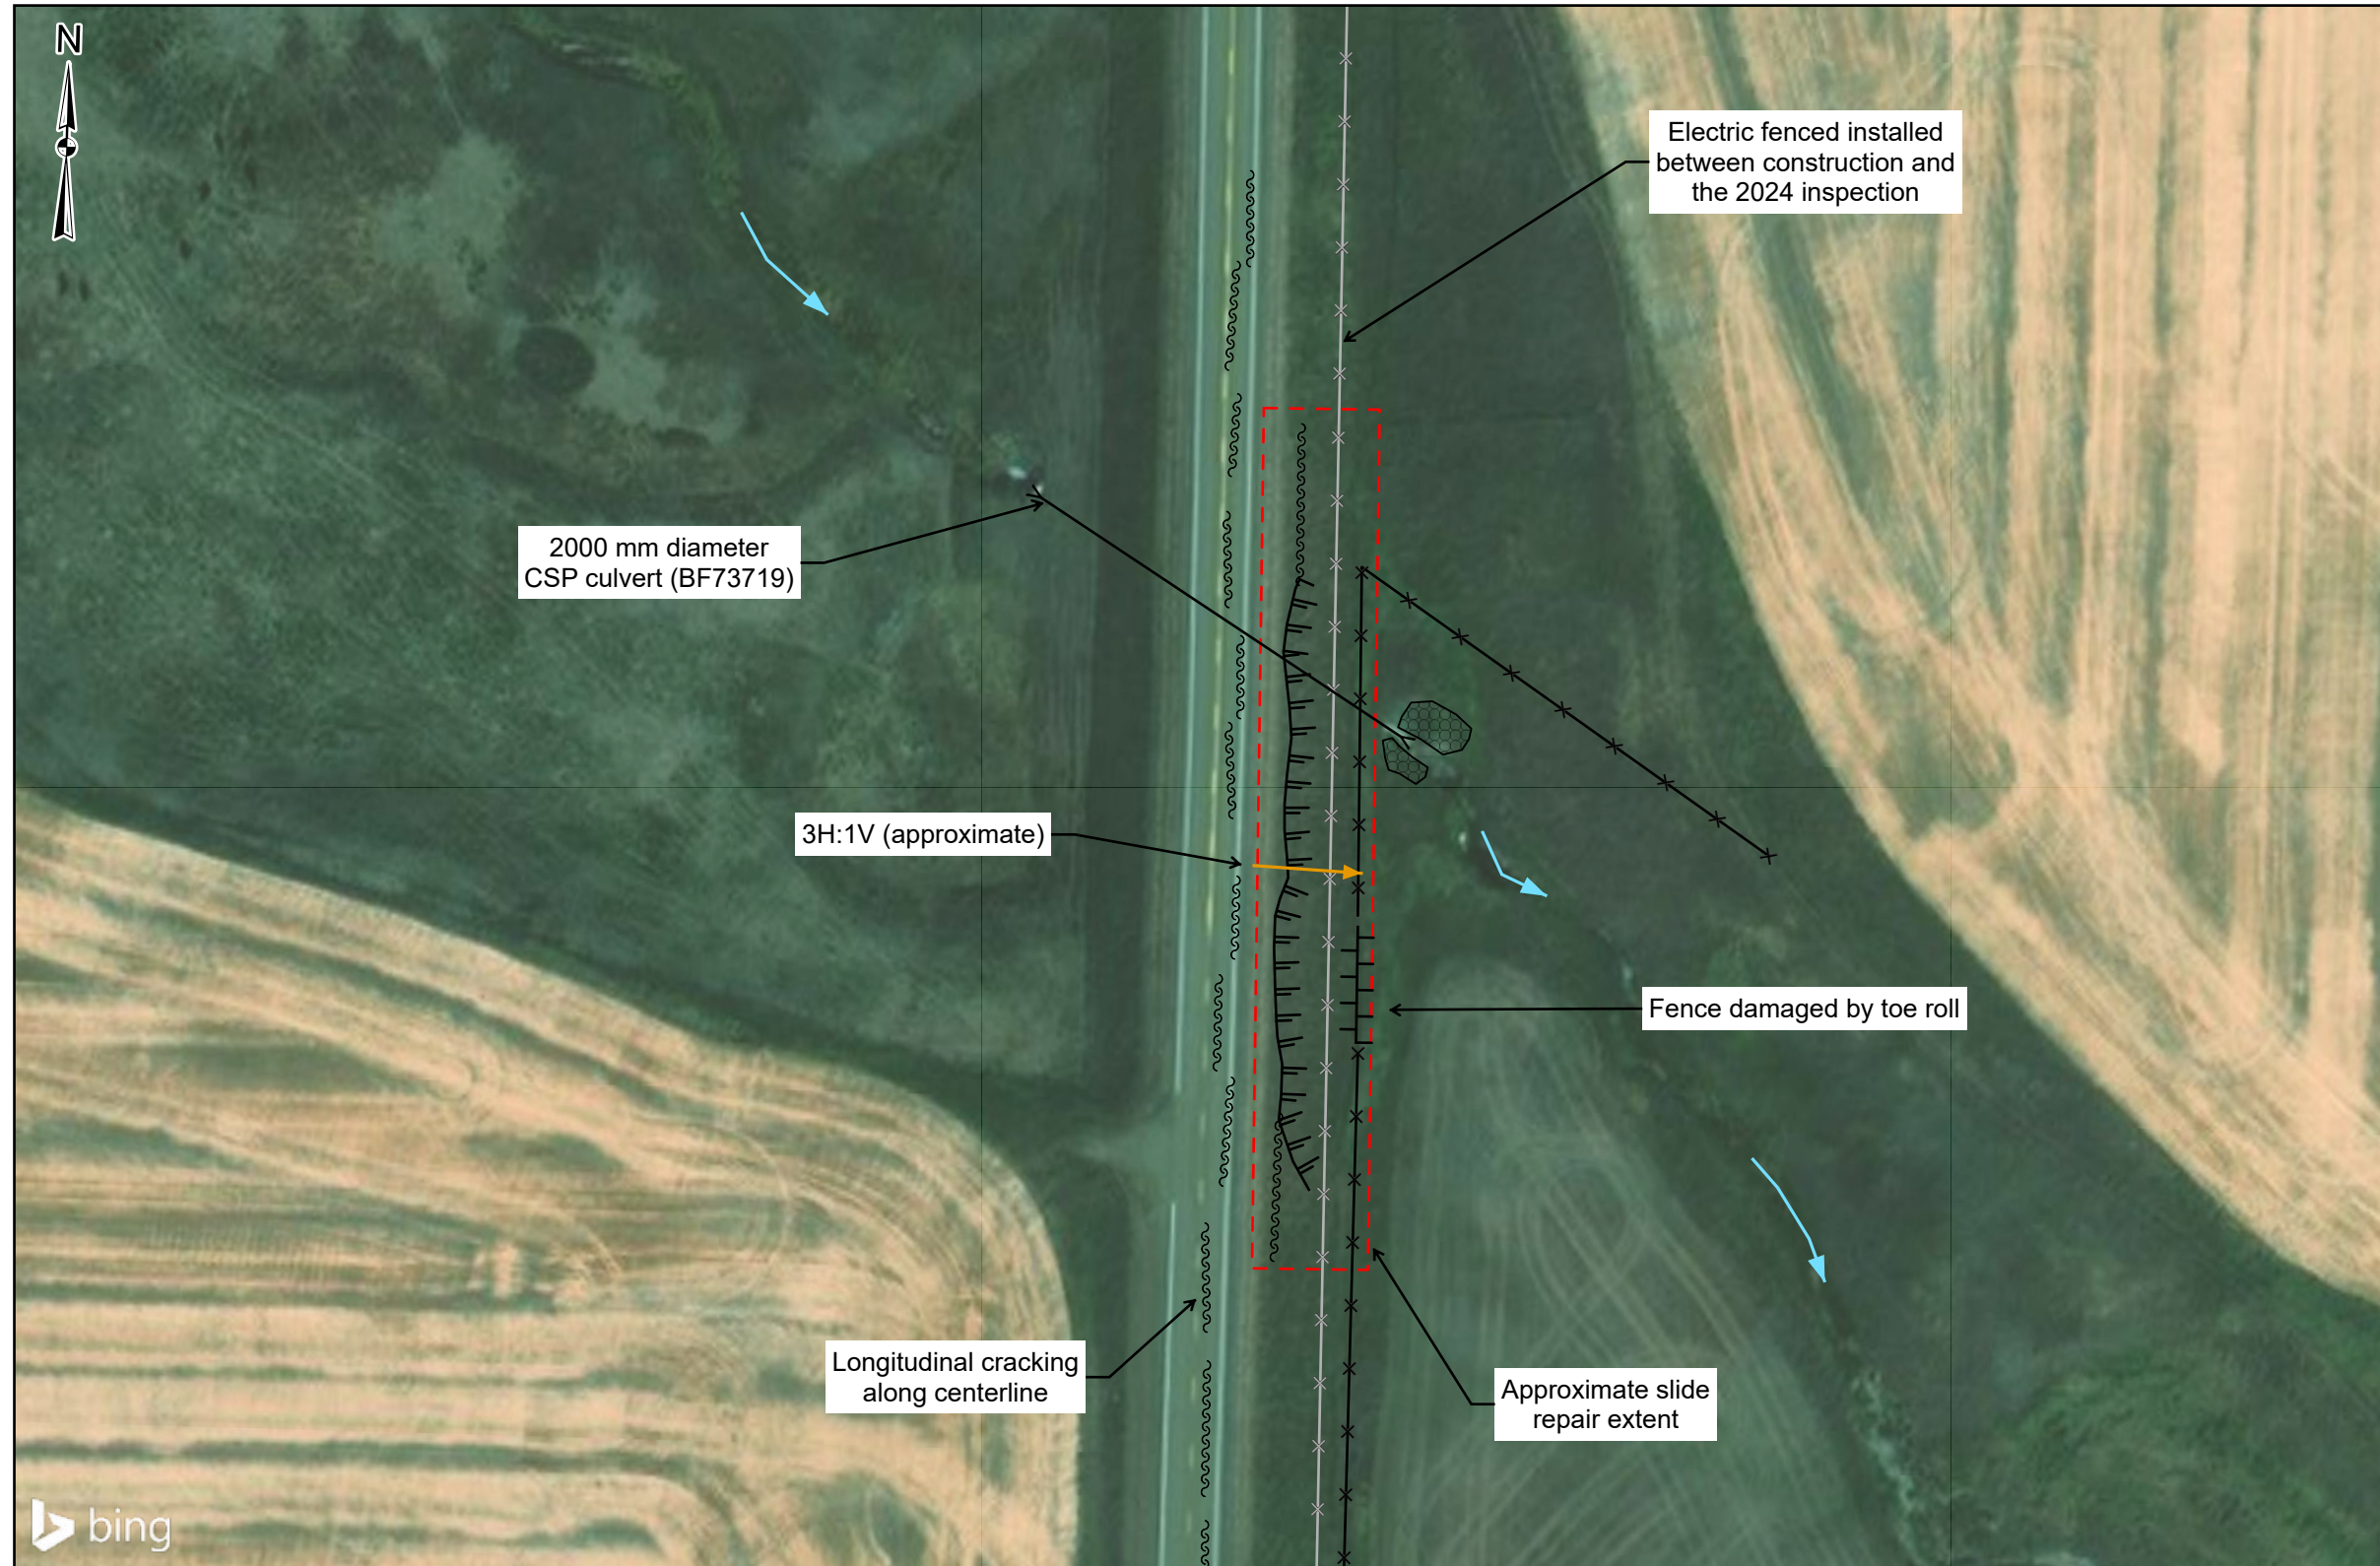
| APPROXIMATE DIMENSIONS: The slide is impacting an approximately length of 115 m of the highway embankment (3H:1V side slopes and 3 m to 4 m in height). The height of the head scarp was approximately 1 m to 2 m in height. | | |

| ITEM | CONDITION EXISTS | | DESCRIPTION AND LOCATION | NOTICABLE CHANGE FROM LAST INSPECTION | |
|---|---|---|---|---|---|
| Slope Movement | X | | 2017 slope failure resulting in ground cracking on east (northbound) highway embankment slope and a toe roll which impacted the existing fence. | | X |

- The site should be removed from the active list of GRMP sites and no longer inspection as part of the GRMP Section B Inspection.
- The site should still be inspected regularly by TEC's MCI.

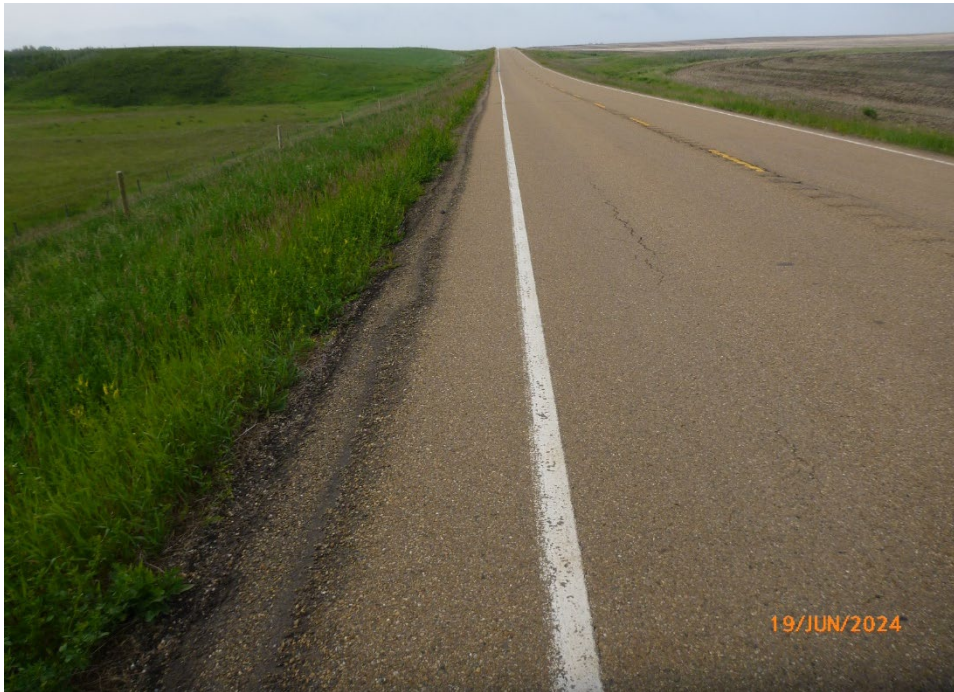
Pavement distress (longitudinal cracking near the highway centerline and minor settlement beneath the wheel path in the west (southbound) lane) was observed during the 2024 inspection (Photo 1 and 2). However, the cracking and settlement does not appear new and is similar to what was observed during 2019 construction.

Photo 1 Highway surface upslope of repair is in fair condition. Photo take June 19, 2024, facing south.

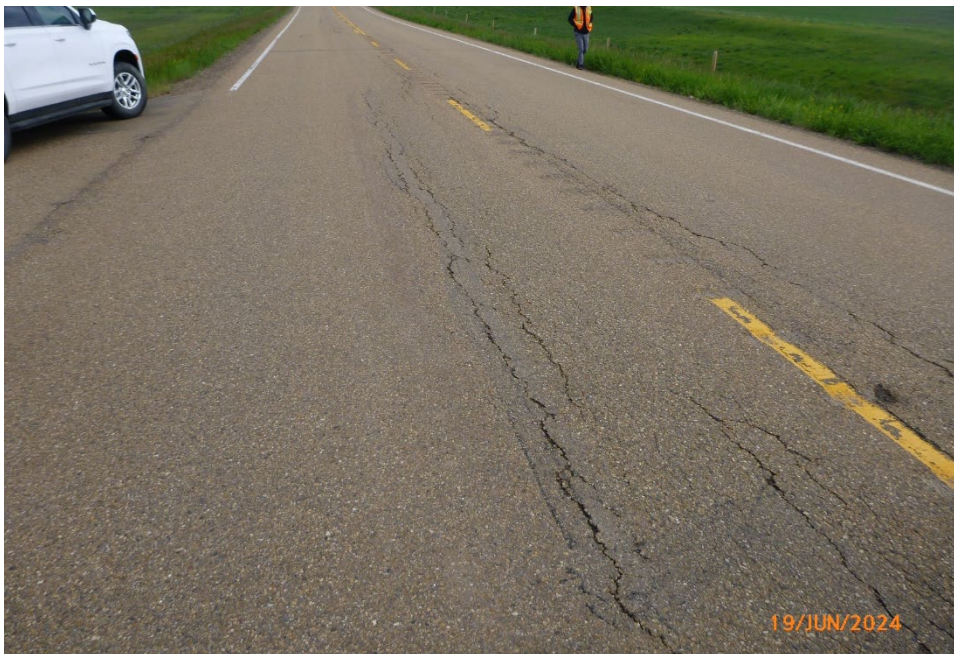
| ITEM | CONDITION EXISTS | | DESCRIPTION AND LOCATION | NOTICABLE CHANGE FROM LAST INSPECTION | |
|---|---|---|---|---|---|
| Pavement Distress | X | | Longitudinal cracking near highway centerline in response to highway loading, not in response to embankment slope failure | | X |

Photo 2 Pavement distress (longitudinal cracking and minor settlement in wheel path) was observed in the west (southbound) lane. Photo take June 19, 2024, facing north.

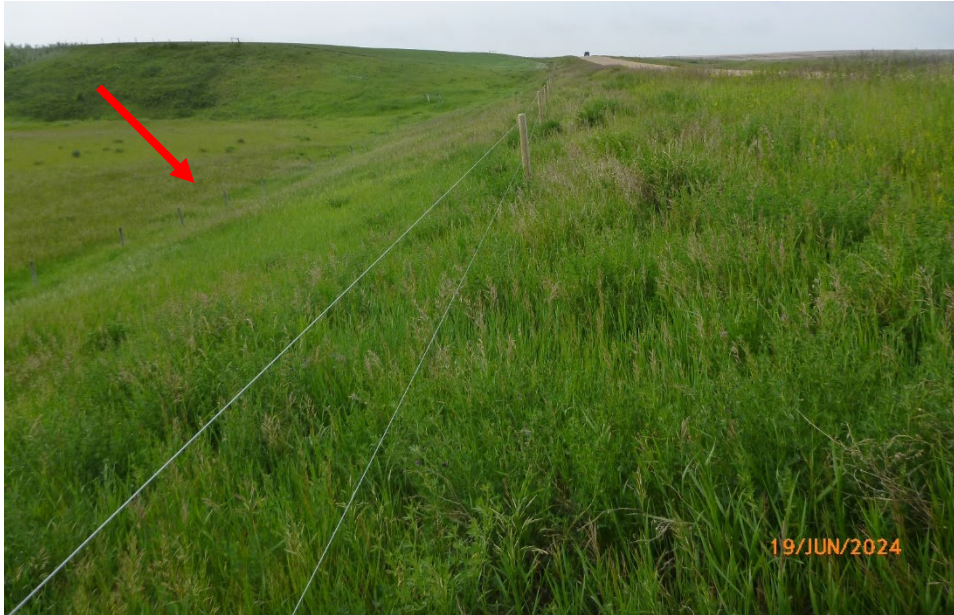
A new electric fence was installed upslope of the existing fence between construction and the 2024 inspection (Photo 3). The new electric fence is much closer to the highway than the existing fence, approximately 4 m from the edge of pavement (i.e. east of the highway), and is within TEC's right-of-way.

Photo 3 New electric fence installed between construction and the 2024 inspection is much closer to the highway than the old fence (indicated by red arrow) and is inside TEC's right-of-way. Photo taken June 19, 2024, facing south.

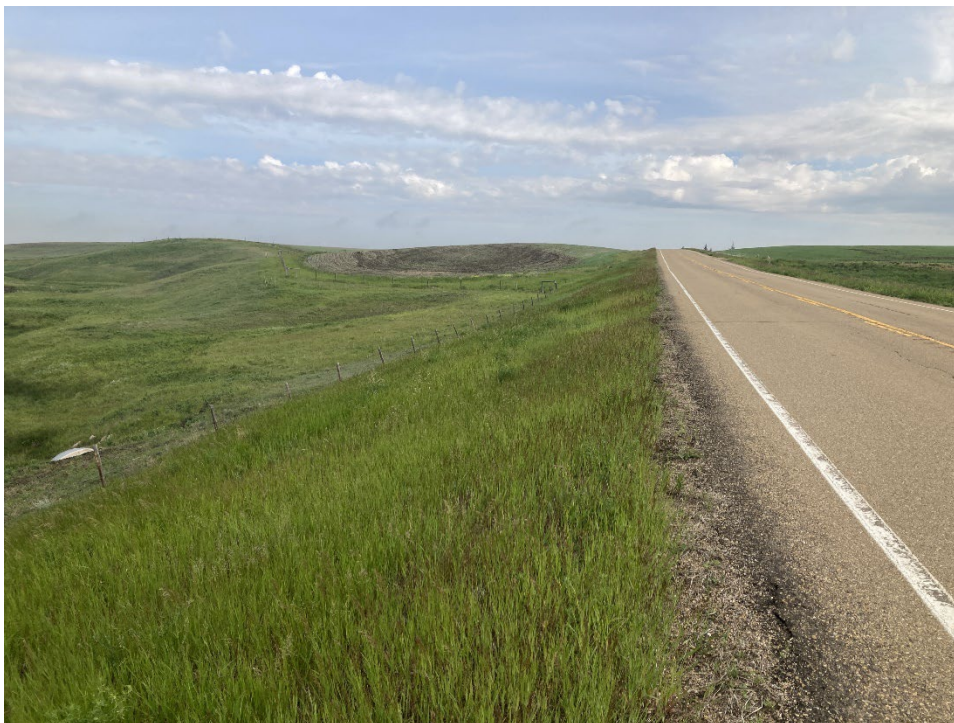
The repaired slope is well vegetated, and no ground cracks were observed during the 2024 inspection (Photo 3 and 4).

Photo 4 The repaired embankment slope is well vegetated and appears to be in good condition. Photo taken June 19, 2024, facing south.
