SITE NUMBER AND NAME: C011-1 and -2 Erosion and Sinkholes		HIGHWAY & KM: 837:02, 5.637	PREVIOUS INSPECTION DATE: May 30, 2022	INSPECTION DATE: June 18, 2024
LEGAL DESCRIPTION: 10-04-30-21-W4M	NAD 83 COORDINATES: UTM Northing Easting 12 5711672 368445 12 5711584 368473		RISK ASSESSMENT: C011-1: PF: 7 CF: 2 TOTAL: 14 C011-2: PF: 11 CF: 6 TOTAL: 66	
AVERAGE ANNUAL DAILY TRAFFIC (AADT): 280 (north) & 310 (south) (Ref No. 106230 & 107250)			CONTRACT MAINTENANCE AREA (CMA): 517

SUMMARY OF SITE INSTRUMENTATION: There is no instrumentation at the C011 site. LAST READING DATE: N/A	INSPECTED BY: Chris Gräpel (KCB) James Lyons (KCB) Tony Penney (TEC) Rocky Wang (TEC)
PRIMARY SITE ISSUE: Erosion in the ditch on the east side (northbound lane) of Hwy 837 near the geocell armoring; and of the unarmored fill that was placed in either 2015 or the spring of 2016.	
APPROXIMATE DIMENSIONS: The site is approximately 200 m long, and the highway embankment above the ditch is approximately 1.2 m high sloped at approximately 4H:1V.	
DATE OF ANY REMEDIAL ACTION: October 2002 – geocell and gabion basket drop structures installed; Spring 2016 – unarmored fill placed downstream of the gabion basket drop stru

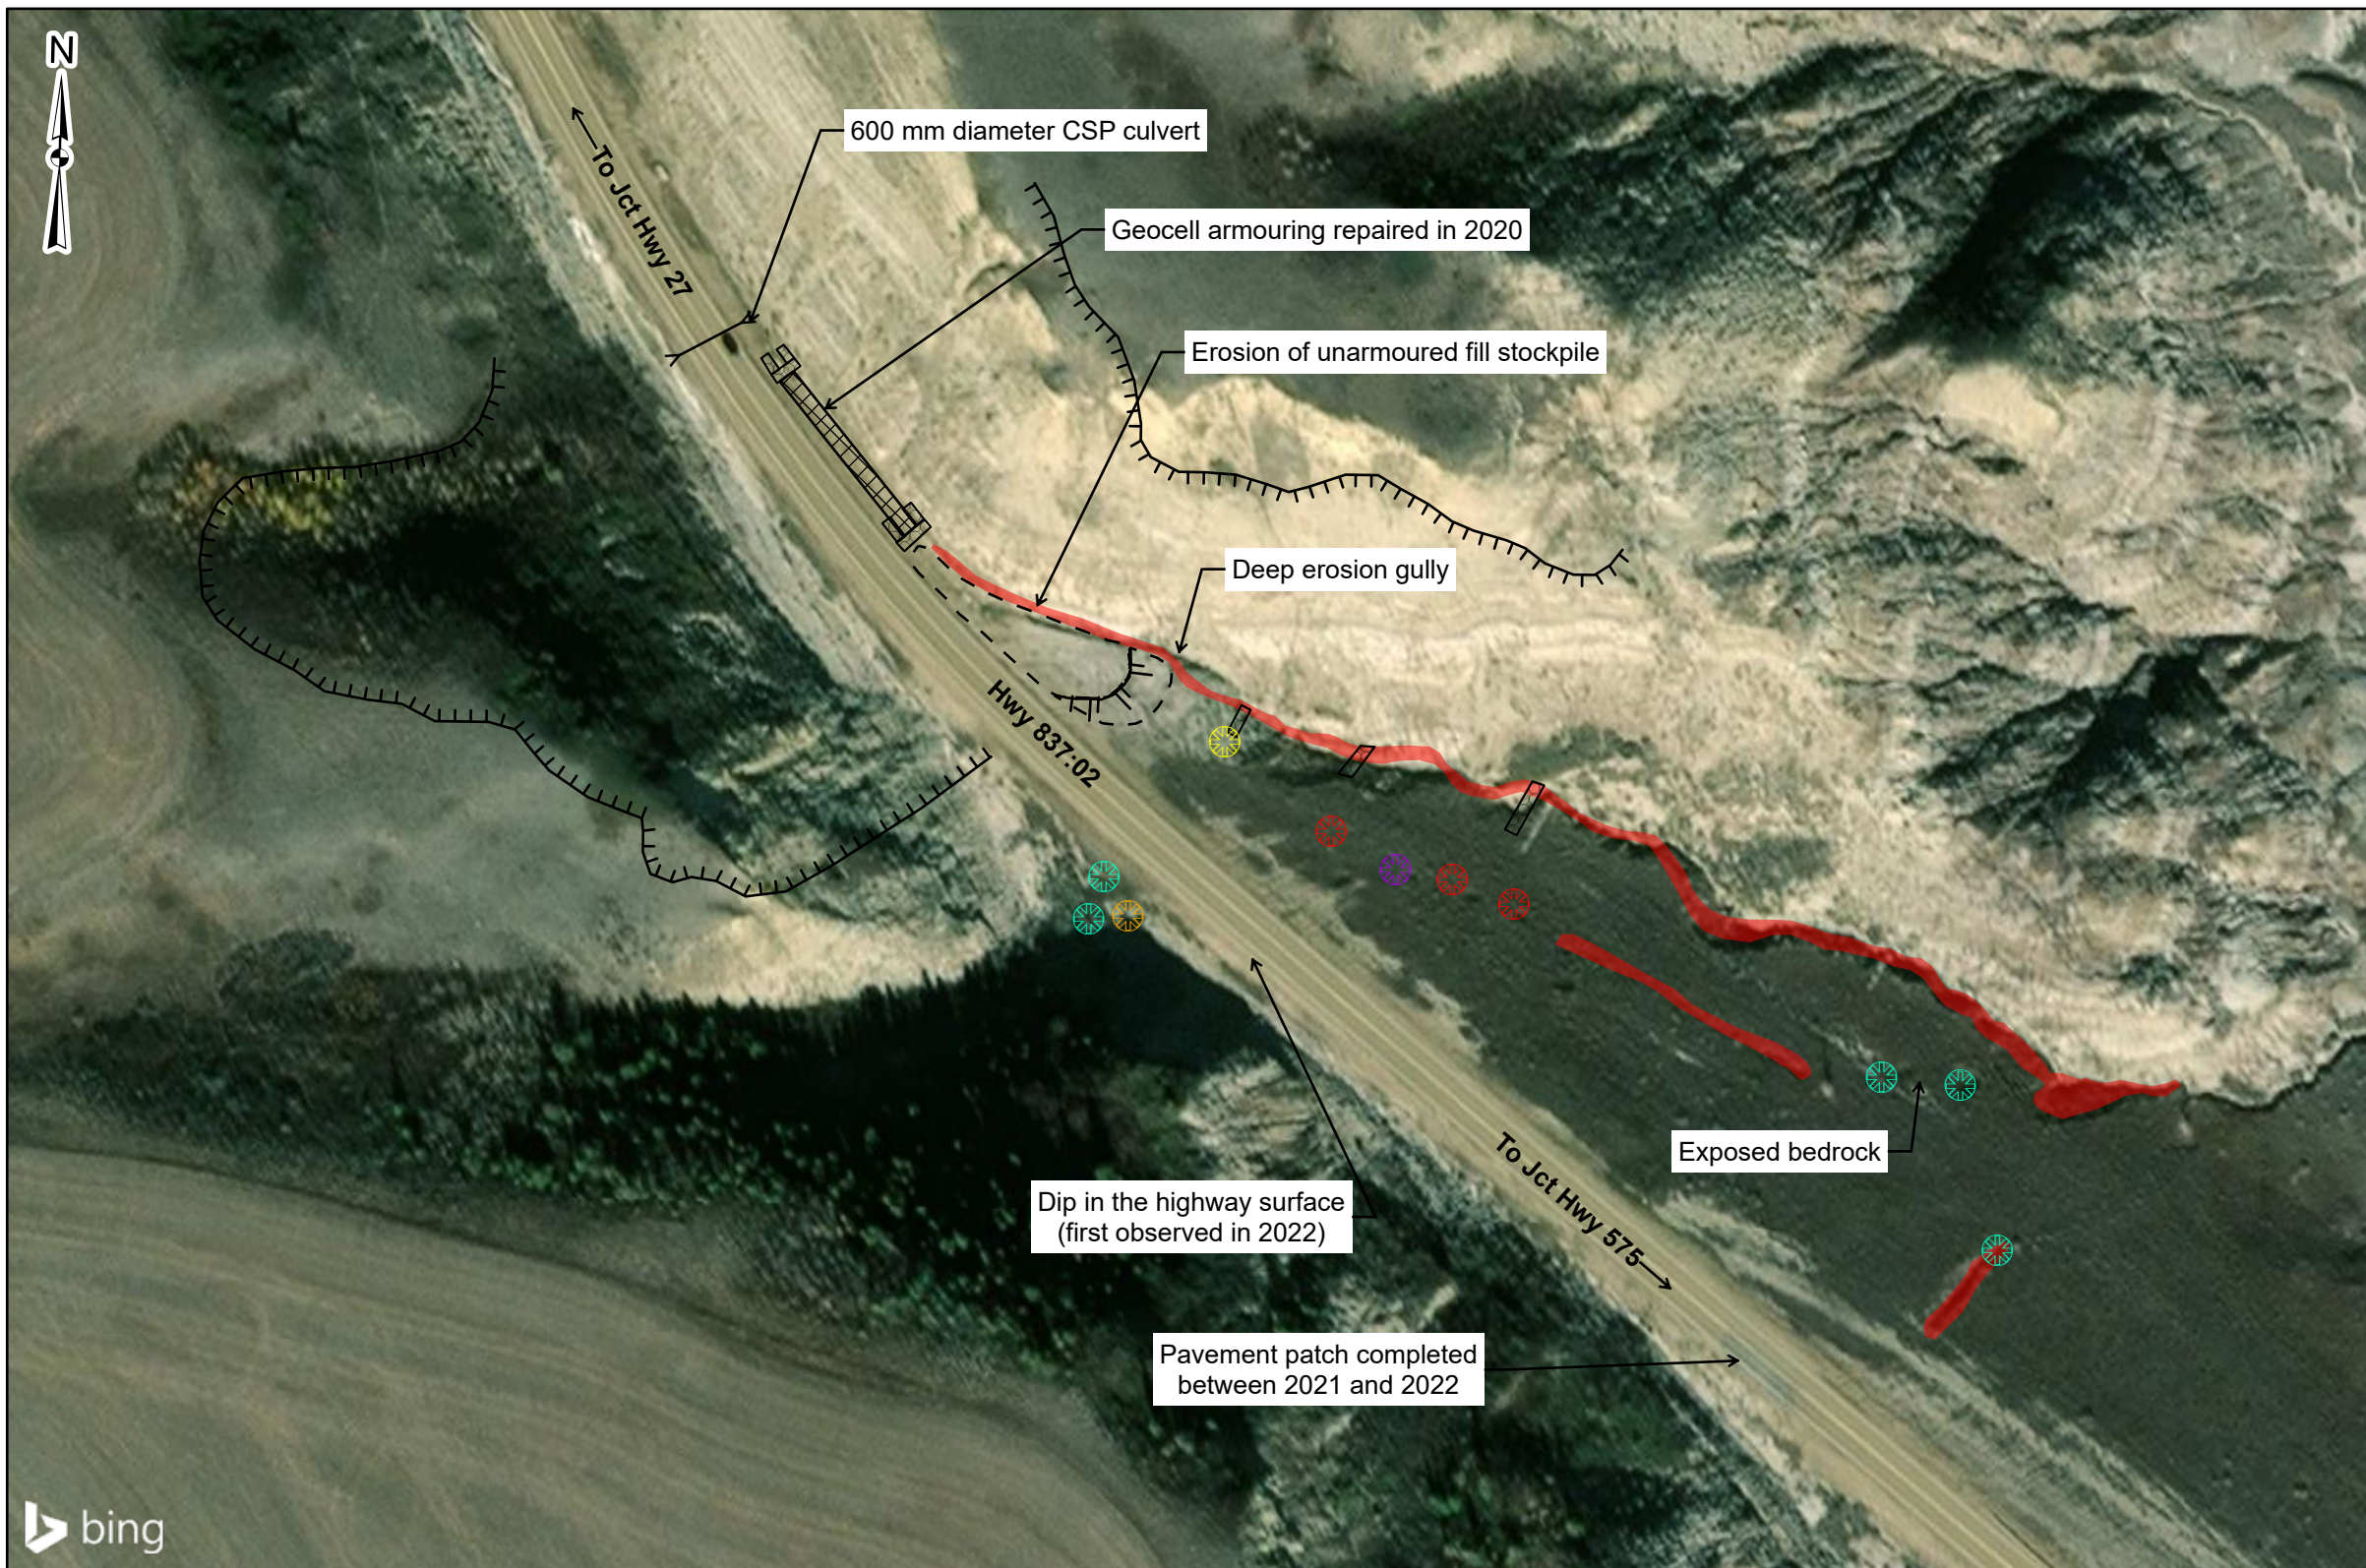
PROJECT CENTRAL REGION GEOHAZARD RISK MANAGEMENT PROGRAM		
TITLE Site Plan C011 - Ditch Erosion Hwy 837:02, km 5.637		
SCALE 1:1,500	PROJECT No. A05116A02	FIG No. 1

- The surface of the embankment slope has several sinkholes as shown in Figure 1, including a line of sinkholes extending southeast along the south edge of the erosion gully. The line between sinkholes on the east and west side of the highway indicates a preferential flow path along the sinkholes on both sides of the embankment at a shallow depth below the highway. The presence of the sinkholes indicates that dispersive soil fill is present in the embankment and foundation.

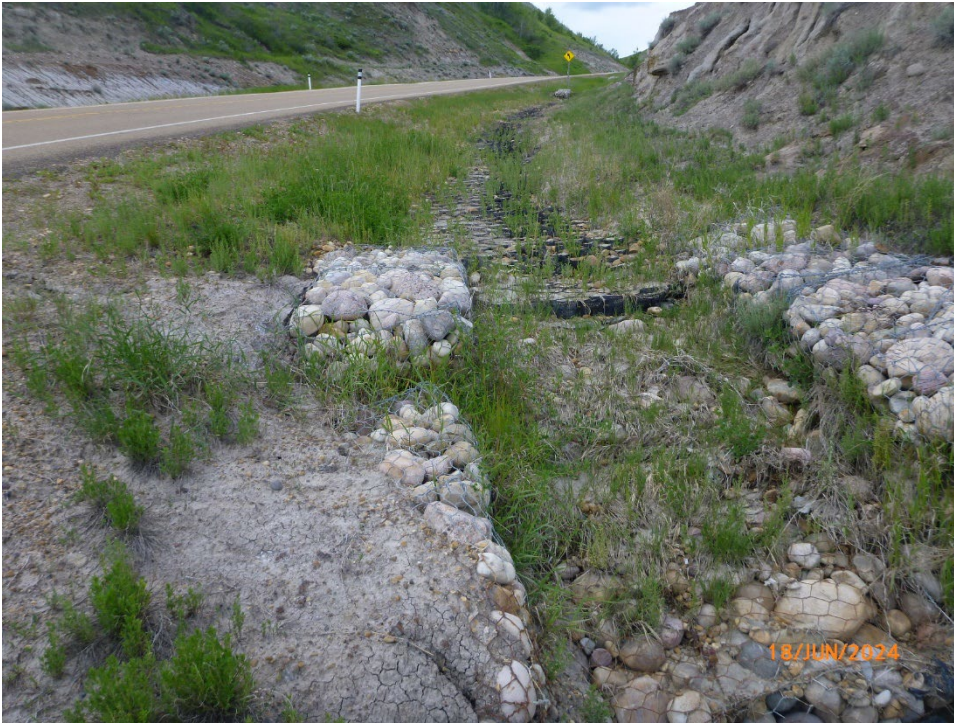
Photo 1 Geocell armouring installed in fall of 2020 is performing well and vegetation cover has improved since the 2022 inspection. Photo taken June 18, 2024, facing northwest.

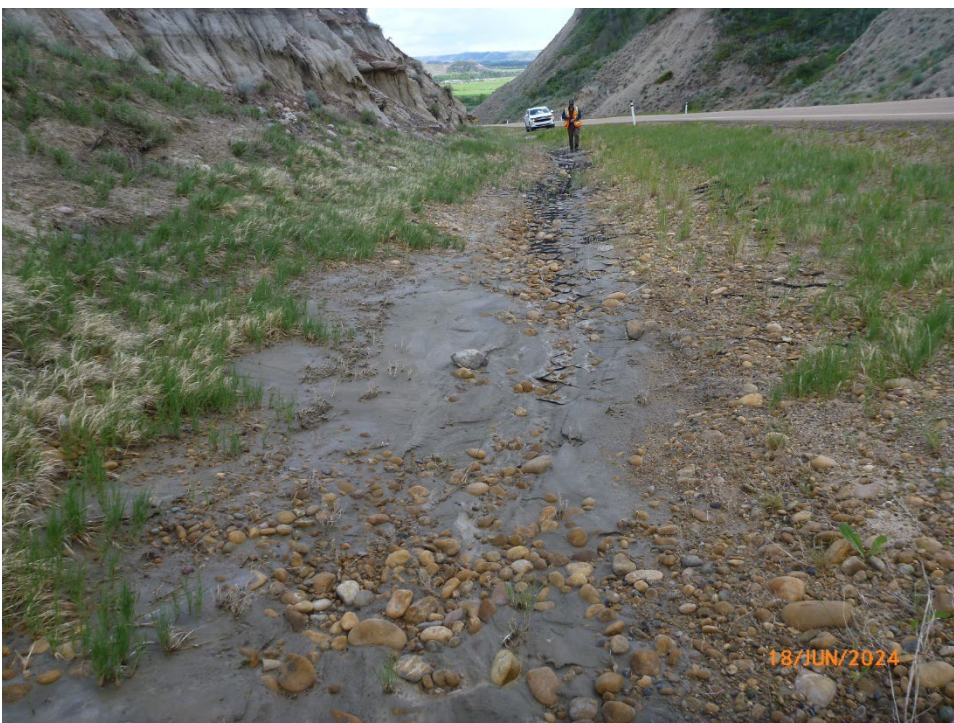
Photo 2 Fine-grained material (silt and clay) has been deposited in the geocell armouring. Photo taken June 18, 2024, facing northwest.

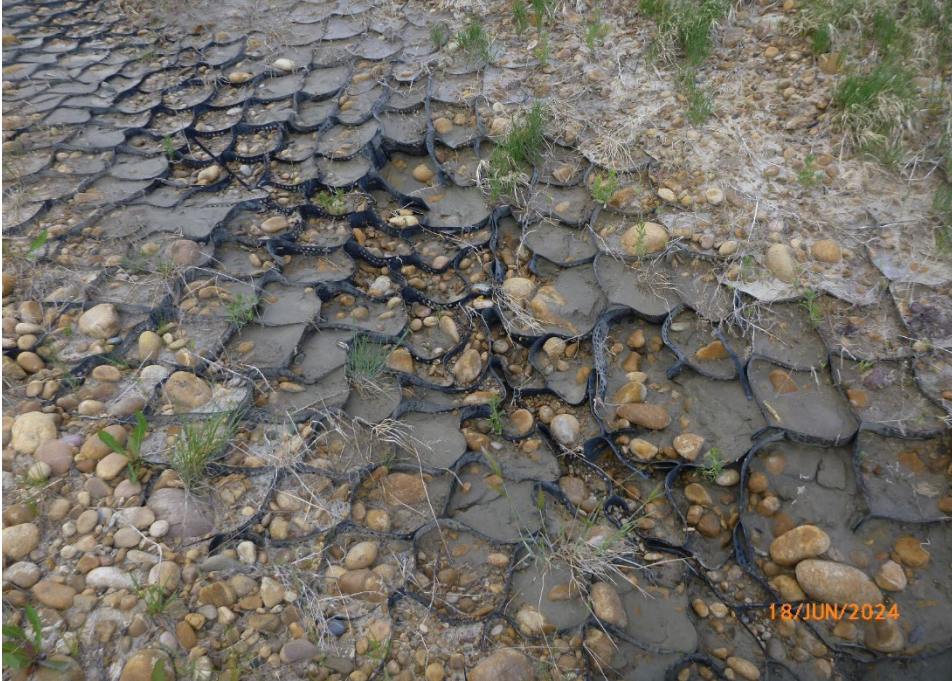
COMMENTS
During the 2021 inspection, KCB and TEC discussed potentially separating the C011 site into two subsites (i.e., C011-1 and -2). C011-1 would be the north portion of the site (ditch erosion that was partially repaired in 2020) and C011-2, which would capture the gully erosion downslope of the geocell armoring/gabion drop structures and the sinkholes on the east and west side of Hwy 837. The site was separated into two subsites in late-2021.
<u>C011-1 Erosion:</u>
<ul style="list-style-type: none"> The geocell armoring upstream of the gabion drop structure was repaired in fall 2020 (Photos 1 through 3) Overall, the repaired geocell armoring appears to be in good condition and vegetation is growing on the ditch side slopes. Along the repair, some material in the geocells has been washed away (likely during significant precipitation events) and some of the cells show minor damage (Photo 3).

Photo 3 Some of the coarse-grained material has been washed out between the individual cells between the 2022 and 2024 inspections. Photo taken June 18, 2024, facing north.

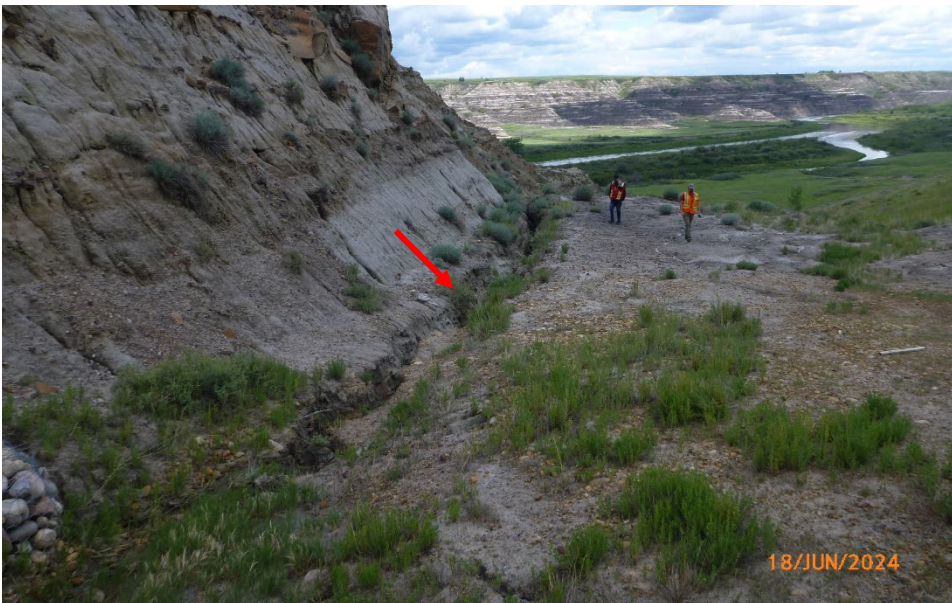
- The unarmoured fill stockpile continues to be affected by gully erosion and the erosion gully downslope of the unarmoured fill stockpile continues to expand off highway right-of-way (Photo 4).

Photo 4 The erosion downstream of the geocell repair and gabions is significantly wider and deeper than during the 2022 inspection (indicated by red arrow). Photo taken June 18, 2024, facing east.

- A seamless HDPE slope drain could be used to convey flows over the eroded areas and into the sediment pond, or to a natural creek channel for discharge into the Red Deer River. An energy dissipation structure would be required at the base of the slope to reduce the flow velocity from the slope drain outlet.

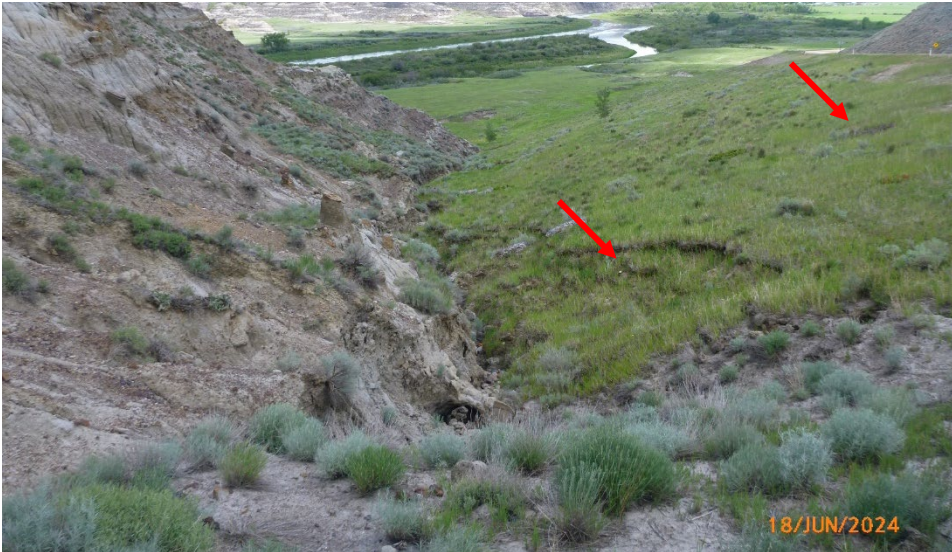
- The erosion is causing slope failures that are enlarging slowly and extending upslope (south) towards the highway (Photo 5). Continued erosion of failed material will eventually cause sliding that is large enough to impact the highway.

- The large sinkhole on the east highway embankment slope (Photo 5 and 6) does not appear to have increased in size between the 2022 and 2024 inspections.

Photo 5 Erosion gully downstream of the geocell repair, along the toe of the natural slope and highway embankment slope. The slide and sinkhole on the highway embankment slope (indicated by red arrows) appears not to have changed significantly since 2022. Photo taken June 18, 2024, facing east.

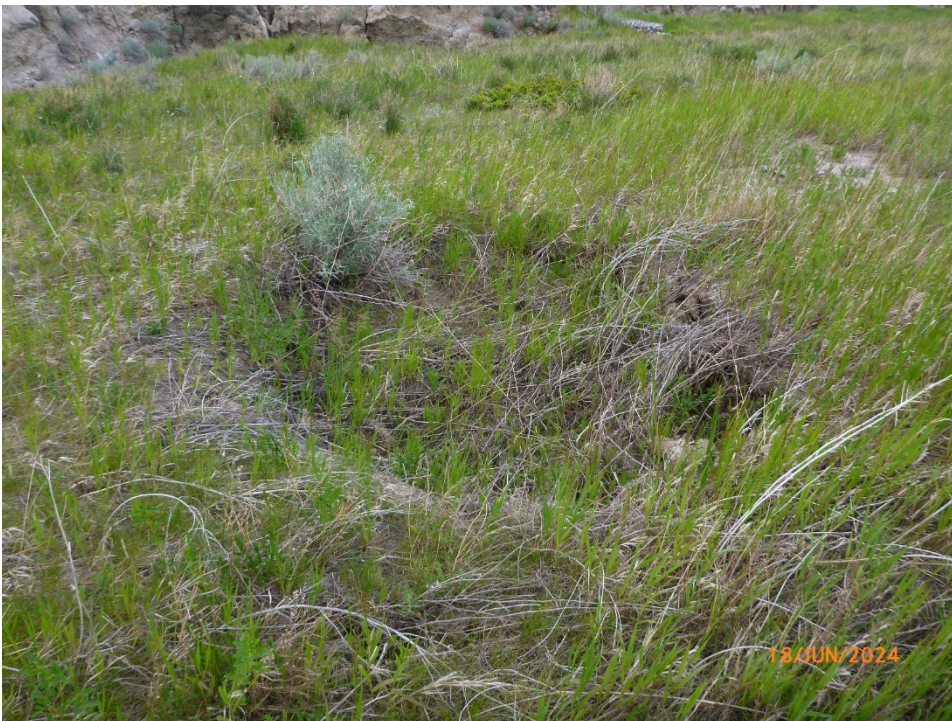
Photo 6 Sinkhole on the highway embankment slope (location shown in Photo 5) appears similar as during the 2022 inspection (approximately 2 m to 3 m in diameter). Photo taken June 19, 2024, facing north.

- A tracer dye test could be completed to assess the connectivity of the sinkholes observed on the north and south sides of the highway.

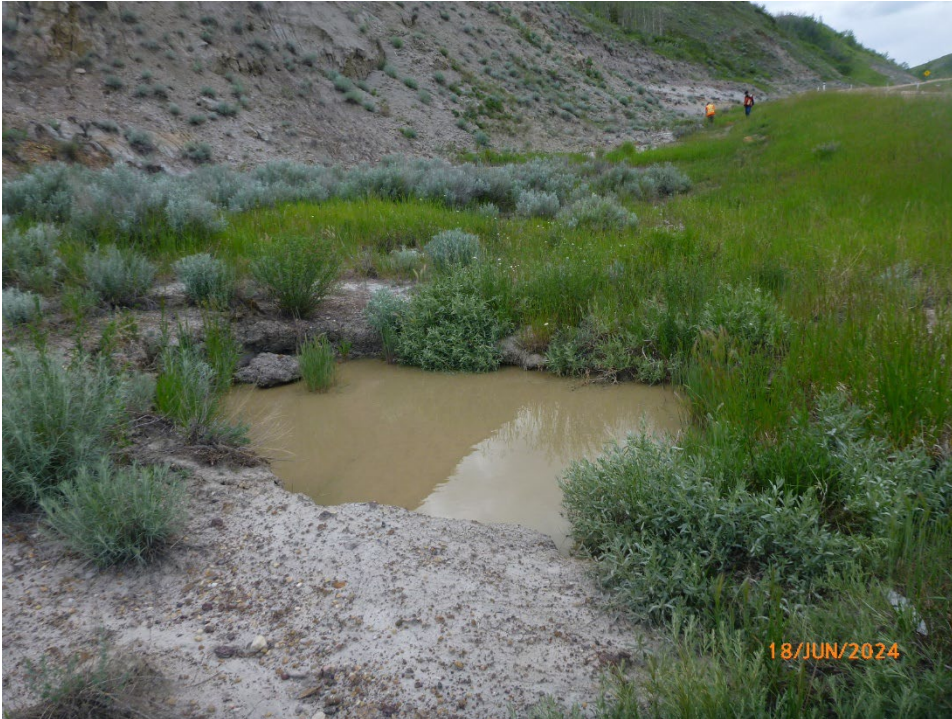
- The sinkhole historically observed on the south side of the highway (Photo 7) is filled with water and does not appear to have increased in size between the 2022 and 2024 inspections.

- The depression in the highway surface, southeast of the large sinkhole south of the highway (Photo 7), appears similar as during the 2022 inspection. The depression is between sinkholes north and south of the highway, which could indicate that void formation and collapse is occurring below the highway surface, likely due to the dispersive soils located at the site.

Photo 7 Sinkhole previously observed on the south side of the highway is full of water. No significant changes were observed since the 2022 inspection. Photo taken June 18, 2024, facing northwest.

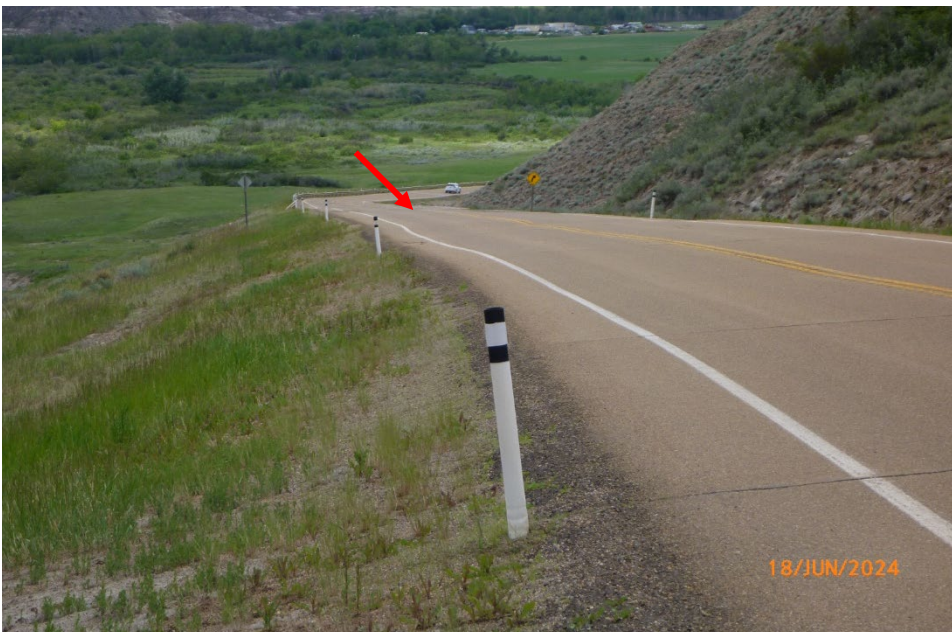
- Depressions in the highway surface downhill (southeast) of the site were observed during the inspection (Photo 8). The depressions can likely be attributed to void formation and collapse below the highway surface due to the dispersive nature of the soils at the site.

Photo 8 Depressions were observed in the highway surface downhill (southeast, location indicated by red arrow) of the C011 site. Photo taken June 18, 2024, facing southeast.

- The site should be regularly inspected by TEC's MCI, particularly after significant precipitation events (spring freshet or heavy and/or prolonged rainfall). TEC operations crews should also monitor this site for possible settlement or collapse of the pavement like they do at the C058 geohazard site on Hwy 570.
- The site should continue to be inspected every two years as part of the GRMP Section B Inspections.
