SITE NUMBER AND NAME: C076 East of Bleriot Ferry		HIGHWAY & KM: 838:02, 22.212	PREVIOUS INSPECTION DATE: November 17, 2023 (post-construction)	INSPECTION DATE: June 18, 2024
LEGAL DESCRIPTION: 6-15-30-21-W4	NAD 83 COORDINATES: UTM Northing Easting 12 5714409 369753		RISK ASSESSMENT: PF: 11 CF: 2 TOTAL: 22	
AVERAGE ANNUAL DAILY TRAFFIC (AADT): 200 (east) & 180 (west) (Ref No. 107250 & 109260)			CONTRACT MAINTENANCE AREA (CMA): 517

SUMMARY OF SITE INSTRUMENTATION: There is no instrumentation at the C076 site. LAST READING DATE: N/A	INSPECTED BY: Chris Gräpel (KCB) James Lyons (KCB) Tony Penney (TEC) Rocky Wang (TEC)
PRIMARY SITE ISSUE: Ditch erosion in the north and south (westbound and eastbound, respectively) ditches, exacerbating by steep ditch grades and dispersive soil at the site.	
APPROXIMATE DIMENSIONS: Ditch erosion is occurring along approximately 600 m of Hwy 838:02, east of Bleriot Ferry in the north and south highway ditches. Erosion gullies are approximately 1 m to 5 m deep and 2 m to 5 m wide (deepest and widest erosion gullies are along the last 100 m of the north (westbound) ditch).	
DATE OF ANY REMEDIAL ACTION: July – October 2023 – as part of the H838 overlay proj

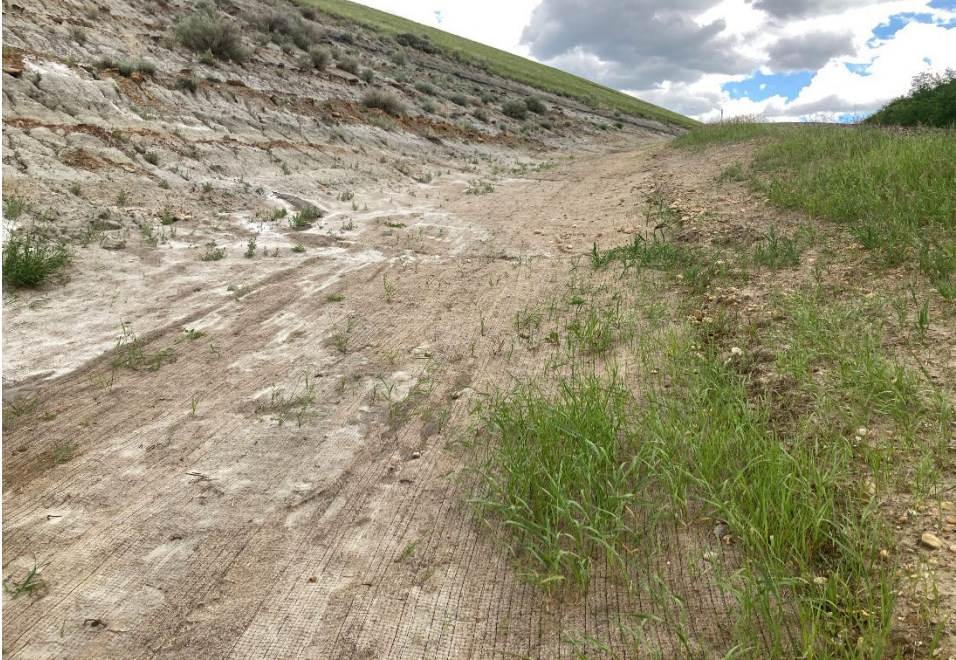
- The east portion of the repair (including the ditch block and the upstream ditch) appears to be in good condition (Photo 1 and 2). Overall, there is poor vegetative cover, but are lengths of the ditch side slopes where grass has begun to grow.

Photo 1 Repair near the east end of the north ditch repair appears to be in good condition and some vegetation growth was observed. Photo taken June 18, 2024, facing east.

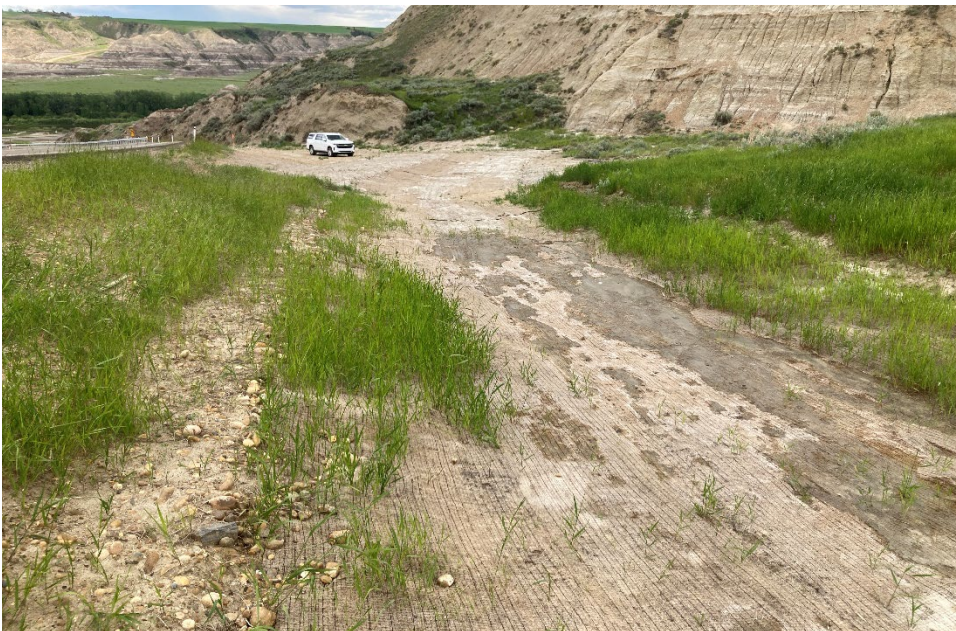
Photo 2 Repair upslope of the ditch block in the north ditch appears to be in good condition and some vegetation growth was observed. Photo taken June 18, 2024, facing west.

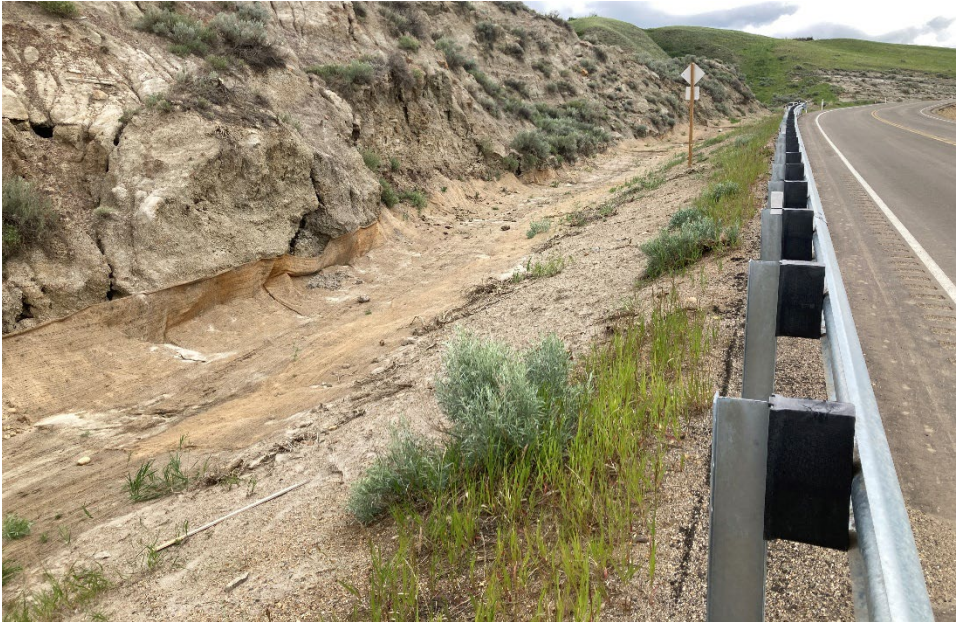
Photo 3 Condition of the north ditch repair downstream (west) of the ditch block. Photo taken June 18, 2024, facing northeast.

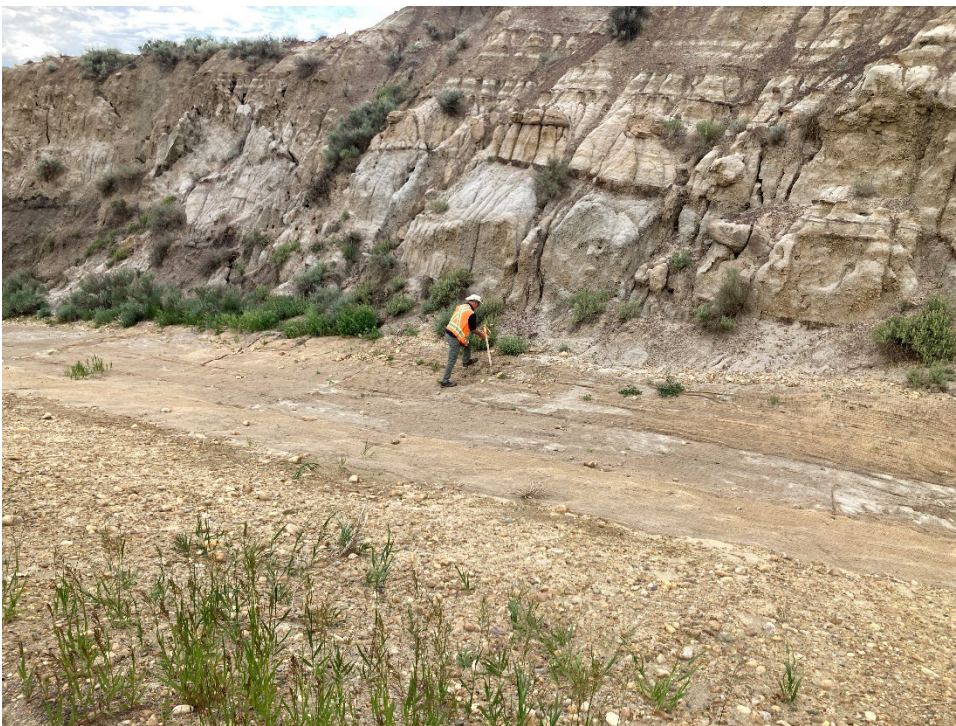
- The repair west of the ditch block (approximately 330 m) is in satisfactory condition, excluding the following:
 - At least two sinkholes were observed downstream (west) of the ditch block (Photo 4 and 6). During the inspection, KCB installed a stake on the north ditch side slope at one of the sinkholes to indicate its location (Photo 4). The downstream sinkhole (Photo 6) was partially filled with water during the inspection. It is unknown if its being filled from surface water flow or from subsurface flow beneath the ditch.
 - Portions of the RECP are damaged and are being undermined (Photos 5, 7, and 8). The damaged RECP is along the steeper portion of the north ditch, approximately 100 m long, where the overall grade increases to be approximately 20%.

Photo 4 KCB installing a wooden stake to indicate the location of an observed sinkhole on the north ditch side slope. Photo taken June 18, 2024, facing north.

- In the north (westbound) ditch, where the RECP is being undermined, or where sinkholes have formed, the RECP should be removed. The erosion gullies/sinkholes should be backfilled with compacted well-graded granular fill, and new RECP should be installed.

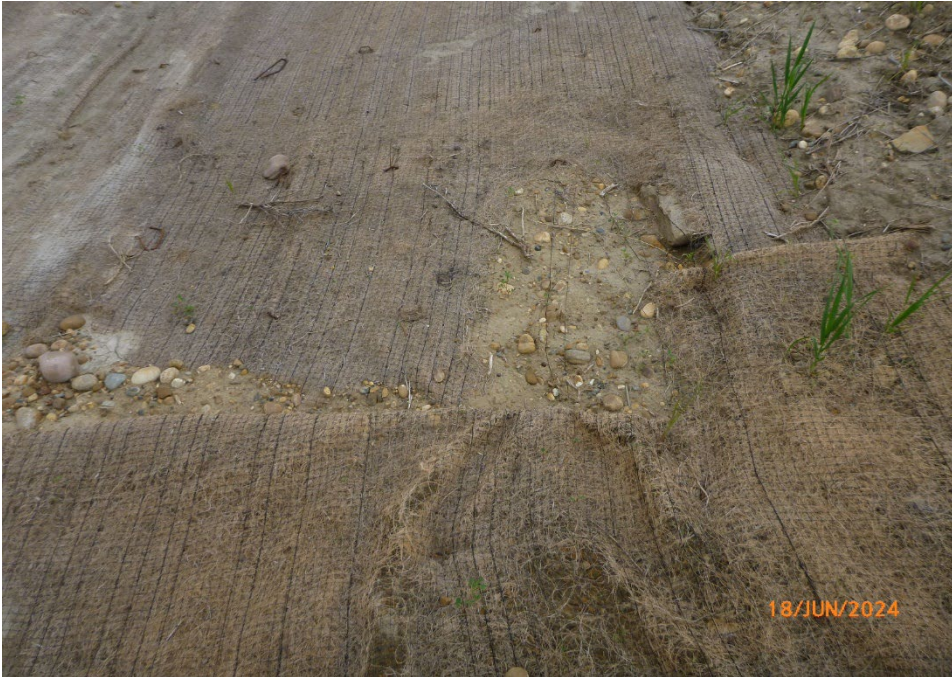
Photo 5 **Damage to the rolled erosion control product (RECP) observed in the north ditch.**
Photo taken June 18, 2024, facing east.

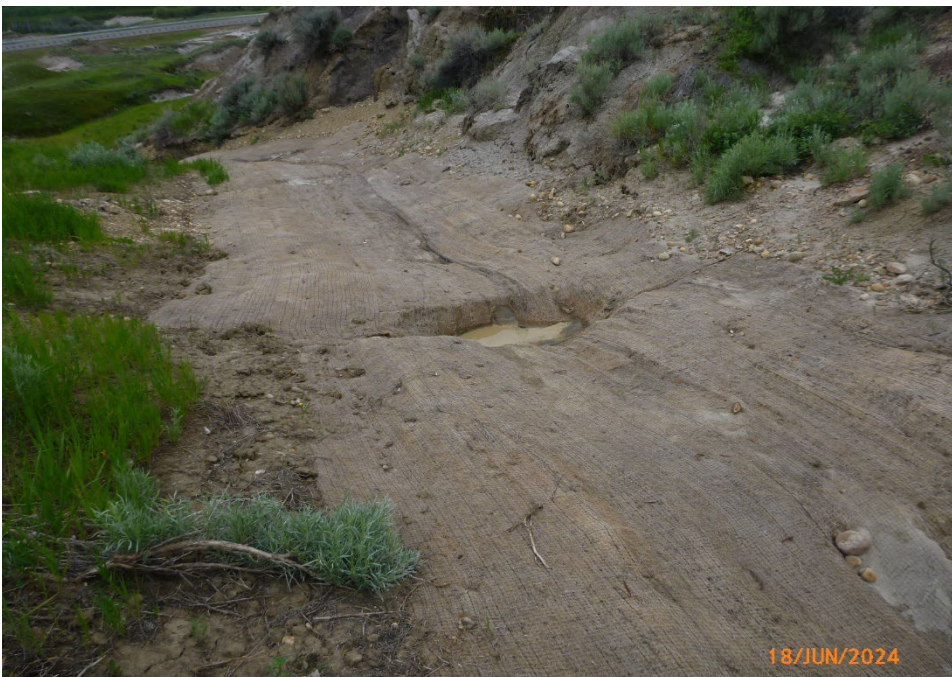
Photo 6 **Sinkhole partially filled with water observed in the north ditch, upstream of the steep section at the west extent of the repair, downstream of a draw on the natural slope north of the ditch. Photo taken June 18, 2024, facing west.**

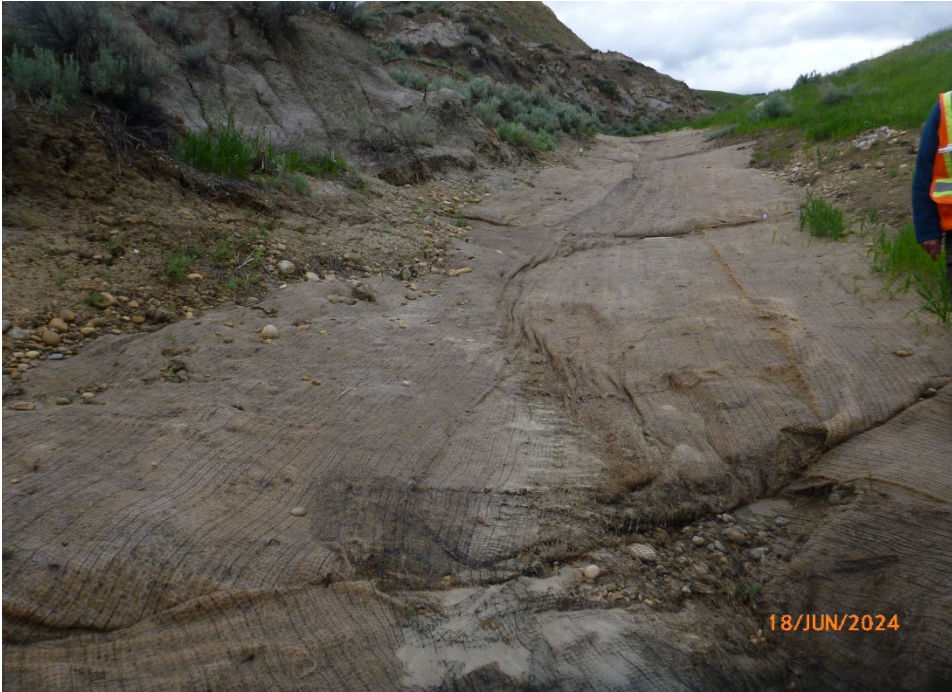
Photo 7 **Damage to the RECP observed in the north ditch, where the ditch grade steepens to approximately 20%. Photo taken June 18, 2024, facing east.**

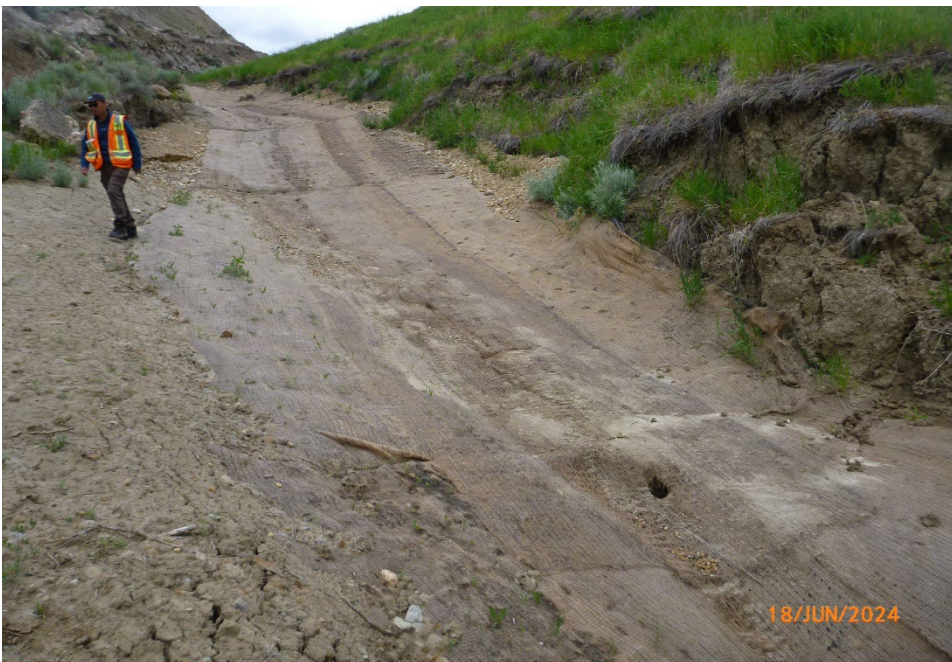
Photo 8 **Undermining of the RECP observed in the north ditch near the west extent of the repair. Photo taken June 18, 2024, facing east.**

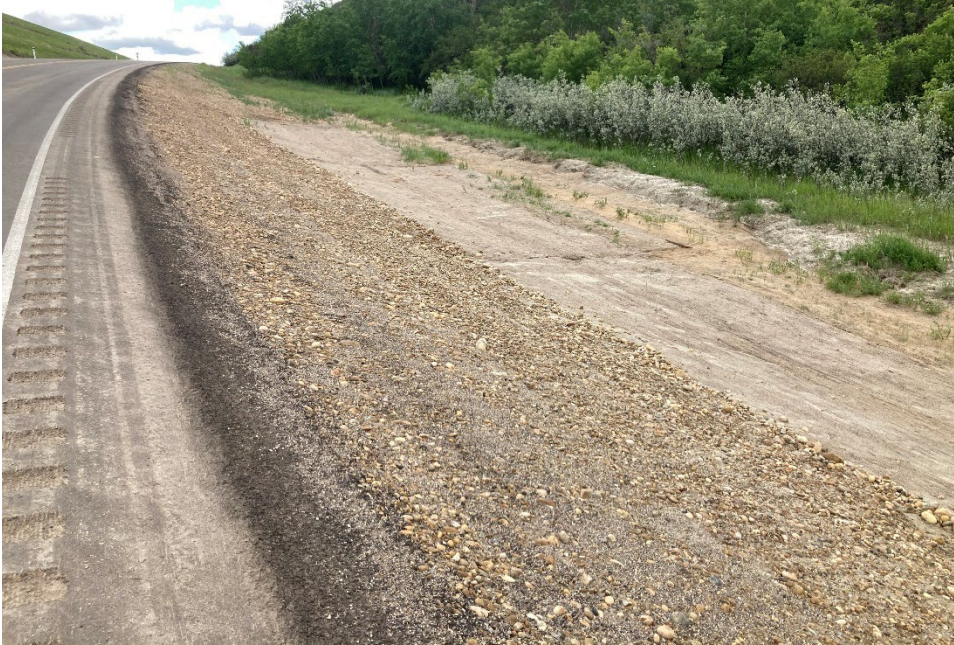
- The 2023 repair is in good condition, excluding the following:
 - There is poor vegetative growth along the repair (Photos 9 through 14).
 - Between the November 2023 and June 2024 inspections, failed material from the south natural slope (existing slide) has slumped into the south ditch and is partially blocking the ditch (Photo 11 and 12). The length of impacted ditch is approximately 50 m long. Seepage has been observed at the toe of the slope during previous inspections and during 2023 construction. A trench was excavated during construction to divert seepage to the ditch bottom but appears to be ineffective as seepage was observed flowing overtop the failed material upstream (east) of the trench.
 - The RECP is being undermined at the downstream (west) extent of the repair (Photo 14).

Photo 9 The east extent of the south ditch repair. A small amount of grass is growing on the south ditch side slope. Photo taken June 18, 2024, facing east.

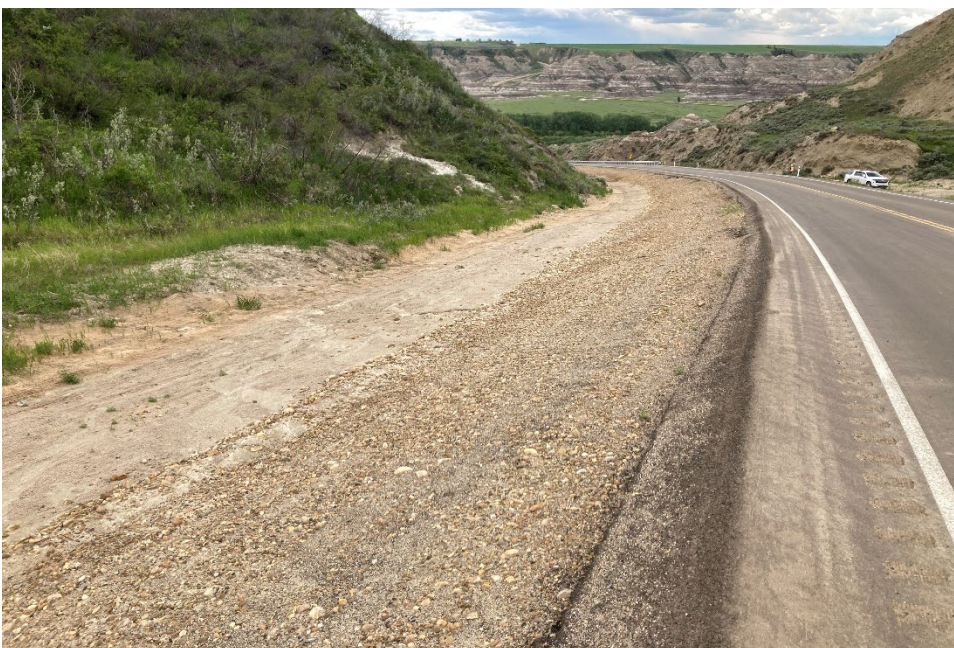
Photo 10 The repair appears to be in good condition near the east extent of the south ditch repair. Photo taken June 18, 2024, facing west.

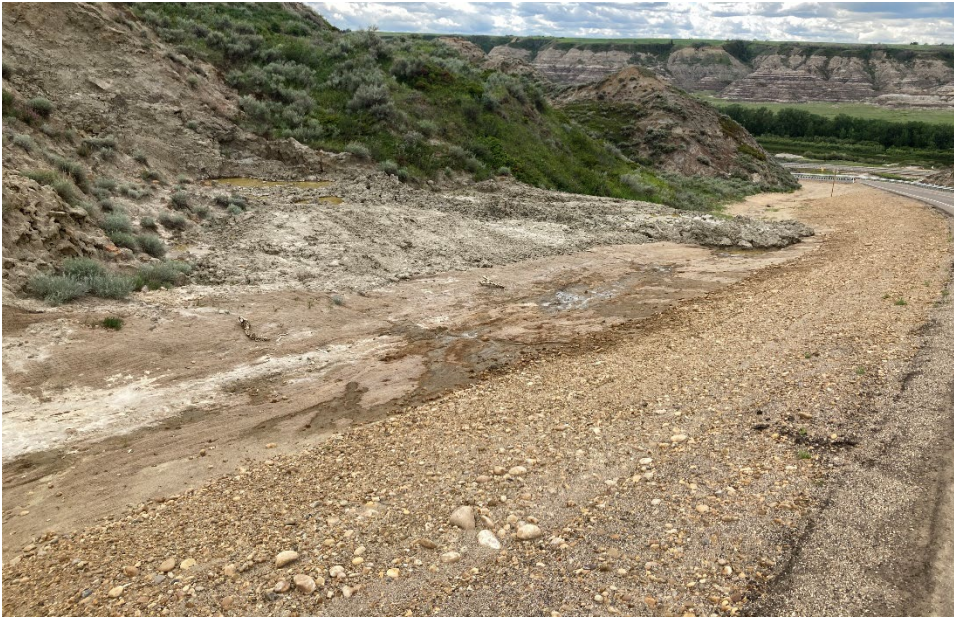
Photo 11 Between the October 2023 post-construction site visit and June 2024 inspection, failed material from the steep and tall natural slope has slumped into the south ditch, partially blocking the ditch and constricting flow. Photo taken June 18, 2024, facing southwest.

- The site should be inspected every two years as part of the Central Region GRMP Section B Inspections.
- A compacted granular fill berm should be built in the south (eastbound) ditch to stop failed material from the south natural slope from slumping into and blocking the ditch. The berm should be at least 50 m long, 1.5 m tall, 3 m wide, with 3H:1V side slopes. Drainage improvements (e.g., finger drain along the base of the berm) should also be included as part of the repair work to convey seepage at the toe of the slope to the ditch bottom.

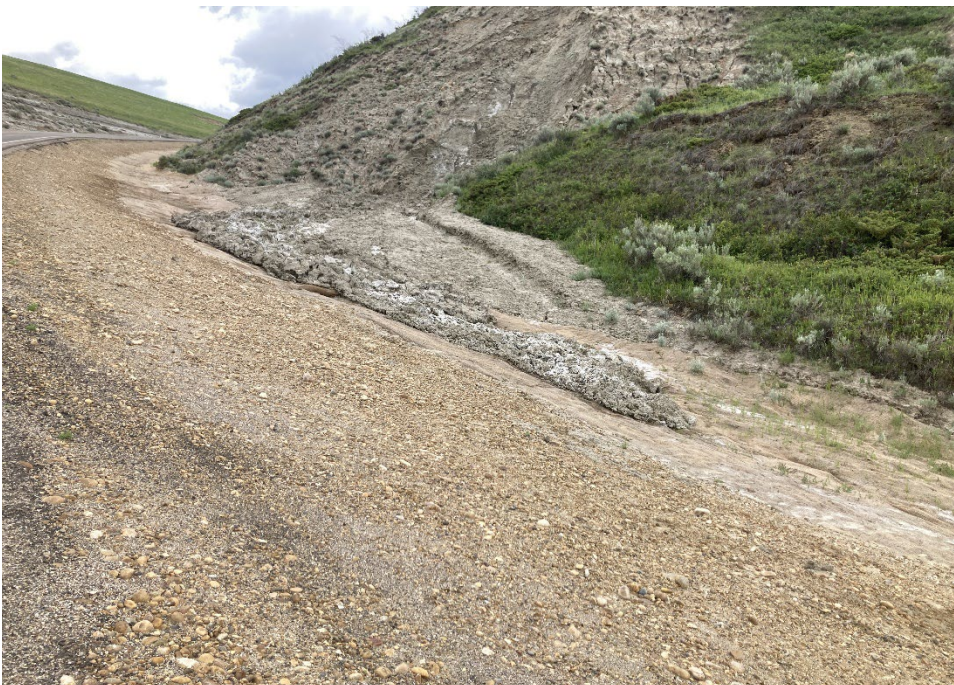
Photo 12 Failed material partially blocking the south ditch. Drainage trench excavated during 2023 construction appears ineffective at conveying seepage from the toe of the slope to the ditch. Photo taken June 18, 2024, facing east.

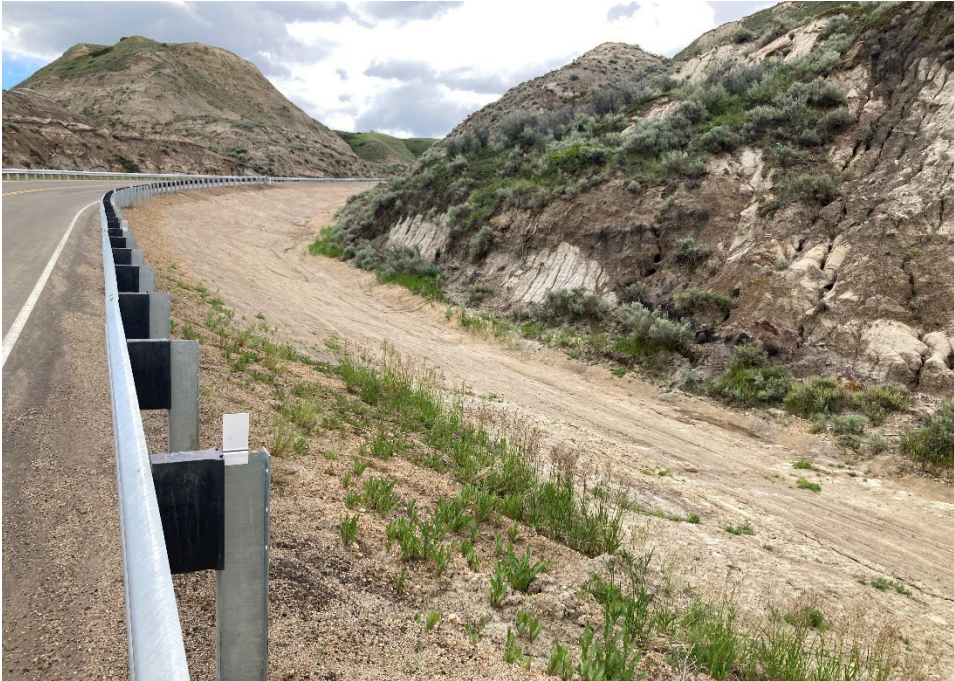
Photo 13 The repair along the west portion of the south ditch repair appears to be in good condition. Photo taken June 18, 2024, facing east.

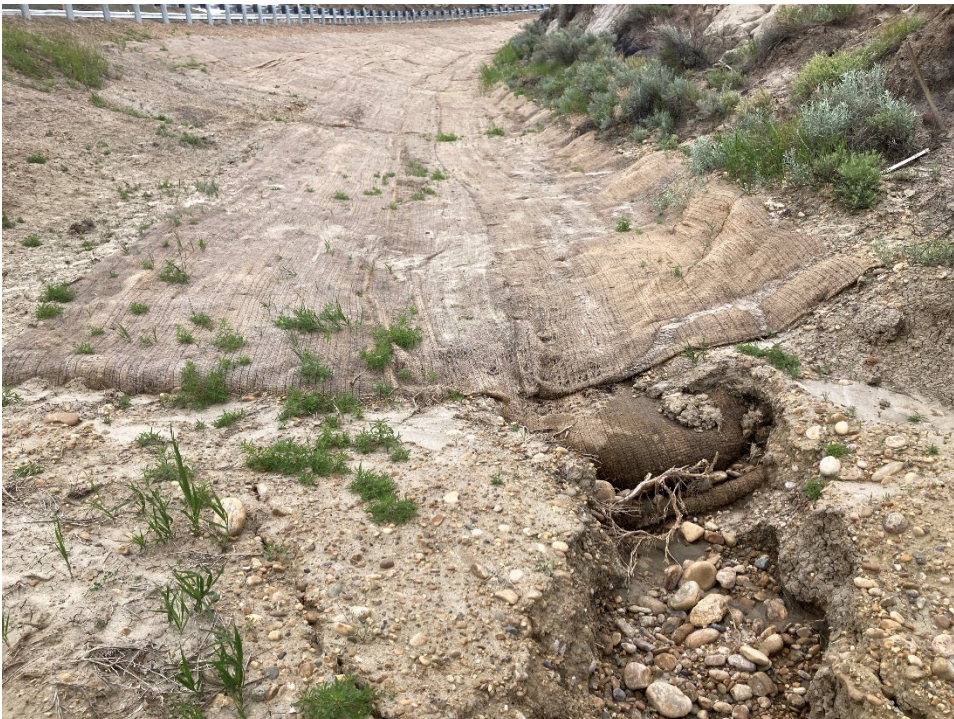
Photo 14 Erosion is ongoing at the outlet of the south ditch repair and is beginning to undermine the RECP. Photo taken June 18, 2024, facing east.
