<b>SITE NUMBER AND NAME:</b> C012 Hwy 841 Ditch Erosion		<b>HIGHWAY &amp; KM:</b> 841:02, 6.495	<b>PREVIOUS INSPECTION DATE:</b> June 27, 2023	<b>INSPECTION DATE:</b> <b>June 18, 2024</b>
<b>LEGAL DESCRIPTION:</b> 33-27-20-W4M	<b>NAD 83 COORDINATES:</b> UTM    Northing    Easting 12      5689847    377129		<b>RISK ASSESSMENT:</b> PF: 11    CF: 3    TOTAL: 33	
<b>AVERAGE ANNUAL DAILY TRAFFIC (AADT):</b> 80 (north) & 200 (south) (Ref No. 109220 & 108240)			<b>CONTRACT MAINTENANCE AREA (CMA):</b> 517

**PRIMARY SITE ISSUE:** Erosion in the west (southbound) ditch of Hwy 841 in previously repaired areas. Ditch erosion upslope of the previously repaired areas is ongoing and is also eroding the toe of an approximately 25 m high natural slope on the west side of Hwy 841. Private land at the crest of the slope is being affected by slope movements.

PROJECT CENTRAL REGION GEOHAZARD RISK MANAGEMENT PROGRAM		
TITLE Site Plan C012 - Hwy 841 Ditch Erosion Hwy 841:02, km 6.71		
SCALE 1:3,000	PROJECT No. A05116A02	FIG No. 1

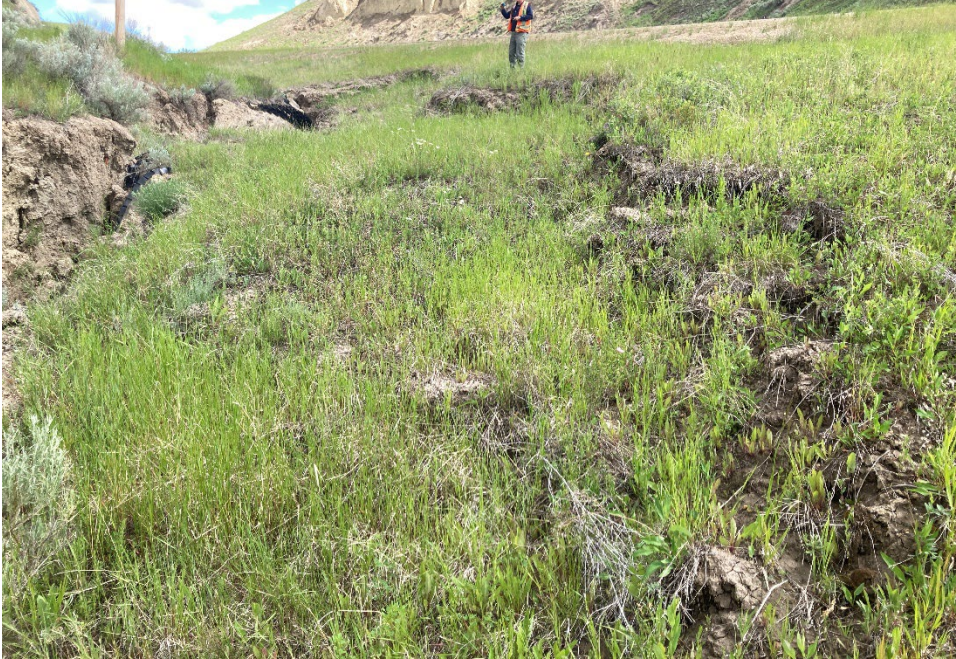
- The erosion has triggered a slope failure on the highway embankment slope that isn't impacting the west (southbound) lane of Hwy 841 (Photo 1 and 2). Flow in the ditch is bypassing the geocell armouring and is eroding the highway embankment (Photo 3).

**Photo 1** The slide in the west (southbound) highway embankment slope appears to have expanded since the 2023 inspection. Photo taken June 18, 2024, facing north-northeast.

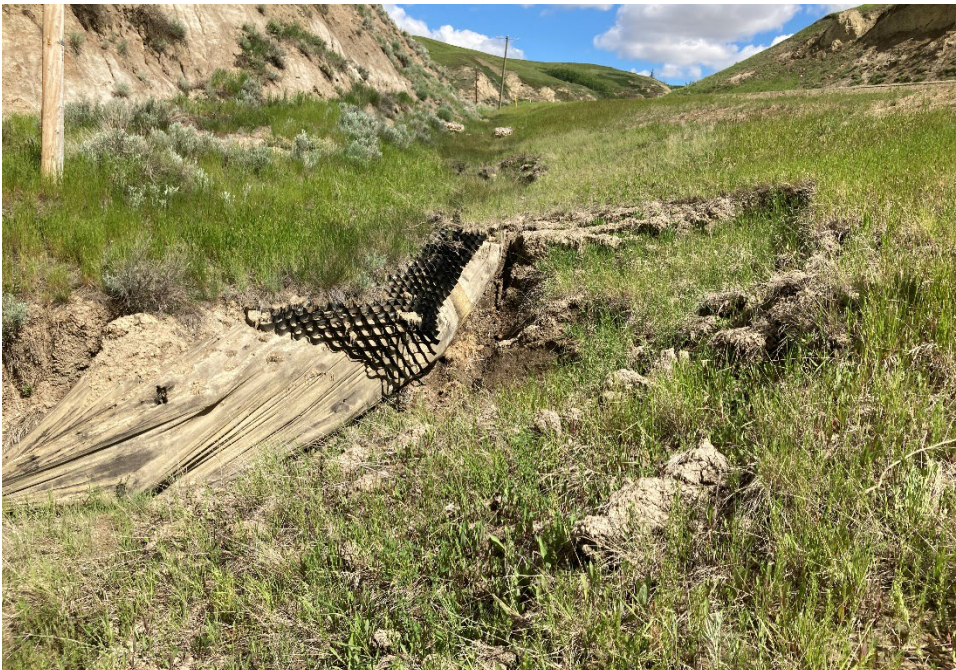
- Portions of the west ditch have been previously repaired with geotextile and geocell armouring. Approximately 25 m to 50 m of the geocell reinforcement has failed (i.e., exposed and undermined). The erosion gullies up to approximately 3 m to 4 m deep. The degree of erosion appears similar between the 2023 and 2024 inspections (Photo 2).

- The erosion will eventually impact a nearby power pole (approximately 2 m to 3 m away) located on the west side of the ditch (Photo 2).
- A sinkhole was observed on the east edge of the gabion basket drip structure (first observed in 2024) (Photo 4). The sinkhole is approximately 0.5 m in diameter and 0.5 m deep.

**Photo 2** The geocell armoring at the south extent of the site has failed and is being undermined. The degree of erosion appears similar as during the 2023 inspection. Photo taken June 18, 2024, facing north.

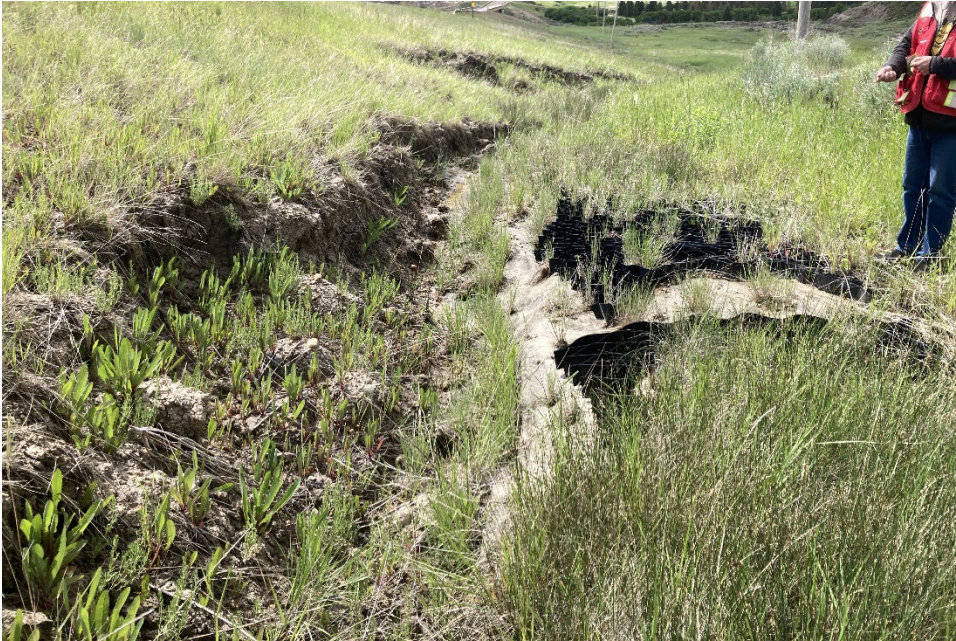
**Photo 3** Flows have bypassed the geocell armoured near the south extent of the site and is eroding the highway embankment. Photo taken June 18, 2024, facing south.

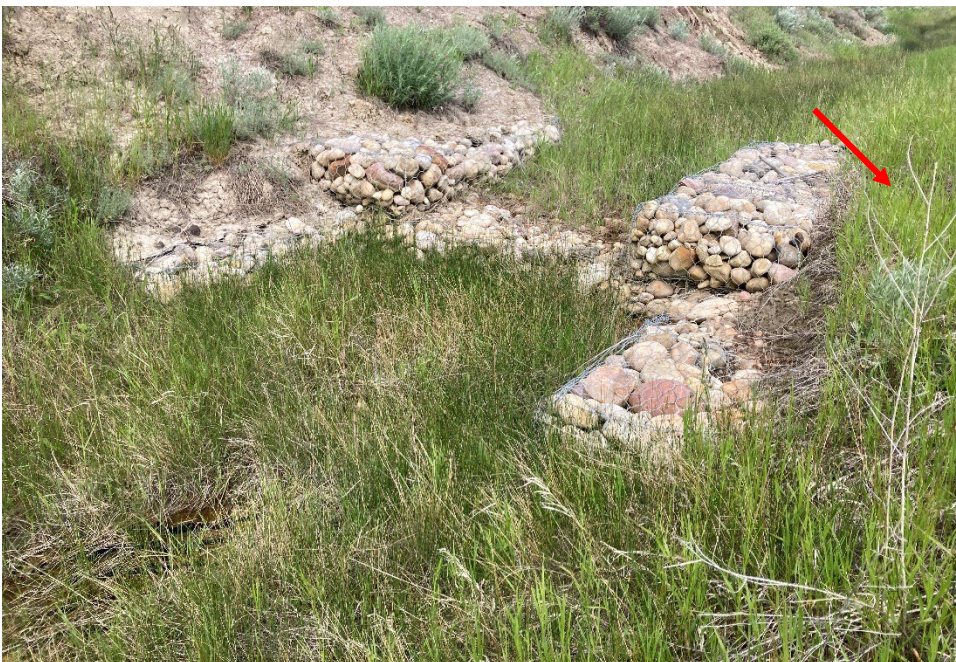
**Photo 4** The gabion basket drop structure near the south extent of the site appears to be in good condition. A sinkhole (approximately 0.5 m in diameter and 0.5 m deep, location indicated by red arrow) was observed near the east (left) edge of the drop structure. Photo taken June 18, 2024, facing north.

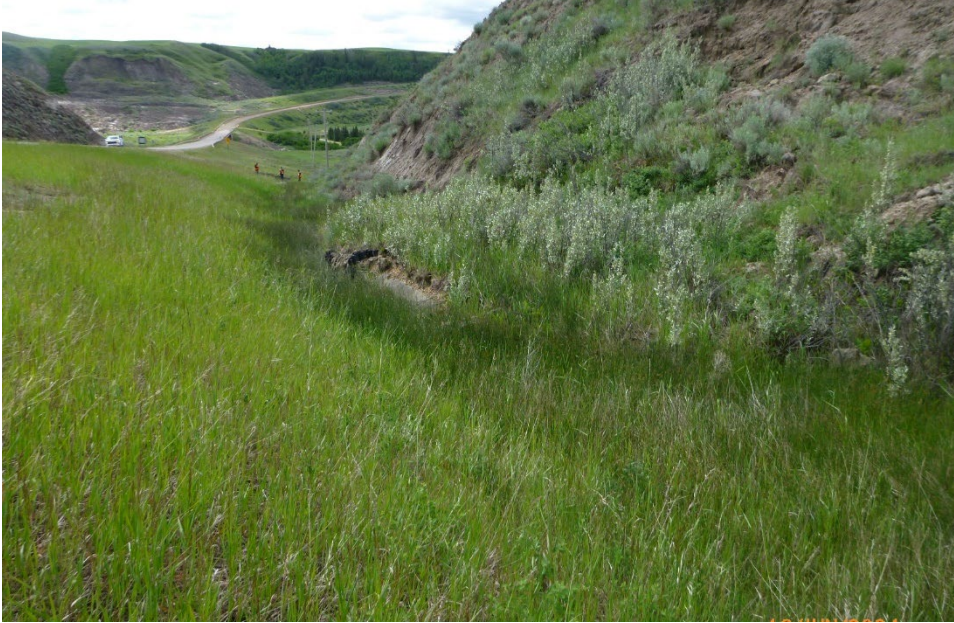
- A slide was observed on the natural slope west of the ditch, approximately 100 m north of the gabion basket drop structure (Photo 5). The slide mass has failed into the ditch bottom and flows are constricted along this section of ditch. The slide does not appear to have changed significantly between 2020 (call-out inspection) and 2024.

**Photo 5** A slide has been observed on the north natural slope upslope (west) of the gabion basket drop structure. Failed material has slumped into the ditch and is constricting flow. Photo taken June 18, 2024, facing west.

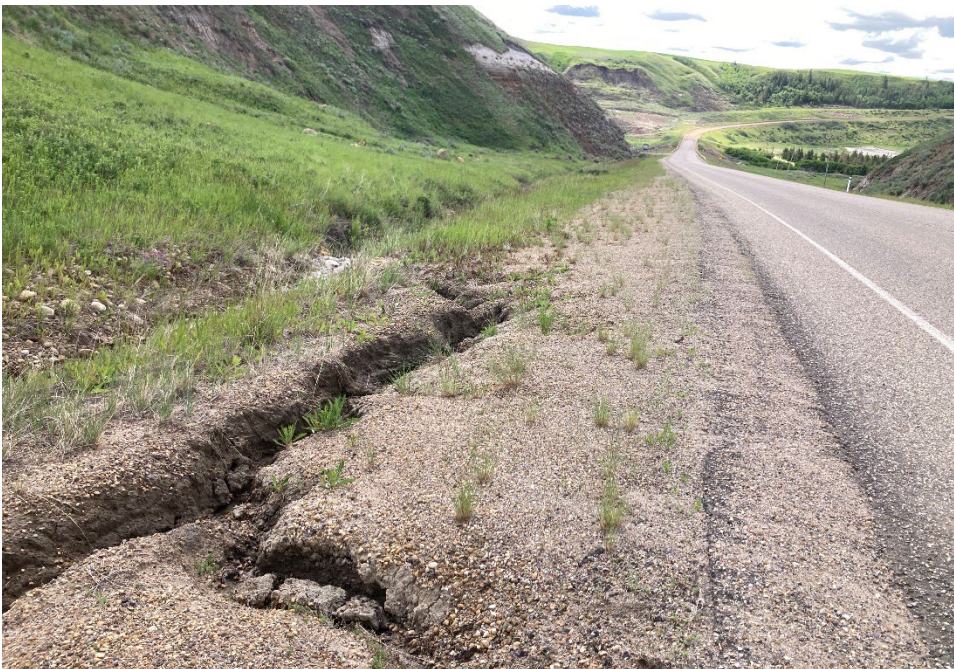
- Upstream (north) of the erosion gullies, the ditch bottom is well vegetated and is performing well.
- There is minor ditch erosion in the east (northbound) ditch, approximately 0.5 m to 1.0 m deep and 1 m to 2 m wide (Photo 6). The erosion has gotten worse since the 2023 inspection and is getting closer to the edge of pavement (within 1 m) near the midpoint of the site. The east ditch erosion is much less severe than the west ditch erosion.

**Photo 6** Erosion in the east (northbound) lane ditch near the midpoint of the site appears to have expanded between the 2023 and 2024 inspections and is less than 1 m from the edge of pavement. Photo taken June 18, 2024, facing south.

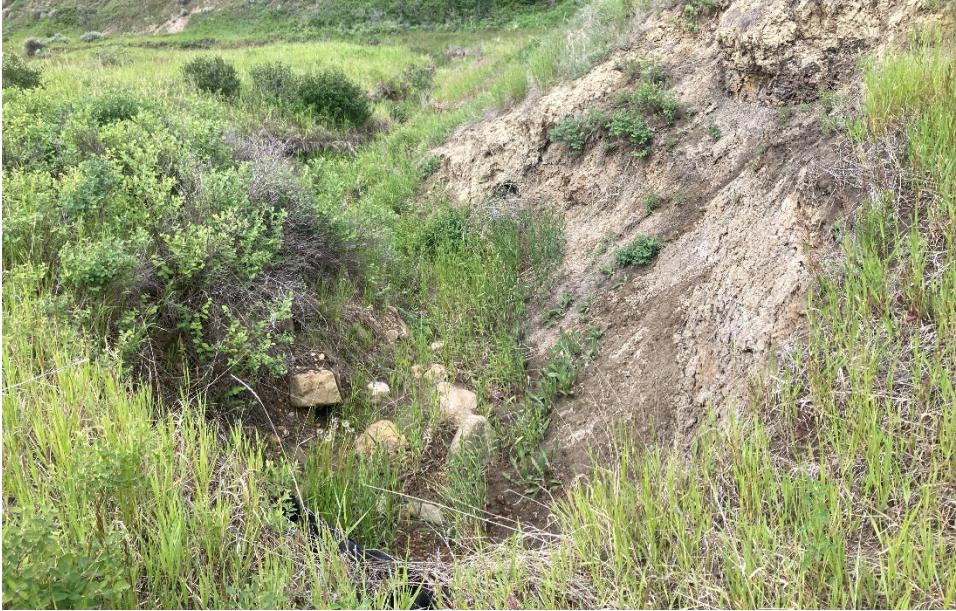
- The ditch erosion downstream of the gabion basket drop structure is approximately 2 m to 3 m deep and up to 4 m to 5 m wide (Photo 7). No significant change has occurred between the 2023 and 2024 inspections.
  - The previous non-woven geotextile and geocell repair is undermined and is hanging downstream of the gabion basket drop structure (Photo 8).

**Photo 7** The erosion gully downstream of the gabion basket drop structure has not changed significantly between the 2023 and 2024 inspections. Photo taken June 18, 2024, facing southwest.

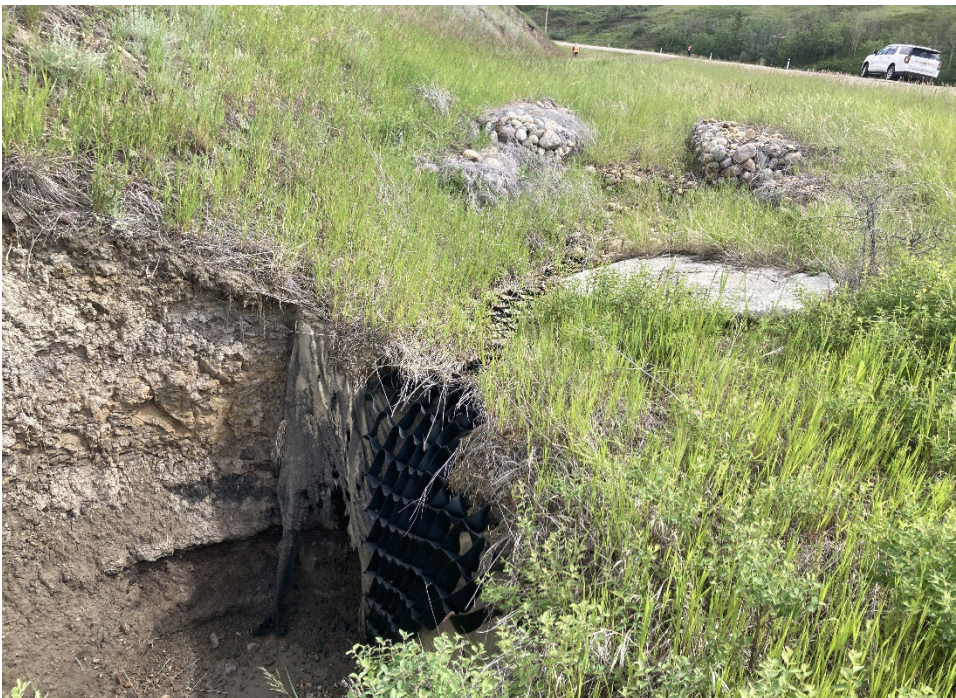
**Photo 8** The geocell armouring in the west (southbound) ditch is undermined and a vertical erosion face is approximately 5 m downstream of the gabion basket drop structure. Photo taken June 18, 2024, facing northeast.

- **Ditch erosion** – (i) where the geocell reinforcement is intact and well vegetated, no repair is required. (ii) The portions of the ditch where there is little to no vegetation, the geocells should be backfilled with granular material or fine-grained material that will promote rapid revegetation. The side slopes should not be disturbed to maintain vegetation cover, since the soil at the site is highly erodible. (iii) Where the geocell reinforcement has been undermined and bypassed by gullying, existing geocell and geotextile should be removed, gullies should be backfilled, and new non-woven geotextile and geocell armoring should be installed and maintain a defined channel shape (i.e., armoring along the ditch base and side slopes, with sufficient freeboard for the design flow). Disturbed areas should be hydro mulched with a seed mix suitable for badlands soil. (iv) Where the failed material has been deposited into the ditch, the slide material should be removed with impacting the toe of the natural slope. New geocell armoring should be installed, as per bullet point (iii), or a culvert could be installed to convey flows along this section of the ditch, since geocell armoring would be damaged if additional material was deposited into the ditch.

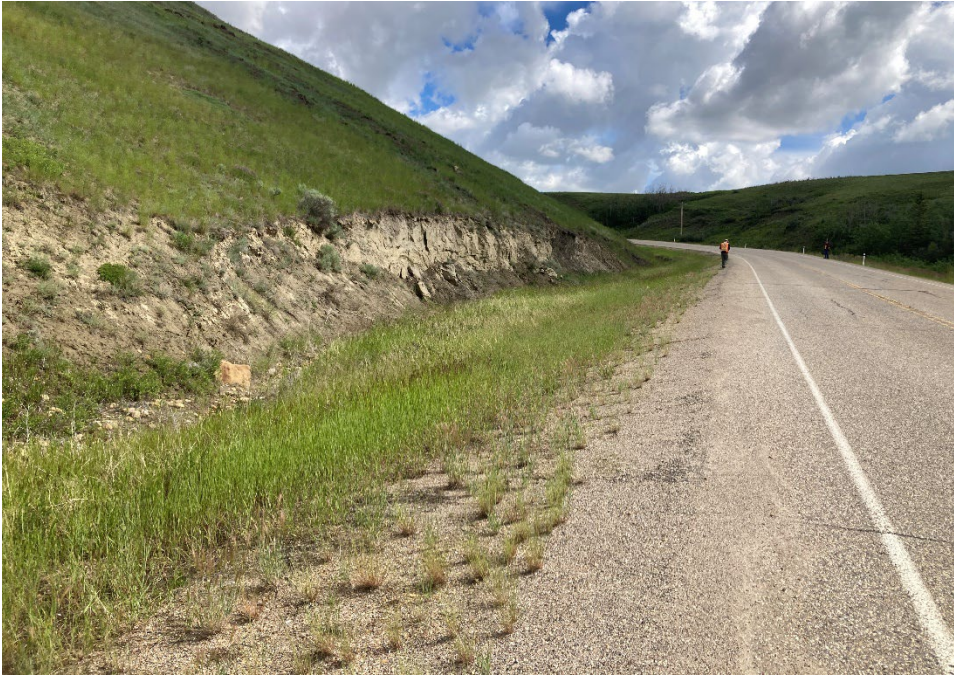
- The erosion gully extends off of TEC's ROW and into the upper portion of the well-vegetated area upslope of the lower erosion site.
- The ditch erosion upstream of the gabion basket drop structure appears to have increased (deeper and wider) between the 2023 and 2024 inspections (Photos 9 through 12). The erosion near the north extent of the site was noticeably worse during the 2024 inspection (Photos 10 through 12). The erosion is impacting the highway embankment and tall natural slope west of the highway. Near the north extent of the ditch erosion, it has retrogressed to the edge of the pavement (Photo 10 and 11). The vertical erosion scarp is approximately 3 m from the edge of the pavement. If not repaired the erosion will begin to undermine the southbound lane of Hwy 841:02.

- Ditch erosion at the toe of the steep and tall (estimated to be 2H:1V and 25 m tall, respectively) natural slope has either caused or exacerbated a natural slope failure approximately 125 m wide that extends to just below the crest of the slope. The erosion scarp above ditch bottom appears to be up to 3 m high (Photos 9, 11, and 12) above base of the eroded ditch bottom and has increased in severity between the 2023 and 2024 inspections. The ditch base appears to be eroded up to 1.5 m below original ditch grade.

**Photo 9** The toe of the tall natural slope west of the highway is eroding and the erosion face is up to approximately 3 m tall. Photo taken June 18, 2024, facing northeast.

- **Erosion along toe of tall natural slope** – A gabion basket retaining wall (at least 3 m tall and 125 m long) should be built along the portion of the natural slope being impacted by the ditch erosion, to stabilize the slope and reduce erosion. The ditch bottom should be graded with well compacted fill to replace eroded material, armoured with gabion mattress or geocell (to be confirmed with hydrotechnical assessment of ditch flows) and establish positive drainage away from the slope.

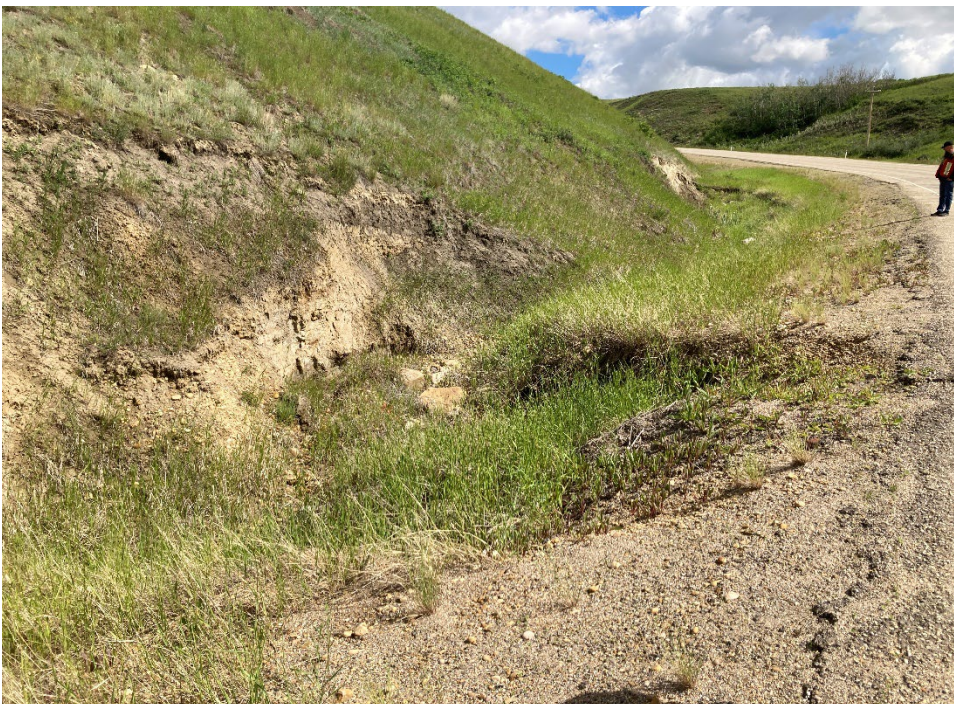
**Photo 10** Erosion in the west (southbound) ditch is eroding the highway embankment slope and has reached the edge of the pavement. Photo taken June 18, 2024, facing northeast.

- Signage (sharp shoulder and speed reduction) and barricade should be installed along the shoulder of the highway where the ditch erosion is starting to encroach upon the shoulder of the west (southbound) lane, until the site can be repaired. TEC's Highway Maintenance Contractor (HMC) should repair as soon as possible by rebuilding the highway embankment/ditch side slope with compacted granular fill. An even shorter-term repair could be end dumping granular material (e.g., 300 mm minus) in areas where the erosion is close to the edge of pavement.

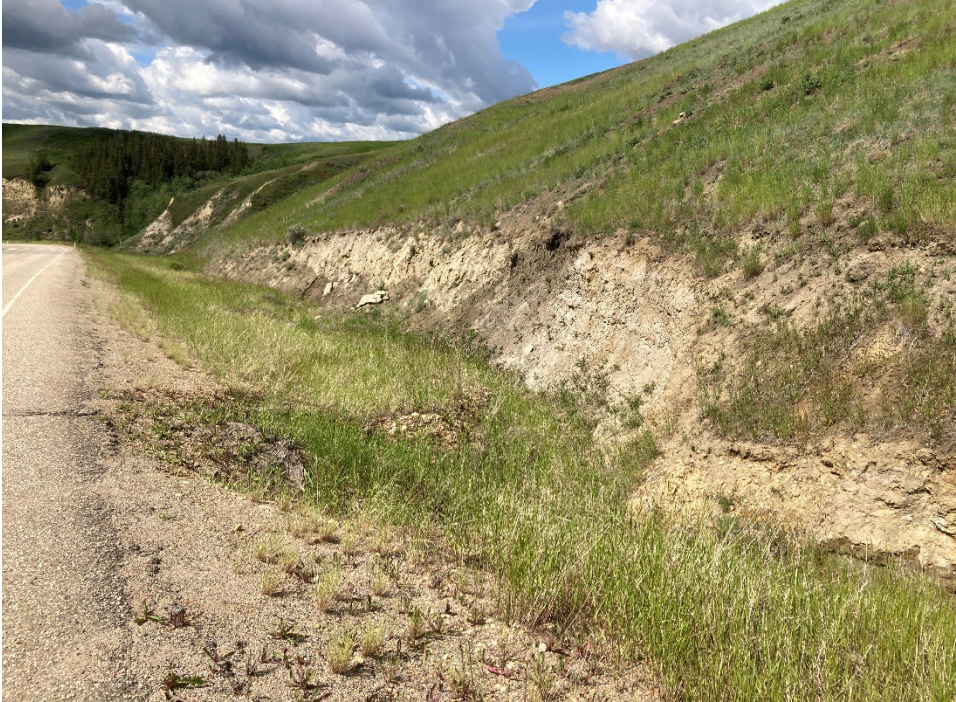
**Photo 11** Erosion in the west (southbound) ditch is eroding the highway embankment slope and has reached the edge of the pavement. Photo taken June 18, 2024, facing southwest.

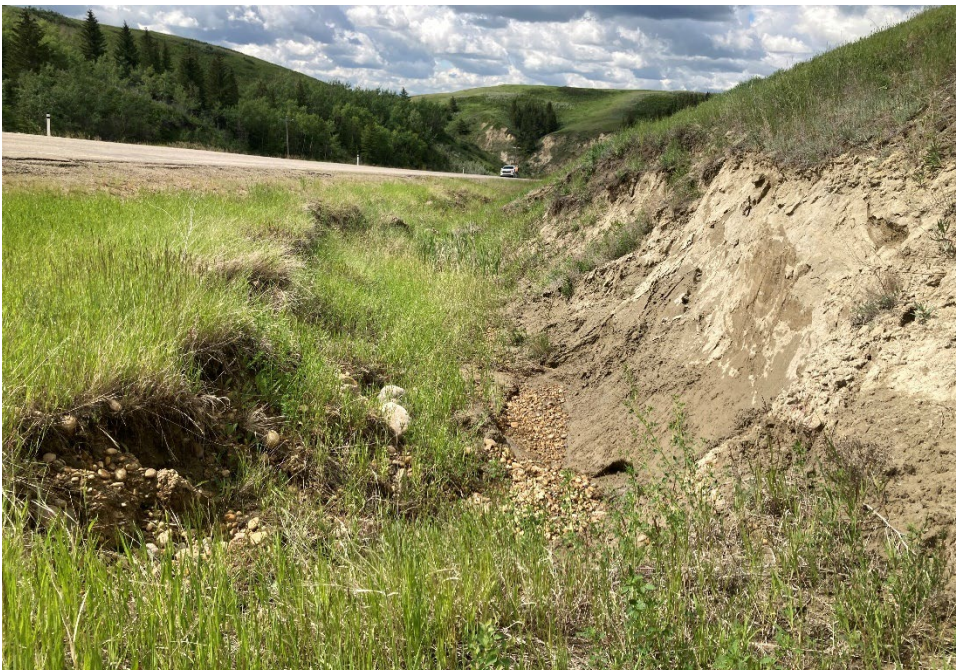
**Photo 12** Ditch erosion at the north extent of the site along the toe of the natural slope. Photo taken June 18, 2024, facing southwest.
