SITE NUMBER AND NAME: C023-1 and -2 Battle River Crossing Erosion and Slope Failure		HIGHWAY & KM: 854:01, 14.017	PREVIOUS INSPECTION DATE: May 31, 2022	INSPECTION DATE: June 17, 2024
LEGAL DESCRIPTION: 16-07-043-17 W4M	NAD 83 COORDINATES: UTM Northing Easting 12 5839557 402074		RISK ASSESSMENT: C023-1 PF: 8 CF: 3 TOTAL: 24 C023-2 PF: 8 CF: 4 TOTAL: 32	
AVERAGE ANNUAL DAILY TRAFFIC (AADT): 120 (south) & 80 (north) (Ref No. 114370 & 997079)			CONTRACTOR MAINTENANCE AREA (CMA): 513

PROJECT CENTRAL REGION GEOHAZARD RISK MANAGEMENT PROGRAM		
TITLE Site Plan C023 - Battle River Crossing Erosion and Slope Failure Hwy 854:01, km 14.017		
SCALE 1:1,250	PROJECT No. A05116A02	FIG No. 1

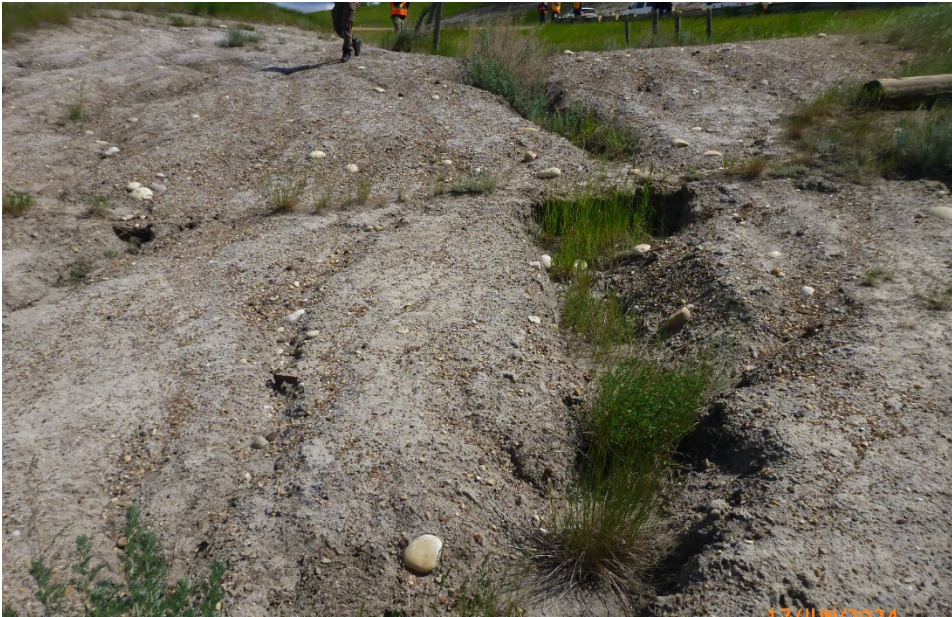
- Since 2018, the west side gabion catch basin inlet structure has overflowed onto the unvegetated slope, resulting in erosion gullies downslope of the gabion catch basin inlet structure (Photo 1). The erosion gullies appear to have enlarged slightly between 2022 and 2024 inspections. The erosion gullies will continue to enlarge if not repaired.
- There is poor vegetative cover downslope of the gabion catch basin inlet structure, where coir rolls, now deteriorated, were previously installed.

Photo 1 Erosion gullies on the north slope of the river valley, south of the gabion basket inlet structure. Gullying is most likely caused by the inlet structure overflowing during precipitation events, since it is clogged with sediment and vegetation. Photo taken June 17, 2024, facing northeast.

- The sediments and vegetation in the gabion basket inlet and outlet structures should be removed (e.g., via vac truck).
- The erosion gullies on the slope and berm downstream of the gabion basket inlet structure should be backfilled with compacted fine-grained non-dispersive material. The slope should be graded and seeded with a suitable Badlands seed mix to promote grass growth. Given that bedrock is exposed at surface, to give the seeds a better chance to germinate and form a stable vegetative cover on the western erosion site, the seed could be applied via hydro-mulch or a bonded-fiber matrix. Silt fencing should be erected at the toe of the slope and maintained until vegetation is established.

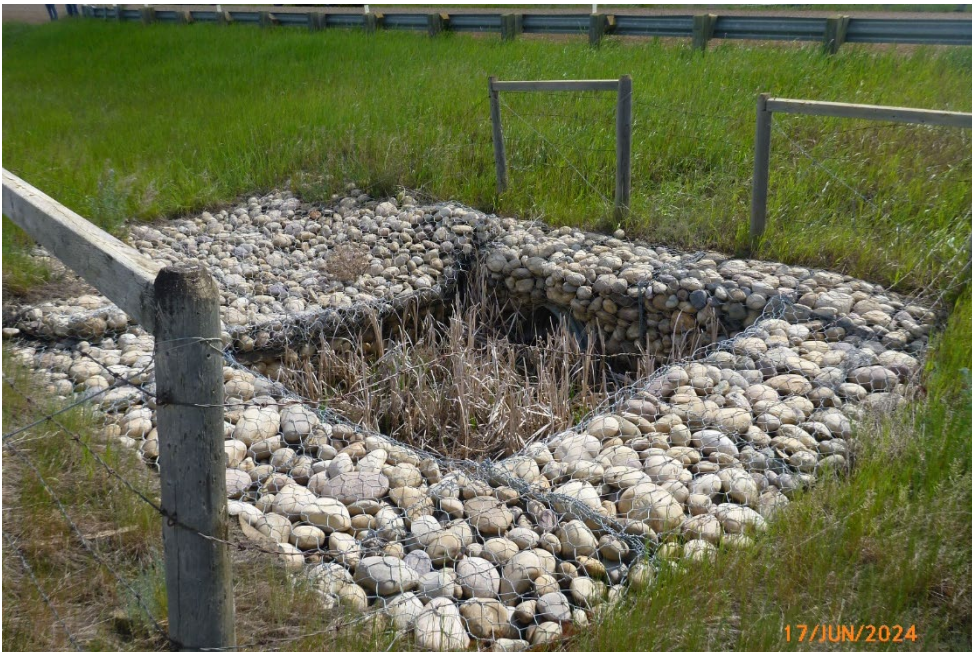
- The inlet and outlet gabion catch basin structures on the north side of the bridge remain partially clogged with sediment and vegetation (Photos 2 and 3). The amount of sediment appears to have increased between the 2022 and 2024 inspections.

Photo 2 Vegetation and sediment build-up at the catch basin structure at the culvert inlet. Photo taken June 17, 2024, facing northeast.

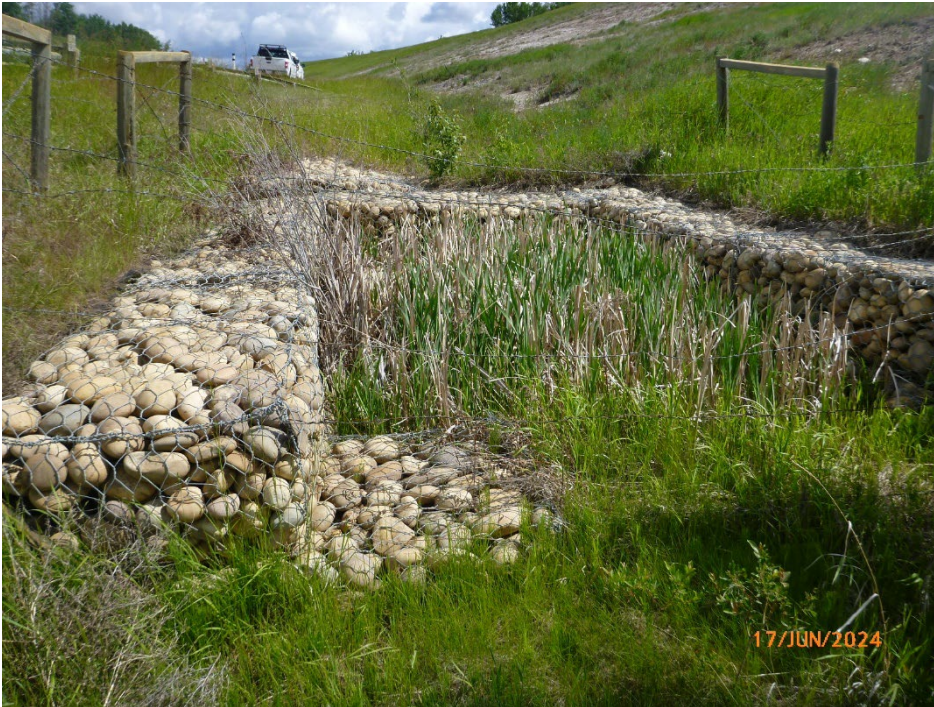
Photo 3 Gabion basket outlet structure on east side of highway is clogged with sediment and dense vegetation. Photo taken June 17, 2024, facing north.

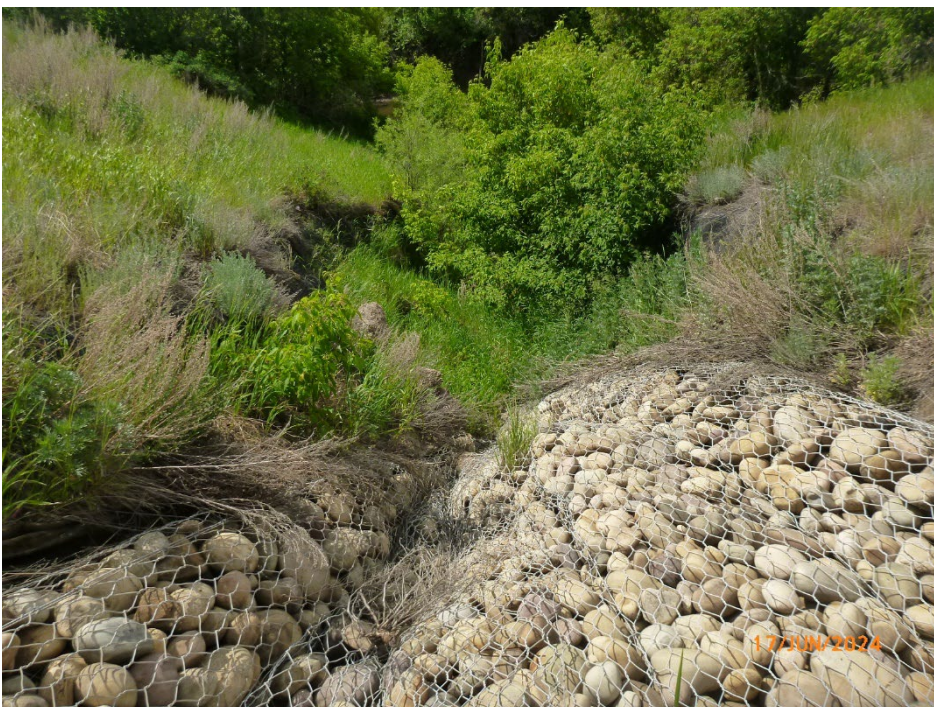
- The gabion mattress armoured ditch east of the highway has not been repaired (Photo 4). The gabion mattress armoured ditch appears to be in similar condition as during the 2022 inspection. However, water will continue to undermine the mattress until it is repaired.

Photo 4 Erosion gully downstream of the failing gabion mattress in the east (northbound) ditch. Dense vegetation (grass, shrubs, and trees) growing within erosion gully. Photo taken June 17, 2024, facing south.

- The failed gabion mattress downslope of the gabion basket outlet structure should be removed. The area should be graded to a channel shape, lined with suitable bedding material, underlying non-woven geotextile, and armoured with riprap. Check trenches should be installed at regular intervals to reduce the likelihood of undermining the non-woven geotextile and riprap.

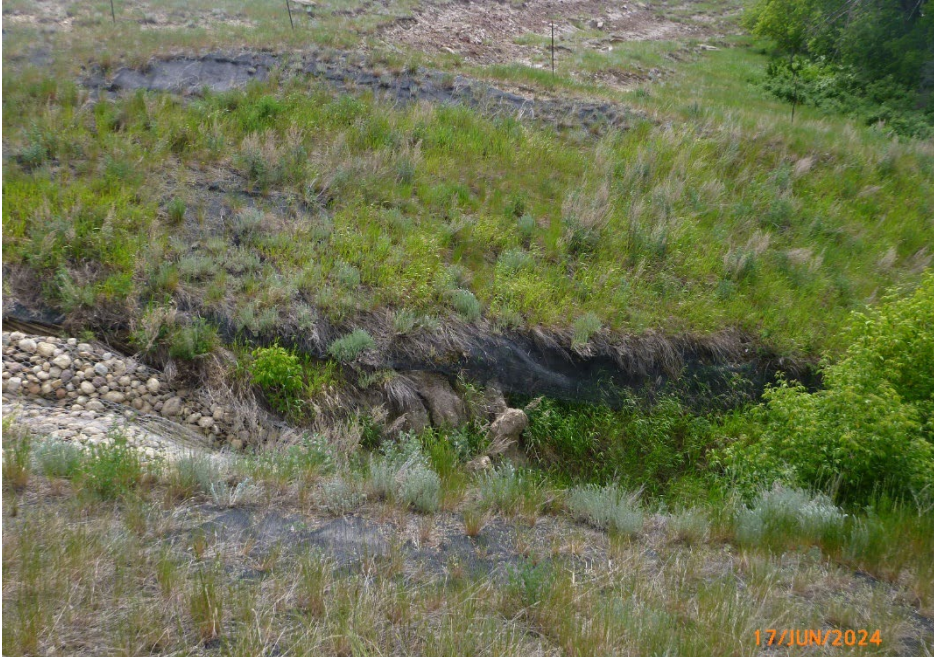
- The gabion mattress armoured channel at/upslope of the discharge point into Battle River is well vegetated and in good condition.
- The east slope upslope (east) of the gabion mattress armoured ditch, protected with a rolled erosion control product (RECP), appears to be in similar condition as during the 2022 inspection. (Photo 5). There is relatively poor vegetation cover and there are small erosion gullies below the RECP where it is being undermined.

Photo 5 Relatively poor vegetation cover on the slope east of the highway and gabion mattress lined ditch, where a rolled erosion control product was previously installed. Photo taken June 17, 2024, facing east.

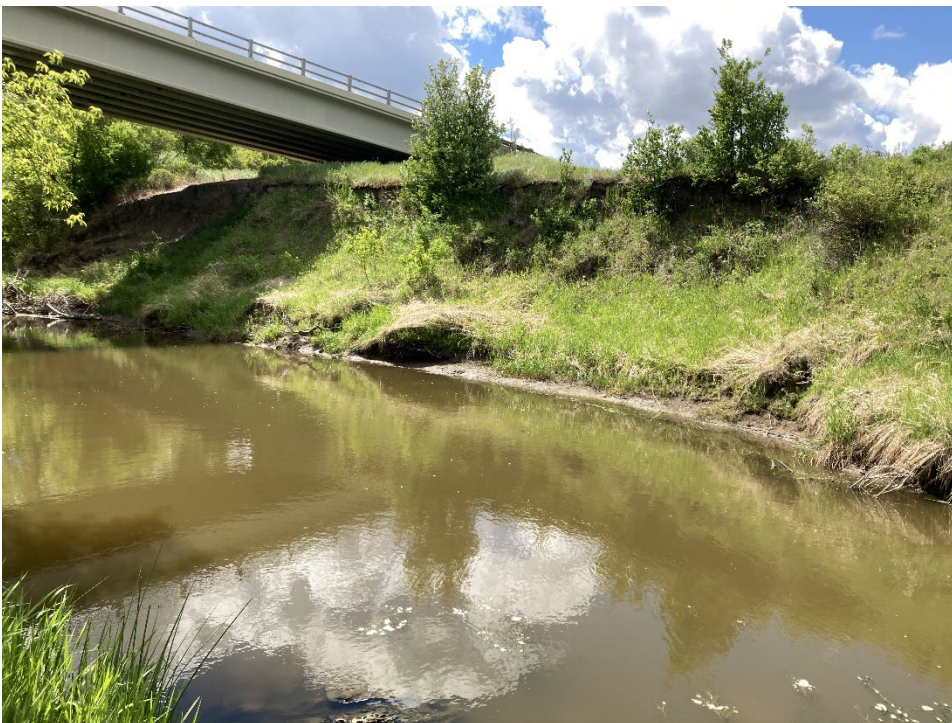
- The riverbank along the south abutment directly below the bridge is showing signs of retrogressive slope failure. A steep (approximately 1H:1V) riverbank slope 4 m to 5 m high is located at the edge of the river, with approximately 15 m between the crest of the slope and the bridge abutment. The riverbank slope failure does not appear to have changed significantly since the 2022 inspection.

Photo 6 No significant changes to the slide on the south abutment were observed between the 2022 and 2024 inspections. Photo taken June 17, 2024, facing southwest.

- The slope failure observed on the west side of and adjacent to the south bridge abutment should be monitored. Potential repair options include:
 - armouring the riverbank to control erosion upstream of and underneath the bridge deck;
 - soil nailing could be used to stabilize the slide;
 - flattening the slope beneath the bridge.
