SITE NUMBER AND NAME: C055-1 and -2 Galahad Slide and Riverbank Erosion		HIGHWAY & KM: 861:02, 26.00	PREVIOUS INSPECTION DATE: May 31, 2022	INSPECTION DATE: June 17, 2024
LEGAL DESCRIPTION: 13-14-040-14 W4M	NAD 83 COORDINATES: UTM Northing Easting C055-1 12 5811270 437304 C055-2 12 5811329 437306		RISK ASSESSMENT: C055-1 PF: 6 CF: 3 TOTAL: 18 C055-2 PF: 7 CF: 2 TOTAL: 14	
AVERAGE ANNUAL DAILY TRAFFIC (AADT): 60 (north) & 60 (south) (Ref No. 70000159)			CONTRACT MAINTENANCE AREA (CMA): 518

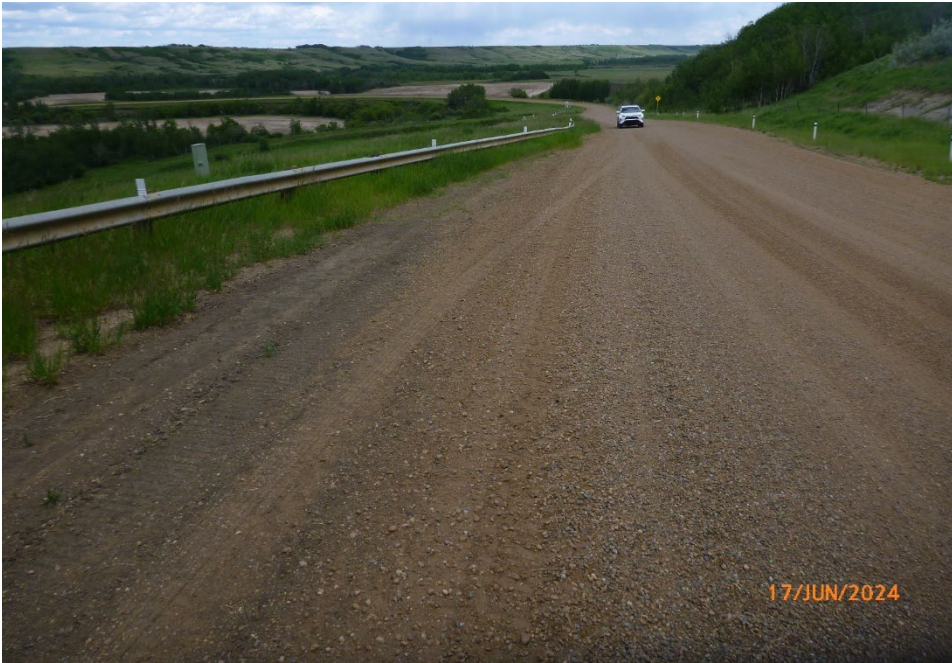
COMMENTS
<p><u>C055-1:</u></p> <ul style="list-style-type: none"> In late-2021 the site was repaired. The repair included guardrail replacement, material placement at the edge of the highway beneath where the guardrail was settled, and slope grading from the crest to toe. During construction, the instrumentation at the top of the slide was removed (one SI and two piezometers) but the instrumentation at the toe (one SI and one piezometer) was not. The SI at the crest of the slope is inoperable (sheared at an approximate depth of 7.7 m at the silty clay till-mudstone bedrock contact) but one of the piezometers was still active before being buried during 2021 construction. The road surface was graded recently and appears to be in good condition with no signs of slope movement (ground cracks and/or settlement) (Photo 1). The south (eastbound) ditch is well vegetated and appears to be in good condition (Photo 2).

Photo 1 **The highway surface upslope of C055-1 is in good condition. Photo taken June 17, 2024, facing east.**

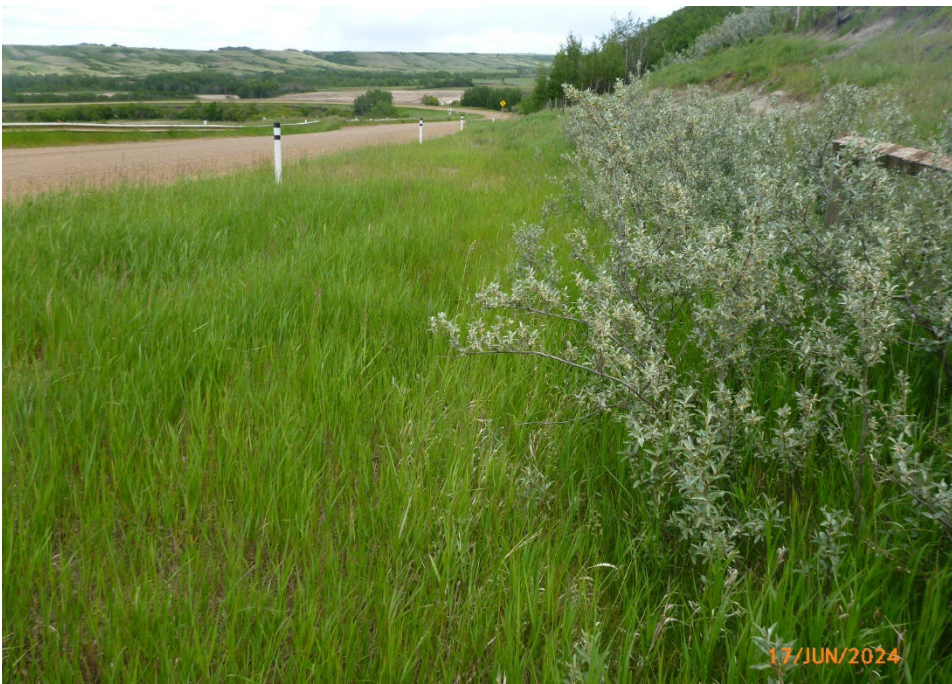
Photo 2 **The south (eastbound) highway ditch is well vegetated and appears to be in good condition. Photo taken June 17, 2024, facing east.**

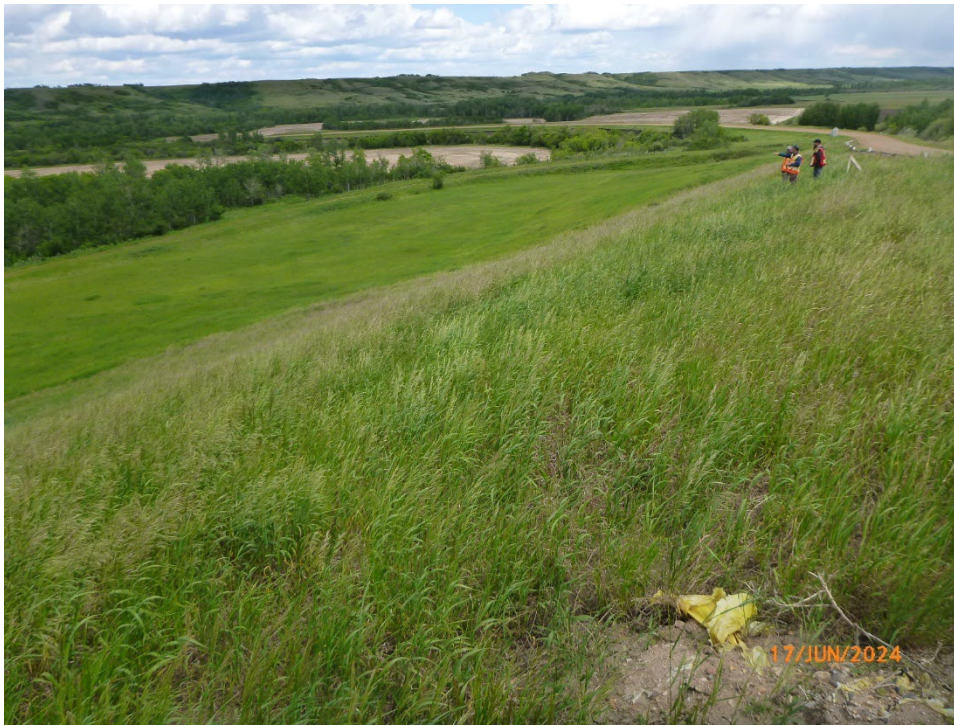
- The repaired highway embankment slope appears to be in good condition. The vegetative cover on the highway embankment slope has improved significantly since the 2021 inspection (Photo 3).
- A black cable runs from the C055-1 site to the C055-2 site (observed on the site for several years, previous marked by highway delineators).

Photo 3 **The regraded slope of C055-1 (repair completed in 2021) is well vegetated and appears to be in good condition. Photo taken June 17, 2024, facing east.**

- If the 2021 repair is not successful (i.e., movement begins and/or accelerates) a toe berm should be constructed approximately 1/3 to 1/2 the overall slope height to buttress the embankment, finger drains should be installed to improve drainage, and replace the upper portion of the embankment with geogrid reinforced fill.
- The toe berm will require land acquisition. A stability assessment should be completed to assess the amount of land required to facilitate the addition of a toe berm.

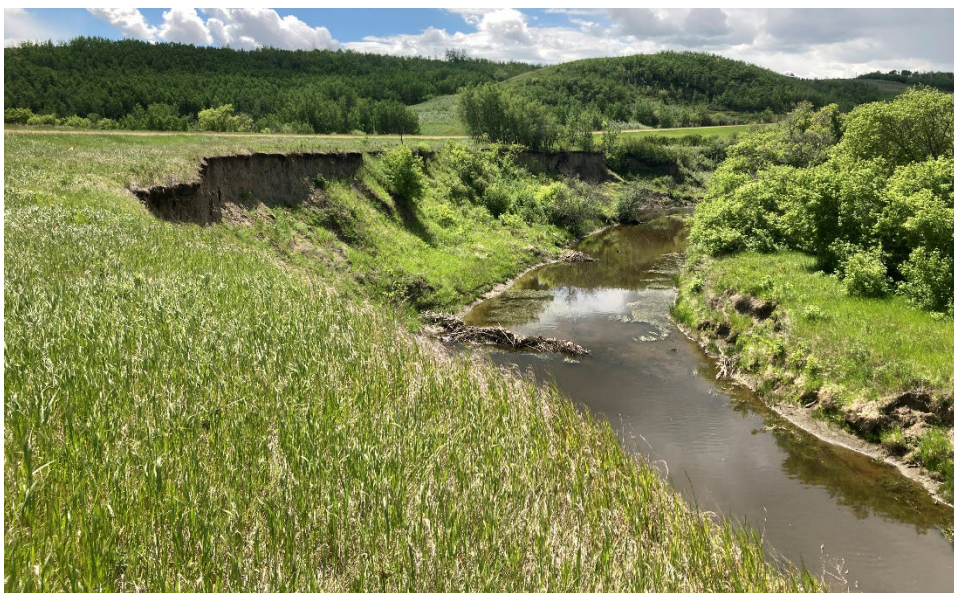
- Riverbank erosion appears to be progressing at a slow but consistent rate and has progressed towards the edge of the highway (Photo 3 and 4).
- Two berms were built in the west (southbound) ditch between the 2019 and 2022 inspections. KCB and TEC believe the berms were built to reduce surface flows from the ditch over the erosion scarp in an effort to reduce the rate of erosion towards the edge of the highway. The vegetation cover on the berms improved between the 2022 and 2024 inspections.
- Three stakes were installed near the midpoint of the site to measure the rate of erosion (Photos 5 through 8). Previous offset stakes appeared to be knocked down by mowing. The offset for each stake (numbered north to south) are as follows:
 - Stake 1: 1.6 m
 - Stake 2: 1.8 m
 - Stake 3: 1.7 m

Photo 4 **View of the south portion of the C055-2 site. Degree of erosion appears similar between the 2022 and 2024 inspections. Photo taken June 17, 2024, facing south.**

- As a short-term measure, TEC should install a guardrail. The installation of an anchored sheet pile wall along the toe of the embankment would reduce the rate of erosion and stabilize the slope. However, vibration and slope disturbance caused by installing sheet pile walls and anchoring may impact sensitive fish species and impact erosion along other nearby locations of the Battle River. Eventually, TEC may have to realign this portion of the highway further away from outside bend and erosion zone of the Battle River. Realigning the highway would require land acquisition.
- KCB can acquire air photos to assess the rate of riverbank erosion.

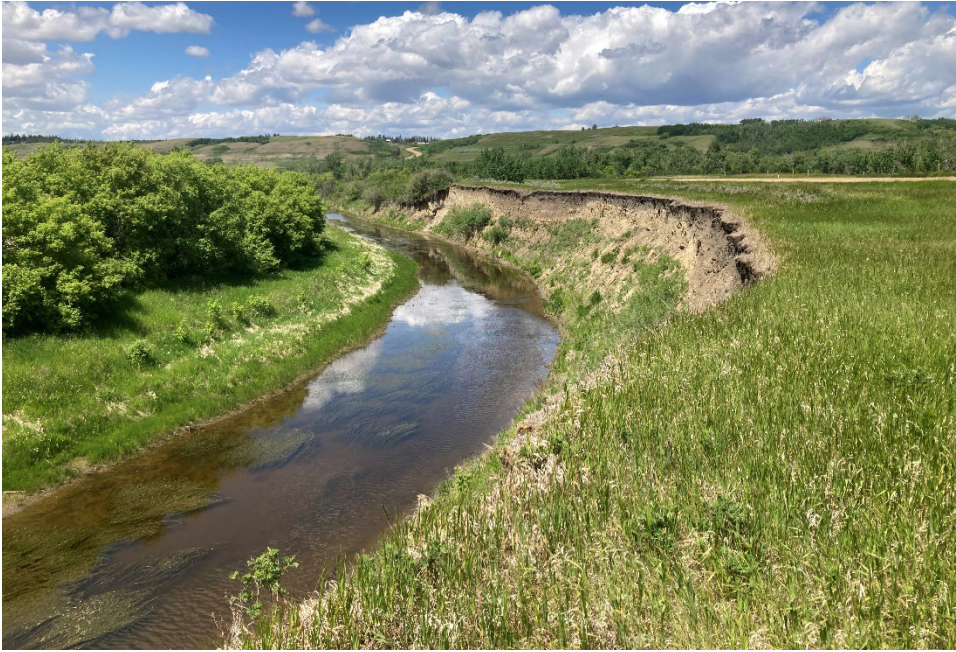
Photo 5 View of the north portion of the C055-2 site. Degree of erosion appears similar between the 2022 and 2024 inspections. Photo taken June 17, 2024, facing north.

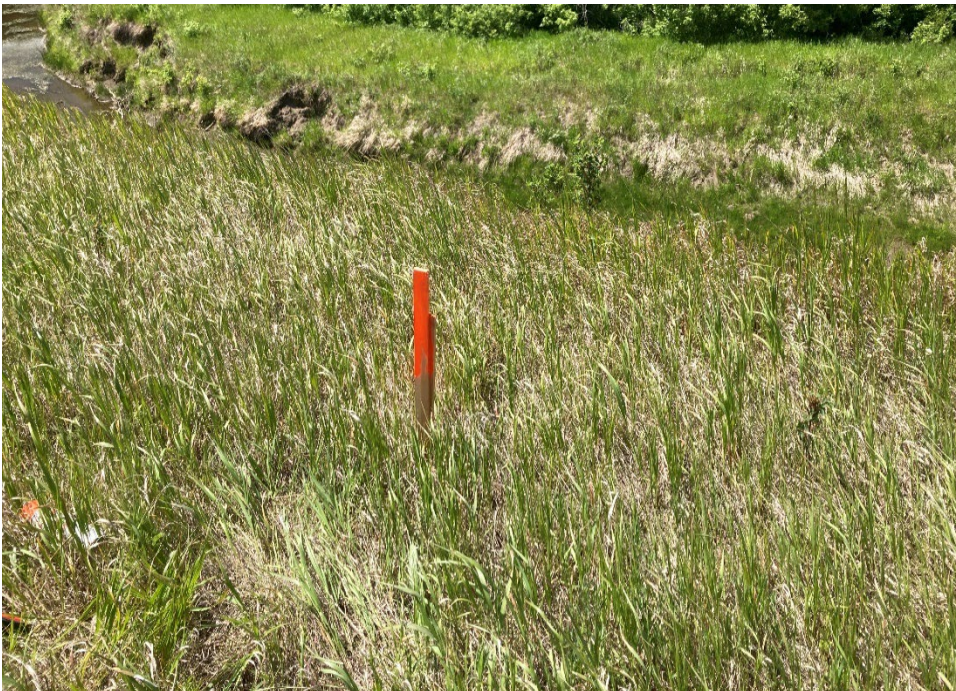
Photo 6 Stake 1 (northmost stake) installed approximately 1.6 m from the near-vertical erosion face to monitor rate of erosion. Photo taken June 17, 2024, facing west.

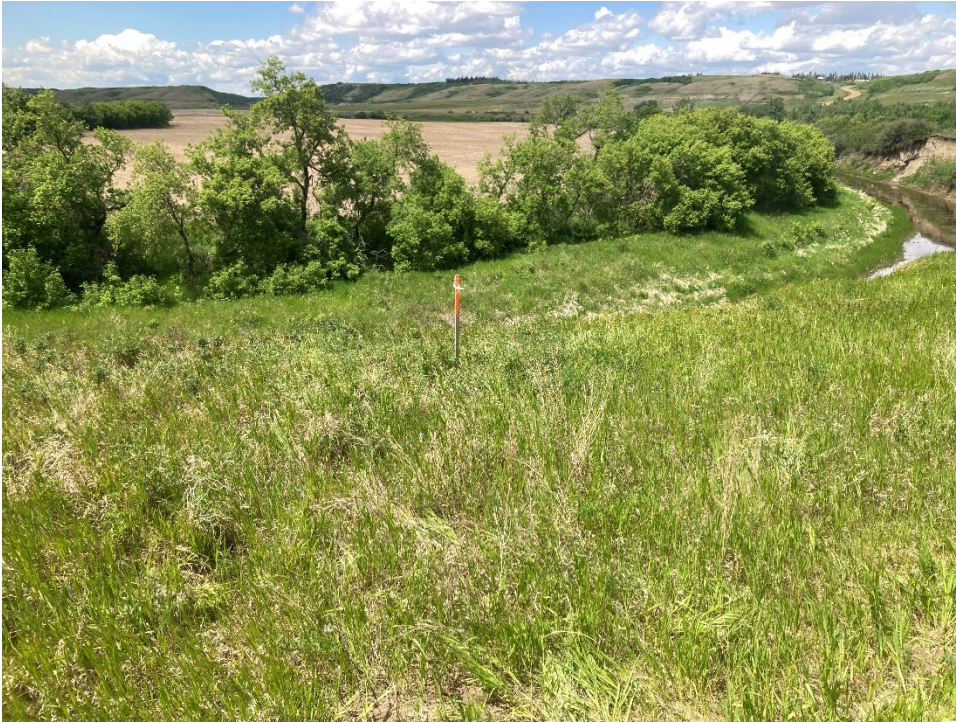
Photo 7 Stake 2 (middle stake) installed approximately 1.8 m from the near-vertical erosion face to monitor rate of erosion. Photo taken June 17, 2024, facing northwest.

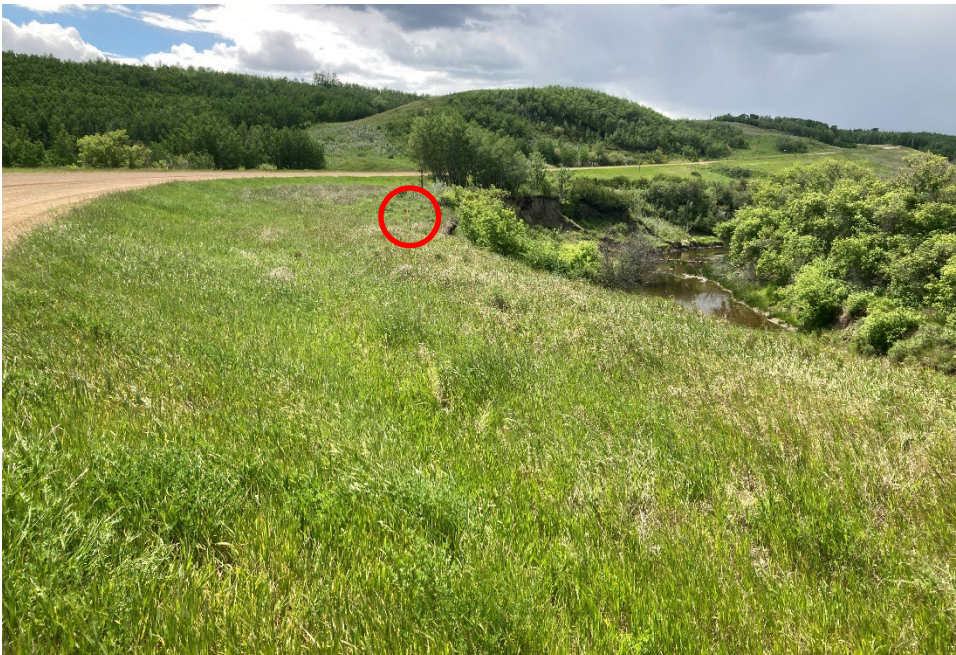
Photo 8 Stake 3 (southmost stake, location indicated by red circle) installed approximately 1.7 m from the near-vertical erosion face to monitor rate of erosion. Photo taken June 17, 2024, facing southwest.
