<b>SITE NUMBER AND NAME:</b> C003 Burma Park Slide		<b>HIGHWAY &amp; KM:</b> 872:06, 0.278	<b>PREVIOUS INSPECTION DATE:</b> June 29, 2021	<b>INSPECTION DATE:</b> <b>June 17, 2024</b>
<b>LEGAL DESCRIPTION:</b> 05-40-10-W4M & 32-39-10-W4M	<b>NAD 83 COORDINATES:</b> UTM Northing Easting 12 5806345 471780		<b>RISK ASSESSMENT:</b> PF: 11 CF: 5 TOTAL: 55	
<b>AVERAGE ANNUAL DAILY TRAFFIC (AADT):</b> 240 (south) & 380 (north) (Ref No. 126340 & 126330)			<b>CONTRACT MAINTENANCE AREA (CMA):</b> 513

PROJECT CENTRAL REGION GEOHAZARD RISK MANAGEMENT PROGRAM		
TITLE Site Plan C003 - Burma Park Slide Hwy 872:06, km 0.278		
SCALE 1:1,000	PROJECT No. A05116A02	FIG No. 1

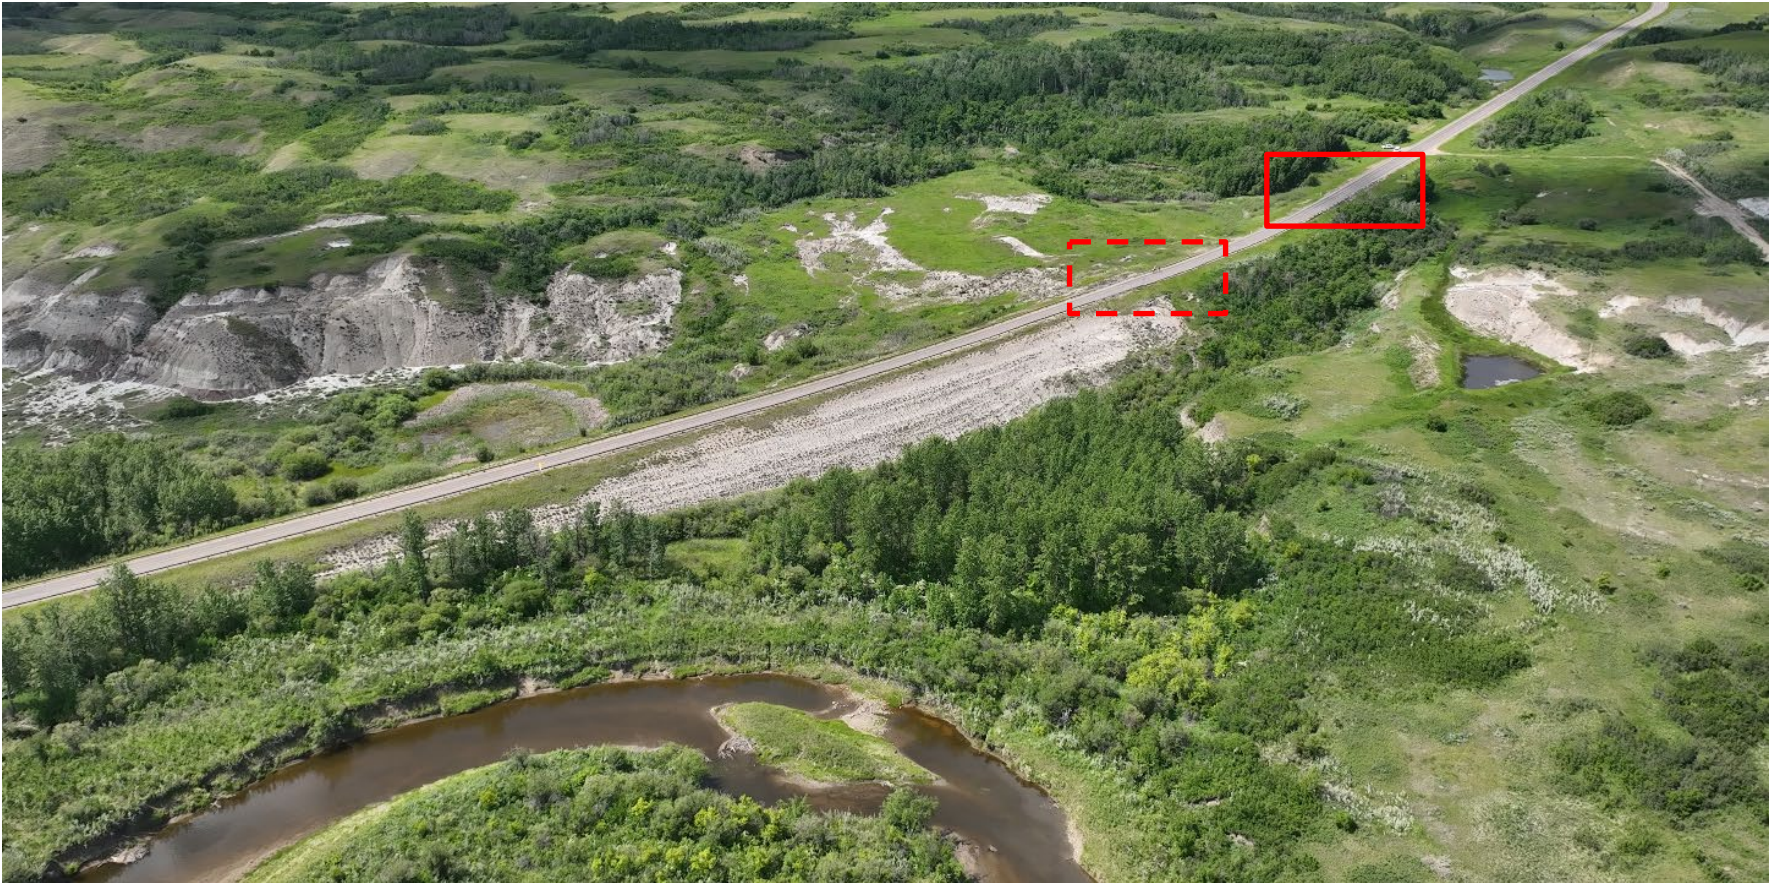
<b>COMMENTS</b>
In 2024, there were traffic accommodations on site, indicating the TEC was completing bridge maintenance (bridge south of the site crossing the Battle River).
Drone flights were completed by KCB during the 2021 and 2024 site inspections (Photo 1 and 2). The UAV video indicates that the horizontal deflection in the guardrails appears to be caused by buckling under compression caused by slide movement impacting the highway embankment. The drone video indicates the slide area appears

There is a dugout pond built east of the slide and upslope of the gully bottom that indicates there may be a high groundwater table in the north valley slope (Photo 1). The upper part of the dugout appears to be an old road that leads to the old bridge downslope. There is also a treed in gully located between the highway embankment and the dugout. In 2021, ground cracking was observed above the east gully slope. A possible graben feature was also observed. The east gully slope is very steep (i.e., steeper than 1H:1V). A wet spot that was well vegetated with lush vegetation was observed upslope of the gully.

**Photo 1** Oblique aerial photo of the C003 site (approximate area of pavement patching indicated by red rectangle and area of pavement patching with recent cracking, settlement, and guardrail buckling indicated by rectangle with red dashed line). Photo taken June 17, 2024, facing northwest.

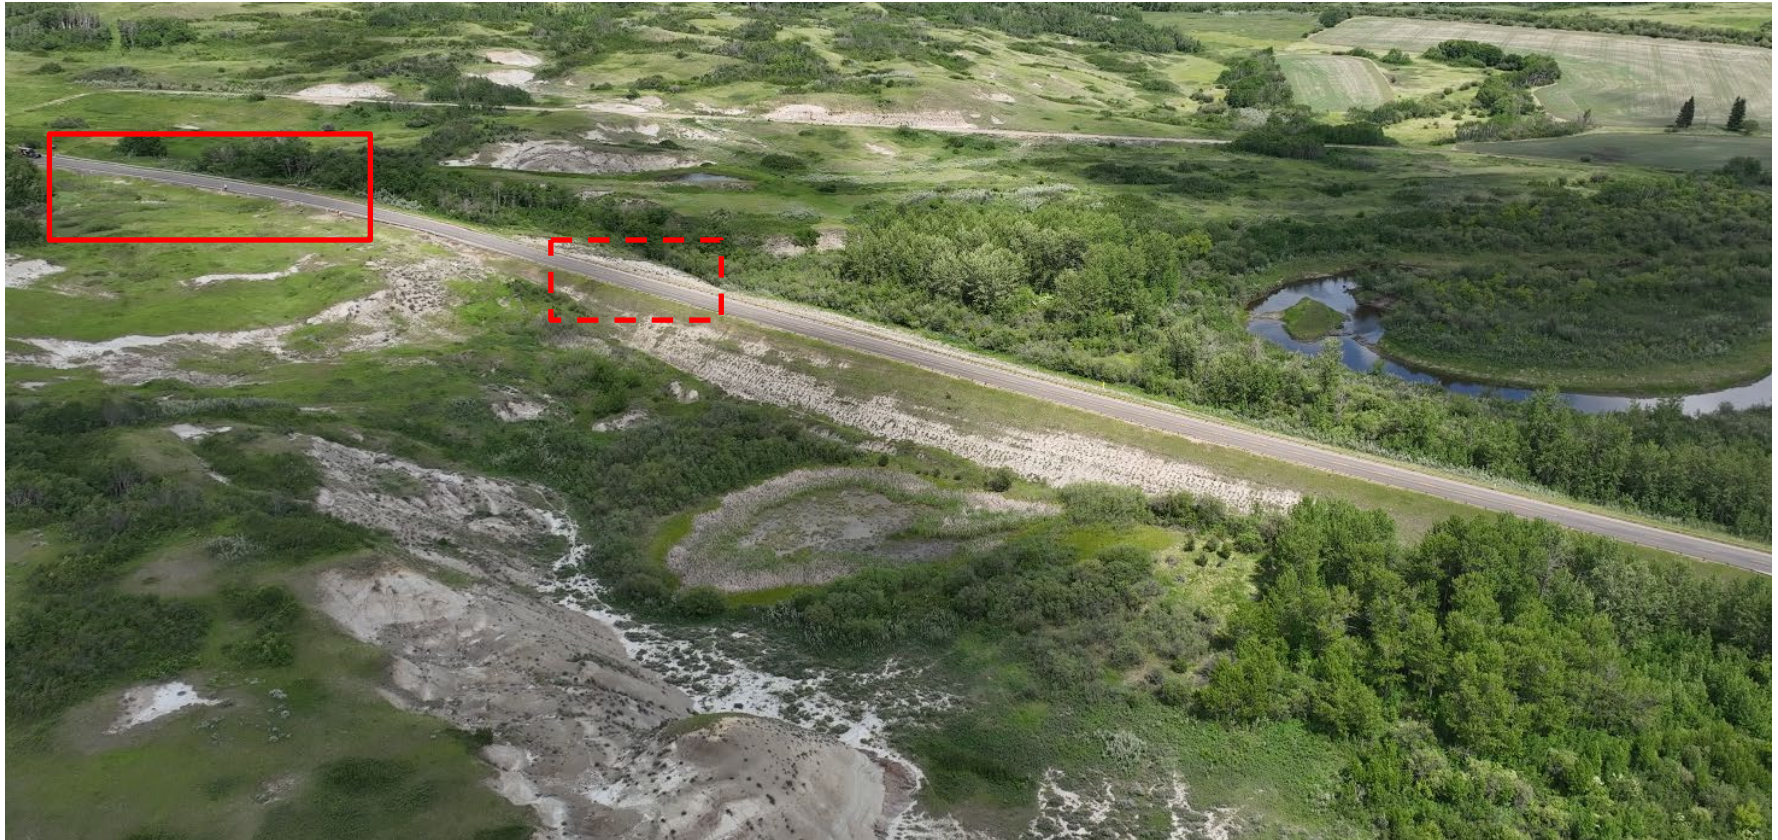
**Photo 2**      **Oblique aerial photo of the C003 site (approximate area of pavement patching indicated by red rectangle and area of pavement patching with recent cracking, settlement, and guardrail buckling indicated by rectangle with red dashed line). Photo taken June 17, 2024 facing east.**

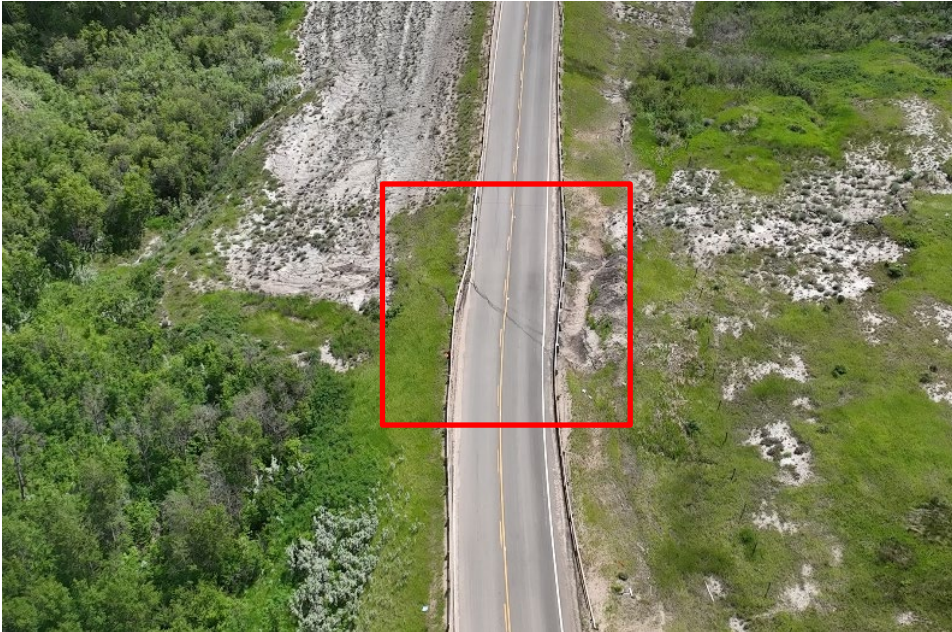
Since 2021, the guardrails on both sides of the highway (east and west) show horizontal deflection (i.e., buckling under compression) (Photos 3, 5, and 7). Due to movement at the side, the west guardrail has been shifted further west, as shown in Photo 7.

**Photo 3** Aerial photo showing transverse pavement crack, settlement, and guardrail deflection near the midpoint of the site (located within red rectangle). The highway alignment is being shifted due to sliding occurring at the site. Photo taken June 17, 2024, facing south.

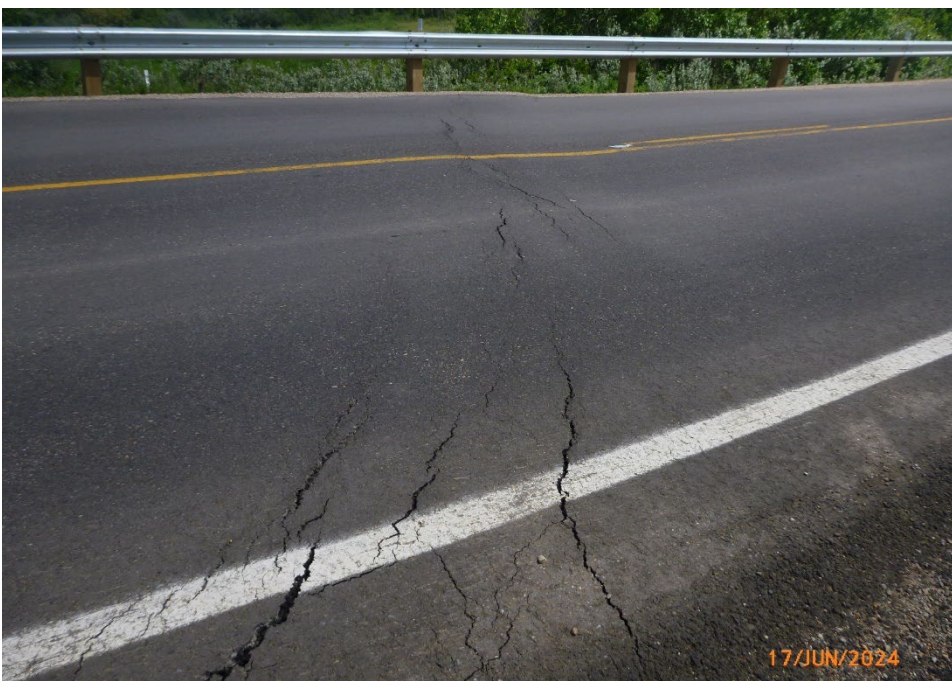
- Near the north extent of the site, pavement cracks (up to 25 mm wide) across both lanes are already showing through a new pavement patch completed in late-2023 or early-2024 (Photo 4). Pavement settlement was observed just south of the pavement cracks.
- A transverse pavement crack across both lanes was observed further south near the south extent of the site (Photos 3, 5, and 7). Settlement up to 25 mm to 50 mm was observed north (uphill) of the transverse pavement crack and lengths of new guardrails had been recently installed on both sides of the highway.
  - At the location of the transverse pavement crack and settlement (Photo 3), due to the movement occurring at the site, the highway alignment is being impacted (i.e., pavement upslope/north of the pavement crack is being shifted east due to sliding).

**Photo 4** Pavement cracks and settlement observed near the north extent of the site are already showing through a recent pavement patch completed in late-2023 or early-2024. Photo taken June 17, 2024 facing east.

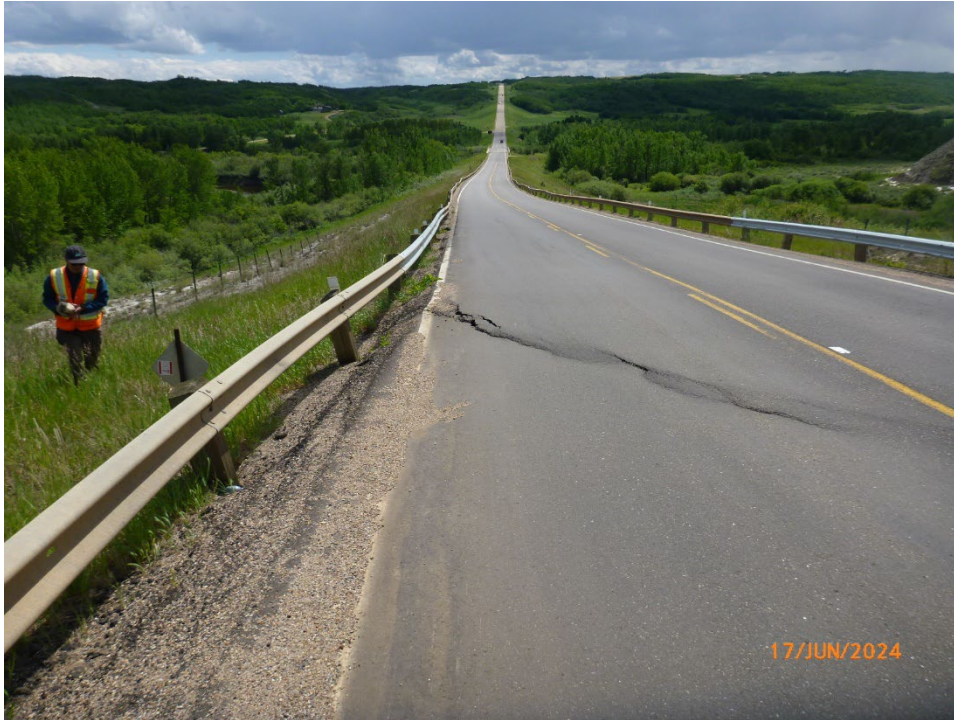
**Photo 5** Transverse pavement crack and settlement observed where the guardrails were recently replaced. Photo taken June 17, 2024, facing south.

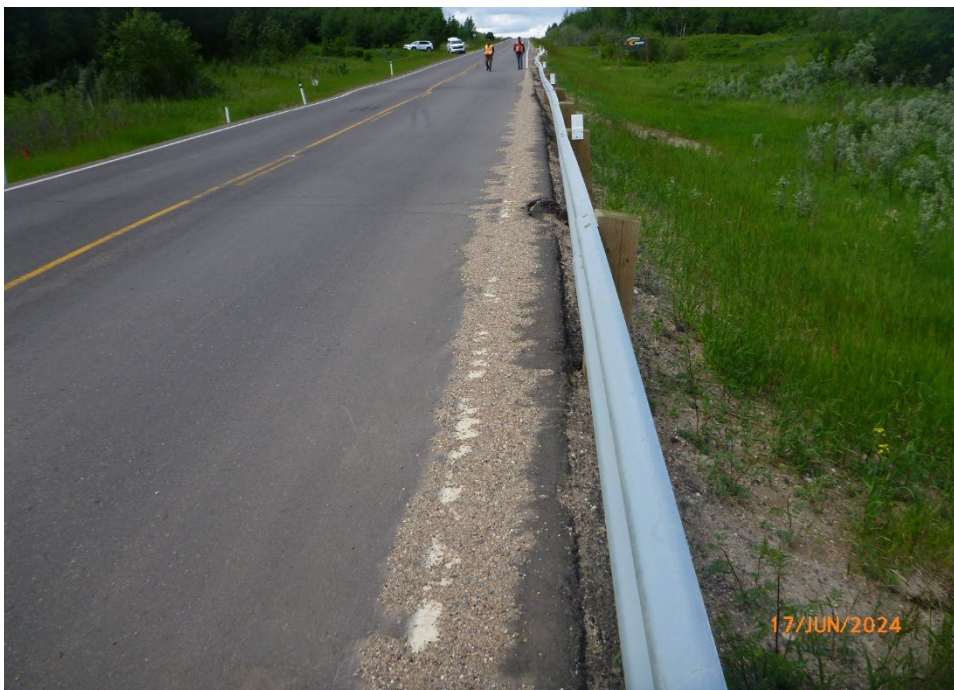
Where the guardrail was replaced along the east side of the highway (Photo 6) there appears to have been approximately 200 mm of movement (shifting of the highway alignment, as indicated by previous guardrail post locations).

**Photo 6** New guardrail posts offset approximately 200 mm from previous location. Photo taken June 17, 2024, facing north.

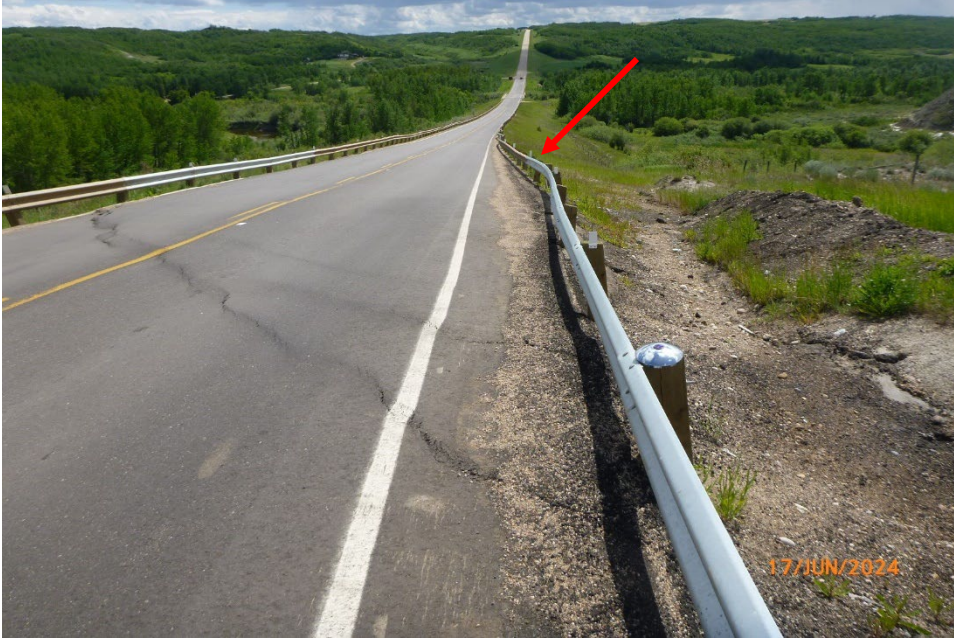
**Photo 7** Transverse pavement crack and settlement observed where the guardrails were recently replaced. Due to movement at the site, the west guardrail has been shifted west (indicated by red arrow). Photo taken June 17, 2024, facing south.

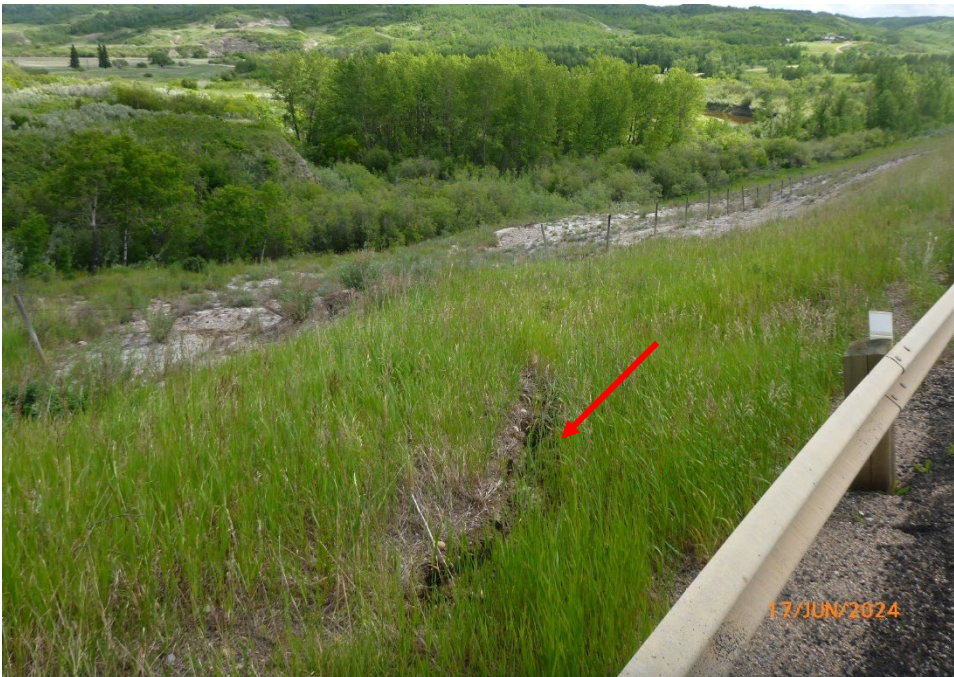
In 2024, a large ground crack was observed in the east highway embankment slope beginning within 1.5 m of the edge of pavement (Photo 8). The ground crack was at least 75 mm to 100 m wide, 10 m long, and approximately parallel to the highway alignment (skew angle of approximately 20°).

**Photo 8** Large ground crack (indicated by red arrow) observed in the east highway embankment slope. Photo taken June 17, 2024, facing east.

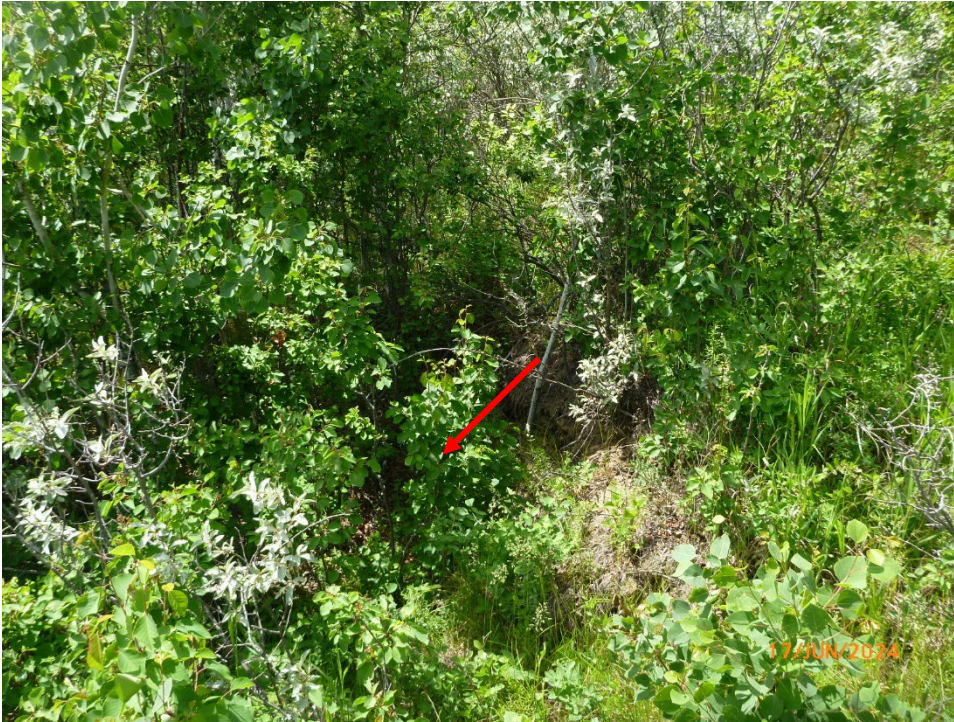
Bedrock is exposed upslope of the highway with a scarp extending laterally to the east. In 2021, slide blocks and other slide features including a horst and graben were observed downslope of the main scarp. In 2024, there was evidence of additional movement between the 2021 and 2024 inspection (scarps more defined, graben blocks dropping, and new ground cracks (Photo 9 and 10)).

**Photo 9** Ground cracking (indicated by red arrow) observed west of the highway embankment. Photo taken June 17, 2024, facing west.

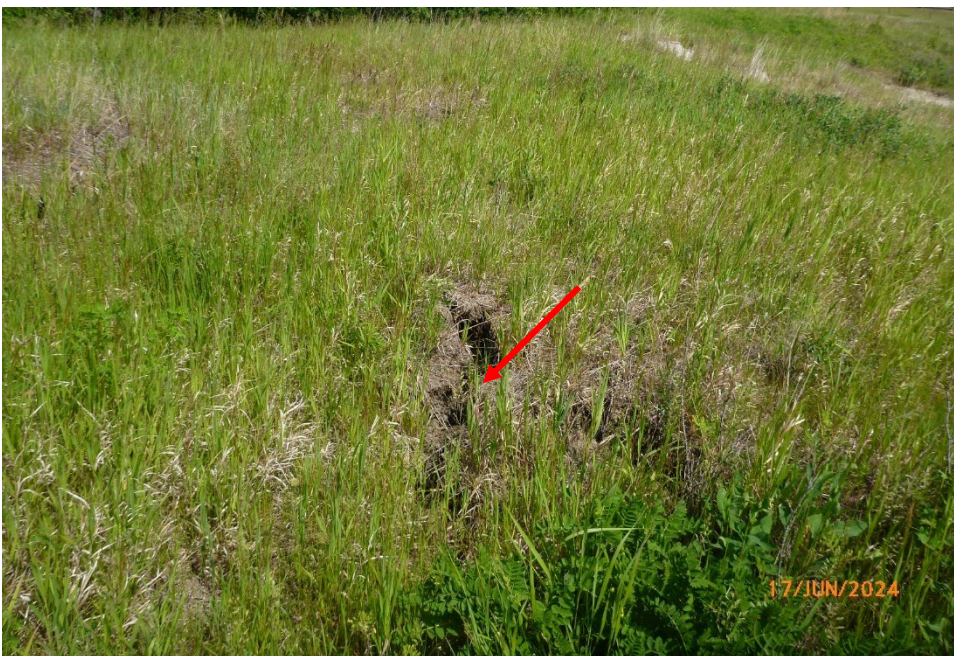
**Photo 10** Ground cracking (indicated by red arrow) observed west of the highway embankment. Photo taken June 17, 2024, facing northeast.
