July 15, 2024

**CON0022160 Central Region GRMP Instrumentation Monitoring
Site C003; H872:06, km 0.278 Burma Park Slide
Section C – 2024 Spring Readings**

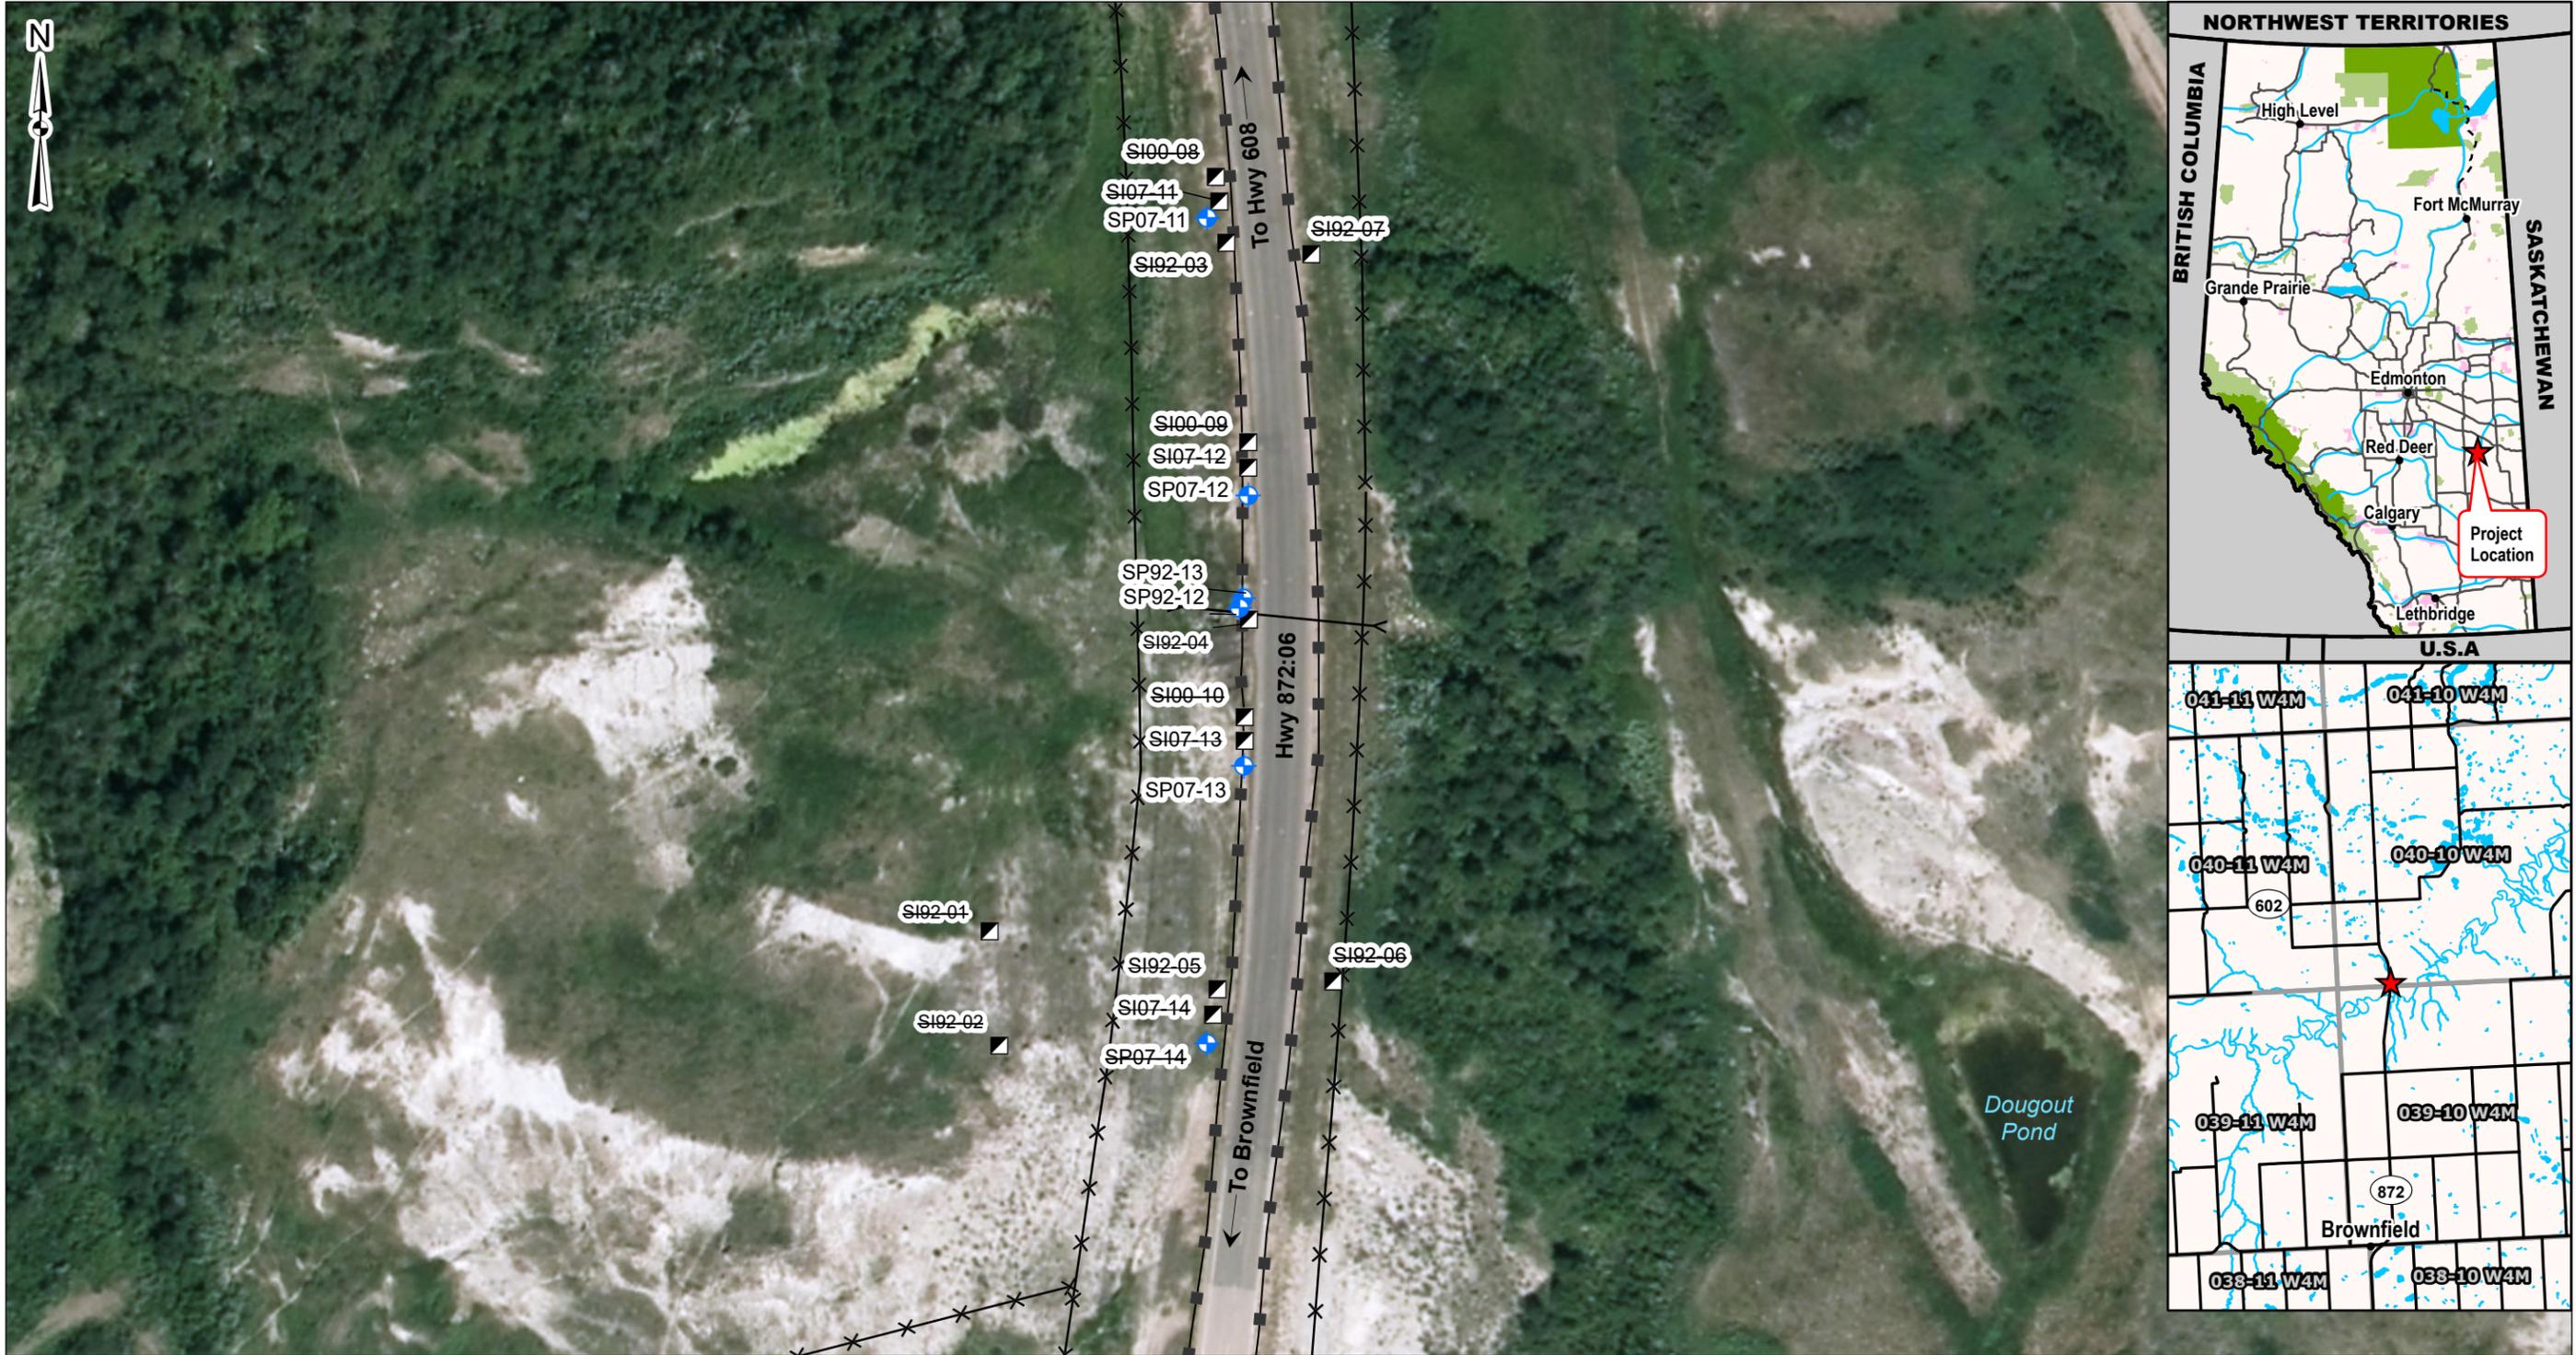
PROJECT CENTRAL REGION GEOHAZARD RISK MANAGEMENT PROGRAM		
TITLE Site Plan C003 - Burma Park Slide Hwy 872:06, km 0.278		
SCALE 1:1,000	PROJECT No. A05116A02	FIG No. 1

Five standpipe piezometers (SPs) (SP92-12, SP92-13, and SP07-11 through SP07-13) were read at the C003 site in the Central Region on May 14, 2024 by Aden Shipton, E.I.T. of Klohn Crippen Berger Ltd. (KCB). These instruments were read as part of the Central Region Geohazard Risk Management Program (GRMP). The site is located on Hwy 872:06, km 0.278, approximately 0.5 km north of the Battle River crossing and 10 km north of Brownfield, Alberta. The approximate site coordinates are 5806345 N, 471780 E (UTM Zone 12, NAD 83). A site plan is presented in Figure 1.

In 2021, KCB began reading the instruments at the C003 site as part of the GRMP. TEC did not request KCB to complete readings before 2021 due to most of the instruments being inoperable, and no significant changes being observed during the Central Region GRMP Section B inspections. As part of the 2019 Section B inspection, KCB read the instruments at the site to assess which SPs were operable, measure water levels inside the SPs (if operable), and to measure the depth of shearing in the SIs (all inoperable). Instrumentation installation details are tabulated in Table 1.1. Instrument locations are presented in Figure 1.

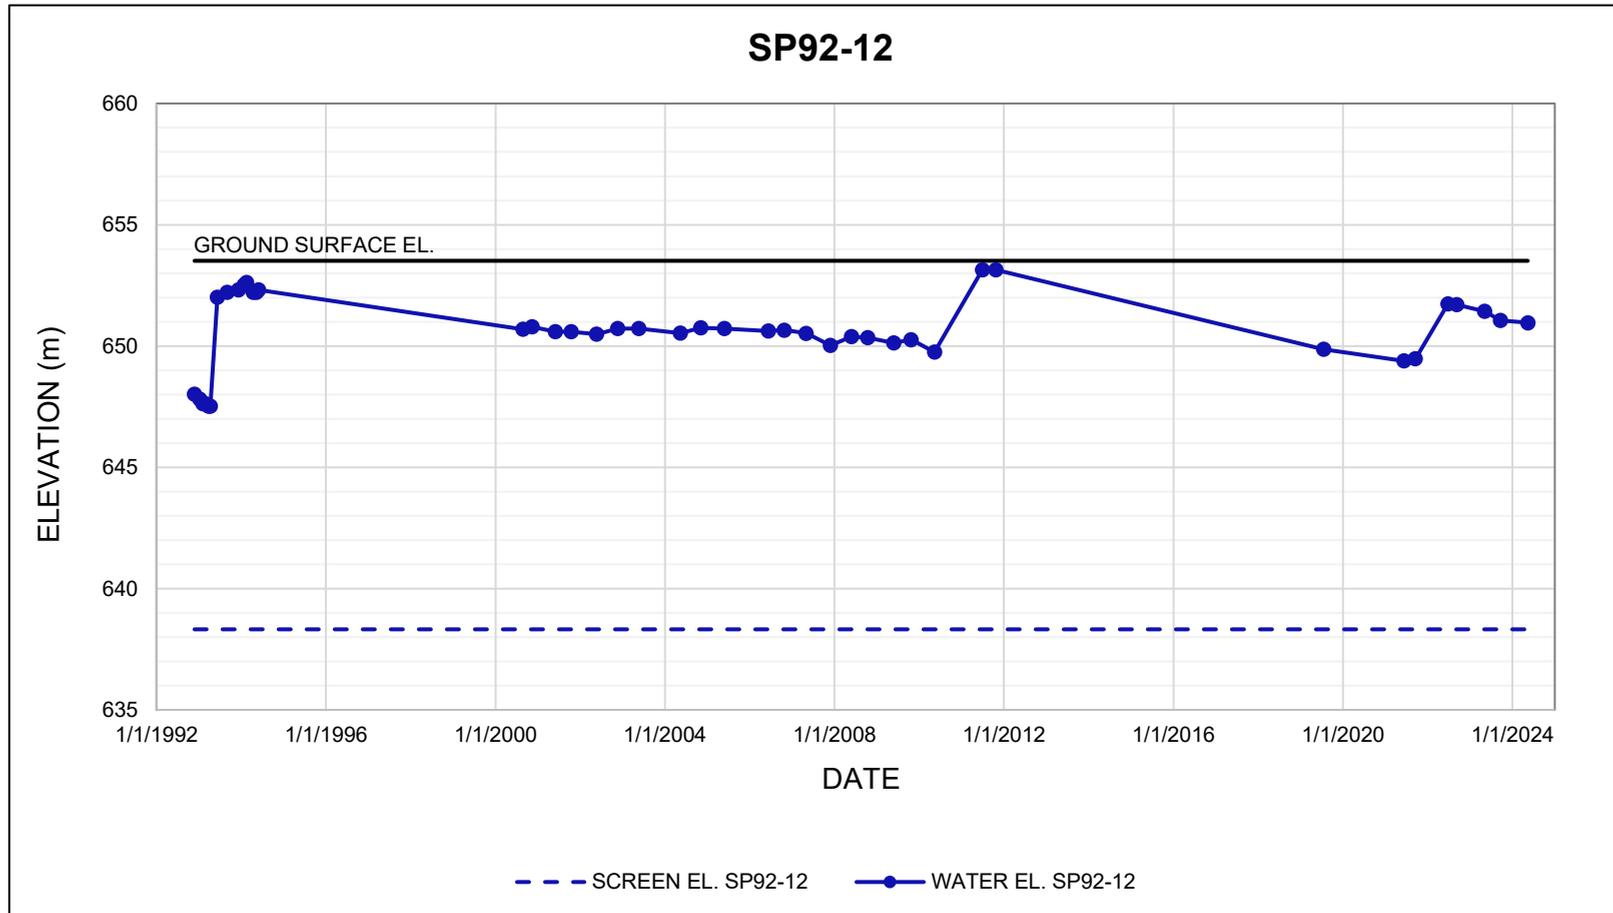
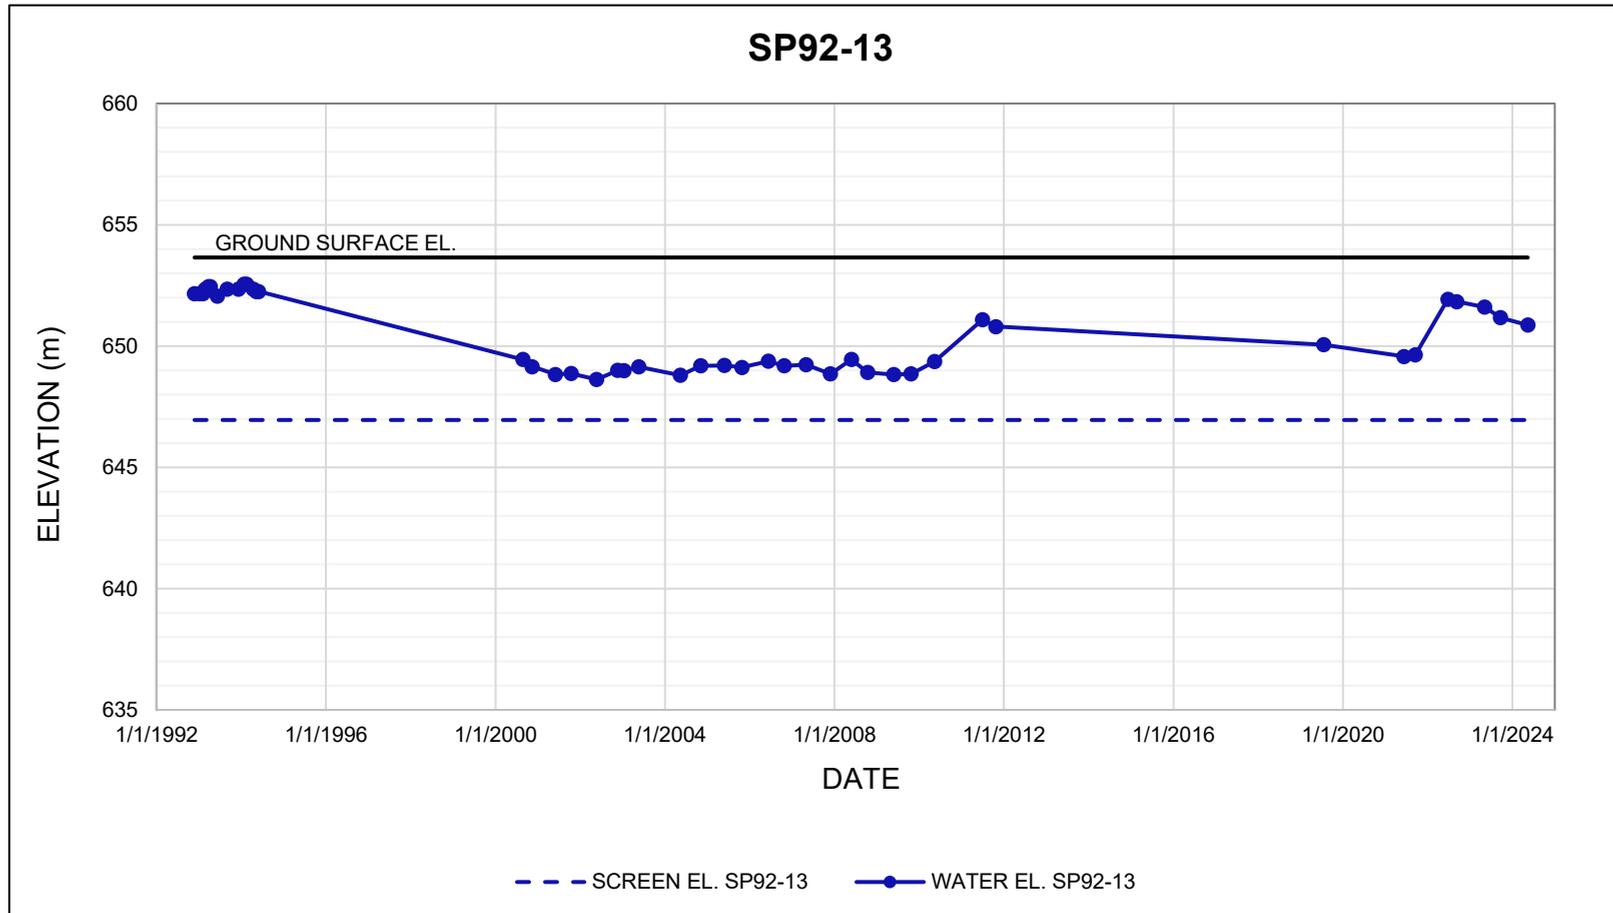
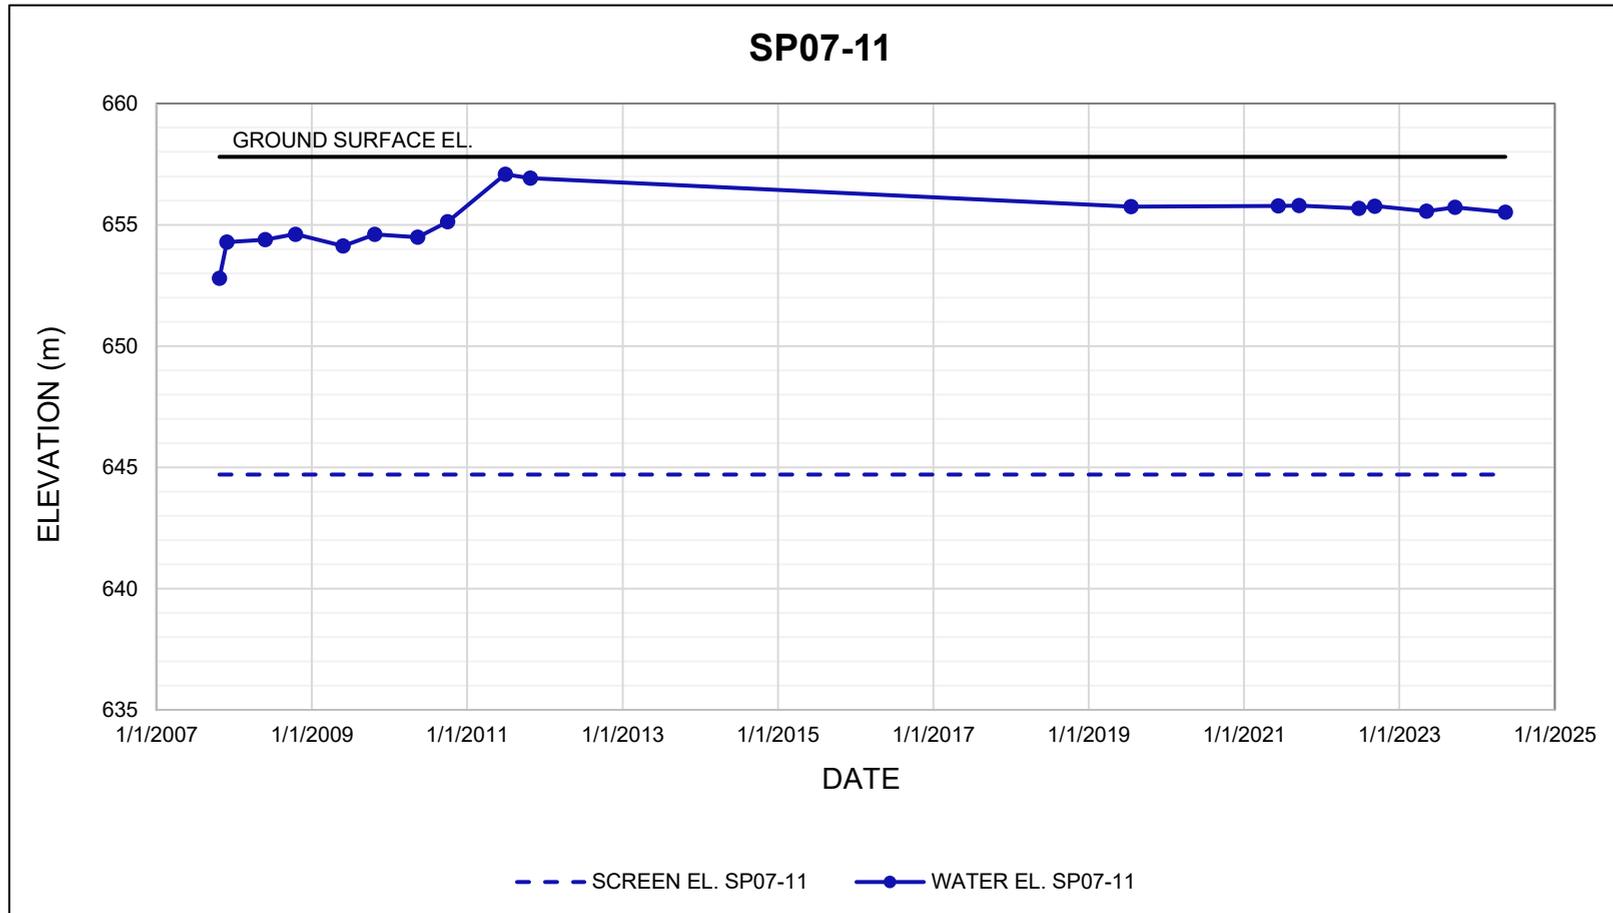
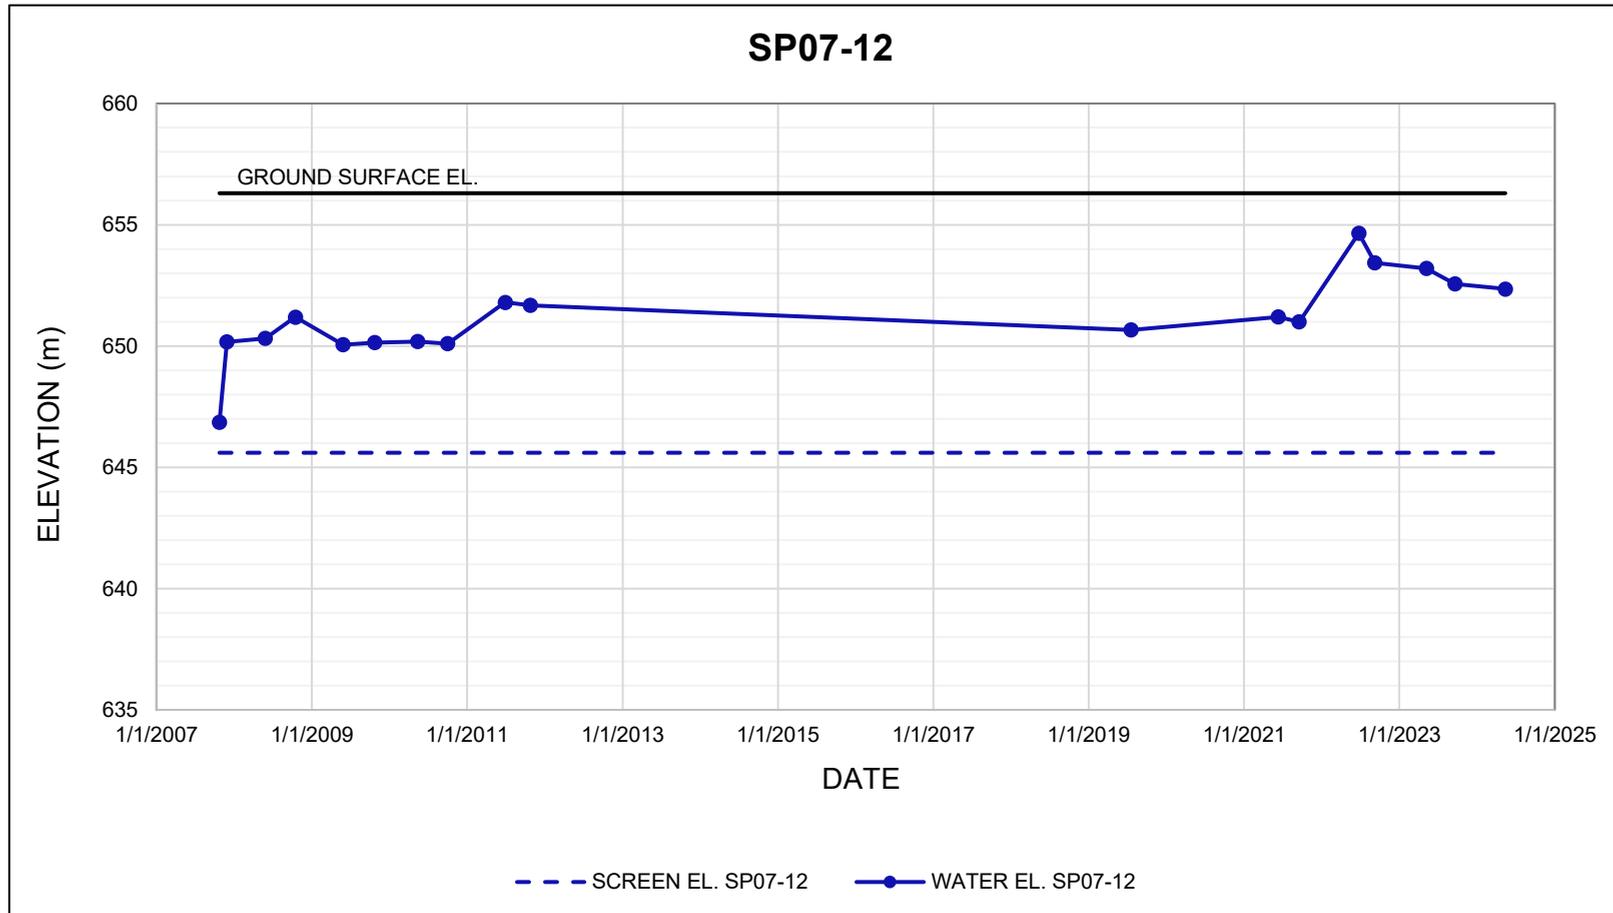
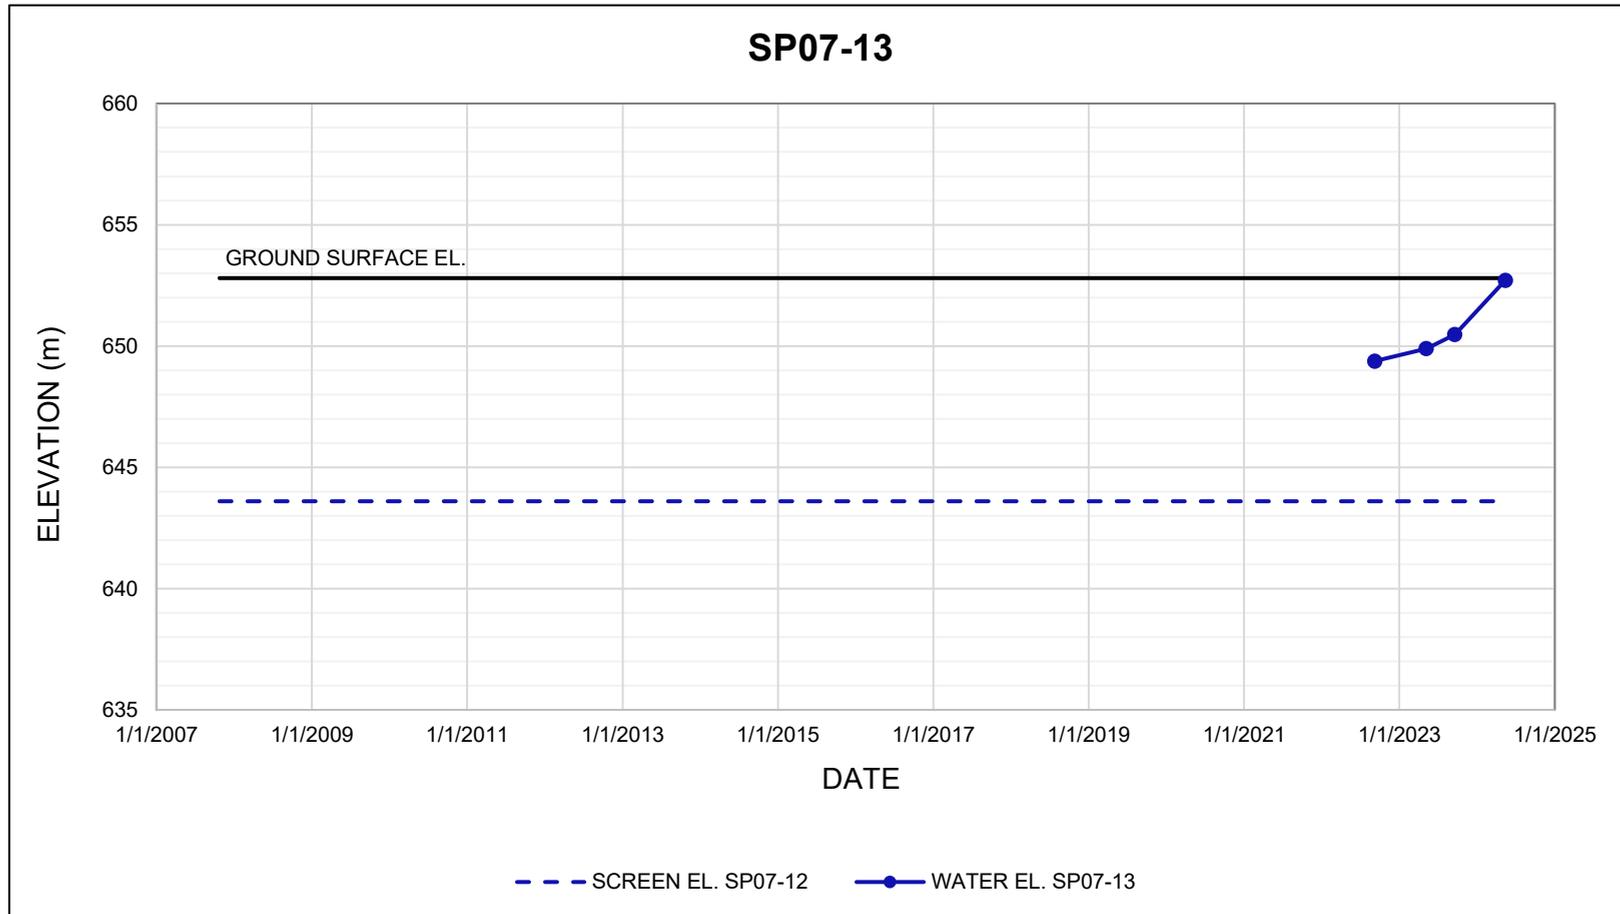
The piezometer data plots are included in Appendix I and a summary of the piezometer data is provided in Table 2.1.

Water level recorded in all the SPs (except SP07-13, see below) have been steady or decreasing since spring 2022 (between 0.15 m and 2.30 m decrease between spring 2022 and spring 2024). These instruments were not read between 2011 and 2020, except for one reading taken in 2019, making it difficult to assess the long-term trends of these instruments. As the slide on the north valley wall of the Battle River is relatively large, there may be additional mechanisms contributing to the continued movement being observed at the site since 2021, such as continued movement after the initial acceleration that appears to have happened in 2022, as indicated by increased damage to the pavement in 2022. The drainage improvements installed in 1998 and 2003 may only be effective for higher water levels below the highway.

Based on the piezometer data, it is likely that the movement observed in 2022 (increased pavement cracking, settlement, and guardrail deflection) at the site occurred in response to elevated groundwater levels within the slide mass. Movement between 2022 and 2023 was difficult to assess due to pavement patching between the fall 2022 and spring 2023 readings, and again between the spring and fall 2023 readings. However, during the spring 2024 readings, transverse pavement cracking (in both the northbound and southbound lanes), pavement heaving, and guardrail settlement (on the west shoulder) was observed. This indicates that the deep-seated slide is active and there is ongoing movement at the site.

The variation in water level recorded between SI92-12, SP92-13, SP07-11 and SP07-12, and SP07-13, may be due to these instruments being installed on either side of a culvert that receives flows from a wet area upslope and to the east of the instruments. Whereas water levels recorded in the instrument upslope to the north have remained relatively steady or decreasing since the spring of 2021, while the water level recorded in SP07-13 has been increasing (approximately 1.1 m) since spring of 2021.

Historically, SP07-13 (instrument downslope to the south) has been dry since installation. However, since fall of 2022, steadily increasing water levels from approximately 4.2 m and 3.1 m below ground surface were recorded in this instrument. KCB suspects the water in the instrument may be due to slope movement shearing the SP casing, resulting in groundwater infiltrating and partially filling the casing. Between the fall 2023 and spring 2024 readings, SP07-13 was broken off at ground surface (likely due to snow clearing activities). KCB suspects that surface water may be flowing into the standpipe, resulting in higher-than-actual water levels at SP07-13.

The reading frequency for all operable instruments should be reduced from twice per year (spring and fall) to once per year (spring only).
