**NORTH CENTRAL REGION GEOHAZARD ASSESSMENT
HWY 16:08 km 11 PAVEMENT DISTRESS (NC68)
2008 ANNUAL INSPECTION REPORT**

SITE PLAN SHOWING SETTLEMENT NEAR NITON JUNCTION

NORTH CENTRAL 2008
 GEOHAZARD ASSESSMENT

SE 35-53-13 W6M
 HWY 16:08 Km 11.015 TO 11.048
 WEST OF NITON JUNCTION, AB

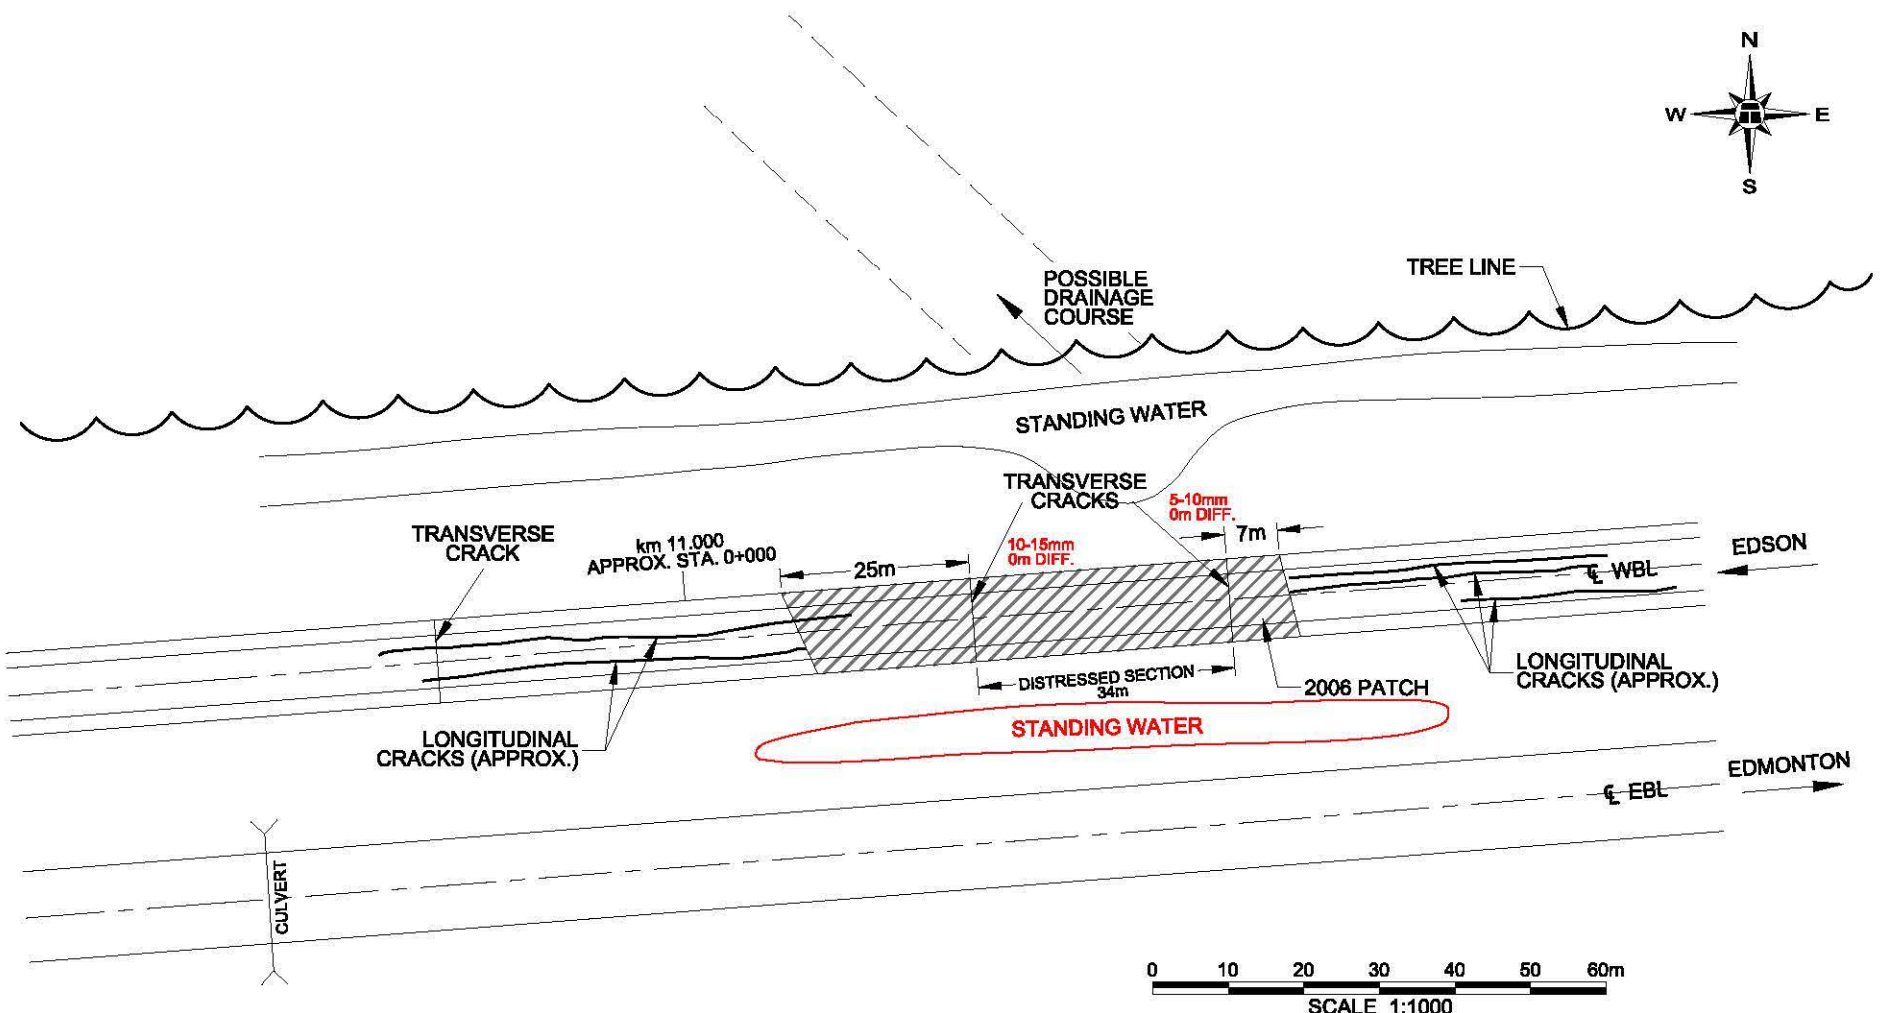
ENGINEER:	KEF	DRAWN:	CMH	APPROVED:	DJL
DATE:	JULY, 2008	SCALE:	1:1,000	DRAWING No.	FIGURE NC68-1

The site features and observed changes in condition are shown on Figure NC68-1 (attached in Section F). Details regarding the observations are provided in the following sections.

The area of pavement distress is located across both of the westbound lanes. The surrounding terrain is forested with an overall slope from south to north. There is a pond surrounded by muskeg terrain located to the south of the highway. Both of the westbound lane ditches had standing water at the time of the site visit. The cracks observed during the February 2008 call-out inspection were still present. However, the east crack widths had reduced in width to typically between 5 mm to 10 mm with portions up to 80 mm where the asphalt has broken out. The west crack widths had also reduced to typically between 10 mm to 20 mm with portions up to 70 mm in width. There was no differential height observed across the cracks and the overall height differential observed between the distress section and the adjacent areas was significantly reduced from about 70 mm at the time of the call-out to nearly level during this inspection.

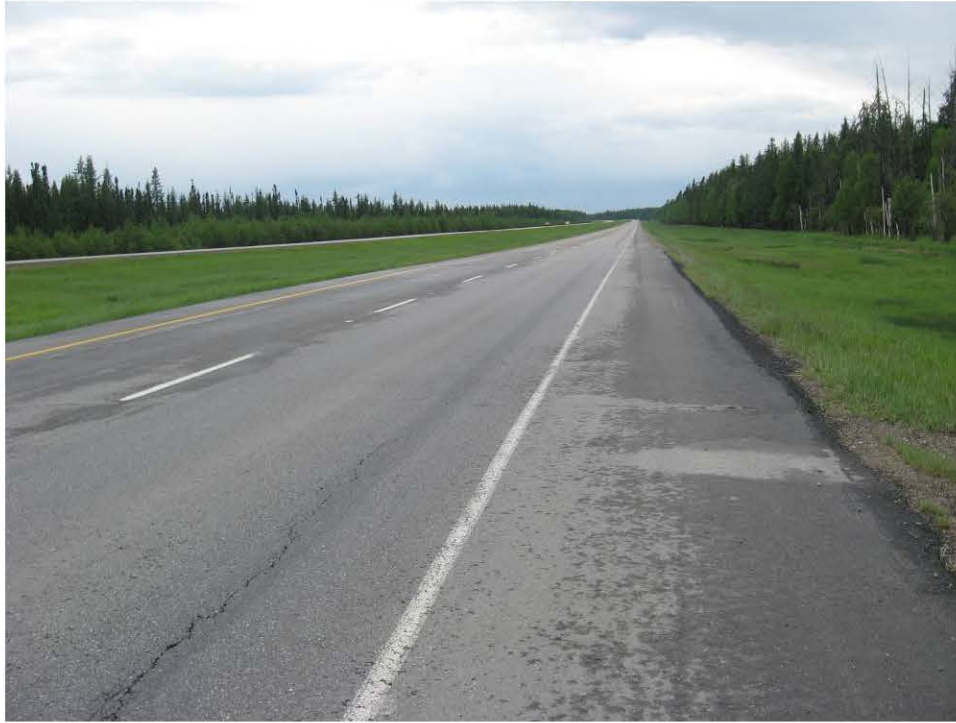
Photo 1 – Looking west toward distressed section, June 11, 2008.

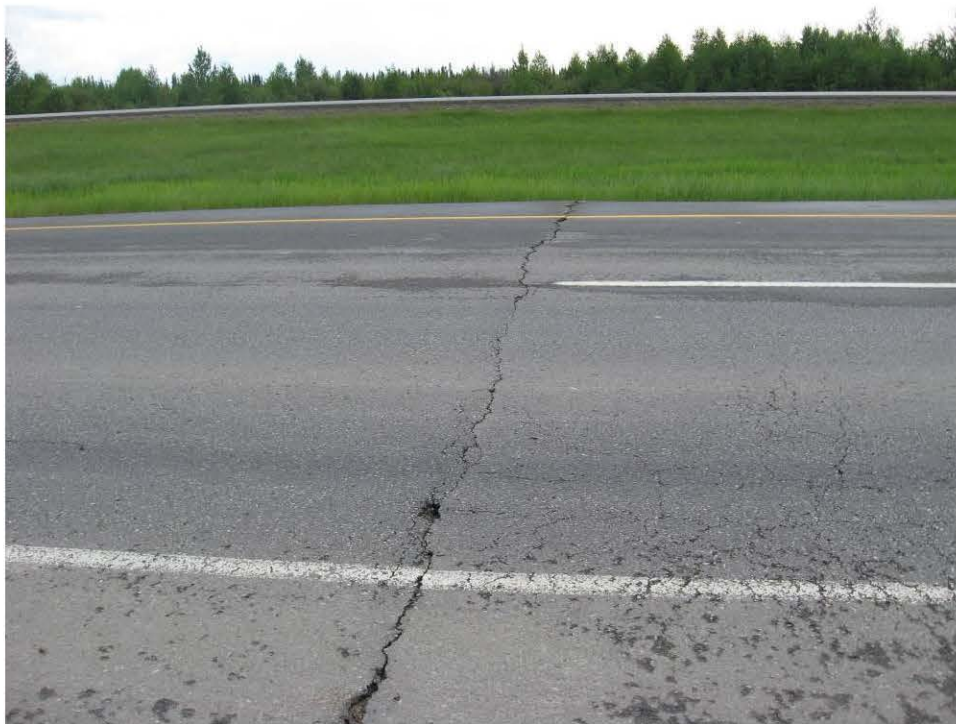
Photo 2 – Looking south at east crack, June 11, 2008.

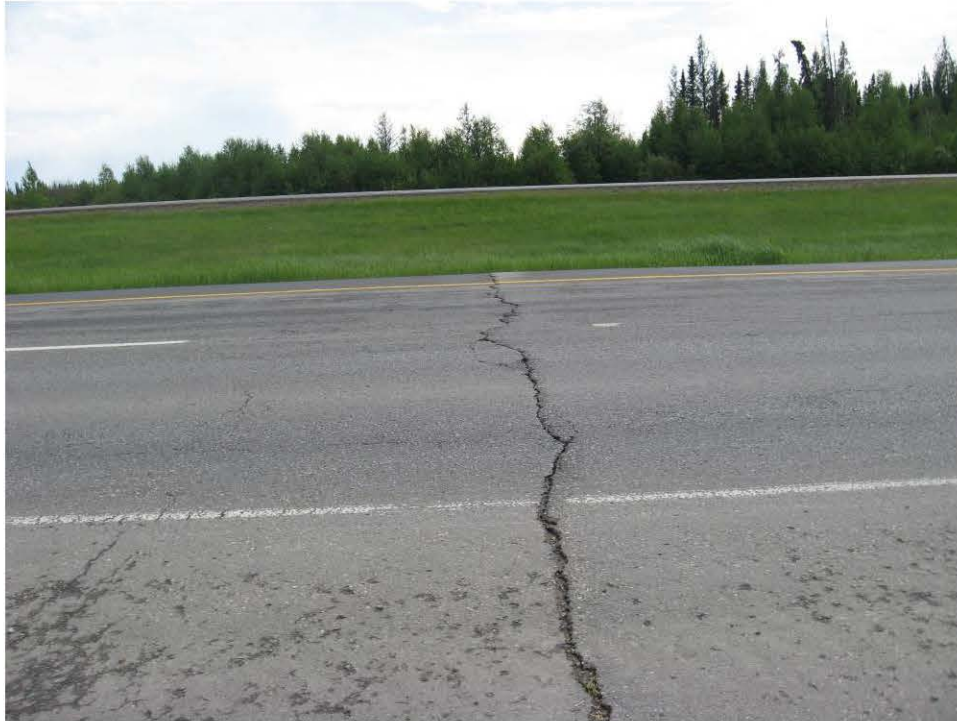
Photo 3 – Looking south at west crack, June 11, 2008.

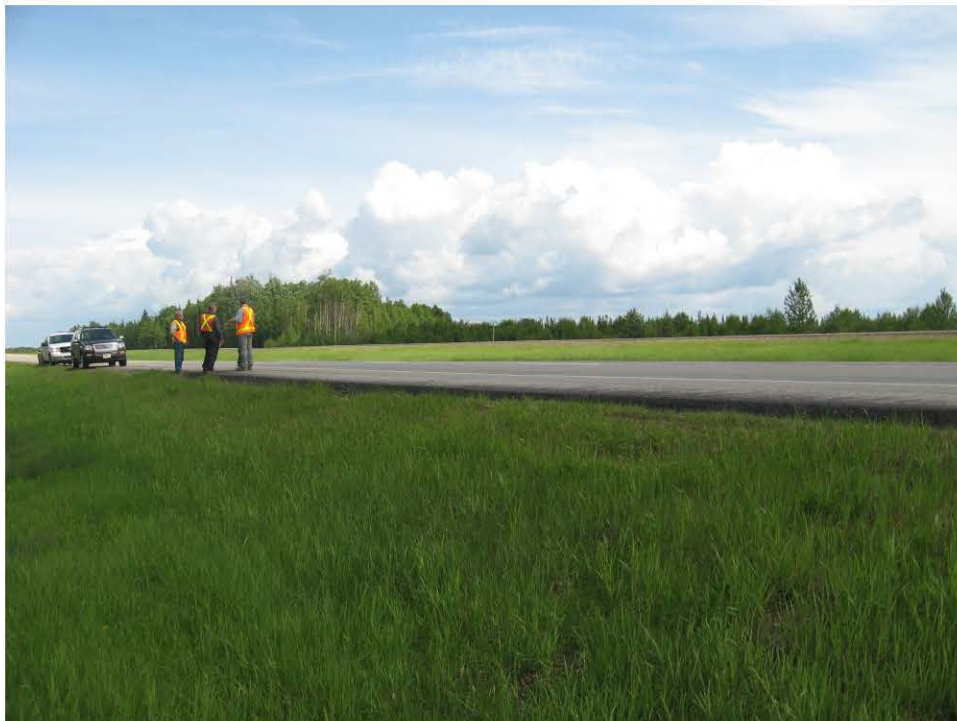
Photo 4 – Looking southeast at distressed section. Note lack of obvious displacement compared to surrounding pavement, June 11, 2008.
