August 25, 2004

File: 15-16-192

**NORTH CENTRAL REGION LANDSLIDE ASSESSMENT
HWY 16:06 EDSON 25TH STREET (NC20)
2004 ANNUAL INSPECTION REPORT**

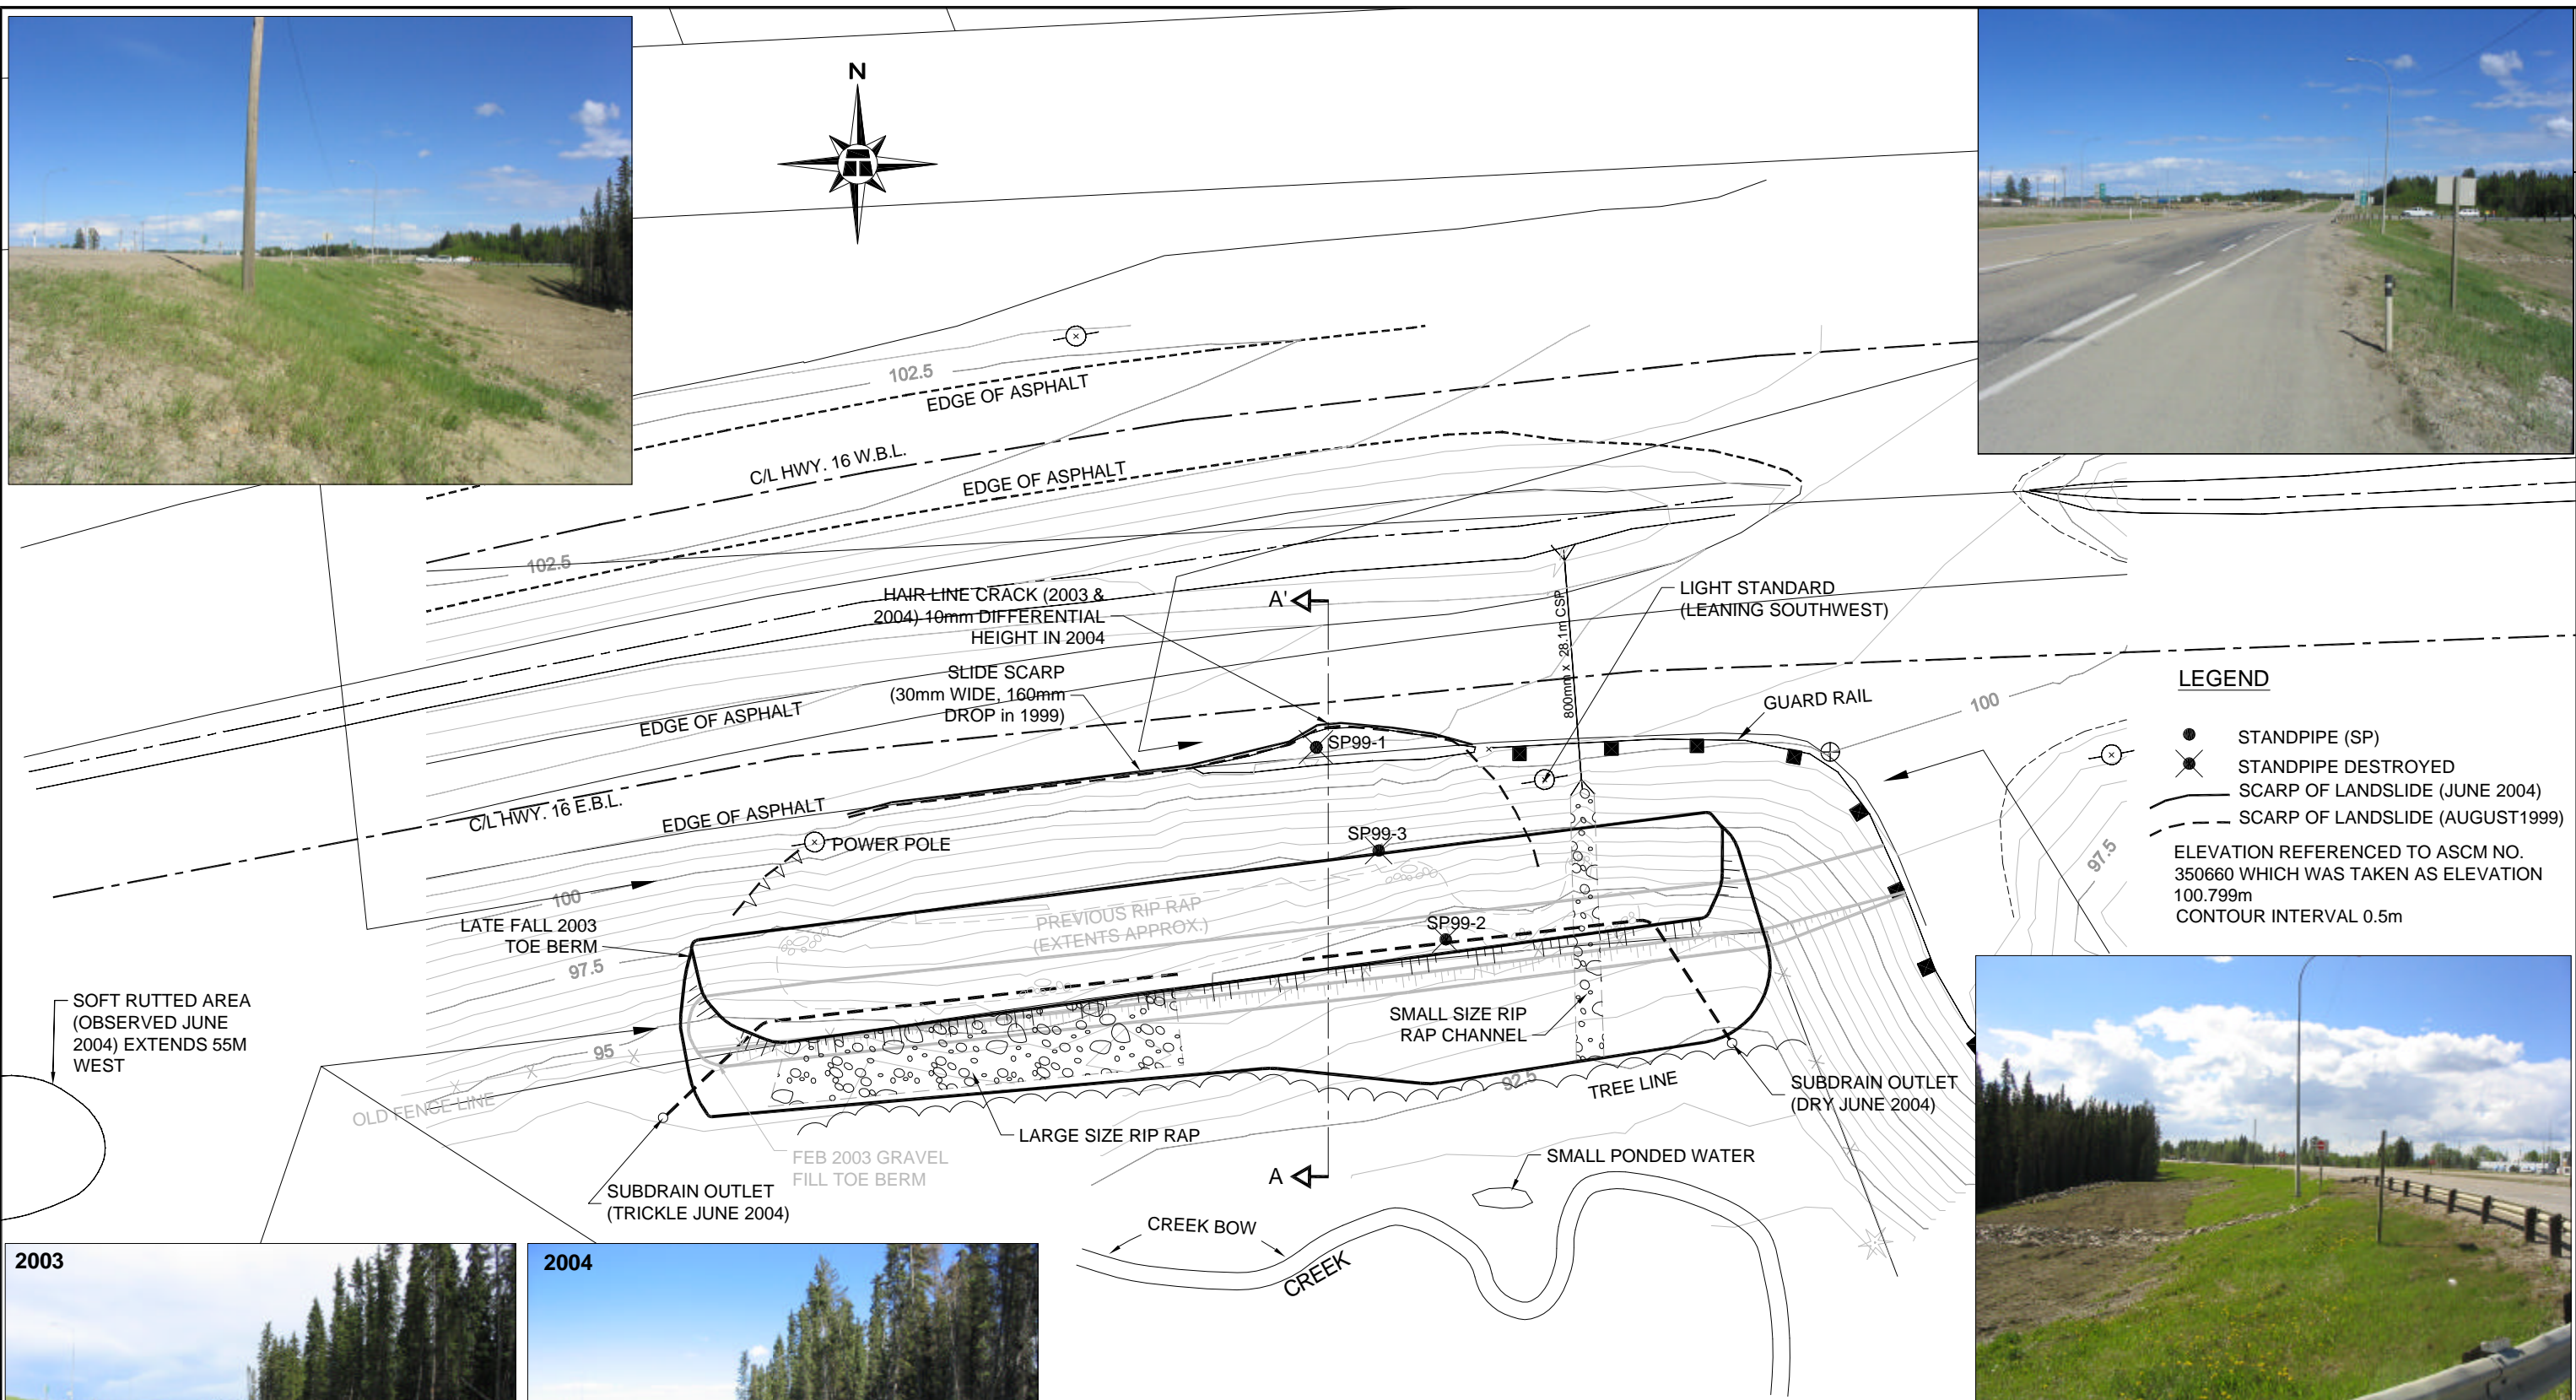
REF: EXH ENG. SERVICES LTD. DWG. NO. 991168-SITE, 11/99		ALBERTA TRANSPORTATION		<p>THURBER</p> <p>DRAWING No. FIGURE NC20-1</p>
ENGINEER	DJL	<p>SITE PLAN SHOWING INSTABILITY FEATURES</p> <p>HWY 16:06 AT 25 STREET</p> <p>EDSON, AB</p>		
DRAWN	ZD			
DATE	JUNE, 2004			
APPROVED				
SCALE	1:750

- ?? Cracking was noted in the asphalt pavement over a length of about 30 m, impacting the shoulder and turning lane at this location. The cracking did not extend into the traveling lanes. The cracking continues west along the edge of the pavement for an additional 50 m. The crack within the pavement is coincident with the slide scarp observed during previous site visits and does not appear to have been active recently. However, unlike previous site visits, there was no evidence of the crack extension on the side slope during the June 2004 reconnaissance. The crack seal is still in place on the east end of the crack, however 10 mm of vertical displacement across the crack was noted in the central portion of the crack length (within the pavement section) in spite of milling operations in the area. Where the crack extends along the edge of pavement it is still open in places up to about 15 mm width. Overall the cracking pattern within the pavement surface is similar to that observed during the June 2003 site visit.

SOFT RUTTED AREA (OBSERVED JUNE 2004) EXTENDS 55M WEST

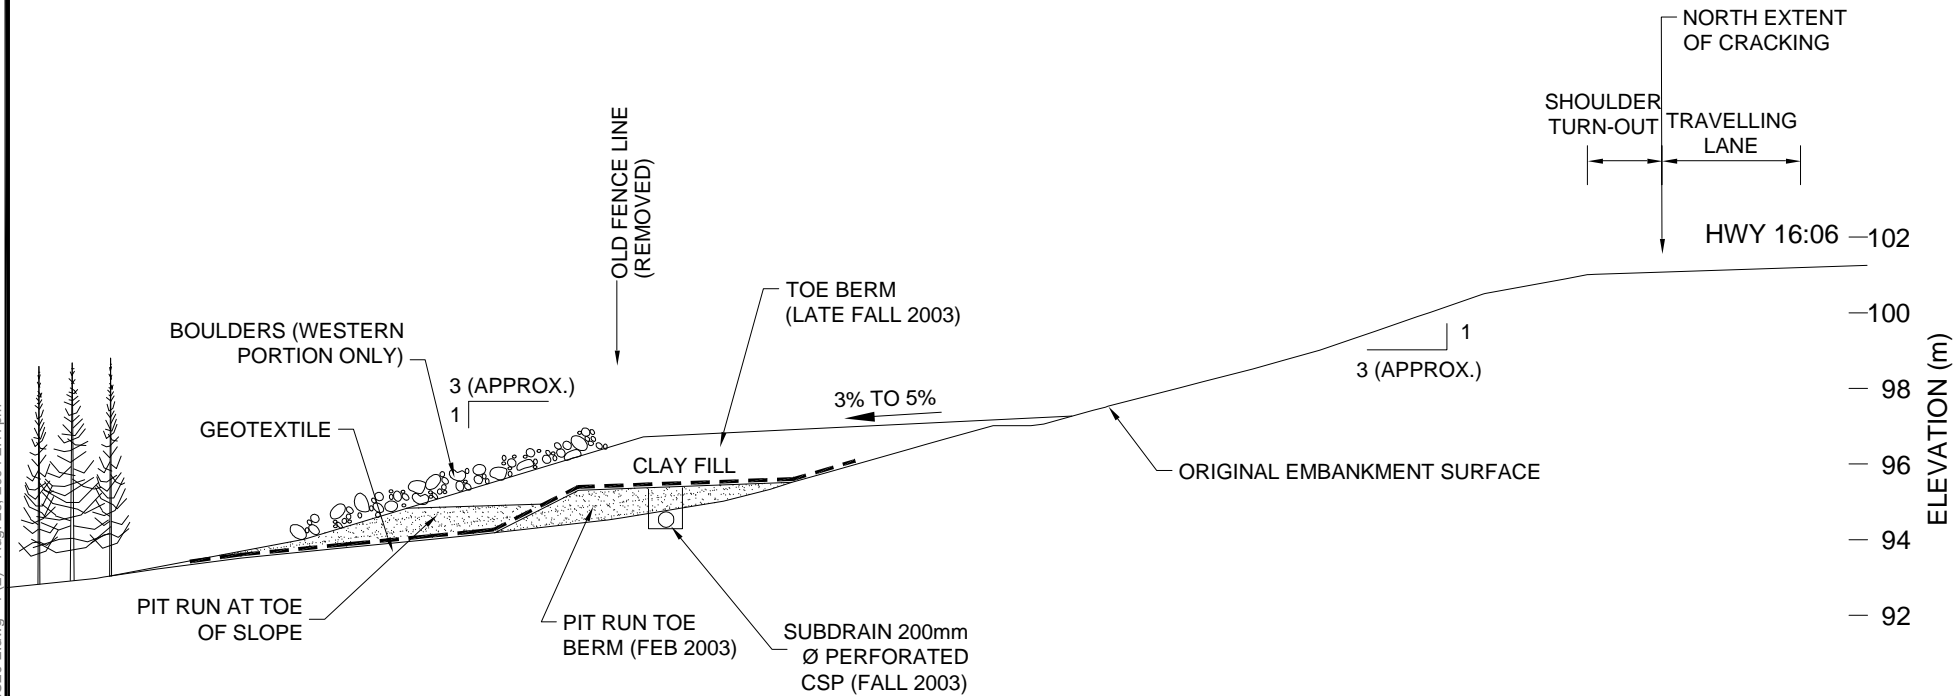
DRAWING No.
FIGURE NC20-2A

Since the last site visit in June 2003, a larger toe berm has been constructed at the site by the Maintenance Contractor (LaPrairie Group). The work was supervised by AT personnel (Mr. Cliff Corner and Mr. Ron Coley). Based on information provided by Mr. Coley, the toe berm construction consisted of the following items, which are also shown in plan and cross section on Figures NC20-1 and NC20-2A in Appendix F:

- ?? Two lengths of subdrain (200 mm dia. perforated CSP with filter sock) were placed in the pit run toe berm located near the toe of the original slope at a depth of about 1.2 m. The subdrain pipes extend over much of the length of the pit run toe berm to outlet points located as shown on the site plan (Figure NC20-1).
- ?? Geotextile and pit run were placed over peat and stumps to a height of approximately 1 m over original ground surface. No stripping was undertaken. The pit run was sourced from Dandurand Pit (25 km haul).
- ?? Clay fill was placed on top of the pit run base, and the boulders existing on the site were relocated on front face of the berm (western portion only).

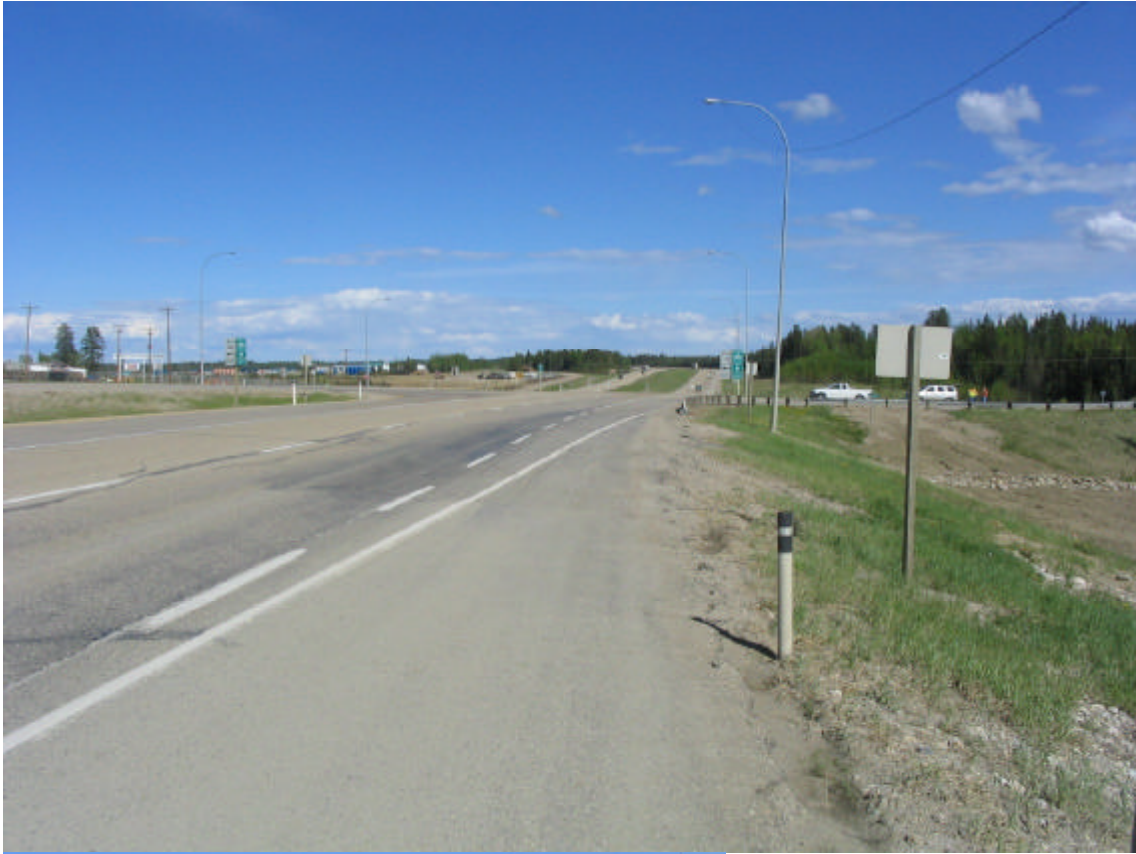
PHOTO 1 AREA OF CRACKS IN PAVEMENT (LOOKING EAST)

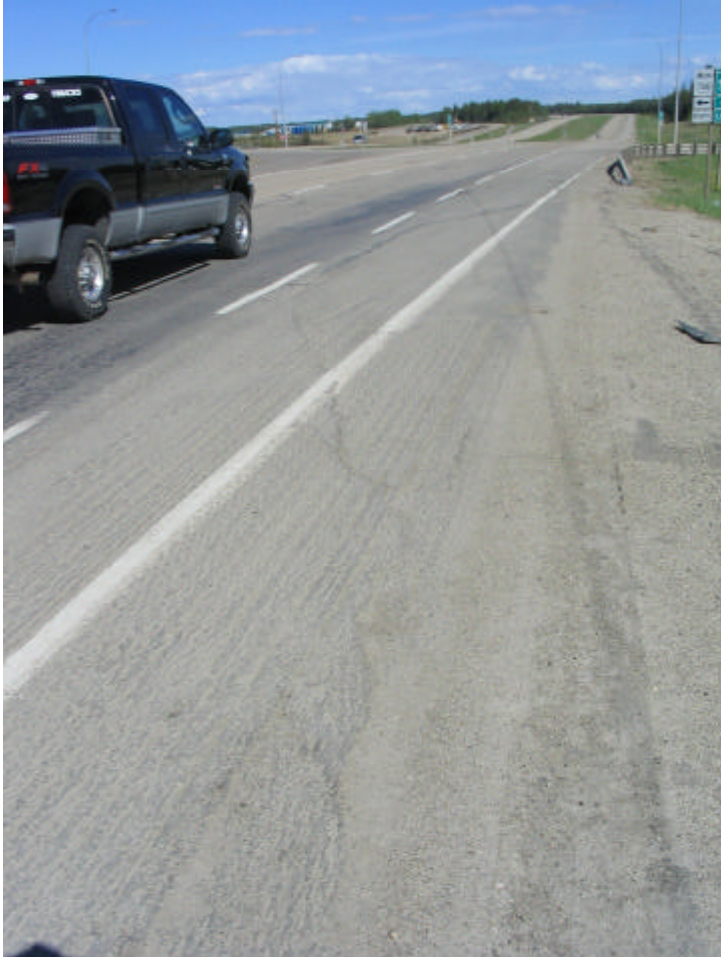
PHOTO 2 CRACK OUTLINING PREVIOUS SCARP LOCATION (LOOKING EAST)

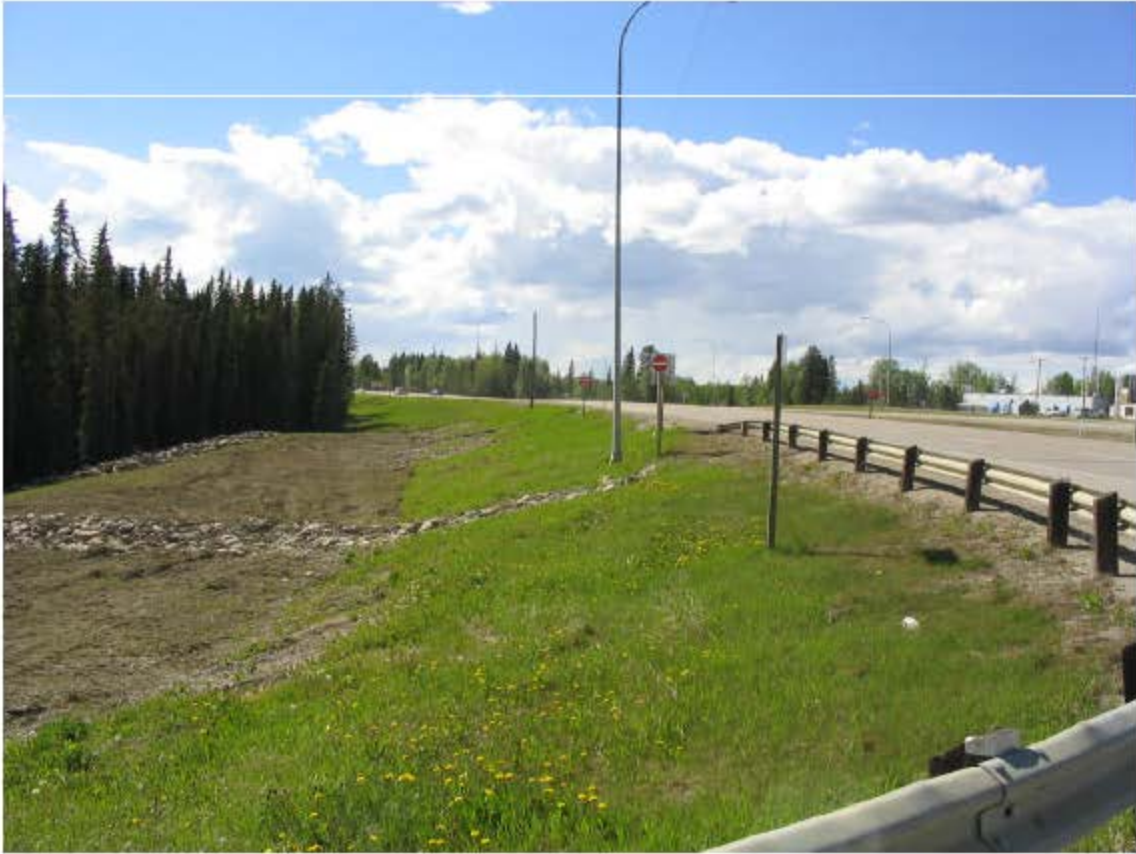
- ?? No signs of slope movement were noted on the side slope, new toe berm, or in the area beyond (i.e. south of) the current toe of the slope. Vegetation cover on the berm area consisted of very sparse grasses. No significant erosion was noted on the berm surface.

PHOTO 3 LOOKING WEST AT UPPER SLOPE AND TOE BERM

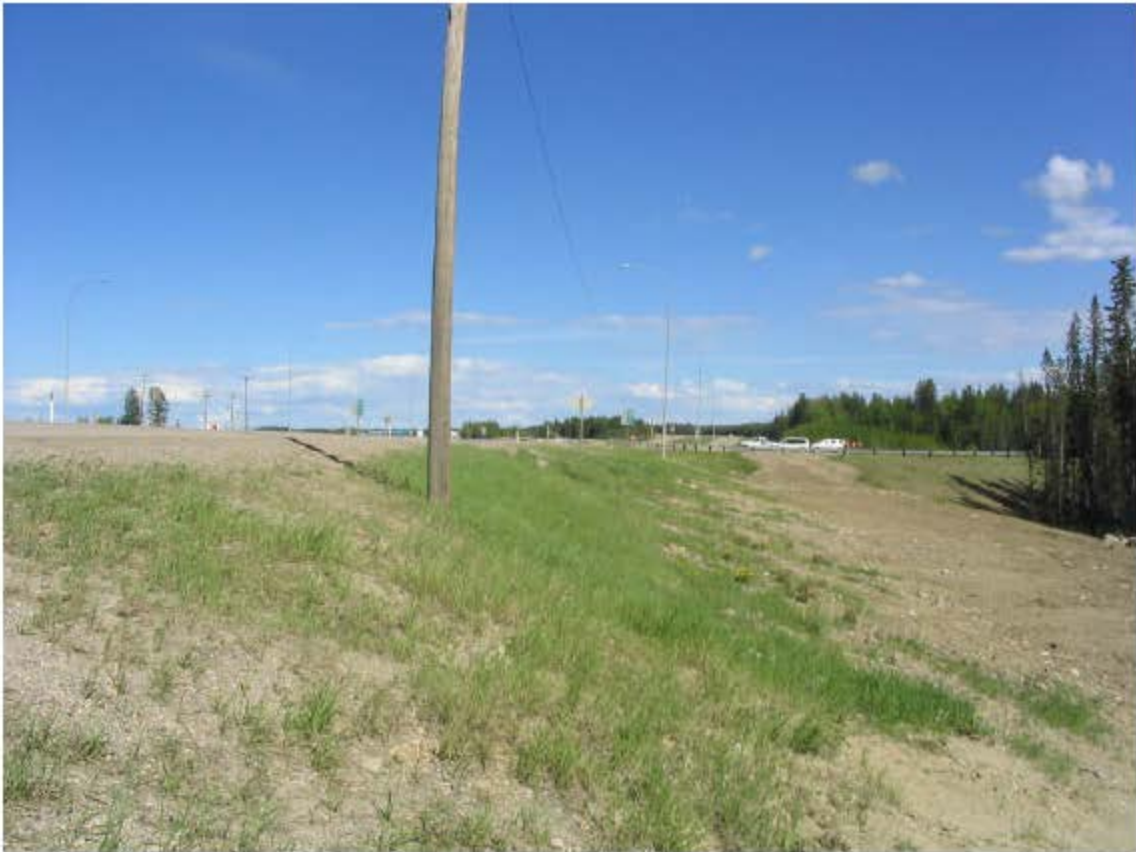
PHOTO 4 LOOKING EAST AT UPPER SLOPE AND TOE BERM

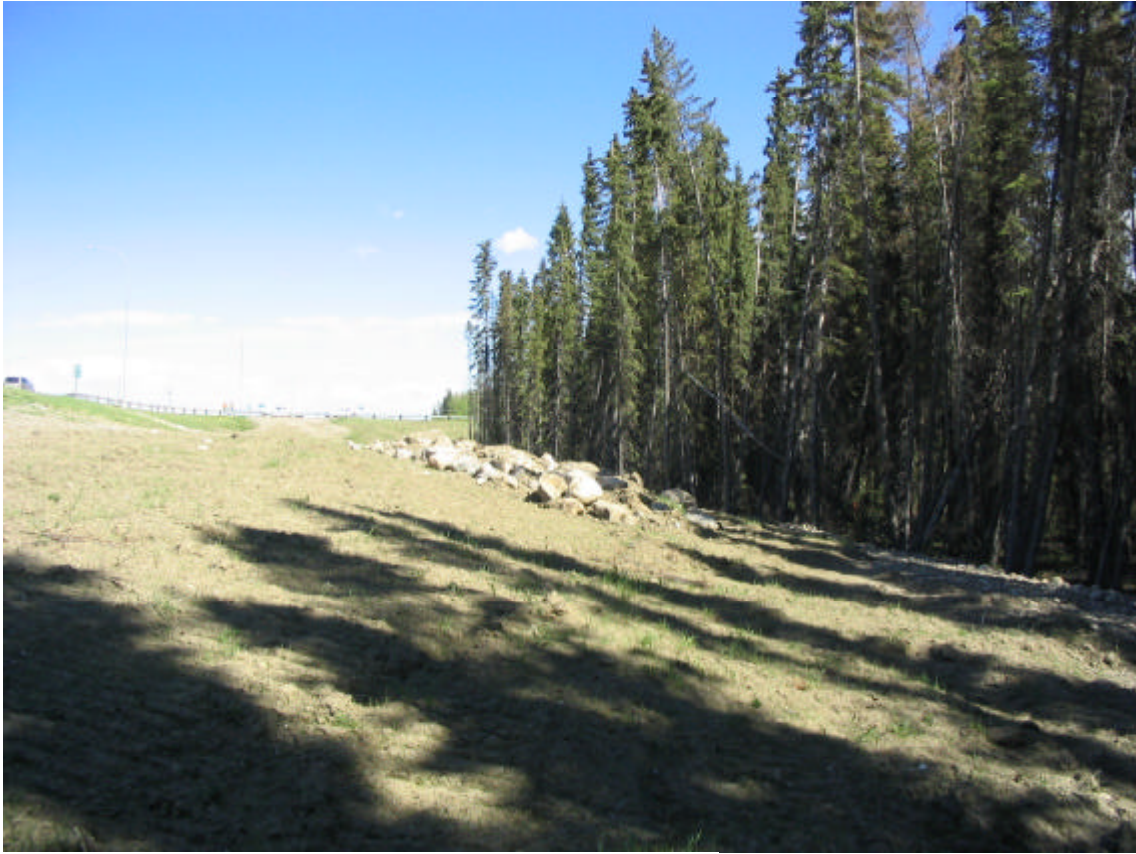
PHOTO 5 LOOKING EAST AT LOWER SLOPE AND RIP RAP FACING

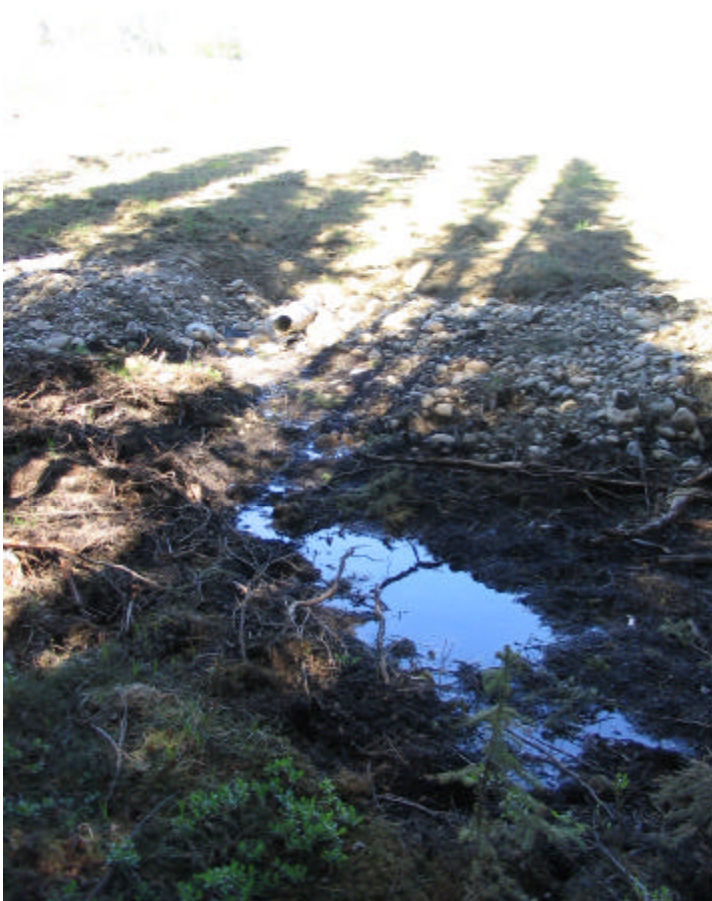
- ?? A trickle of flow was noted from the west subdrain outlet at the time of the site visit. The east subdrain outlet was dry.

PHOTO 6 OUTFLOW FROM WEST SUBDRAIN OUTLET

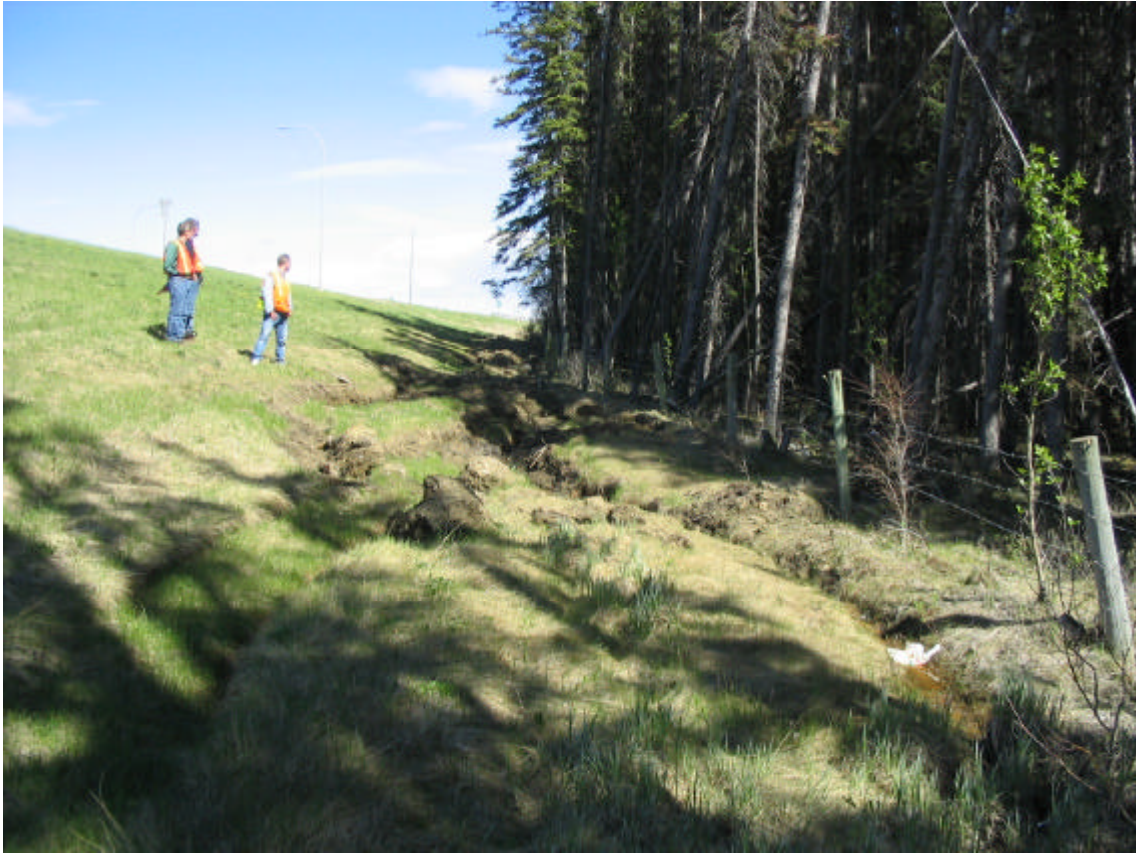
The area of rutted soft ground is located approximately 75 m west of the west end of the toe berm. The ruts extend over a length of about 55 m and are located in the right of way to the north of the existing fence line. There is some pooling of water within the ruts and in the nearby bush area located within the adjacent landowner's property. In addition, there are some trees that are leaning and a few that have blown down in this area.

Based on inspection of the ruts, the near surface soil conditions consist of grass cover over saturated clayey silt. No peat was observed in the rutted zone, however muskeg was noted within the treed area immediately adjacent to (i.e. south of) the rutted zone.

PHOTO 7 RUTTED ZONE WEST OF SLIDE AREA (LOOKING EAST)

The rutted zone located west of the site is located adjacent to an area of natural shallow muskeg terrain, which is normally wet and soft. Similar deposits are located elsewhere in the Edson region and are often associated with a high water table or ponded water at surface. The trees in such areas typically have shallow root penetration and hence are prone to blow-over. As stated previously, no signs of embankment slope instability were noted in this area. Based on these observations, the wet and soft muskeg conditions (including ponded water) and fallen trees within the bush areas adjacent to the rutted zone are expected to be a natural condition and are not related to slope instability or the formation of the ruts in the right of way. It is recommended to backfill the ruts with granular fill, smooth out the area and topsoil/seed to promote revegetation.

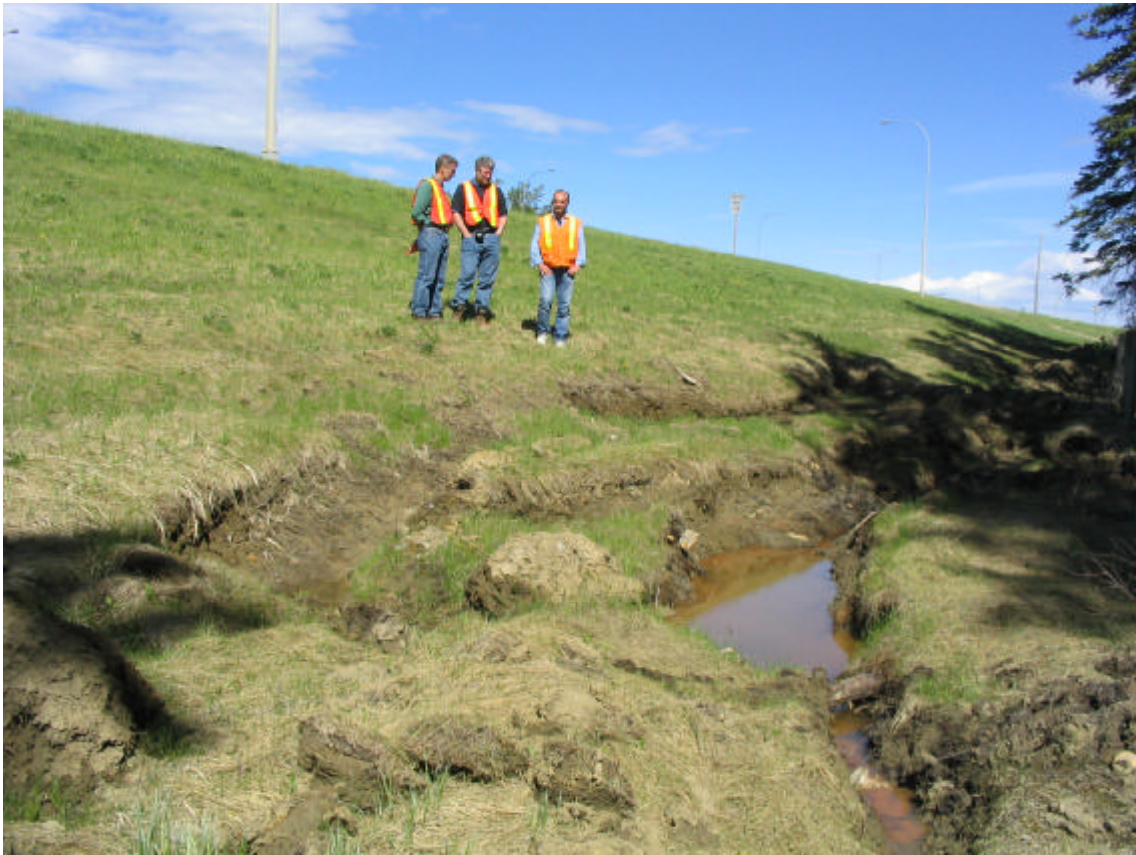
PHOTO 8 PONDED WATER IN RUTS

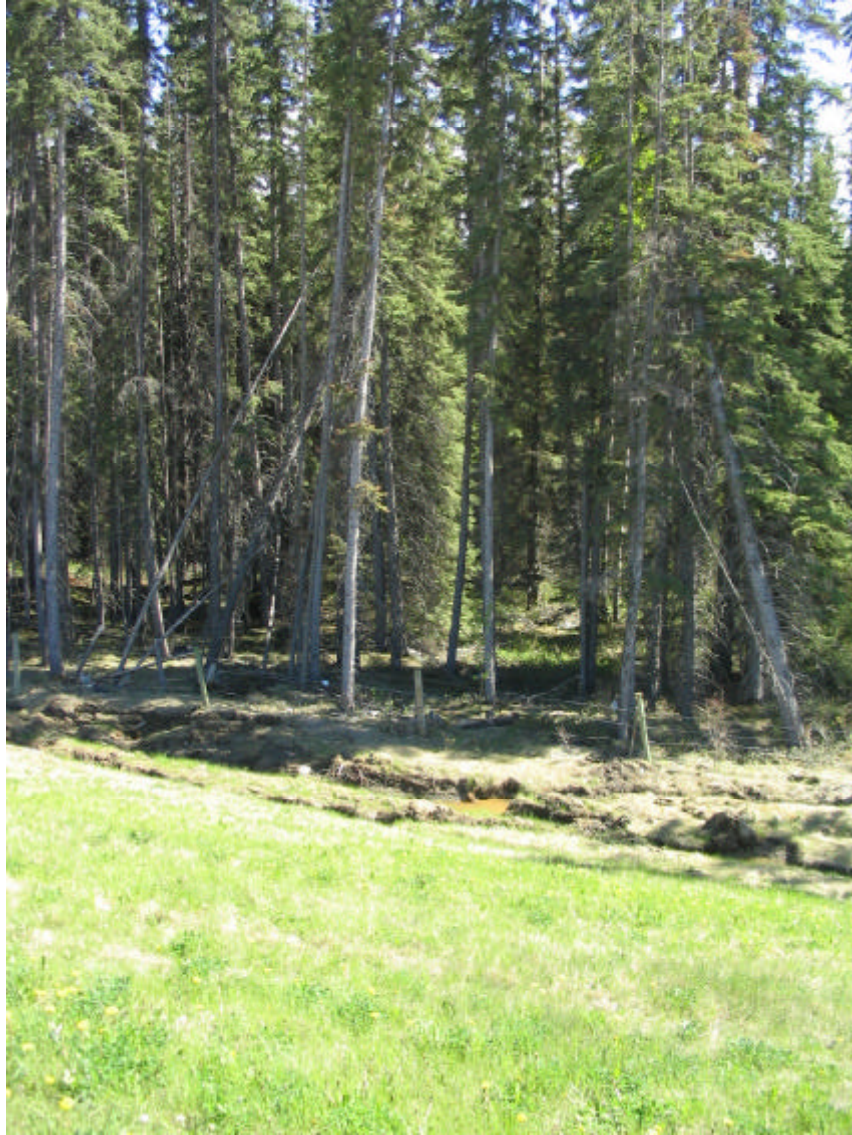
PHOTO 9 MUSKEG AREA AND WIND BLOWN TREES ADJACENT TO RUTTED ZONE (LOOKING SOUTHEAST)

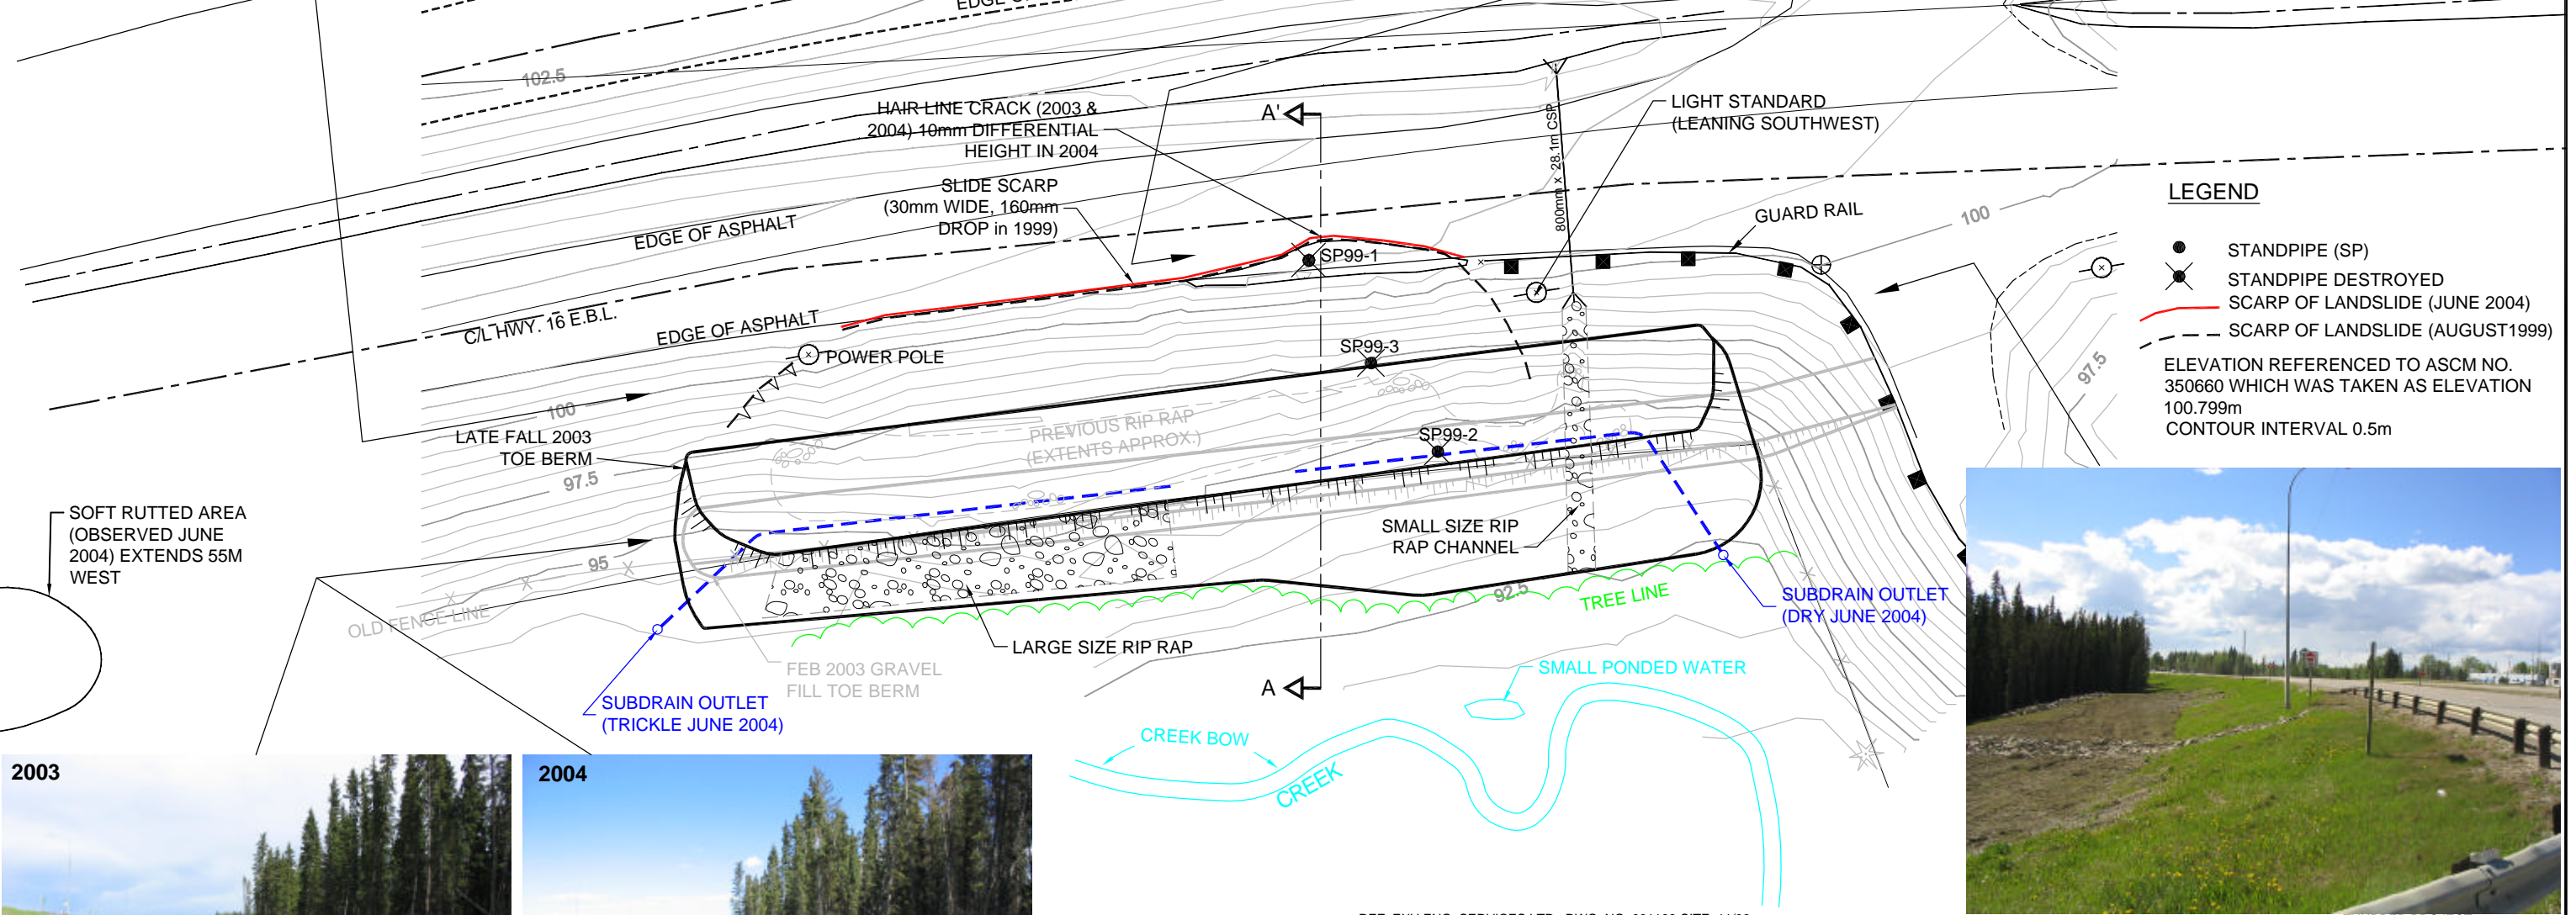
DRAWING No.
FIGURE NC20-1

SOFT RUTTED AREA (OBSERVED JUNE 2004) EXTENDS 55M WEST

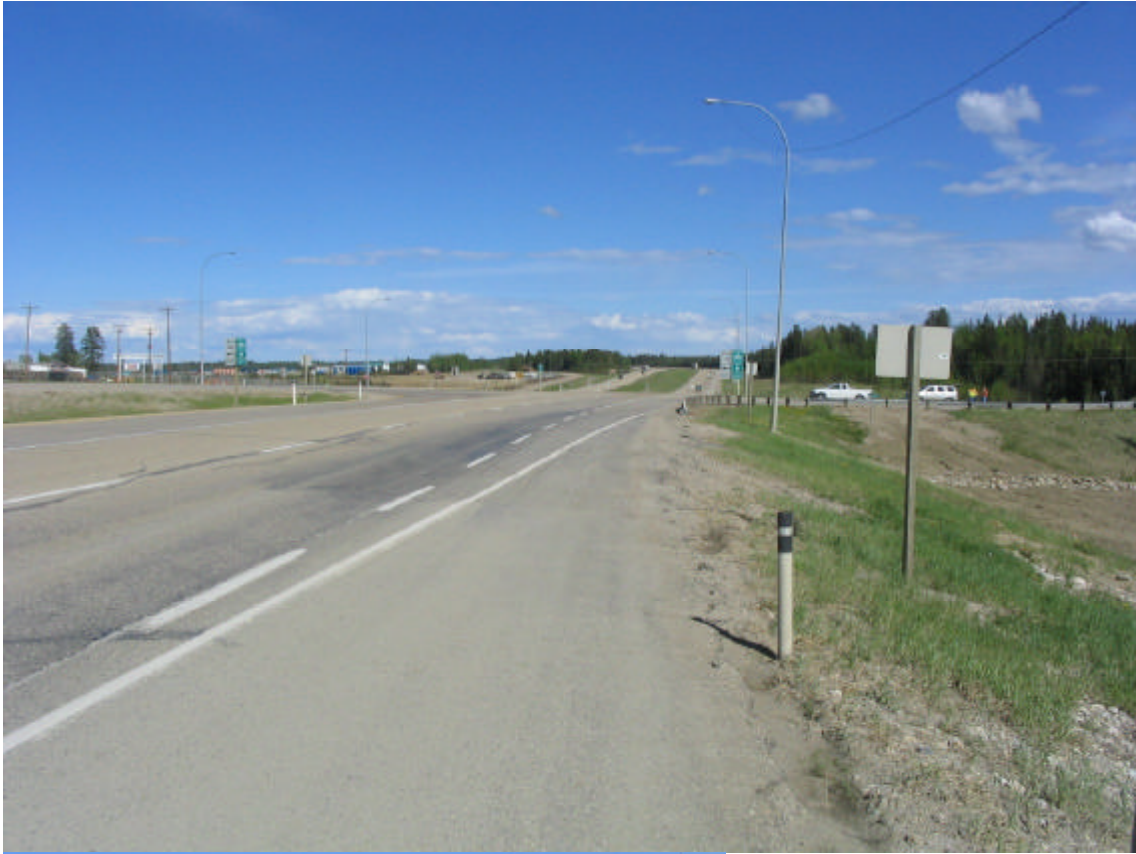
PHOTO 1 AREA OF CRACKS IN PAVEMENT (LOOKING EAST)

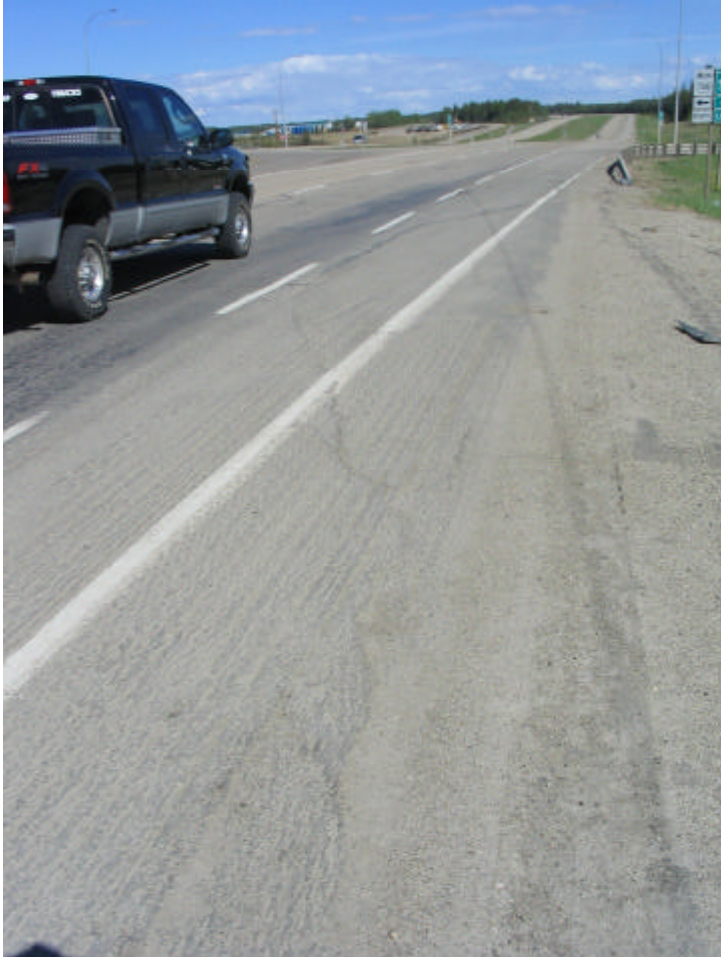
PHOTO 2 CRACK OUTLINING PREVIOUS SCARP LOCATION (LOOKING EAST)

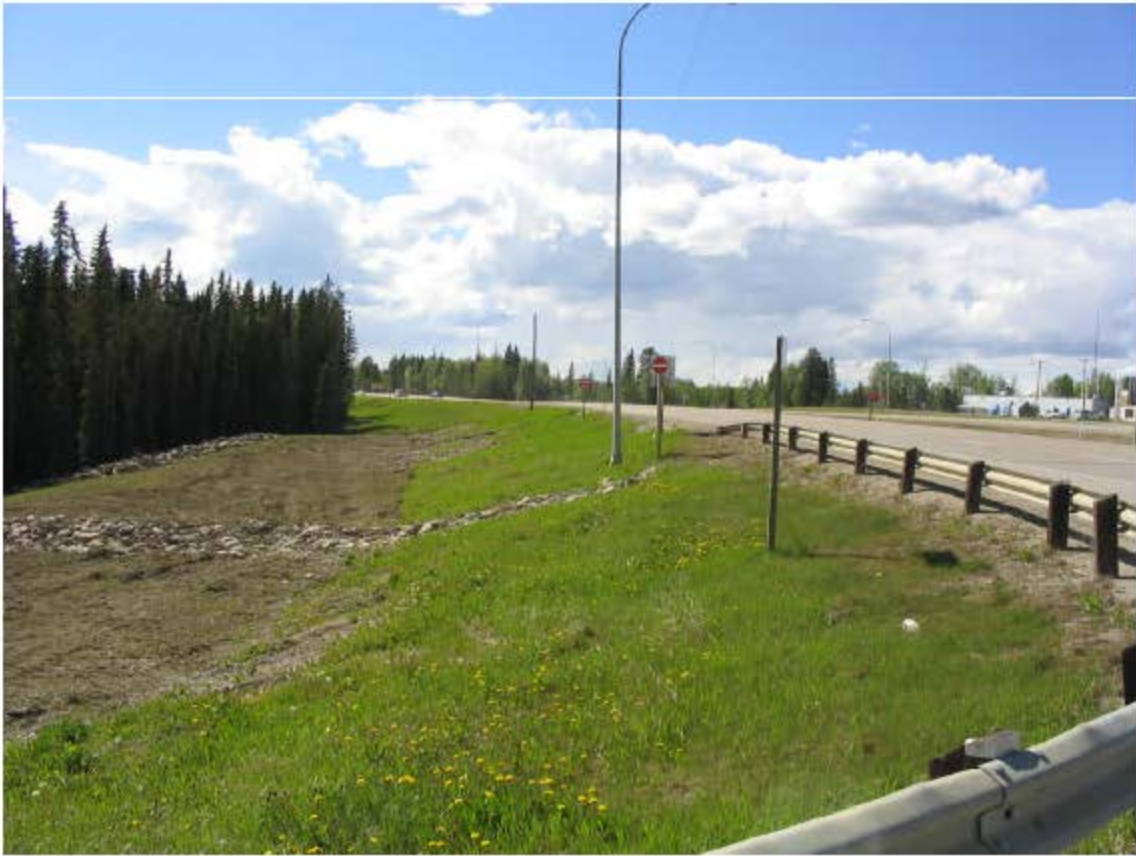
PHOTO 3 LOOKING WEST AT UPPER SLOPE AND TOE BERM

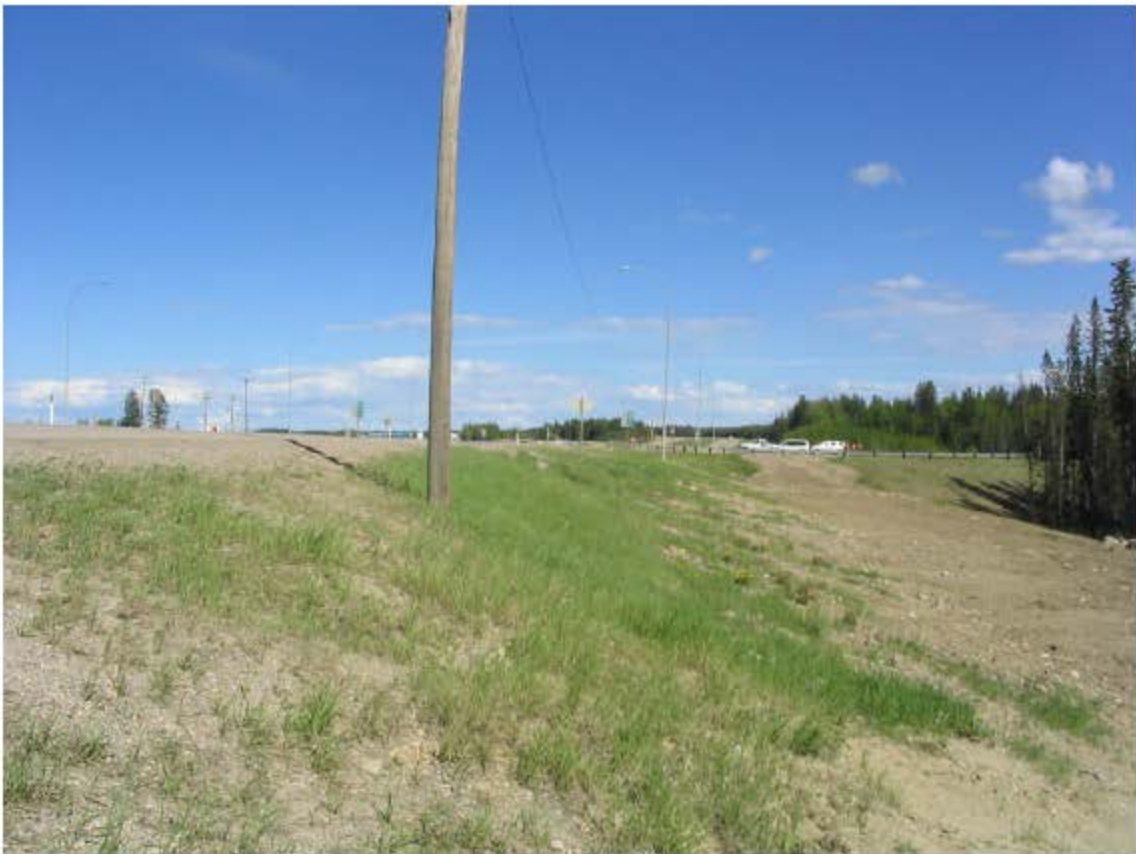
PHOTO 4 LOOKING EAST AT UPPER SLOPE AND TOE BERM

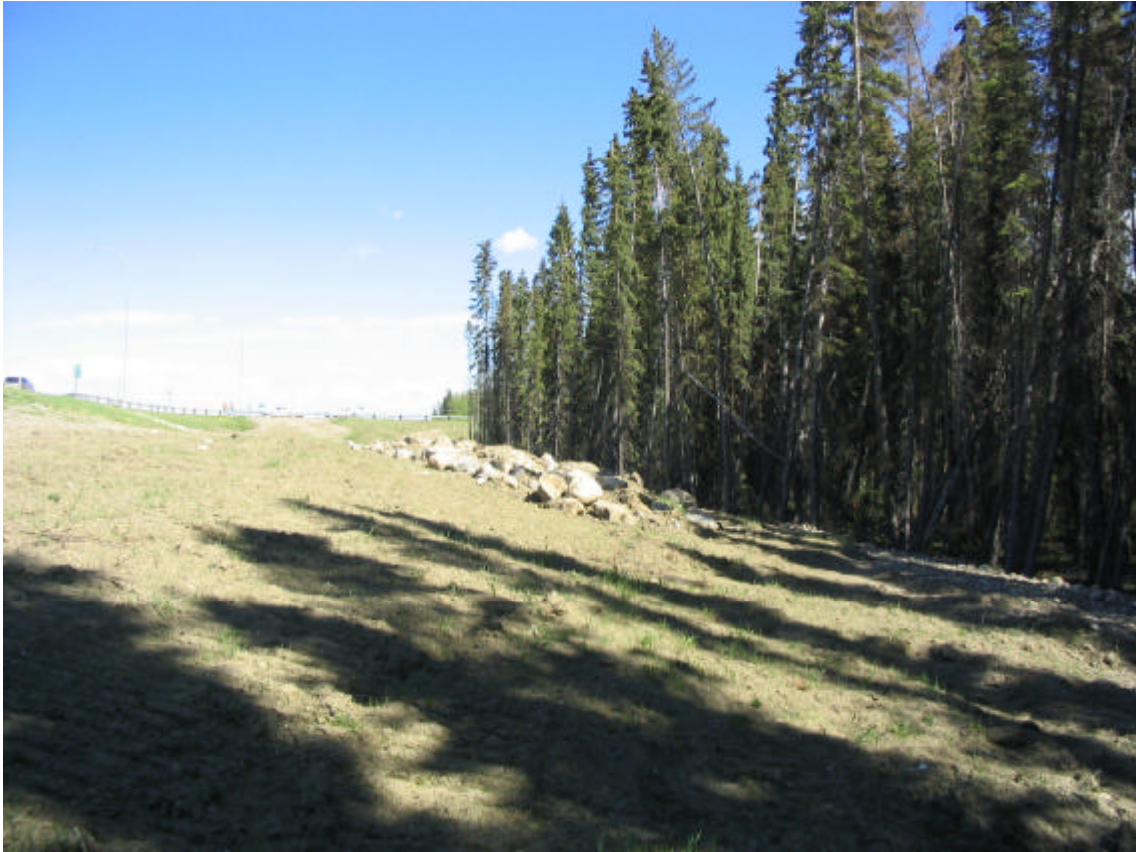
PHOTO 5 LOOKING EAST AT LOWER SLOPE AND RIP RAP FACING

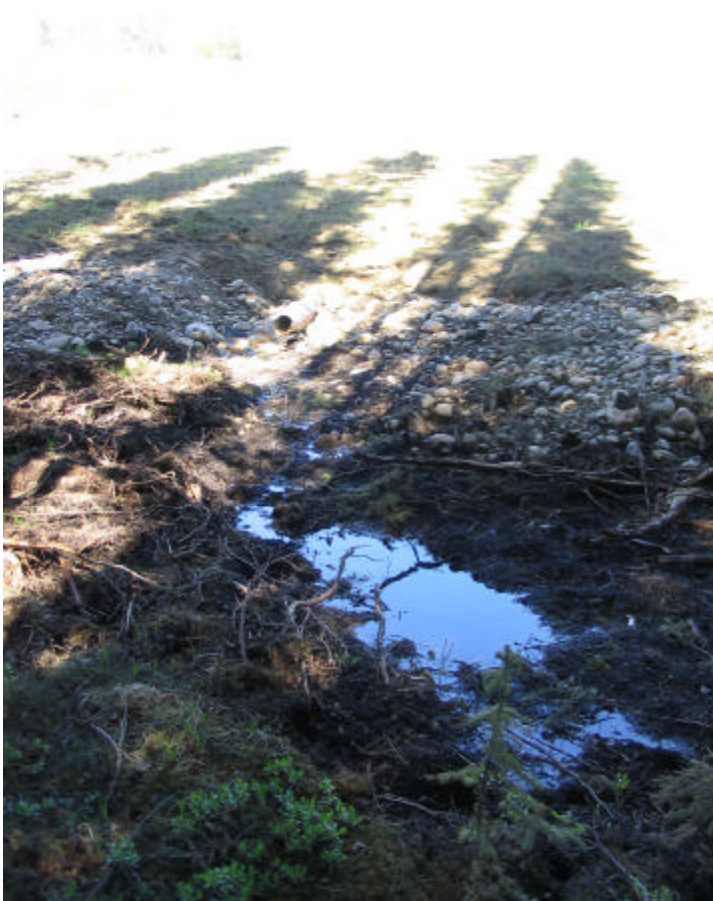
PHOTO 6 OUTFLOW FROM WEST SUBDRAIN OUTLET
