August 25, 2004

File: 15-16-192

**NORTH CENTRAL REGION LANDSLIDE ASSESSMENT
HWY 16:06 EDSON 25TH STREET (NC20)
2004 ANNUAL INSPECTION REPORT**

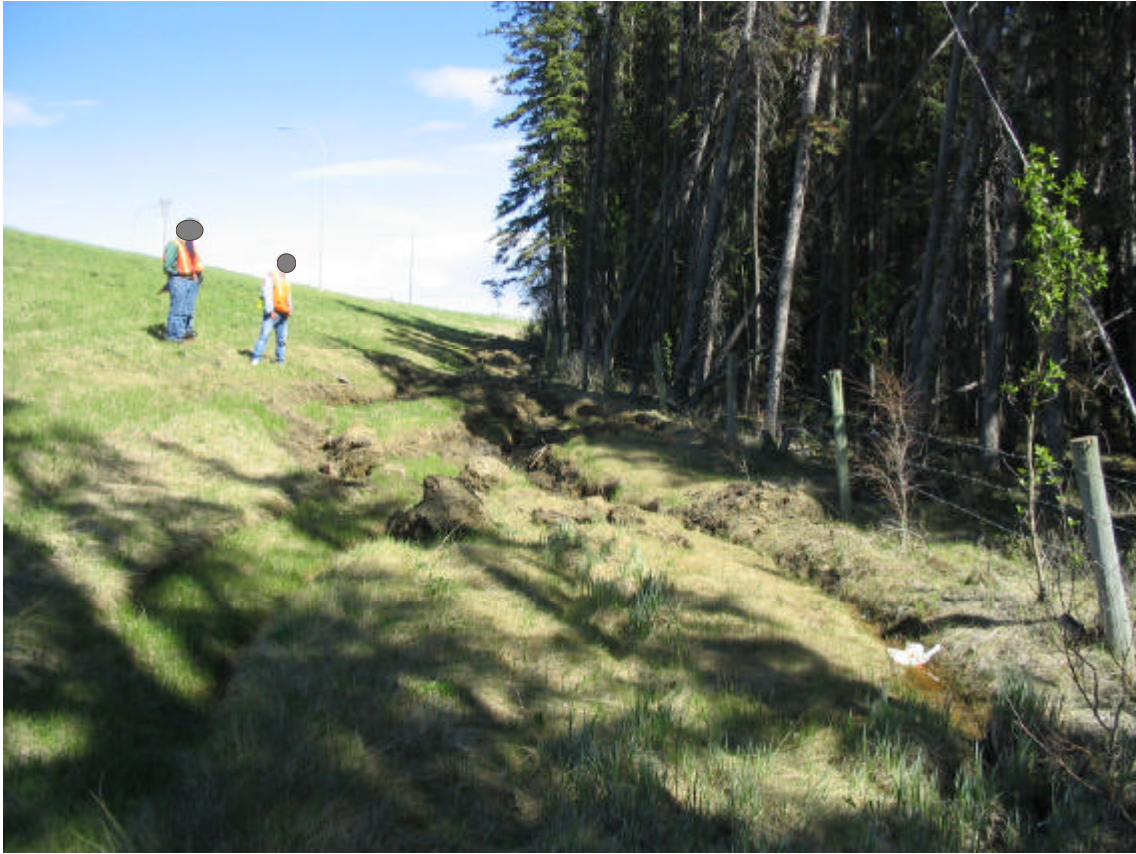
The area of rutted soft ground is located approximately 75 m west of the west end of the toe berm. The ruts extend over a length of about 55 m and are located in the right of way to the north of the existing fence line. There is some pooling of water within the ruts and in the nearby bush area located within the adjacent landowner's property. In addition, there are some trees that are leaning and a few that have blown down in this area.

Based on inspection of the ruts, the near surface soil conditions consist of grass cover over saturated clayey silt. No peat was observed in the rutted zone, however muskeg was noted within the treed area immediately adjacent to (i.e. south of) the rutted zone.

PHOTO 7 RUTTED ZONE WEST OF SLIDE AREA (LOOKING EAST)

The rutted zone located west of the site is located adjacent to an area of natural shallow muskeg terrain, which is normally wet and soft. Similar deposits are located elsewhere in the Edson region and are often associated with a high water table or ponded water at surface. The trees in such areas typically have shallow root penetration and hence are prone to blow-over. As stated previously, no signs of embankment slope instability were noted in this area. Based on these observations, the wet and soft muskeg conditions (including ponded water) and fallen trees within the bush areas adjacent to the rutted zone are expected to be a natural condition and are not related to slope instability or the formation of the ruts in the right of way. It is recommended to backfill the ruts with granular fill, smooth out the area and topsoil/seed to promote revegetation.

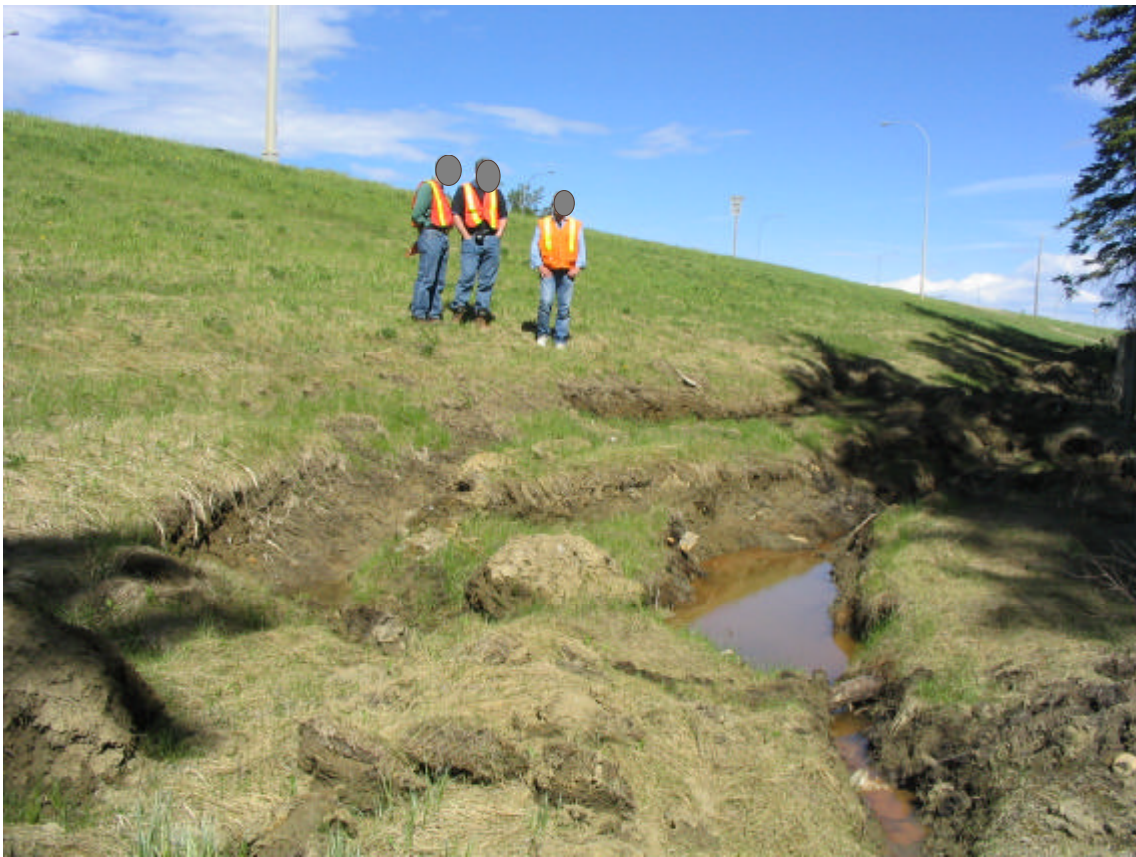
PHOTO 8 PONDED WATER IN RUTS

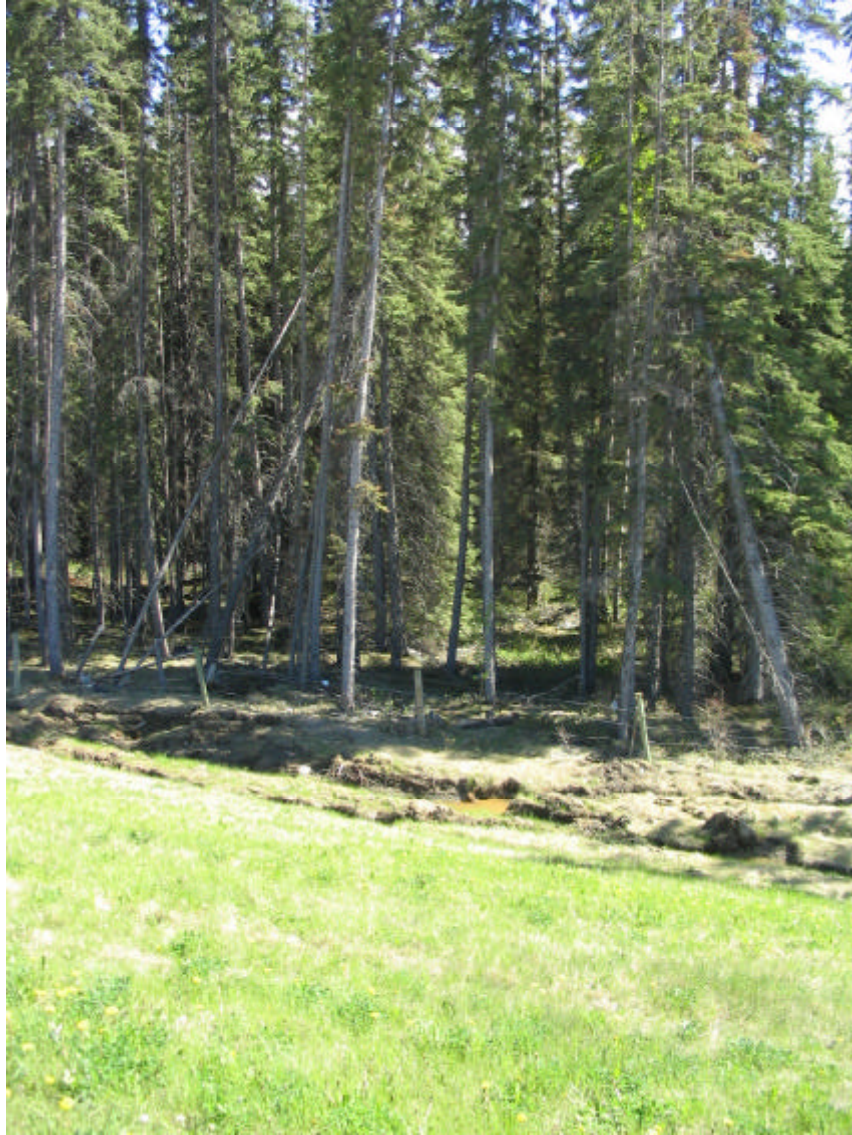
PHOTO 9 MUSKEG AREA AND WIND BLOWN TREES ADJACENT TO RUTTED ZONE (LOOKING SOUTHEAST)
