December 9, 2005

File: 15-85-11

**NORTH CENTRAL REGION GEOHAZARD ASSESSMENT
HWY 16:06 EDSON 25TH STREET (NC20)
2005 ANNUAL INSPECTION REPORT**

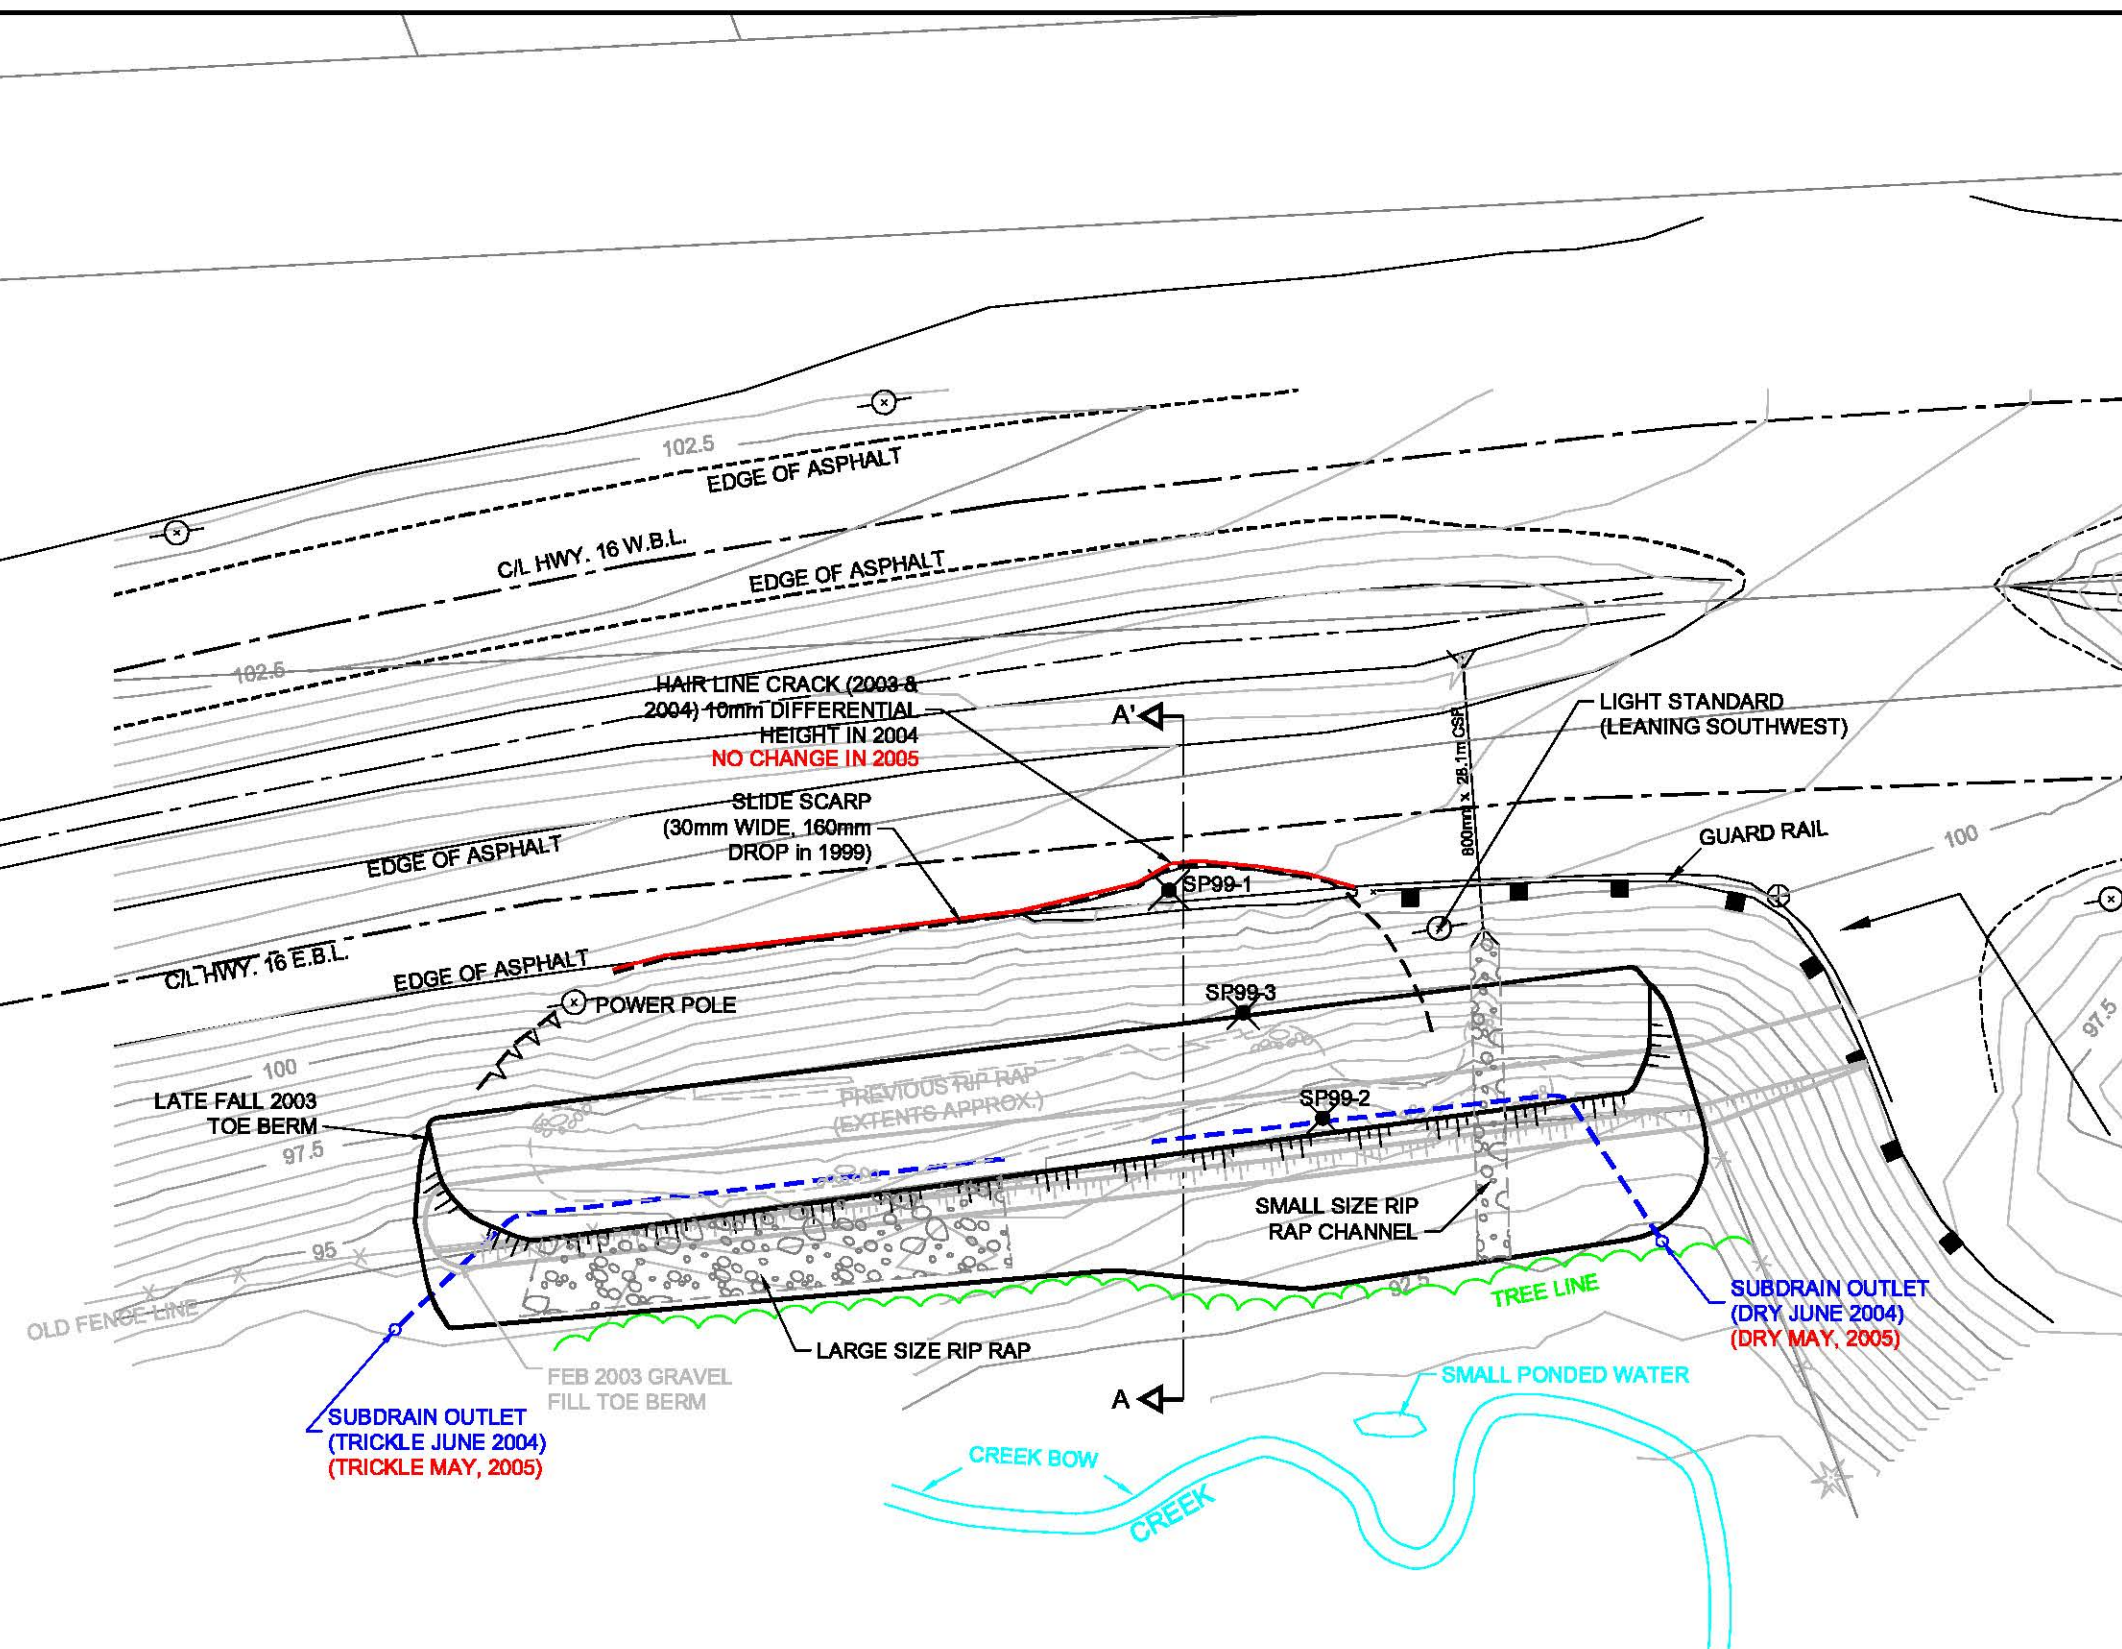
DRAWING No.
FIGURE NC20-1

The following points summarize the observations made during the reconnaissance. The locations of the site features are shown on Figure NC20-1 in Section F. Cross-Section A-A' on Figure NC20-2A included previously in Section F is considered applicable with no changes. Selected photographs taken during the site reconnaissance are attached.

SOFT RUTTED AREA (OBSERVED JUNE 2004) EXTENDS 55M WEST
 NOT REPAIRED AS OF MAY 31, 2005 SITE VISIT

If not already completed, the rutted zone located west of the site should be backfilled with granular fill, smoothed out and topsoil/seed placed to promote revegetation.

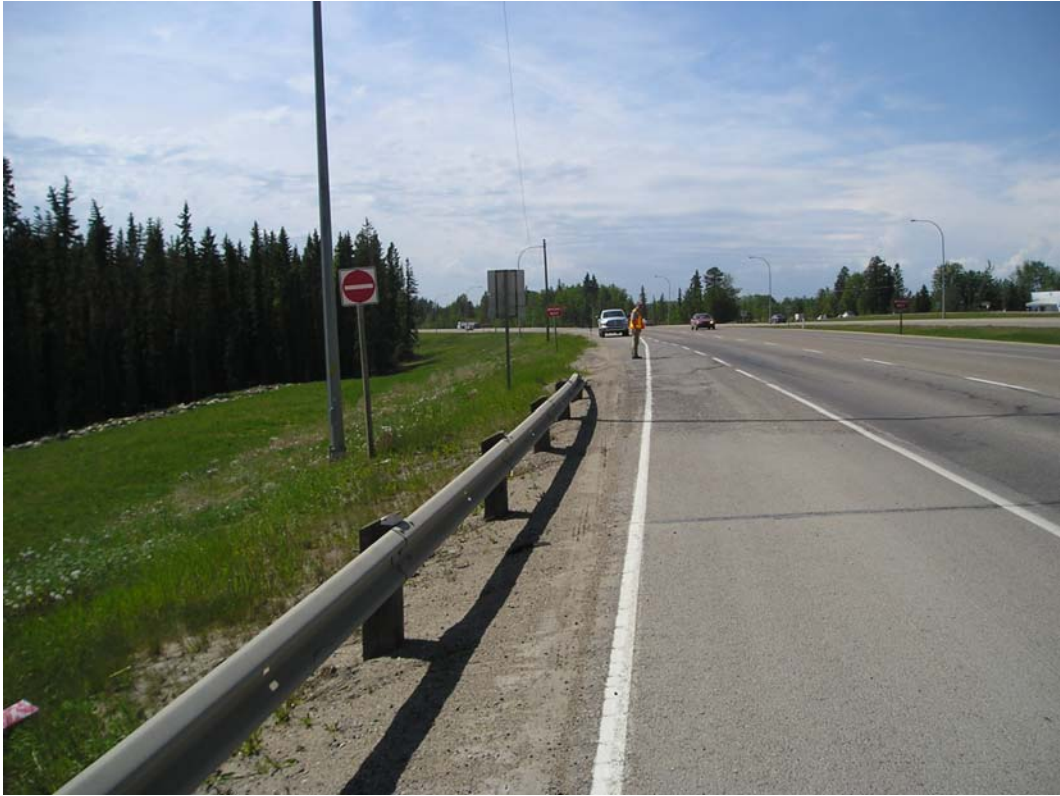
- The crack pattern noted in previous years over a length of about 30 m was still visible in the asphalt pavement within the shoulder and turning lane at this location. The cracking did not extend into the traveling lanes. Up to 10 mm of vertical displacement across the crack was noted in the central portion of the crack length. The crack within the pavement is coincident with the slide scarp observed during previous site visits and has not changed since the last site visit in June of 2004.

Photo 1 - Looking west at pavement distress area.

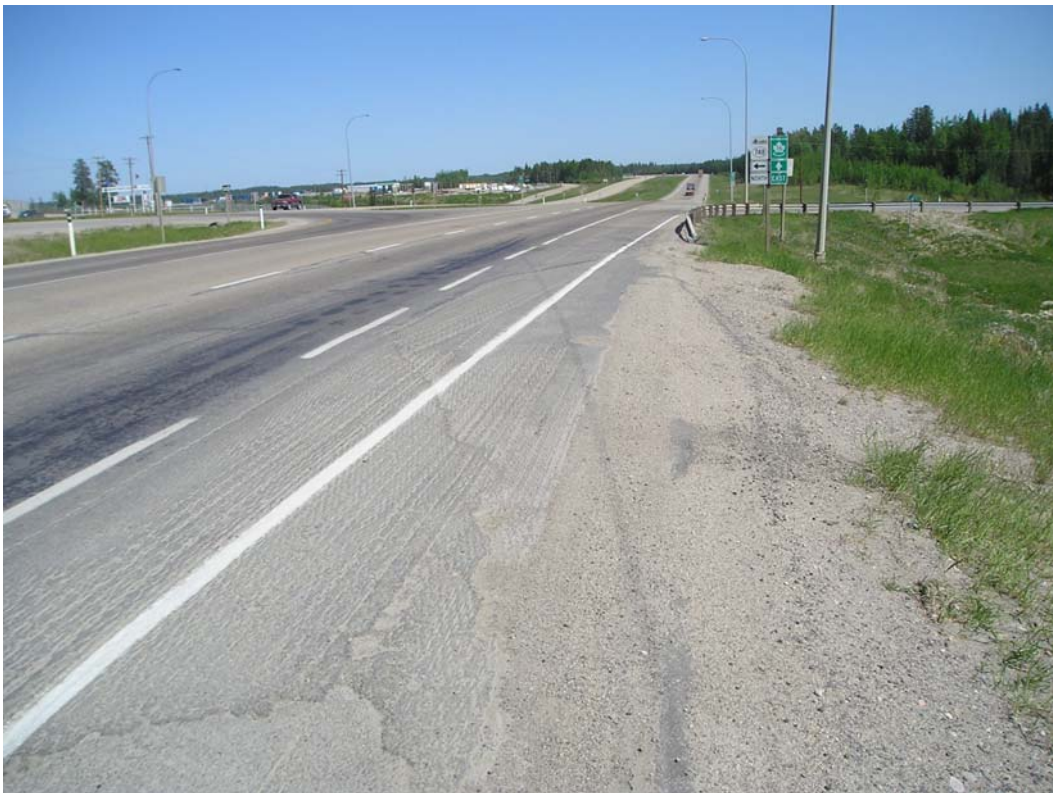
Photo 2 – Looking east at main crack location.

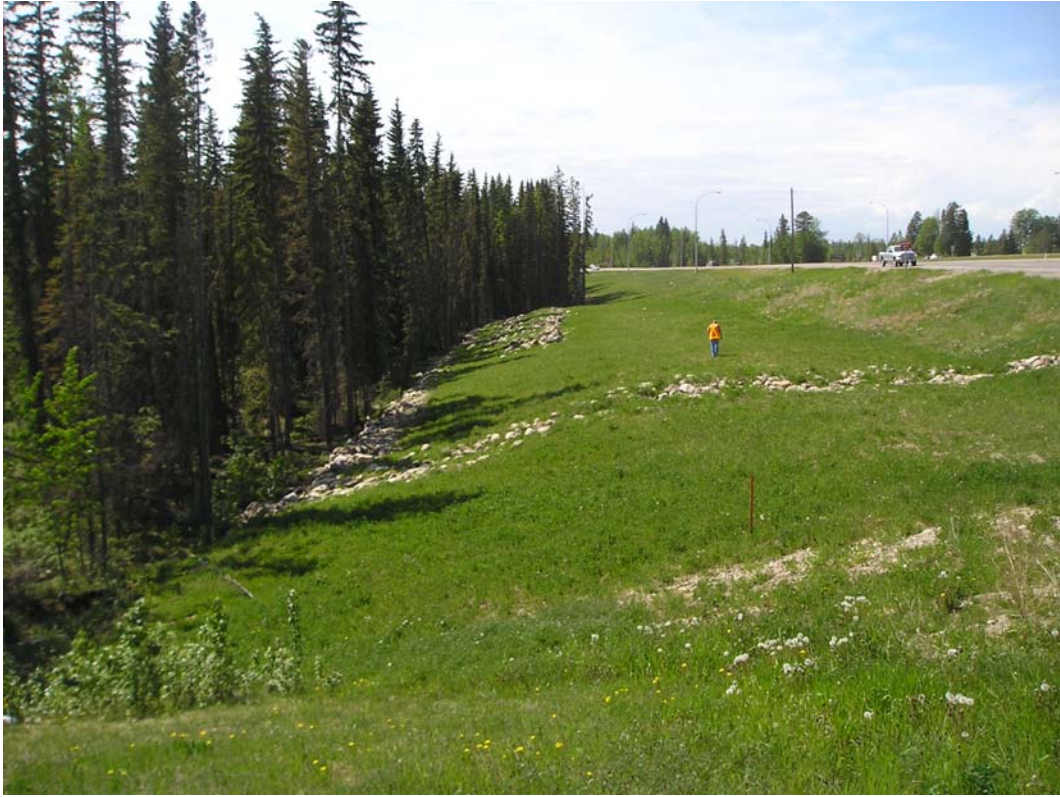
- No signs of slope movement were noted on the side slope, new toe berm, or in the area beyond (i.e. south of) the current toe of the slope. Vegetation cover on the berm area consisted of grasses and provided significantly better cover than that observed last year. No significant erosion was noted on the berm surface.

Photo 3 – Berm and toe area (looking west).
