November 28, 2008

File: 15-16-218

**NORTH CENTRAL REGION EDSON AREA GEOHAZARD ASSESSMENT  
HWY 22:32 km 32.3 SOUTH OF MAYERTHORPE – NC63  
2008 ANNUAL INSPECTION REPORT**

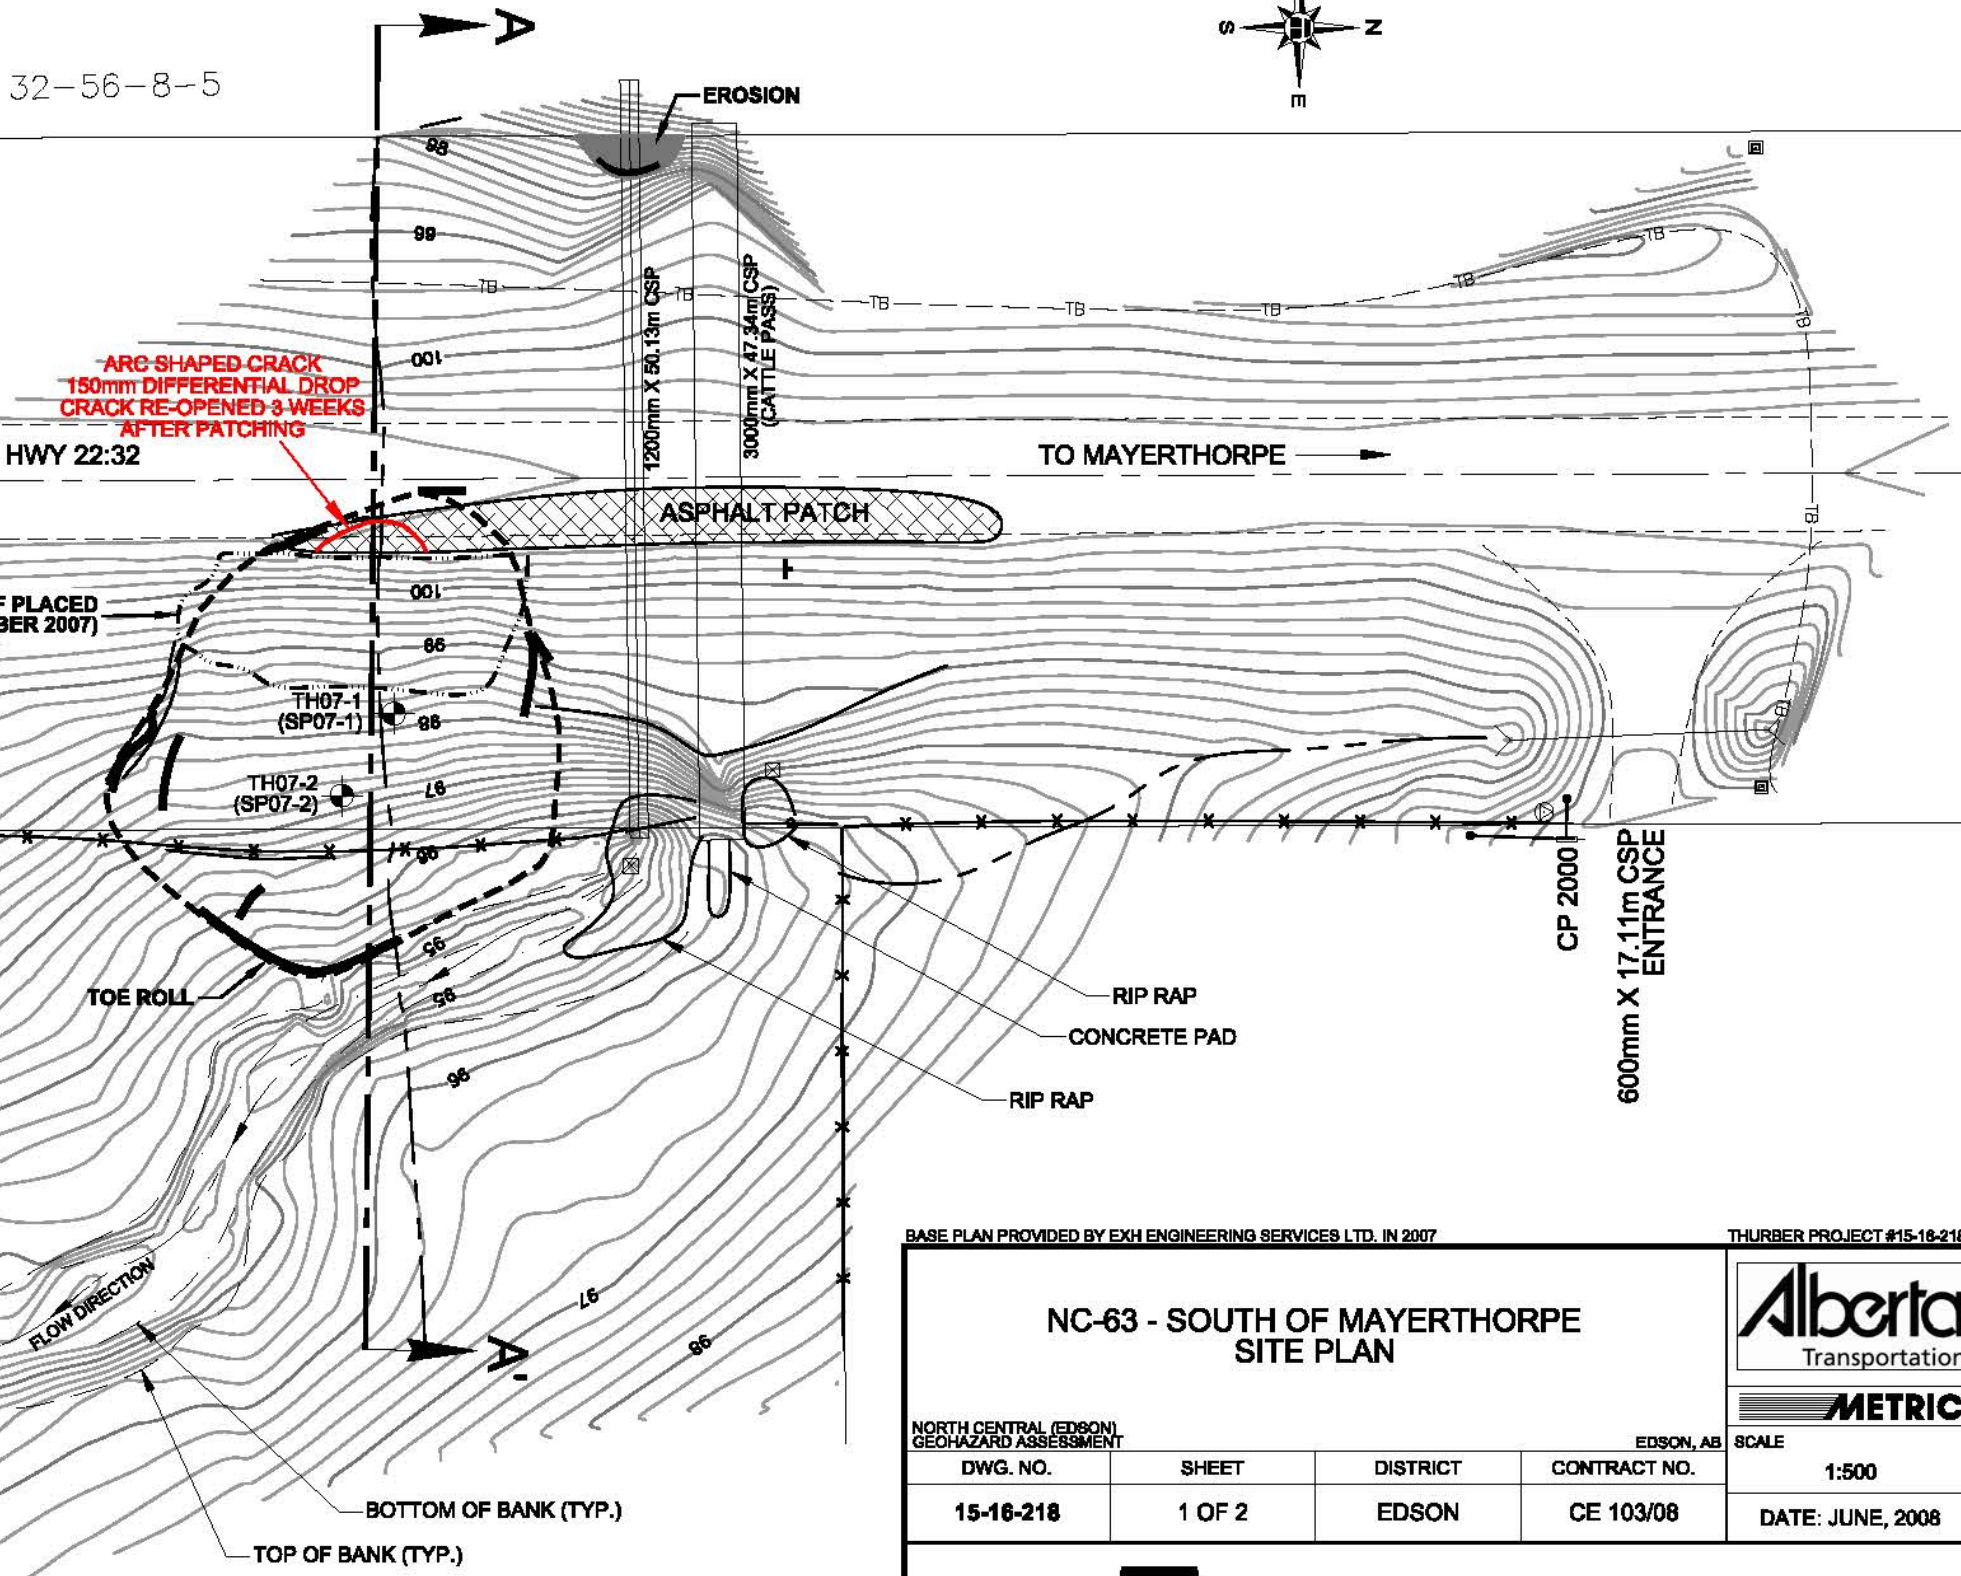
<b>NC-63 - SOUTH OF MAYERTHORPE SITE PLAN</b>				 <b>METRIC</b>
NORTH CENTRAL (EDSON) GEOHAZARD ASSESSMENT				
DWG. NO.	SHEET	DISTRICT	CONTRACT NO.	SCALE
15-16-218	1 OF 2	EDSON	CE 103/08	1:500
				DATE: JUNE, 2008

The changes in condition since last year's call-out are shown on the attached site sketch plan (Figure NC63 sheet 1 of 2). A cross section through the main portion of the slide is presented in Figure NC63 sheet 2 of 2 and selected photographs taken during the visit are also attached for inclusion in Section F.

JUNE, 2008 OBSERVATIONS SHOWN IN RED

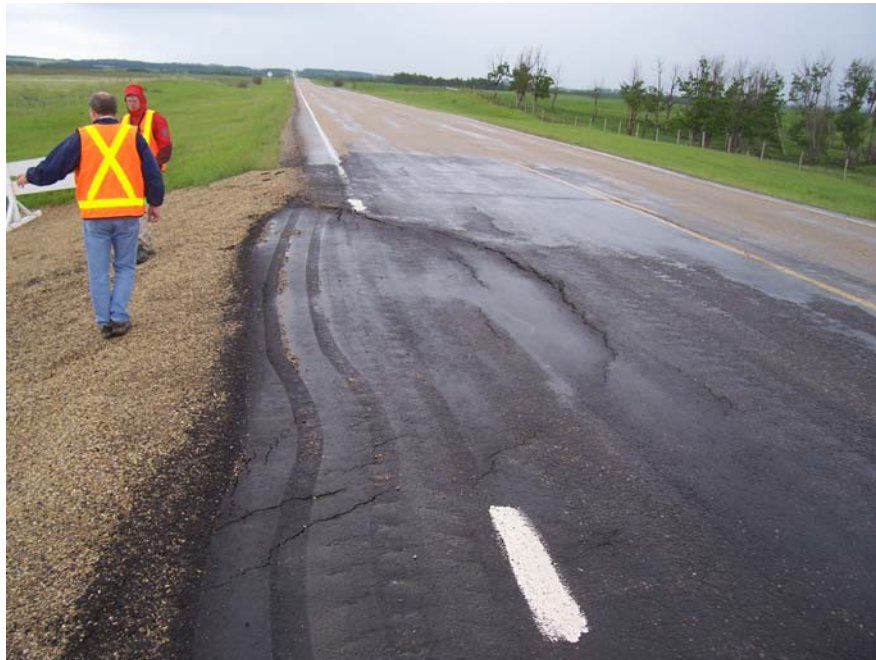
According to Mr. Swan the area was patched in the fall of 2007 and pavement cracks were re-appearing about three weeks after the patching.

The slide appeared to be very active. At the time of the site visit there was a well defined arc shaped crack with a differential drop across the crack of approximately 150 mm. No significant change in the toe roll was observed.

Photo 1 - View of the distressed area.

Until full pile wall mobilization has occurred pavement cracking is expected to appear and the maintenance contractor should fill cracking periodically to reduce water infiltration into the pavement. Depending on the width of the cracking pavement re-patching may be required to keep a smooth road surface.

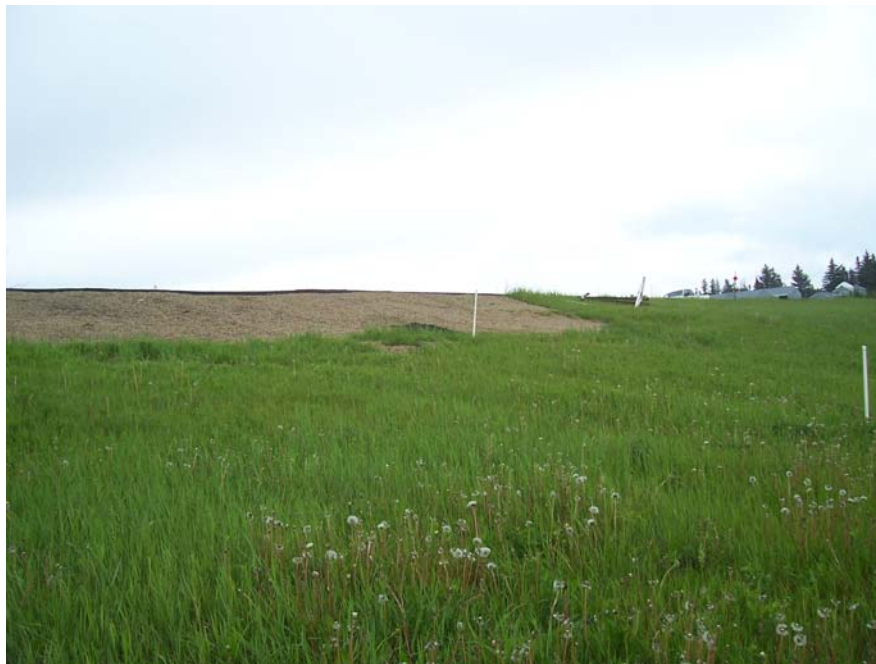
Photo 2 – View of the side slope below the slide area.

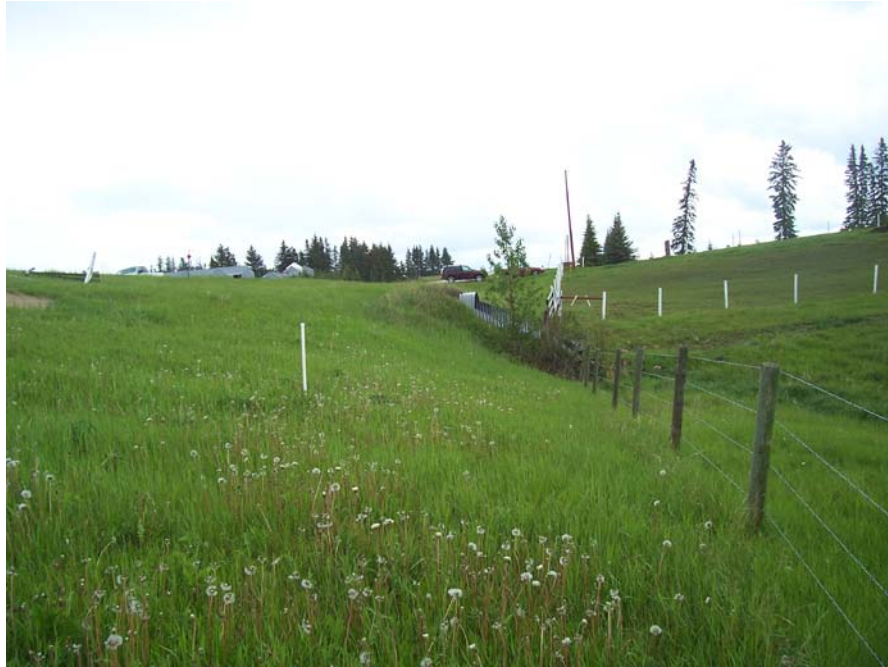
Photo 3 – View of the slide toe roll.
