GEOHAZARD ASSESSMENT PROGRAM

NORTH CENTRAL REGION – EDSON

2009 INSPECTION

Site Number	Location	Name	Hwy	km
NC63	S. of Mayerthorpe, AB	South of Mayerthorpe	22:32	32.3
Legal Description		UTM Co-ordinates		
SW¼ 33-56-8 W5M		11U E 622123.7	N 5971086.9

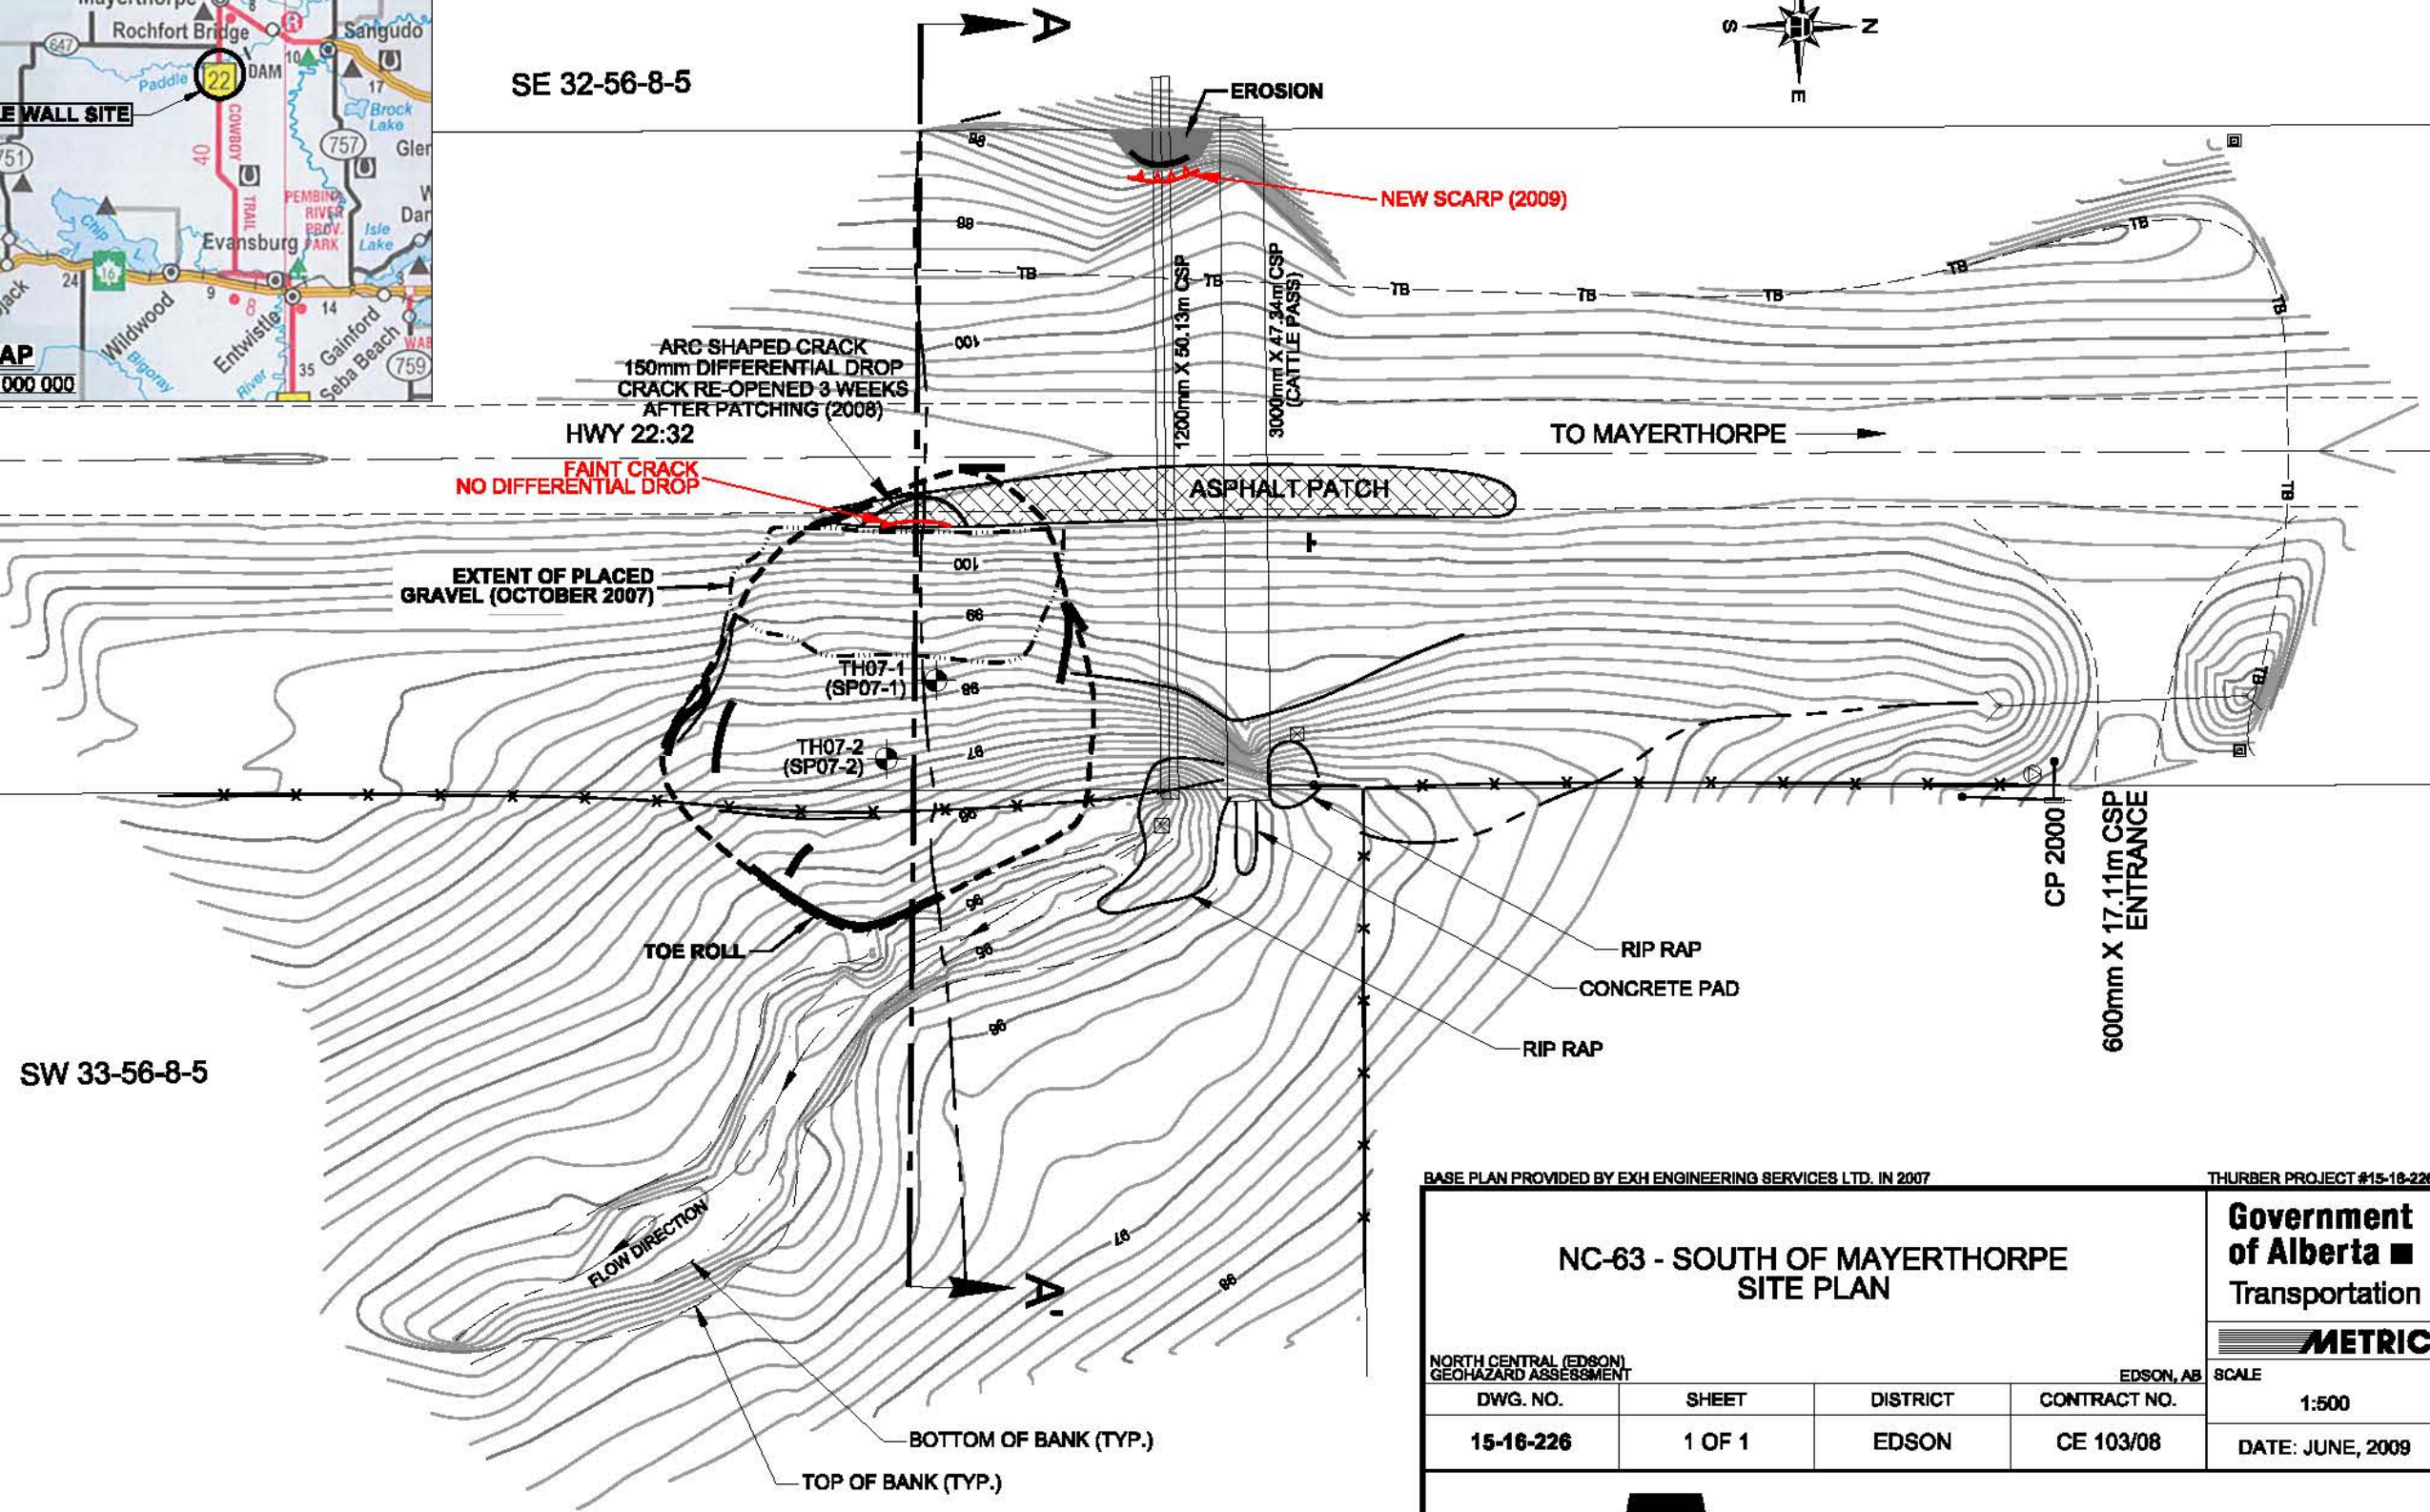
FIGURE NC63

Assessment (Refer to Figure NC63):
 The remediation repair is performing well and no signs of pavement or sideslope distress were observed during this site visit. A faint arc shaped crack was noted on the pavement, however this crack was expected to occur until the pile wall reaches its final equilibrium position.
 There is currently a small slump occurring above the existing culvert inlet that is retrogressing.

JUNE, 2009 OBSERVATIONS SHOWN IN RED

Recommendations:
 This site may be discontinued from the program.
 Consideration should be given to repair the culvert slump now while it is small and is relatively inexpensive to repair. The estimated cost to repair the slump is \$ 5,000, which could consist of removing the failed soil, replacing it with well compacted medium plastic clay and readjusting the riprap protection at the inlet.

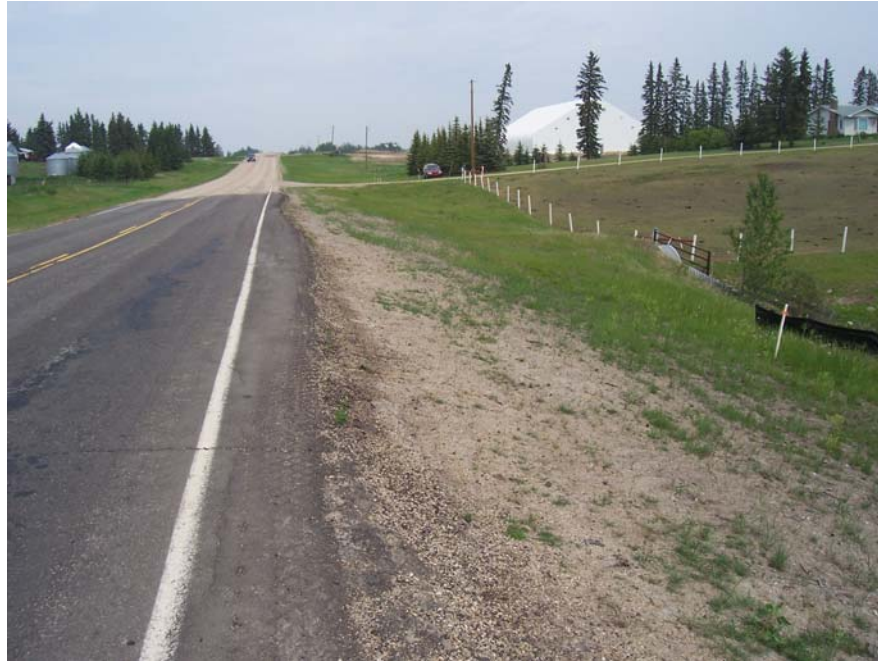
Site general view looking north.

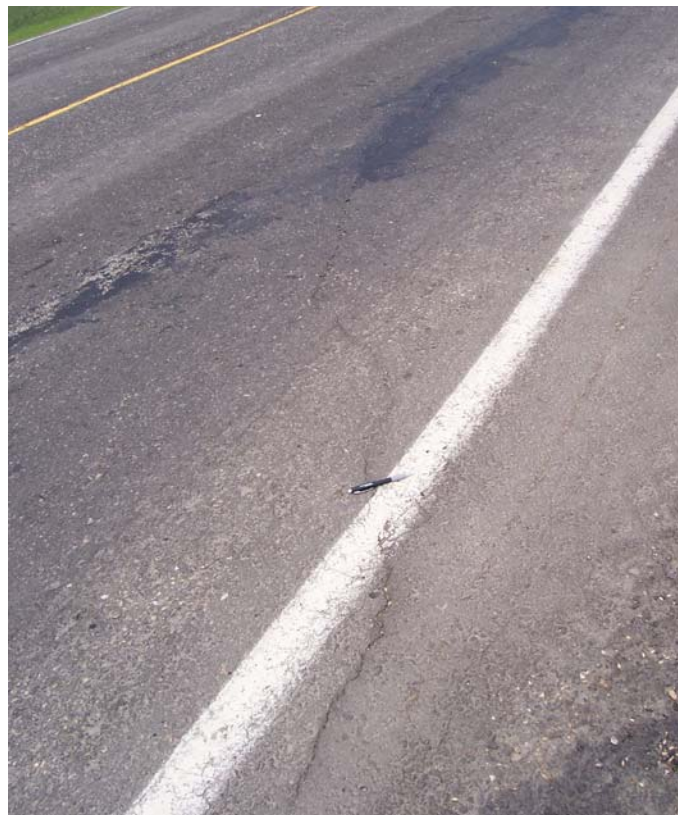
Faint pavement crack with no differential drop.

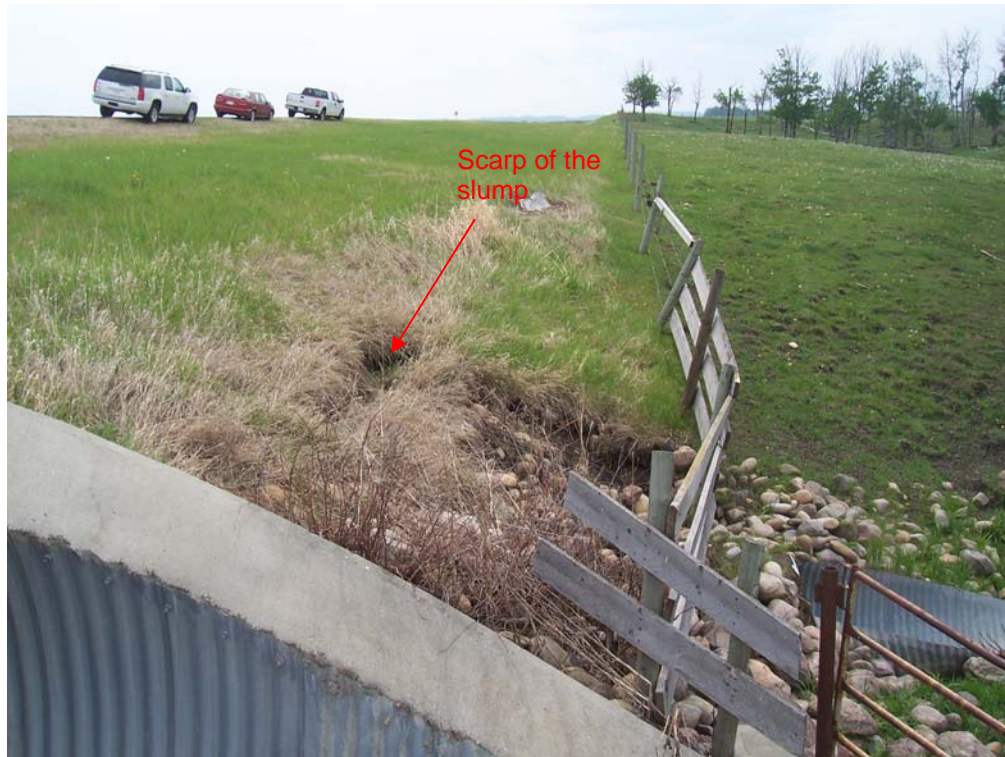
Culvert inlet slump.
