<b>SITE NUMBER AND NAME:</b> NC105 – Hwy 32:10 Backslope Slump	<b>HIGHWAY AND KM:</b> 32:10, km 18.943	<b>PREVIOUS INSPECTION:</b> N/A	<b>CURRENT INSPECTION:</b> June 17, 2022
<b>LEGAL DESCRIPTION:</b> SW 26-58-13-W5M	<b>NAD83 COORDINATES:</b> UTM11U 5988362N, 576370E		<b>RISK ASSESSMENT:</b> PF: 5 CF: 2 Total: 10
<b>AVERAGE ANNUAL DAILY TRAFFIC (AADT):</b> 1,790 (2021)		<b>CONTRACTOR MAINTENANCE AREA (CMA):</b> 508

2022 Site Inspection Photos at NC105

Client/Project: Alberta Transportation  
 Geo/Cad Monitoring Program  
 NC105  
 123315222

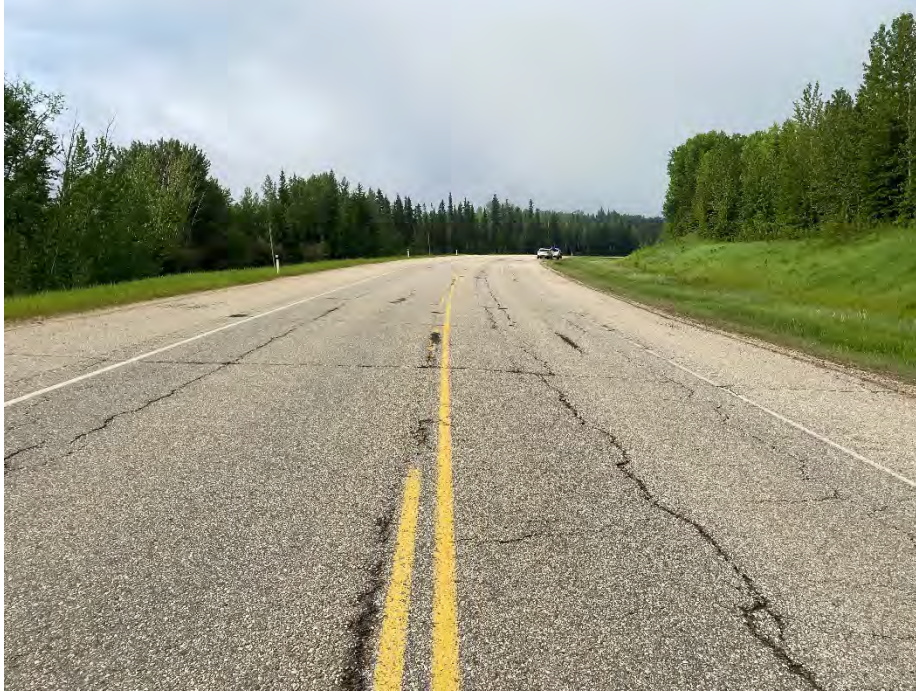
**Photo 1:** Pavement cracks along Highway 32, near slope failure. Looking south.

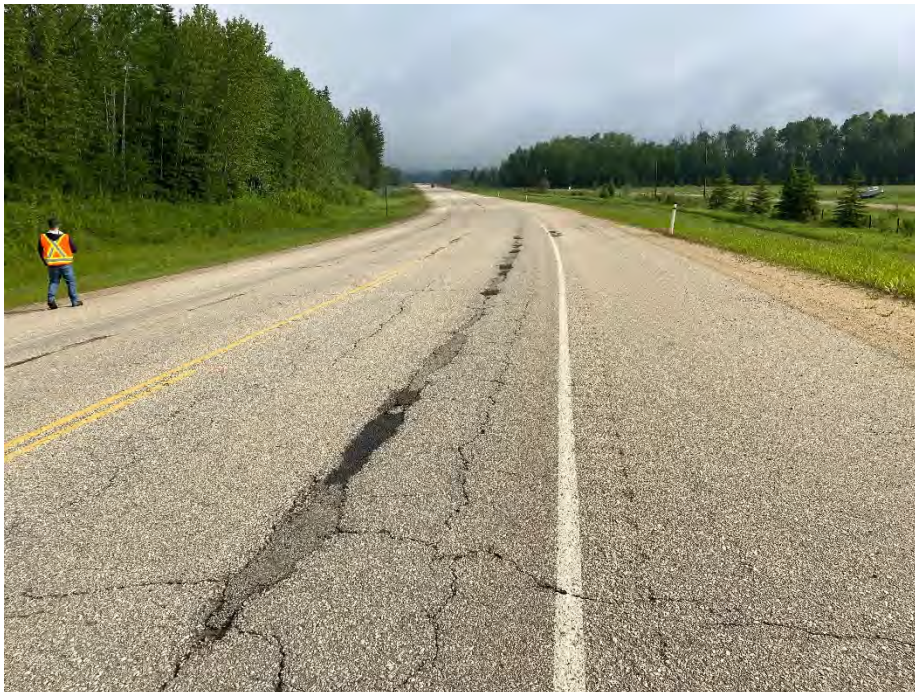
**Photo 2:** Pavement cracks along Highway 32, north of slope failure. Looking north.

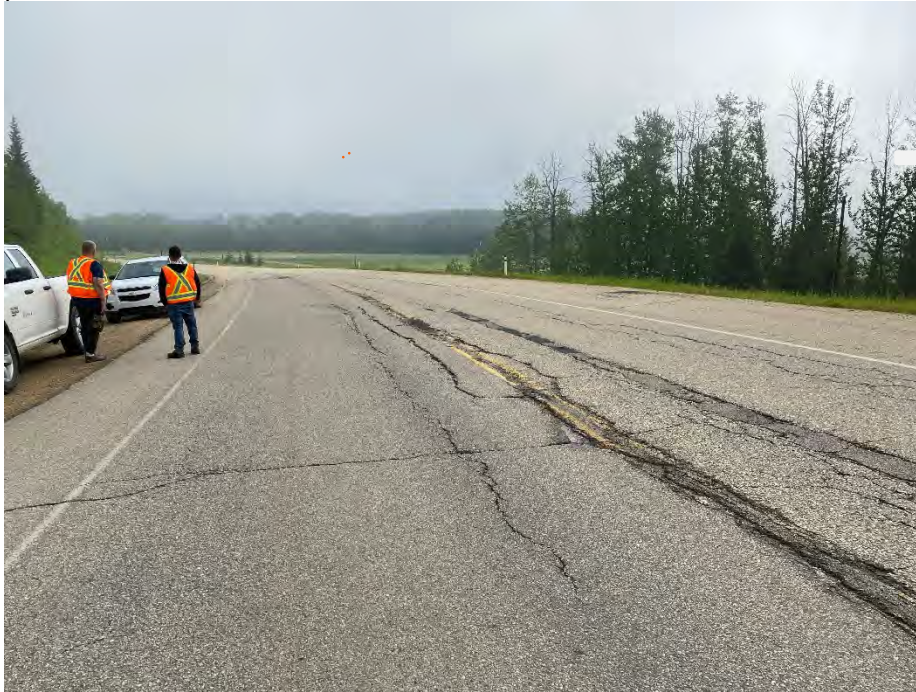
**Photo 3:** Pavement cracks along Highway 32, north of slope failure. Looking northeast.

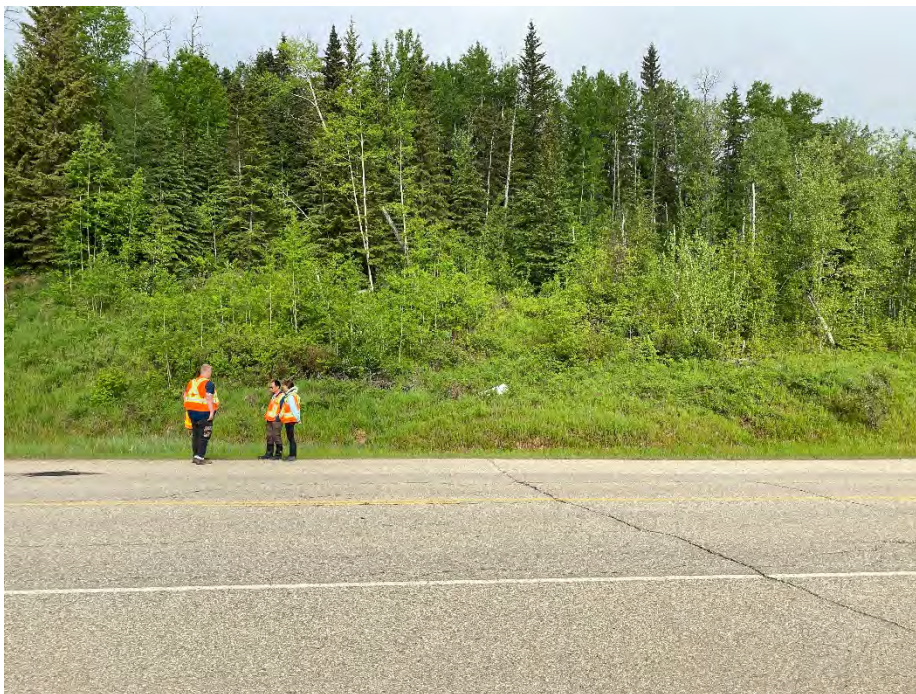
**Photo 4:** Slope failure. Looking west.

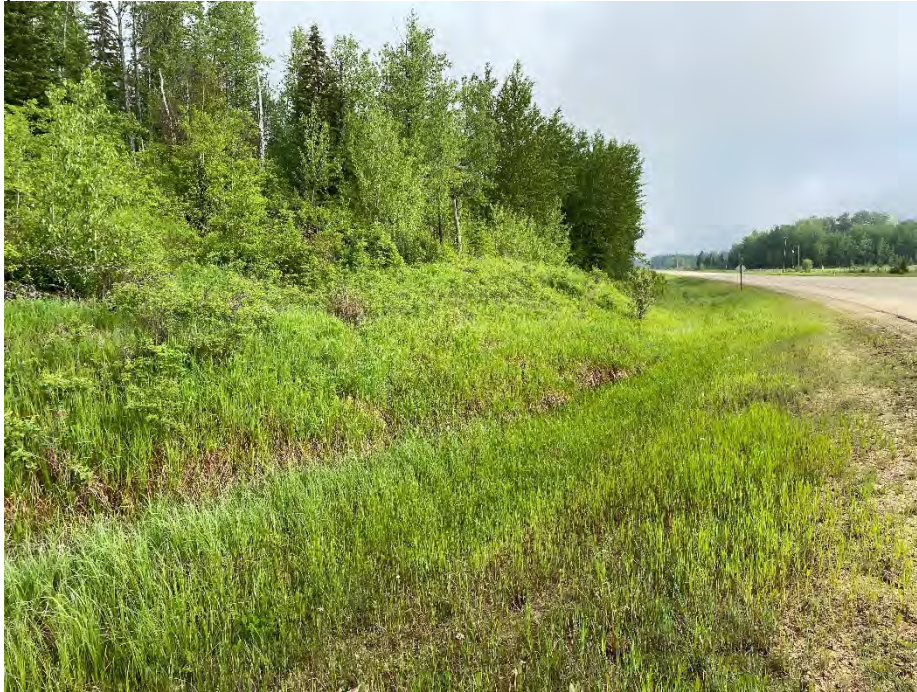
**Photo 5:** South side of slope failure. Looking north.

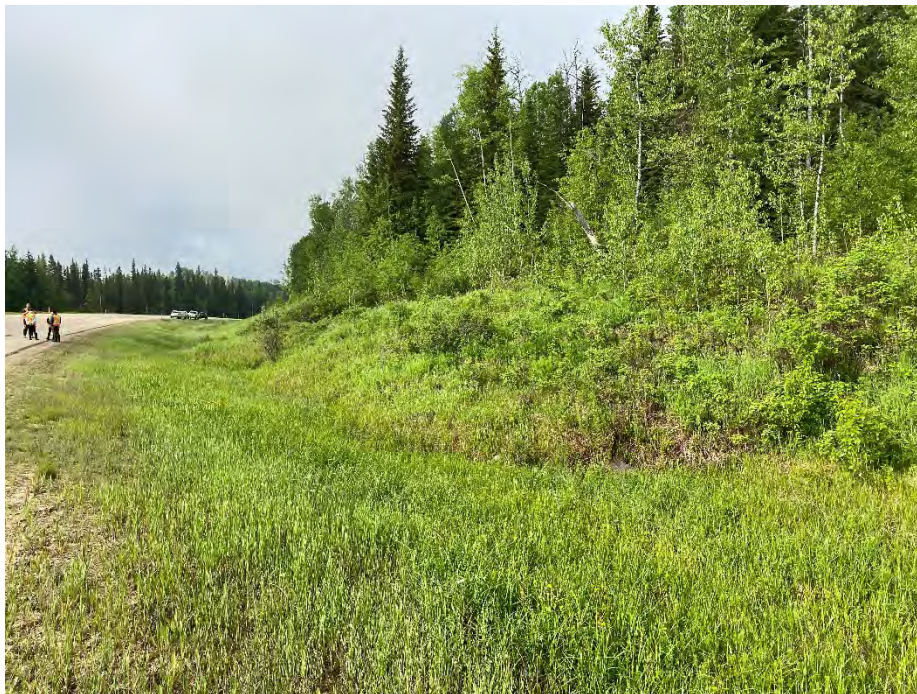
**Photo 6:** North side of slope failure. Looking southwest.
