December 9, 2005

File: 15-85-11

**NORTH CENTRAL REGION GEOHAZARD ASSESSMENT
HWY 32:10 km 33.6 SELECT CONTROLS SUBSIDENCE (NC45)
CALL OUT INSPECTION REPORT**

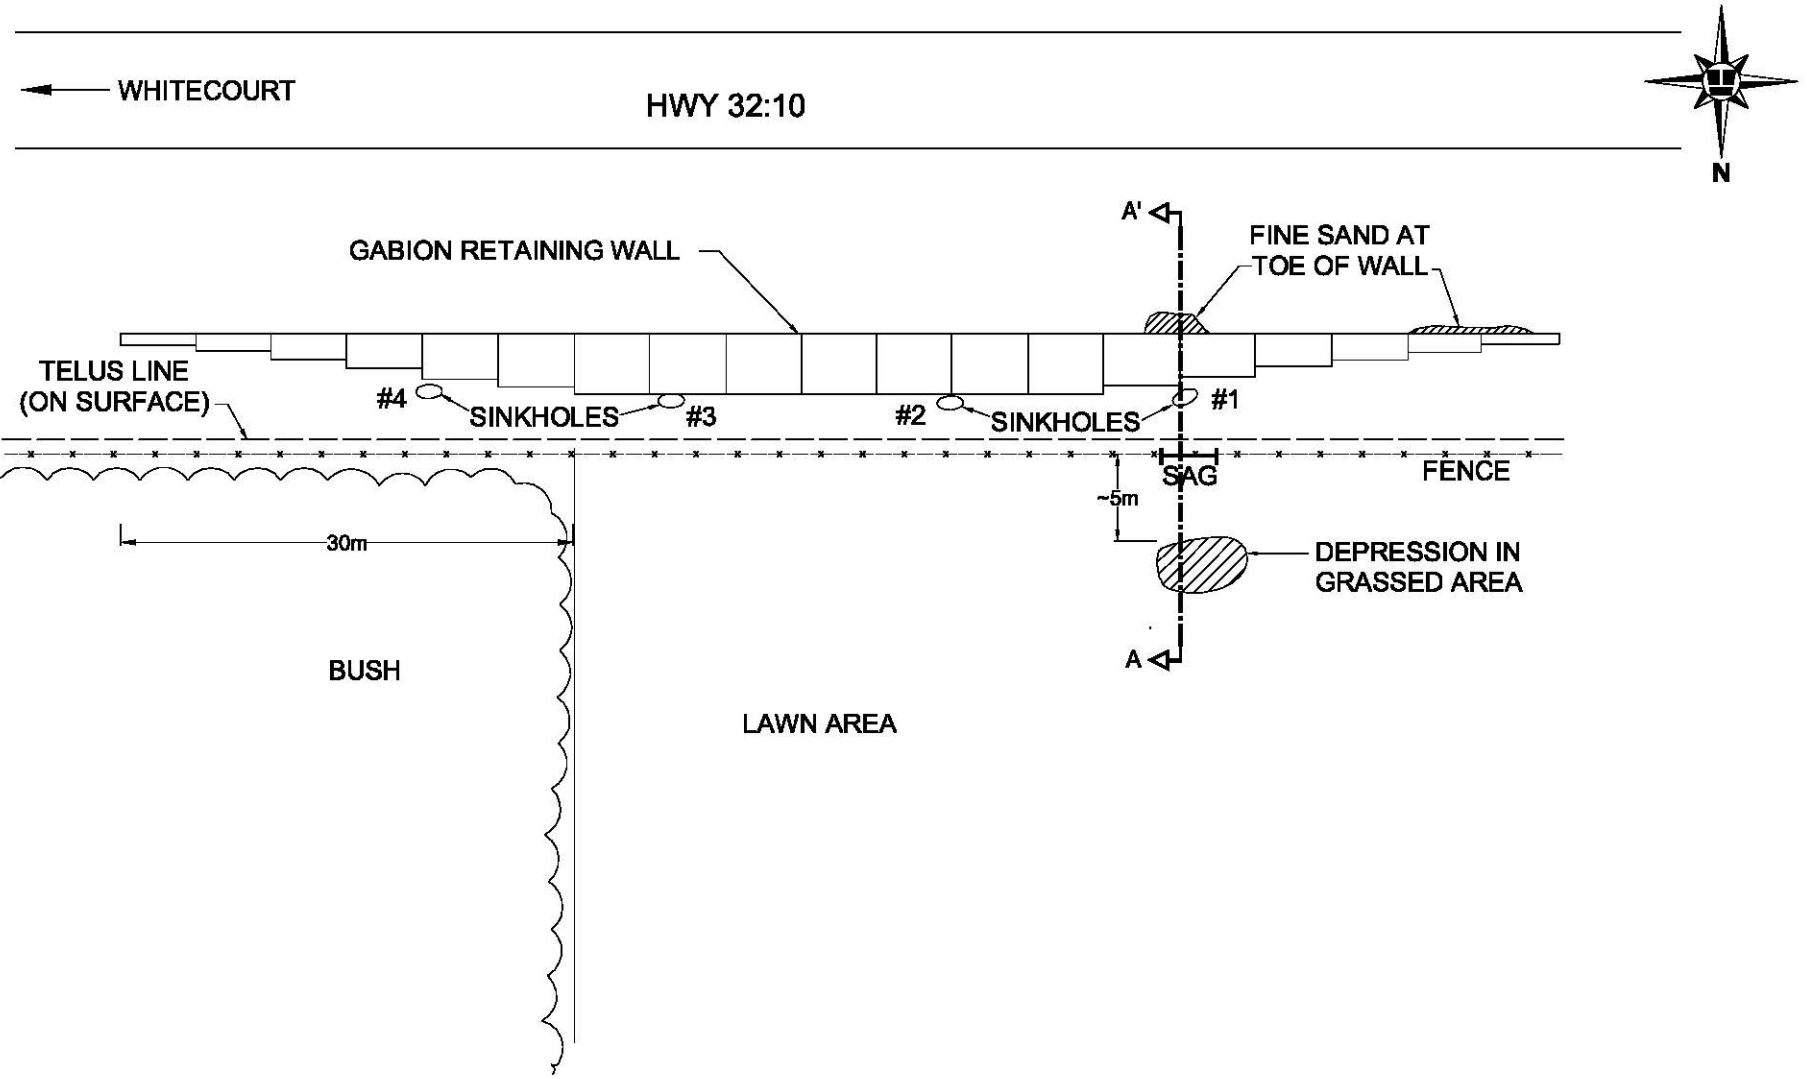
NORTH CENTRAL GEOHAZARD ASSESSMENT		HWY. 32:10 km 33.8 SELECT CONTROLS SUBSIDENCE	
ENGINEER: D.J.L.	DRAWN: C.M.H.	APPROVED:	
DATE: DECEMBER, 2005	SCALE: APPROX. 1:500	DRAWING No. FIGURE NC45-1	REV.:

- Four sink holes were noted in the soil immediately behind the wall, located approximately as shown on the site plan. Sinkhole #1 was the largest, with approximate dimensions of 1 m x 1 m x 0.65 m deep. Sinkhole #3 was about 0.4 m deep and Sinkholes #2 and #4 were smaller and somewhat shallower. A zone of fine sand was noted at the toe of the wall adjacent to Sinkhole #1, and also along a zone of the toe of the west end of the wall as shown approximately on the drawing. Other smaller sand zones were noted along the toe of the wall but are not shown on the drawing. These sand deposits appeared to have come from inside the wall relatively recently (i.e. Spring of 2005).

- A depression was noted in the lawn area covering an area approximately 15 m², located approximately as shown on the site plan. The depression was up to about 100 mm lower than the surrounding ground surface.

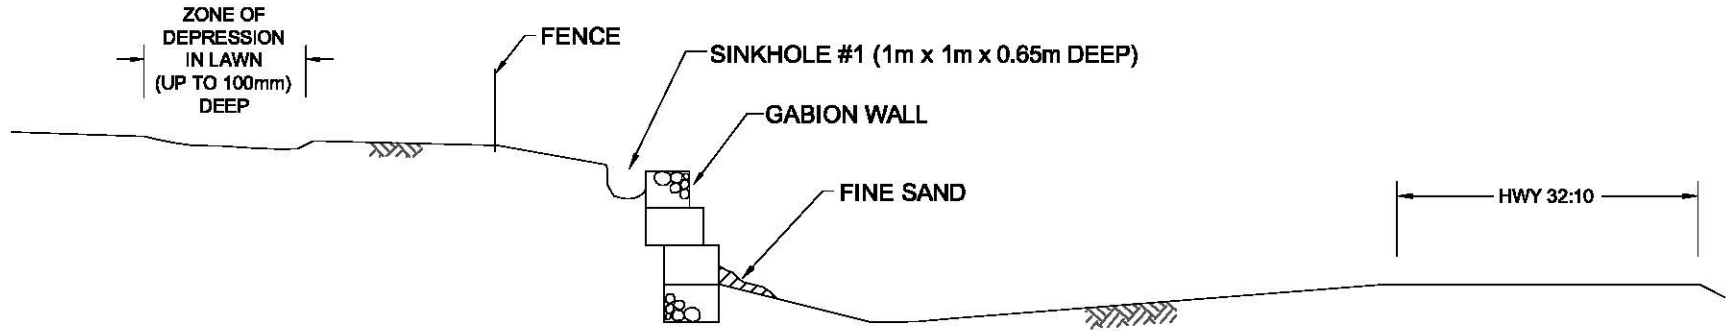
EXISTING PROFILE - CROSS-SECTION A-A'
(APPROX. 1:200)

The following points summarize the observations made during the reconnaissance. Site features are shown on the site plan (Figure NC45-1), attached for inclusion in Section F. A cross-section through the wall and subsidence feature is provided in Figure NC46-2. Selected photographs taken during the site reconnaissance are attached.

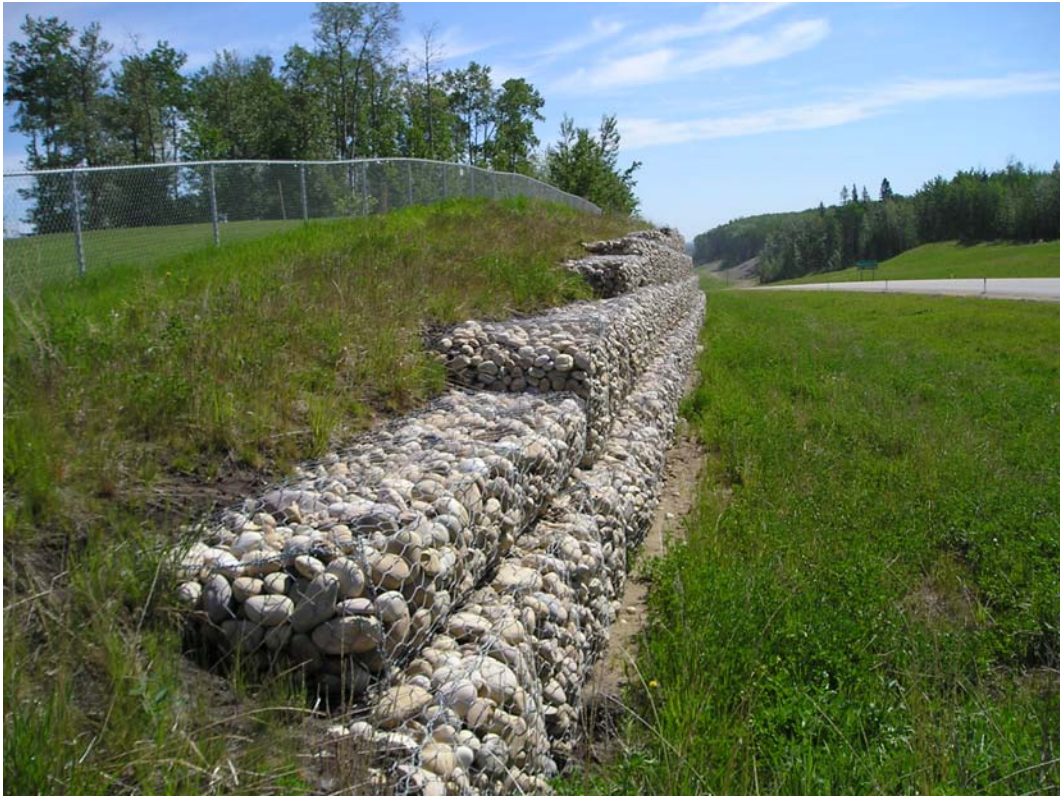
- The gabion wall was approximately 95 m long and 3 m high at its highest point. The wall appeared in good shape from a structural standpoint; no sags or bulges were noted along the top or face of the structure. A chain link fence exists behind the wall approximately 4 m to 5 m from the gabion top.

Photo 1 – Looking east at west end of gabion wall.

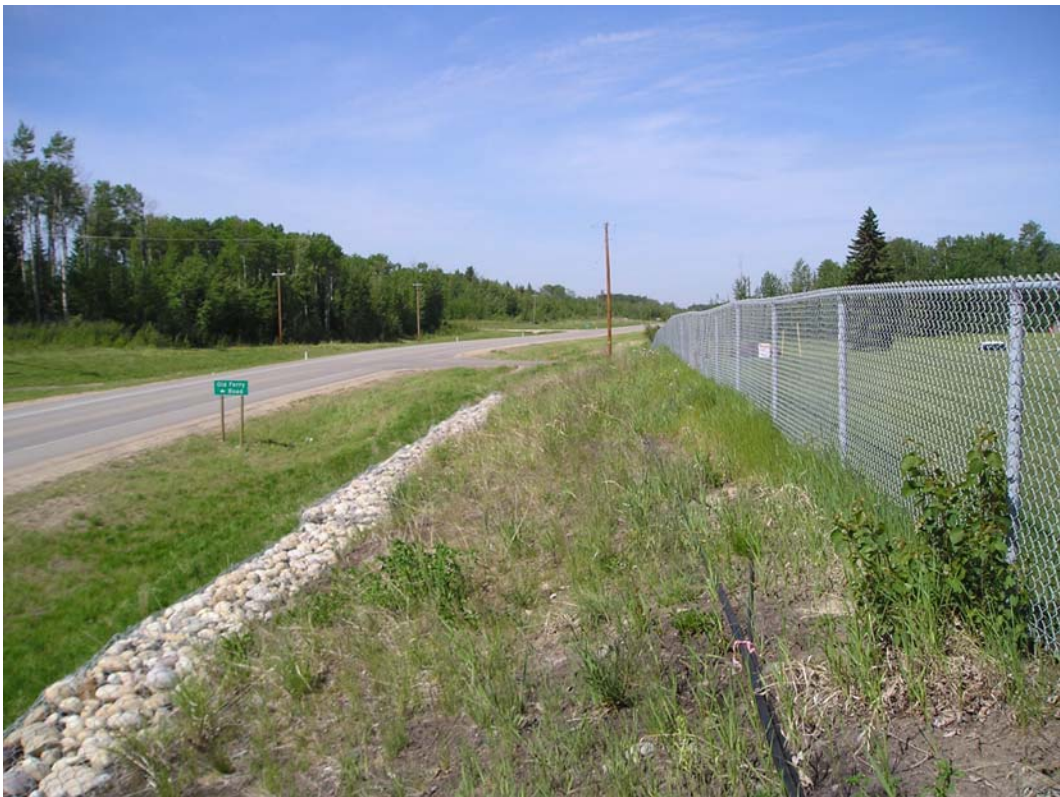
Photo 2 – Looking west at area behind wall (Telus line in foreground).

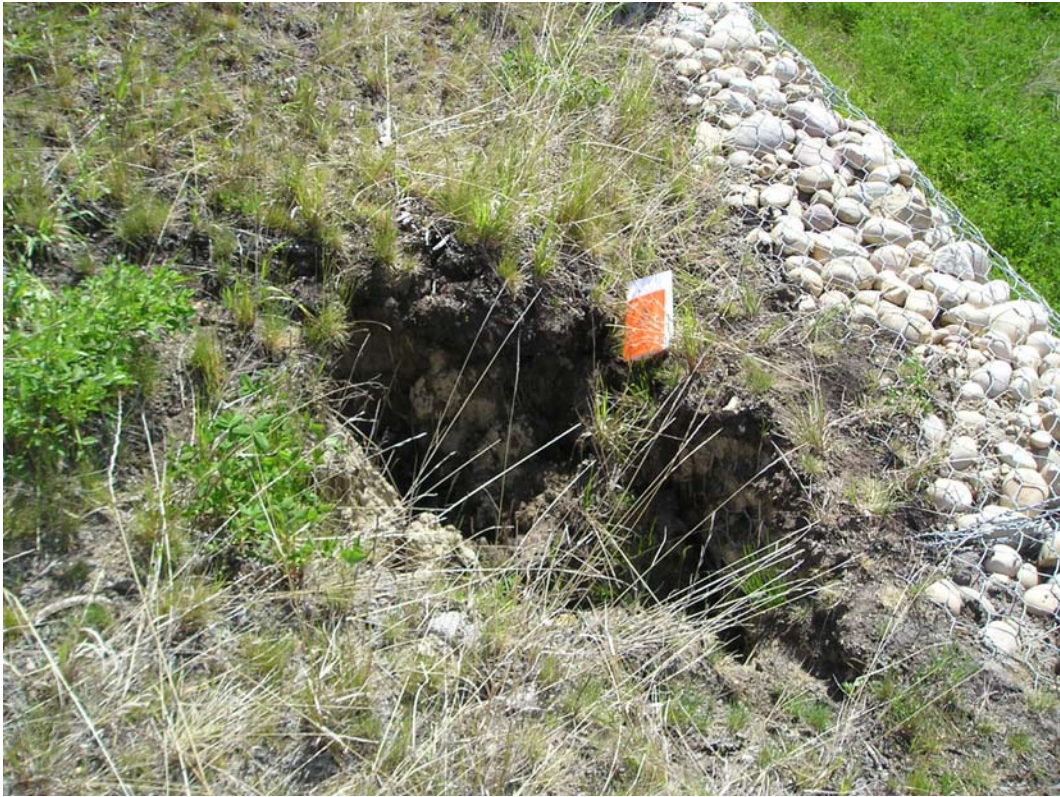
The formation of sinkholes behind the wall and sand deposits in front of the wall as observed during the site reconnaissance are consistent with the migration of fine sand (piping) from behind the wall through the open rock work within the gabion structure. The piping is likely caused by infiltration of water through the soil from precipitation events and snow melt. Due to the lack of evidence of seepage from the toe of the wall, the groundwater does not appear to be a source of water for the piping.

Photo 3 – Sinkhole #1.

A clay cap combined with placement of a non-woven geotextile on the back face of the wall along its full length is recommended, as shown schematically in the conceptual design detail provided on Figure NC45-2. The non-woven geotextile should extend down the back of the wall to a minimum depth of 2 m. The clay cap should extend a distance of at least 6 m back from the wall and should be a minimum thickness of 1 m to provide an effective seal from infiltrating water. The clay cap should be extended back further in the area of the depression in the lawn to cover an area extending at least 1 m beyond the visible limits of the depression. The clay should be compacted in 200 mm thick lifts to at least 95% of Standard Proctor maximum dry density. A layer of non-woven geotextile should be placed between the clay and the native sand to provide separation. The as-built drawings for the wall should be reviewed prior to finalizing the design of the remedial measures.

The placement of the geotextile, clay cap and geomembrane as described above is expected to significantly reduce the infiltration behind the wall and may be sufficient to stop the piping. There is some risk however that the piping may persist below the clay cap. In addition to the clay cap and associated work, injection grouting may be considered to fill voids at depth behind the wall and below the depression within the lawn, and thereby provide a seal to further reduce the potential for future piping. Injection grouting may be considered during the initial remediation to augment the clay cap, or as a secondary measure should further distress occur after the clay cap is placed. The grout mixture, injection spacing and application pressure should be designed by an experienced contractor.

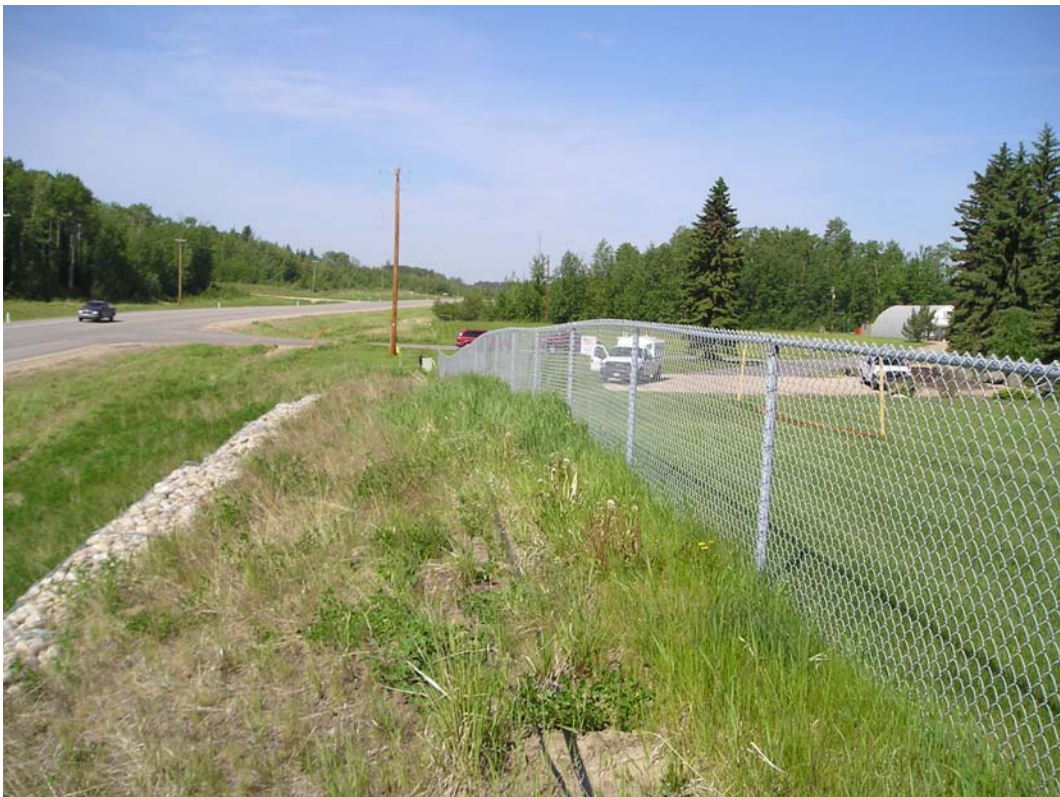
Due to the alignment of the depression in the lawn area with the sag in the fence, the largest sinkhole and the largest pile of sand at the toe of the wall, it is expected that these distress features are interrelated and represent the most active zone of piping.

- Sags in the chain link fence were noted in a few locations along its length. The largest sag was noted in a location between the depression in the lawn area and Sinkhole #1.

Photo 4 – Sag in Fence between Sinkhole #1 and depression in lawn.
(Looking west).

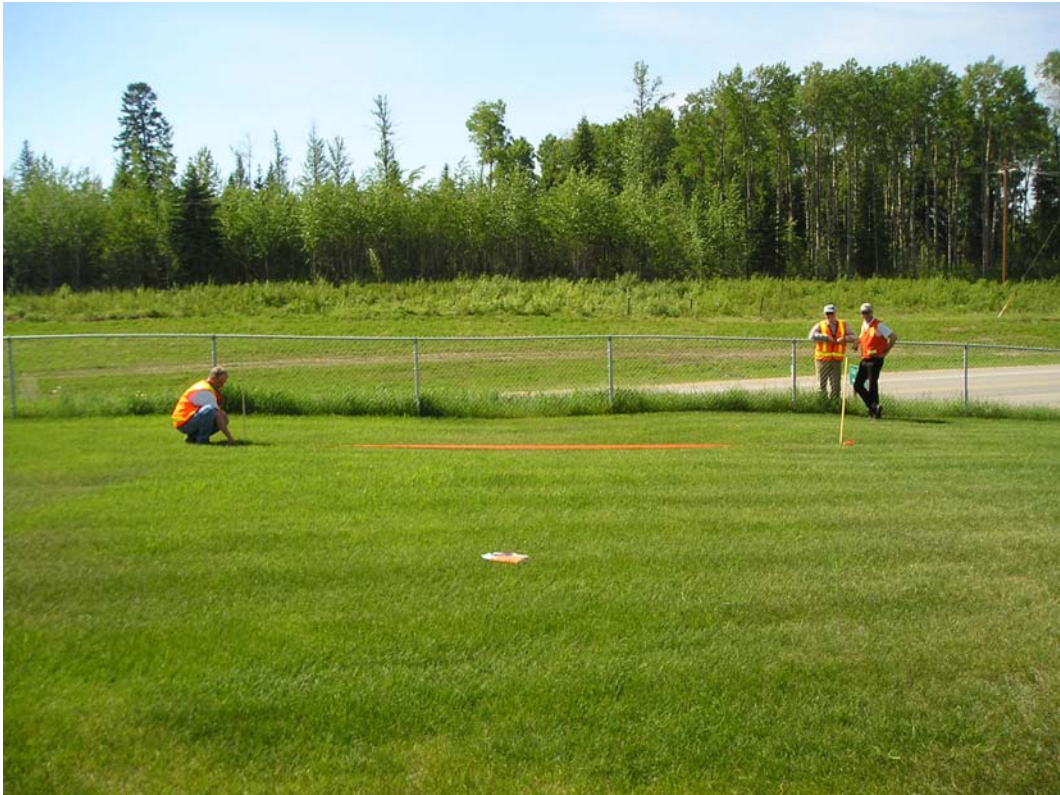
Photo 5 – Depression in lawn area and sag in fence. May 31, 2005

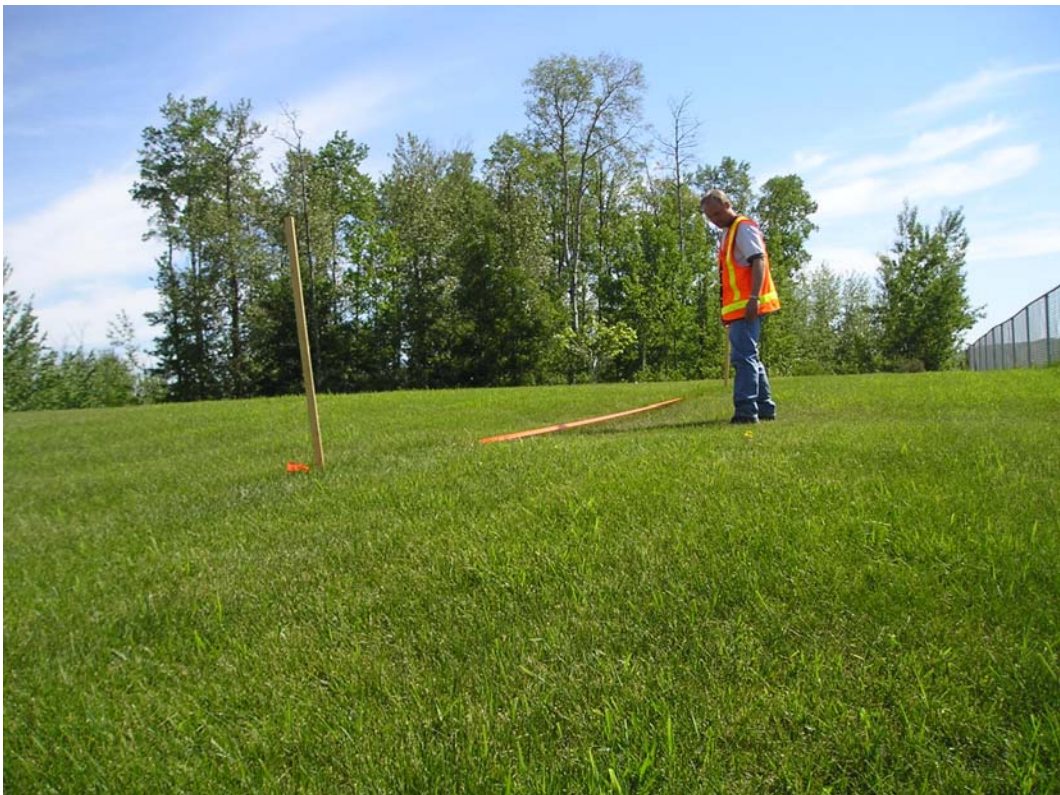
Photo 6 – Depression in lawn area. May 31, 2005

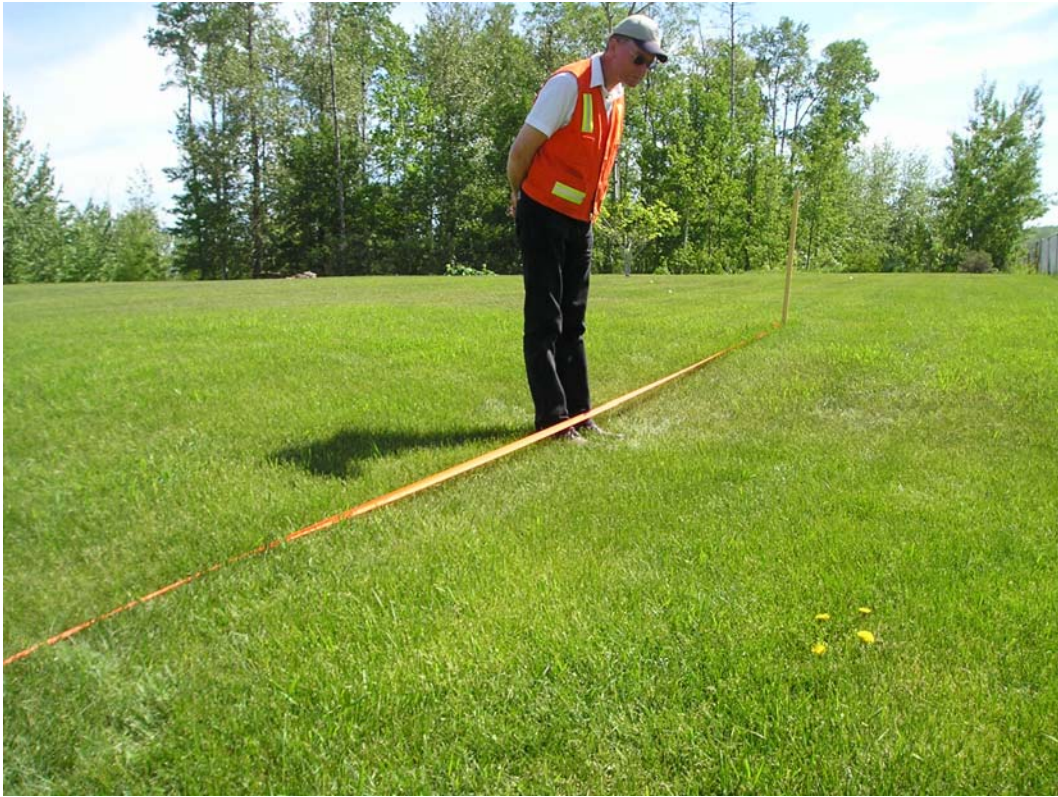
Photo 7 – Depression in lawn area.

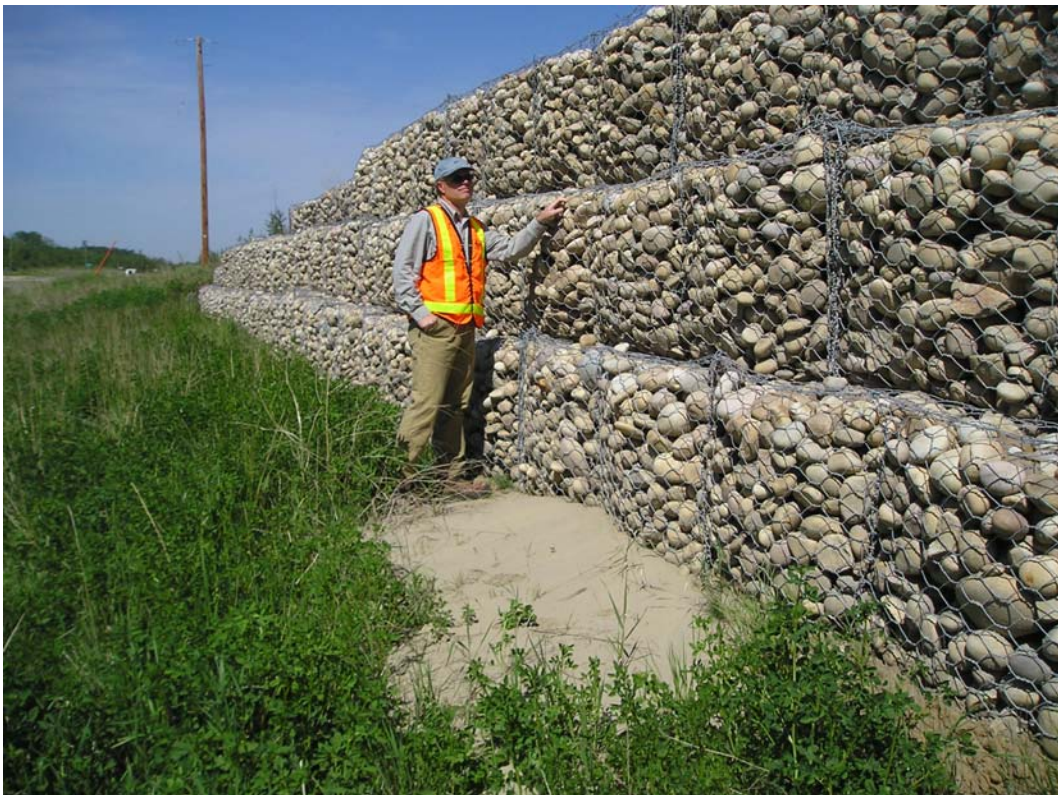
Photo 8 – Fine sand deposit at toe of wall adjacent to Sinkhole #1. May 31, 2005

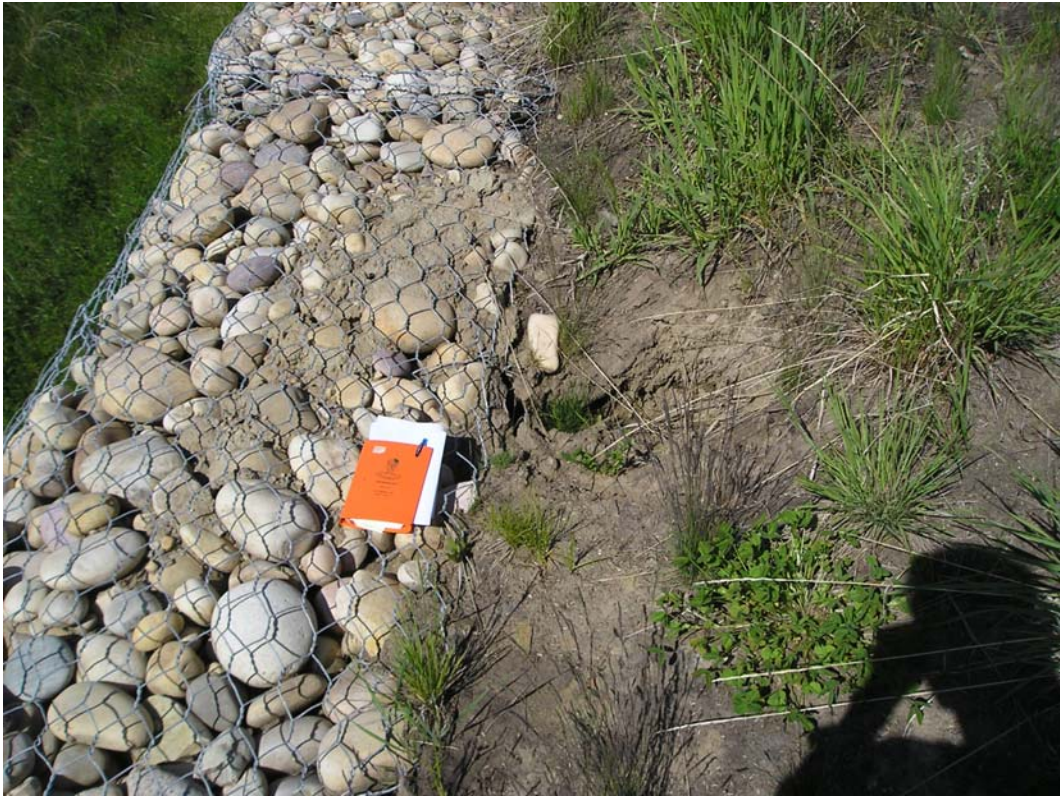
Photo 9 – Sinkhole #2.

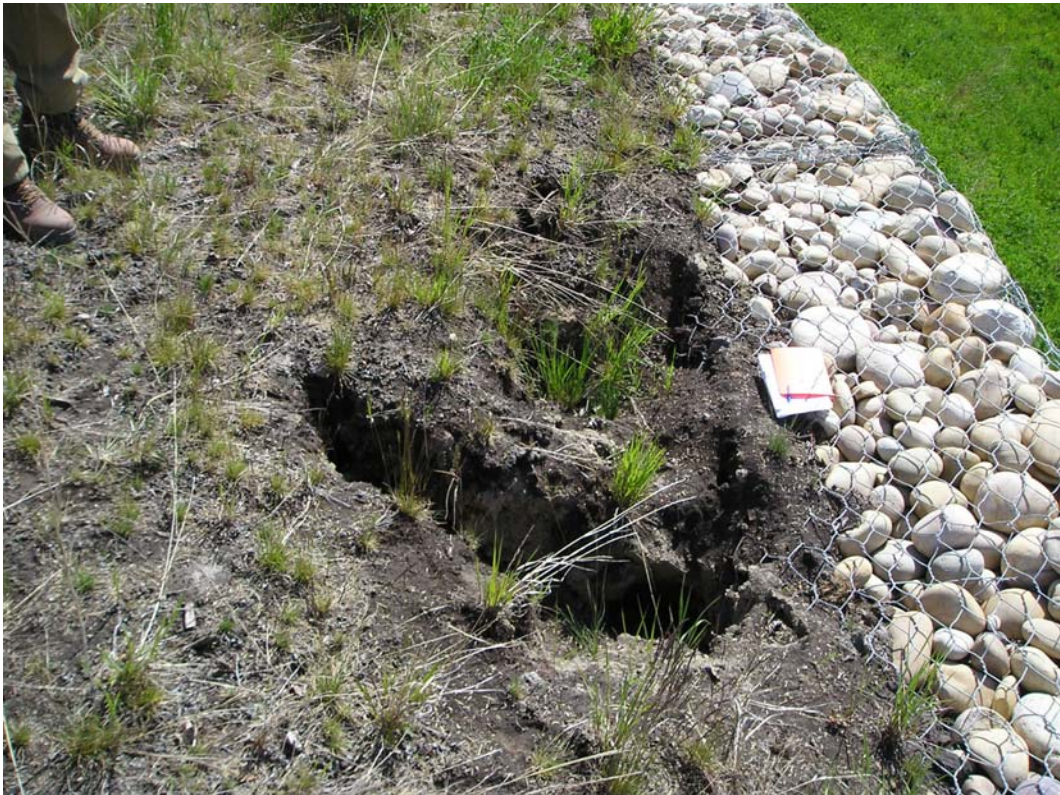
Photo 10 – Sinkhole #3.
