December 9, 2005

File: 15-85-11

**NORTH CENTRAL REGION GEOHAZARD ASSESSMENT
HWY 32:10 km 32.2 STOCKWELL EROSION (NC46)
CALL OUT INSPECTION REPORT**

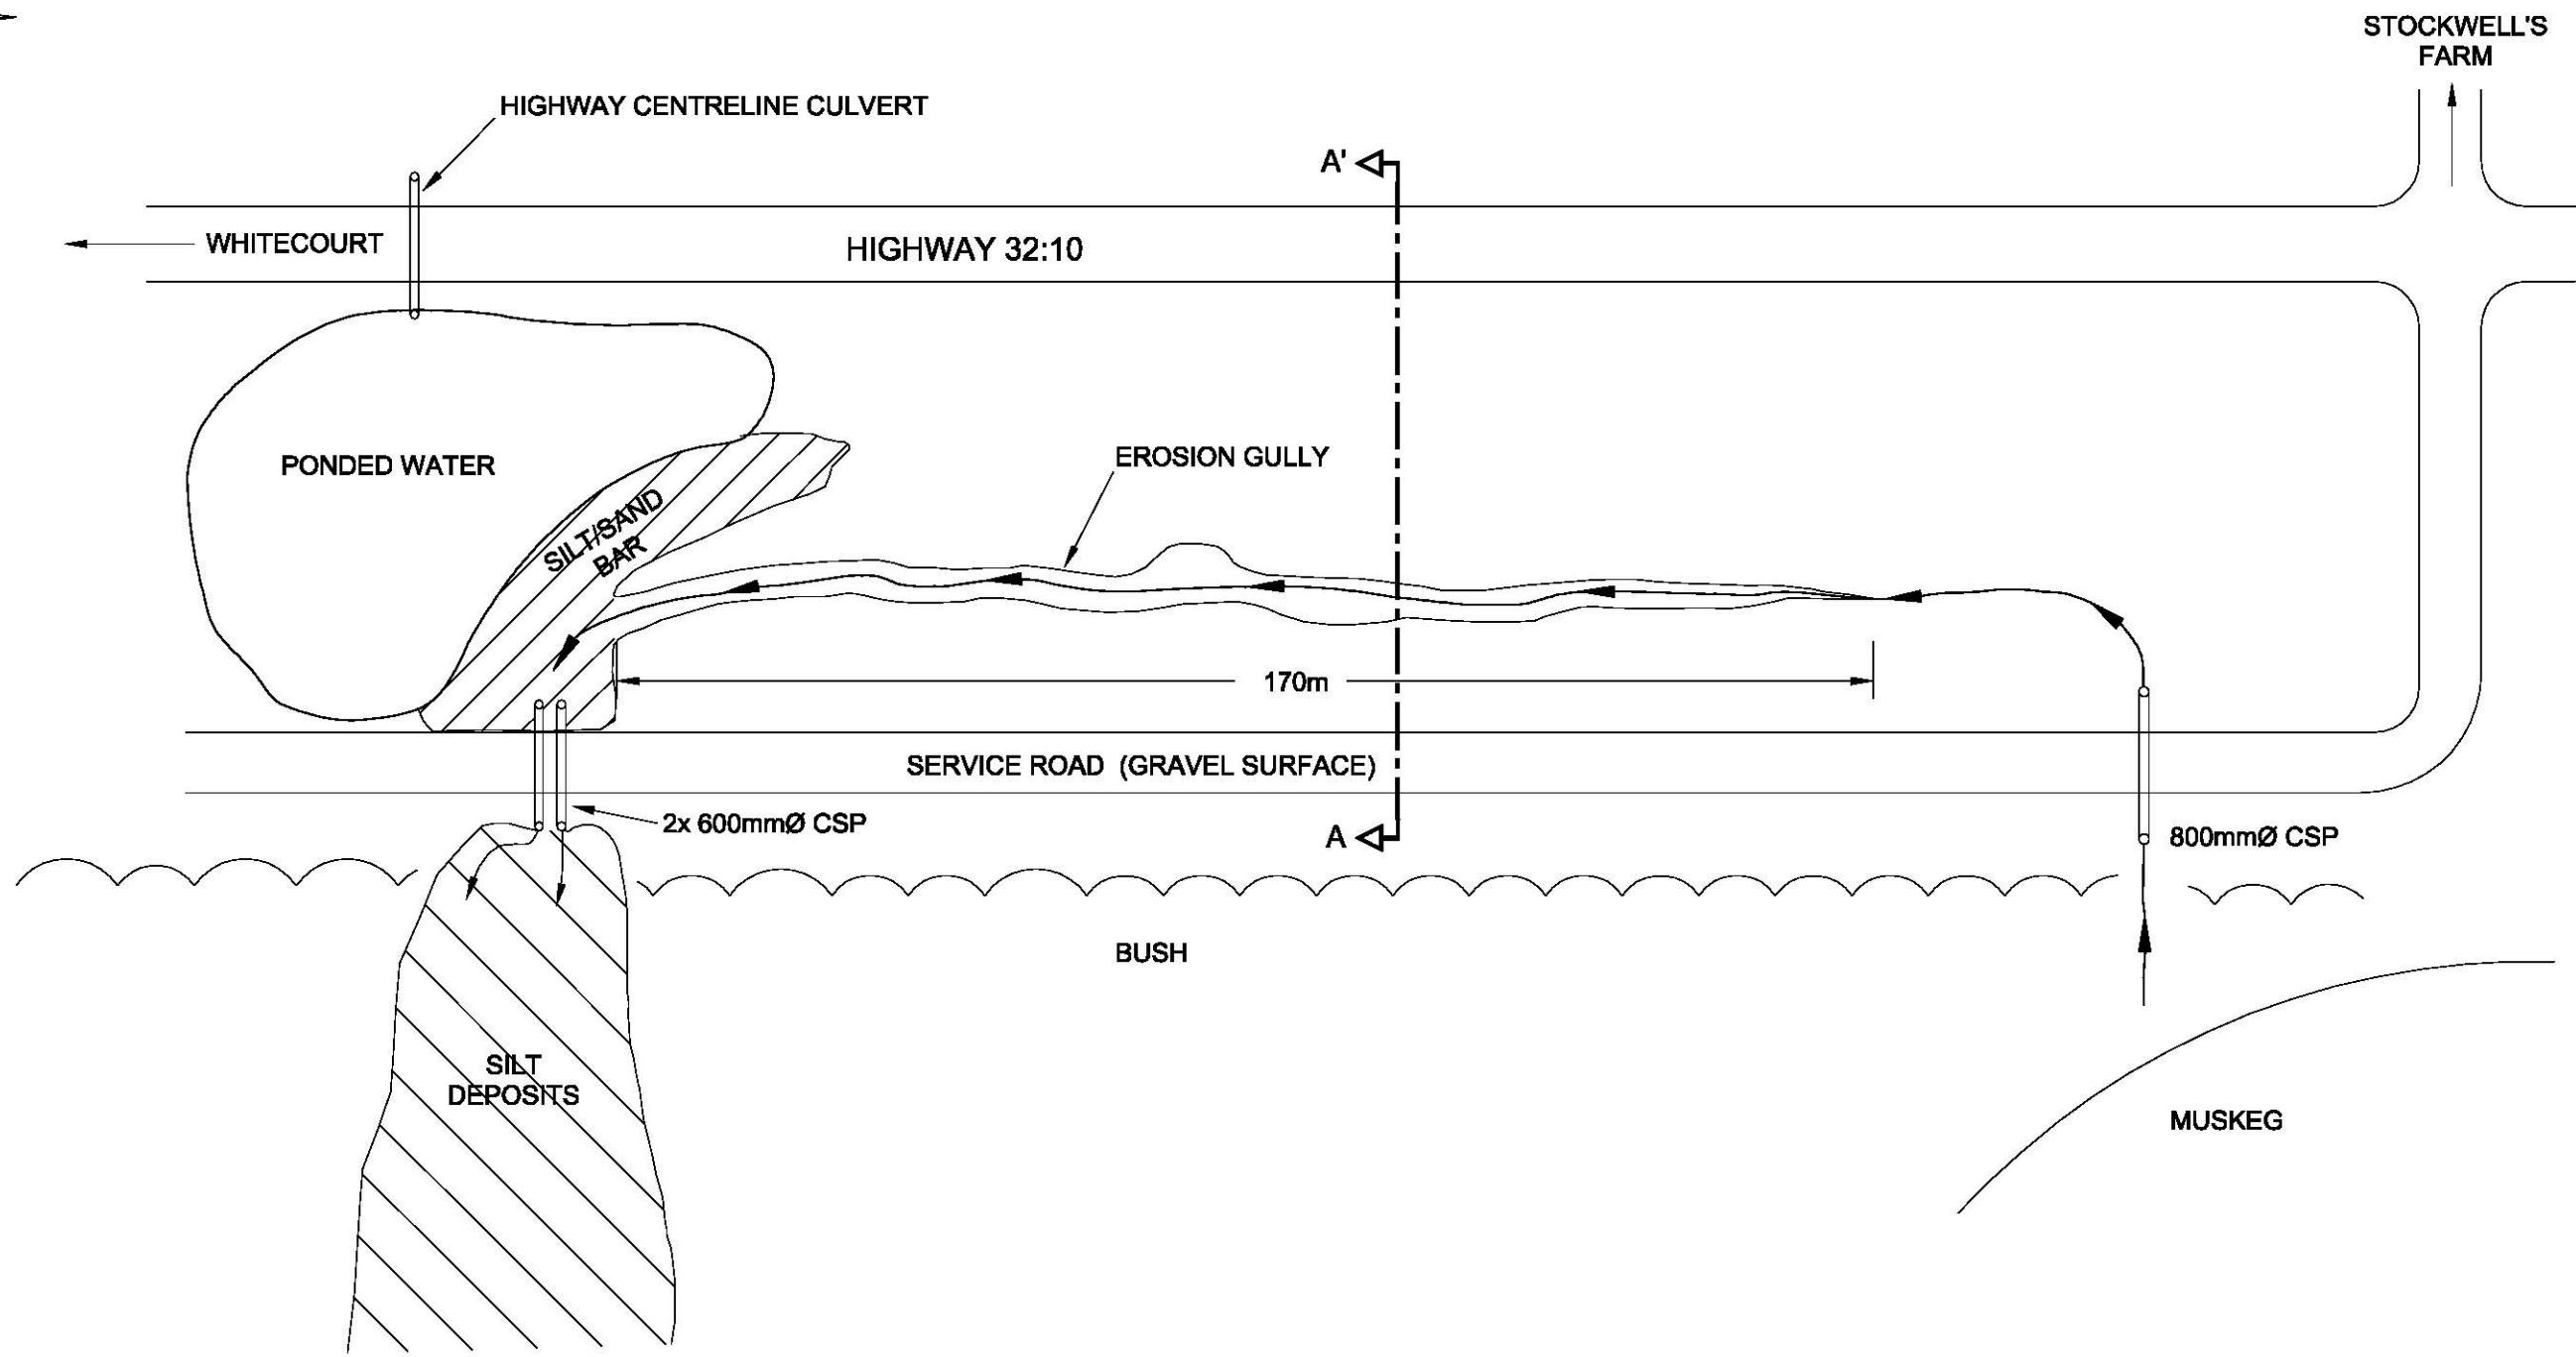
ENGINEER: DJL	DRAWN: CMH	APPROVED:
DATE: DECEMBER, 2005	SCALE: N.T.S.	DRAWING No. FIGURE NC46-1

The ditch area between the highway and the service road was inspected. In addition, the area upstream and downstream of the erosion was viewed to assess the topography for possible realignment. The following points summarize the observations made during the reconnaissance. Site features are shown on the site plan (Figure NC46-1) attached for inclusion in Section F. A cross-section through the erosion feature is provided in Figure NC46-2. Selected photographs taken during the site reconnaissance are attached.

- Water draining from a wet muskeg deposit runs south through an 800 mm diameter CSP culvert under the service road, and then to the east between the highway and the service road over a distance of about 210 m. The ditch water then discharges to the north through two 600 mm diameter CSP culverts (twin culverts).

- An erosion gully was observed over a length of about 170 m, located approximately as shown on the site plan. The gully was typically 0.8 m to 1.0 m deep and 4 m to 6 m wide, but was up to 1.5 m deep in some places. The erosion gully was formed in very silty sand and sandy silt soil. The gully was flat lying across its base, was observed to have a relatively uniform gradient along its length, and consisted of a very stiff to hard clay soil in the four locations observed in detail along its length. The ditch water appeared to be meandering across the bottom of the gully, and the meandering action had widened the gully locally in some places along its length.

- A silt and sand bar was observed at the downstream end of the gully, located approximately as shown on the site plan. The inlet ends of the culvert were completely buried with sand/silt material at the time of the site visit, with the ditch water seeping through the silt/sand bar before entering the culvert. Water was observed ponded behind the silt/sand bar, which provides a barrier to flow from a highway centerline culvert that discharges to a location southeast of the twin culverts, as shown on the site plan. The outlet (north) end of the centerline culvert was approximately one-third submerged, whereas the inlet end was dry at the time of the site reconnaissance.

- Silt and sand deposits were observed downstream of the twin culvert outlets extending a distance of approximately 100 m into the bush. The ditch water eventually dissipates in this area. The twin culvert outlets are approximately 80% to 90% full of silt and sand deposits.

The erosion gully side slopes should be flattened to a typical slope angle of 2H:1V or flatter by excavation and removal of the silt and sand material. A suitable offsite waste disposal location site should be determined for the excavated material. The slope material should not be pushed into the ditch bottom. The estimated excavation quantity required for the erosion gully is about 200 to 300 m³.

The sediment collected in the silt/sand bar area in the vicinity of the twin culvert inlets and the sediment deposits observed in the area downstream of the twin culvert outlets should be removed and disposed of in a suitable manner. The culverts should be flushed to remove all remaining sediment and to reestablish effective flow through the twin culverts. The estimated quantity of sediment material in these two areas is in the order of 1500 m³ and 2500 m³, and will depend somewhat on the extent of sediment removal determined to be necessary within the bush area downstream of the twin culverts. Disturbed areas should be topsoiled and revegetated soon after removal of the sediment to reduce the likelihood of further erosion in these areas.

The base and sides of the erosion gully after trimming and removal of loose sediment should be lined with large (up to about 200 mm diameter) well graded pit run gravel. The pit run gravel treatment should extend over the full length of the ditch; approximately 220 m. The gravel should be placed on a non-woven geotextile for separation from the underlying silt, sand and clay soils, and should be compacted in one lift at a thickness of about 200 mm (compacted thickness). The estimated quantity of pit run gravel is 250 m³ to 300 m³. Grading of the pit run surface may be designed to include small ditch check structures at selected intervals to impede the flow and reduce the erosive force in the ditch. This design should be finalized once the survey information is available.

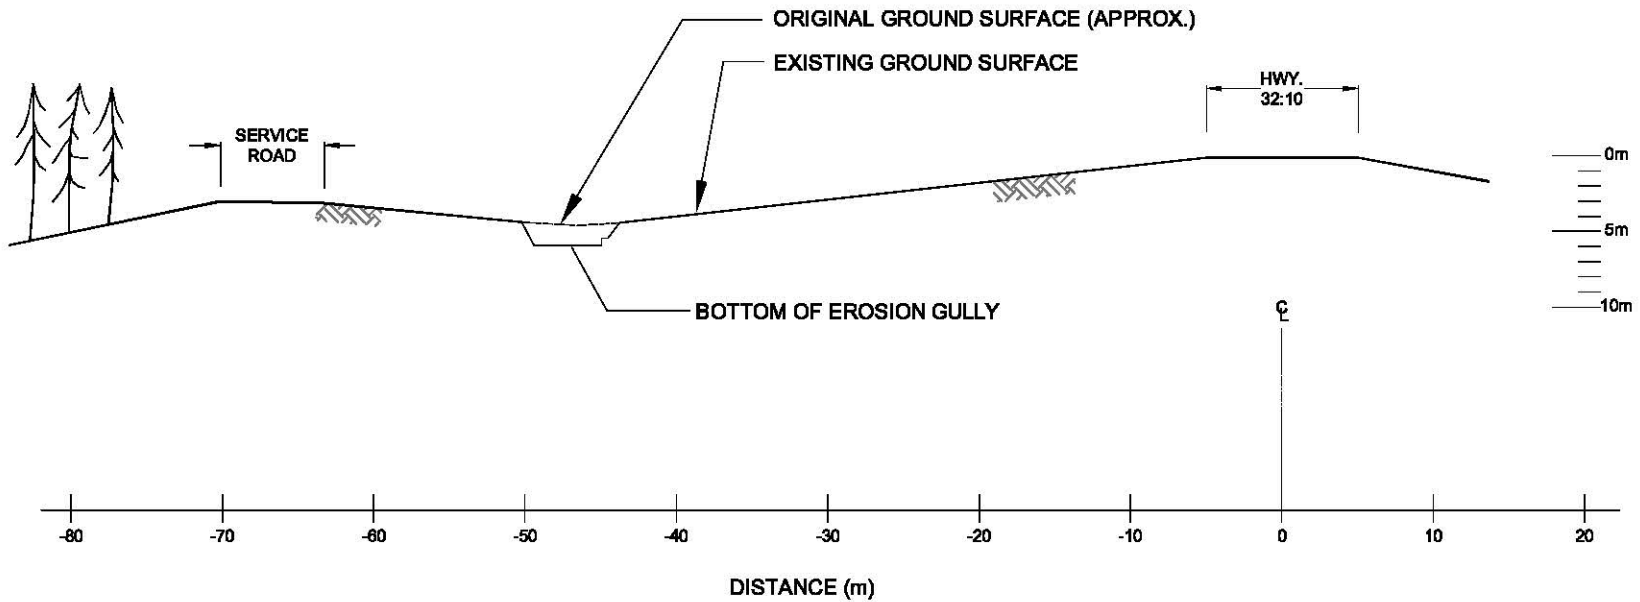
THURBER ENGINEERING LTD. GEOTECHNICAL • ENVIRONMENTAL • MATERIALS	
CROSS-SECTION A-A'			
NORTH CENTRAL GEOHAZARD ASSESSMENT		HWY. 32:10 km 32.2 STOCKWELL EROSION	
ENGINEER: D.J.L.	DRAWN: C.M.H.	APPROVED:	
DATE: DECEMBER, 2005	SCALE: APPROX. 1:500	DRAWING No. FIGURE NC46-2	REV.:

Based on the relatively wide base and flat bottom observed in the erosion gully and the meandering nature of the streambed, it is anticipated that the erosion has occurred quickly through surficial silts and sand fill material, and further downcutting has been slowed significantly by the hard clay base (likely native soil).

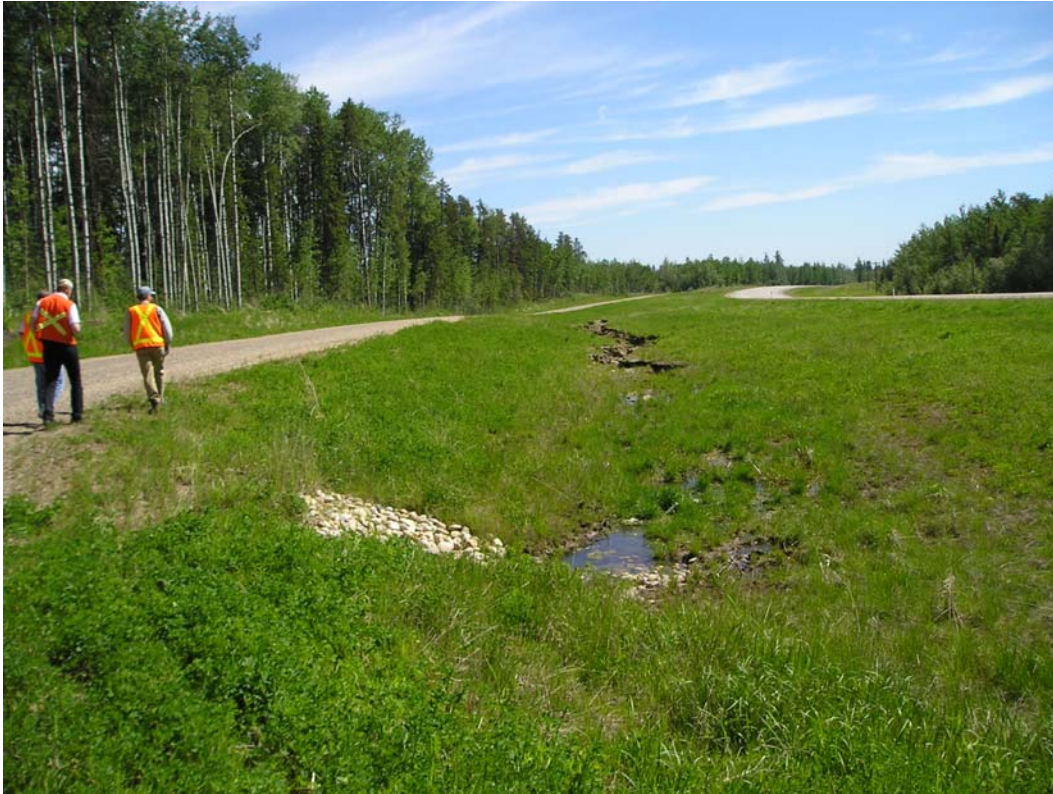
Photo 1 – Looking east from 800 mm dia CSP outlet. May 31, 2005

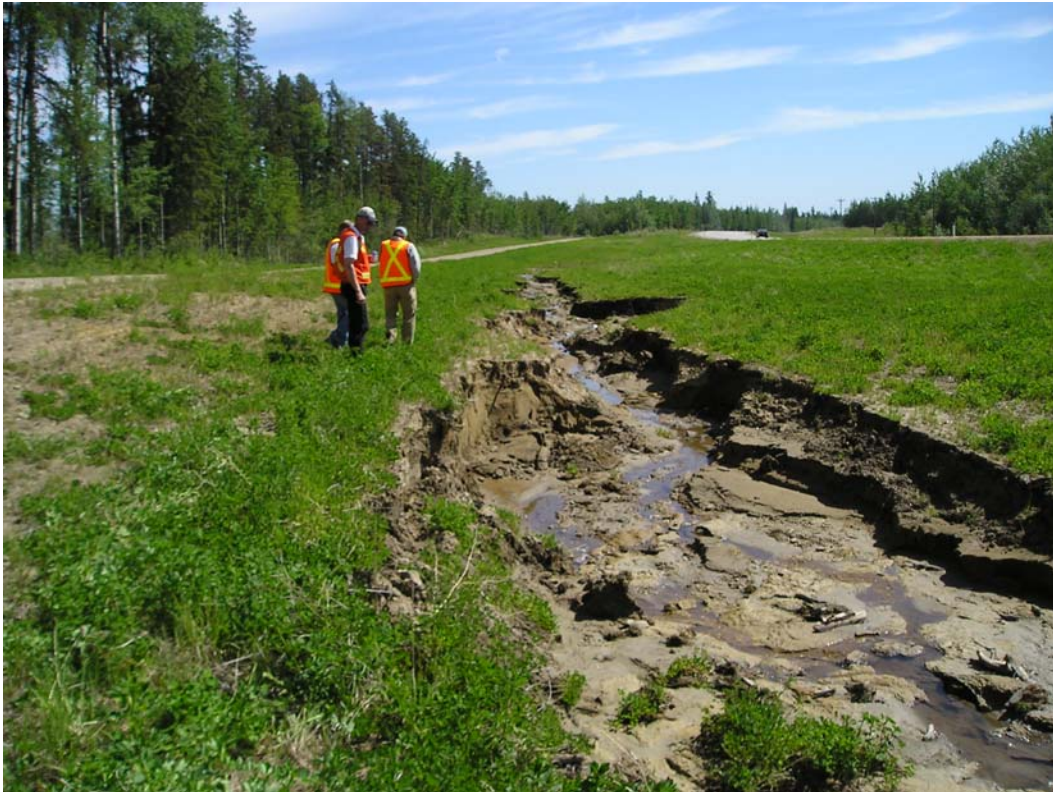
Photo 2 – Looking east from approx. Section A-A'. May 31, 2005

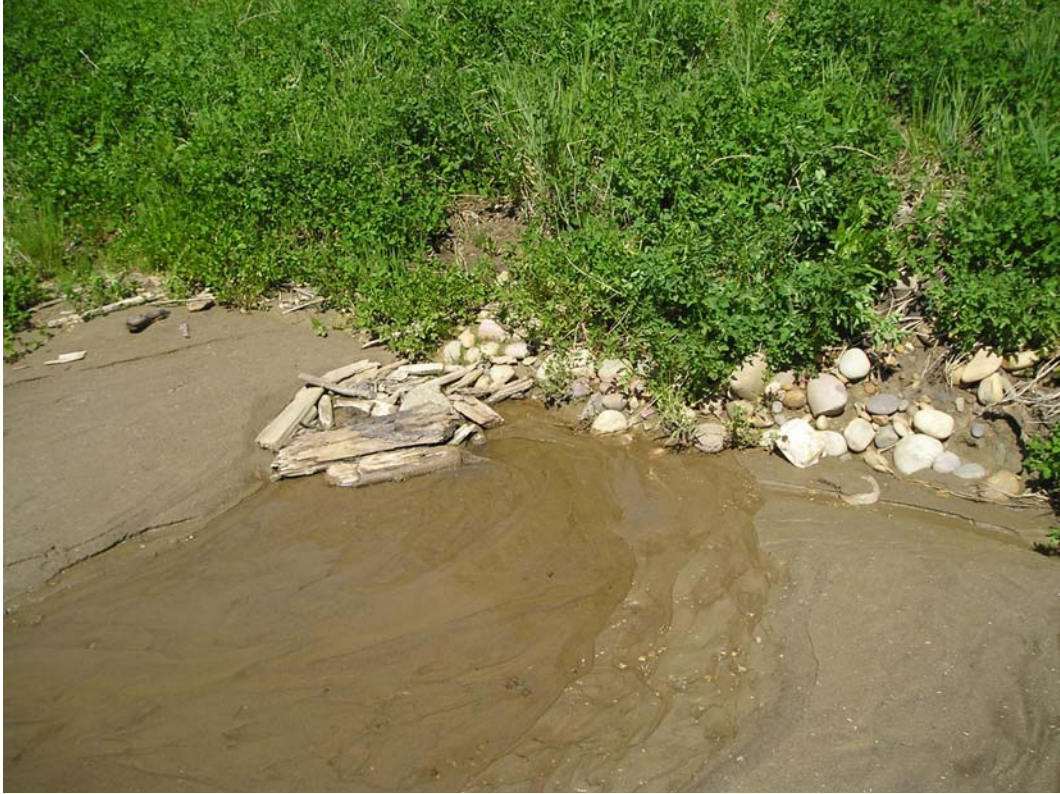
The twin culverts were not functioning well at the time of the site visit due to the accumulation of silt and sand at the downstream end of the erosion gully. The source of the deposits is expected to be material removed from the sides and base of the gully during erosion, and re-deposited at the twin culvert inlet location. A significant amount of the eroded material has been transmitted through the twin culverts and has been deposited downstream in the bush area. There is no potential for further migration of the sediment into a body of water (river or lake).

Photo 3 – Inlet of twin culverts (water seeping in through overlying silt and sand).

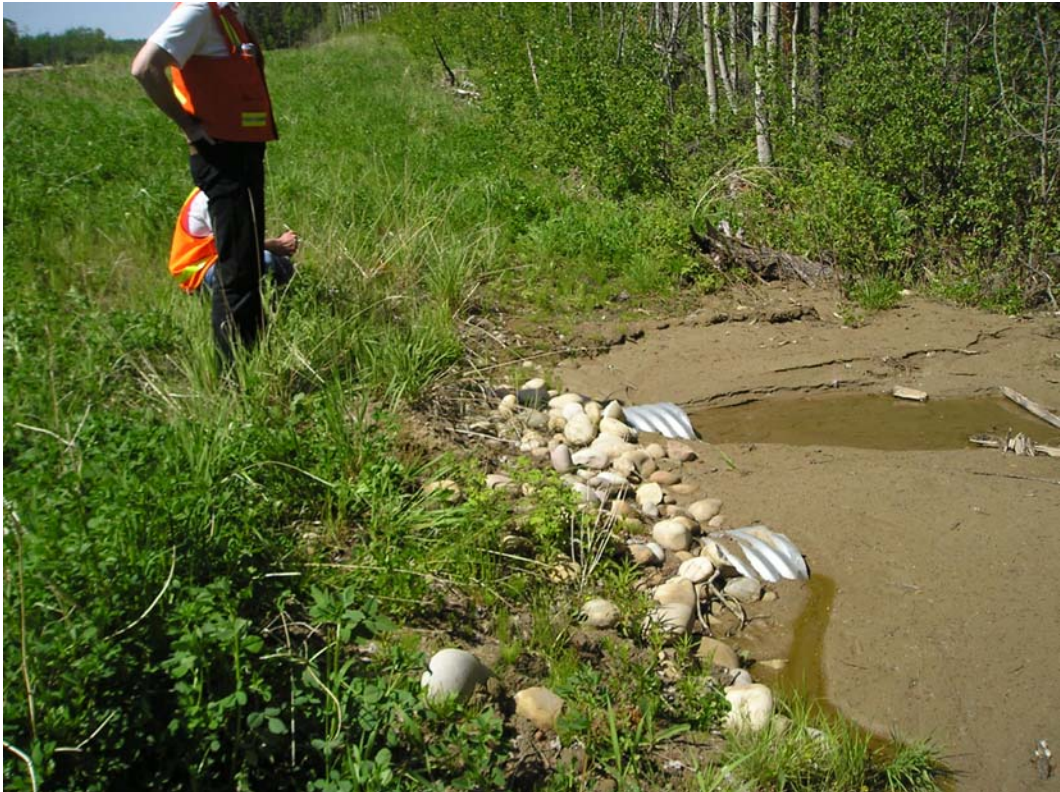
Photo 4 – Twin culvert outlet area (looking west).

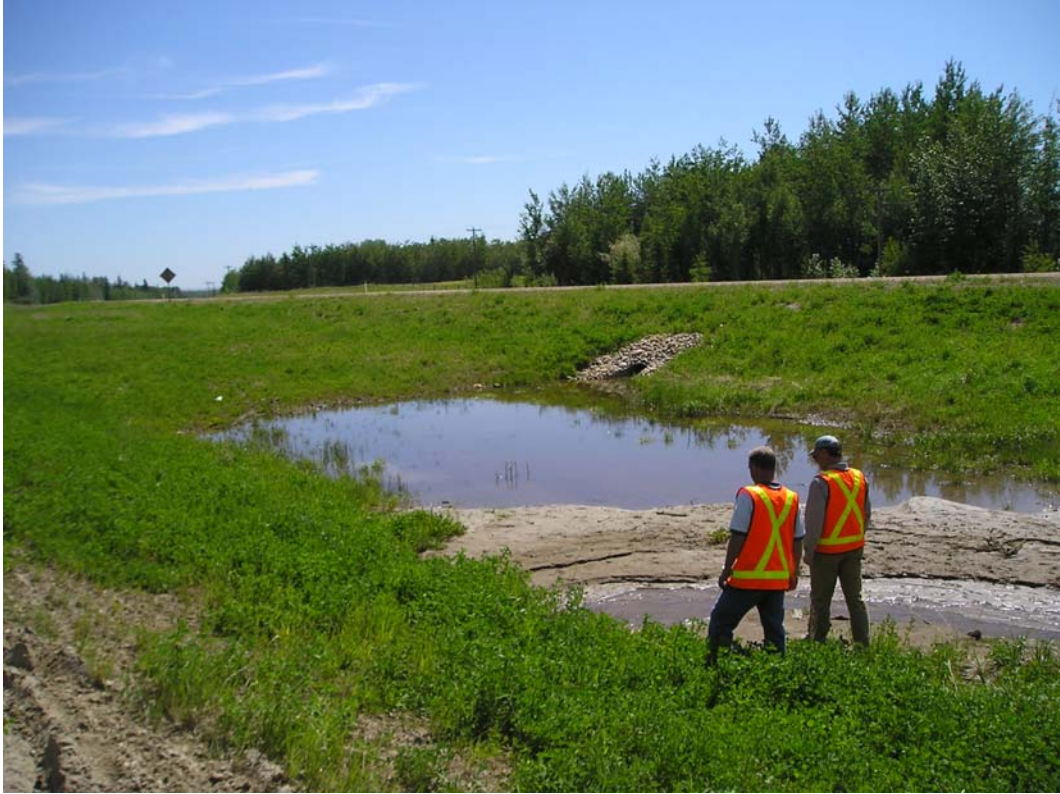
Photo 5 – Sand/Silt bar and ponded water in twin culvert inlet area. May 31, 2005

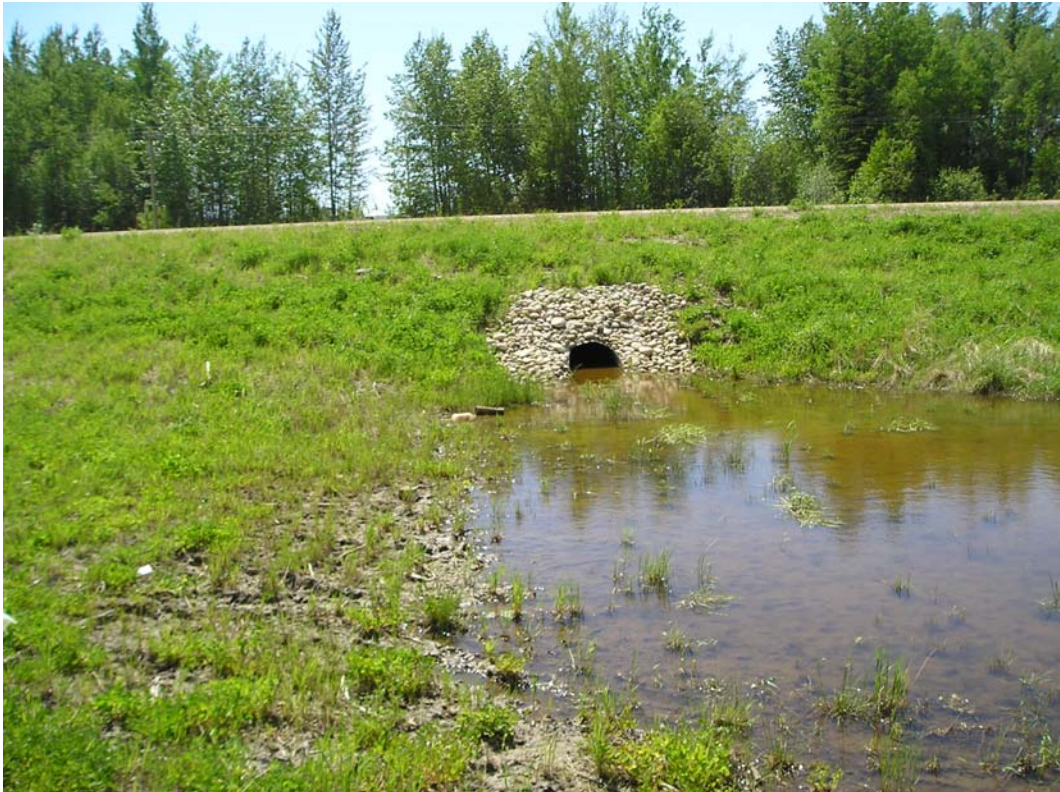
The erosion gully is not impacting the highway or service road at the present time. However, if left untreated, the erosion gully may migrate laterally a sufficient distance to impact the service road in the future. As a result, additional sediment transport may be experienced which would deposit in the vicinity of the twin culvert inlets and potentially completely block flow through the culverts in the future. Further, the ponded water may build up higher in the outlet area of the highway centerline culvert, which may soften the side slope and potentially trigger slope instability.

Photo 6 – Ponded water in centreline culvert outlet area. May 31, 2005
