August 7, 2007

File: 15-85-68

**NORTH CENTRAL REGION GEOHAZARD ASSESSMENT  
HWY 32:10 km 23 to 24 Groat Creek (NC60)  
2007 ANNUAL INSPECTION REPORT**

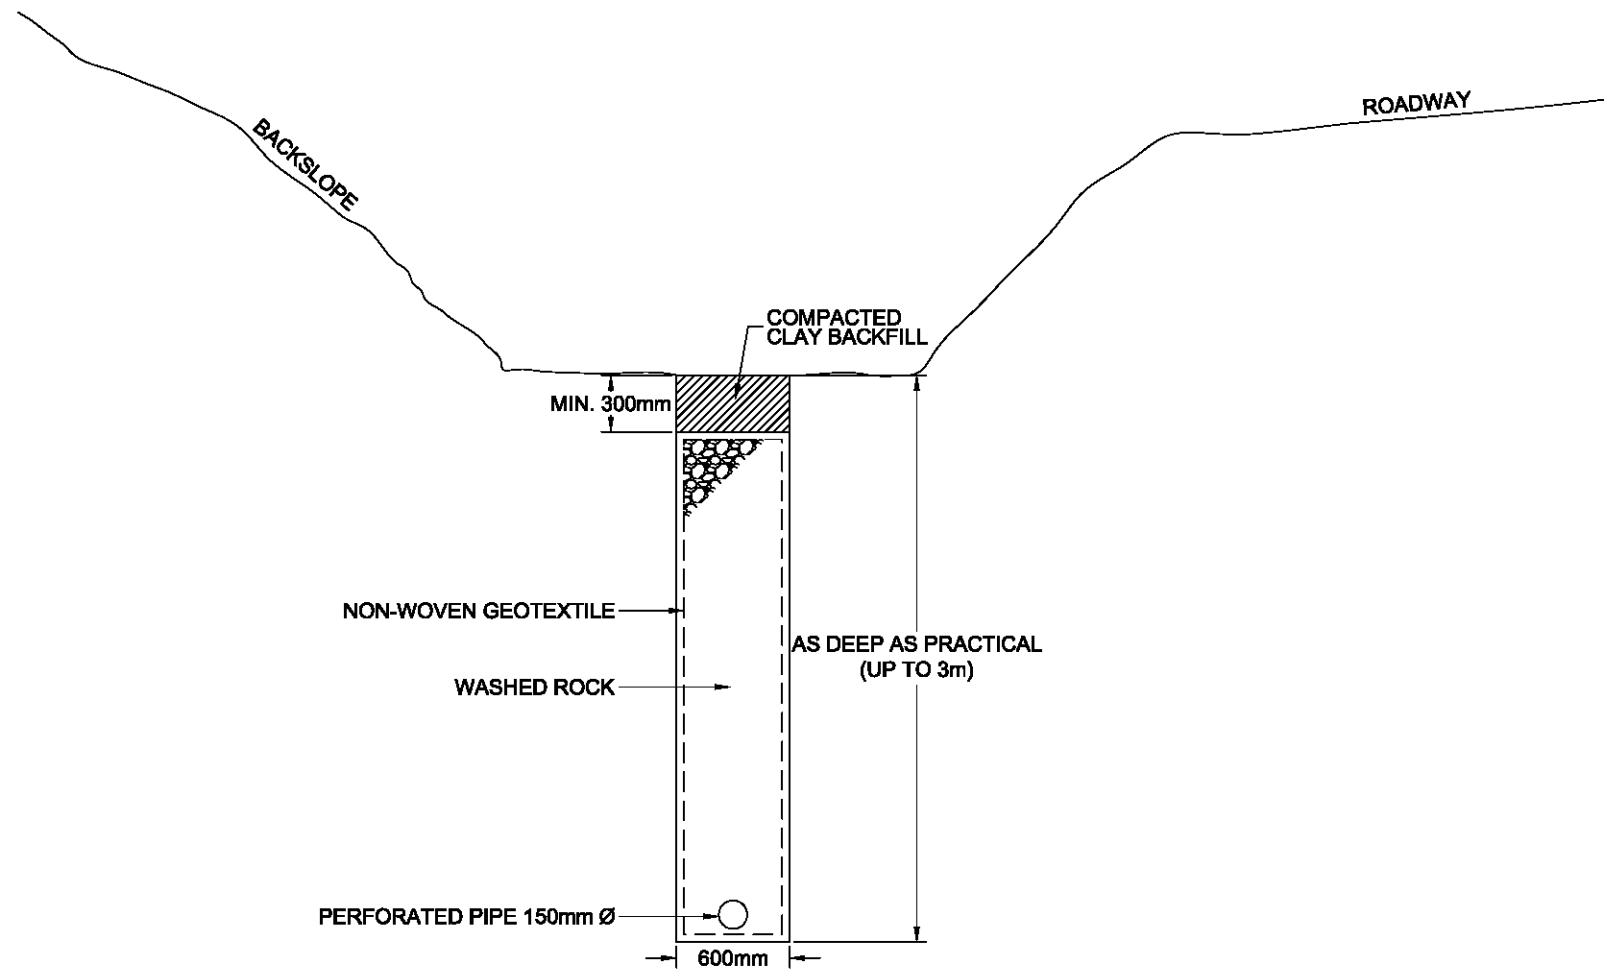
**FIGURE 1**

TYPICAL SUBDRAIN DETAIL

It is recommended that the west ditch be regraded to prevent ponding of water adjacent to the highway where it can infiltrate and lead to subgrade softening and frost action. Intercepting subsurface drainage may also reduce the recurrence of the dip features. A subdrain is recommended below the west ditch, located as shown on the site plan and should consist of a 150 mm-diameter perforated pipe surrounded by washed rock, enveloped in a non-woven geotextile for separation (see Figure 1). The drain should be about 700 m in length starting at the Dip 1 location continuing south, and should be approximately 3 m in depth or as deep as practical to intercept groundwater. A positive gradient should be maintained on the drain to transmit water away from the ditch.

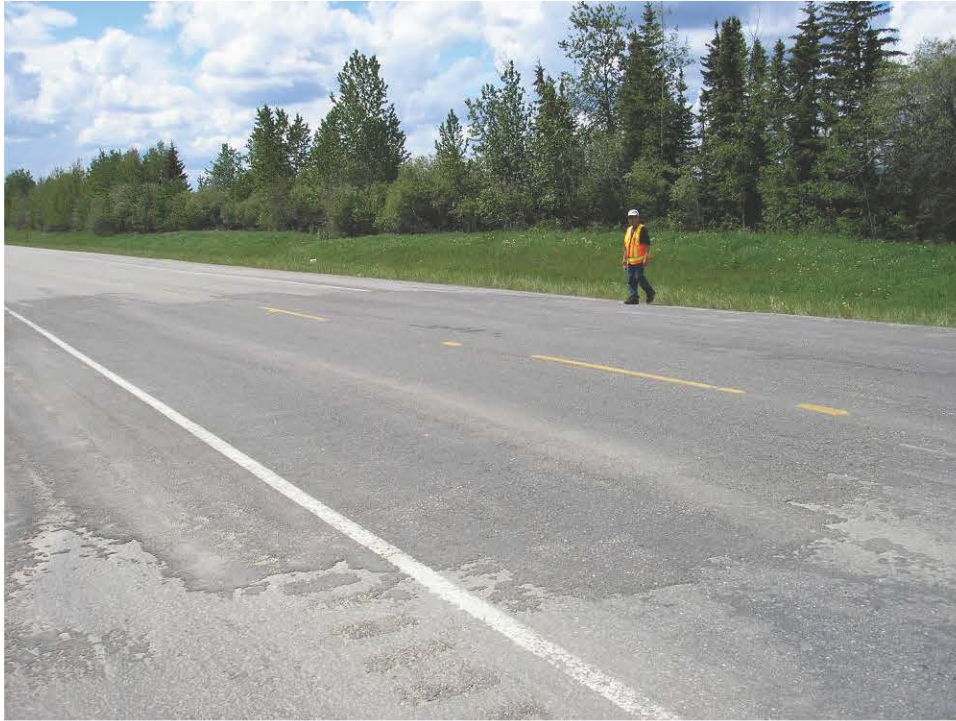
At Dip 1, there was a 910 mm diameter culvert that was observed to be sagging and ponding water over its east half. The dip in the roadway is centered over the culvert.

Photo 1 – Looking northeast at patch over Dip 1, June 11, 2007.

Patching should be undertaken as required to maintain the ride quality of the highway.

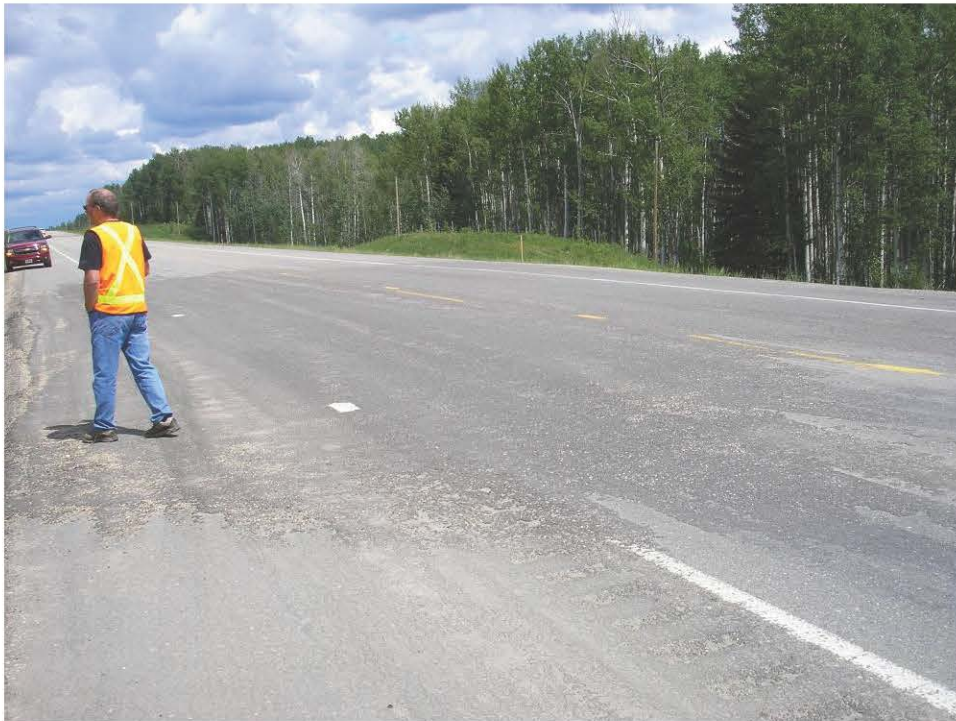
Dip 2 also has a 910 mm diameter culvert centered under the dip; however, there is only a slight sag over its length. Although not flowing at the time of the site visit, it appears that water may bypass the culvert inlet and enter the soil beside the culvert.

Photo 2 – Looking north at patch over Dip 2, June 11, 2007.

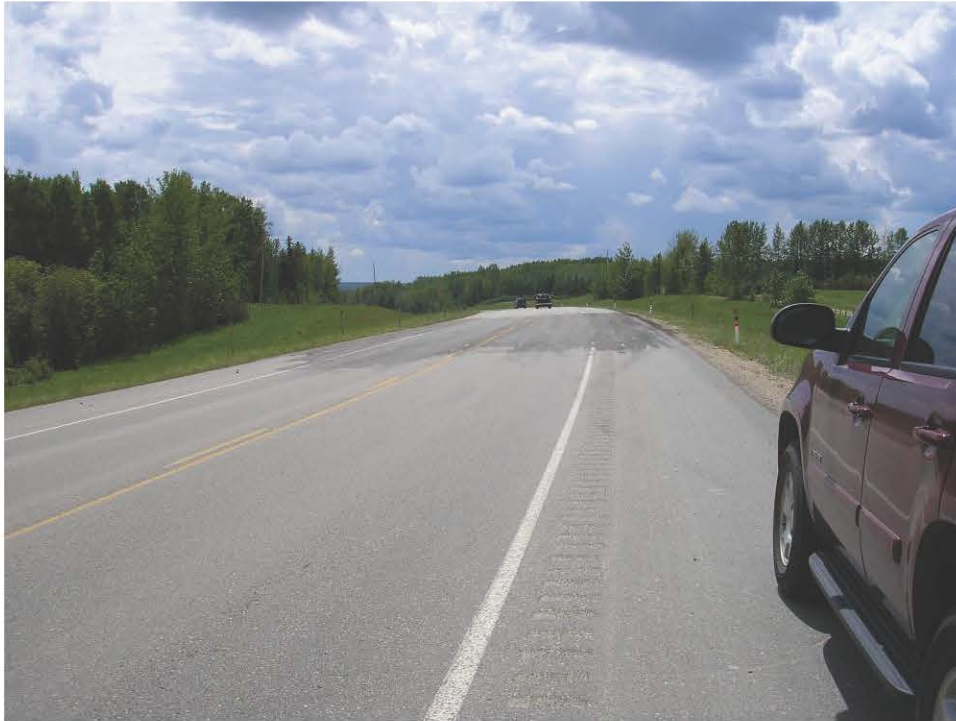
Photo 3 – Looking south at patch over Dip 3, June 11, 2007.

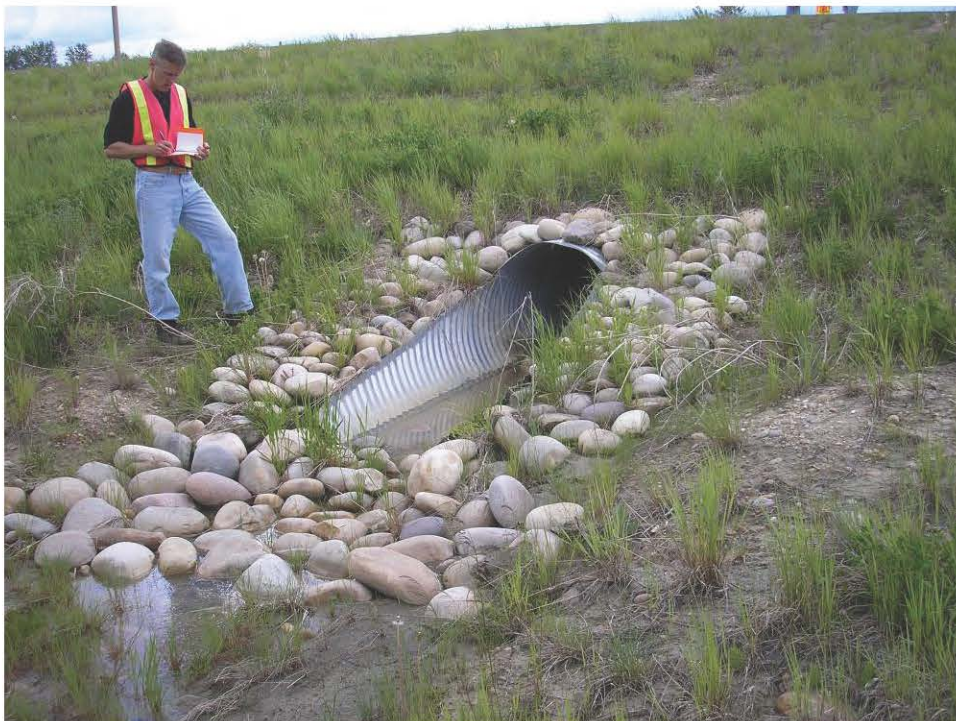
Water was ponding in the upslope ditch between Dips 2 and 3. The 910 mm diameter culvert at Dip 3 had no apparent sagging but there was water ponding at the outlet end.

Photo 5 – Ponding water at outlet of culvert at Dip 3, June 11, 2007.

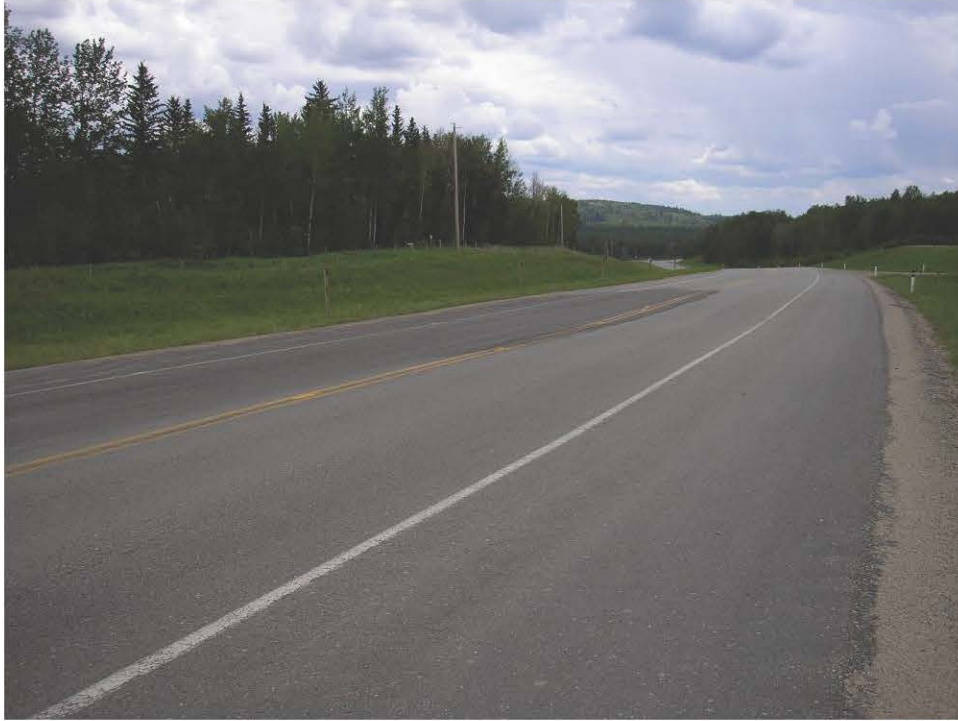
At Dip 4, the patching was limited to the downslope lane and there is no culvert installed at this location. Several shallow dips were observed in the pavement surface between Dips 3 and 4.

Photo 6 – Looking southeast at Dip 4, June 11, 2007.
