**NORTH CENTRAL - EDSON**  
**GEOHAZARD RISK ASSESSMENT**  
**SITE INSPECTION FORM**

SITE NUMBER AND NAME: <b>NC60 – Groat Creek</b>		HIGHWAY & KM 32:10 km 23 to 24	PREVIOUS INSPECTION DATE: June 11, 2007	INSPECTION DATE: June 15, 2009
LEGAL DESCRIPTION: NE2 & SE11-59-13-W5M	UTM COORDINATES (NAD83): 11 N 5993127 E 576628		RISK ASSESSMENT PF: 8 CF: 1 TOTAL: 8

NC60 GOAT CREEK  
SITE PLAN

NORTH CENTRAL 2009  
GEOHAZARDS ASSESSMENT

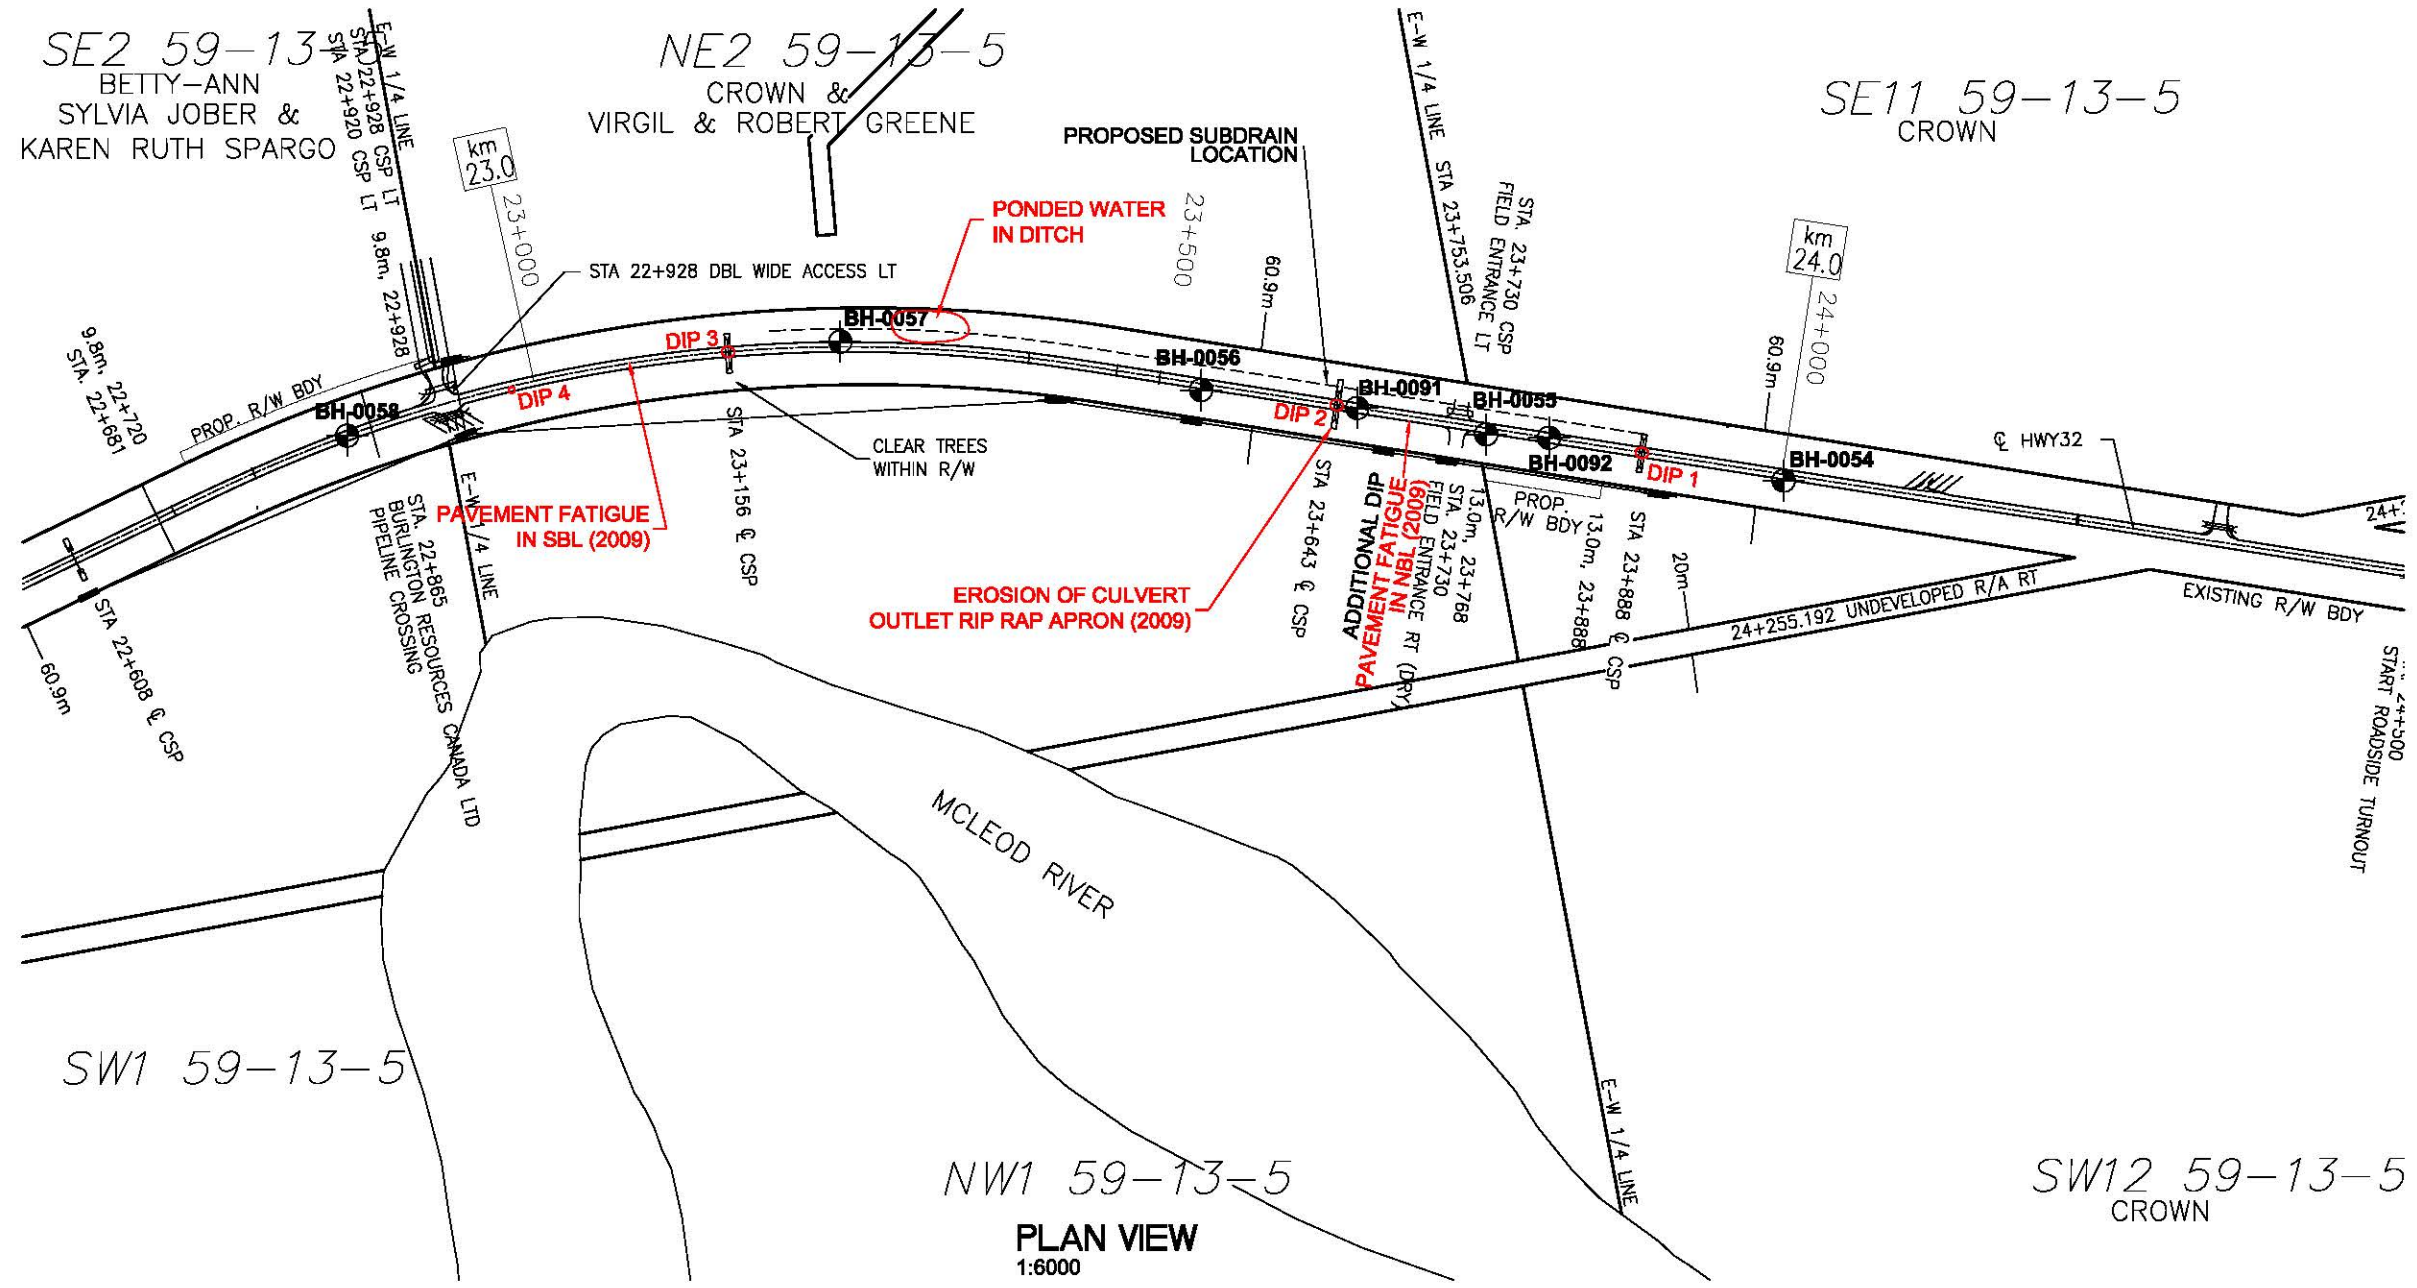
ENGINEER: KEF	DRAWN: KLW	APPROVED: DJL
DATE: AUGUST 2009	SCALE: AS SHOWN	DRAWING No. FIGURE NC60-1

**COMMENTS (Refer to Figure NC60-1)**  
The four main dips are located: km 23.88 (Dip 1), km 23.63 (Dip 2), km 23.15 (Dip 3), and km 22.98 (Dip 4). There are 910 mm diameter culverts located beneath Dip 1 through Dip 3. Dip 4 is located in only the downslope (east) lane. An additional dip was noted at km 23.70 between Dips 1 and 2 and several shallower dips were present between Dips 2 and 4. In 2007, it was observed that water may be bypassing the culvert inlet at Dip 2 and water was ponding between Dips 2 and 3 in the upslope (west) ditch. The grade was lowered through this area between 0.8 m and 1.6 m and was noted to have soft subgrade conditions and required lime stabilization. Pavement fatigue was noted at several locations in 2009.

**RECOMMENDATIONS**  
The distress is likely caused by insufficient compaction of the culvert backfill and soft subgrade conditions resulting from frost action failing under traffic loading. Although the McLeod River is located nearby (to the east) large-scale slope movement is not likely and LiDAR information provided by AT shows no obvious signs of movement.  
In the short-term, patching is recommended to maintain ride quality. The long-term solution is to reduce the potential for water to soften the subgrade. The west ditch should be regraded to reduce ponding and a subdrain should be installed starting at or north of Dip 1 and continuing at least 700 m south to where the ditch grade will allow gravity drainage. Additional details regarding this subdrain were provided in the 2007 Annual Inspection Report. It is recommended to continue bi-annual inspections at this site.

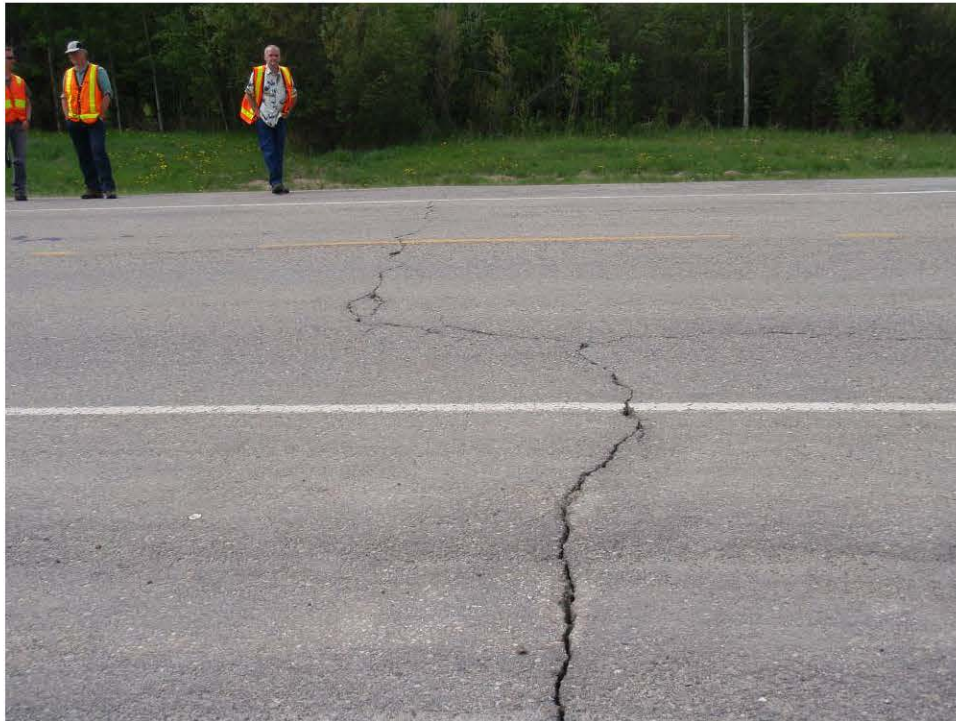
Photo 1 – Looking at crack that formed over Dip 1 (June 15, 2009).

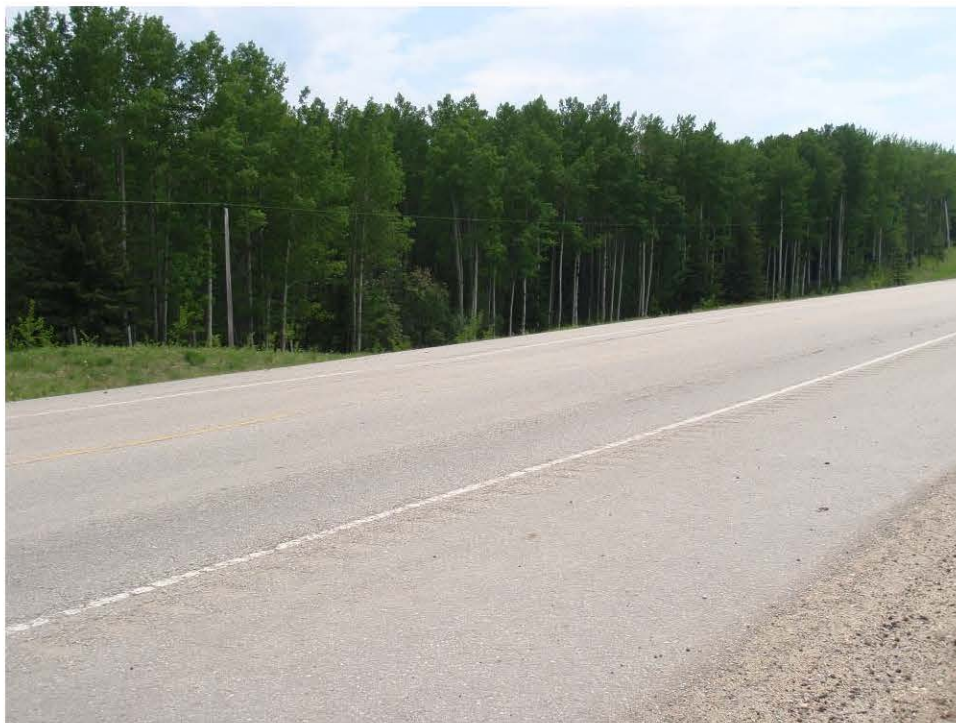
Photo 2 – Looking south at Dip 2.

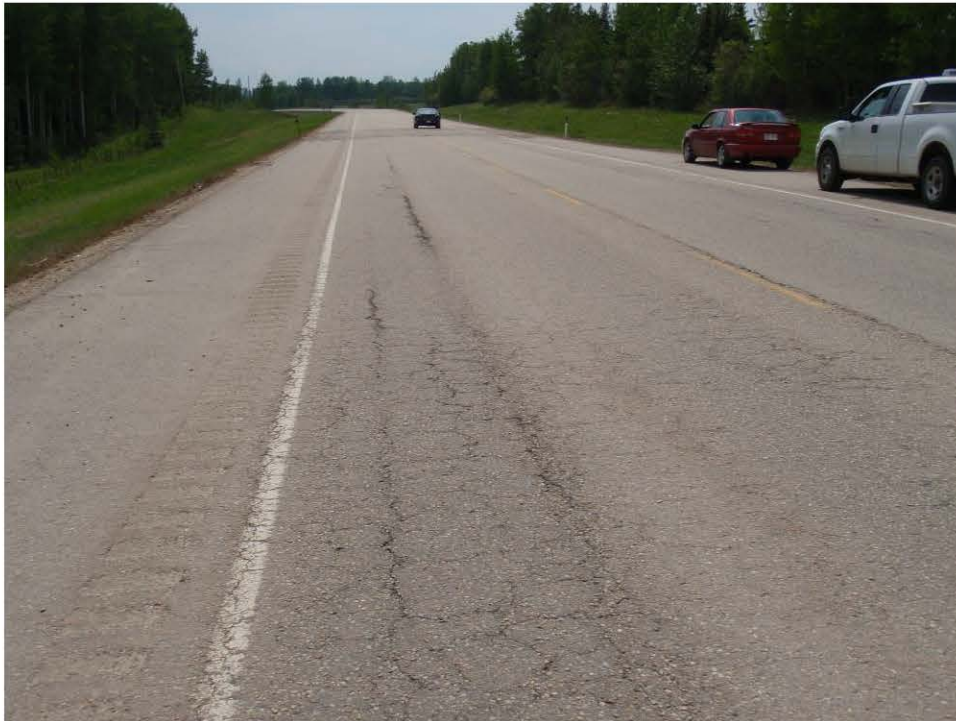
Photo 3 – Looking at pavement fatigue near Dip 2.

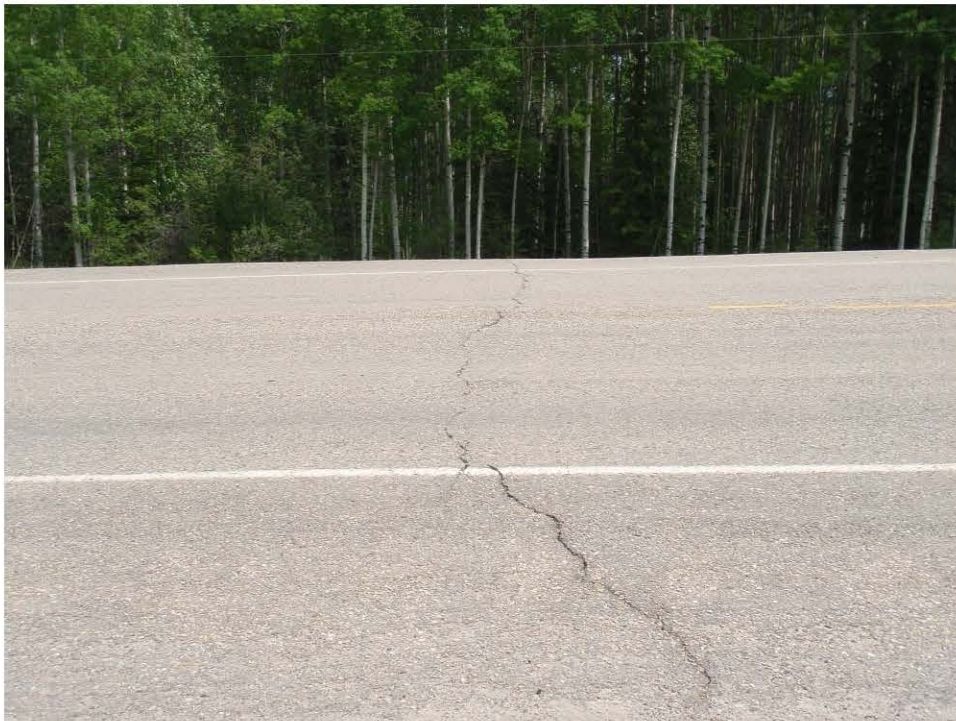
Photo 4 – Looking at transverse crack over Dip 2.

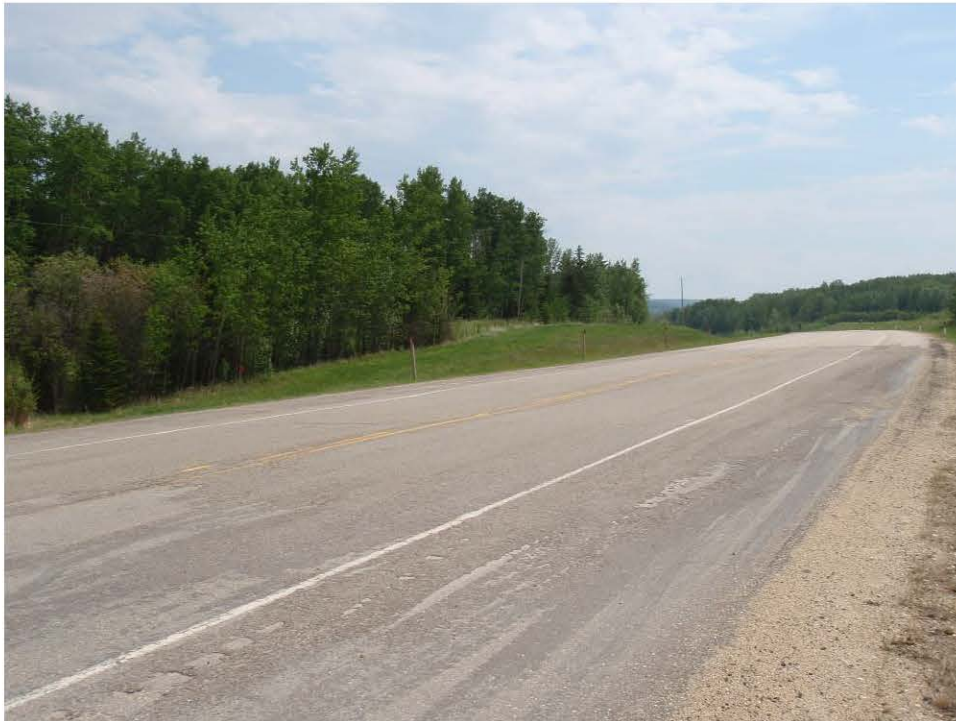
Photo 5 – Looking south at patch over Dip 3.

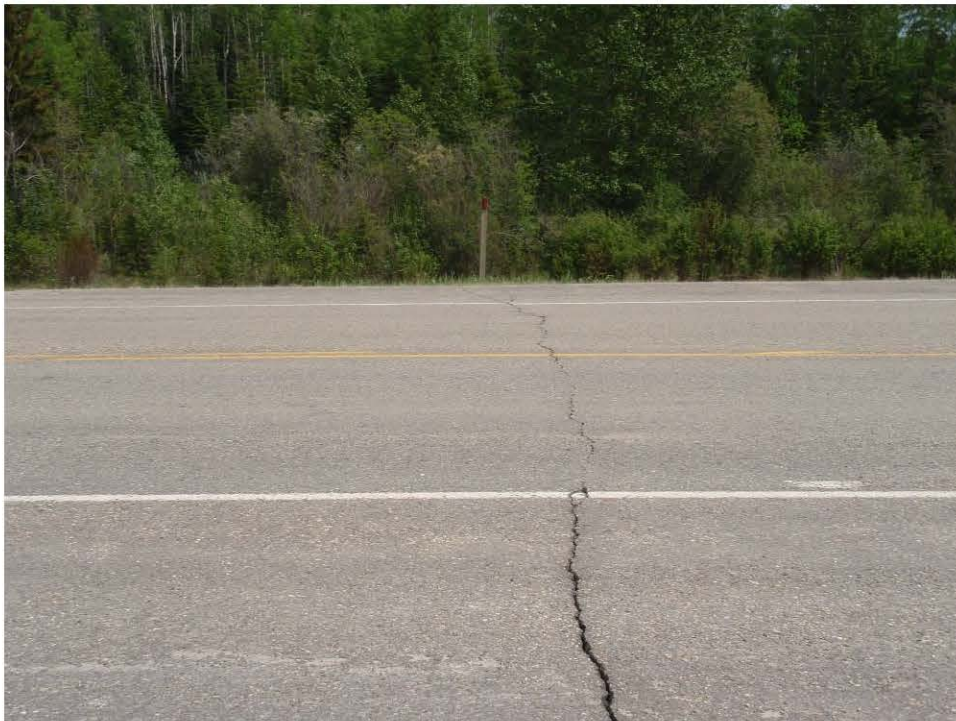
Photo 6 – Transverse crack just north of culvert at Dip 3.

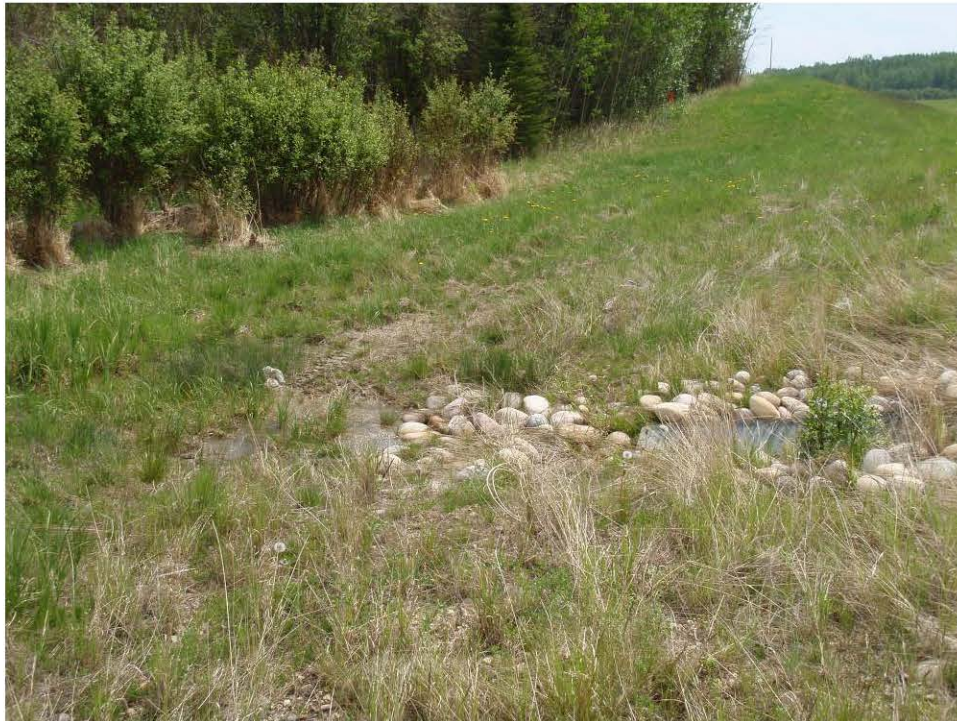
Photo 7 – Ponding water at outlet of culvert at Dip 3.

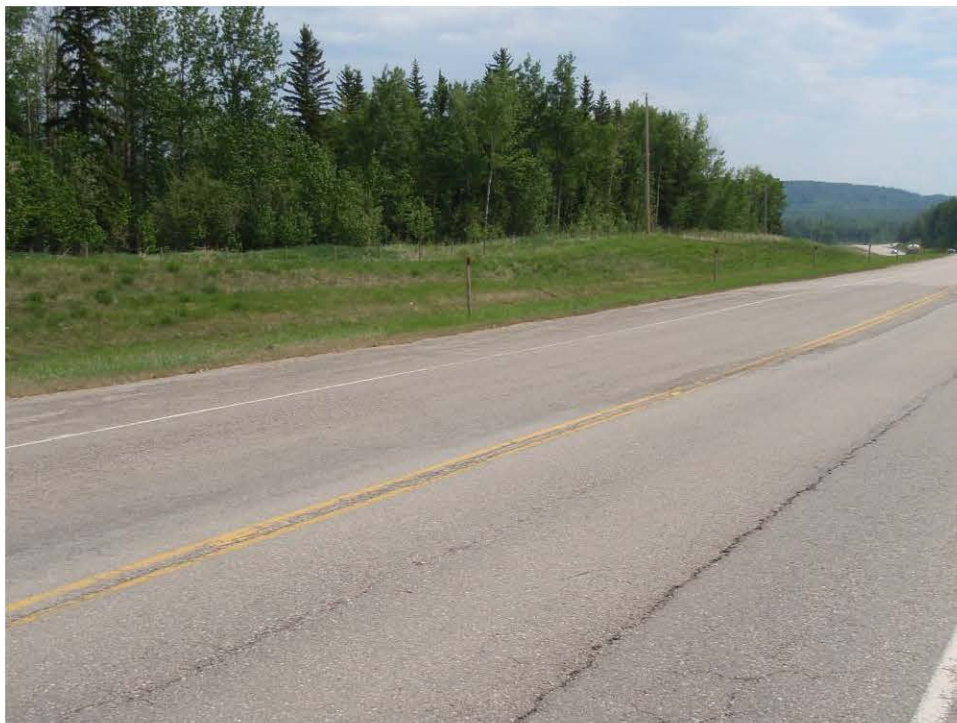
Photo 8 – Looking southeast at Dip 4.
