THURBER ENGINEERING LTD.

October 15, 2004

**NORTH CENTRAL REGION GEOHAZARD ASSESSMENT
HWY 40:28 GREGG RIVER BRIDGE (NC34)
2004 ANNUAL INSPECTION REPORT**

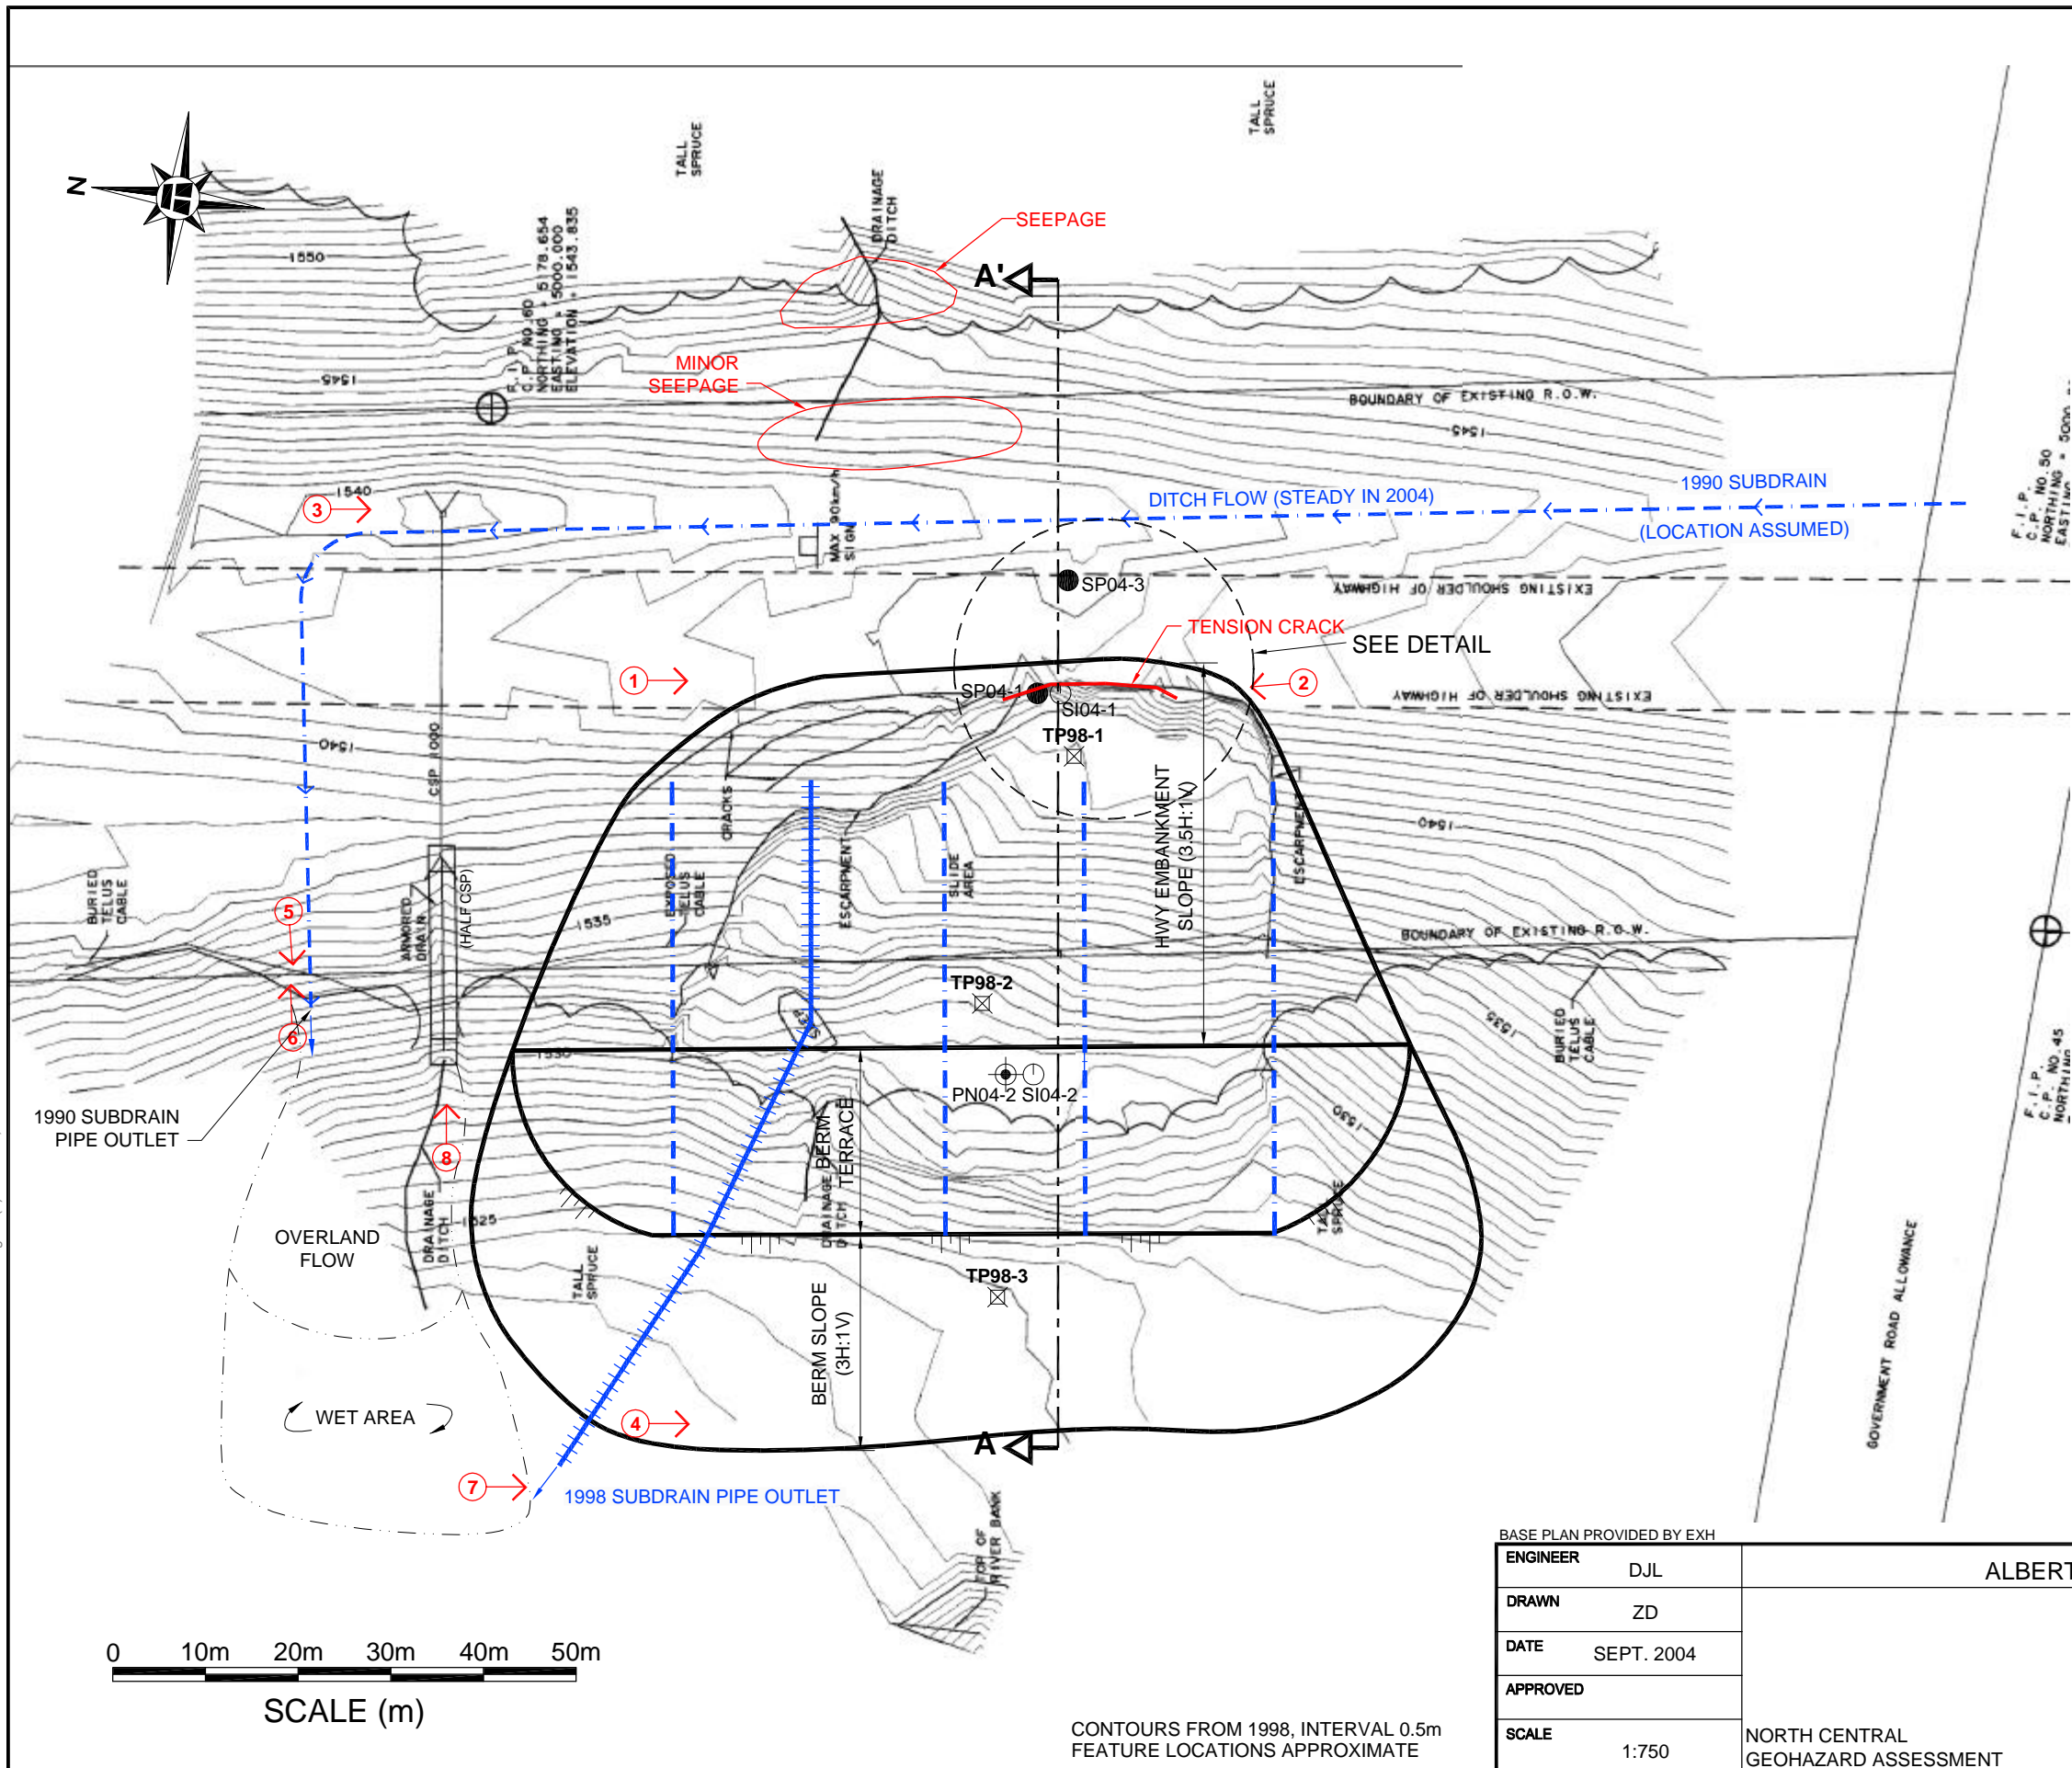
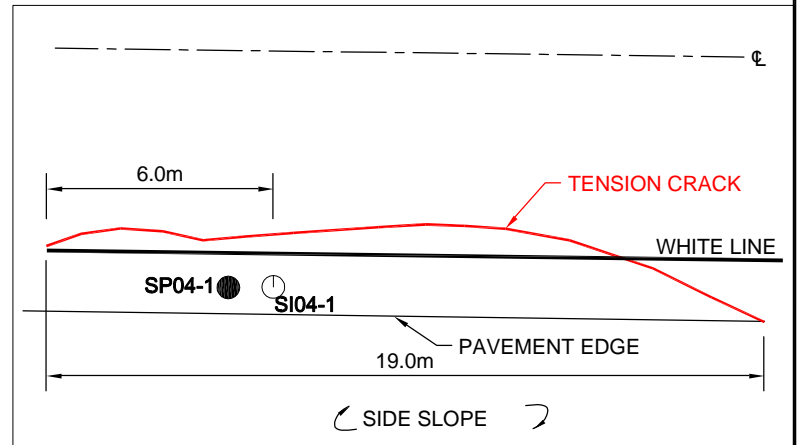
DRAWING No.
FIGURE NC34-1

Tension cracking was noted in the pavement surface over a distance of 19 m, located approximately as shown on Figure NC34-1. The crack does not extend

into the side slope. The crack was open to 10 mm in some locations, and was less defined in the central portion of its length. No differential height difference was noted across the crack. The cracking location appears coincident with the scarp of the previous failure, and is similar to that observed in the fall of 2003.

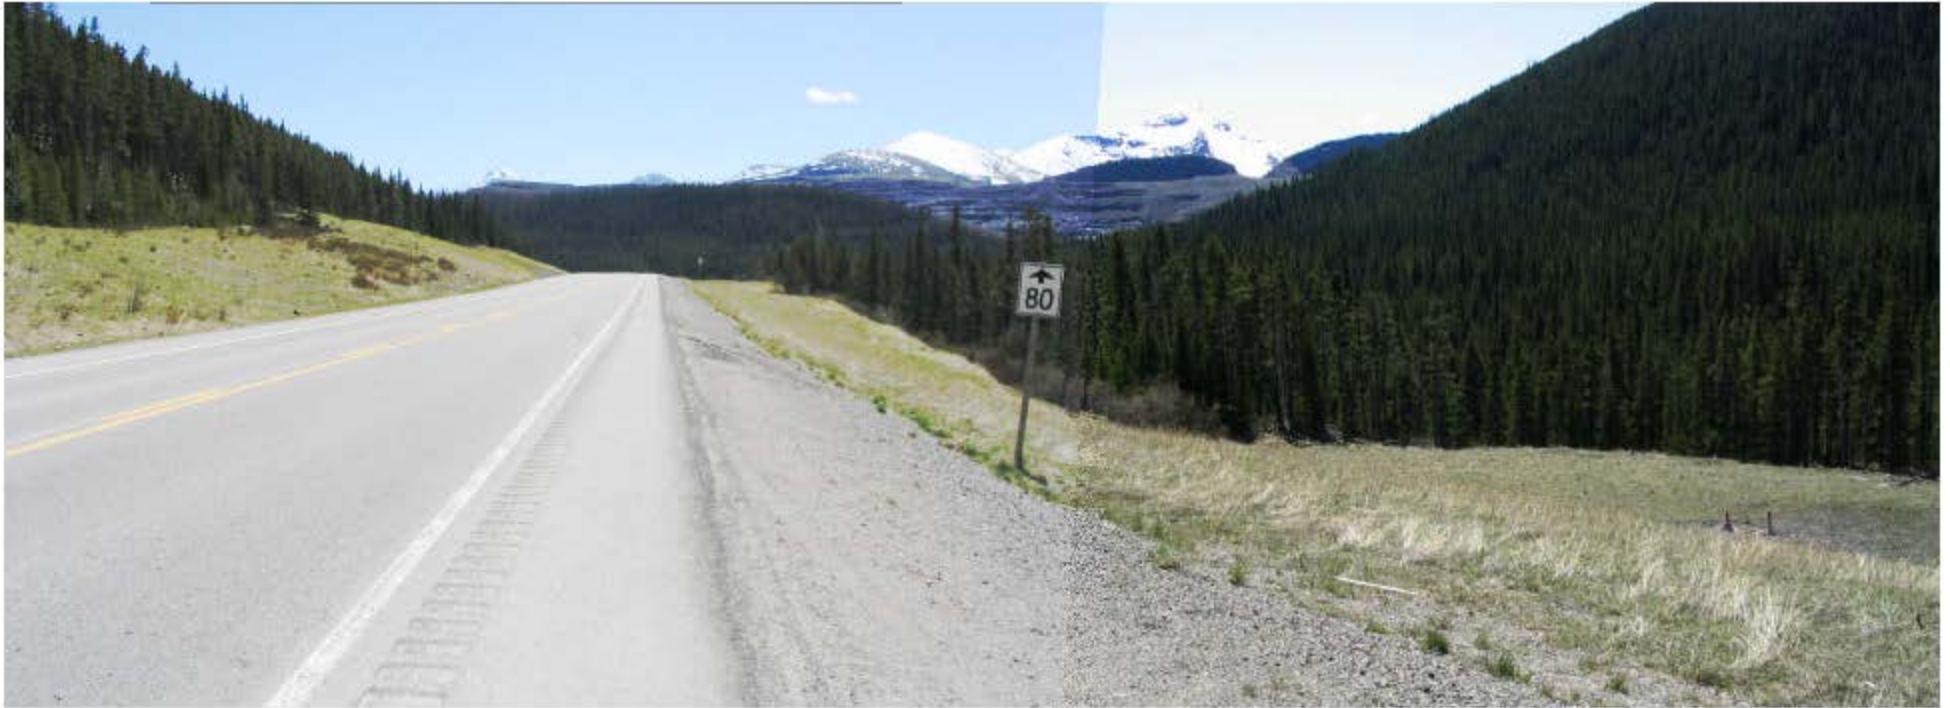
Based on the above noted observations and the results of recent instrumentation monitoring, the cracks in the roadway surface are expected to be a result of a minor reactivation of the old slide, likely due to high water levels within the slope. These movements have not registered on the slope inclinometers since the time of their installation; hence it is possible that water levels were higher in the slope last fall than those recently measured.

PHOTO 1 - PAVEMENT DISTRESS AREA (LOOKING SOUTH)

Crack filling should be undertaken to reduce the potential for surface water flow into the embankment through the tension cracks.

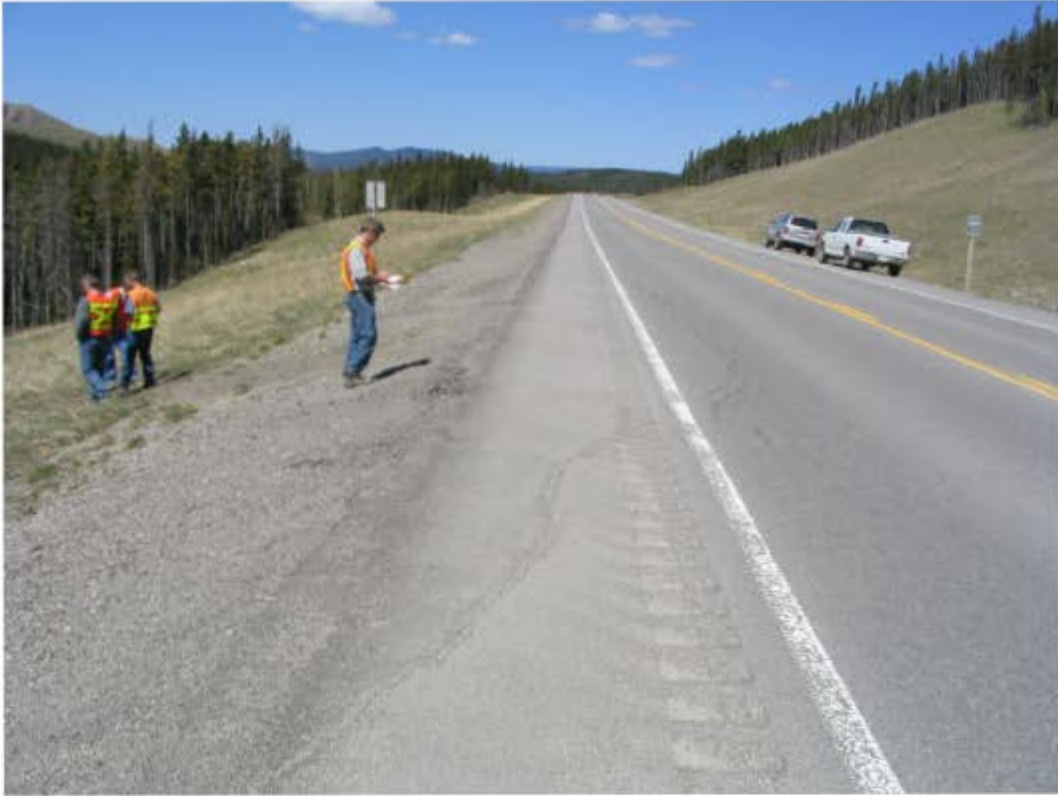
PHOTO 2 - PAVEMENT CRACKS (LOOKING NORTH)

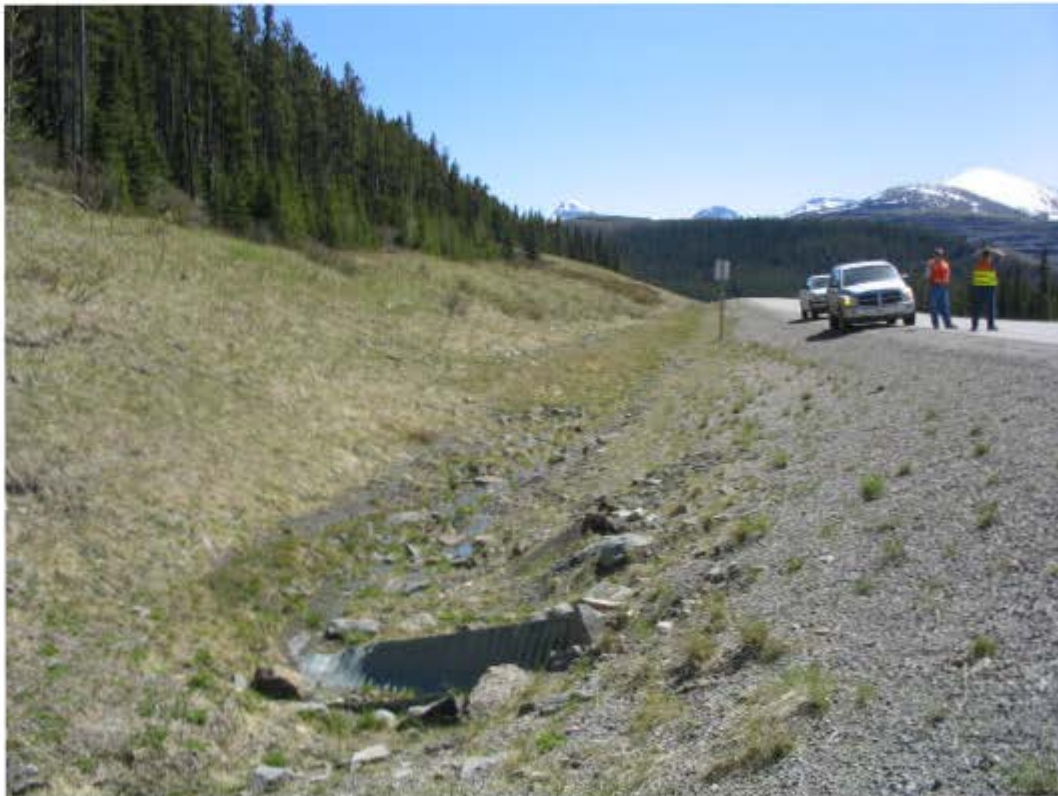
The surface flow in the east ditch is steady and originates from a small creek located in the back slope approximately 150 m to 200 m south of the slide area. The flow from the creek enters the ditch at its crest, and approximately 20% of the flow travels south with the remainder flowing north toward the slide area.

Flow from the east ditch is transmitted to the west side of the highway through the 1000 mm diameter centerline culvert located north of the slide area as shown on the site plan. The outlet spills into an open half round culvert to a point partway down the side slope, and travels overland from there.

PHOTO 3 - EAST DITCH LOOKING SOUTH
(CENTERLINE CULVERT INLET IN FOREGROUND)

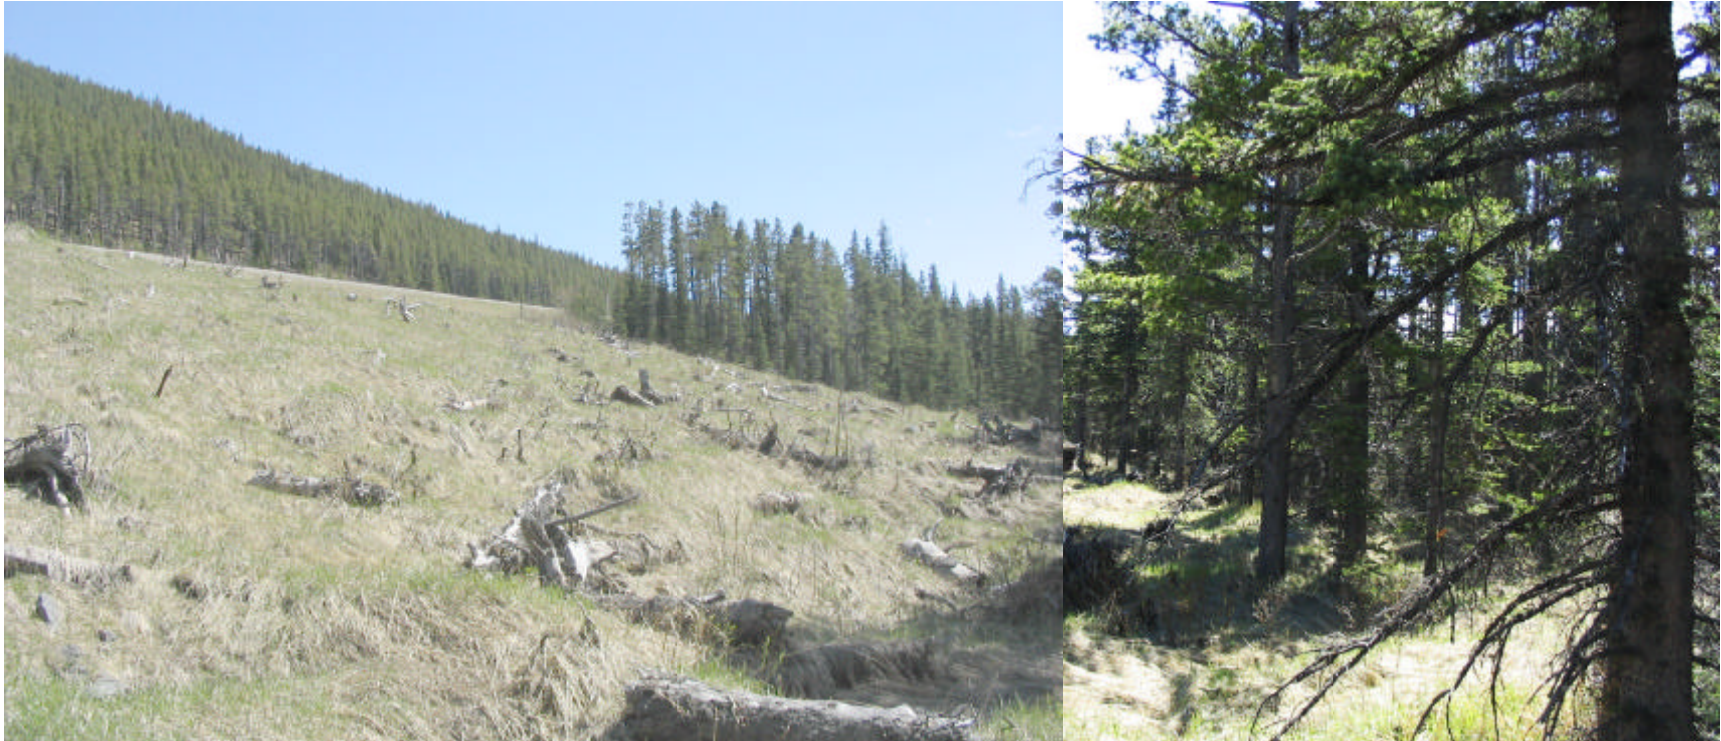
There was no indication of slope failure in the side slope or toe berm area.

PHOTO 4 - TOE BERM AND TOE AREA (LOOKING SOUTH)

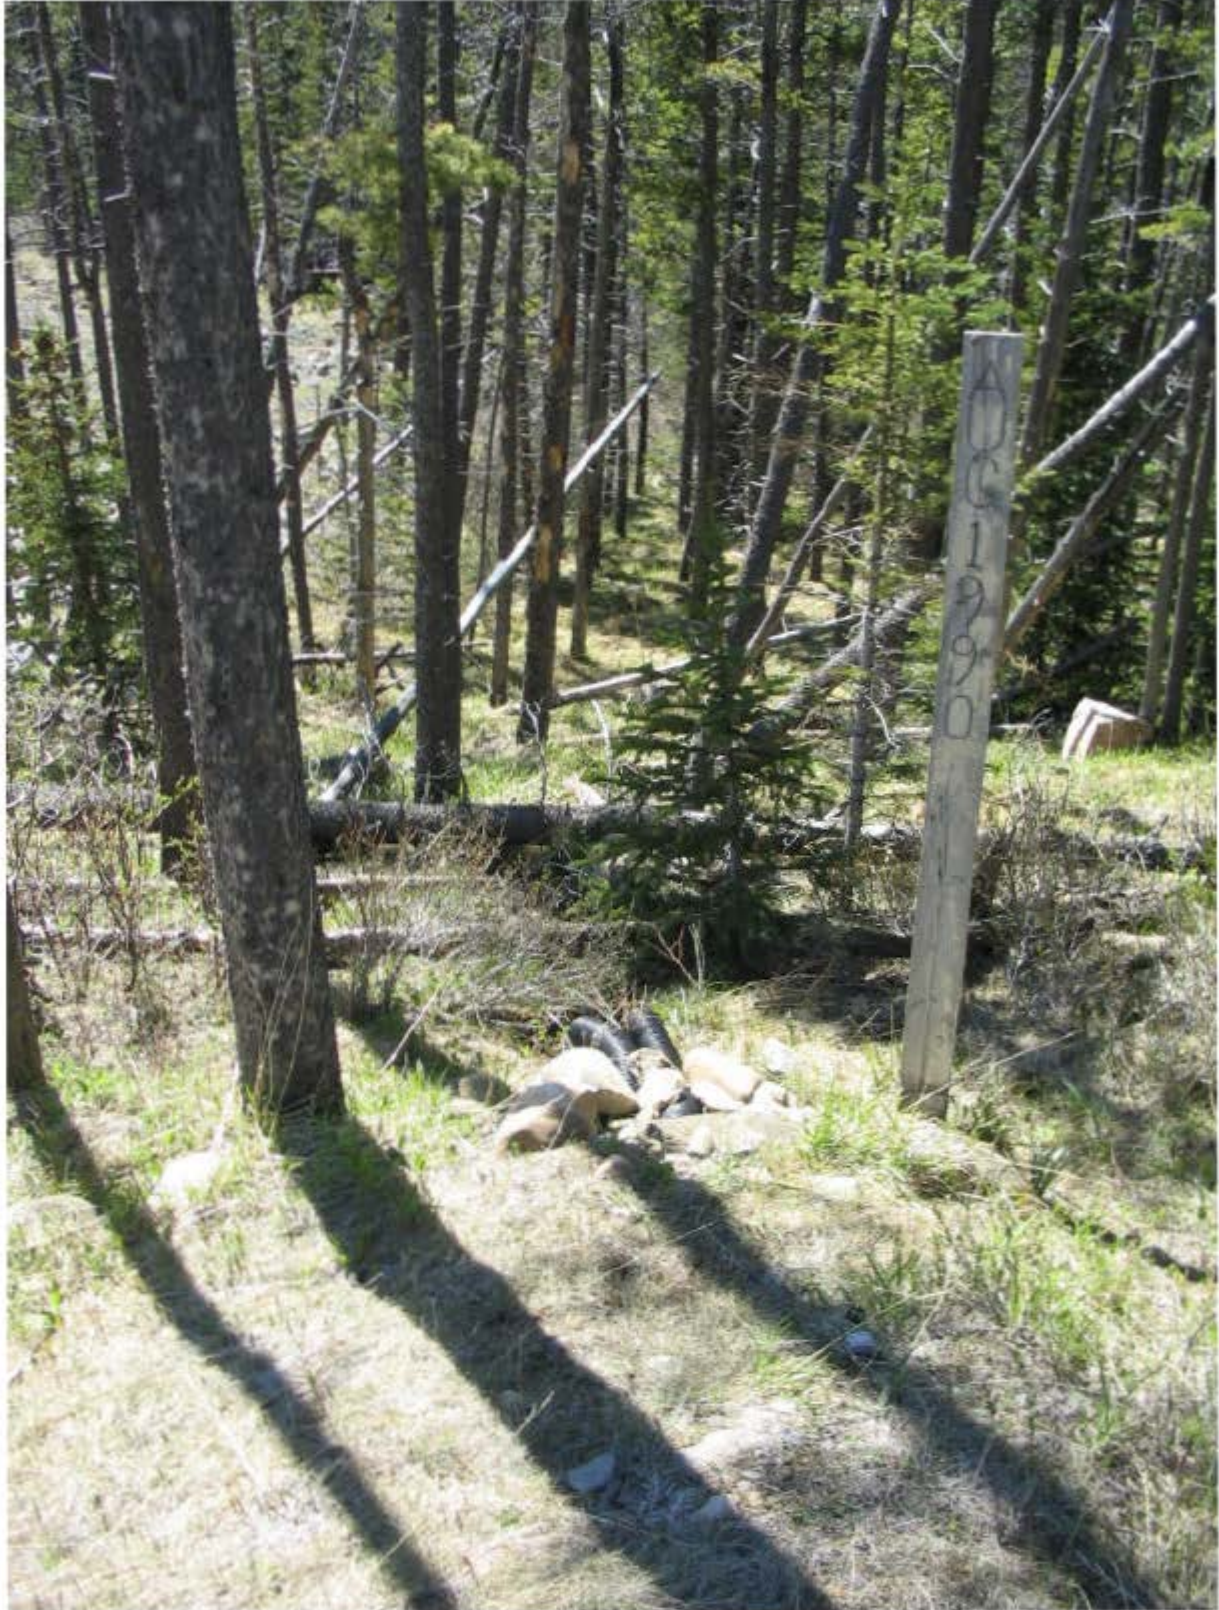
Significant flow (10 to 15 litres per minute) was noted from the outlet of the CSP subdrain installed during the 1998 construction, located northwest of the toe berm. In addition, approximately 4 litres per minute of flow was observed from each of the two subdrain outlets installed in August 1990 (sign post on site). Flow from these sources travels overland and pools near the toe of the slope to the north of the toe berm (wet area shown on the site plan), where it infiltrates into the ground surface. The flow from the half round culvert discussed previously also flows into this area.

PHOTO 5 - 1990 SUBDRAIN OUTLET (LOOKING WEST)

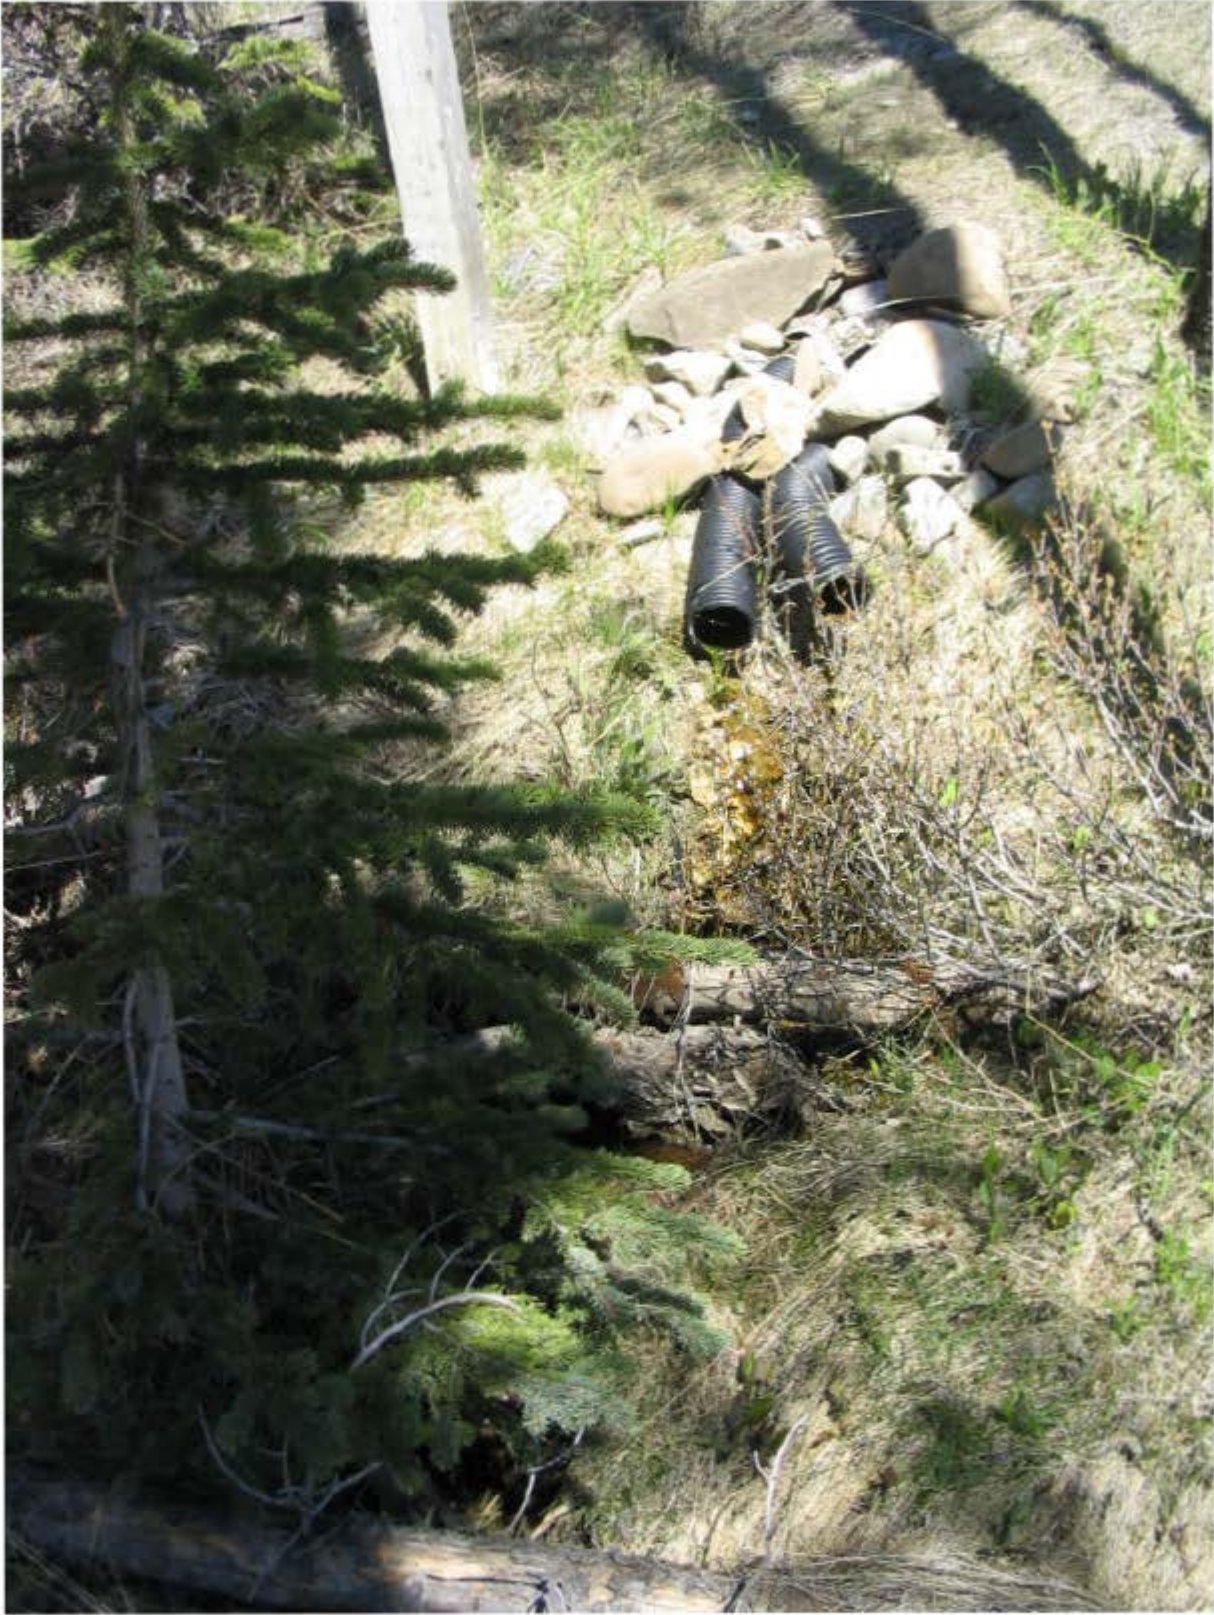
PHOTO 6 - 1990 SUBDRAIN OUTLET (LOOKING EAST)

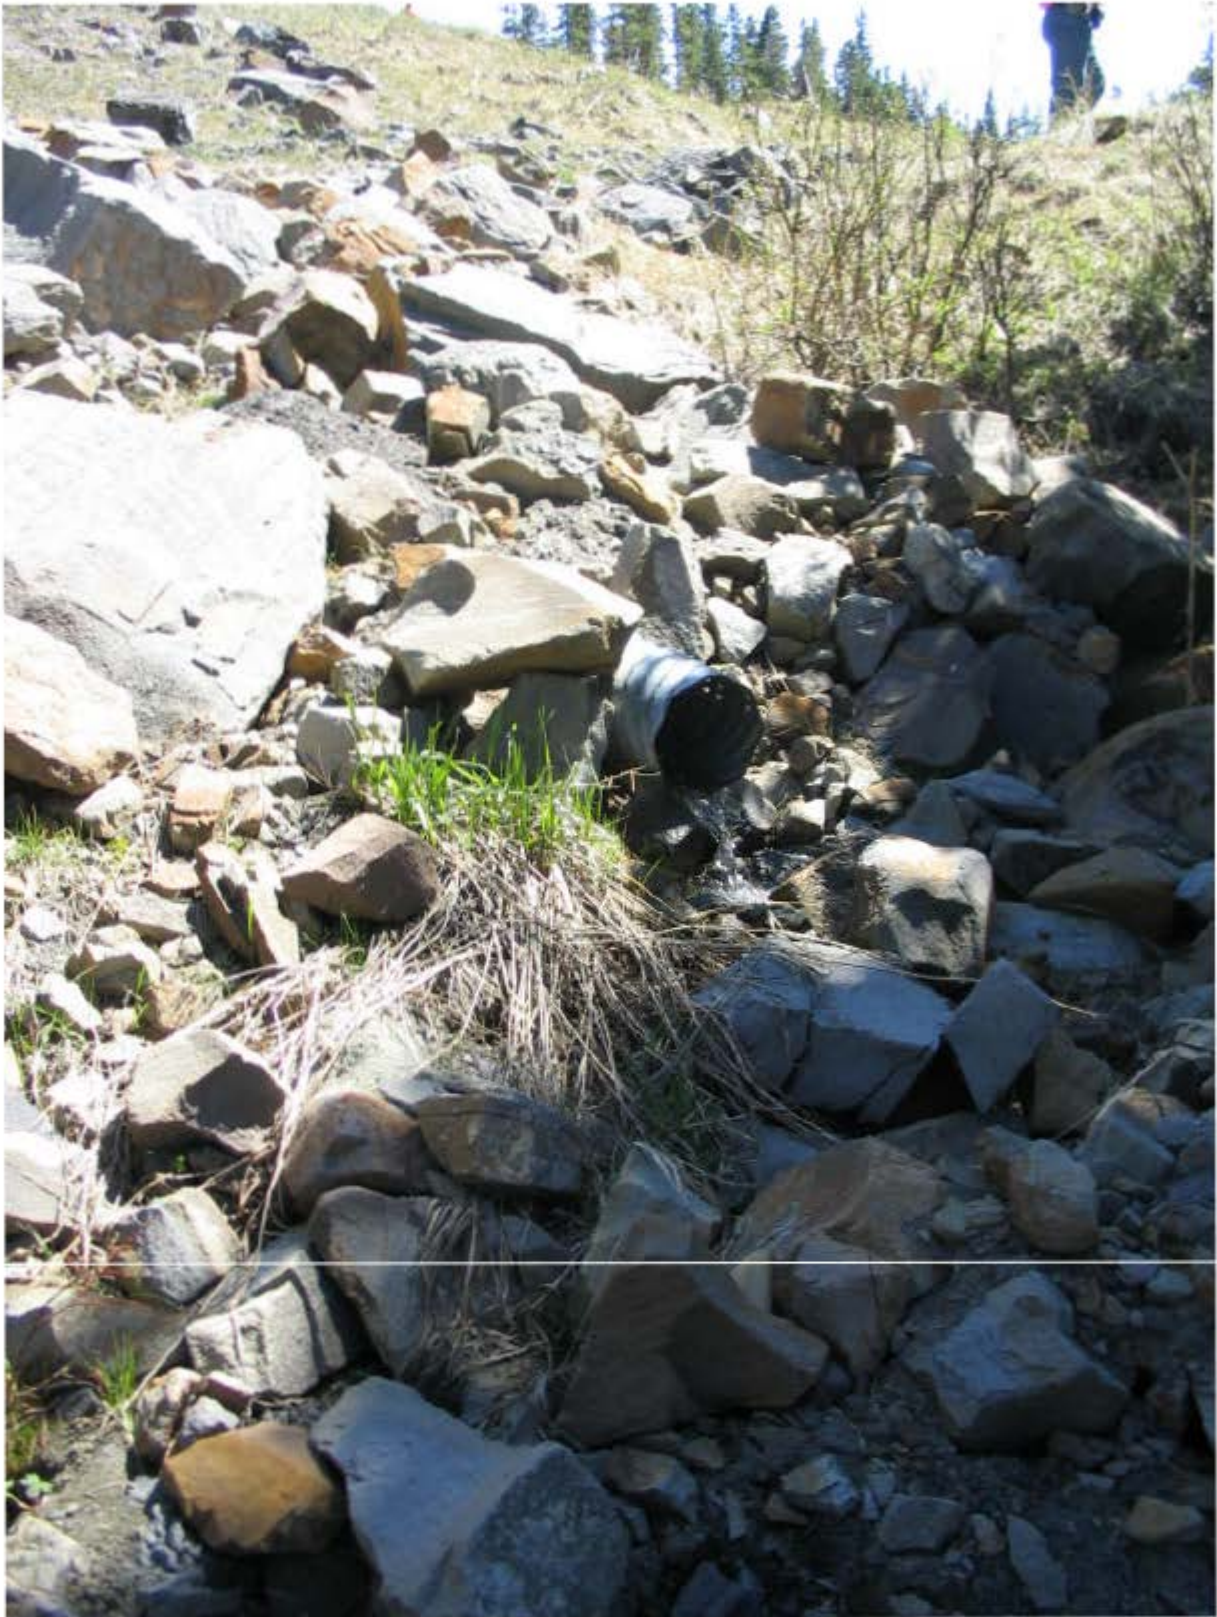
PHOTO 7 - 1998 SUBDRAIN OUTLET (LOOKING SOUTH))

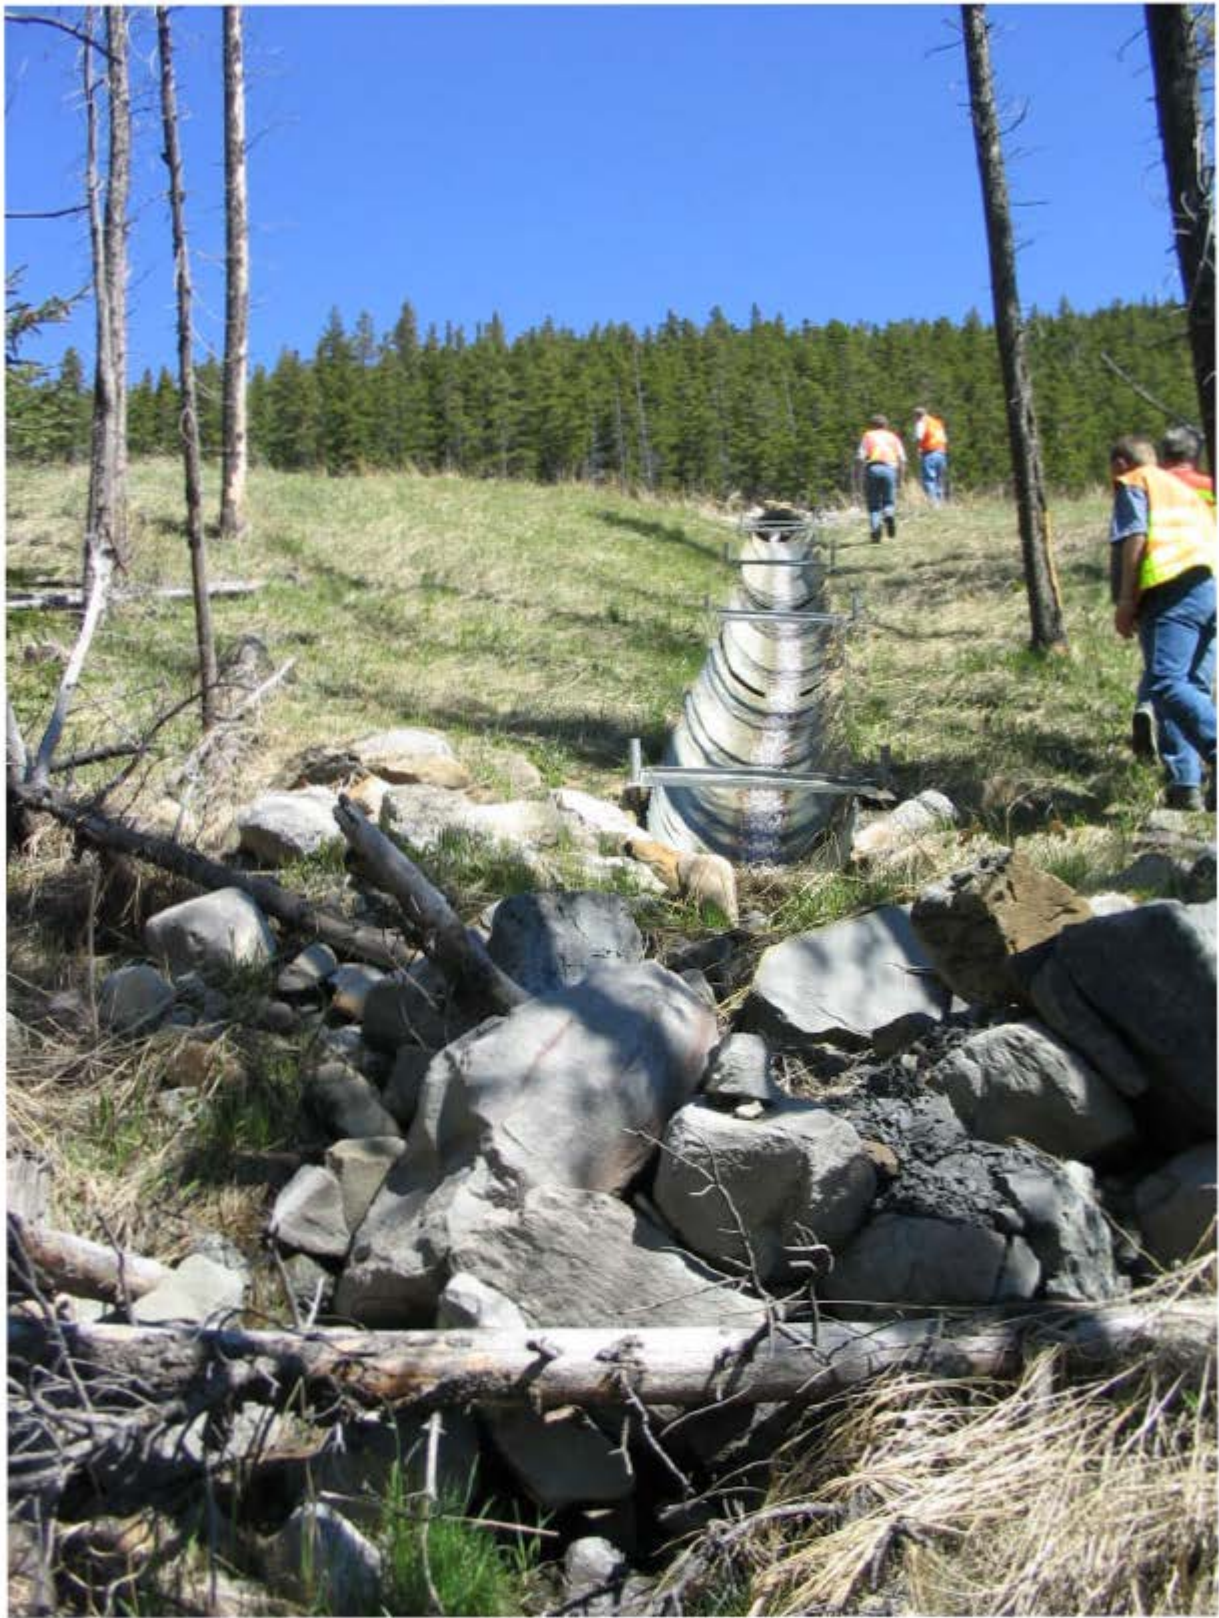
PHOTO 8 - HALF ROUND CULVERT FLOW FROM EAST DITCH (LOOKING EAST)
