November 30, 2005

File: 15-85-11

**NORTH CENTRAL REGION GEOHAZARD ASSESSMENT
HWY 40:28 GREGG RIVER BRIDGE (NC34)
2005 ANNUAL INSPECTION REPORT**

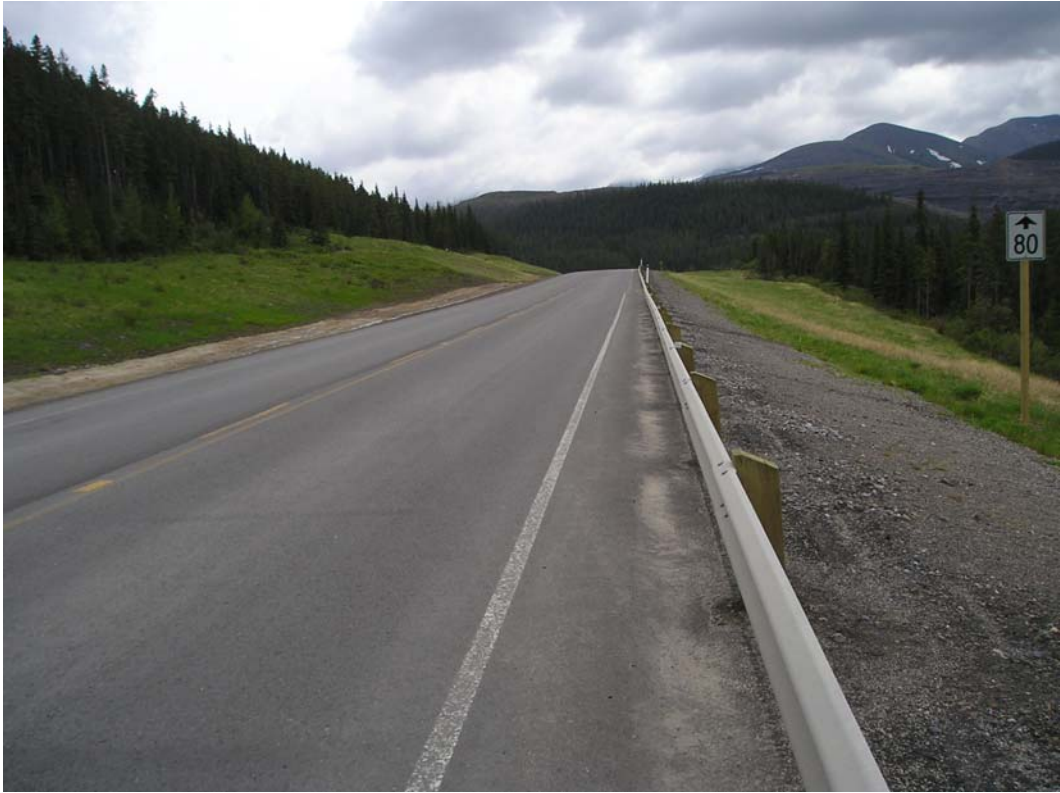
The roadway surface had been overlaid with asphalt through this area in the fall of 2004. No signs of cracking were noted in the pavement surface at the previous slide area. In addition, there was no indication of slope failure in the side slope or toe berm areas.

Photo 1 – Previous slide area looking south.

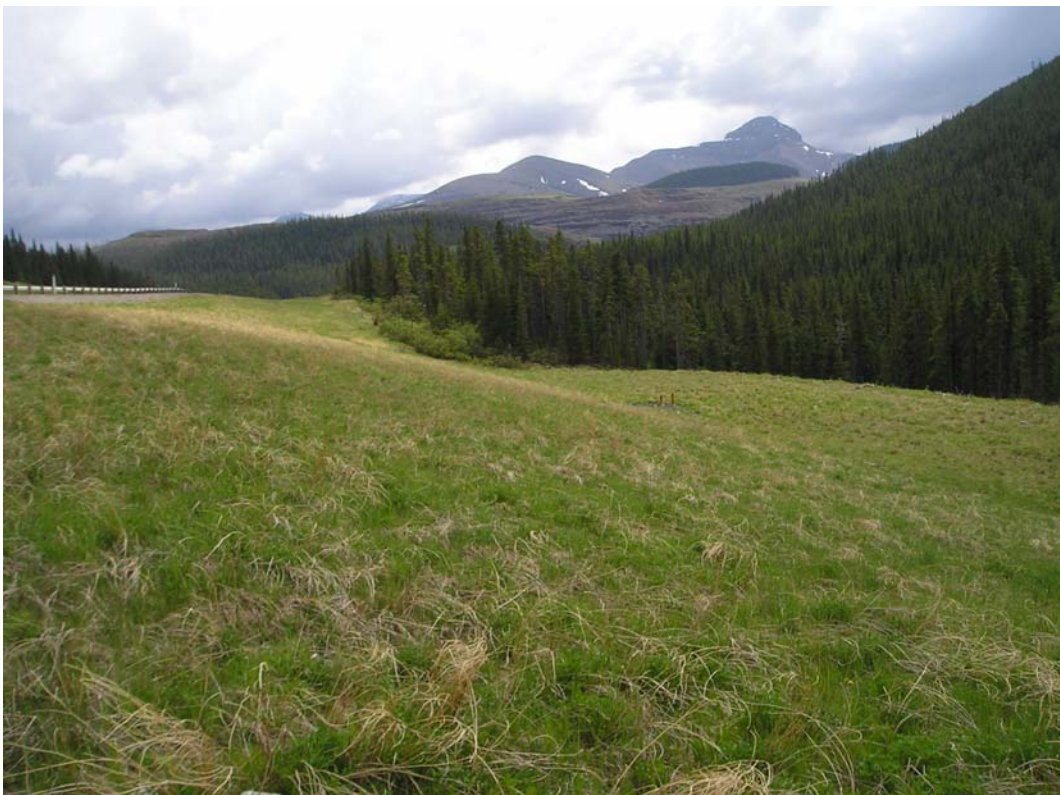
A new guardrail adjacent to the side slope in the area of previous distress was added as part of the overlay project.

Photo 2 – Looking south at repaired side slope.

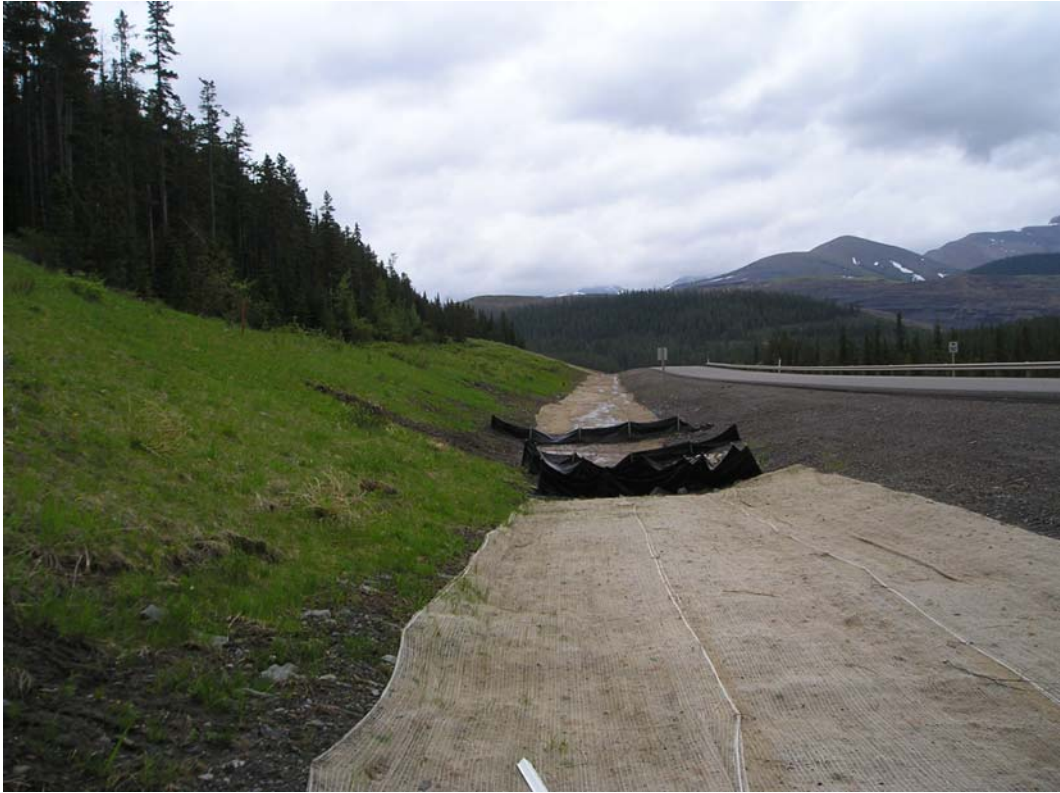
The east ditch had been regraded as part of the overlay program through the area, and included a clay cap and erosion control soil covering on the ditch bottom. The existing grade in the ditch is relatively flat and drains north by the slide area to a centerline culvert with a 1 m diameter located north of the slide area as shown on the site plan. The flow in the ditch is relatively steady, with areas of ponded water observed within the ditch due to its relatively small gradient.

Photo 3 – East ditch (looking south, culvert inlet in foreground) June 1, 2005

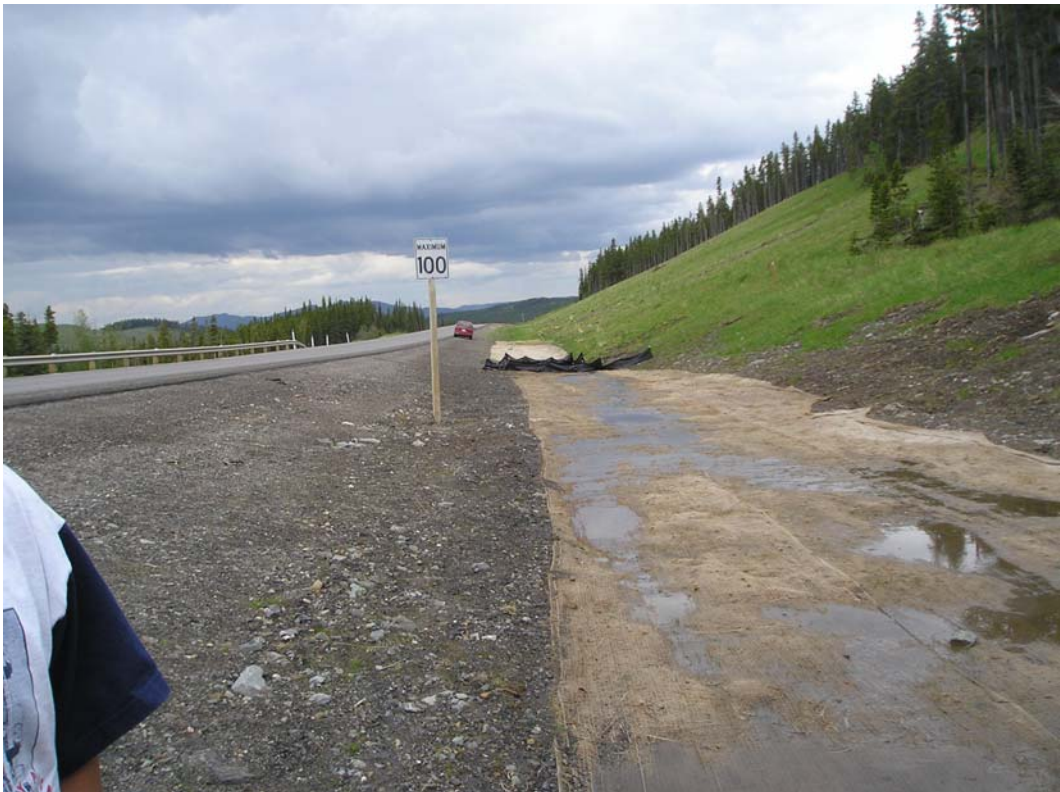
Photo 4 – Ponded water in east ditch (looking north). June 1, 2005

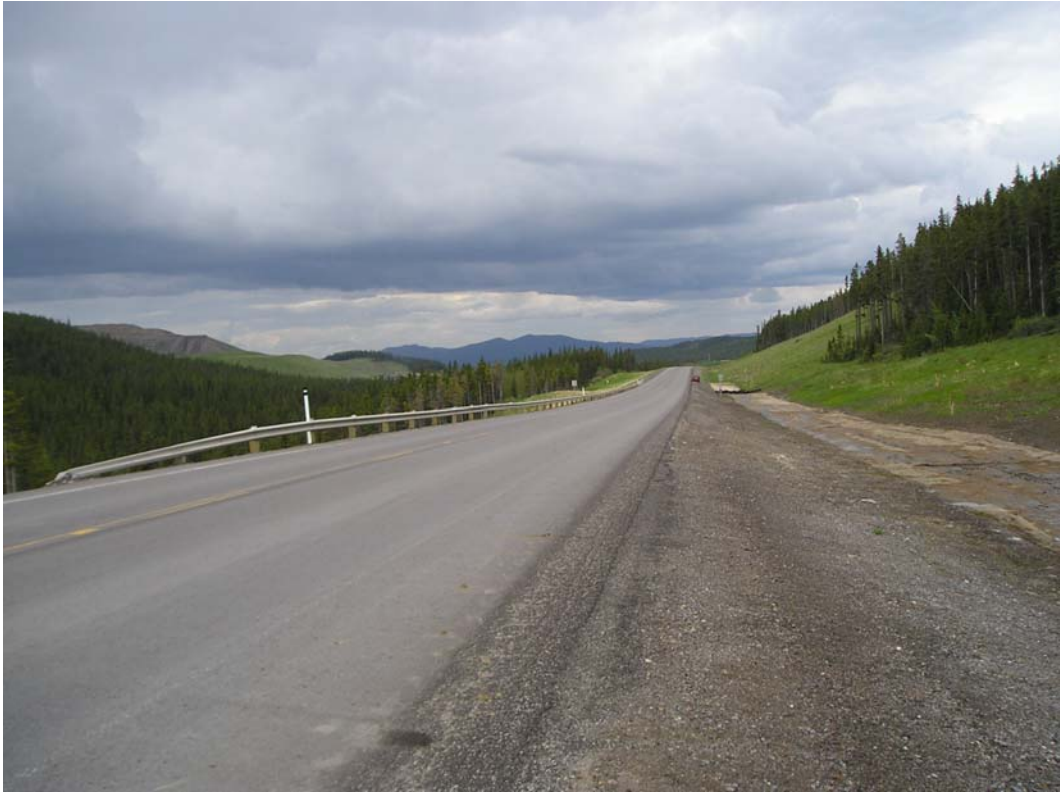
Photo 5 – East ditch and pavement surface (looking north). June 1, 2005

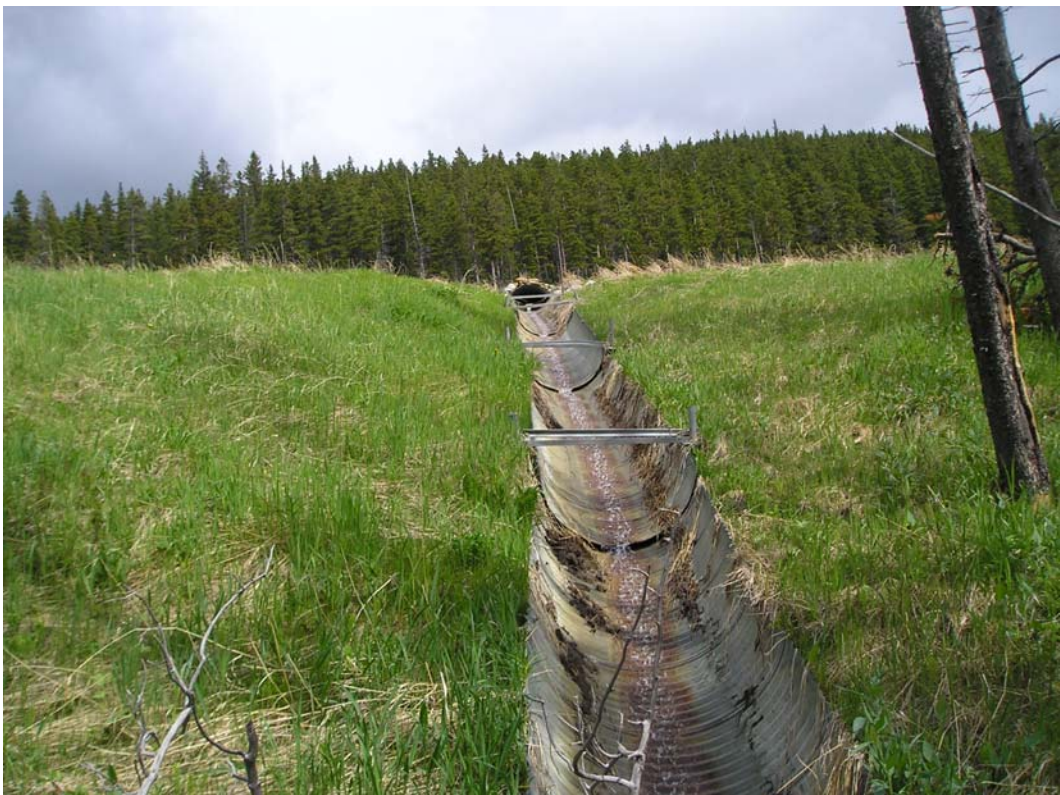
Flow through the culvert located north of the slide area spills into an open half round culvert to a point partway down the side slope, and travels overland from there. The flow rate at the end of the half round down pipe was estimated to be about 20 litres per minute.

Photo 6 – Half round culvert flow from east ditch (looking east) June 1, 2005
