**NORTH CENTRAL - EDSON**  
**GEOHAZARD RISK ASSESSMENT**  
**SITE INSPECTION FORM**

SITE NUMBER AND NAME: <b>NC30 Rochfort Bridge</b>		HIGHWAY & KM Hwy 759:04 km4.8	PREVIOUS INSPECTION DATE: May 22, 2007	INSPECTION DATE: June 10, 2008
LEGAL DESCRIPTION: NE5-57-7-W5M	UTM COORDINATES (NAD83): 11 N5,974,472.6 E631,654.3		RISK ASSESSMENT PF: 1 CF: 3 TOTAL: 3

NORTH CENTRAL (EDSON) 2008  
GEOHAZARD ASSESSMENTS  
ROCHFORD BRIDGE (COOPER'S FLATS), AB

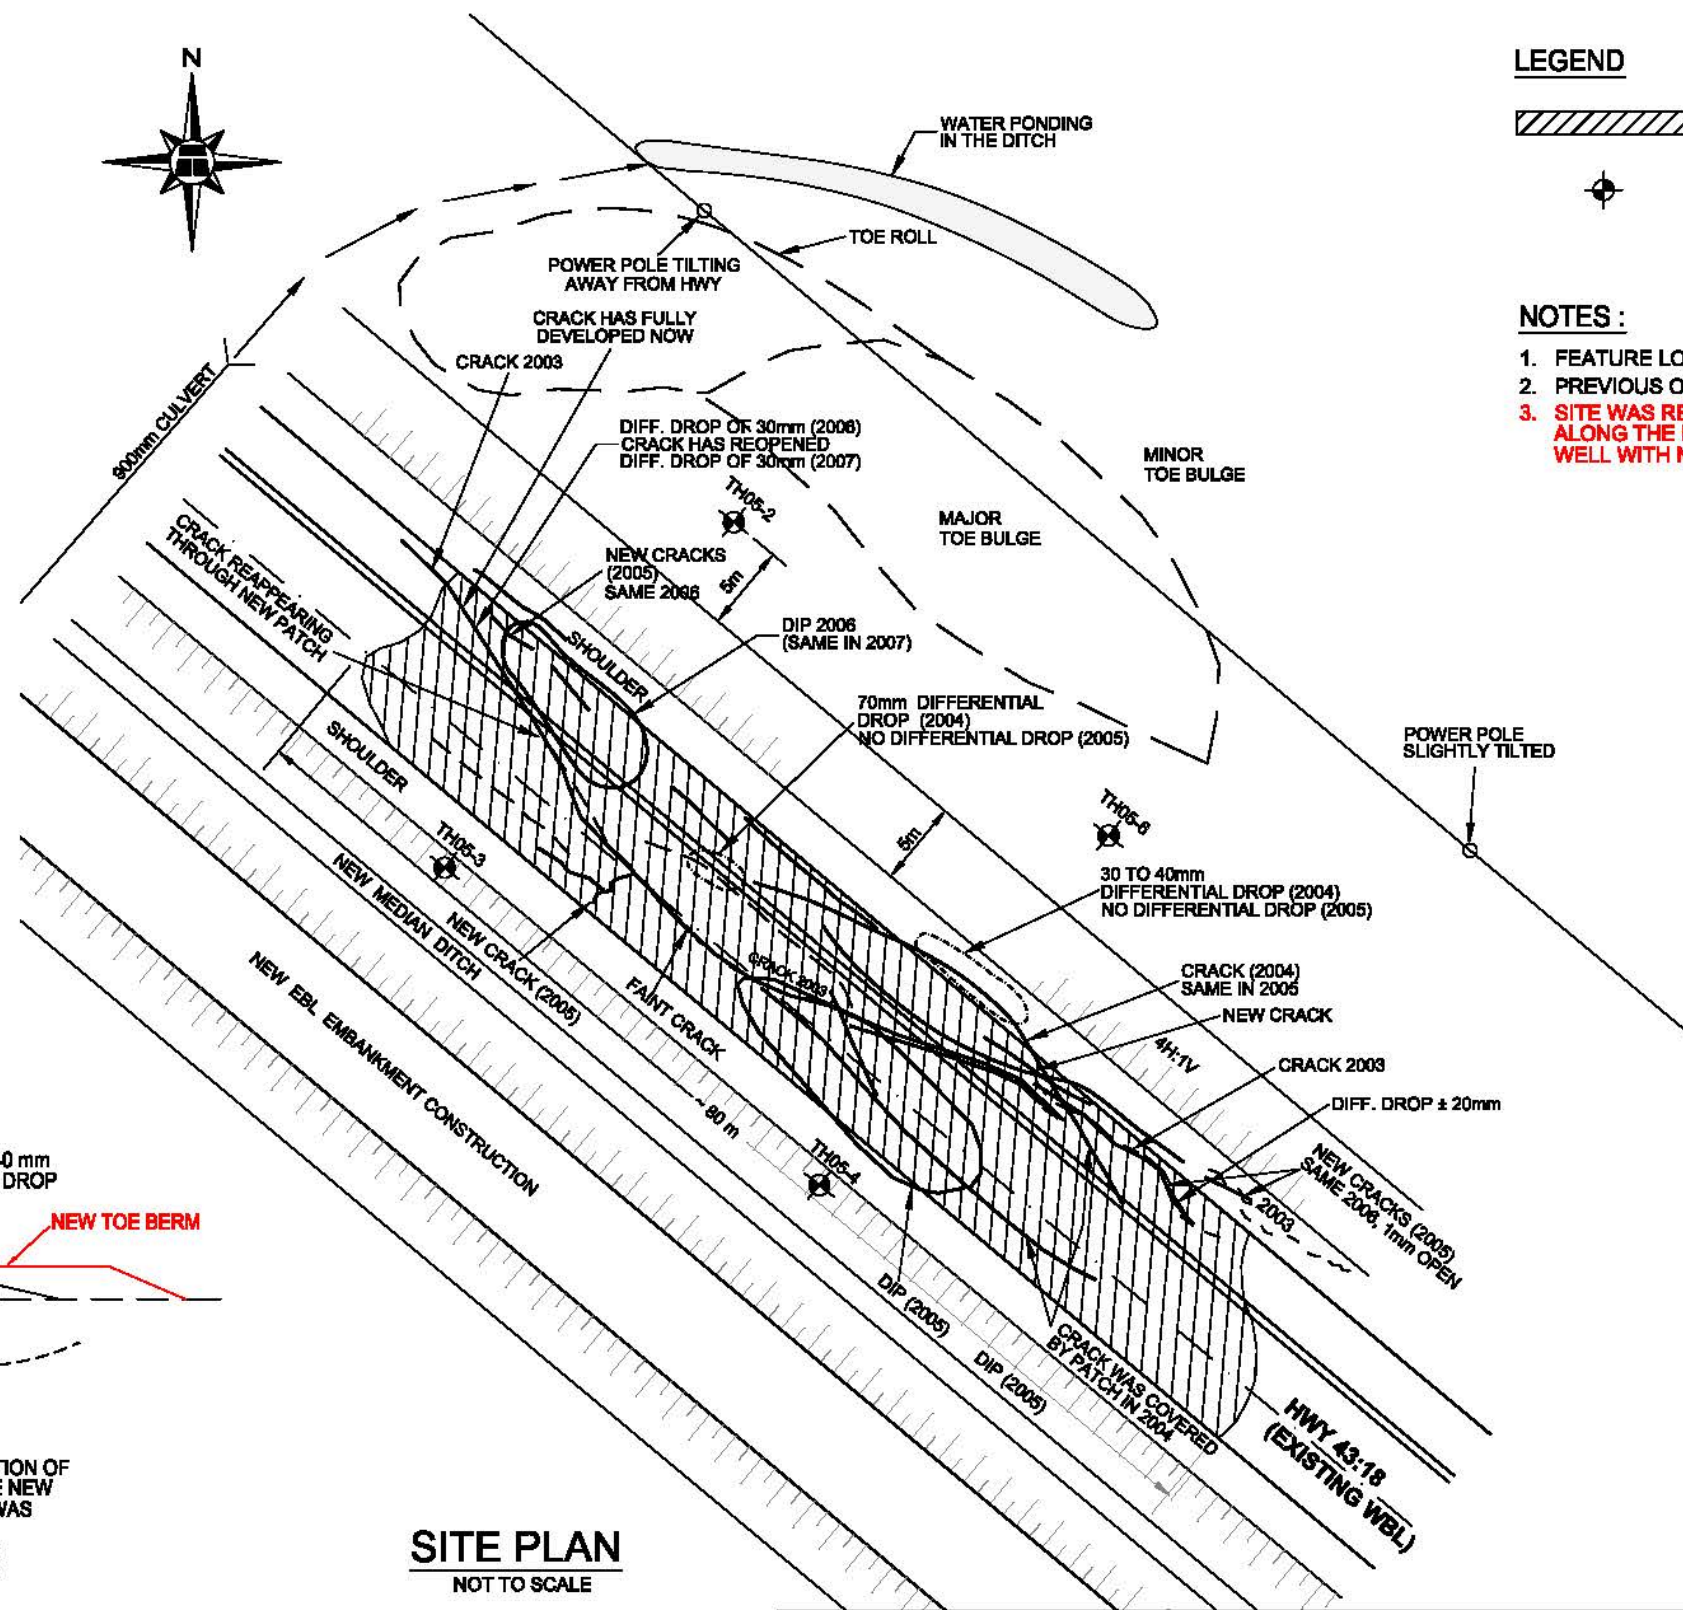
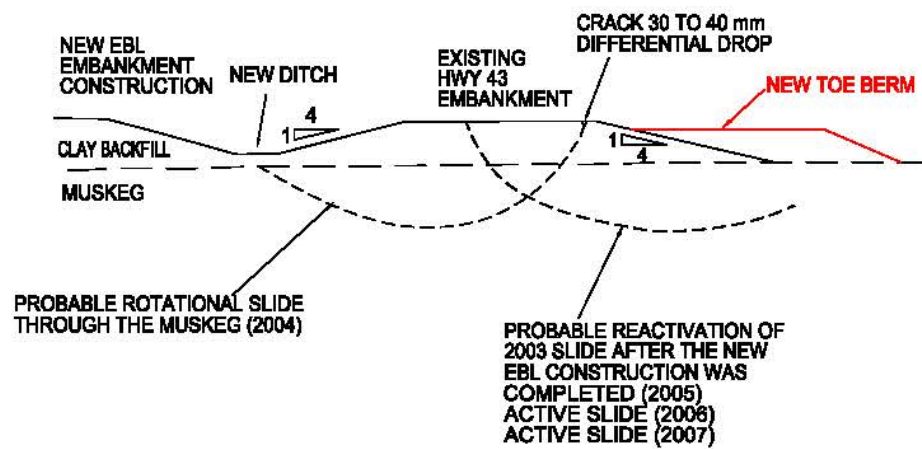
ENGINEER:	RVC	DRAWN:	CMH	APPROVED:	DWP
DATE:	JUNE, 2008	SCALE:	N.T.S.	DRAWING No.:	FIGURE NC30-1

COMMENTS (Refer to Figure NC30-1):  
The site was remediated with a toe berm constructed along the northeast sideslope.

1. FEATURE LOCATIONS ARE APPROXIMATE.
2. PREVIOUS OBSERVATIONS SHOWN IN BLACK
3. SITE WAS REPAIRED IN 2007 WITH A TOE BERM PLACED ALONG THE NORTHEAST SIDESLOPE. SITE IS PERFORMING WELL WITH NO PAVEMENT DISTRESS.

RECOMMENDATIONS:  
The remediation repair is performing well with no need of additional action.  
This site should be discontinued from the program.

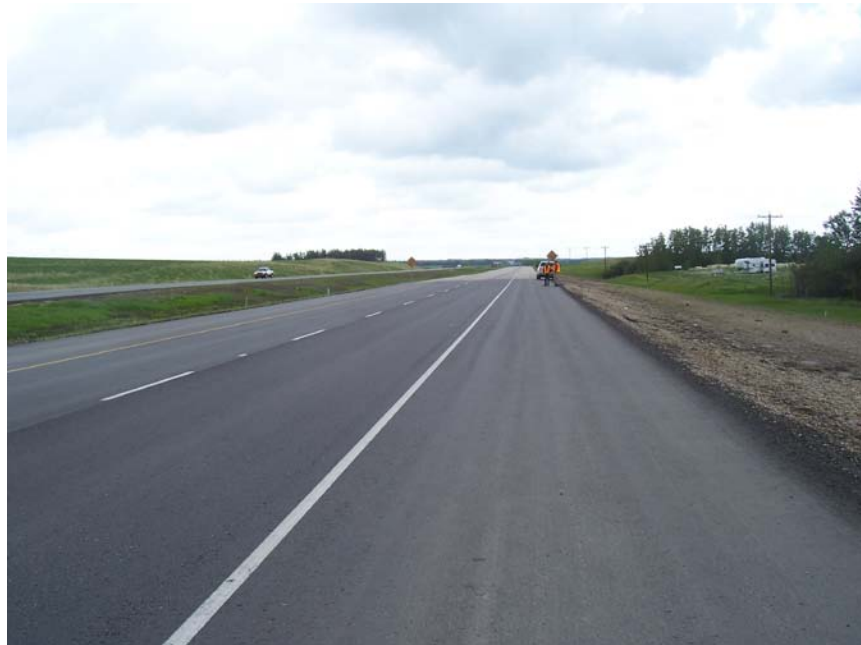
Photo 1 – New pavement overlay.

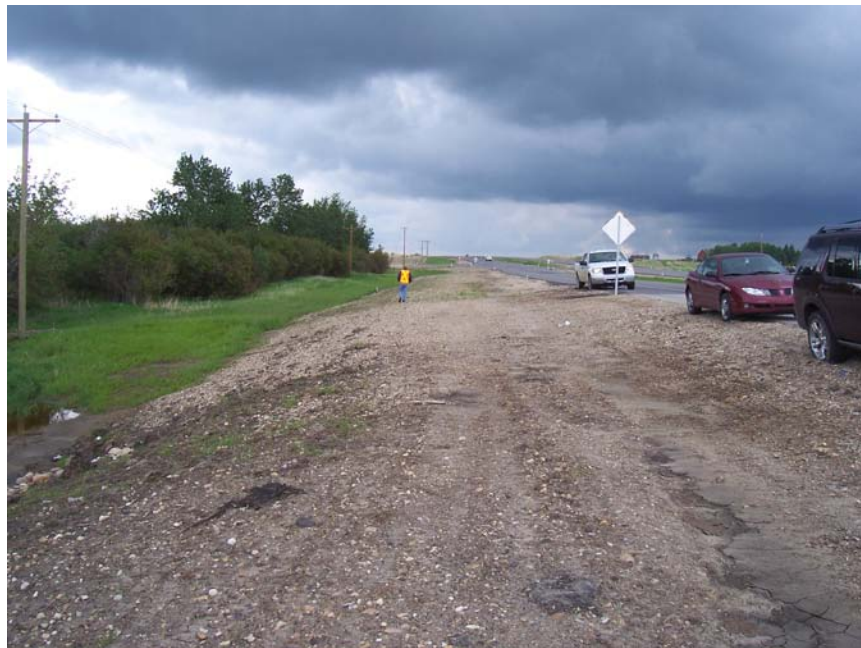
Photo 2 – New toe berm.
