GEOHAZARD ASSESSMENT PROGRAM

NORTH CENTRAL REGION – EDSON

2009 INSPECTION

Site Number	Location	Name	Hwy	km
NC30	Near Mayerthorpe, AB	Rochfort Bridge	43:18	9.5
Legal Description		UTM Co-ordinates		
NE¼ 05-57-7 W5M		11U E 631654.3	N 5974472.6

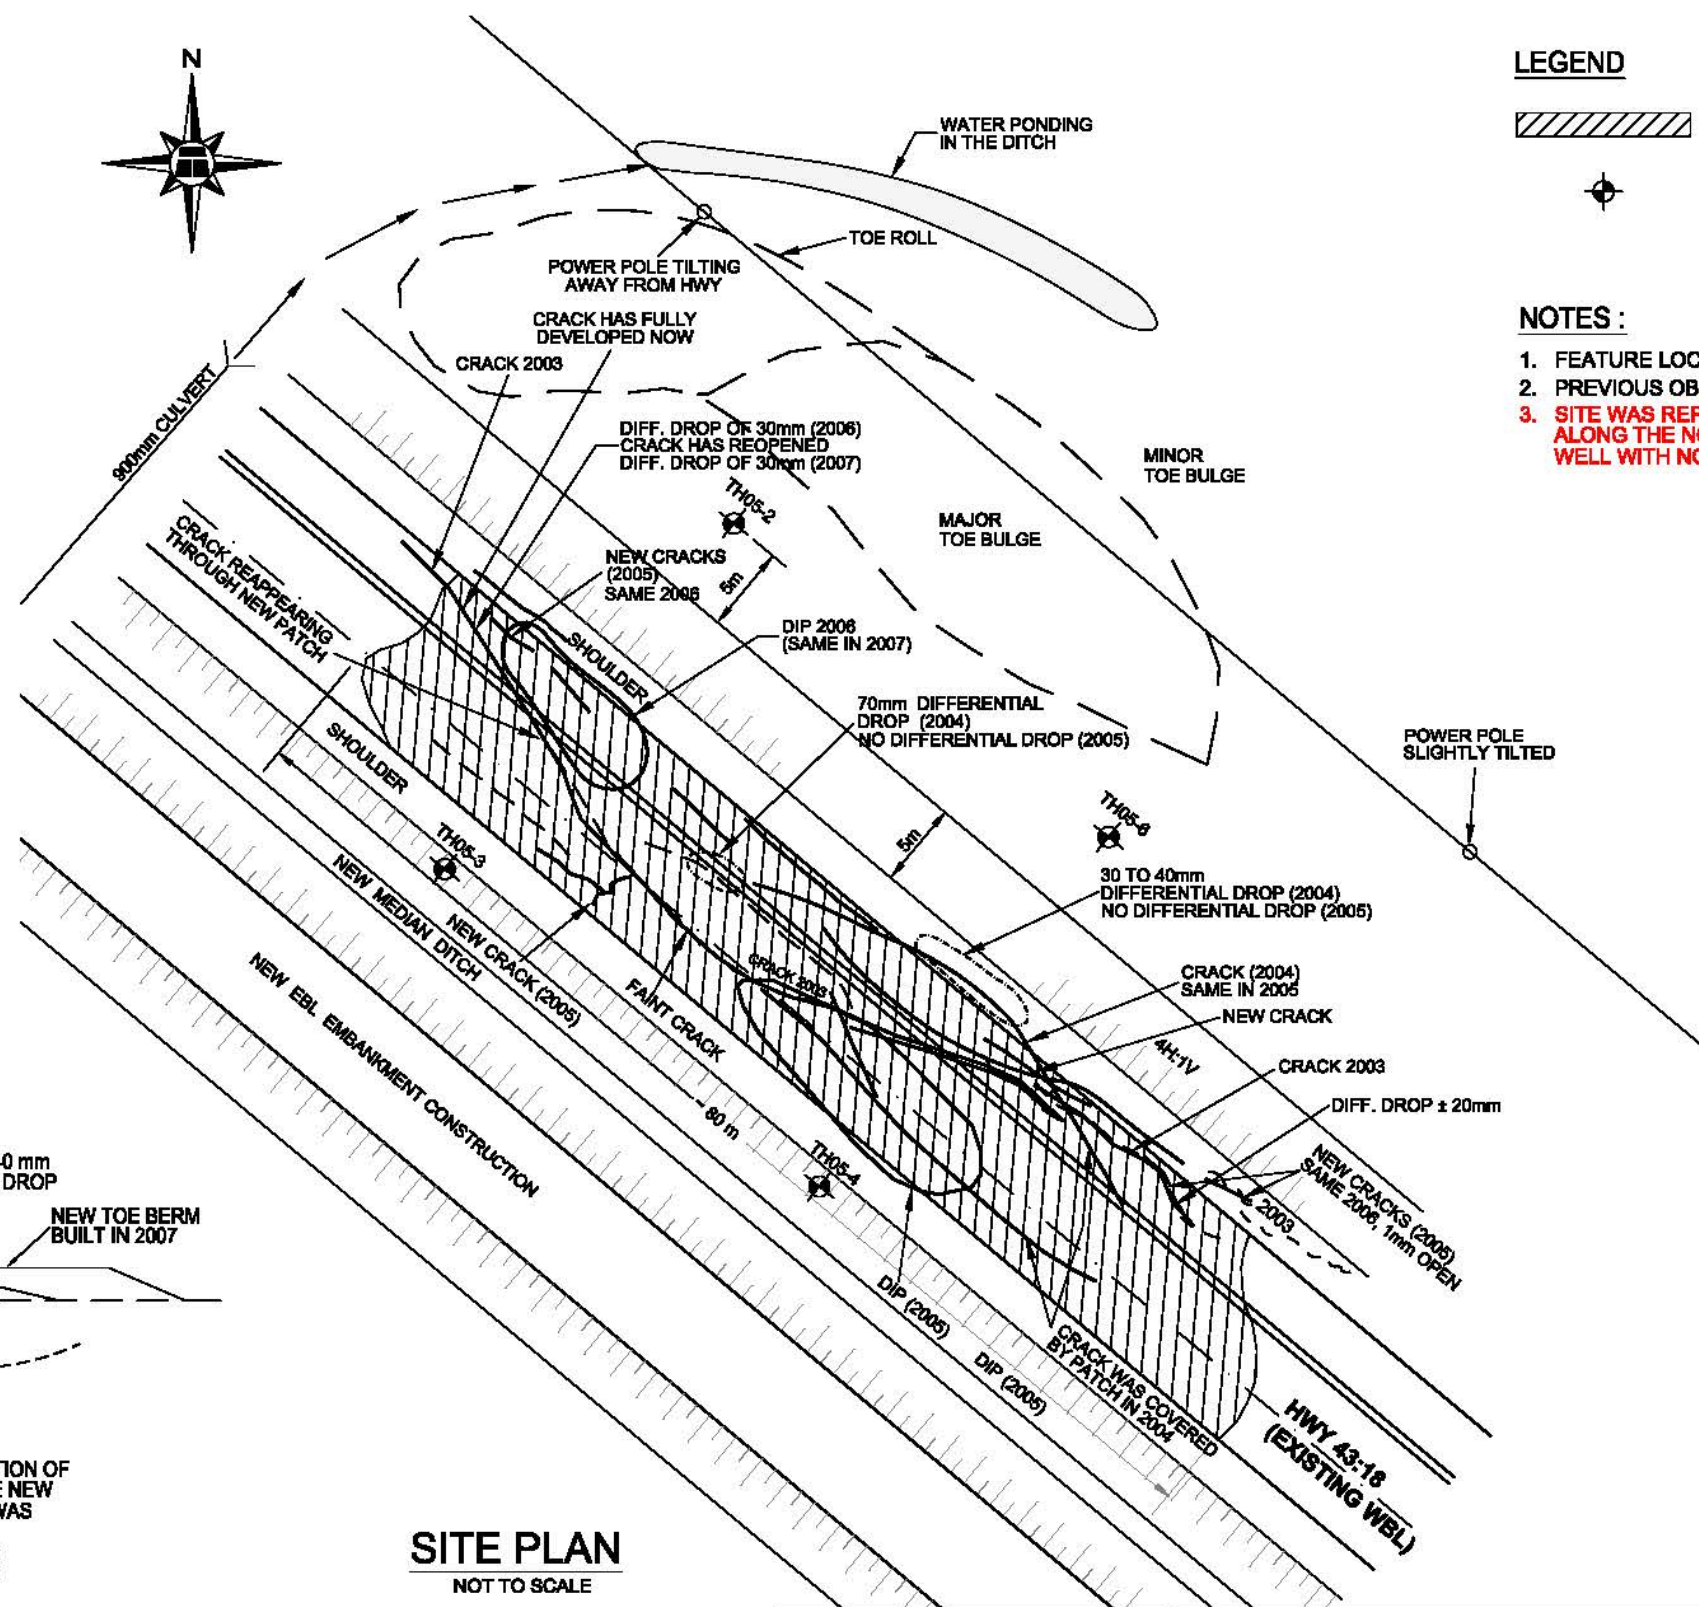
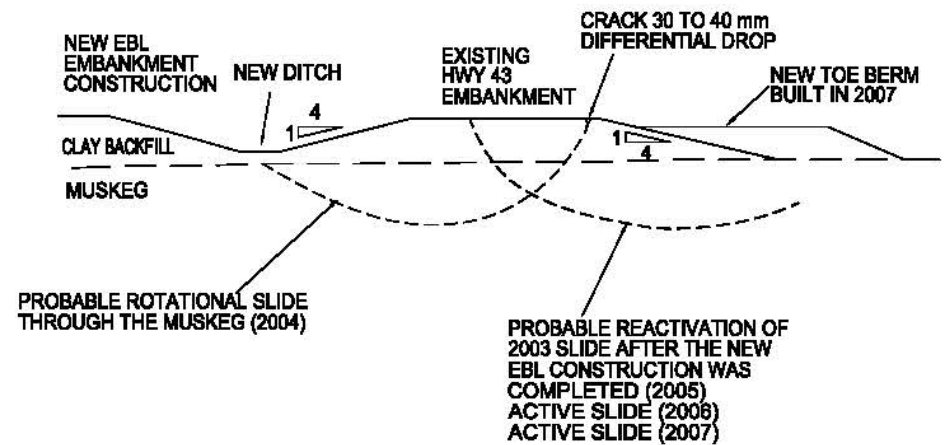
ENGINEER: RVC	DRAWN: KLW	APPROVED: DWP
DATE: JUNE, 2009	SCALE: N.T.S.	DRAWING NO. FIGURE NC30-1

Assessment (Refer to Figure NC30-1):
The remediation repair is performing well and no signs of pavement or sideslope distress were observed during this site visit.

1. FEATURE LOCATIONS ARE APPROXIMATE.
2. PREVIOUS OBSERVATIONS SHOWN IN BLACK
3. **SITE WAS REPAIRED IN 2007 WITH A TOE BERM PLACED ALONG THE NORTHEAST SIDESLOPE. SITE IS PERFORMING WELL WITH NO PAVEMENT DISTRESS.**

Recommendations:
This site may be discontinued from the program.

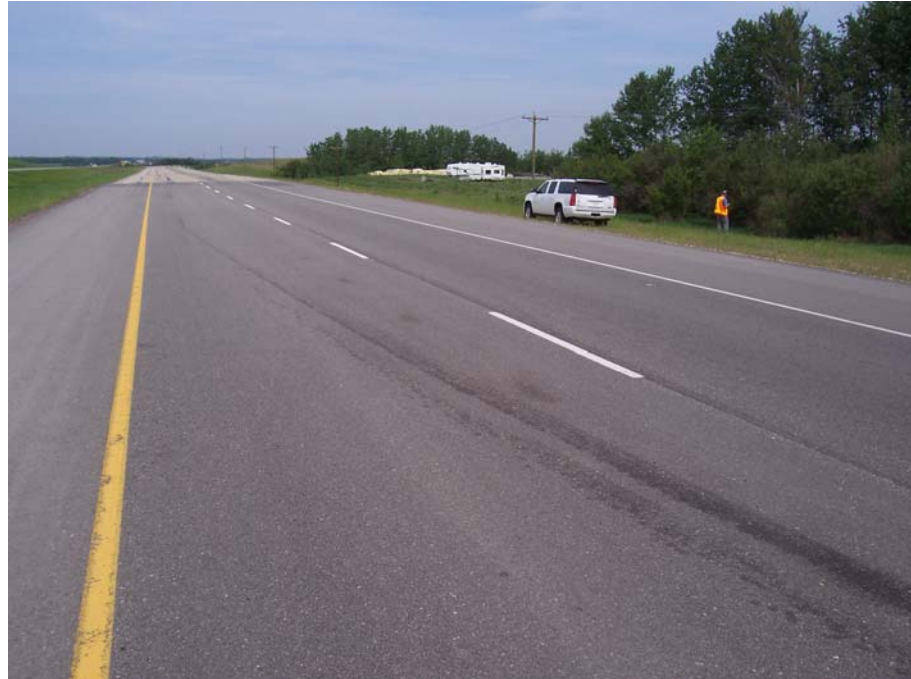
Northbound lane – No pavement distress.

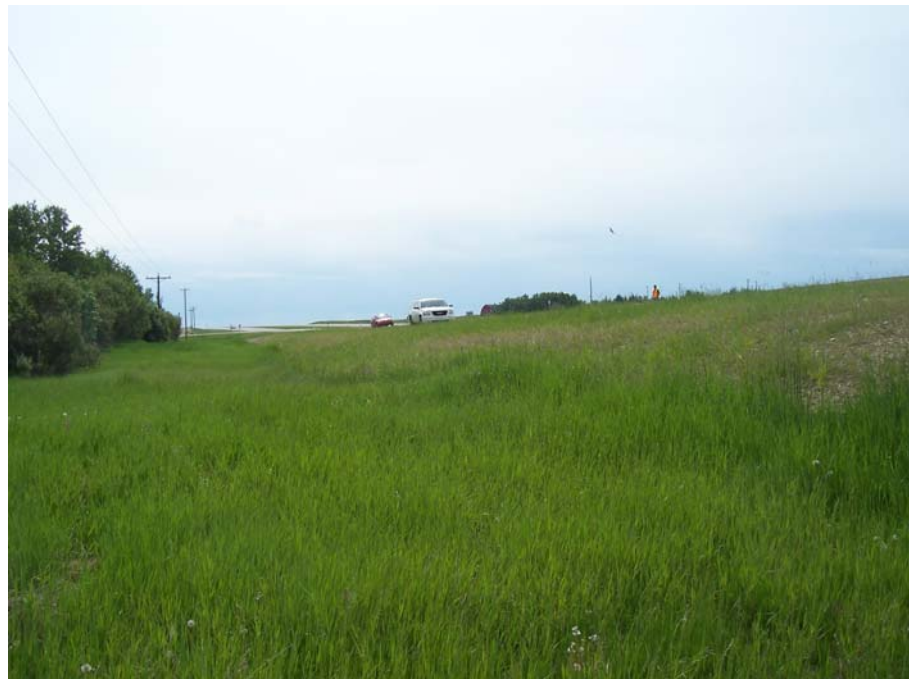
Toe berm looking southeast.
