November 25, 2005

**NORTH CENTRAL REGION GEOHAZARD ASSESSMENT CALL OUT  
NC38 HWY 47:06 EMBARRAS CREEK  
2005 ANNUAL INSPECTION REPORT**

**HWY 47:06 - km 4.2 - EMBARRAS CREEK (NC38)**

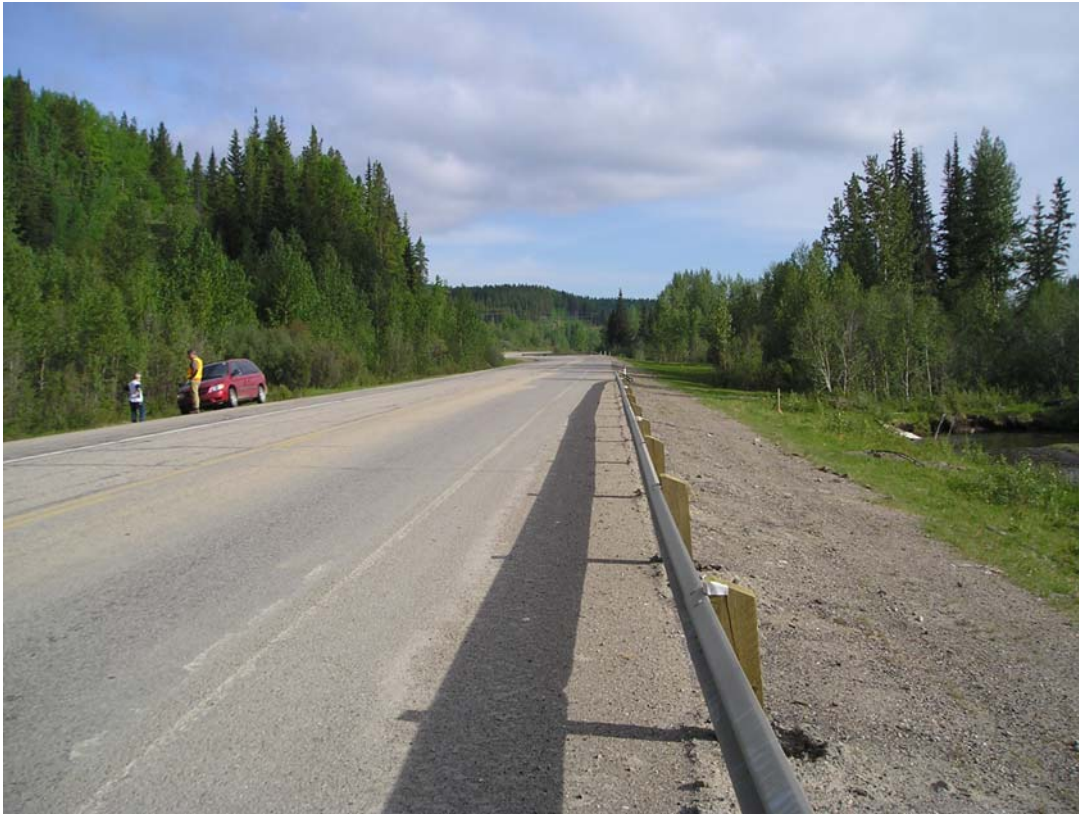
Photo 3 – Looking north along edge of pavement.
