## GEOHAZARD RISK MANAGEMENT PROGRAM

### North Central Region – Edson / Stony Plain Area

#### 2017 Inspection Report

Site Number	Site Name		Hwy	km
NC75	Frost Heave near Robb		47:06	0.4
Legal Land Description	SW 33-48-21-W4M			
UTM Coordinates (NAD 83)	Zone 11U	N5892678	E499010	
Operational Site Instrumentation	Slope Inclinometers		0	
	Pneumatic Piezometers		0	
	Vibrating Wire Piezometers		0	
	Standpipe Piezometers		0	
Date of Last Instrumentation Readings	n/a

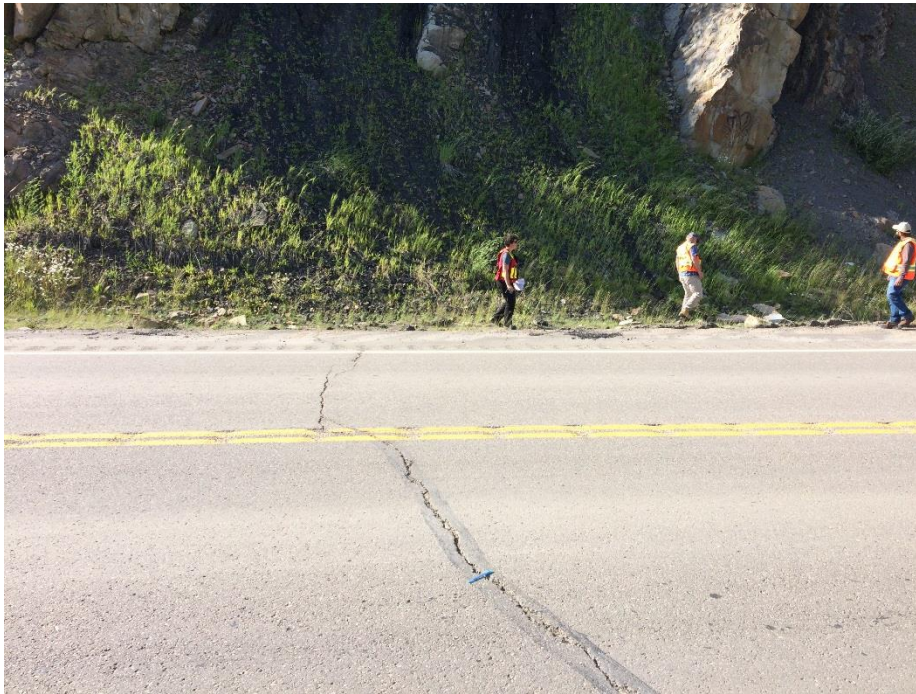
<b>Discussion</b>	<p>The previously sealed transverse crack approximately 70 m west of the bridge abutment has re-opened as shown in Photo 1. This crack has a width of about 10 mm and coincides with the location of the previously observed frost heave. It is understood that the frost heave previously reached up to 200 mm in 2013. Frost heave in 2014 was observed to be up to 50 mm. No frost heaving was observed during winter 2015 or 2016.</p> <p>A small amount of water was observed in the north ditch as shown in Photo 2. Very little vegetation was observed along the ditch slopes. The silt fences downstream of the ditch were not observed during this site inspection.</p> <p>A scour hole was observed at the base of the concrete spillway on the northside of the west abutment as shown in Photo 3. Ponded water was observed in the scour hole.</p> <p>The trench drain installed in 2014 appeared to be functional with water flowing out of the subdrain as shown in Photo 4.</p> <p>The fill settlement on the west abutment was unchanged and remained at approximately 300 mm as shown in Photos 5 and 6. Signs of erosion were also observed at the west abutment. Ponded water was also observed at the exposed H-piles as shown in Photo 6.</p> <p>The previously observed springs and ponded water were not observed during this inspection.</p>

**Photo 1:** Crack sealed in May 2016 has re-opened. Looking north

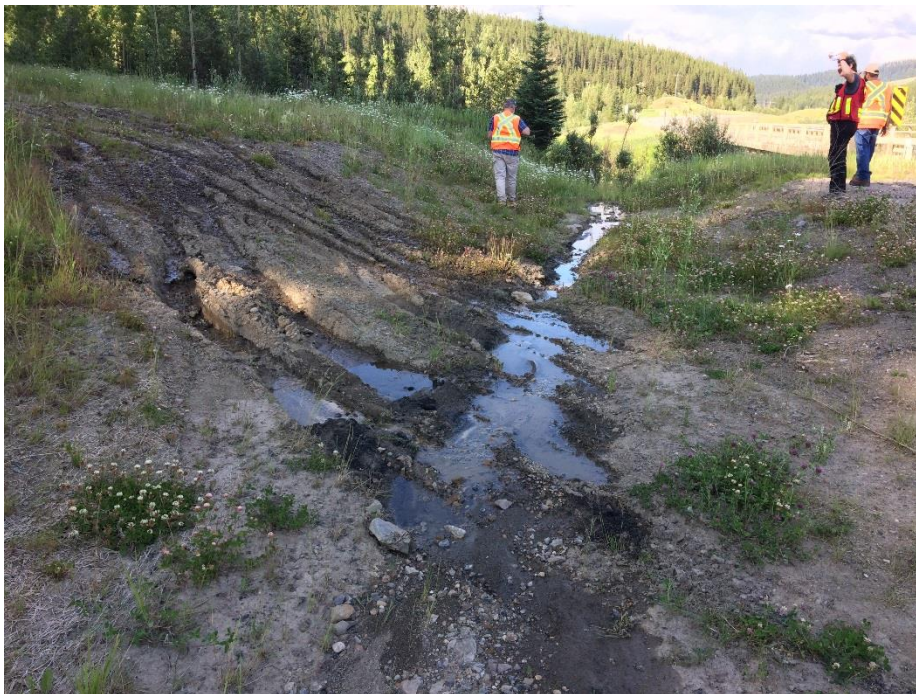
**Photo 2:** Water in north ditch. Looking northeast.

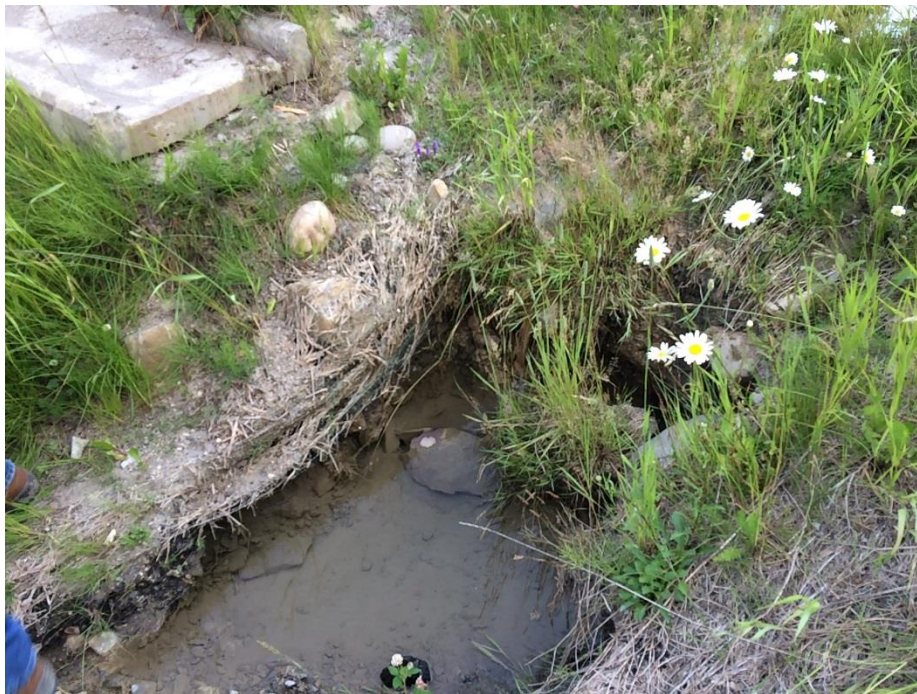
**Photo 3:** Scour hole at the base of the concrete spillway on the north side of the west abutment.

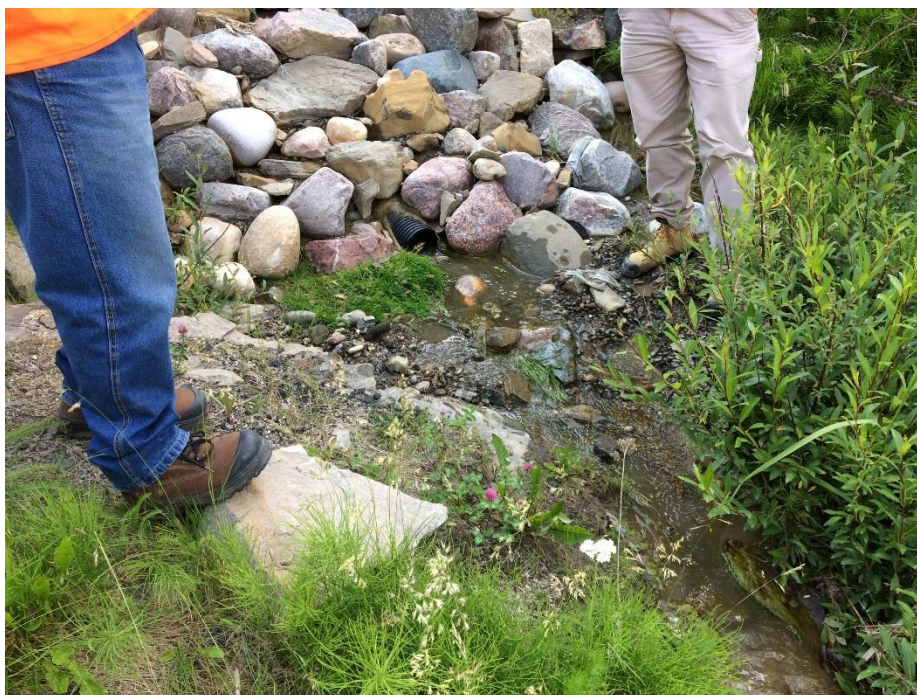
**Photo 4:** Water flowing through the subdrain installed in 2014.

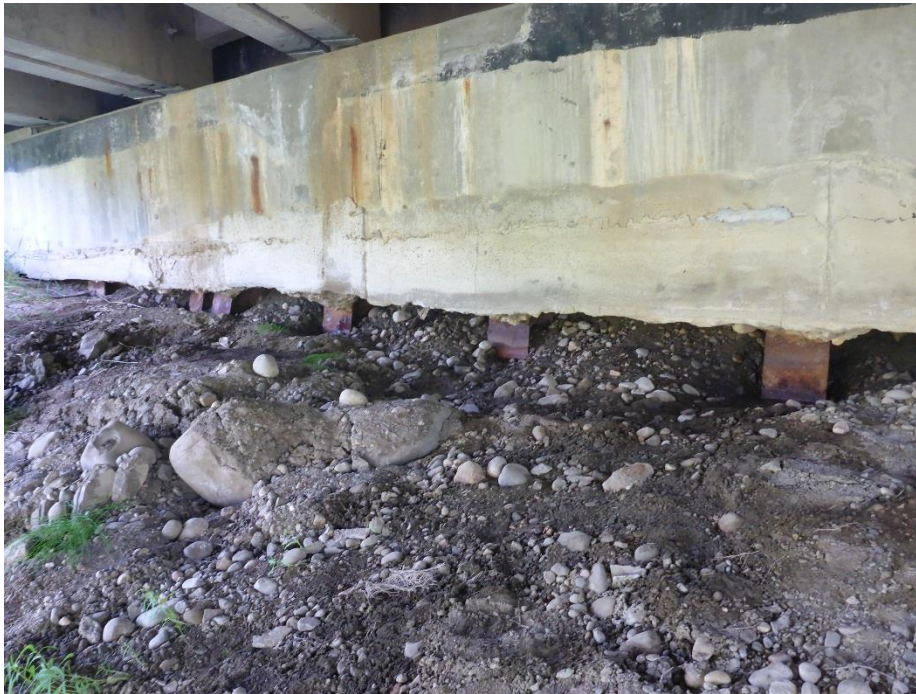
**Photo 5:** Erosion and fill settlement on west bridge abutment. Looking west.

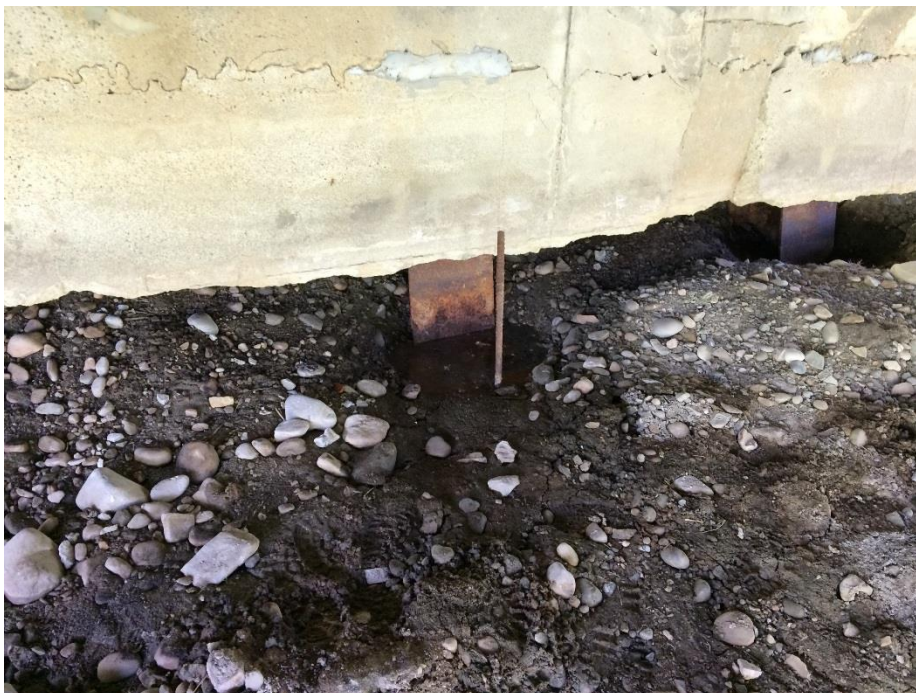
**Photo 6:** Ponded water at exposed piles. Looking west.
