GEOHAZARD RISK MANAGEMENT PROGRAM

North Central Region – Edson / Stony Plain Area

2018 Inspection Report

Reference: 2018 Annual Inspection Photographs at NC75 – Frost Heave near Robb
File Number: 123312435

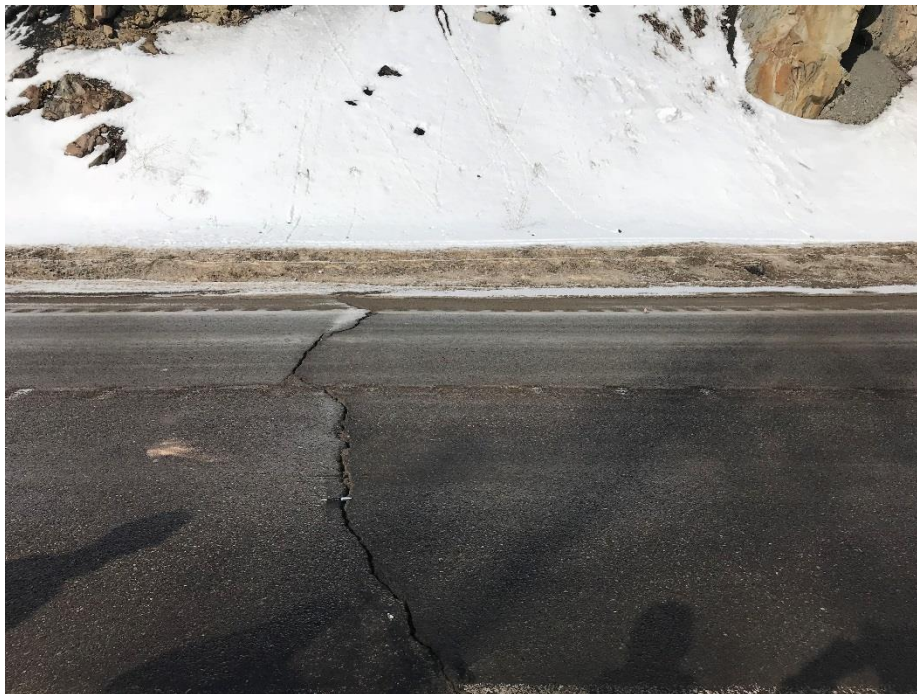
Discussion	<p>The current inspection is Stantec's first winter inspection at NC75. The previously sealed transverse crack approximately 70 m west of the bridge abutment has re-opened as shown in Photo 1. This crack appears wider up to about 40 mm wide and coincides with the location of the previously observed frost heave. Slight heaving at the crack up to 20 to 25 mm was observed. It is understood that the frost heave previously reached up to 200 mm in 2013. Frost heave in 2014 was observed to be up to 50 mm. No frost heaving was observed during winter 2015 or 2016 by MCI.</p> <p>Due to snow cover, water was not observed in the north ditch. The scour hole at the base of the trough drain on the northside of the west abutment was also not observed due to snow cover.</p> <p>The trench drain installed in 2014 appeared to be functional with water flowing out of the drain as shown in Photo 2.</p> <p>It appears that fill was placed in summer 2017 to provide cover for the exposed H-piles that were observed during earlier inspections as shown in Photo 3. Two 100mm diameter subdrains pipes were installed in the new fill and shown in Photo 4. A small amount of water was observed running through the new subdrains.</p> <p>The springs and ponded water previously observed by others could not be confirmed during this inspection due to snow cover.</p>

Assessment	<p>Water is believed to infiltrate into and through the coal seam. Water is then able to infiltrate under the highway causing frost heave in the winter months. It is also possible that frost susceptible soils lie beneath the highway.</p> <p>The reduction in frost heave since the trench drain installation suggests that the trench drain is functioning well and as intended. However, the reduction in frost heave in 2014 may have been due to a milder winter compared to 2013. Furthermore, the winter of 2015 saw even milder temperatures and may have contributed to the frost heave reduction. The widening of the crack and slight heaving observed confirmed that the frost heave is still on-going but less than that observed prior to 2014. However, the winter of 2017/2018 was relatively colder than 2016 and may partially explain the crack widening.</p>

Photo 1: Crack sealed in May 2016 re-opened in 2017. Slight heaving observed. Crack up to 40 mm wide. Looking north

Recommendations	<p>Short term recommendations include sealing open pavement cracks to reduce surface water infiltration. The pavement surface should also be monitored regularly for vertical differential settlement to assess the effectiveness of the drain.</p> <p>Consideration to placing riprap at the abutment trough drain and repairing the erosion is recommended. Reseeding the north ditch may also be considered given that very little vegetation has grown since the drain construction. These recommendations may have already been undertaken, however, Stantec was unable to confirm due to snow cover.</p> <p>The frequency of inspection at this site should be reduced to every other year (i.e. next visit 2020). Monitoring of the frost heave should continue in winter to assess the trench drain performance.</p>
------------------------	--

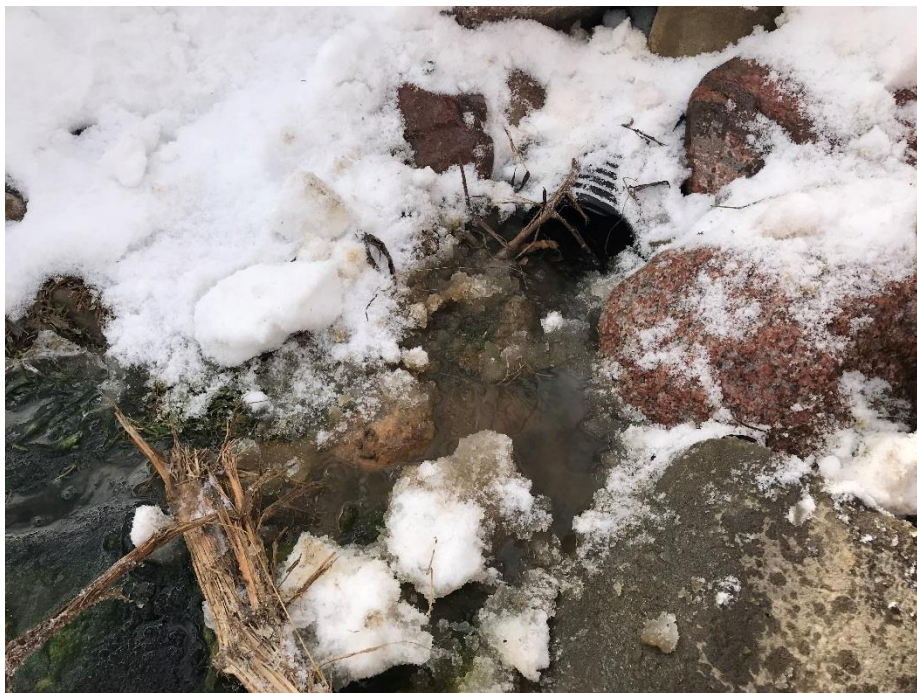
Photo 2: Water flowing out of trench drain outlet on north side of west abutment.

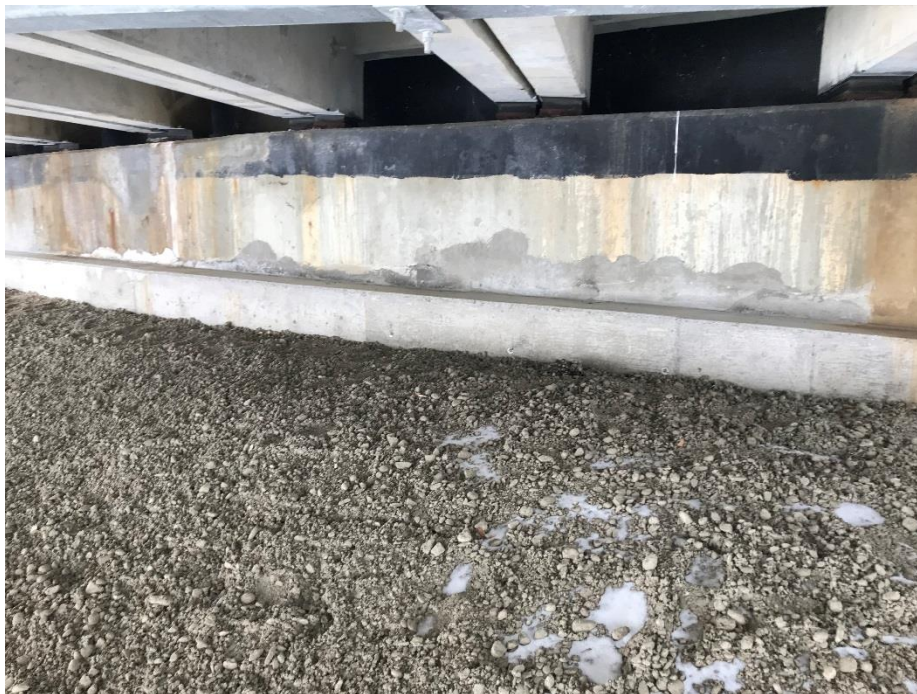
Photo 3: Fill placed over previously observed fill settlement location. Exposed H-piles backfilled. Looking west.

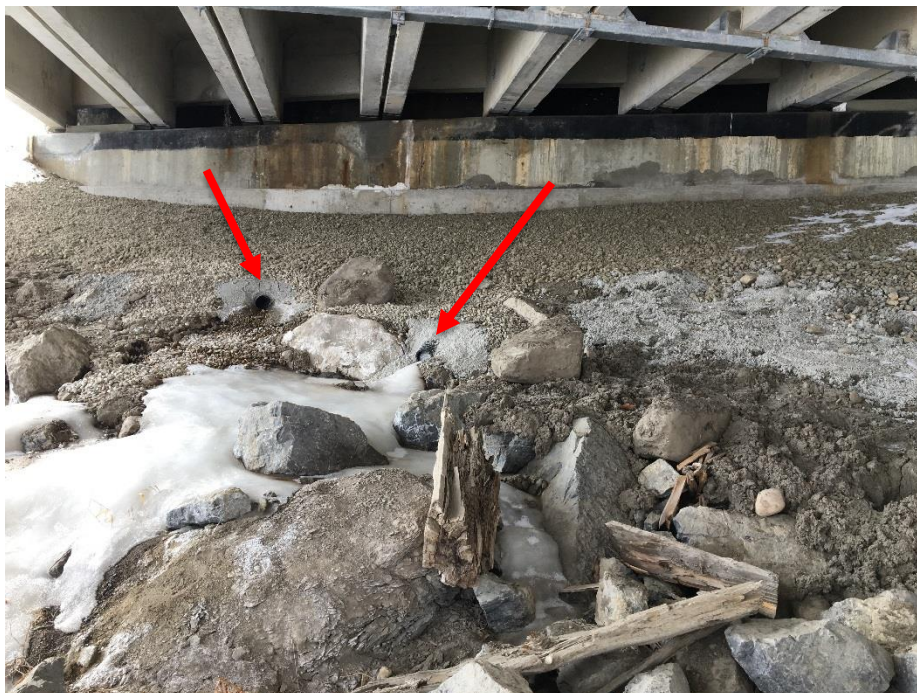
Photo 4: Two new subdrains installed in west abutment. Looking west.
