## GEOHAZARD RISK MANAGEMENT PROGRAM

### North Central Region – Edson / Stony Plain Area

#### 2017 Inspection Report

<b>Site Number</b>	<b>Site Name</b>		<b>Hwy</b>	<b>km</b>
NC85	Pembina River Slide		16A:08	11.74
<b>Legal Land Description</b>	SW 29-53-7-W5M			
<b>UTM Coordinates (NAD 83)</b>	Zone 11U	N5941379	E632506	
<b>Operational Site Instrumentation</b>	<b>Slope Inclinometers</b>		0	
	<b>Pneumatic Piezometers</b>		0	
	<b>Vibrating Wire Piezometers</b>		0	
	<b>Standpipe Piezometers</b>		0	
<b>Date of Last Instrumentation Readings</b>	N/A

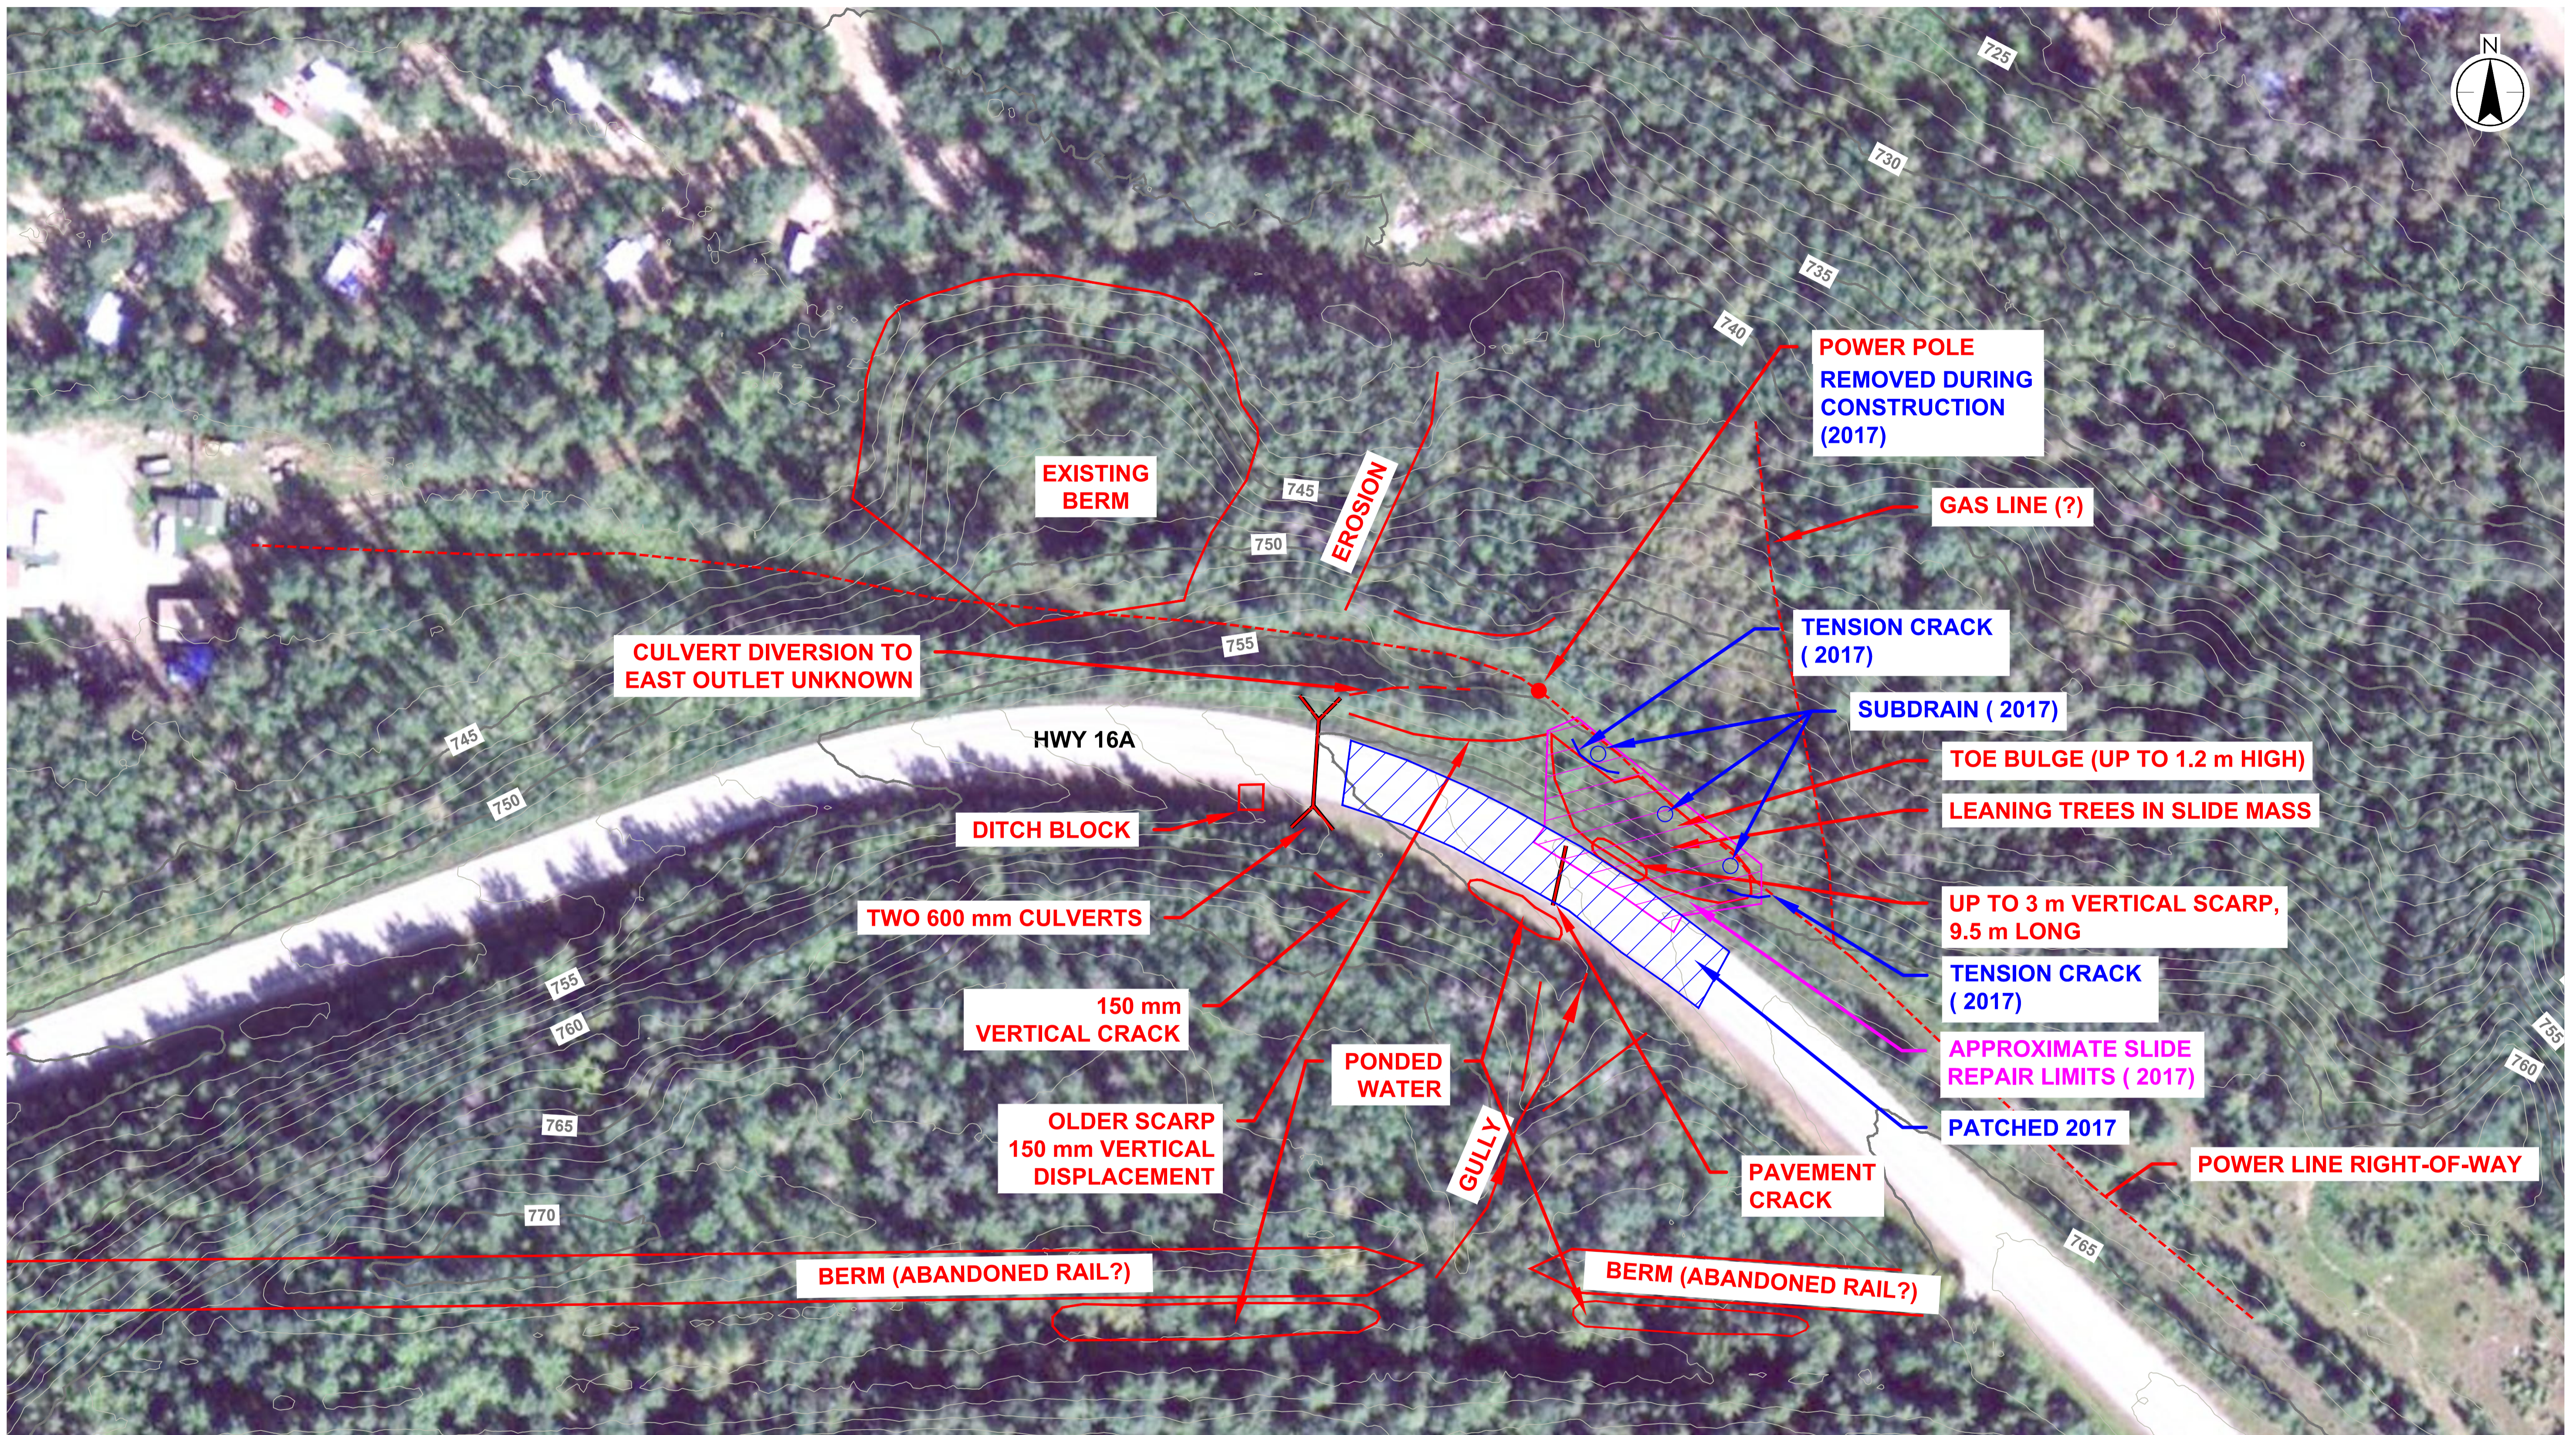
FIGURE -1

1. FEATURE LOCATIONS ARE APPROXIMATE
2. 2016 OBSERVATIONS SHOWN IN RED (NOV. 2016 CALL-OUT INSPECTION)
3. 2017 OBSERVATIONS SHOWN IN BLUE
4. APPROXIMATE SLIDE REPAIR LIMITS (2017) IN MAGENTA

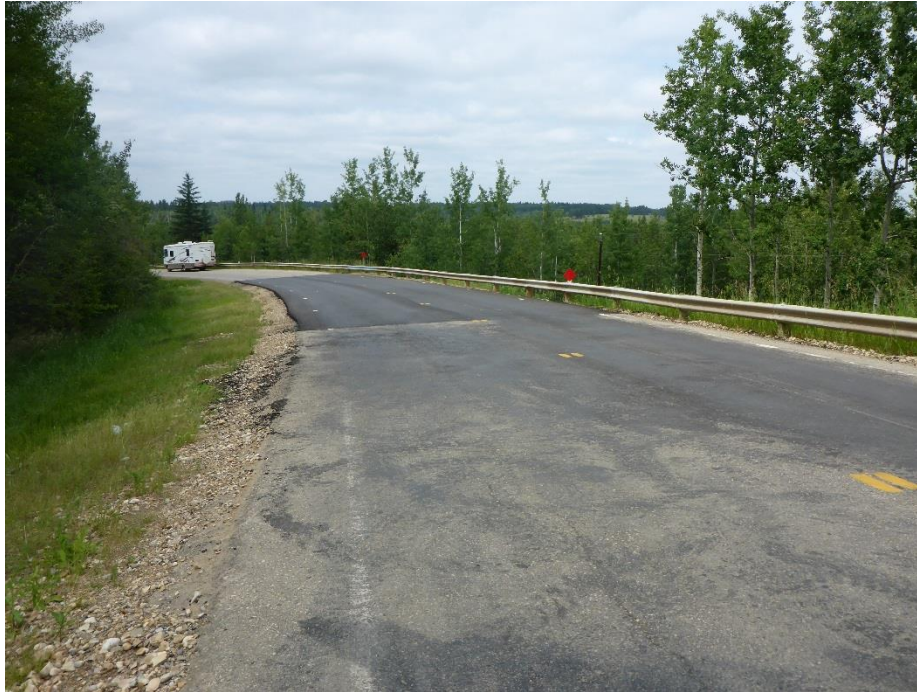
**Photo 1:** Highway 16A recently patched. Looking north.

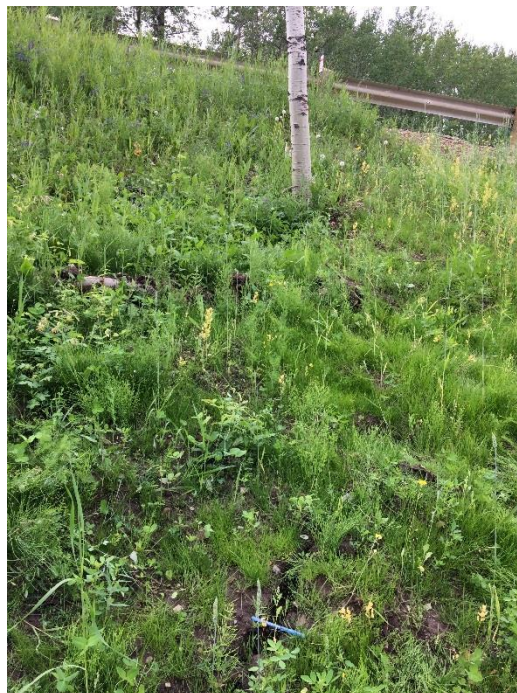
<b>Assessment</b>	<p>Although the slope was recently repaired, there were tension cracks observed near the east limits of repair. It is possible that the repair area did not fully encompass the slide limits or that sufficient compaction at the transition between native ground and fill was not achieved.</p> <p>The tension cracks are potential locations where water can infiltrate the slope. During periods of wet weather, increased slope movements may be anticipated.</p>

**Photo 2:** Tension crack near eastern remediation limits. Looking south

<b>Recommendations</b>	<p>It is recommended that minor regrading of the slope to fill in the tension cracks be completed to reduce surface water infiltration into the slope.</p> <p>It was decided by AT and Stantec during this site inspection that the site be removed from the annual inspection list unless issues arise from the Maintenance Contractor.</p>
------------------------	--

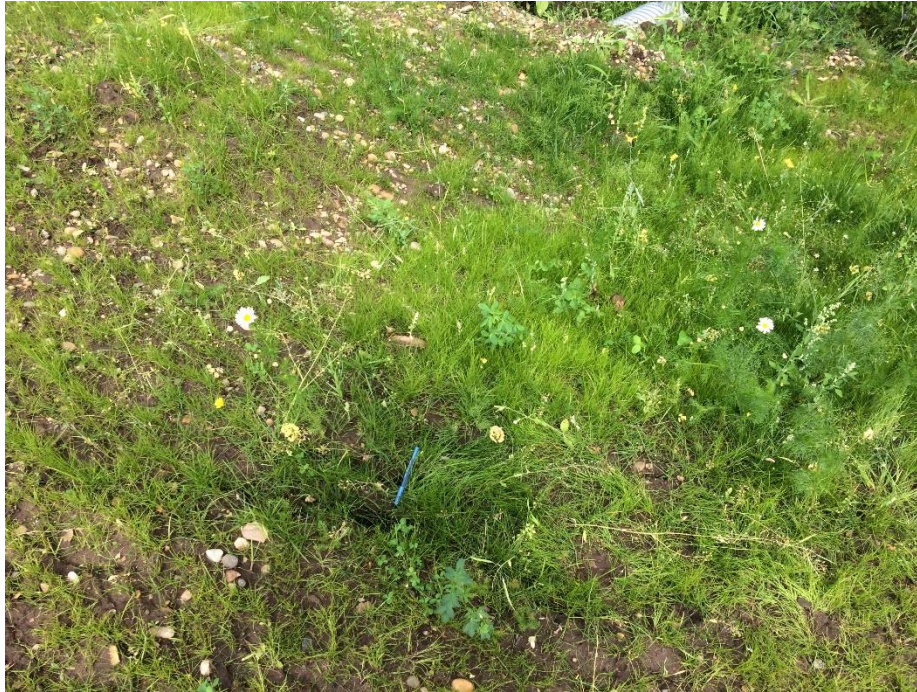
**Photo 3:** Tension crack upslope from sub-drain. Looking down.

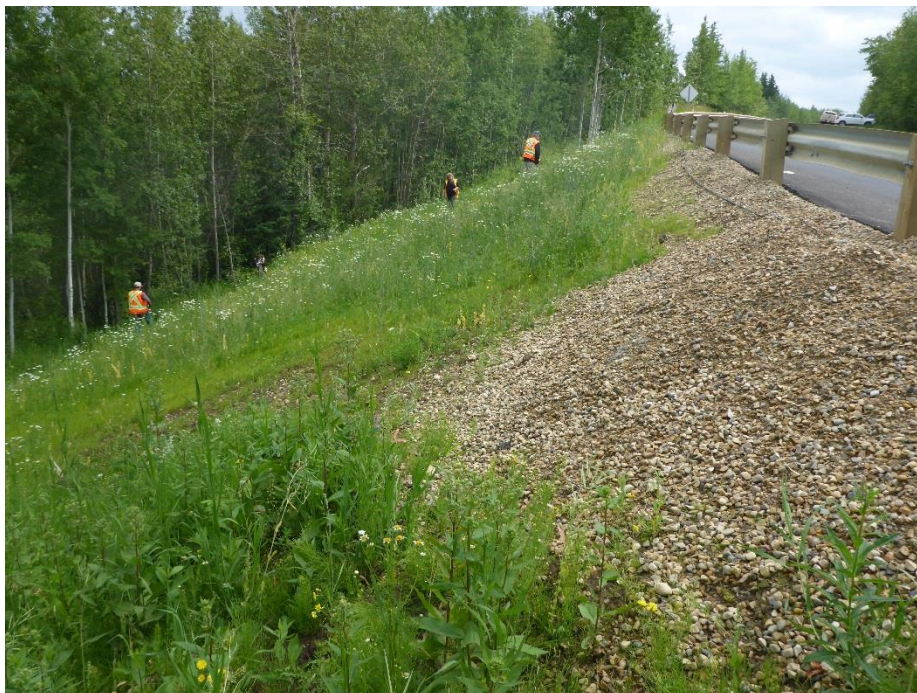
<b>Discussion</b>	<p>On October 31, 2016, a landslide was observed by the Maintenance Contractor along the westbound lane of HWY16A. Stantec completed an emergency call-out inspection on November 2, 2016. Observations during the call-out inspection included a vertical scarp parallel to the westbound lane of the highway with a maximum height of 3 m. The guardrail was noted to be unaffected, however, three guardrail posts were exposed over a length of 9.5 m. No significance subsidence or cracking was noted on the pavement surface. Ponded water and saturated ground surface were observed in the south highway ditch near the landslide area. The landslide was subsequently repaired in March 2017.</p> <p>Based on discussion with Alberta Transportation (AT), the highway was noted to have been patched in May 2017 as shown in Photo 1.</p> <p>Tension cracks were noted near the eastern limits of the slope remediation as shown in Photo 2. Tension cracks were also observed upslope from the west-most subdrain as shown in Photo 3. Vegetation appears to be growing well over the slope. An overall view of the slope is shown in Photo 4.</p>

**Photo 4:** Overall view of the repaired slope. Looking east.
