File: 15-85-68

**NORTH CENTRAL REGION GEOHAZARD ASSESSMENT
HWY 734:22 EROSION OF PEMBINA RIVER BANKS (NC28)
SITE 1
2007 ANNUAL INSPECTION REPORT**

**NORTH CENTRAL REGION GEOHAZARD ASSESSMENT
HWY 734:22 EROSION OF PEMBINA RIVER BANKS (NC28)
SITE 8
2007 ANNUAL INSPECTION REPORT**

**NORTH CENTRAL REGION GEOHAZARD ASSESSMENT
HWY 734:22 EROSION OF PEMBINA RIVER BANKS (NC28)
SITE 9
2007 ANNUAL INSPECTION REPORT**

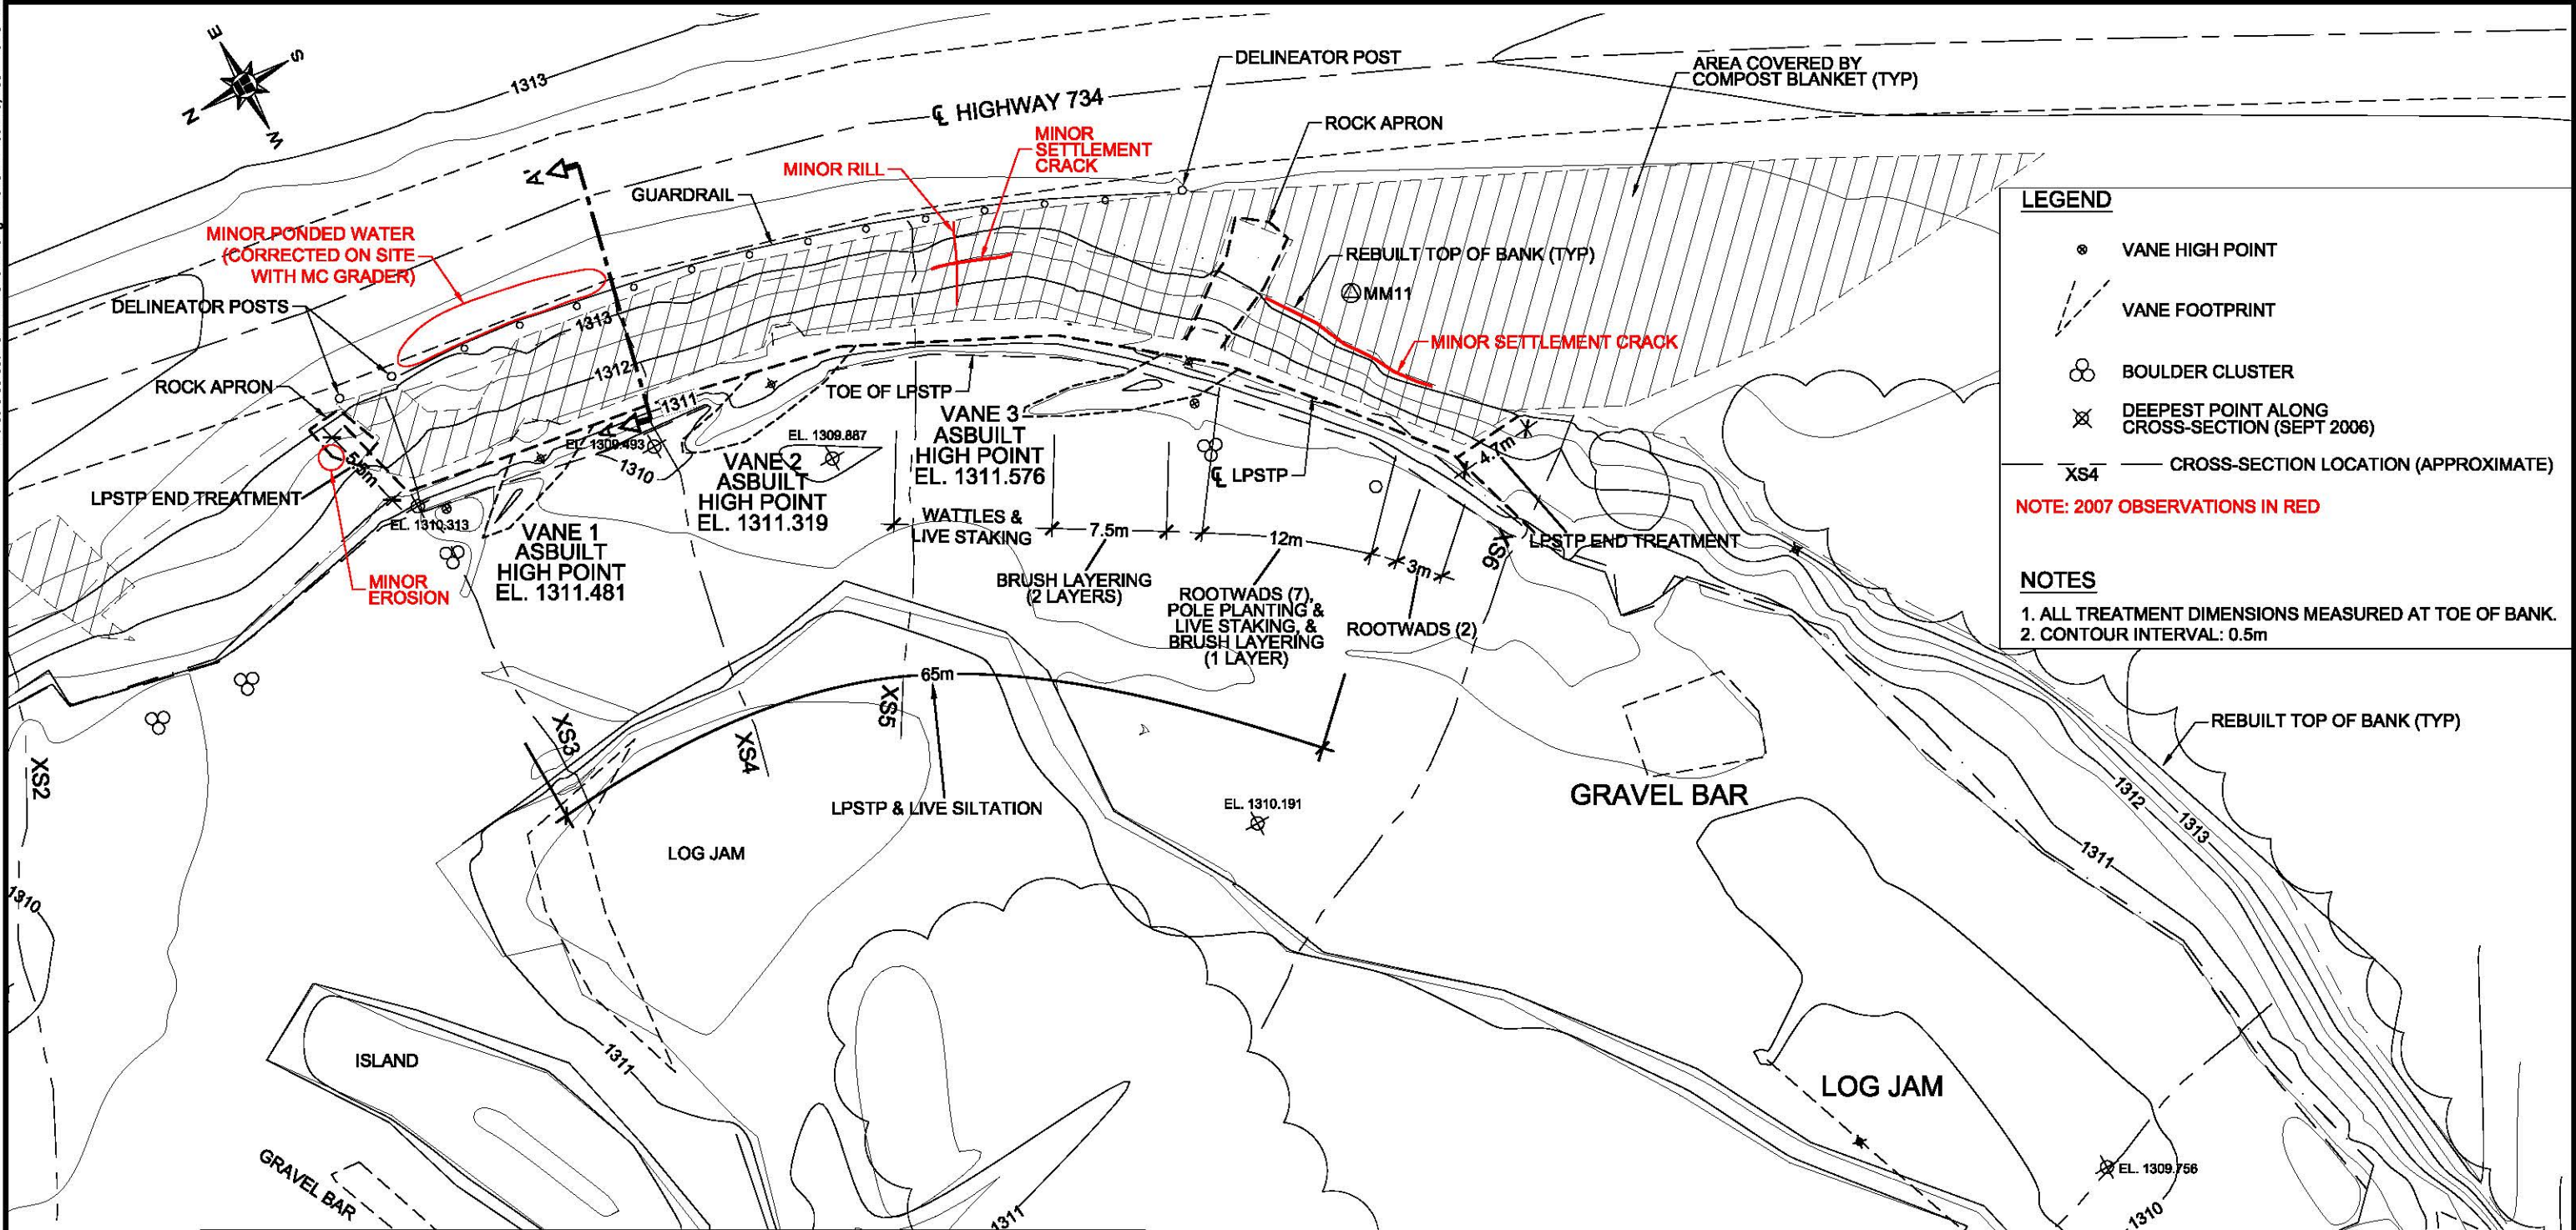
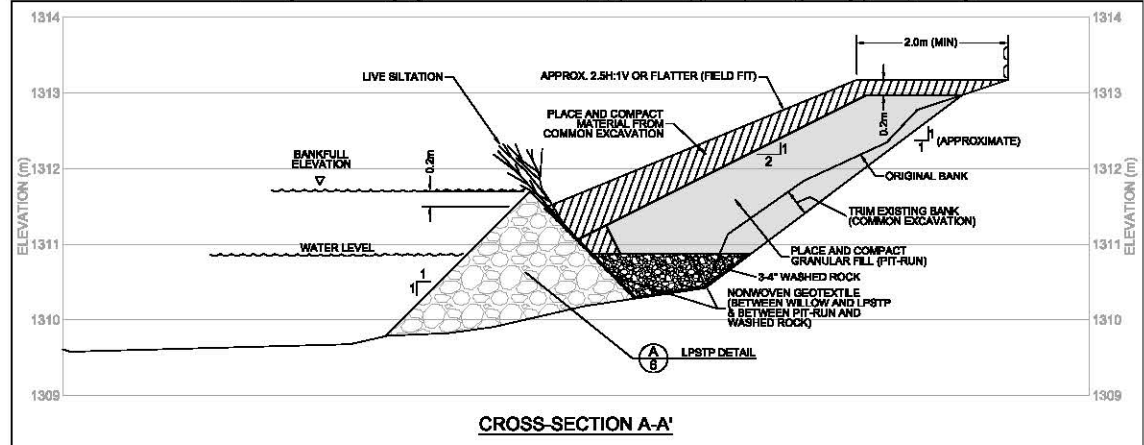
ENGINEER:	KEF	DRAWN:	PS	APPROVED:	DJL
DATE:	JULY 2007	SCALE:	1:400	DRAWING No.:	FIGURE NC28-2A

Site 8 is located 37 km southeast of Robb on Hwy 734:22 (km 40.4, corrected from past reports) at legal land description S18-46-18-W5M (also corrected from past reports). Site features are shown in Figures NC28-2A and -2B (attached for inclusion in Section F). Cross-section A-A' on Figure NC28-2A shows the reconstructed slope in the guardrail area.

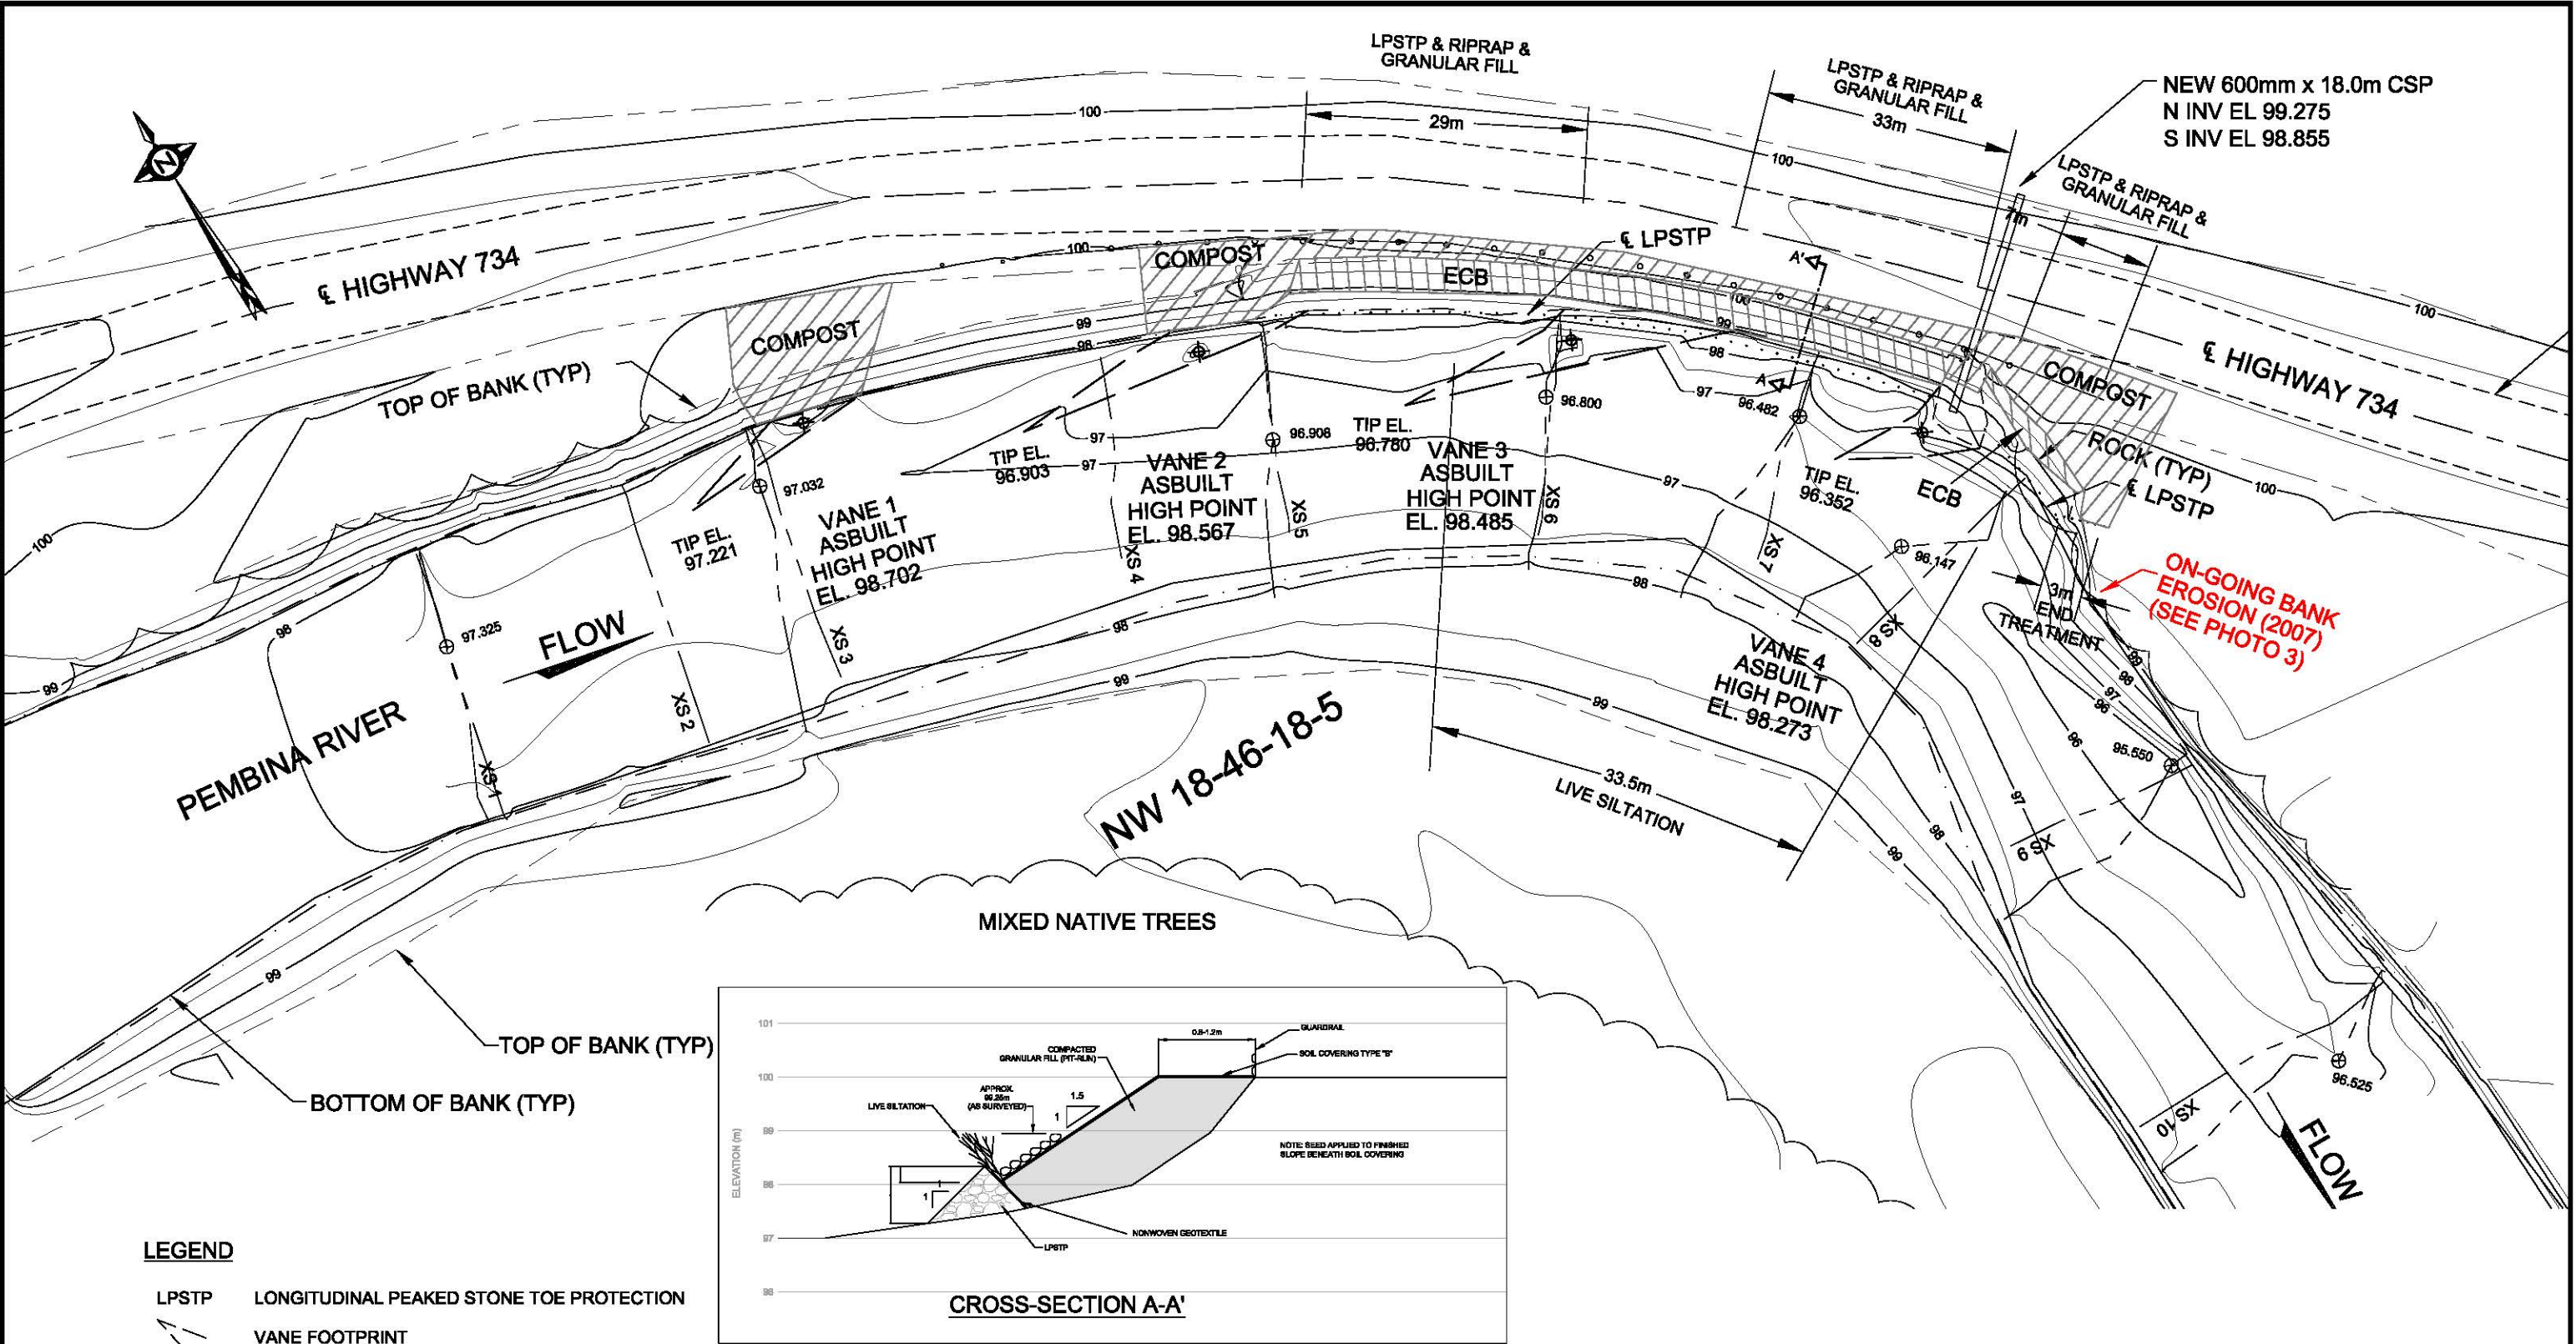
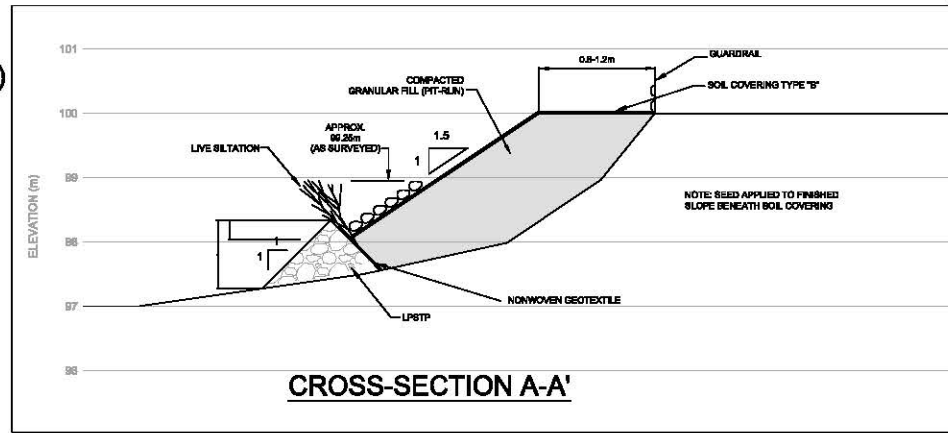
ENGINEER:	KEF	DRAWN:	HH	APPROVED:	DJL
DATE:	JULY 2007	SCALE:	1:500	DRAWING No.:	FIGURE NC28-1A

Site 9 is located 36.5 km southeast of Robb on Hwy 734:22 (km 42.3) at legal land description NW18-46-18-W5M (Figure NC28-1A, attached for inclusion in Section F). Cross-section A-A' on the figure shows the reconstructed slope profile.

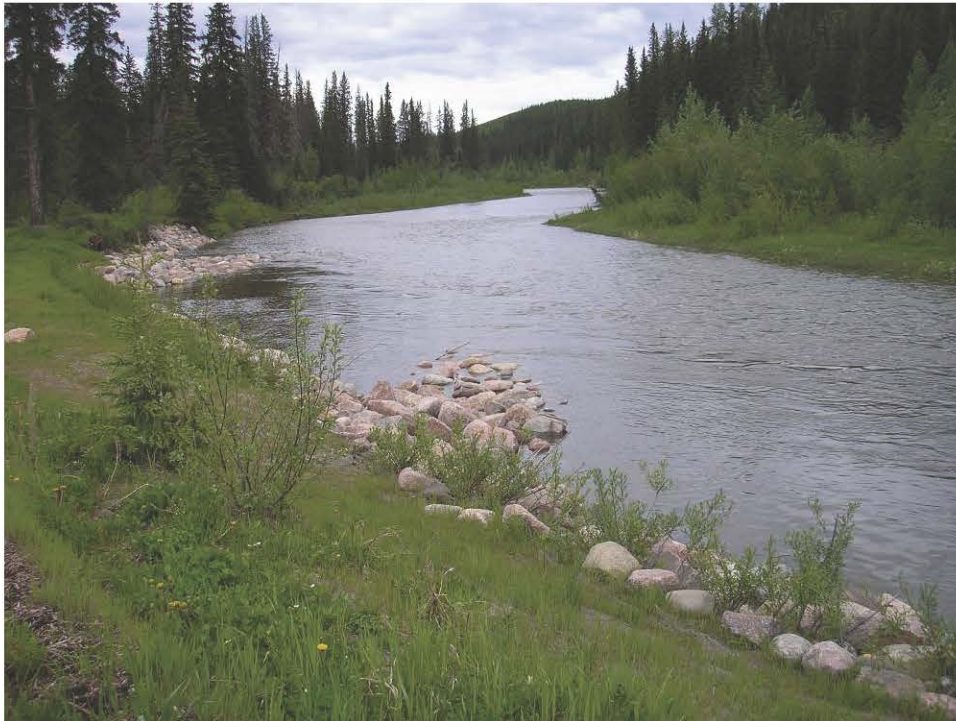
The repairs appear to be stable with no cracking observed on the roadway or bank slopes. No erosion gullies or rills were observed and vegetative growth including willow plants and grasses is well established. It was observed that the rock vanes have pushed the thalweg away from the bank and several areas of deposition have been established against the toe of the slope in backwater areas between the vanes.

Photo 1 – Looking northwest at Vane 2 and upstream – note higher water levels and vegetation growth compared to 2006 visit, June 12, 2007.

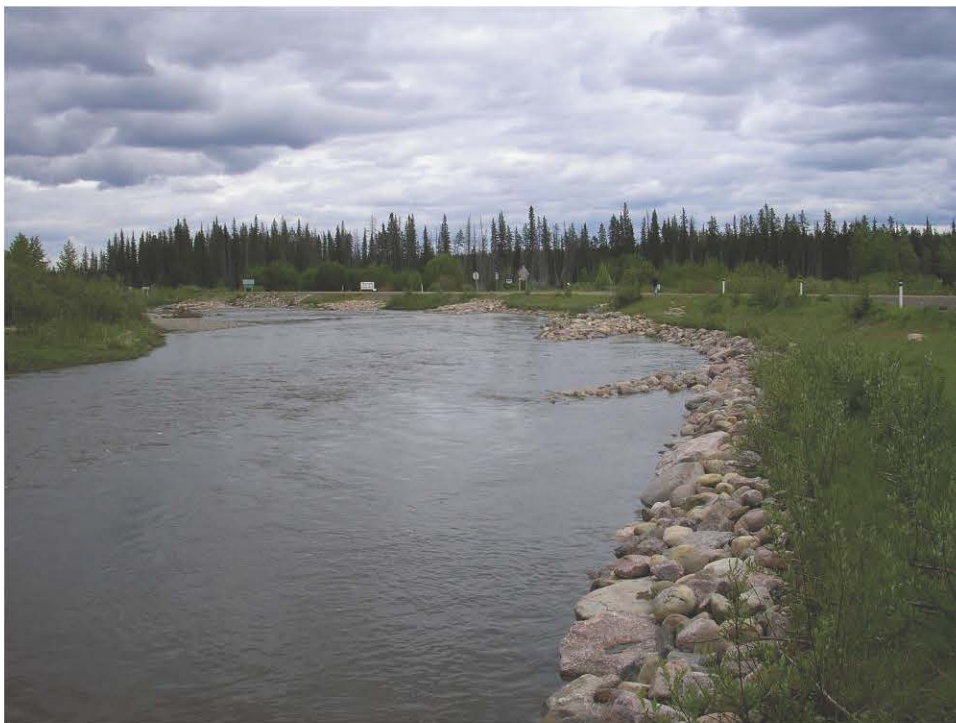
Photo 2 – Looking east at Vane 2 and downstream, June 12, 2007.

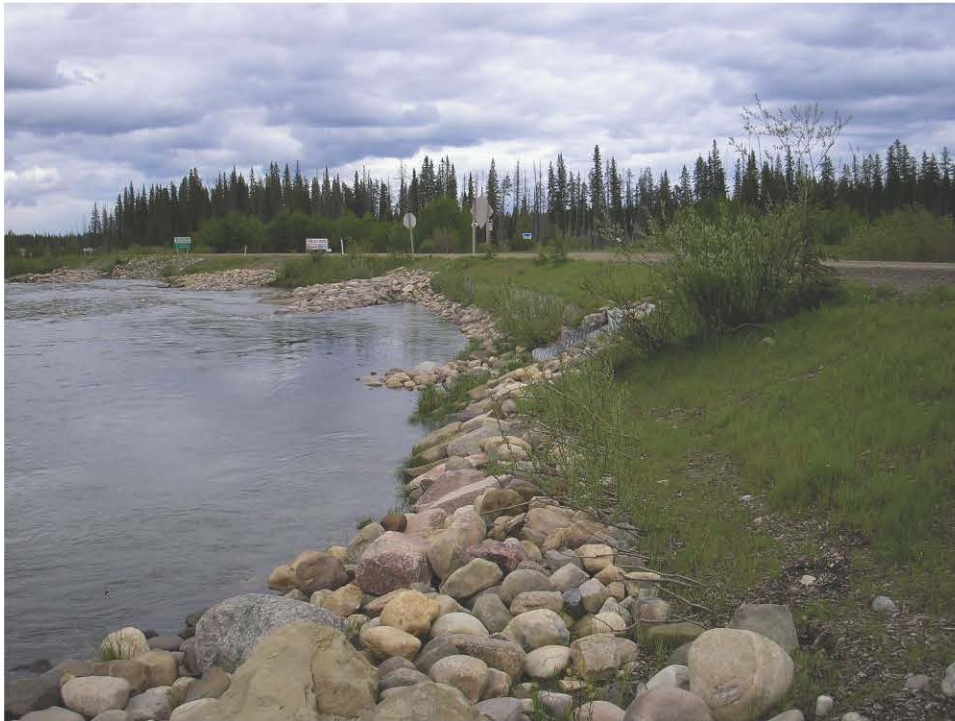
No erosion was noted at the culvert inlet and outlet. Flow appeared to be contained within the culvert for its whole length.

Photo 3 – Looking east (downstream) at culvert and Vanes 4 to 6, June 12, 2007.

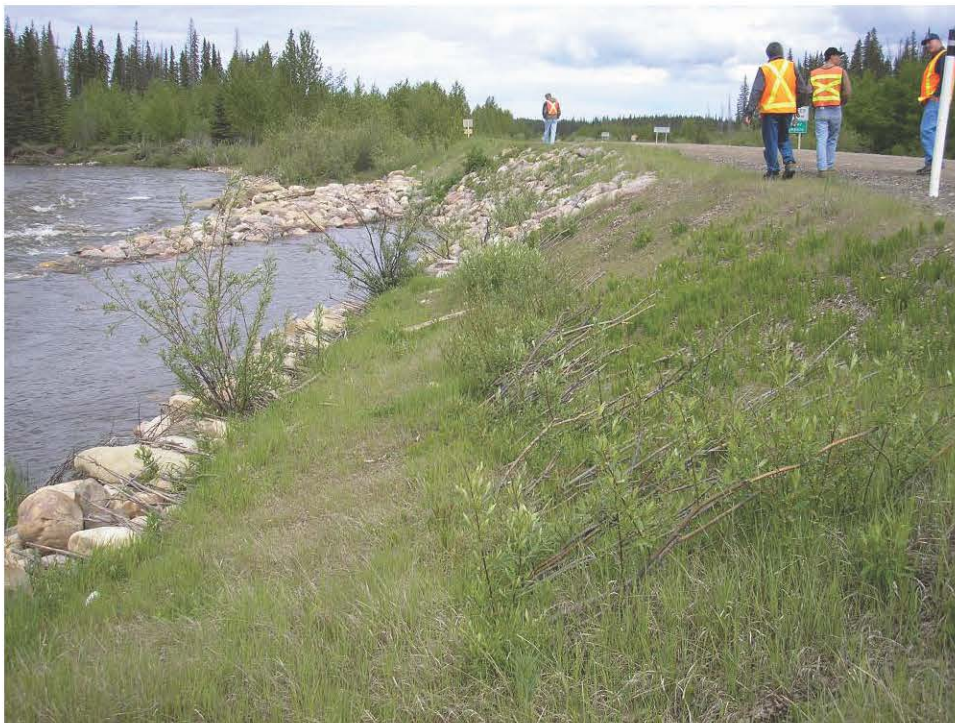
The area of concern noted in 2005 between Spurs 3 and 4 was repaired using vegetated riprap and showed no evidence of distress or continued regression in 2006 or 2007.

Photo 4 – Looking east (downstream) toward Vane 6 – this had been the slumping section between Spurs 3 and 4, June 12, 2007.

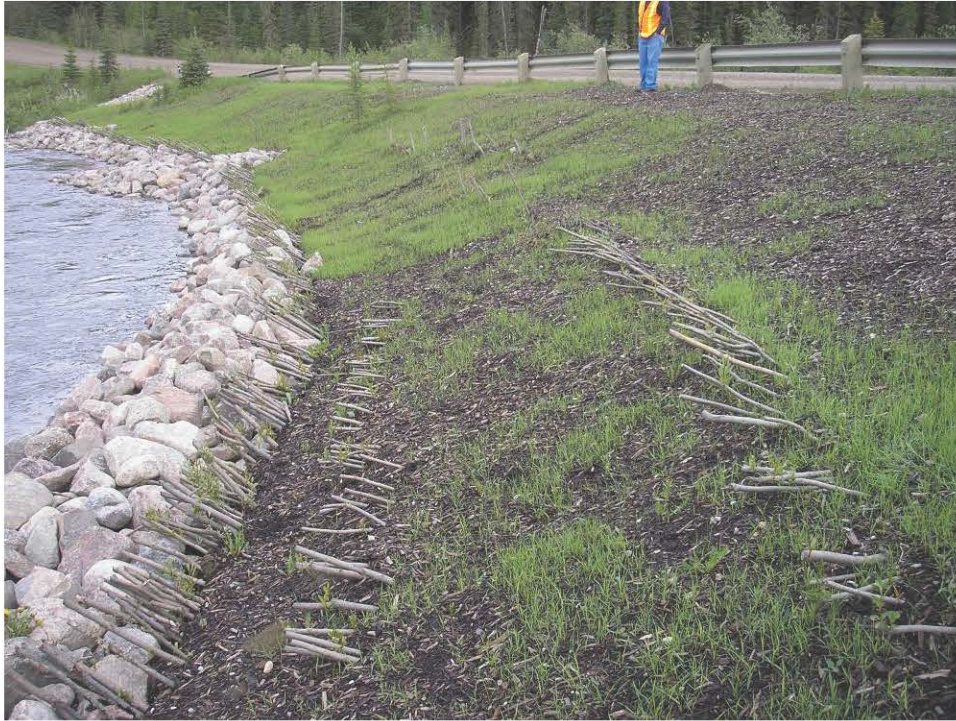
Conditions have significantly improved since 2006 as the site was rebuilt later that same fall. The repairs appear to be stable with no cracking observed on the roadway. Some minor settlement cracking was noted on the slope below the guardrail and over the rootwad installations. Some minor rills were observed in the blown compost cover along the guardrail section. It was observed that the rock vanes were successful in maintaining the thalweg away from the bank.

Photo 1 – Looking northeast at repaired slump area below guardrail, June 12, 2007.

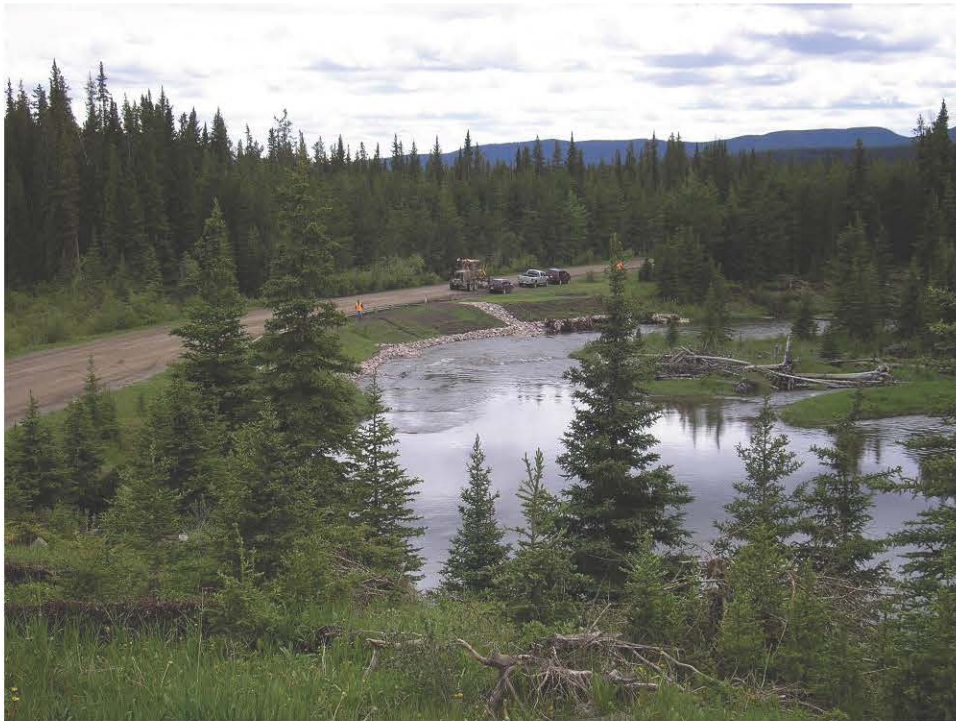
Photo 2 – Looking southeast at repaired main slump area, June 12, 2007.

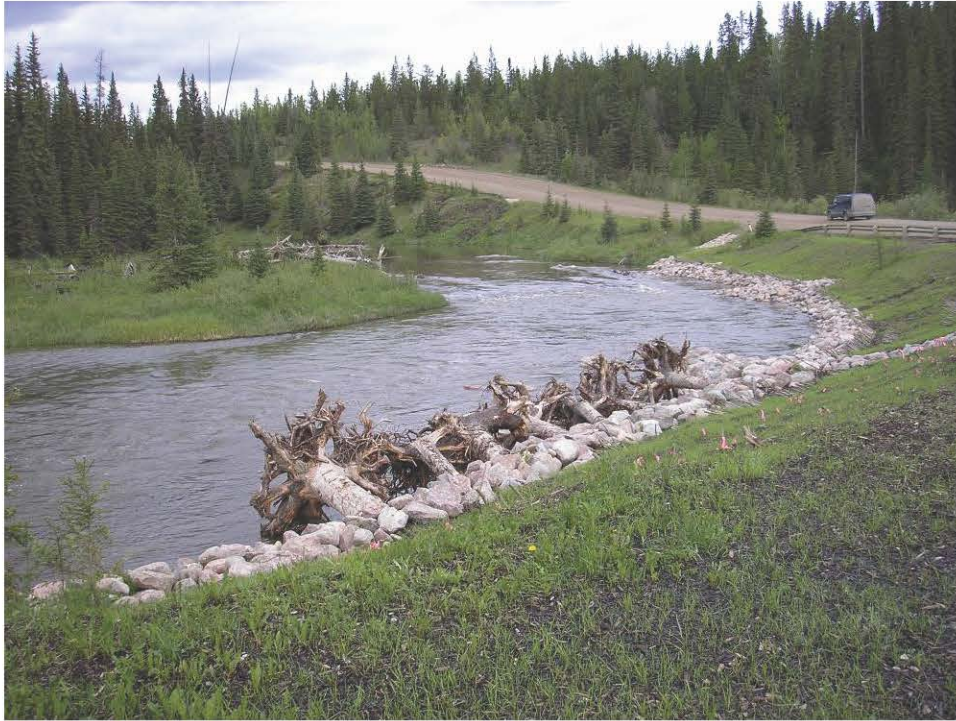
As part of the repairs, the top of bank was extended at least 2 m from the guardrail. Several compost berms were installed further north along the west ditch to direct surface runoff away from the high slopes that had experienced slumping in the past. This runoff is directed to the river partially via a live pole drain at the end of the compost berm and through a rock apron further downhill (immediately upstream of the guardrail). Minor erosion was noted at the rock apron. It also appeared that runoff was accumulating in the ditch beside the guardrail. This ponding was corrected on-site by the LaPrairie grader operator as directed by Mr. Ron Coley, AIT.

Photo 3 – Looking north at north slope area, June 12, 2007.

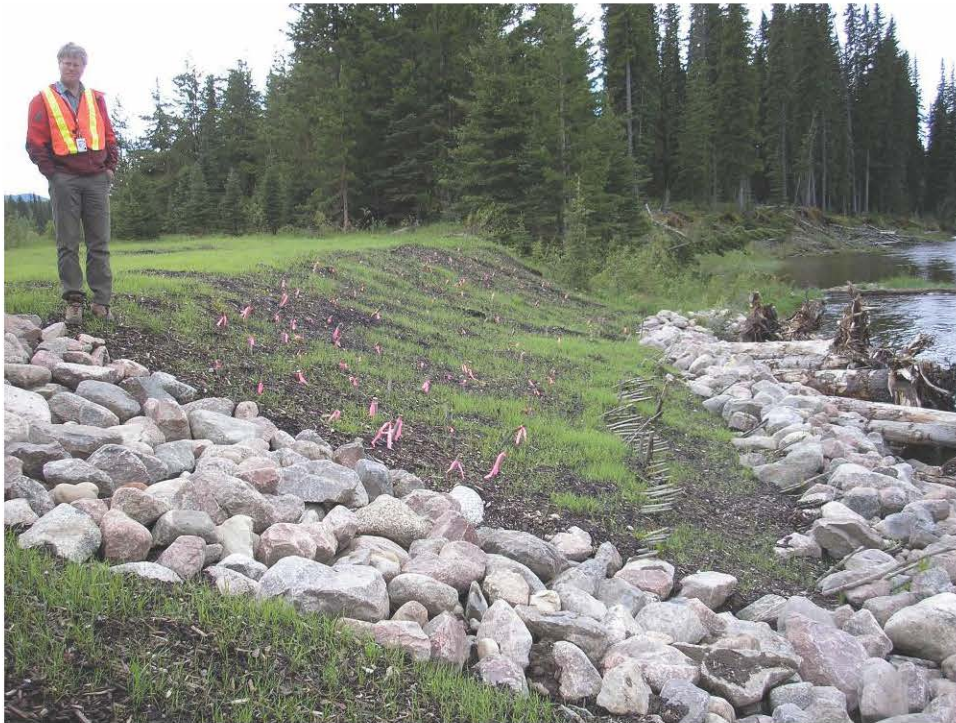
Photo 4 – Looking southwest at repaired slump area at south end of site, June 12, 2007.

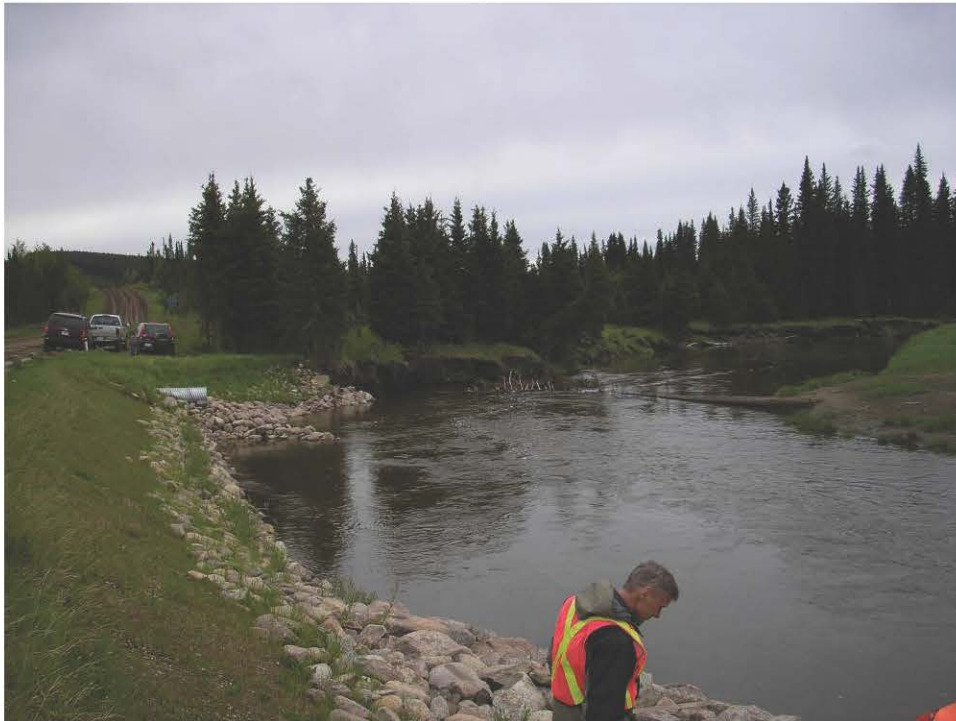
As part of the repairs, the top of bank was extended at least 0.8 m from the guardrail and the previously damaged culvert was replaced and extended. The inlet ditch (north side) was modified to improve flow to the culvert. No erosion was noted at either end of the culvert and flow appeared to be contained within the culvert for its whole length.

Photo 1 – Looking east (downstream) at culvert and Vane 4, June 12, 2007.

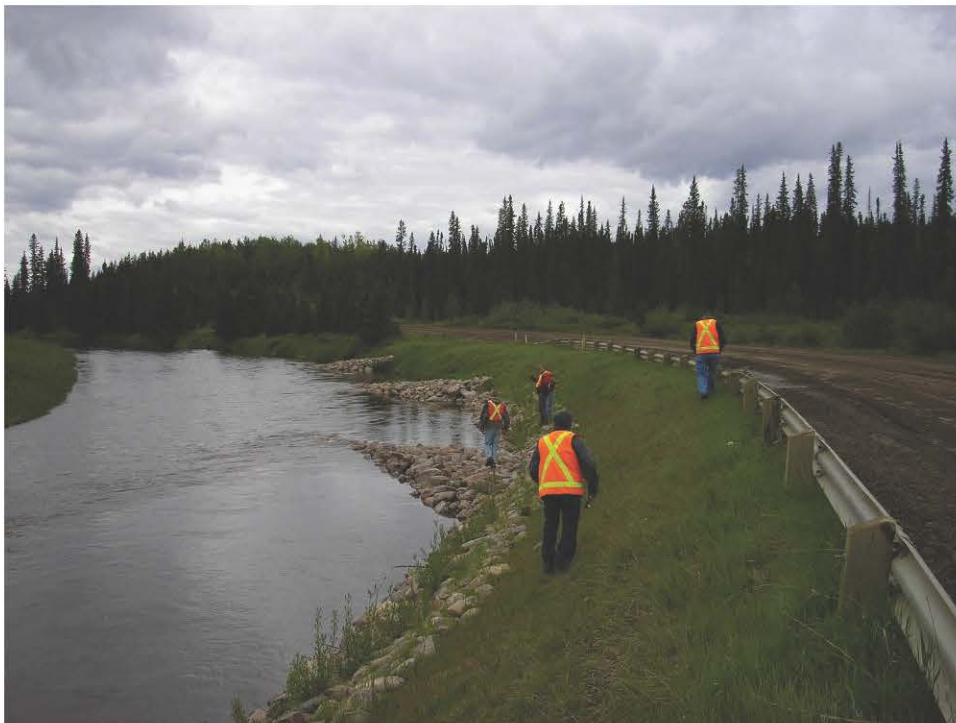
Conditions have significantly improved since 2005 as the site was rebuilt in Fall 2005. The repairs appear to be stable with no cracking observed on the roadway or bank slopes. No erosion gullies or rills were observed. It was observed that the rock vanes were successful in maintaining the thalweg away from the bank.

Photo 2 – Looking west (upstream) at Vanes 3, 2, and 1, June 12, 2007.

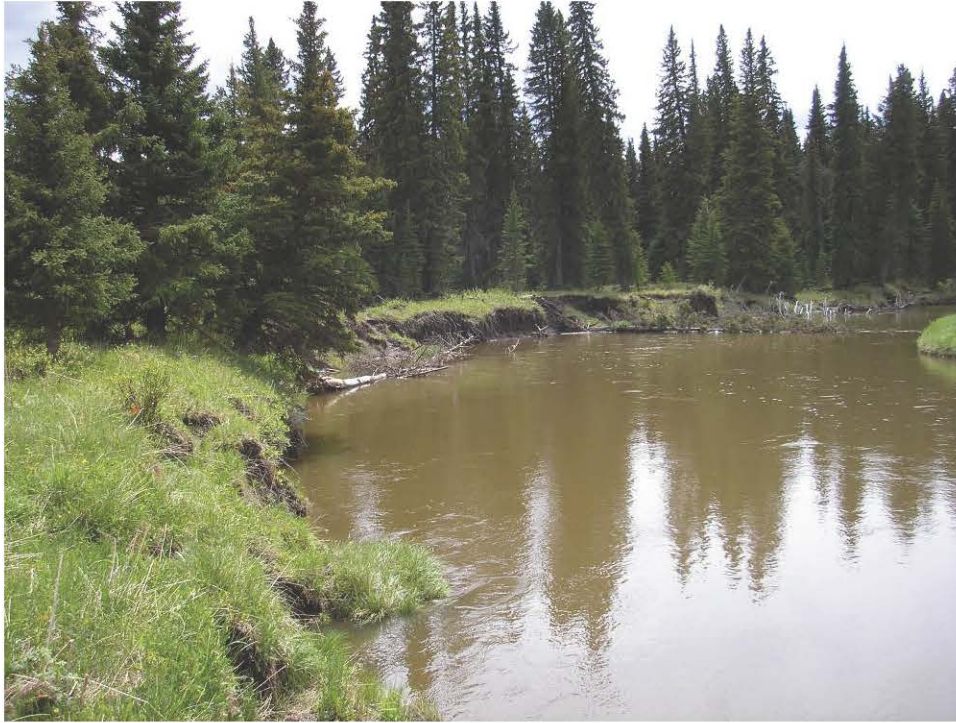
There is on-going erosion of the bank immediately downstream of the end of the riprap as evidenced by bank under-cutting and leaning trees. The erosion noted downstream of the riprap protection had begun before the repairs were undertaken and is similar to areas of the bank slightly further downstream. As this is away from the roadway, the impact to the highway is expected to be negligible.

Ongoing vegetative growth will continue to improve the surficial soil stability at the site. It is believed that the eroding area immediately downstream of the riprap treatment will stabilize with time.

Photo 3 – Looking at eroding outside bank downstream of Site 9, June 12, 2007.

No short term measures need to be undertaken at this time although on-going monitoring of the downstream area should continue.

Long term remediation measures have been undertaken and appear to be functioning as expected. Furthermore, a separate monitoring program is in place to undertake frequent inspections of the site. However, given the on-going bank regression downstream of the treatment zone and discussions with Fisheries and Oceans Canada, it is recommended that detailed inspection and reporting for Site 9 continue for at least one more year.

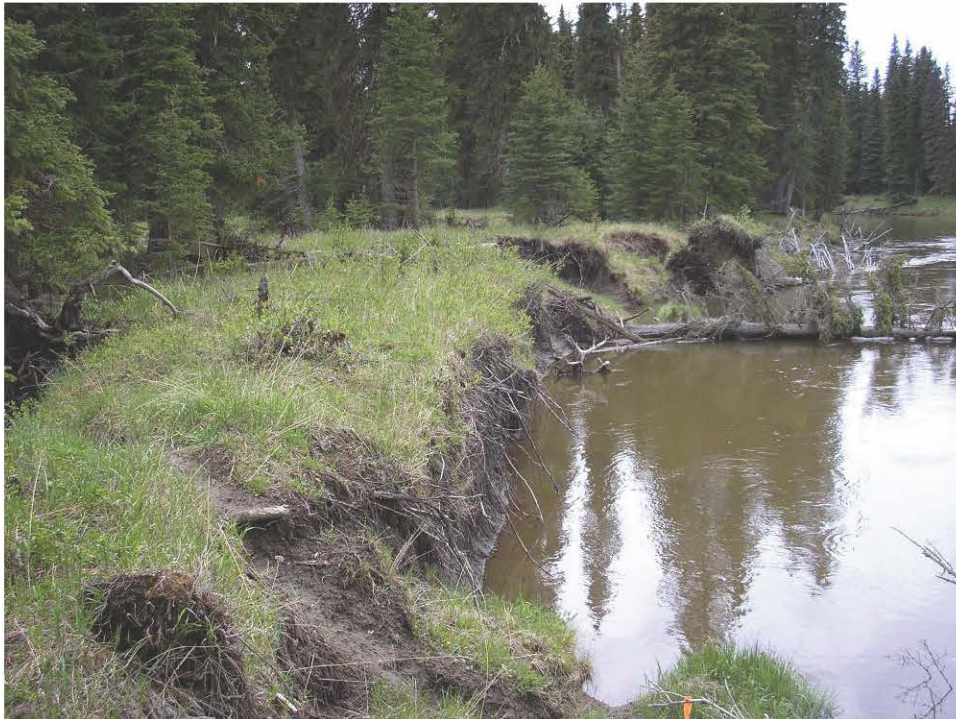
Photo 4 – Closer view of bank in Photo 3, June 12, 2007.
