August 26, 2008

File: 15-16-218

**NORTH CENTRAL REGION GEOHAZARD ASSESSMENT  
HWY 734:22 EROSION OF PEMBINA RIVER BANKS (NC28)  
SITE 8  
2008 ANNUAL INSPECTION REPORT**

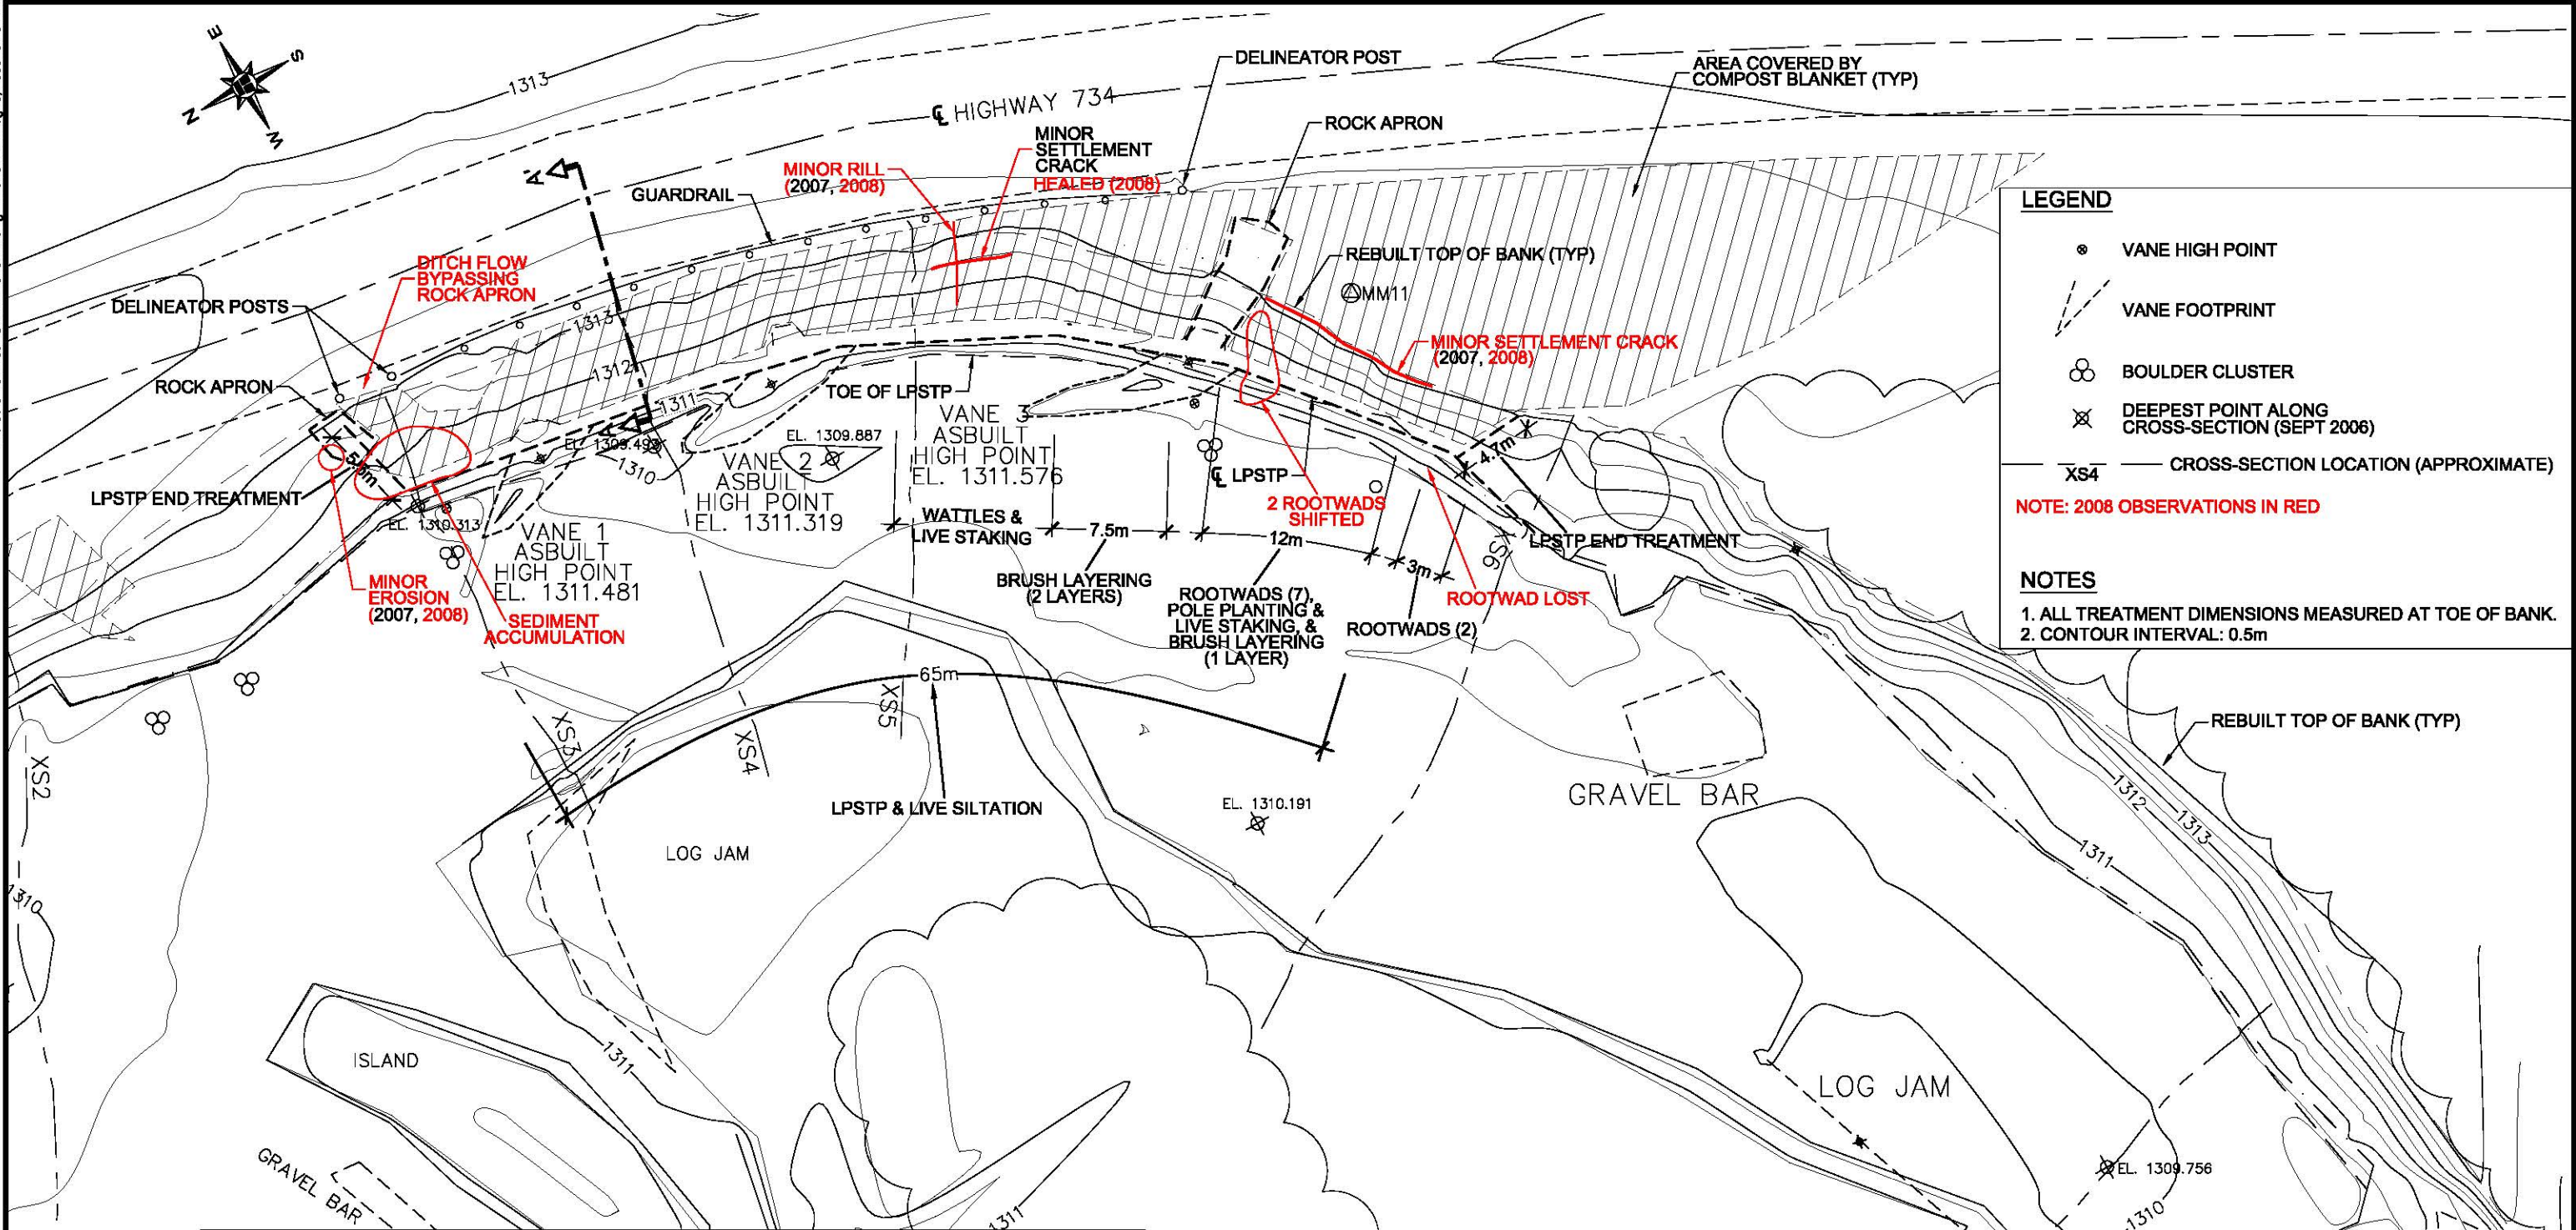
ENGINEER:	KEF	DRAWN:	CMH	APPROVED:	DJL
DATE:	JULY 2008	SCALE:	1:400	DRAWING No.:	<b>FIGURE NC28-2A</b>

Site 8 is located 39 km southeast of Robb on Hwy 734:22 (km 40.2, corrected from past reports) at legal land description SW18-46-18-W5M. Site features are shown in Figures NC28-2A and -2B (attached for inclusion in Section F). Cross-section A-A' on Figure NC28-2A shows the reconstructed slope in the guardrail area.

As part of the repairs, the top of bank was extended at least 2 m from the guardrail. Several compost berms were installed further north along the west ditch to direct surface runoff away from the high slopes that had experienced slumping in the past. This runoff is directed to the river partially via a live pole drain at the end of the compost berm and through a rock apron further downhill (immediately upstream of the guardrail). The voids in the rock apron were filled with road gravel and it appeared that some sediment had accumulated on the bank below the apron. In addition, inappropriate ditch grading had created a swale between the rock apron and the guardrail resulting in ditch flow bypassing the apron (see Photo 8).

The maintenance contractor should be directed to create a swale at the rock apron immediately upstream of the guardrail rather than between the apron and the guardrail (Photo 8 and location shown on Figure NC28-2A).

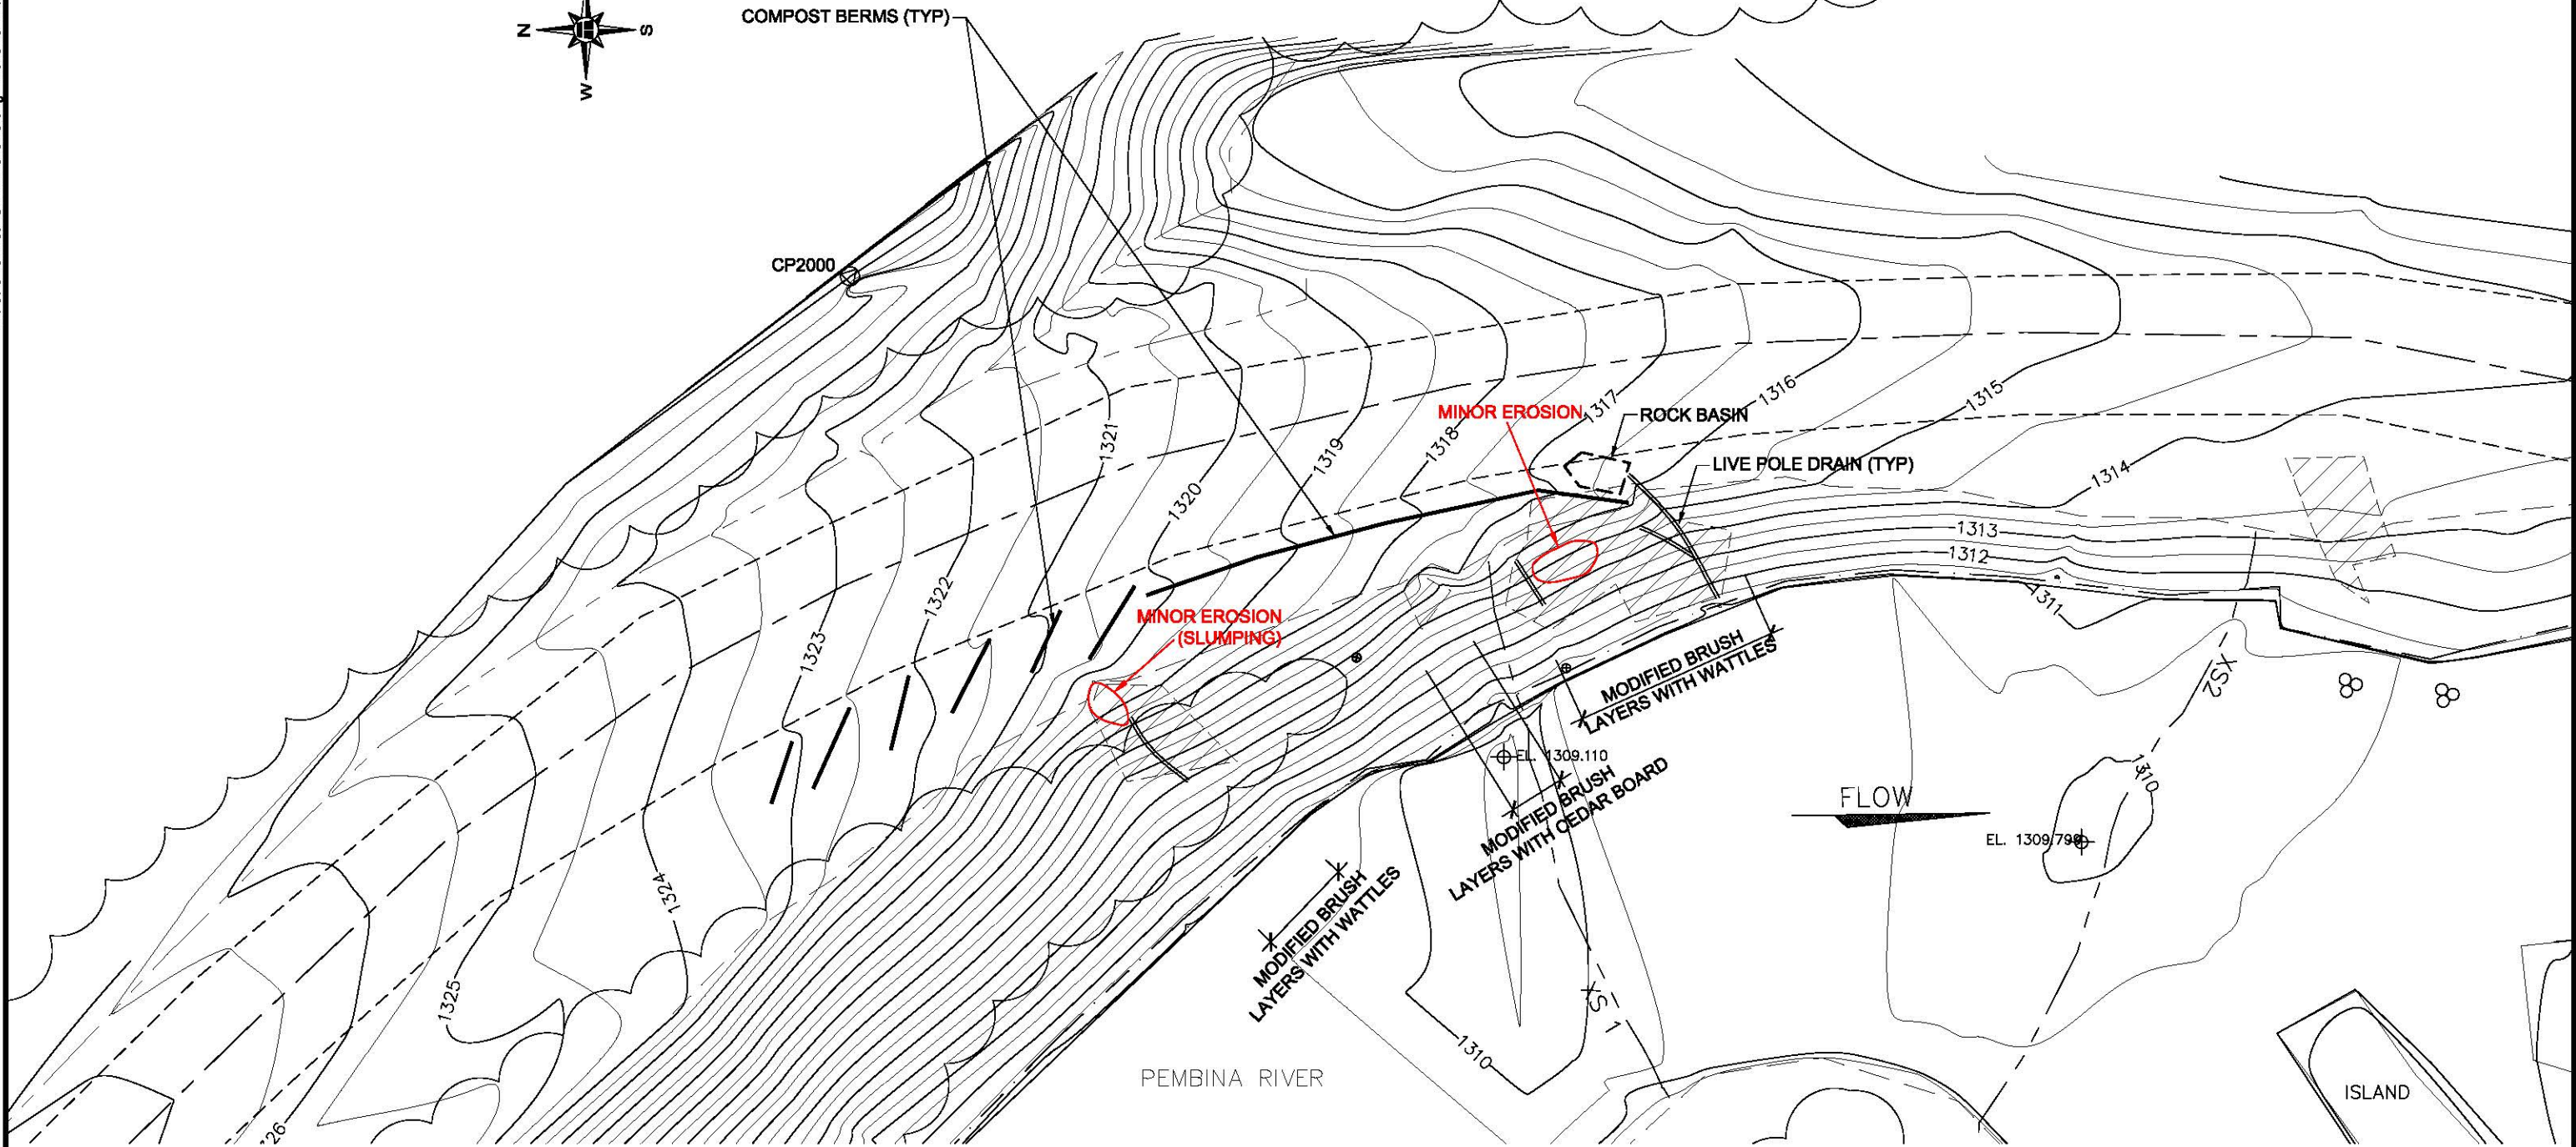
ENGINEER:	KEF	DRAWN:	CMH
DATE:	JULY 2008	SCALE:	1:400
APPROVED:	DJL	DRAWING No.:	<b>FIGURE NC28-2B</b>

The treatments on the uphill portion of the site were also relatively stable. Willow and grass growth is becoming established and there was only minor erosion noted over most of the areas. One bare spot was noted just upstream of the live pole drain/rock apron but compost was still in place. The furthest upstream gully had slumped or eroded slightly at the top end likely due to heavy runoff or spring rains but the debris has been contained by the vegetation.

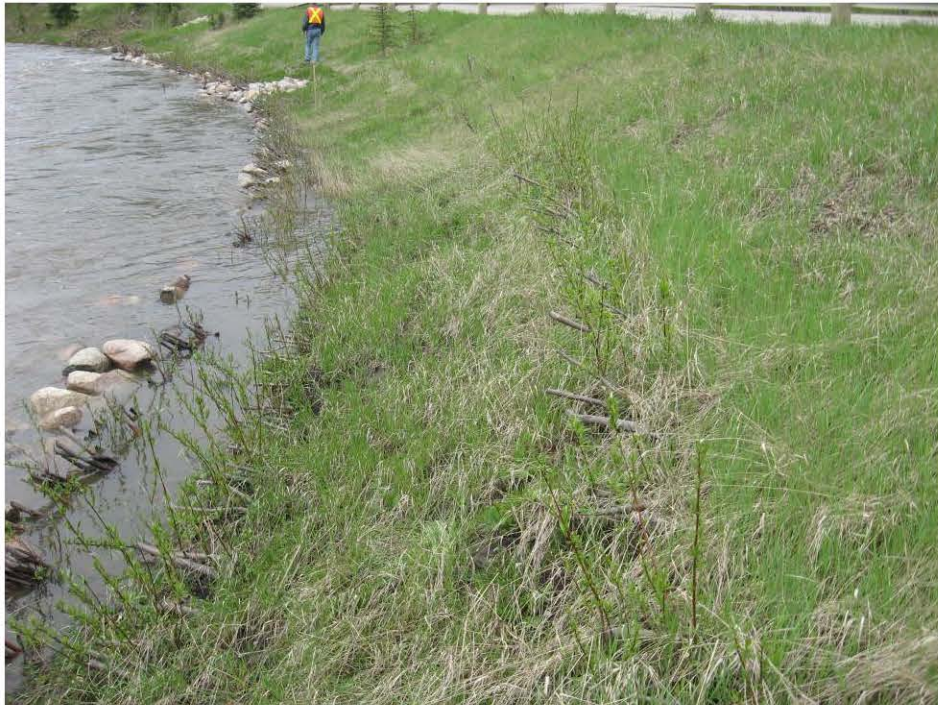
Photo 1 – Looking northeast at repaired slump area below guardrail, June 12, 2008.

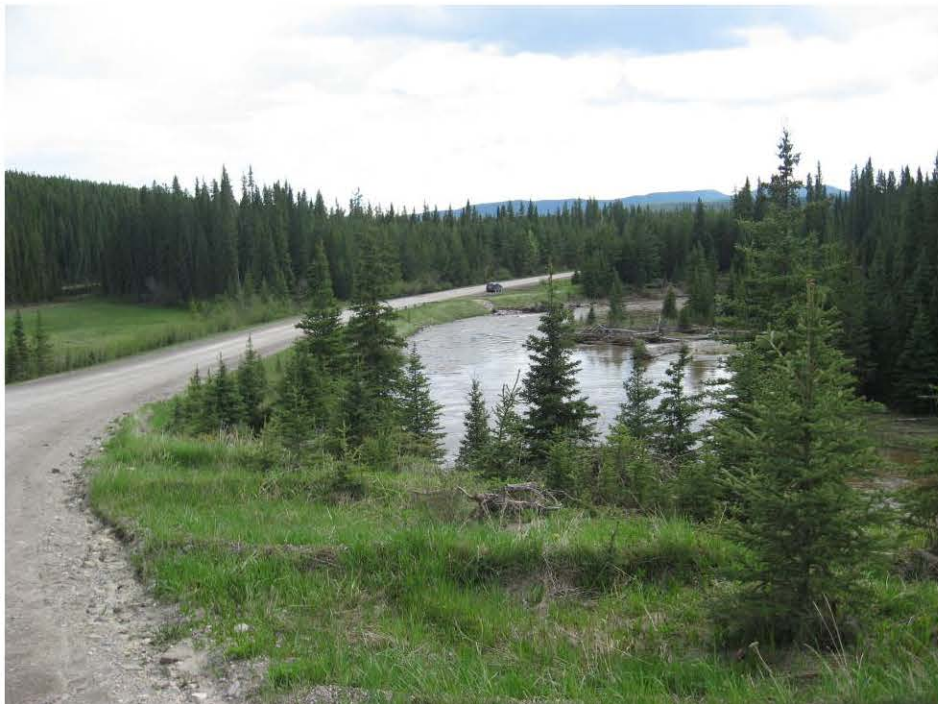
Photo 2 – Looking southeast at repaired main slump area, June 12, 2008.

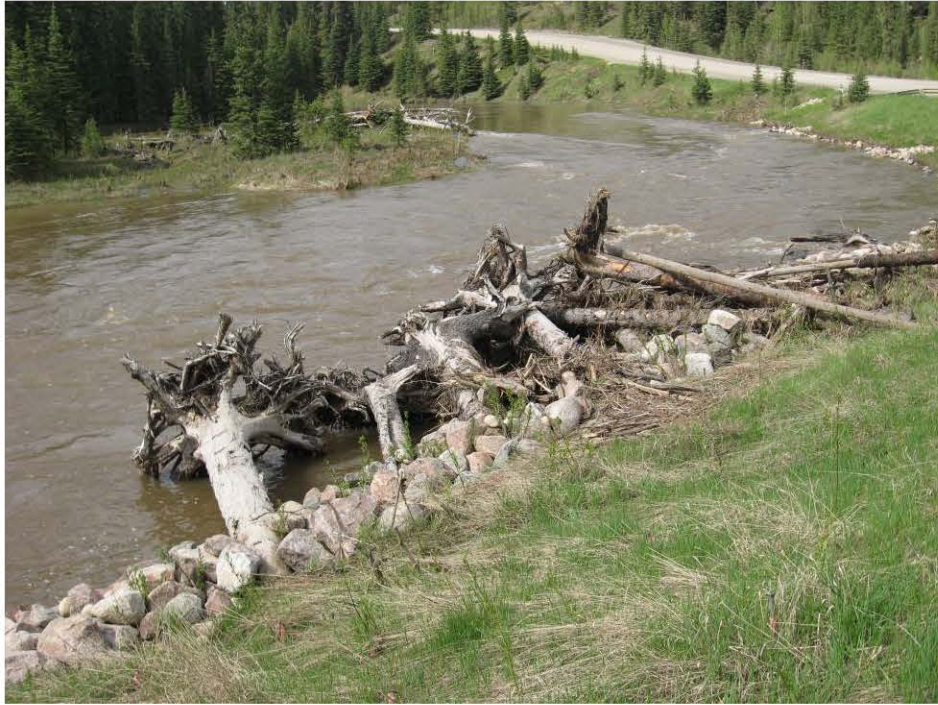
Photo 3 – Looking upstream at rootwads. Note that upstream 2 have shifted, June 12, 2008.

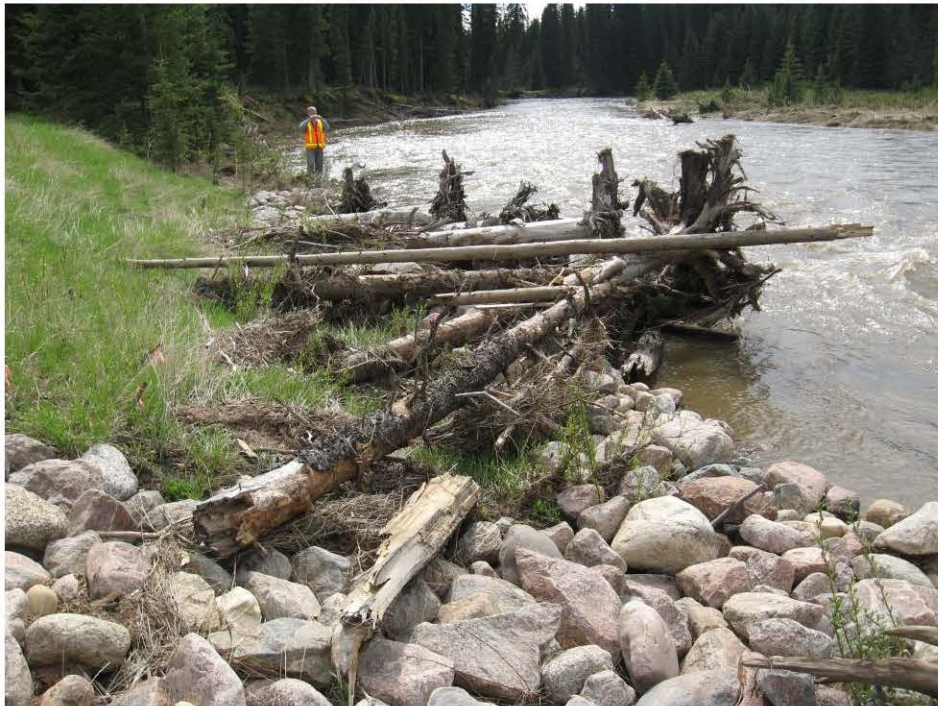
Overall, the repairs appear to be stable and vegetation growth has continued to improve since 2007. No cracking was observed on the roadway but some minor settlement cracking was noted over the rootwad installations. Some minor rills were observed in the blown compost cover along the guardrail section. It was observed that the rock vanes were successful in maintaining the thalweg of the river flow away from the bank. It appeared that high water levels, buoyancy, ice breakup, debris, or a combination thereof, had caused some damage to the rootwads. The first two at the upstream end had partially pulled out of the bank and shifted downstream. The furthest downstream rootwad was entirely missing. This particular rootwad was installed by “stinging” rather than excavation and had only minimal cover which is likely the reason it was fully dislodged.

Photo 4 – View of displaced rootwads at upstream end of treatment, June 12, 2008.

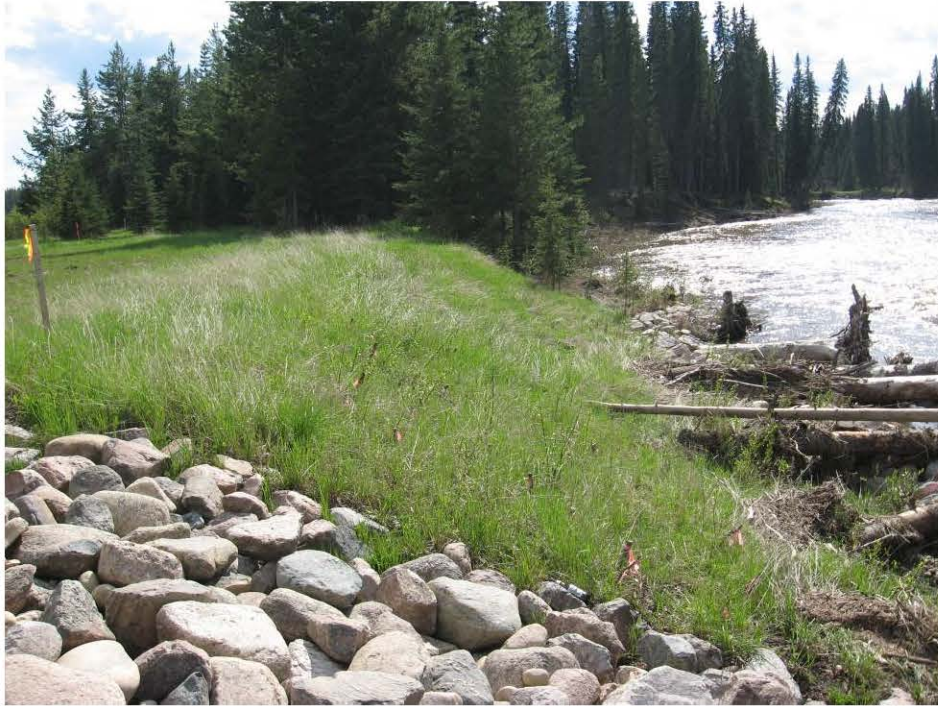
Photo 5 – Looking southwest at repaired slump area at south end of site, June 12, 2008.

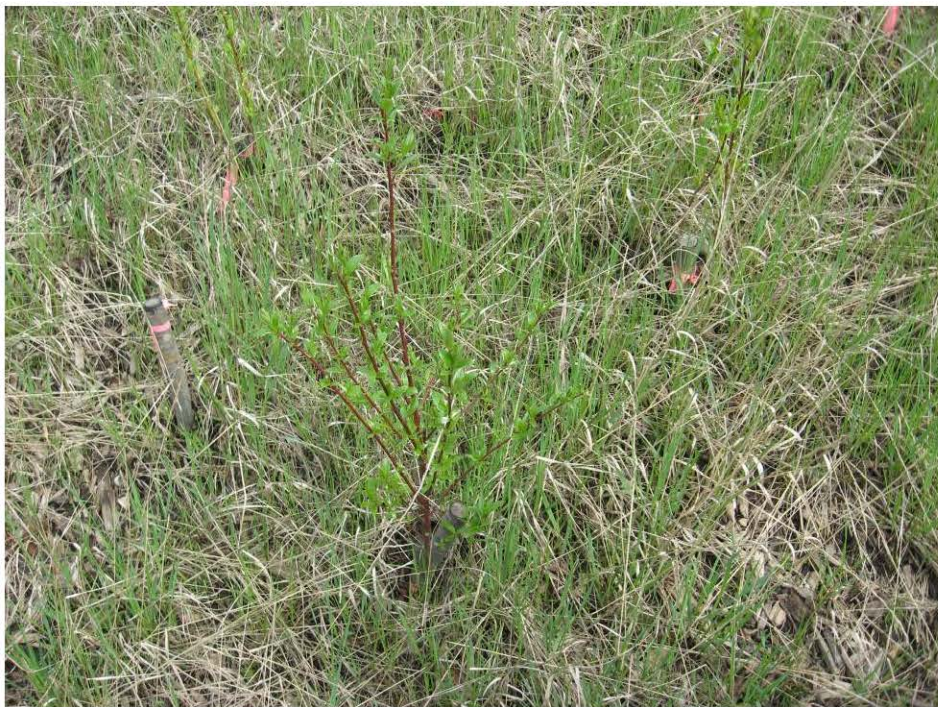
Photo 6 – Typical live staking growth after one full growing season, June 12, 2008.

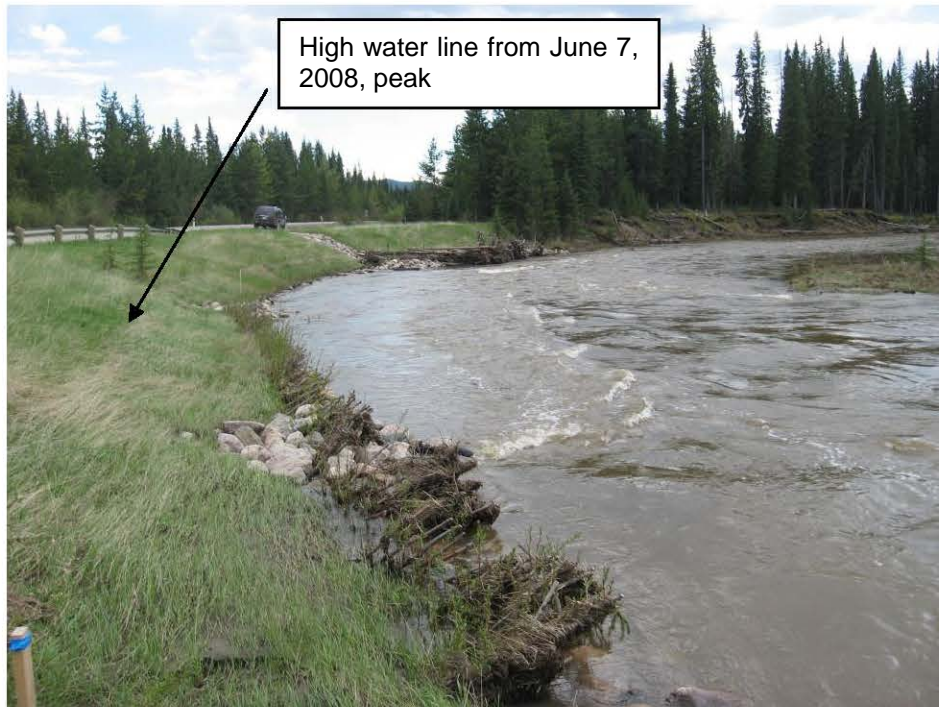
The water level was high during the site visit; significantly higher than the same time in 2007. The river was flowing at just below bankfull elevation and there was evidence that the water level had been up to 0.5 m higher earlier in the month. Based on water level measurements at the nearby bridge (where the monitoring station is located), the river elevation was 1296.19 m at the time of the site visit (compared to 1295.62 m during the previous visit) and the peak elevation for 2008 was 1296.78 m and occurred on June 7 (about 0.4 m higher than previous record in 2006). Bankfull elevation is estimated to be 1295.97 m at the bridge location.

High water line from June 7, 2008, peak

Photo 7 – Looking downstream at repaired section along guardrail. Note high water line, June 12, 2008.

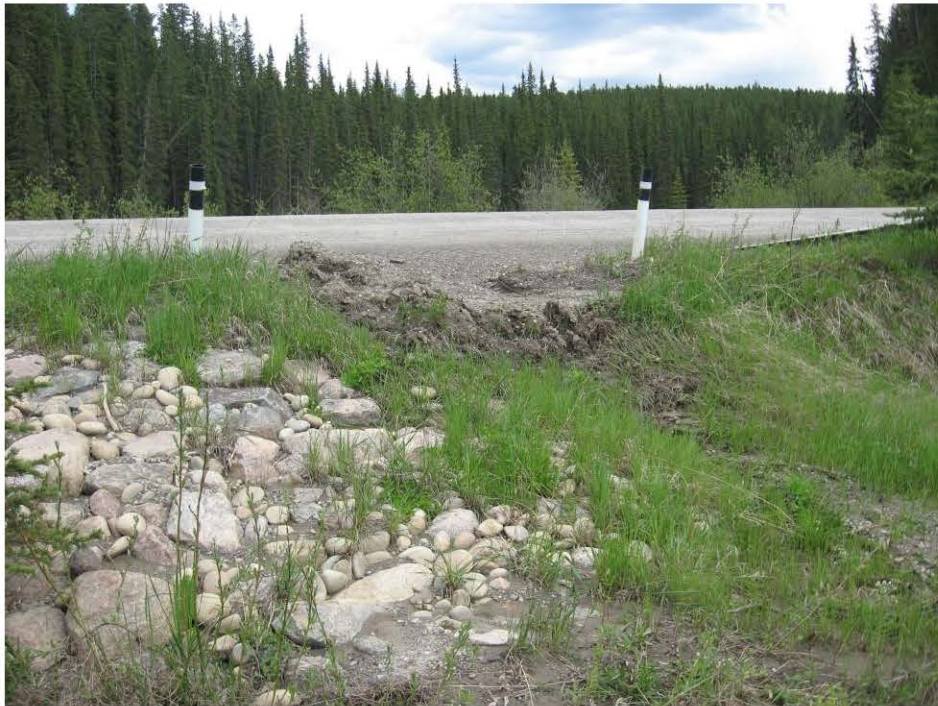
Photo 8 – Accumulated debris on rock apron upstream of guardrail and bypassing ditch flow, June 12, 2008.

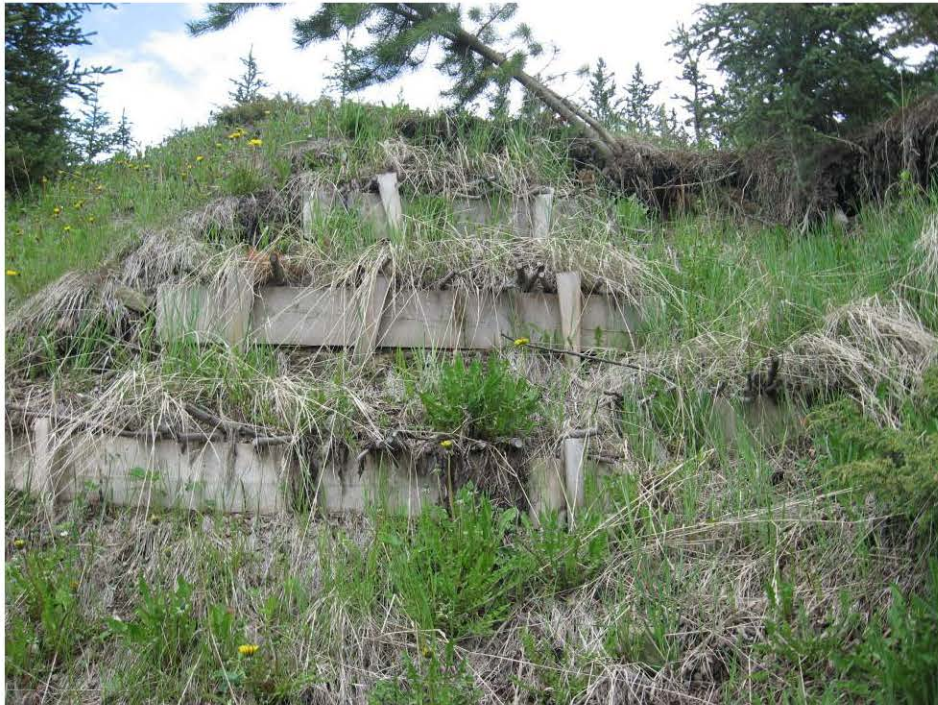
Photo 9 – Modified Brush Layering with Cedar Boards, June 12, 2008.

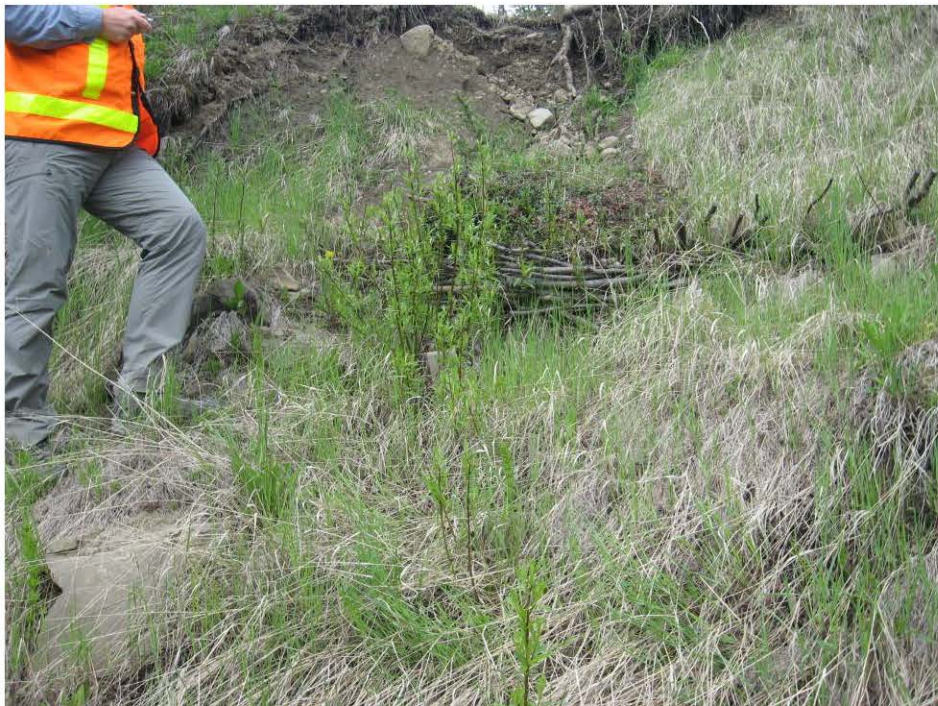
Photo 10 – Modified Brush Layering with Wattles (furthest upstream) showing one season's growth and minor slumping at top, June 12, 2008.
