ALBERTA TRANSPORTATION

NC15 NORTH OF EDSON RIVER BRIDGE

NW 10 - 54 - 17 - W5M
HWY748:02, Km 6.2 (NC15)
NORTH OF EDSON, AB

NORTH CENTRAL 2011
GEOHAZARD ASSESSMENT

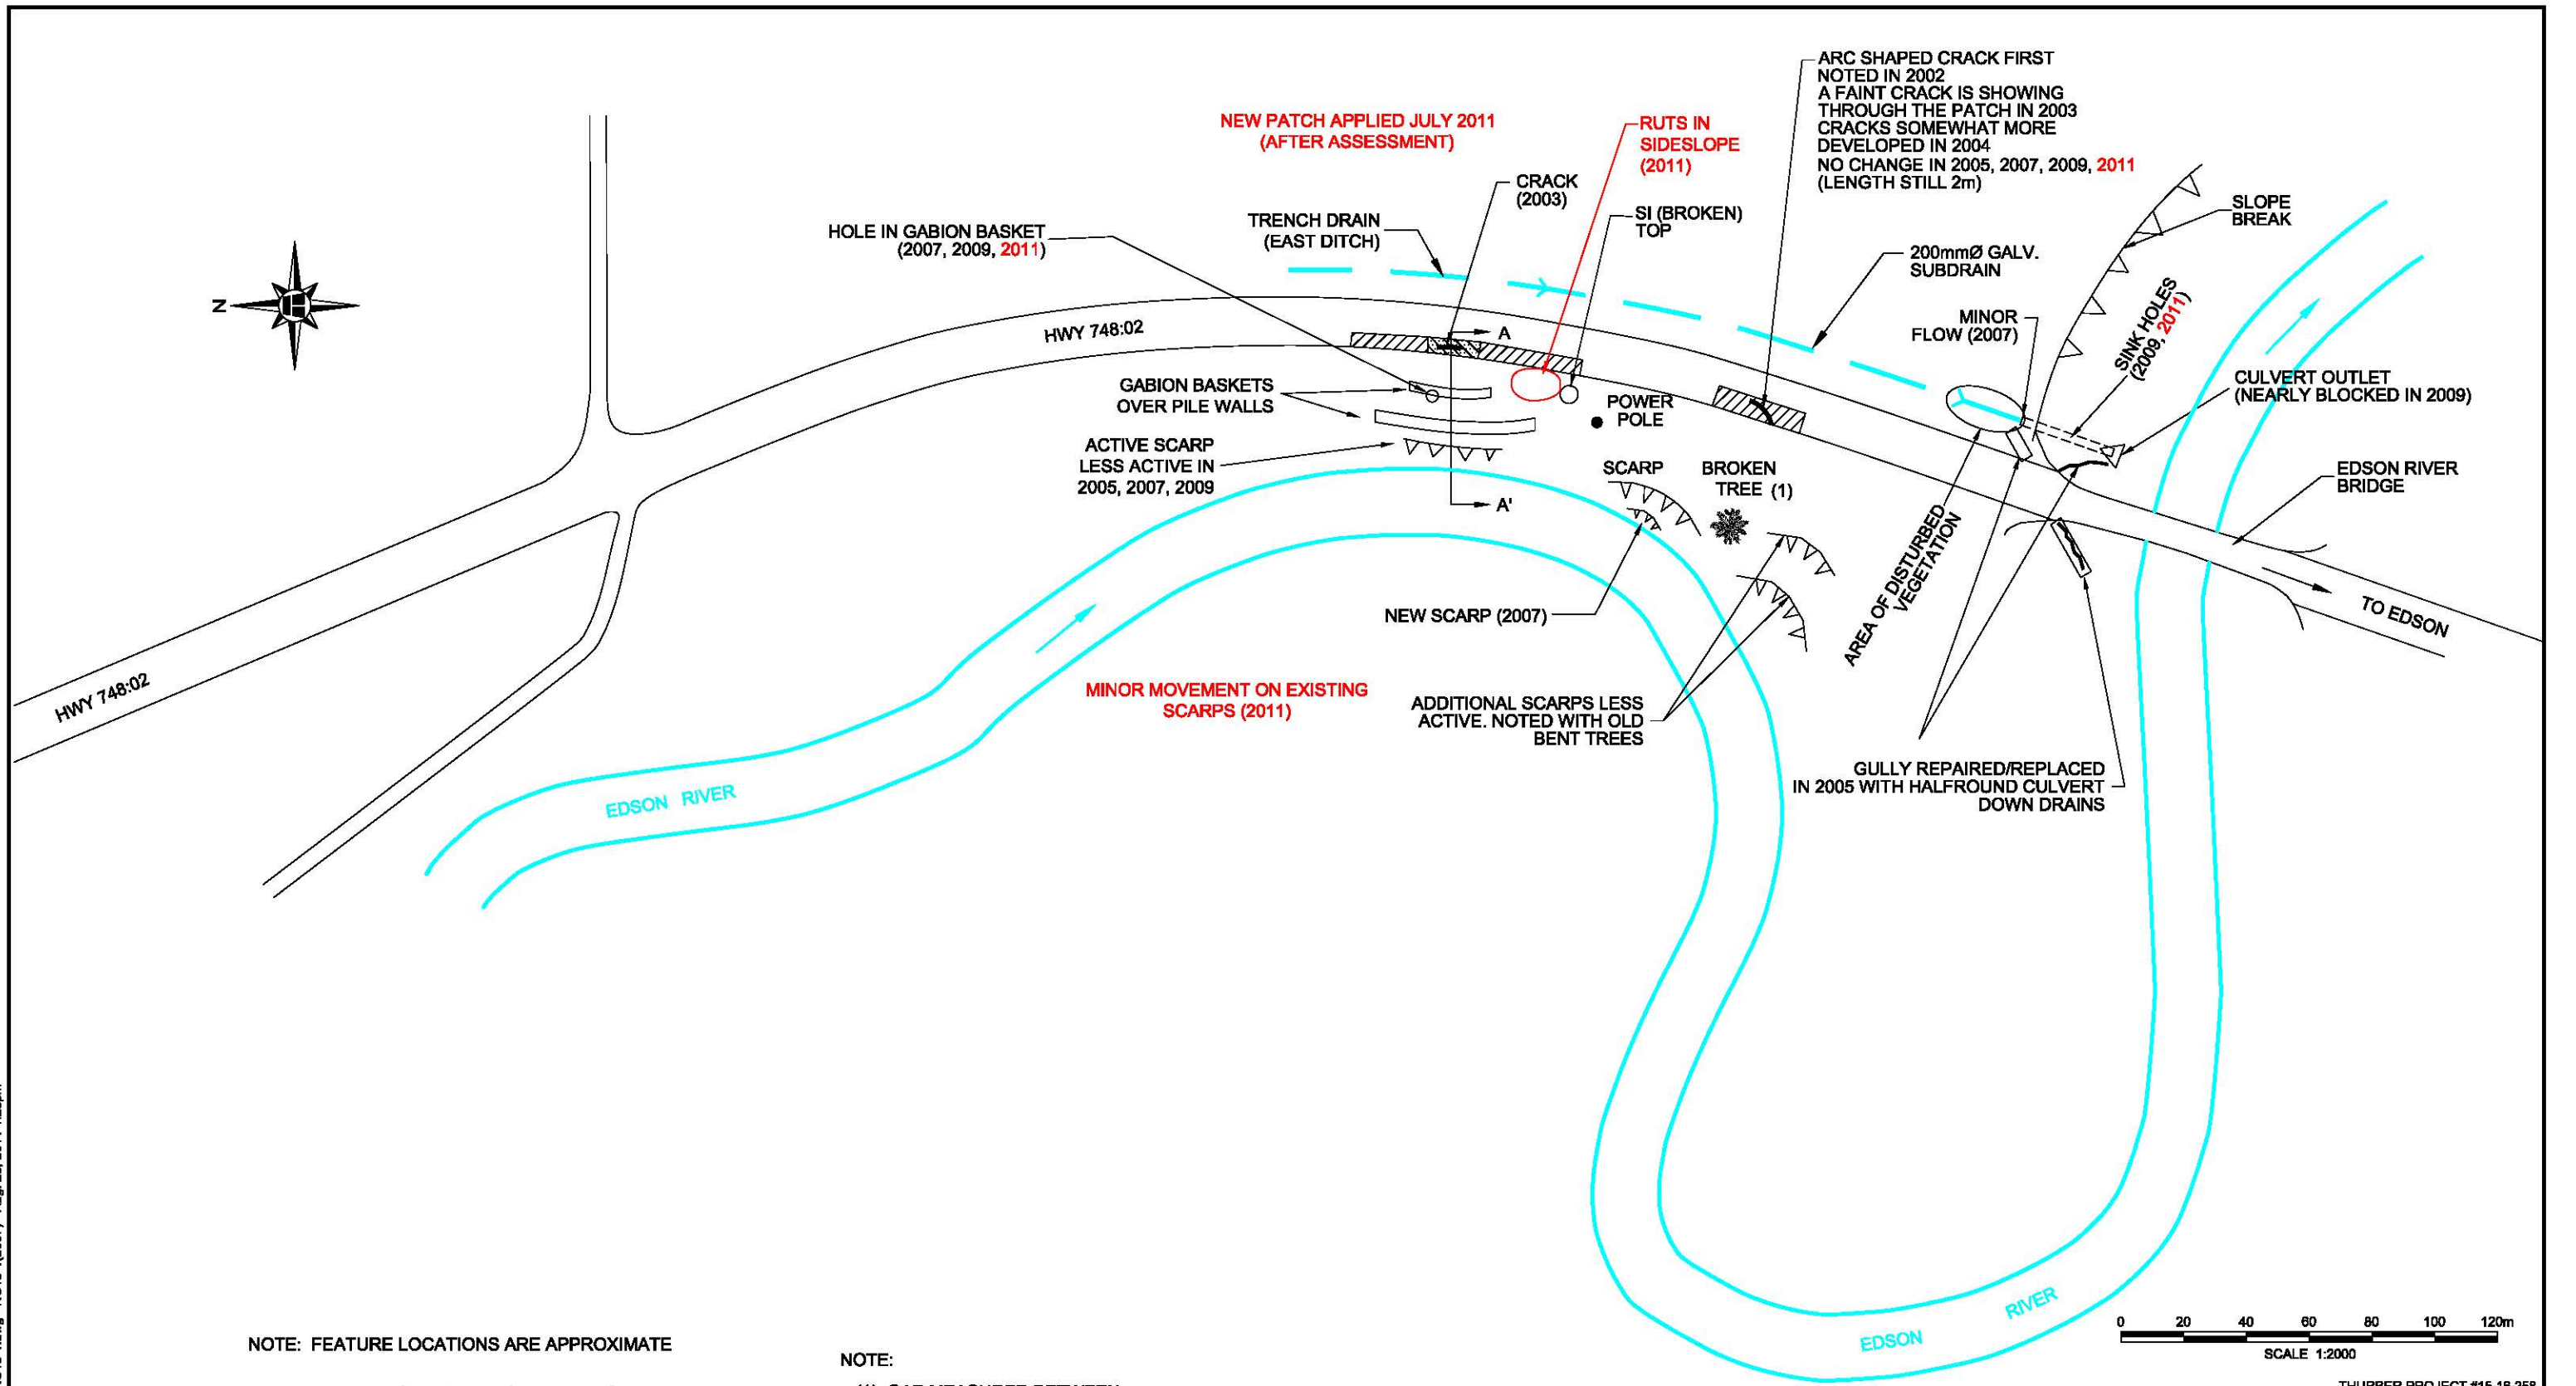
DRAWING No.
FIGURE NC15-1

- (1) GAP MEASURED BETWEEN MARKS NOTCHED IN TREE:
 - 660mm IN 2004
 - 670mm IN 2005
 - 708mm IN 2007
 - NOT MEANINGFUL IN 2009

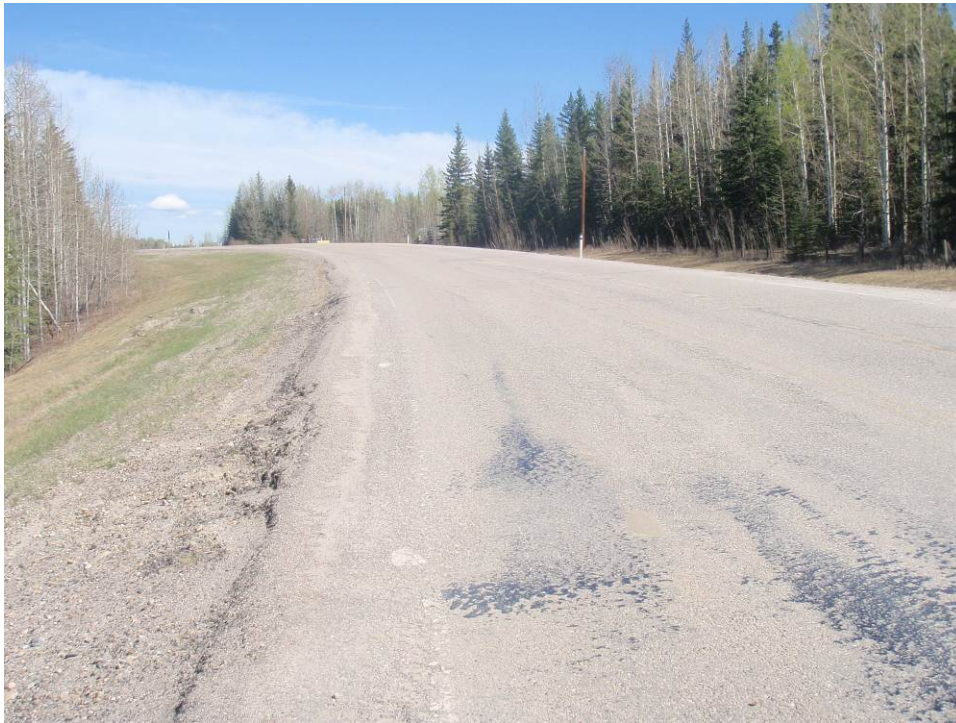
Photo 1 – Looking north at roadway above repaired side slope (May 17, 2011).

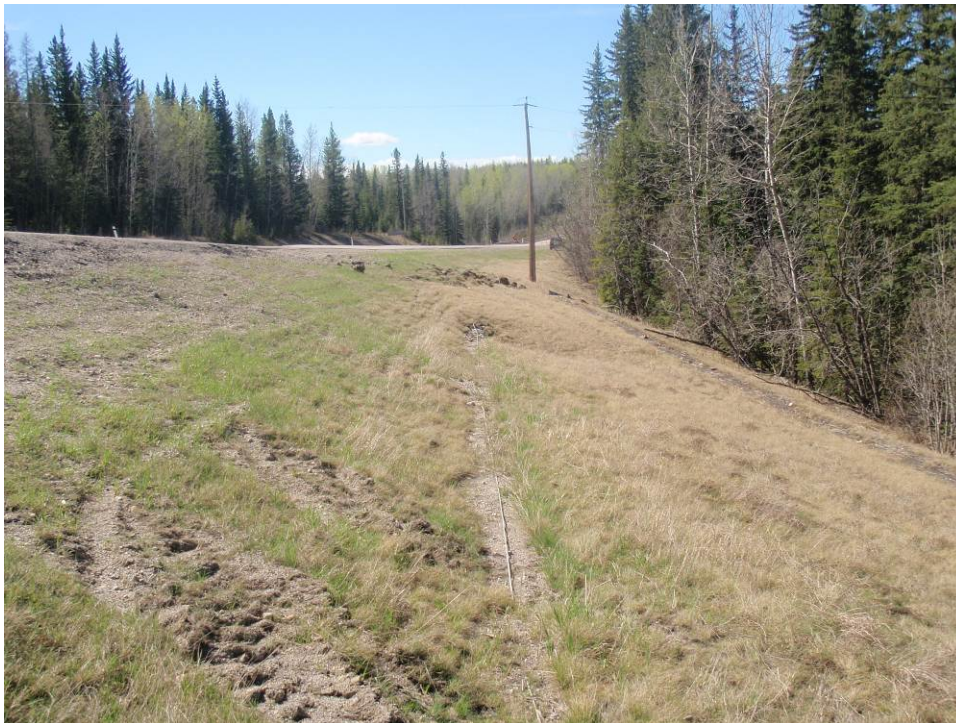
Photo 2 – Looking south at repaired side slope; note rutting near wooden power pole (May 17, 2011).

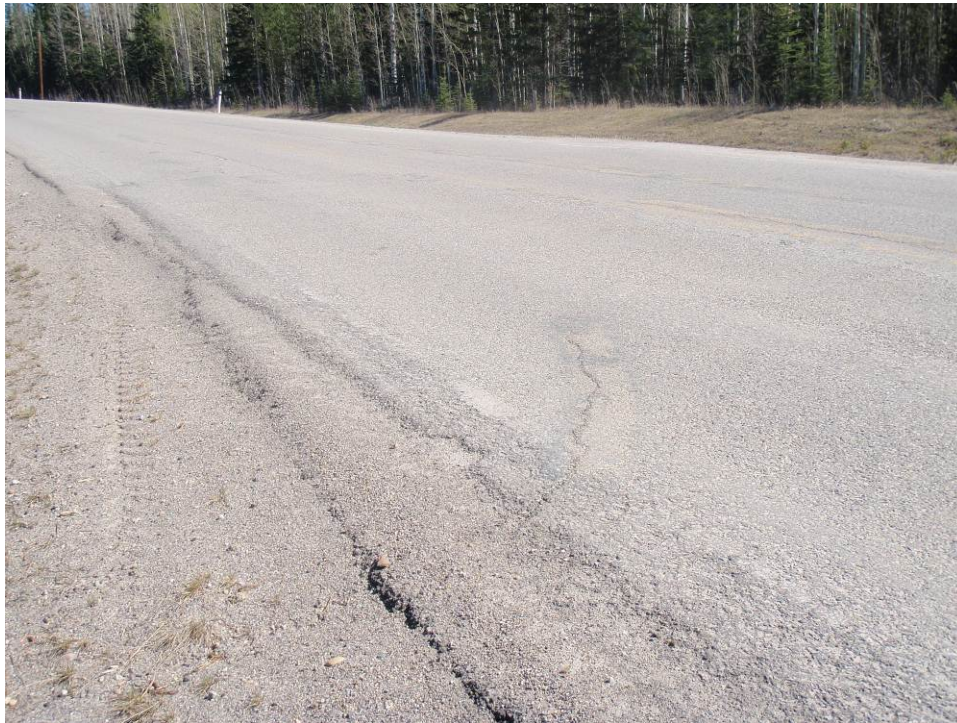
Photo 3 – Crack in south patch area (looking north) (May 17, 2011).

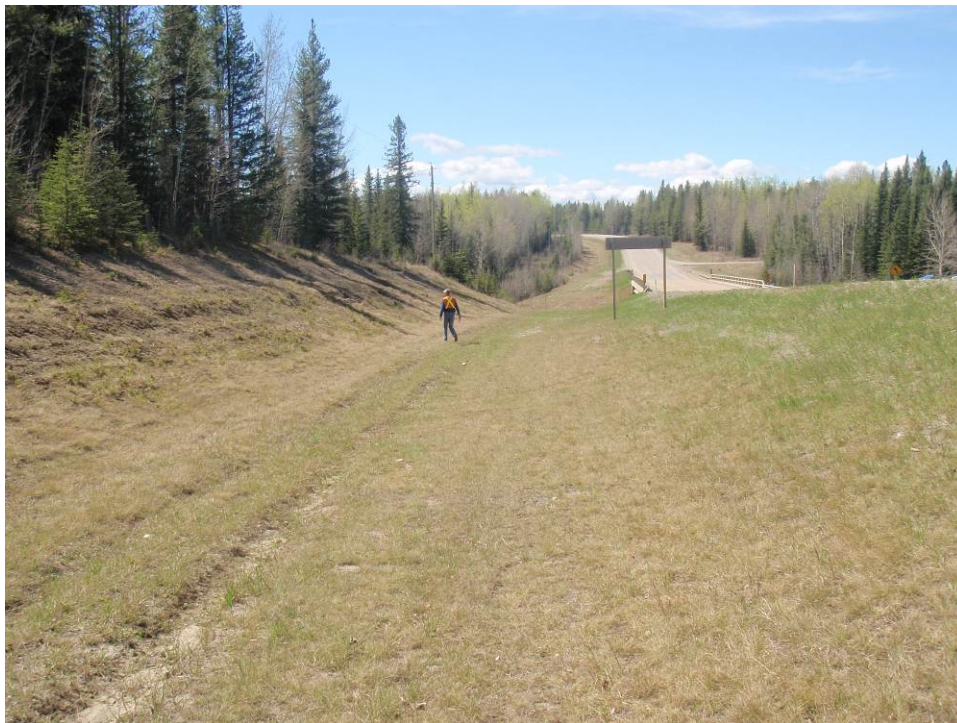
Photo 4 – East ditch across from south area (looking south) (May 17, 2011).

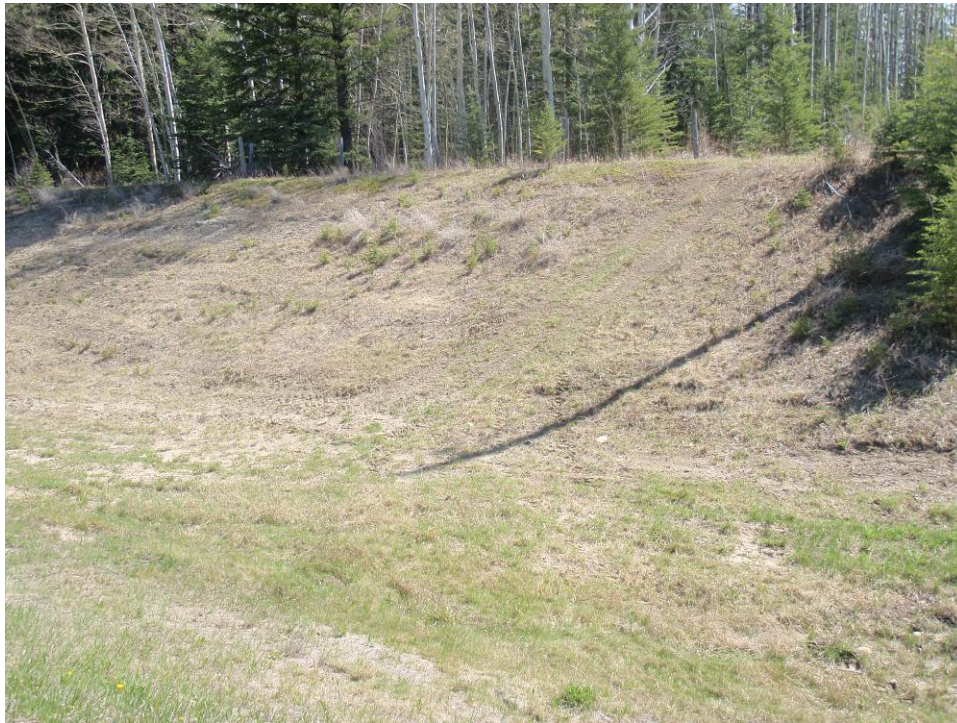
Photo 5 – Looking northeast where vegetation had been disturbed in east ditch (May 17, 2011).

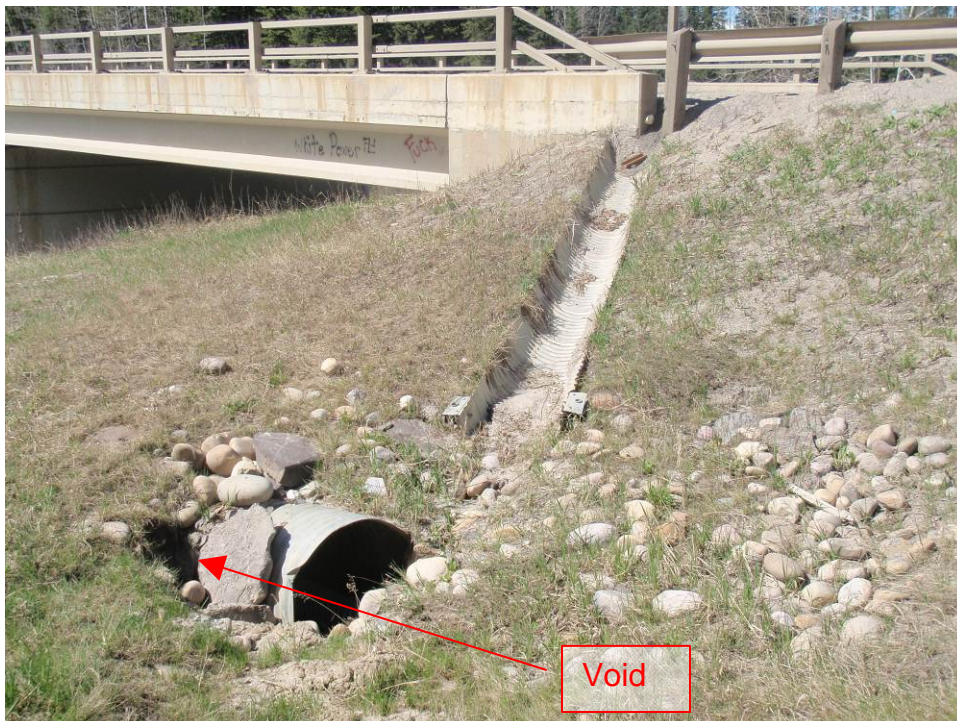
Photo 6 – Culvert inlet and half round down drain at NE bridge quadrant (May 17, 2011).

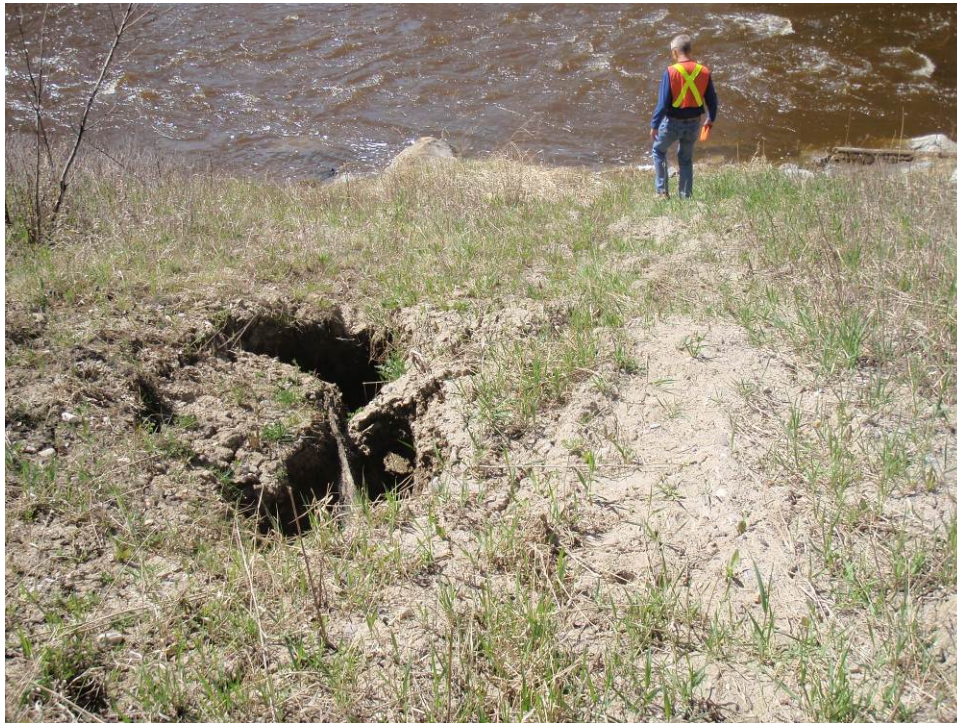
Photo 7 – Sinkhole downslope (south) of the culvert inlet, second sinkhole to right appears to have filled in (May 17, 2011).

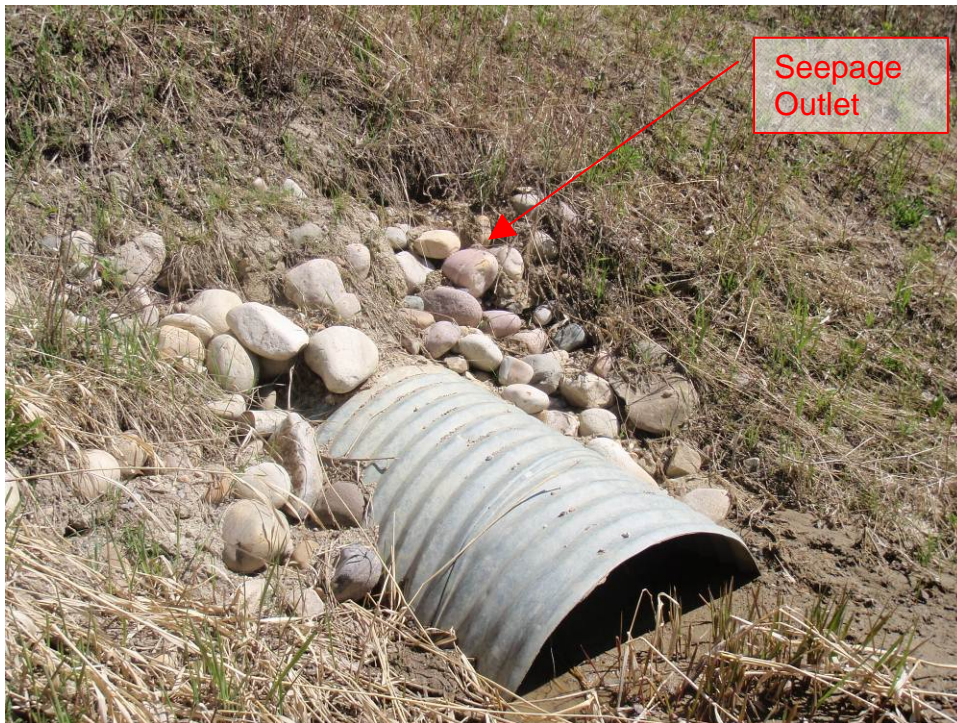
Photo 8 – Culvert outlet near NE bridge quadrant. Note seepage location above and to the right (east) of the culvert and sedimentation at outlet (May 17, 2011).

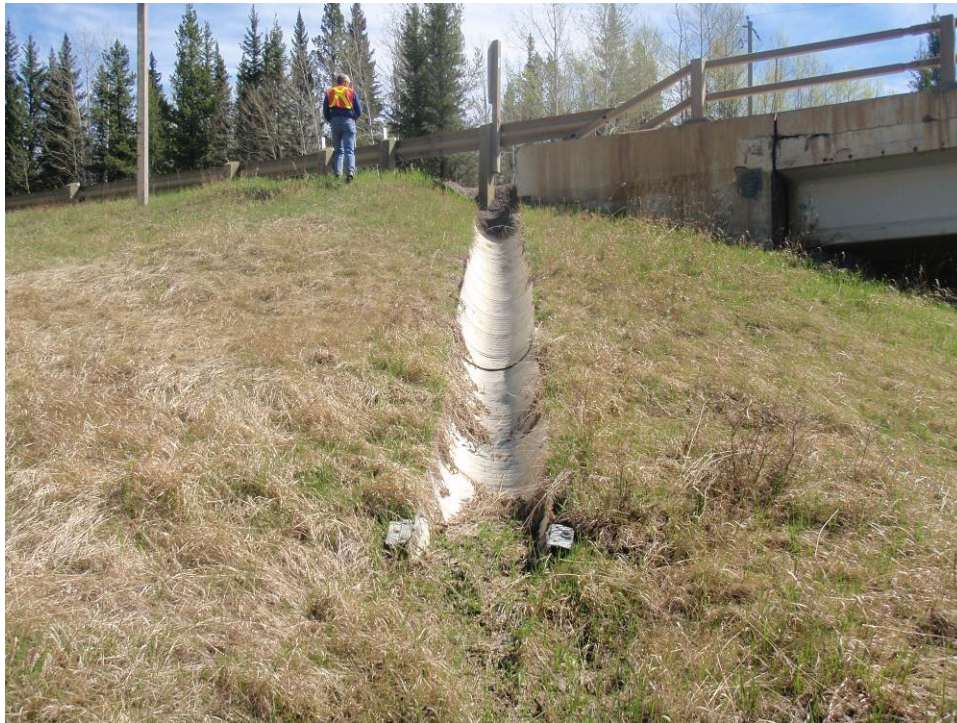
Photo 9 – Half round down drain at NW bridge quadrant (May 17, 2011).
