GEOHAZARD RISK MANAGEMENT PROGRAM
North Central Region – Edson Area
2013 Inspection Report

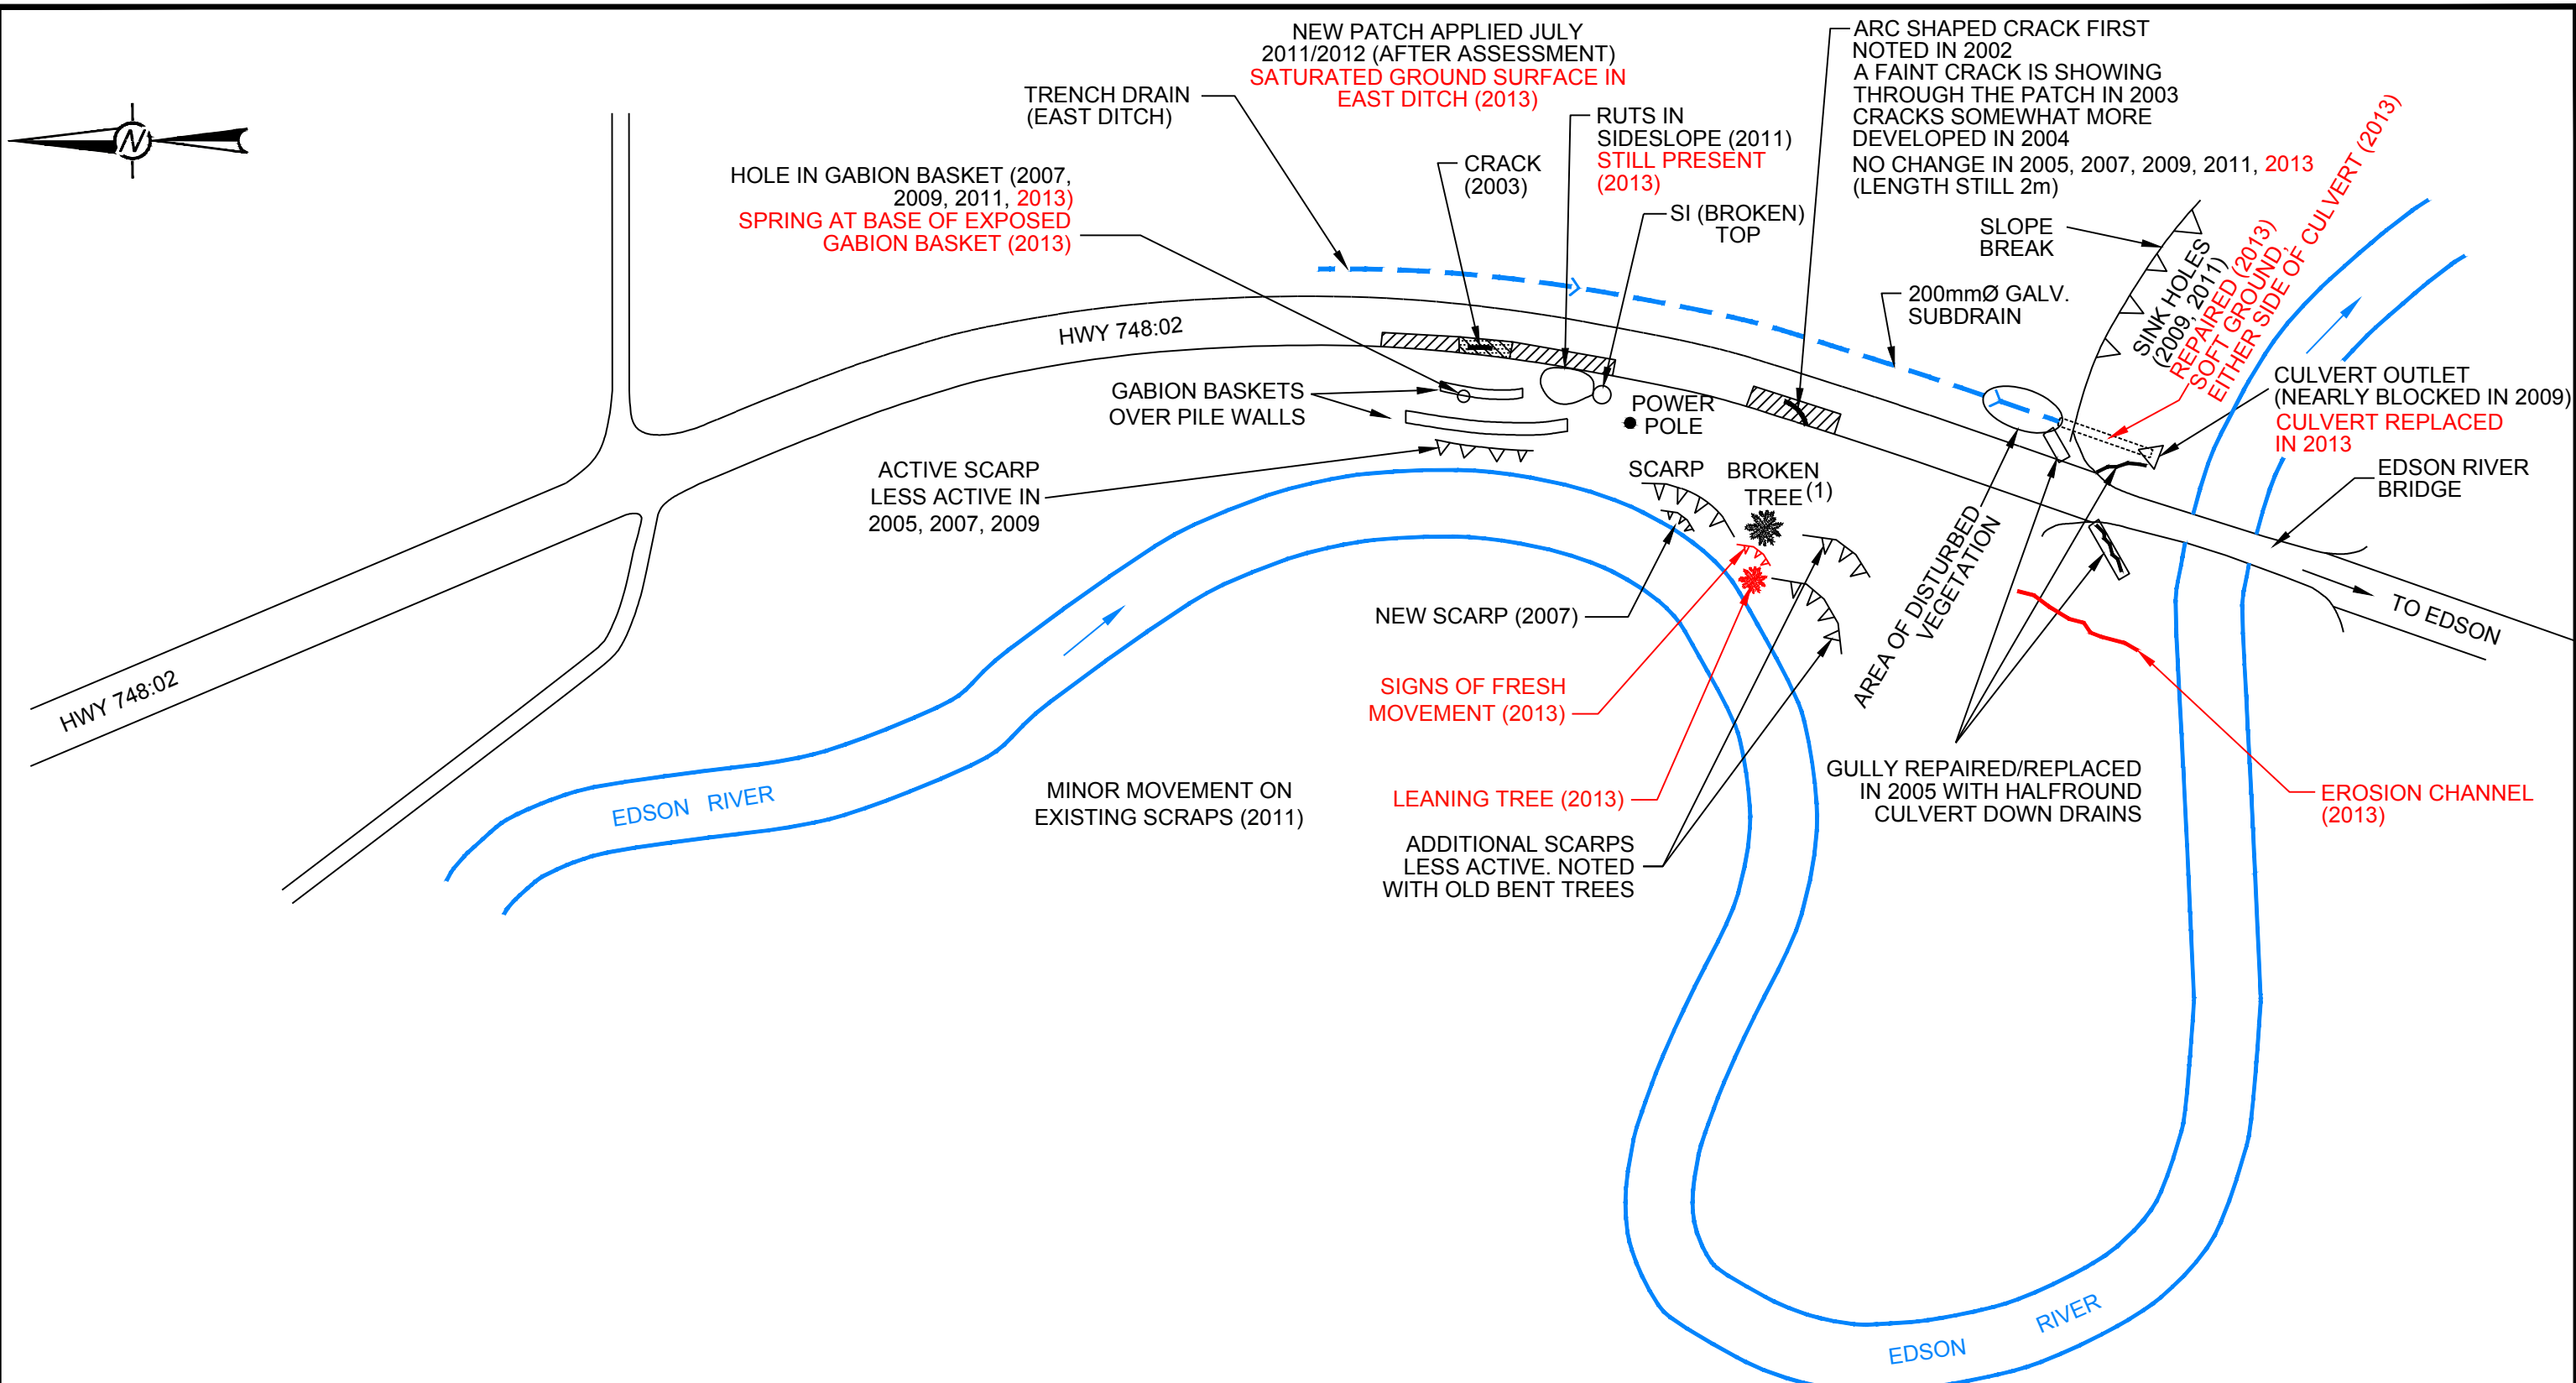
L:\2013\1376\13-1376-0027\2000\2100\13137600272000A005_NC15.dwg | Layout: Layout | Modified: A\Magheran 08/21/2013 1:20 PM | Plotted: A\Magheran 08/21/2013

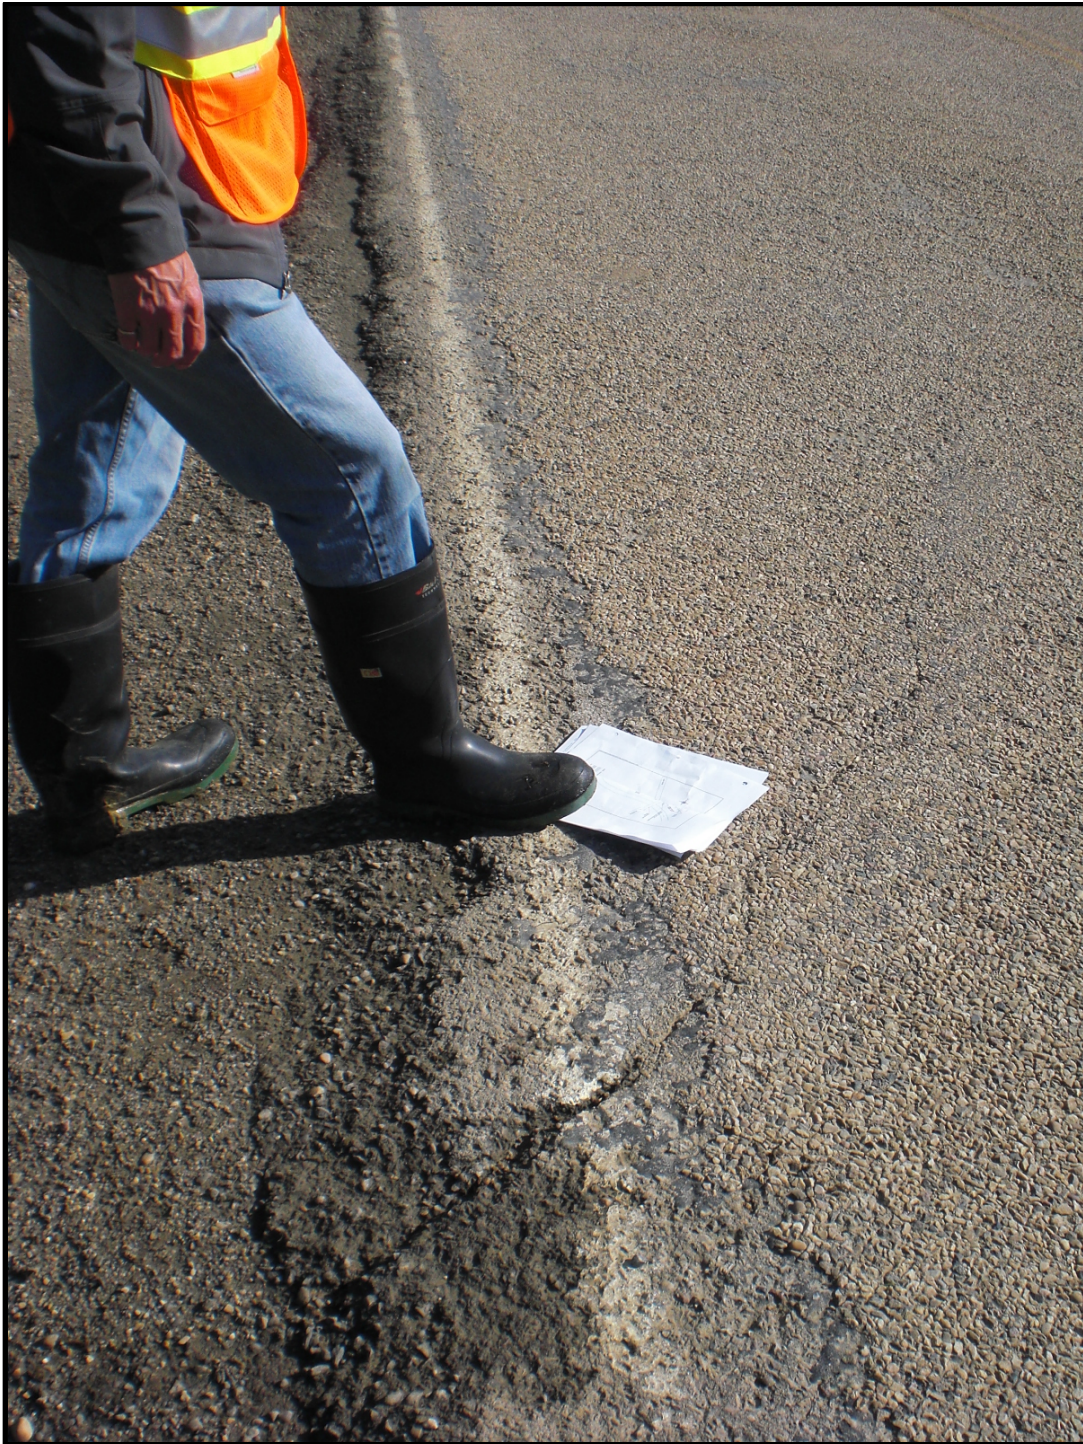
PHOTO 1: Pavement crack south of retaining wall reflecting through patch, less than 5 mm wide.

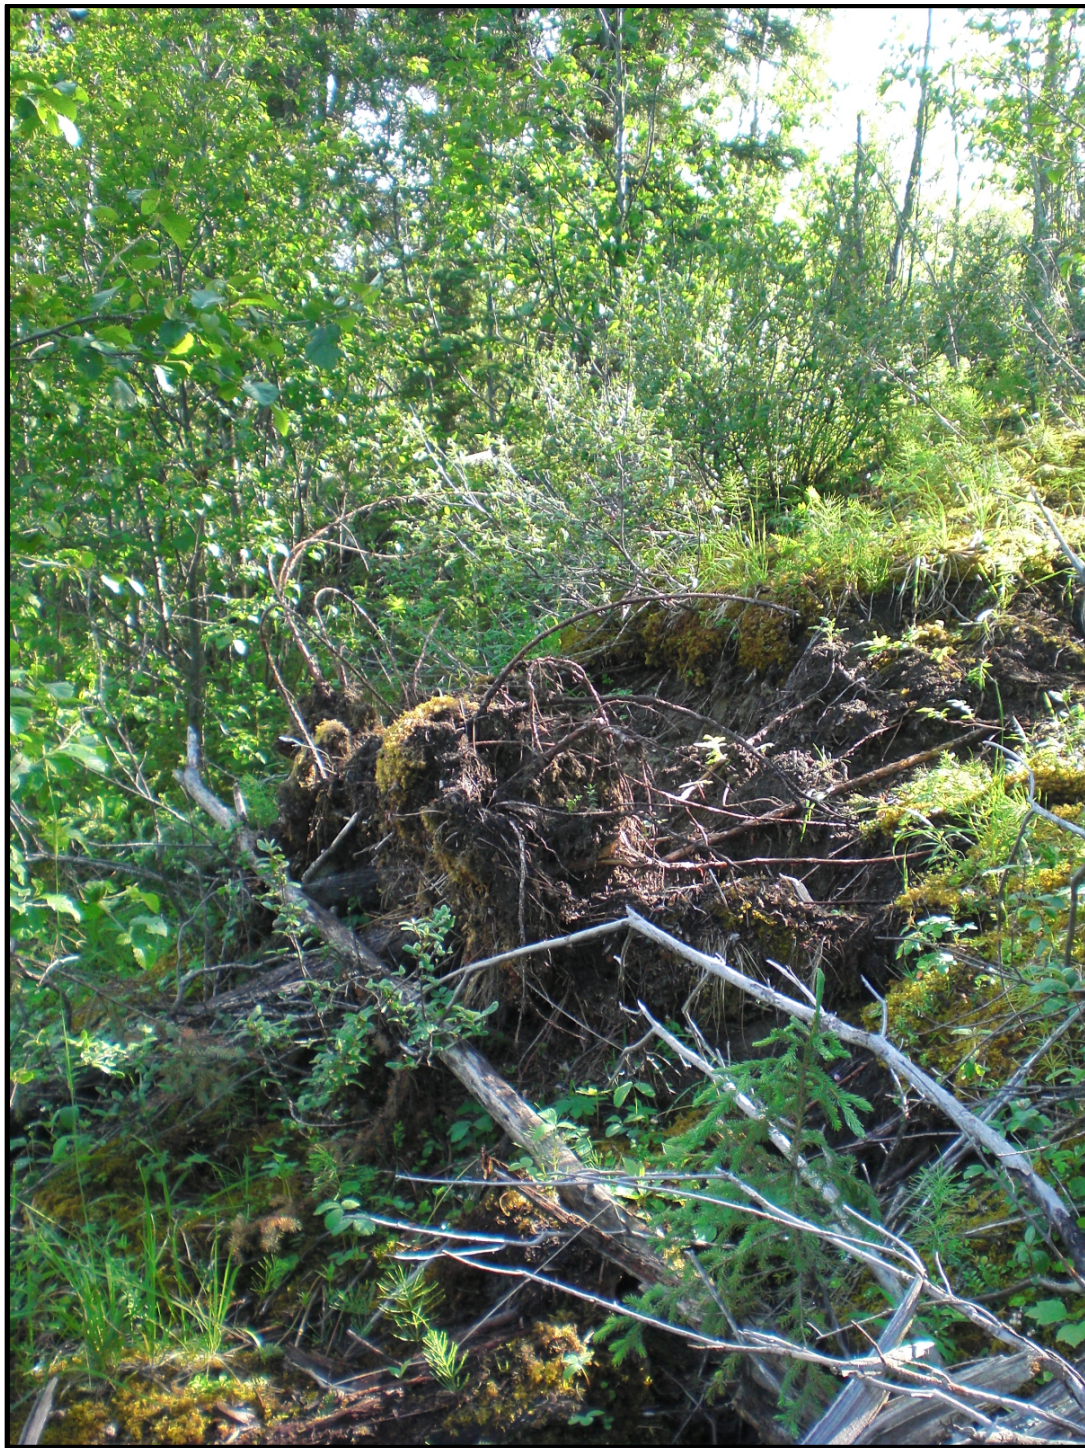
PHOTO 2: Freshly exposed earth in scarps south of pile wall.

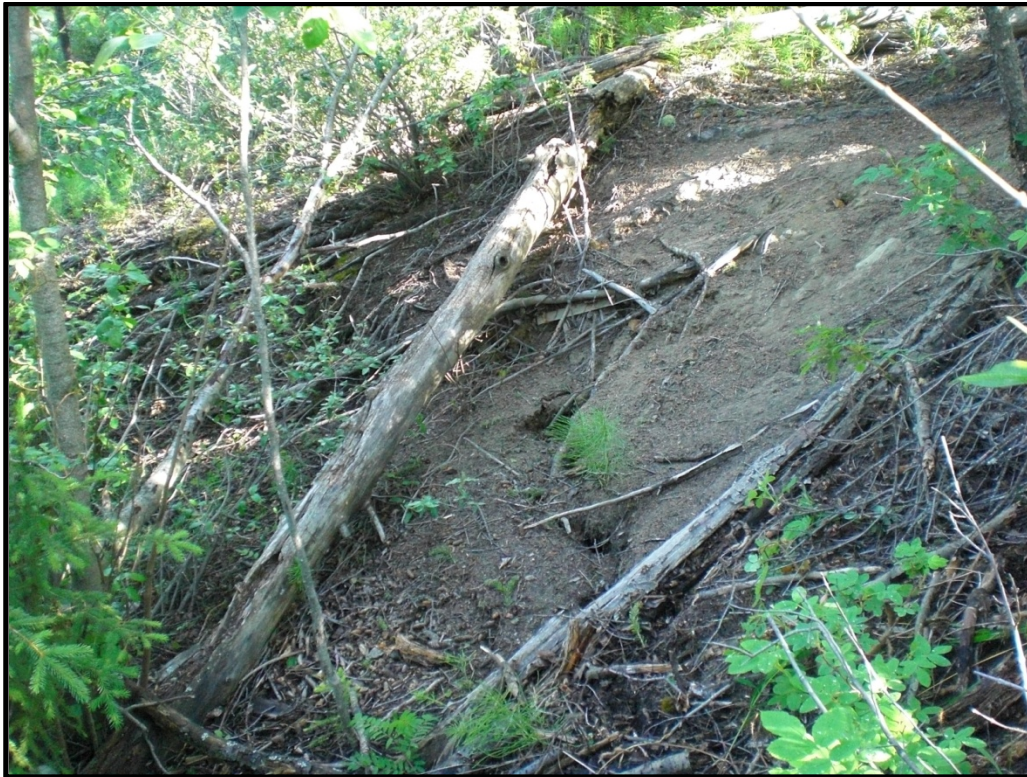
PHOTO 4: Tension cracks in slope below crack south of pile wall.

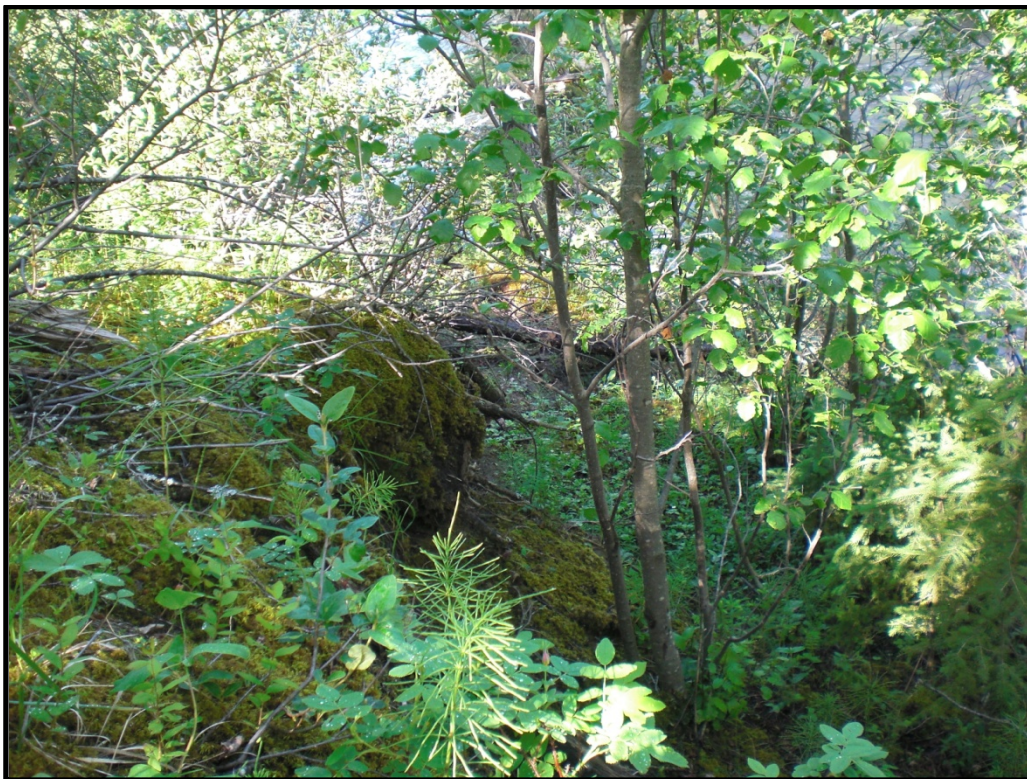
PHOTO 5: Hummocky terrain/toe bulge, south of pile wall.
