- 2005: Erosion gulleys were observed on the east abutment.
- 2008: Erosion and damage of the gabion mattress adjacent to the NW corner of Pier 5 was observed.

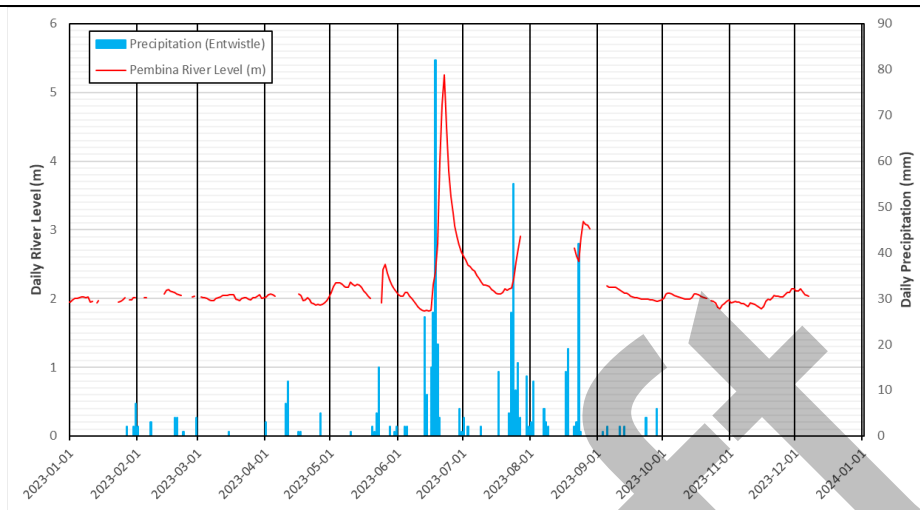
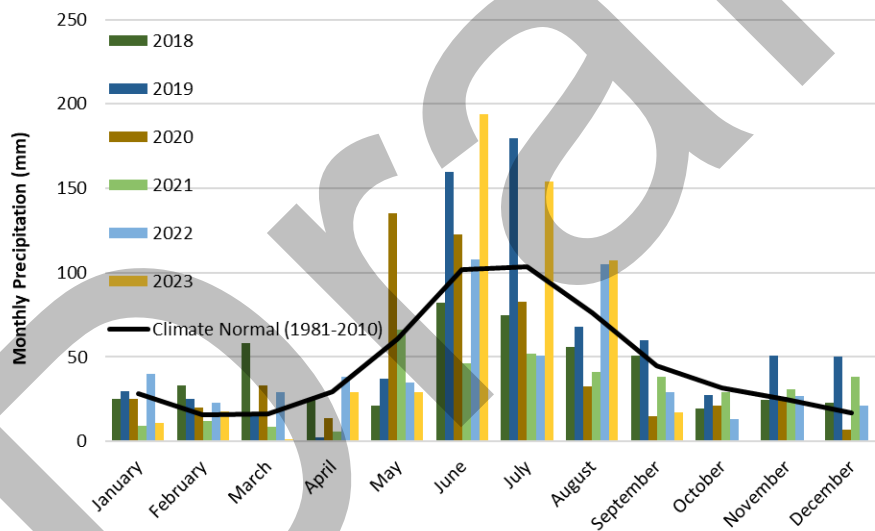
PROBABILITY FACTOR AND CONSEQUENCE FACTOR:

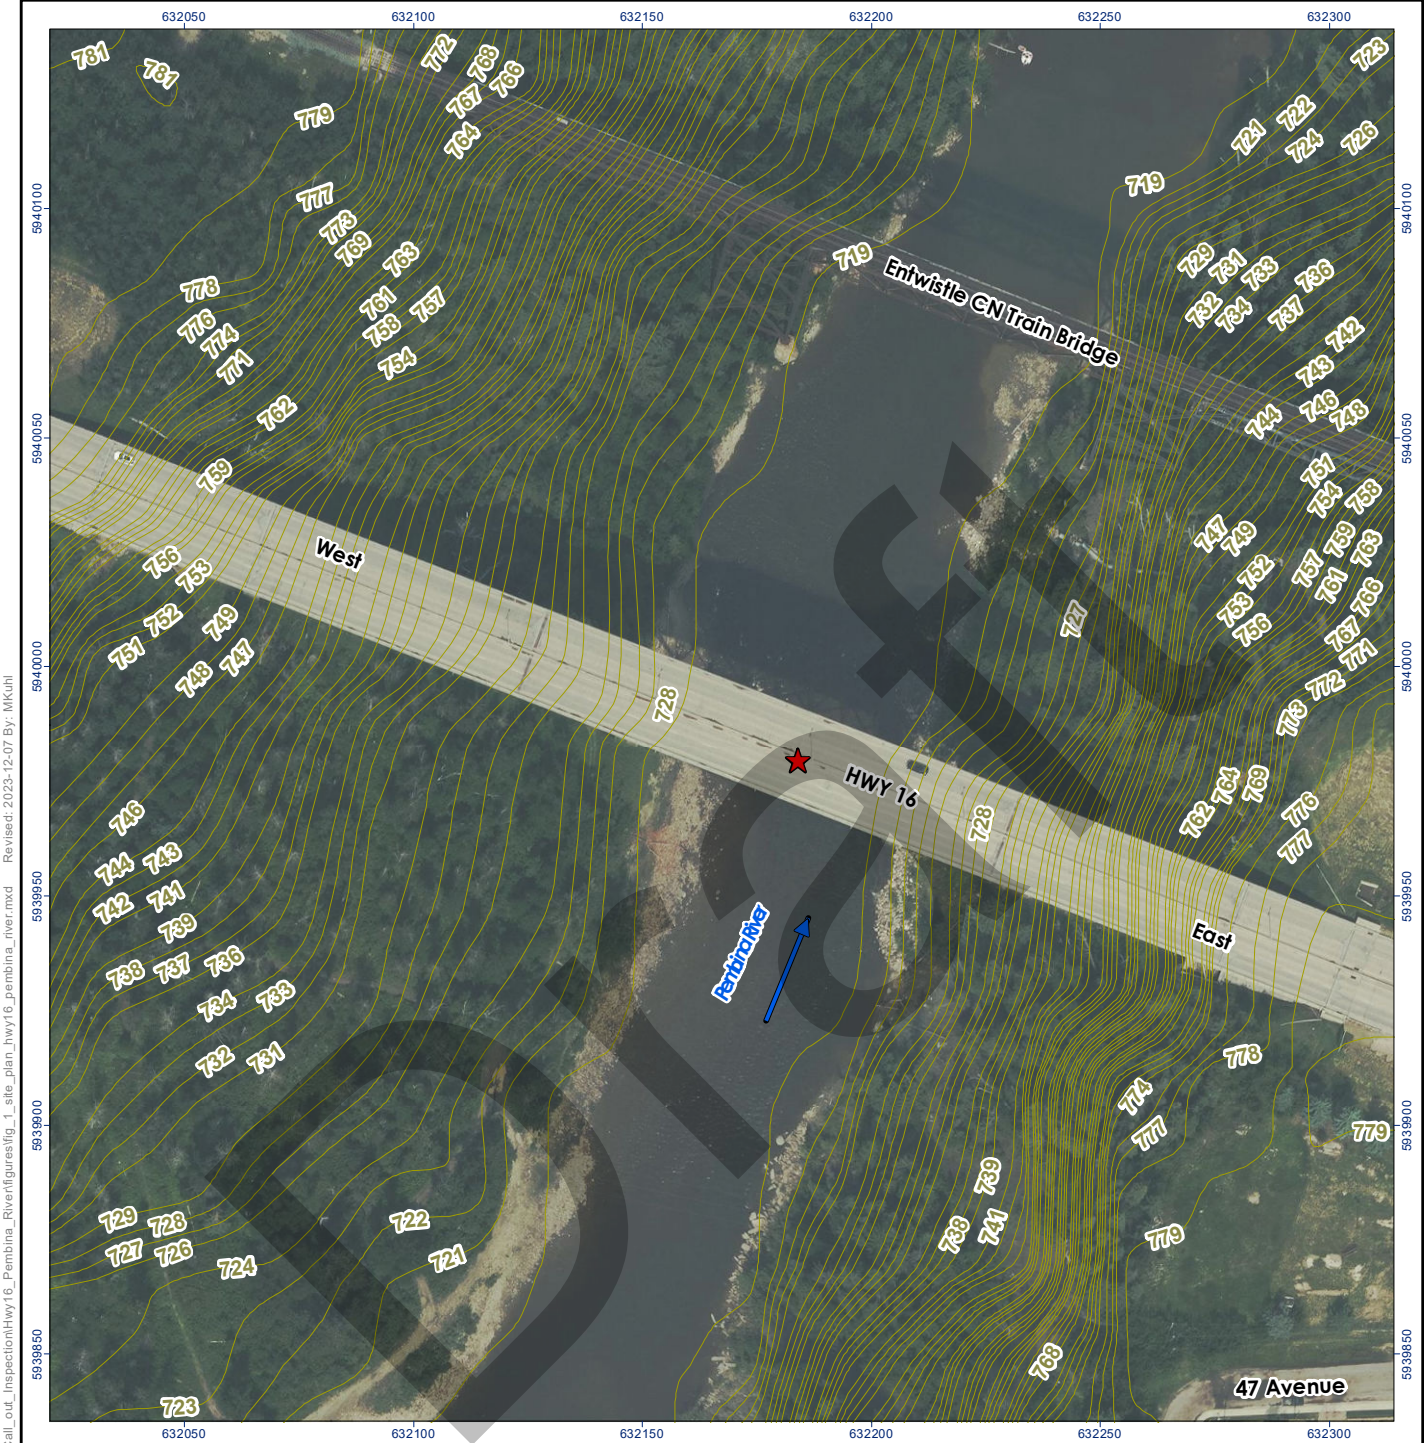
- ★ Site Location
 - Ground Elevation Contours (m AMSL)
 - Direction of Waterflow
- m AMSL - metres above mean sea level

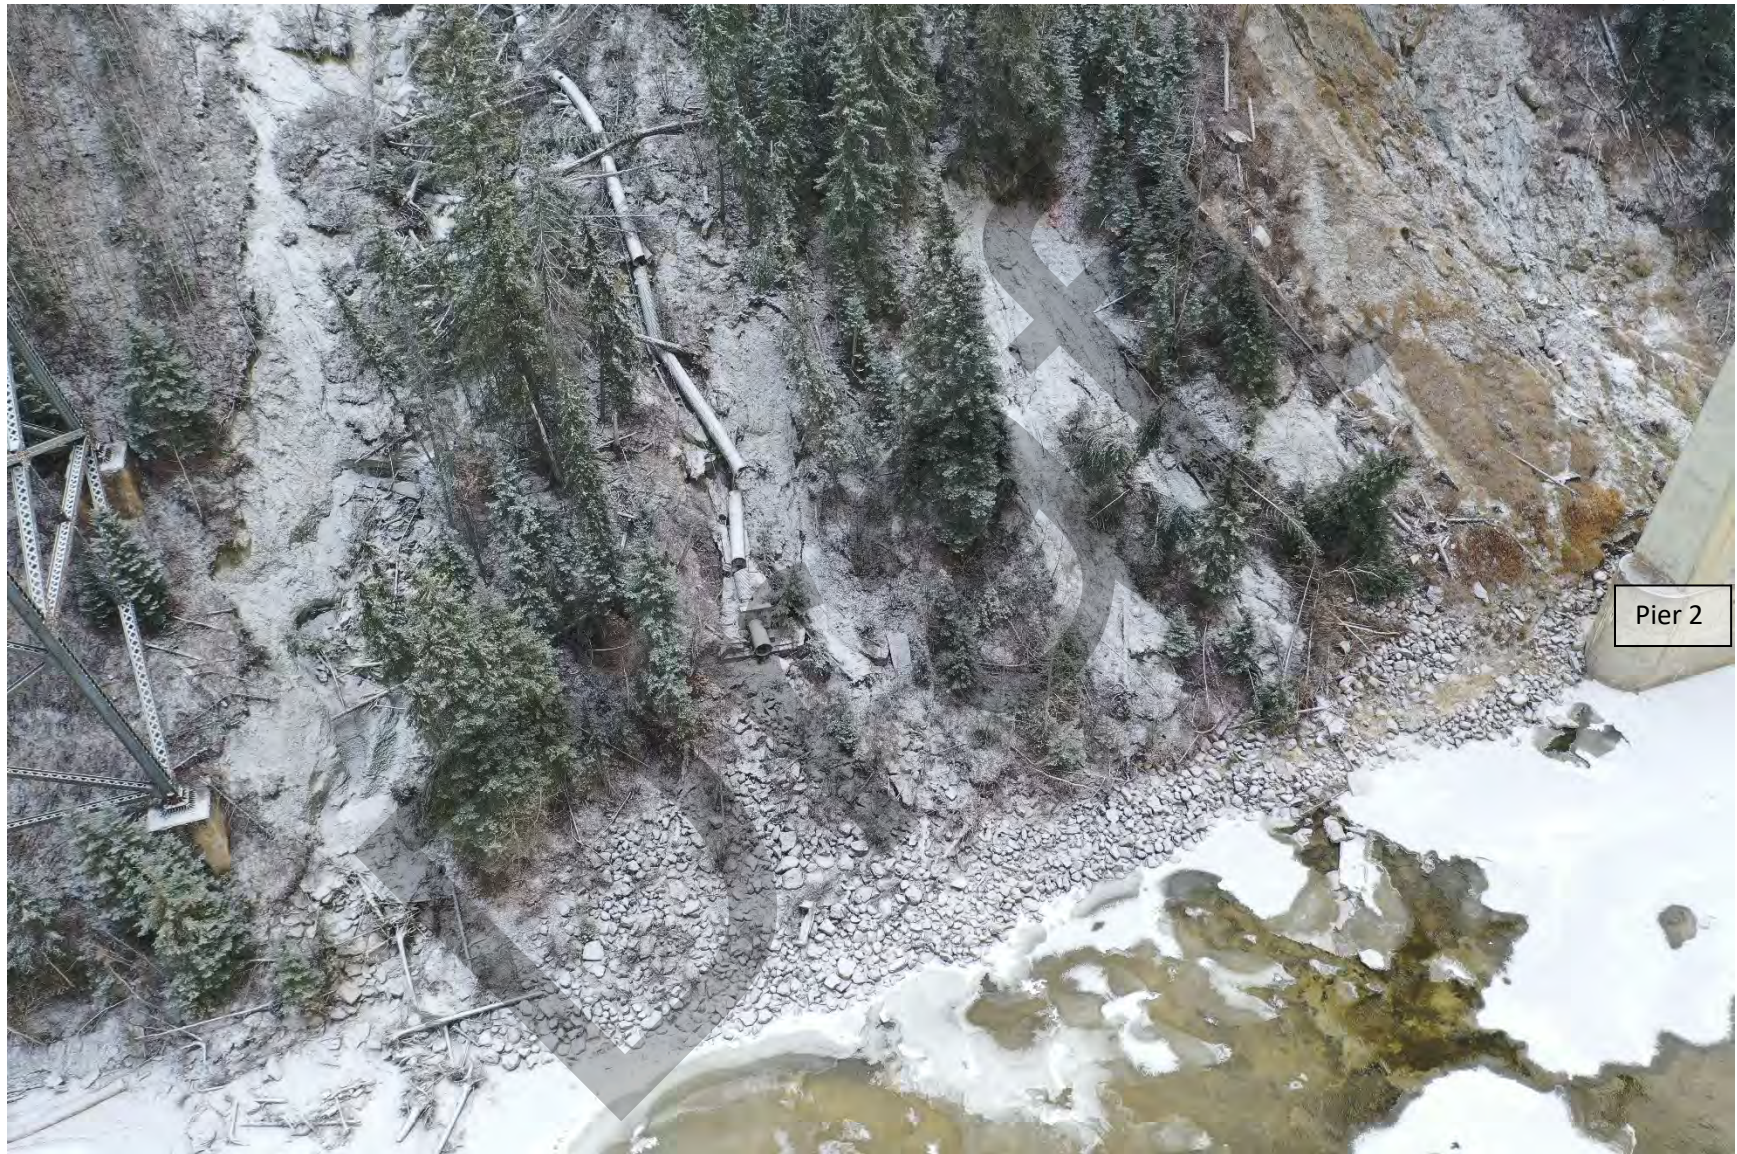
Photo 7: Slope north of east abutment, showing displaced broken culvert sections

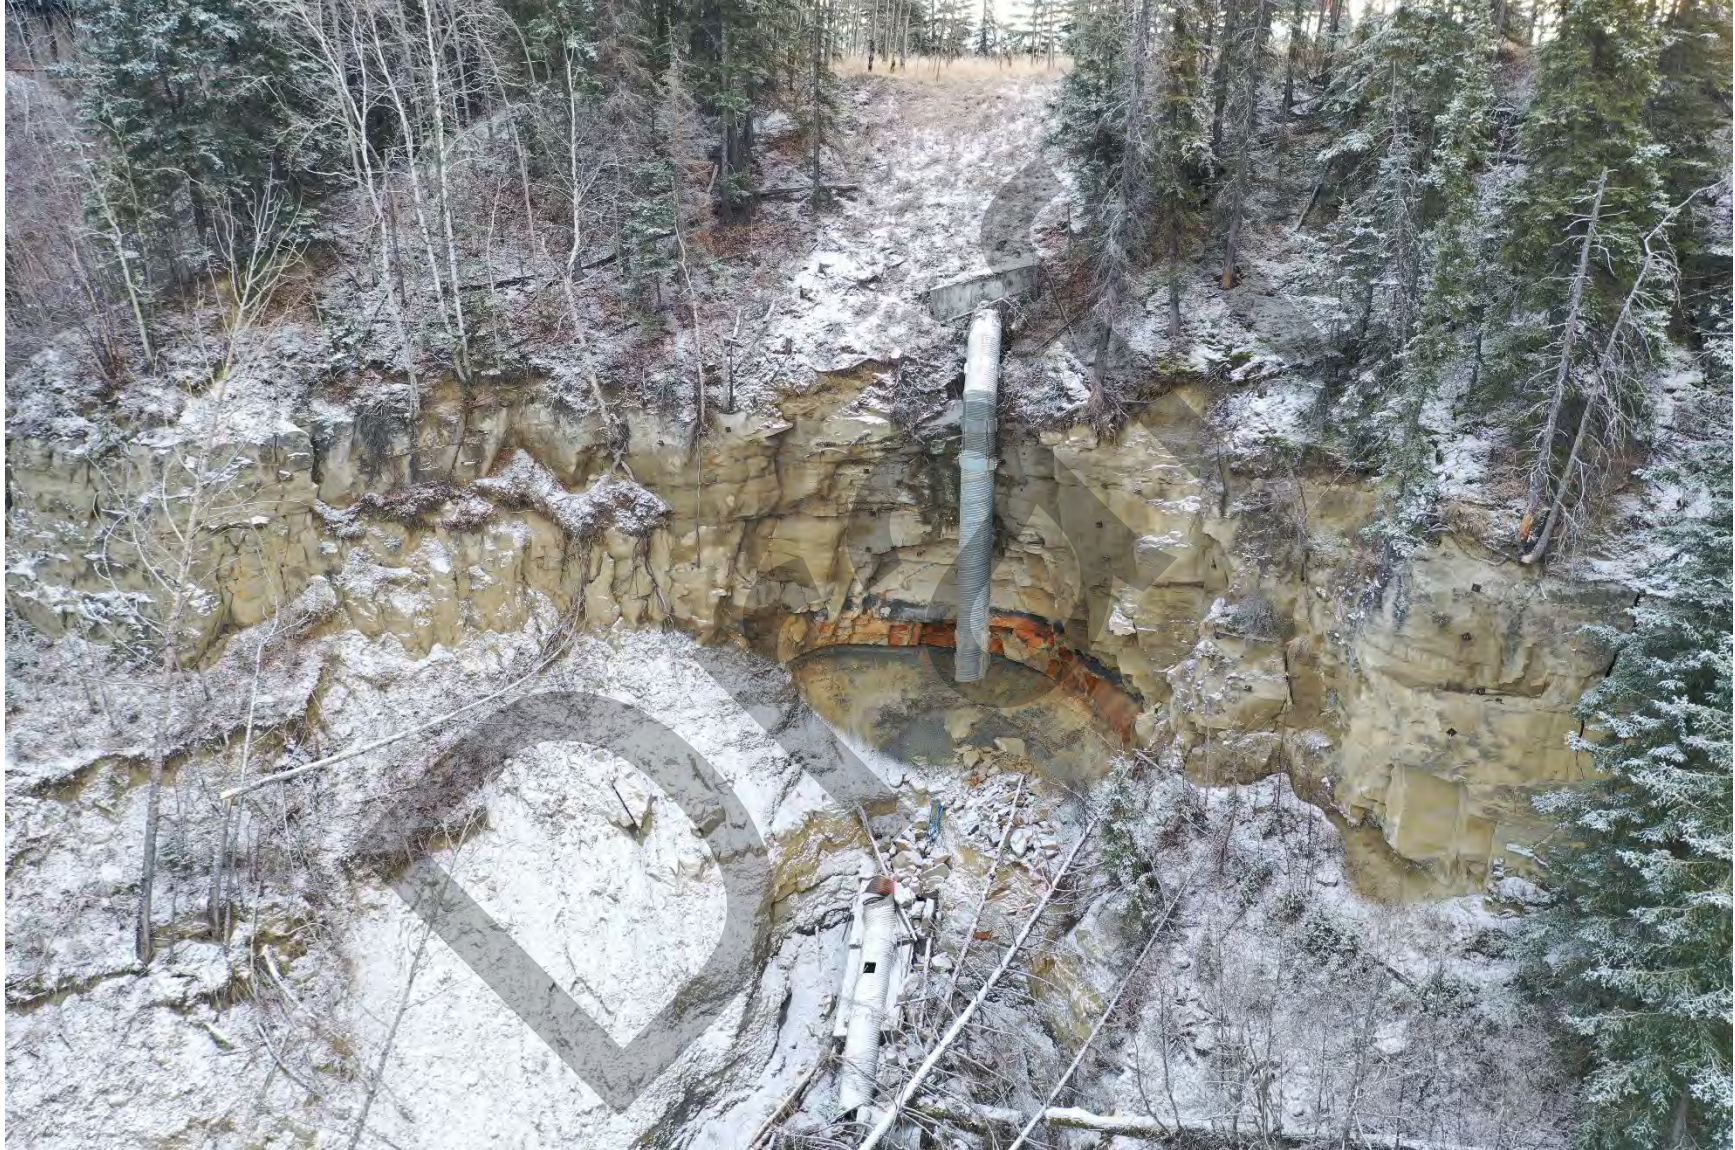
Photo 8: Culvert north of east abutment, showing broken sections and evidence of scour

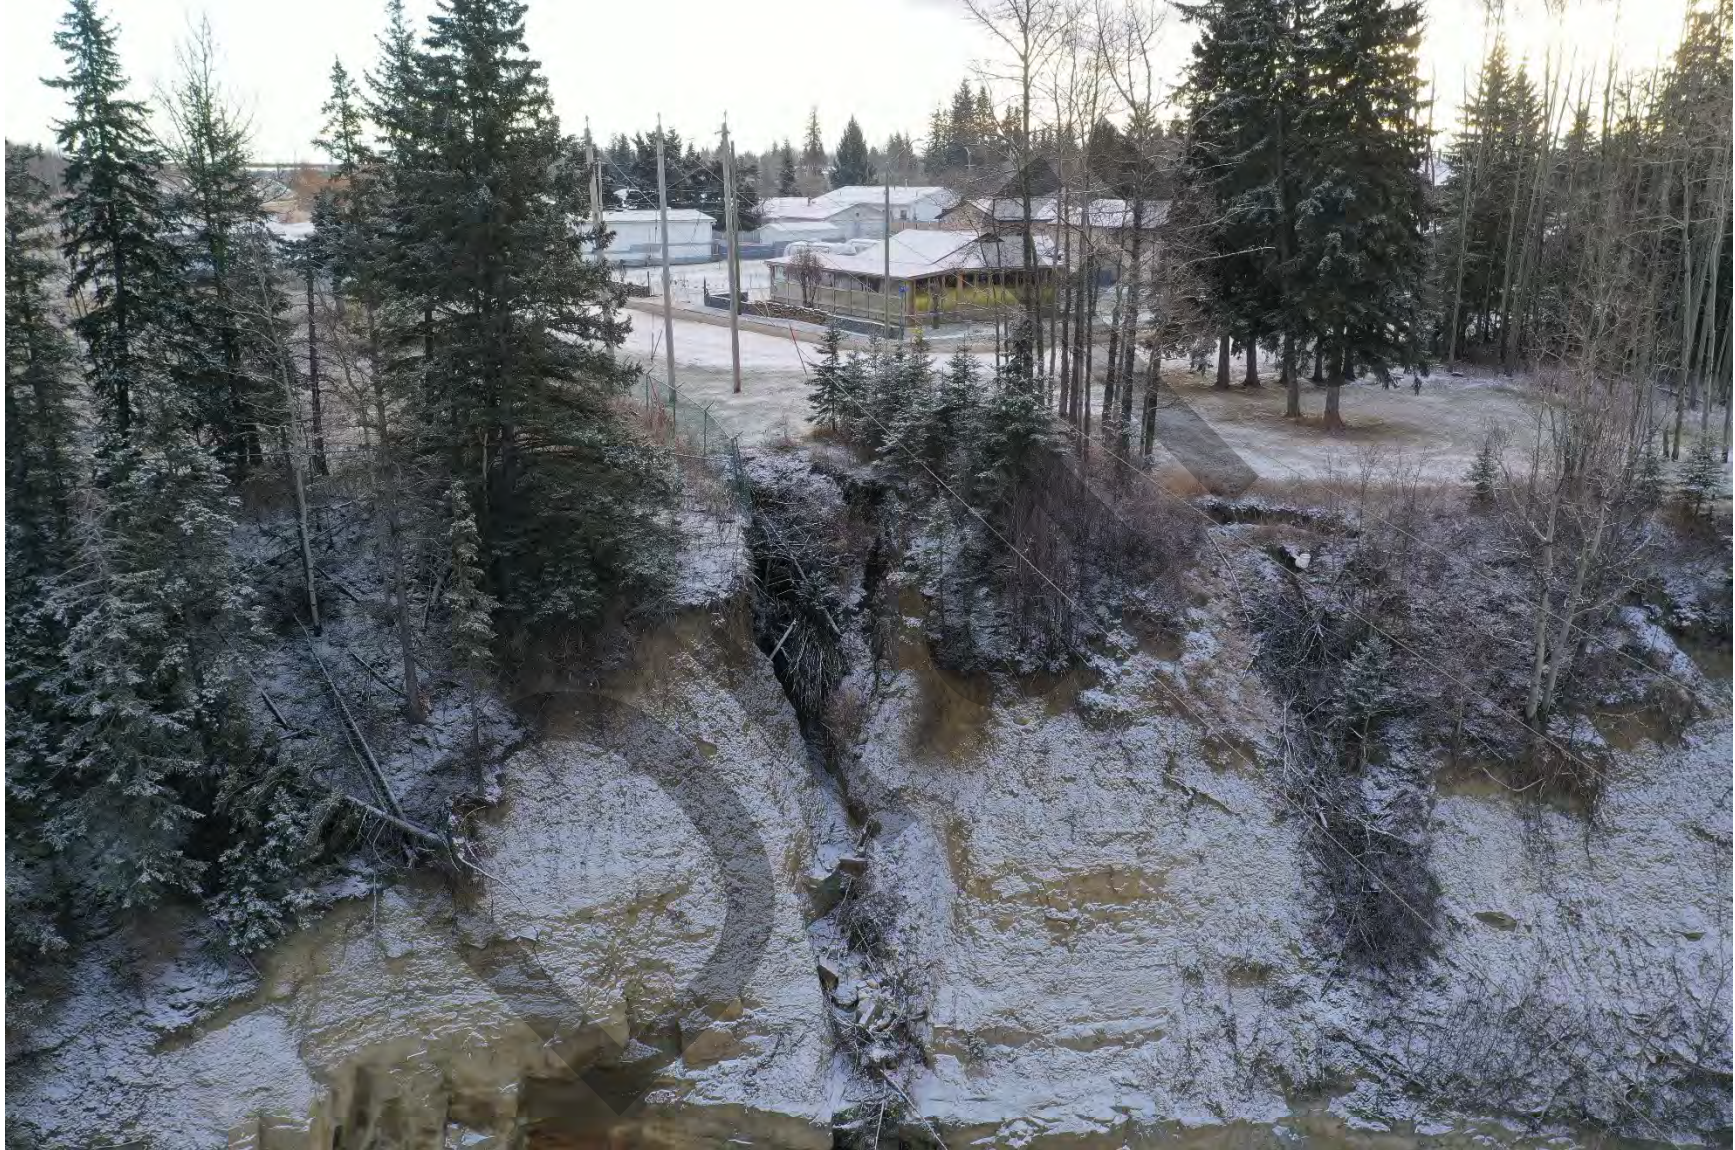
Photo 9: Erosion gully south of east abutment

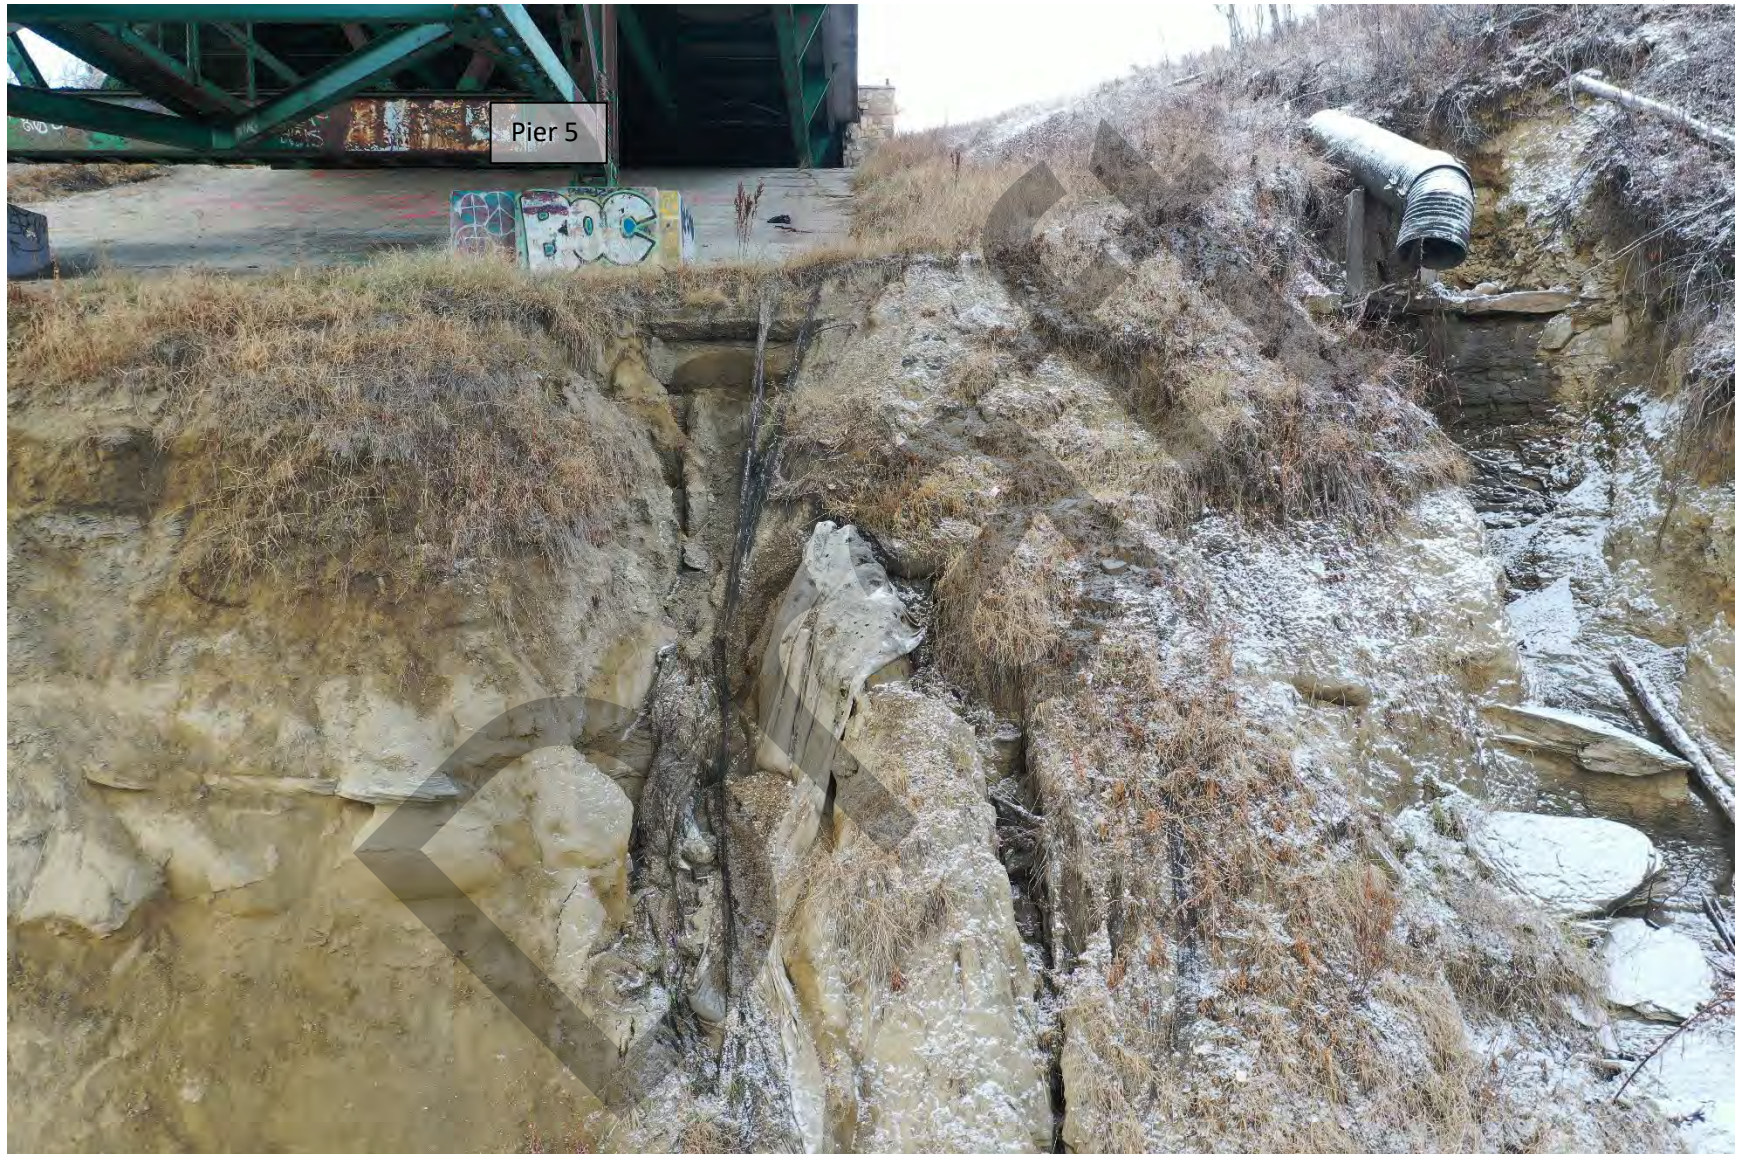
Photo 14: Erosion gullies and broken culvert on north side of west abutment

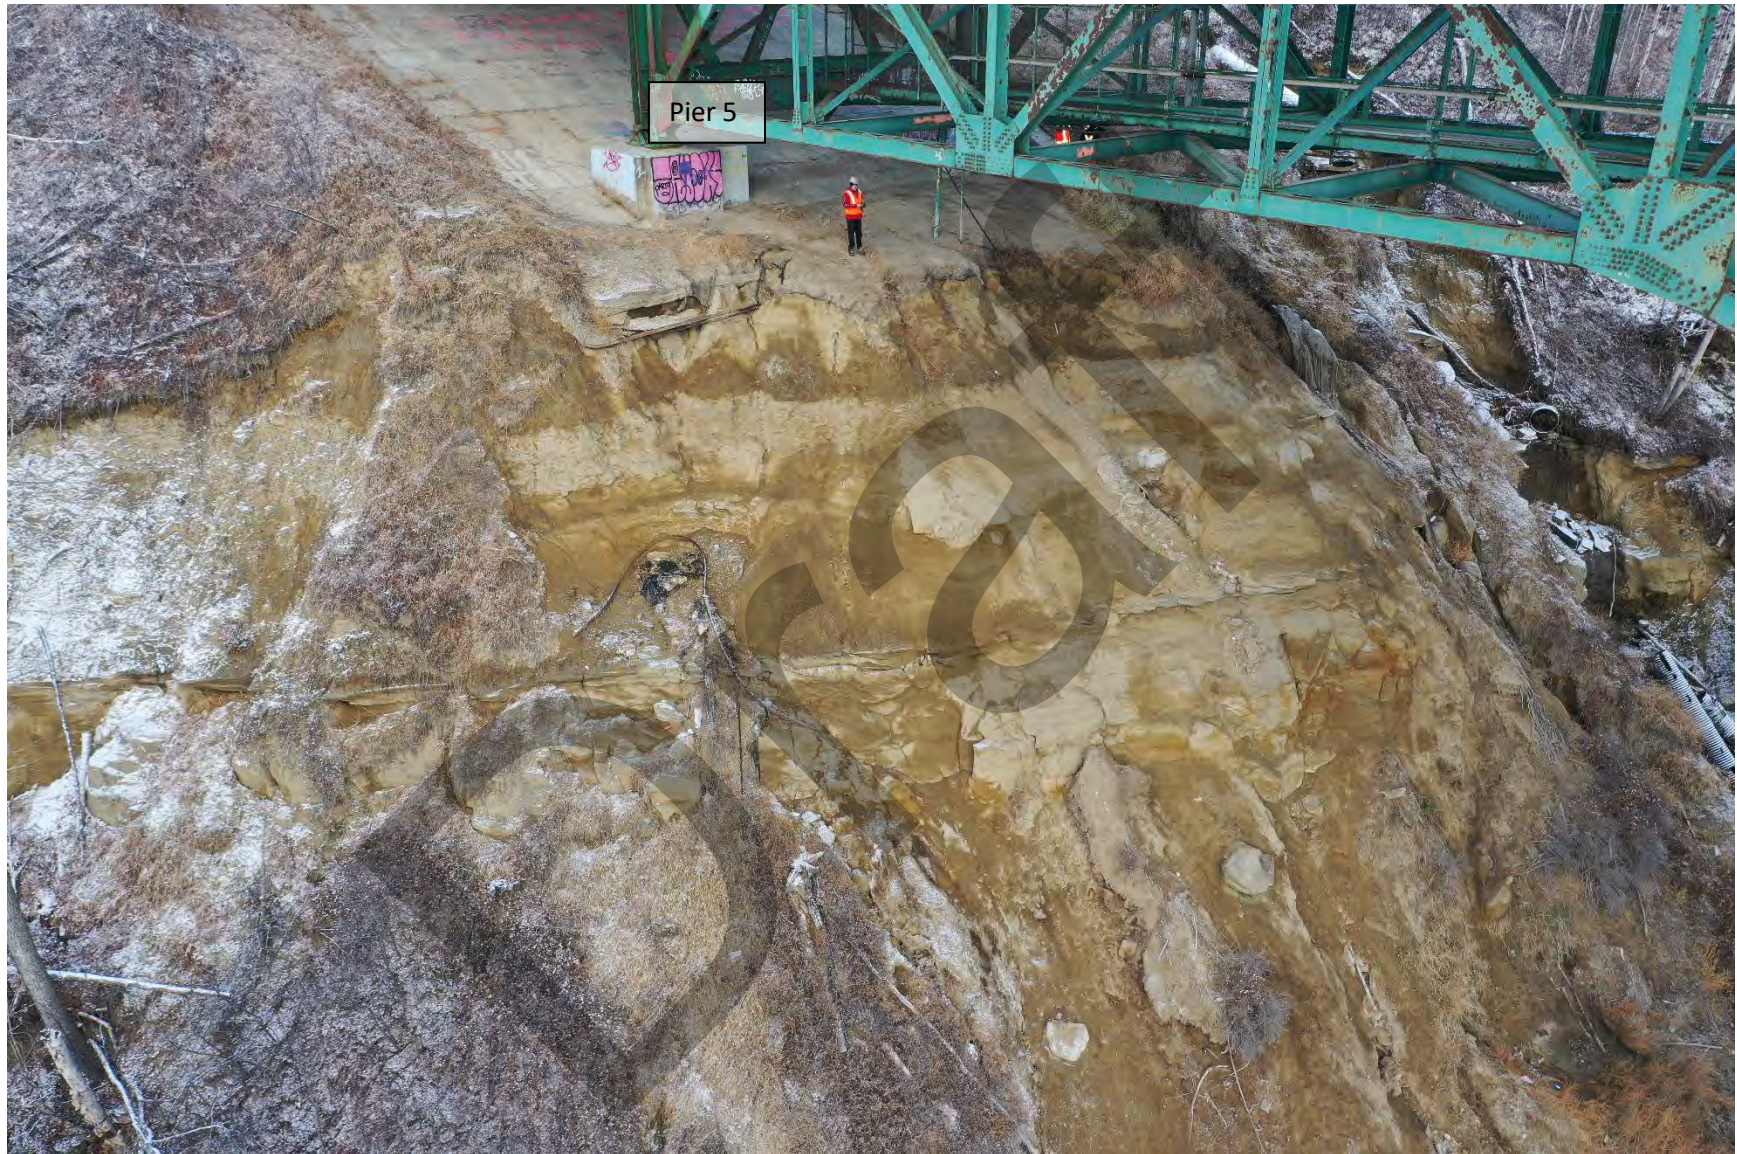
Photo 15: Erosion at west abutment slope, showing abutment undermining and exposed utility cables, facing northwest

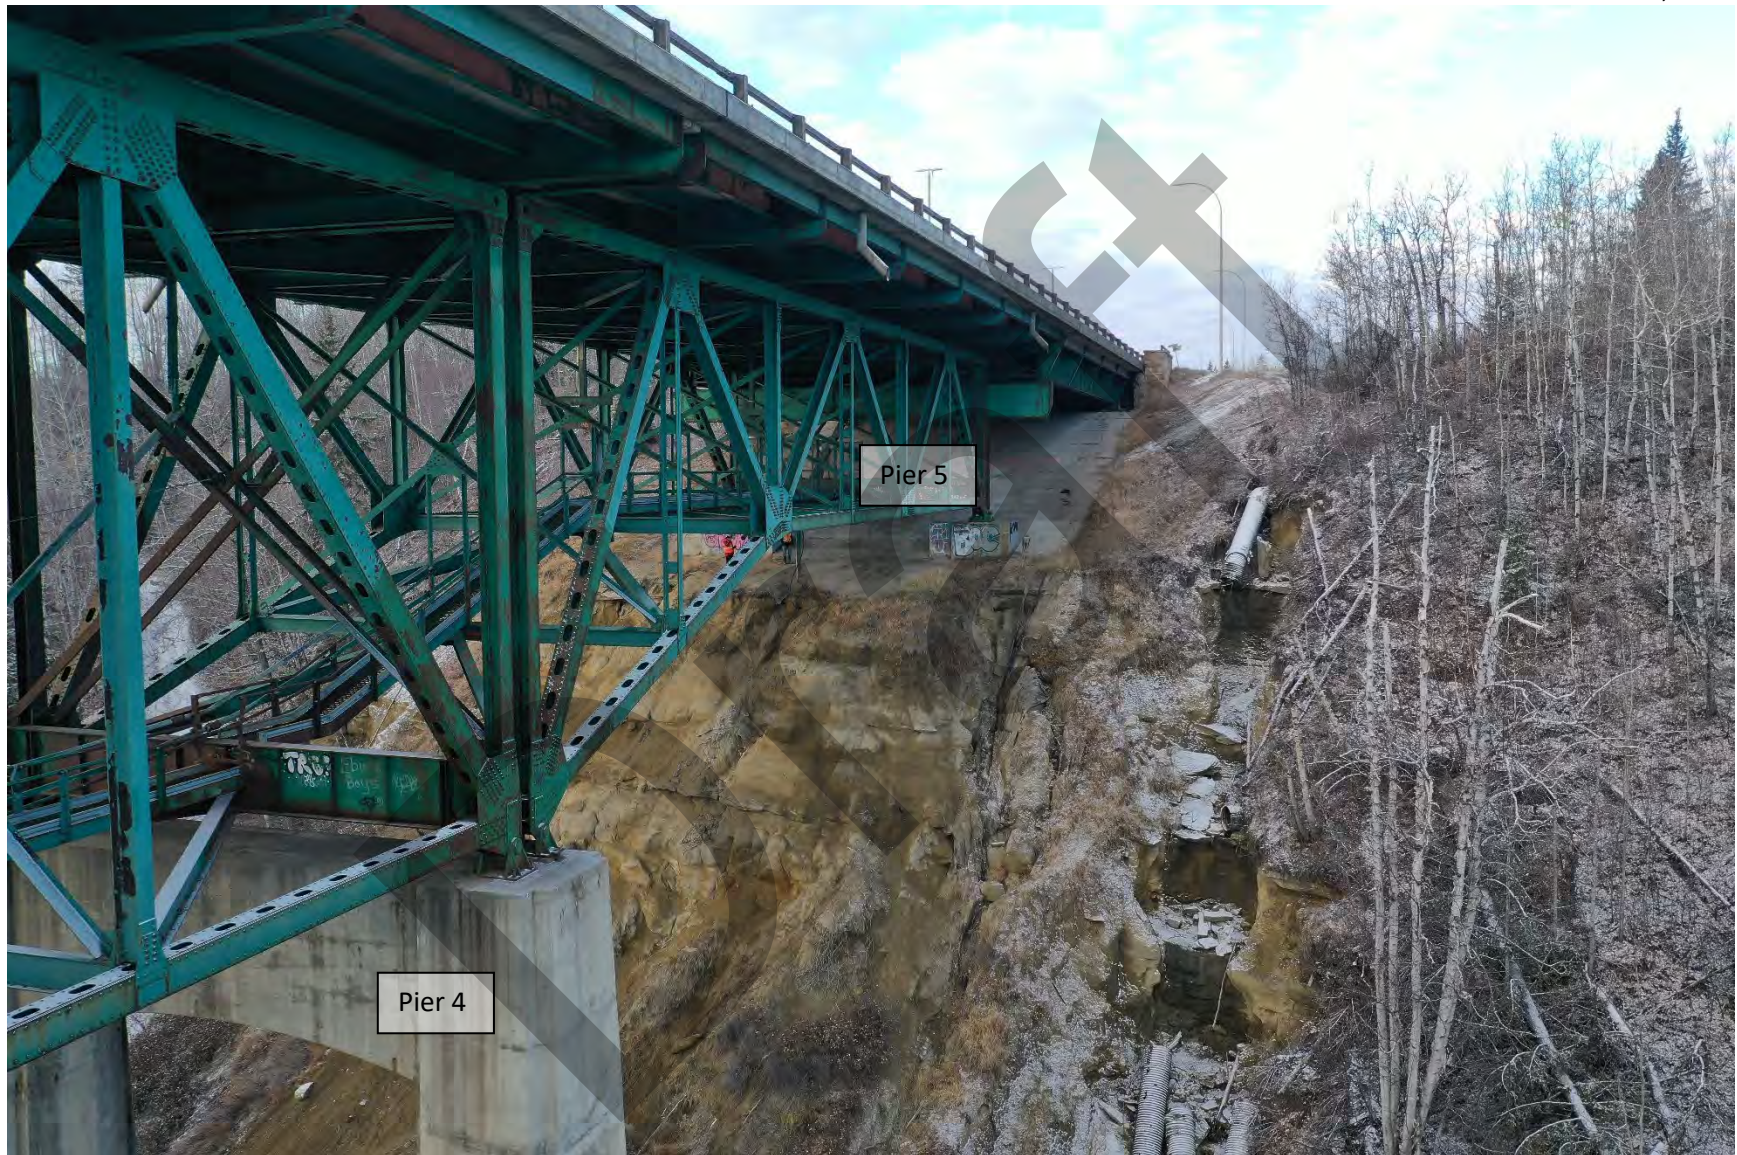
Photo 17: Erosion at west abutment slope, facing west, showing broken sections of culvert and erosion gullies

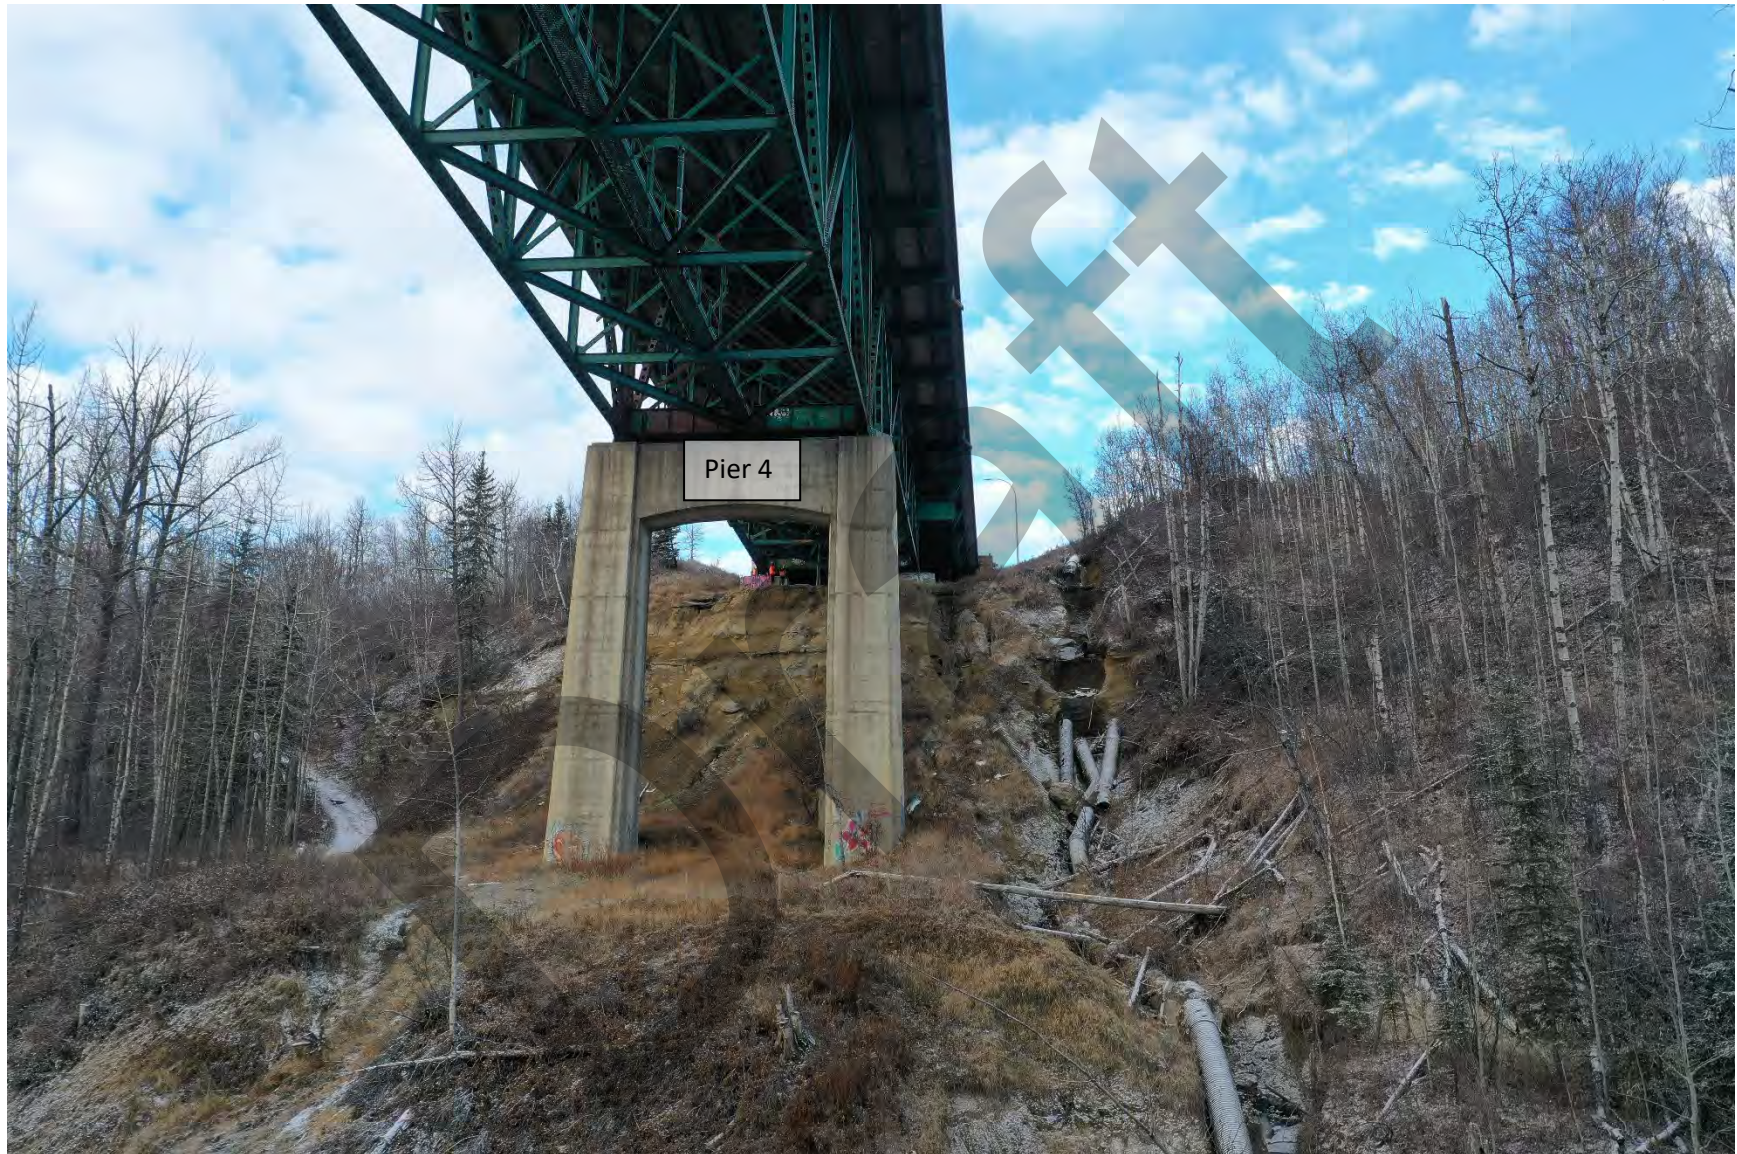
Photo 18: West abutment slope, facing west, showing broken culvers and fallen trees

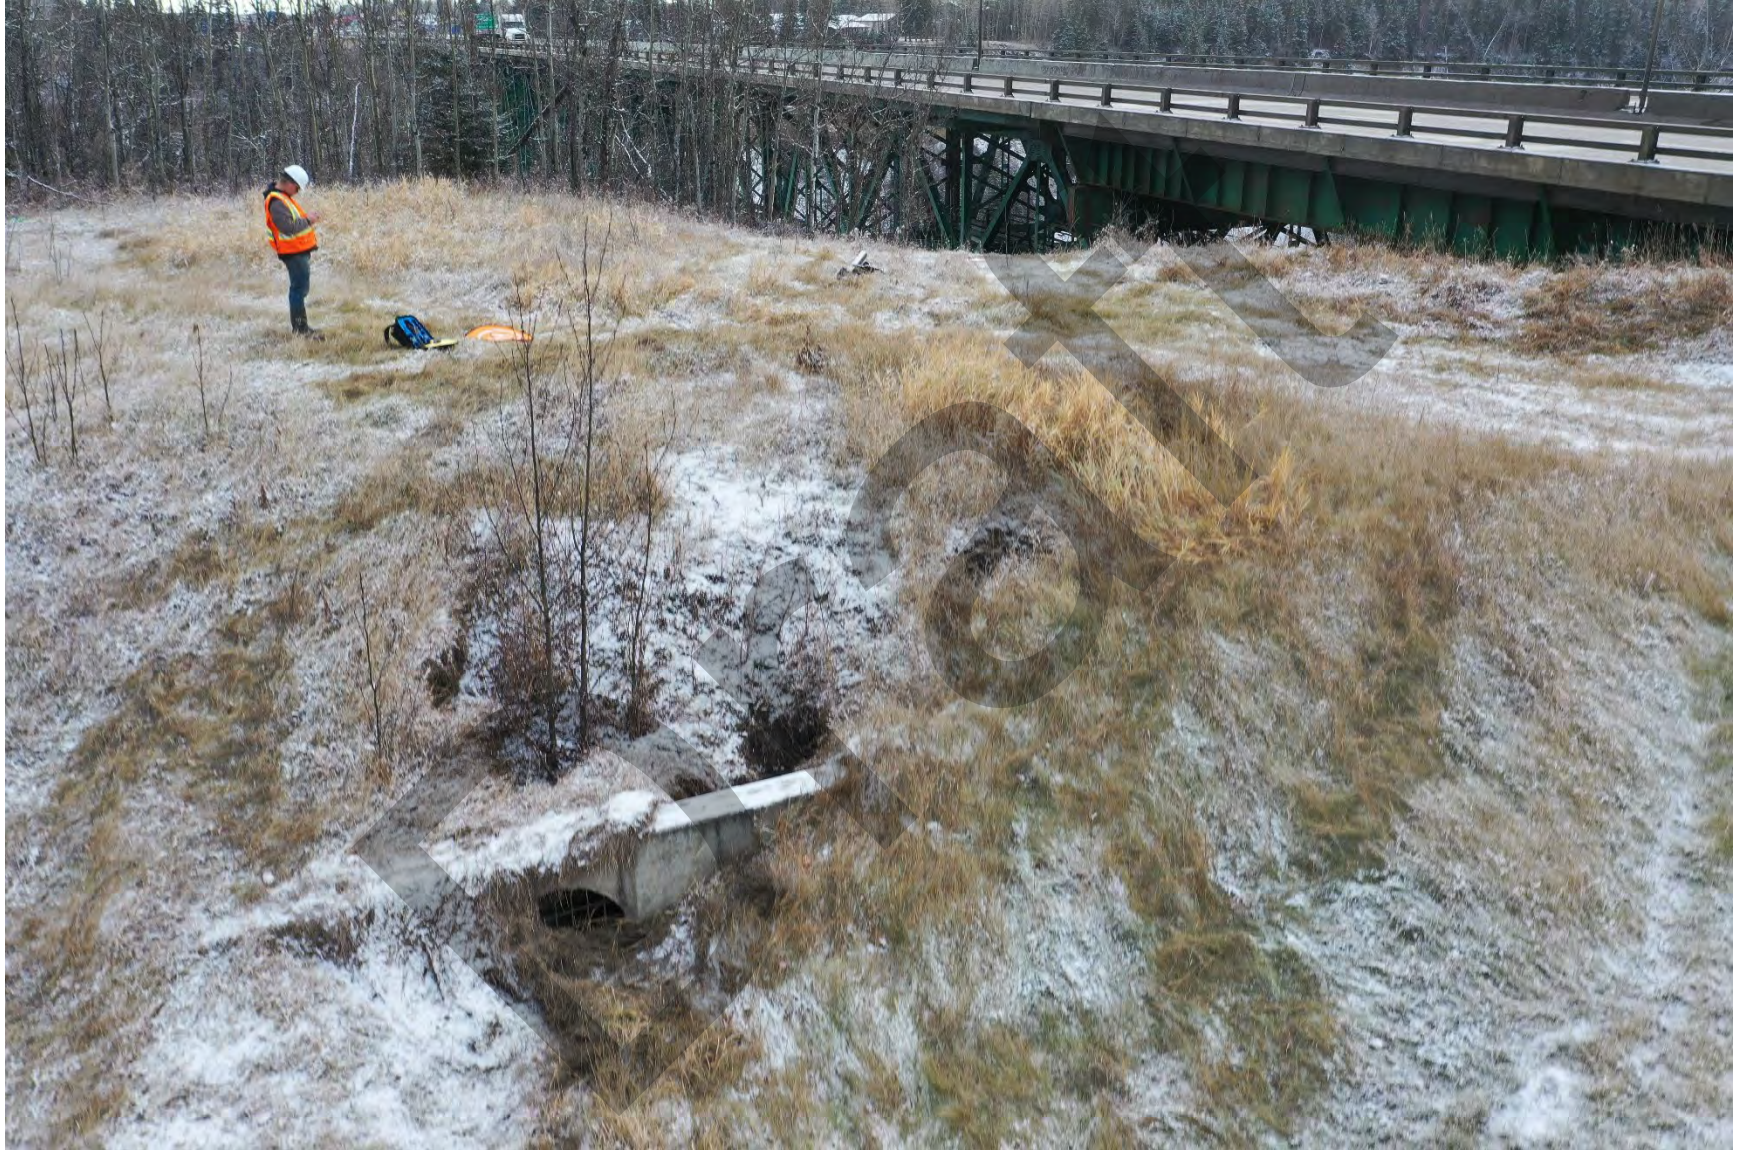
Photo 19: Entrance to culvert north of west abutment, facing east
