COMMENTS
East Abutment / Bank:

- Significant erosion is present below the sandstone outcropping near the top of the bank, both below the bridge and near the bridge on the north and south sides.

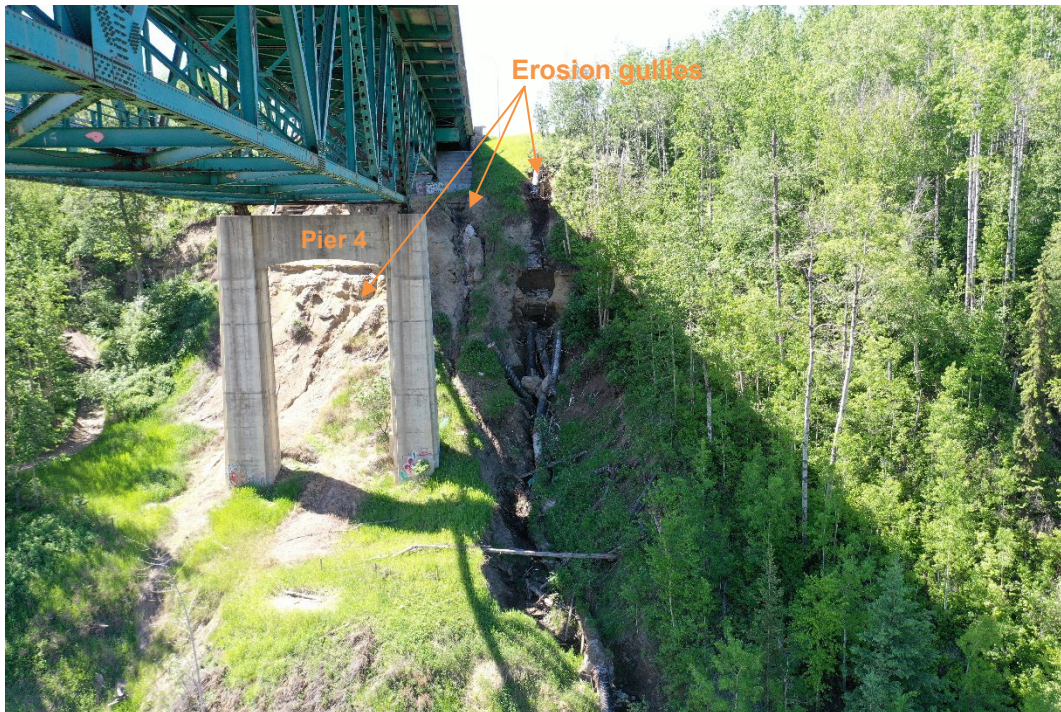
Photo 6: Broken culvert and gully on the north side of the west abutment. Looking west.

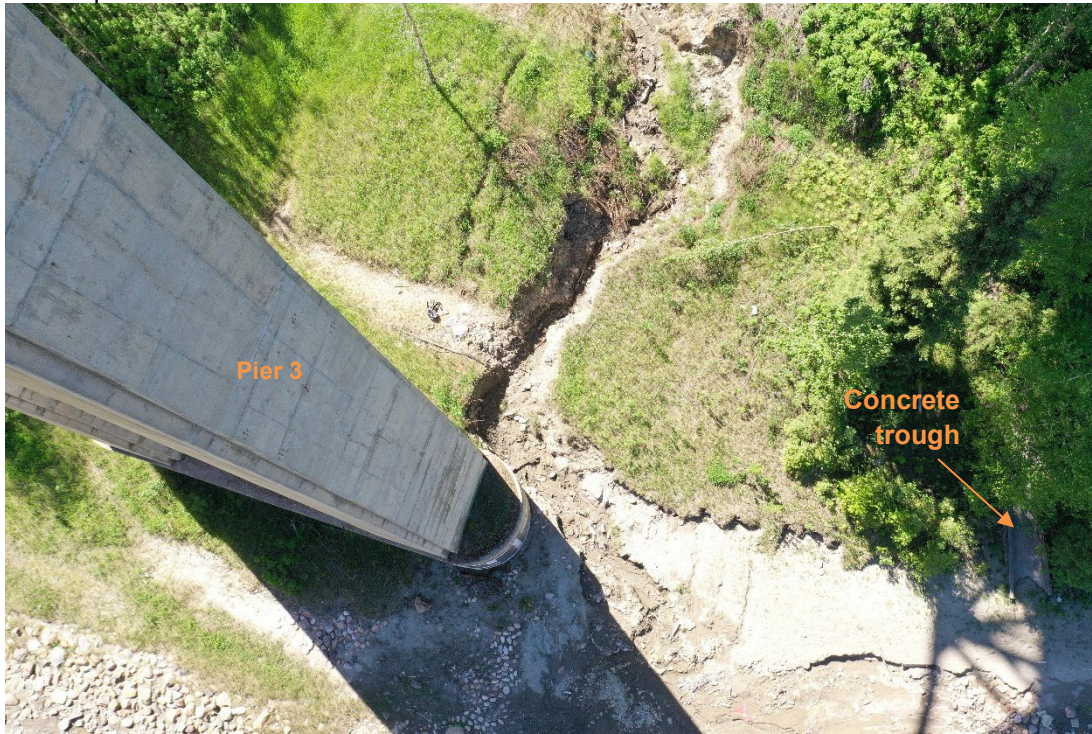
Photo 7: Erosion gully next to west pier at river level, facing southwest.
