GEOHAZARD RISK MANAGEMENT PROGRAM

North Central Region – Edson / Stony Plain Area

2019 Inspection Report

Site Number	Site Name	Hwy	km
NC74	South of Entwistle Slide	22:30	44.2
Legal Land Description	SE 17 and SW 16-52-07-W5M		
UTM Coordinates (NAD 83)	Zone 11N	N5928504	E633710
Operational Site Instrumentation	Slope Inclinometers	0	
	Pneumatic Piezometers	0	
	Vibrating Wire Piezometers	1	
	Standpipe Piezometers	0	
Date of Last Instrumentation Readings	May 7, 2019

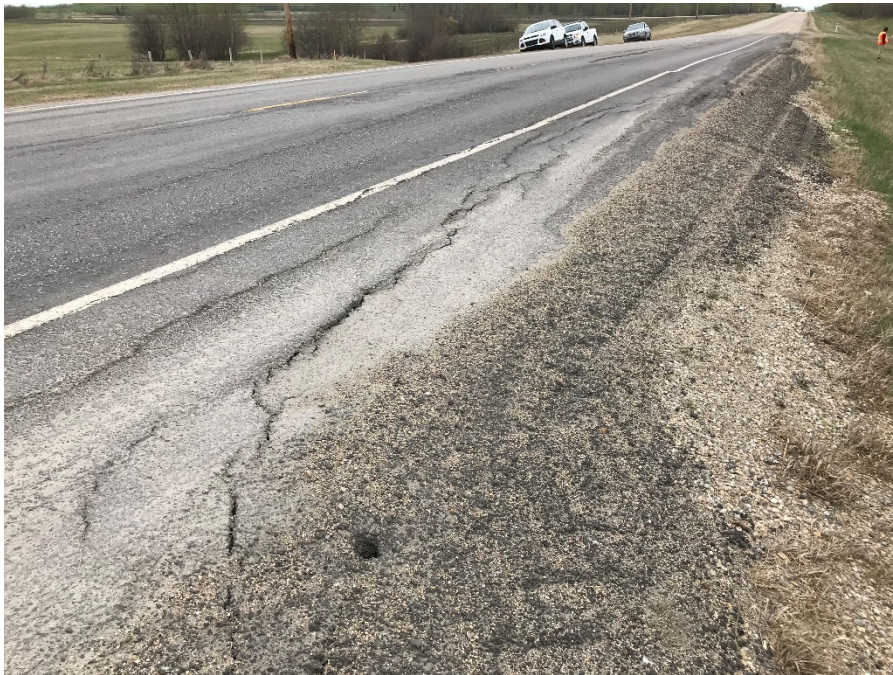
Discussion	<p>At the time of the site inspection, the last noted patch at the site occurred on the SBL of Highway 22. Since then, pavement cracking has reflected through the highway patches and appeared more severe than in 2018 as shown in Photos 1 to 3.</p> <p>The leaning fence posts appeared unchanged from 2017 with angles up to 16°.</p> <p>Standing water was observed at the outlet of the culvert similar to the previous inspections dating back to 2013 as shown in Photo 4. The creek appeared to be partially blocked at the outlet. The culvert inlet in the east ditch was measured to be 500 mm above ground similar to the 2017 inspection. Additionally, the culvert inlet was rusted through and erosion was observed around the inlet as shown in Photo 5.</p> <p>The overall west slope is shown in Photo 6.</p> <p>On July 11, 2019, a call-out inspection was conducted by Stantec and AT due to active movement of the SBL. Photos showing the site observations are provided in Photos 7 to 10 for comparison and continuity during the next inspection. Additional information can be found in the Call-Out Report dated August 1, 2019.</p>

Photo 1: Cracks reflecting through Highway 22 patch along west shoulder. Looking south.

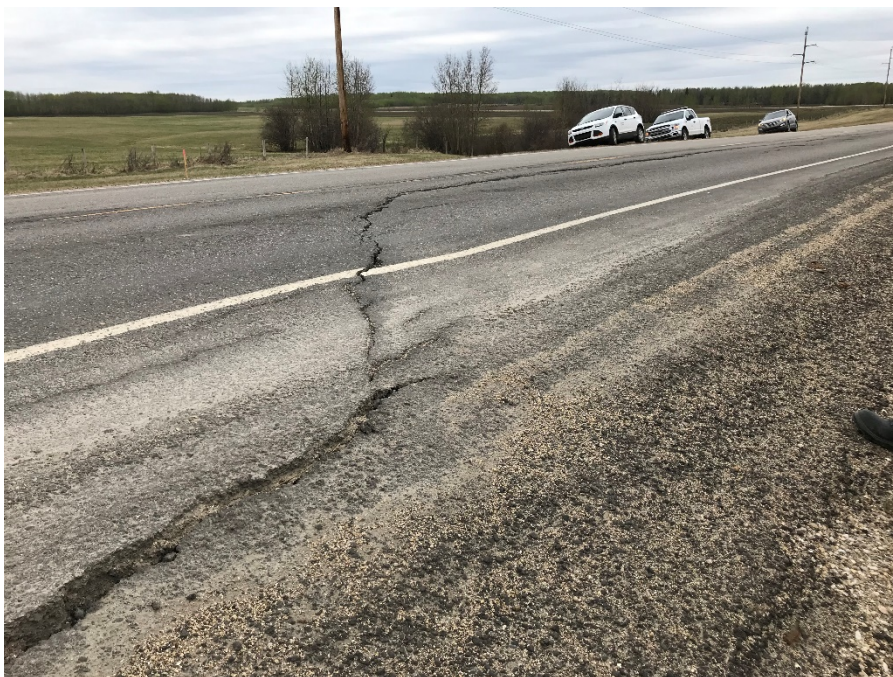
Photo 2: Semi-circular pavement crack along southbound lane. Looking southeast.

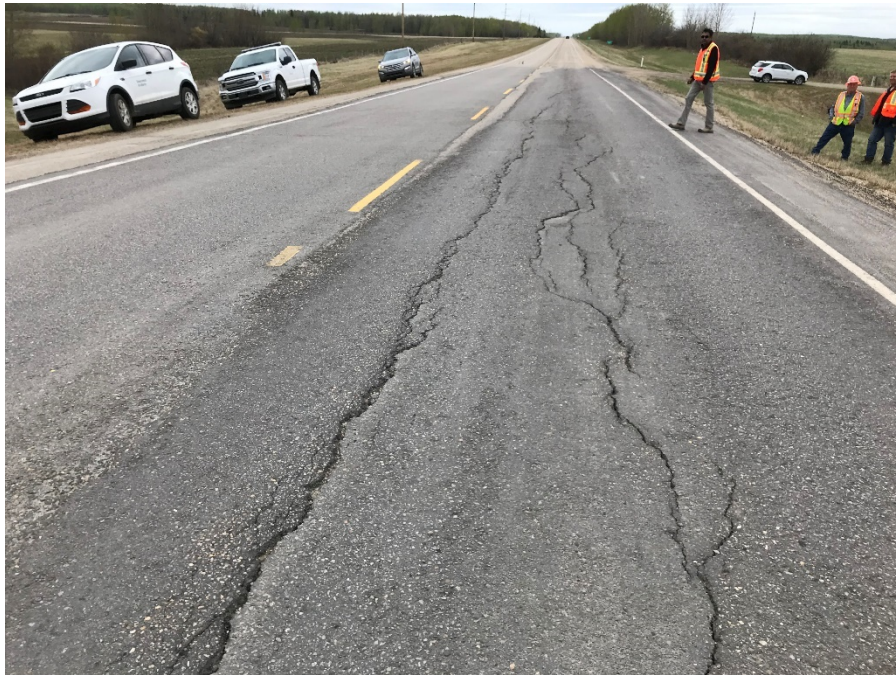
Photo 3: Pavement cracking along southbound lane. Looking south.
Photo taken May 14, 2019.

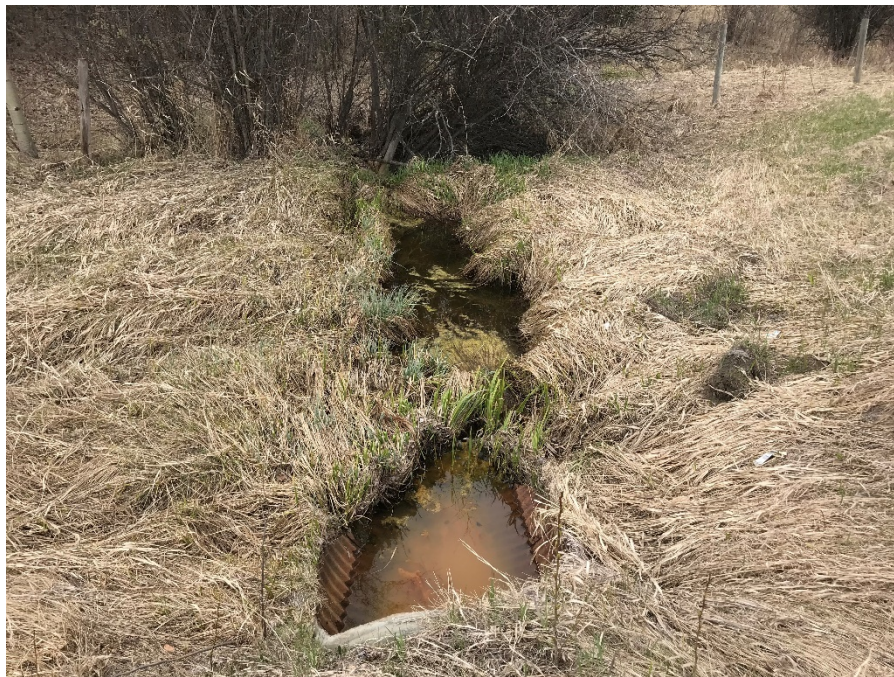
Photo 4: Standing water at the culver outlet on the west ditch. Creek partially blocked. Looking northwest. Photo taken May 14, 2019.

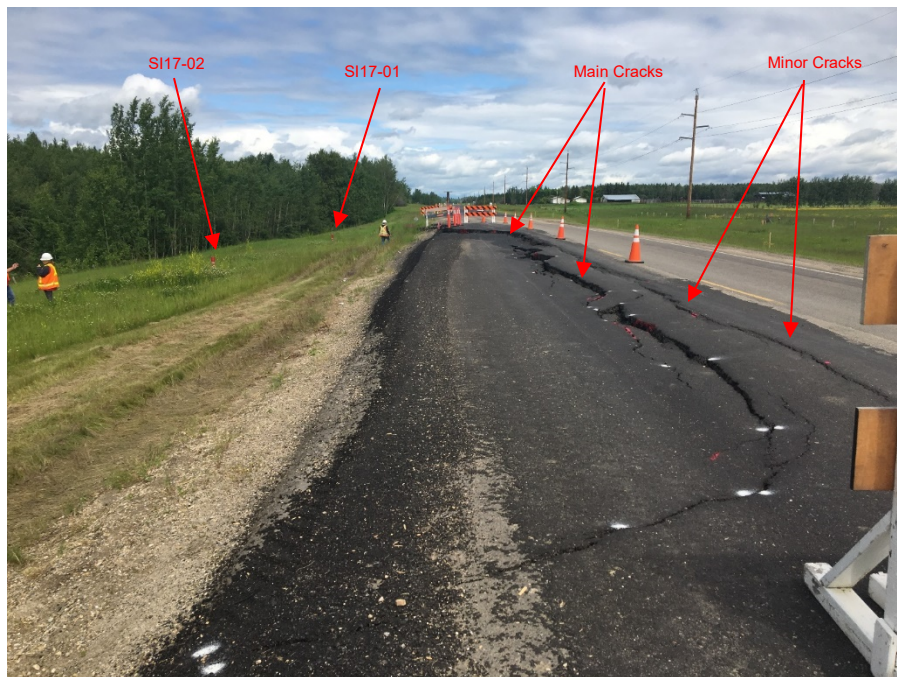
Photo 7: Pavement cracking from Call-Out Inspection. Looking north. Photo taken July 11, 2019.

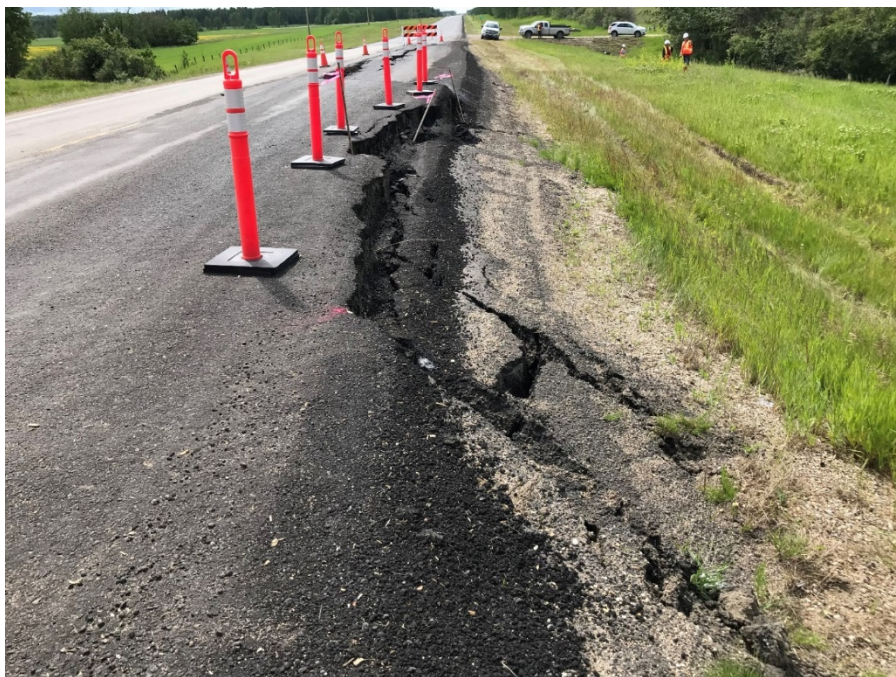
Photo 8: Overall site and pavement cracks, looking south. Grade drop was evident. Photo taken July 11, 2019.

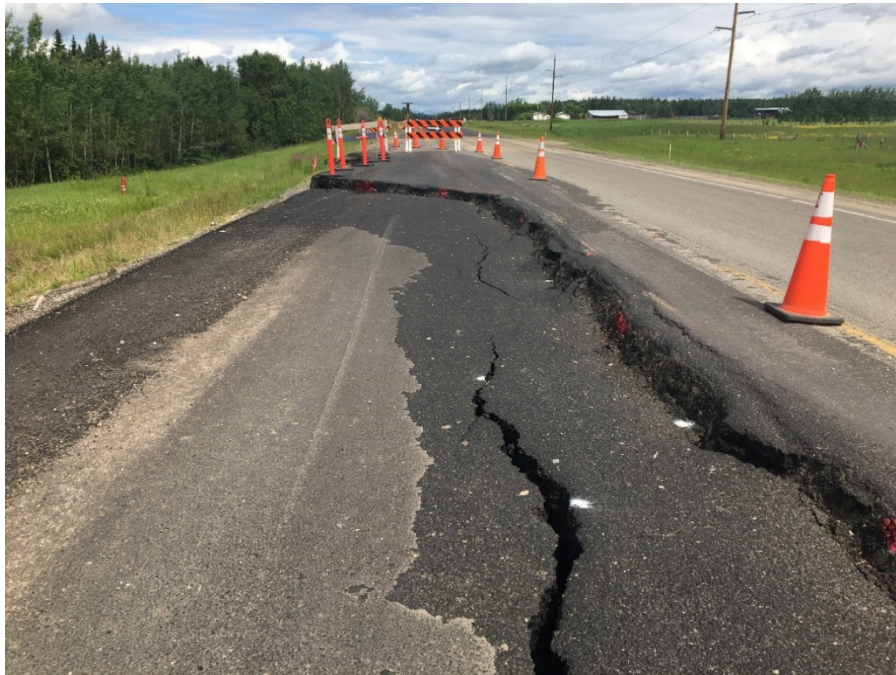
Photo 9: Looking toward north at pavement cracks. Grade drop was obvious. Photo taken July 11, 2019.

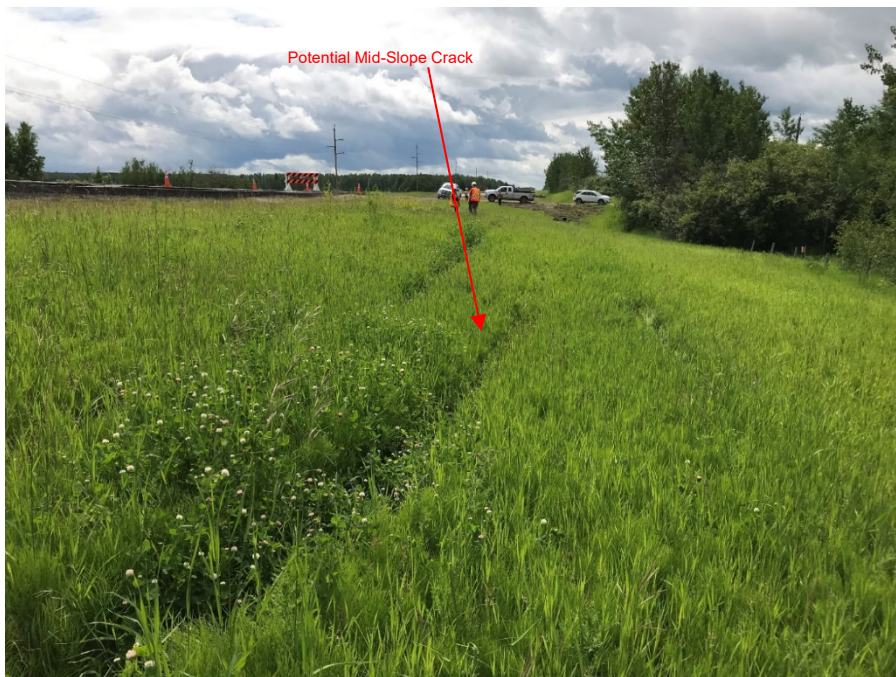
Photo 10: Looking south at the mid-slope. Note potential mid-slope crack. The foot track was created during locating the potential mid-slope crack. Photo taken July 11, 2019.
