GEOHAZARD RISK MANAGEMENT PROGRAM

20120 Inspection Report

Site Number	Site Name	Hwy	km
NC74	South of Entwistle Slide	22:30	44.2
Legal Land Description	SE 17 and SW 16-52-07-W5M		
UTM Coordinates (NAD 83)	Zone 11N	N5928504	E633710
Operational Site Instrumentation	Slope Inclinometers	3	
	Pneumatic Piezometers	0	
	Vibrating Wire Piezometers	1	
	Standpipe Piezometers	0	
Date of Last Instrumentation Readings	May 20, 2020

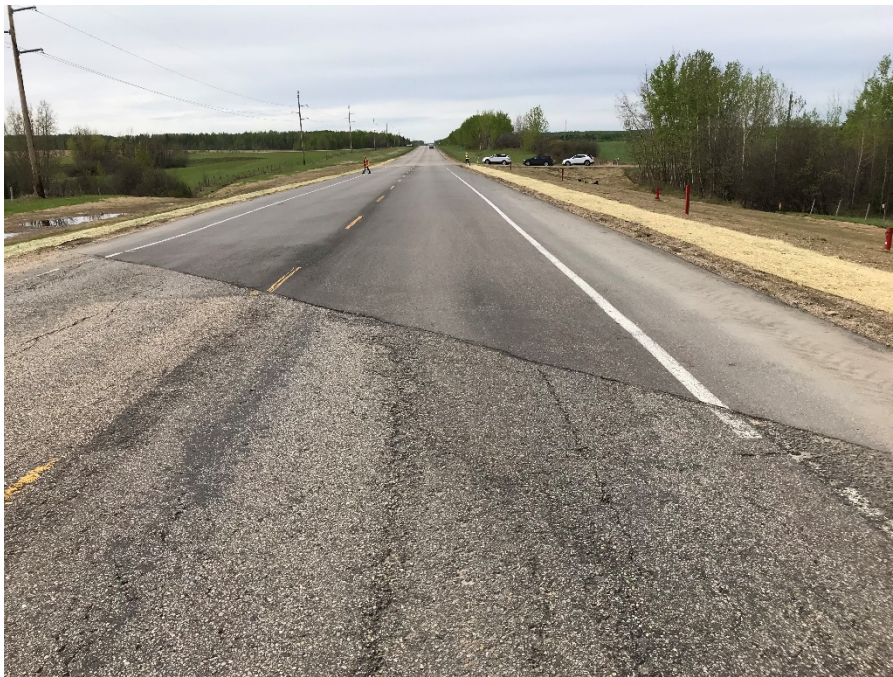
Discussion	<p>Remediation of NC74 was completed during October to November of 2019. As part of remediation, the failed pavement was removed and reconstructed. No signs of distress were observed along the remediated pavement as shown in Photos 1 and 2.</p> <p>Ground depression of various dimensions around each of the SI were observed as shown in Photos 3 to 5. The dimensions of each are recorded in the Site Inspection Figure.</p> <p>The replaced culvert appeared to be performing well with no signs of distress. Erosion matting was displaced at the outlet. Culvert photos are provided in Photos 6 to 8.</p> <p>No signs of distress along the embankment slope were observed. The overall embankment slope is shown on Photos 9 and 10.</p>
Assessment	<p>The depressions around each of the SI is likely due to a combination of poor fill compaction during winter construction and the Contractor's "carefulness" with compaction equipment around the SI. The slope inclinometers showed deflection of the top of pile of about 1 mm to 3 mm, with the typical shape of pile wall deformation. Currently, the pile wall appears to be performing well.</p>

Photo 1: Reconstructed pavement at north end of remediation limits. Looking south.

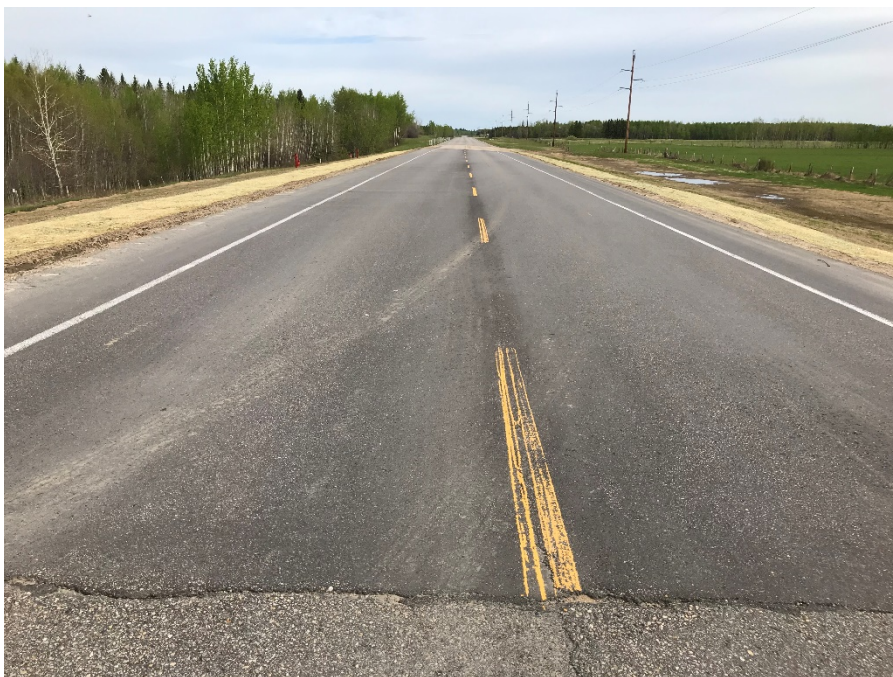
Photo 2: Reconstructed pavement at north end of remediation limits. Looking south.

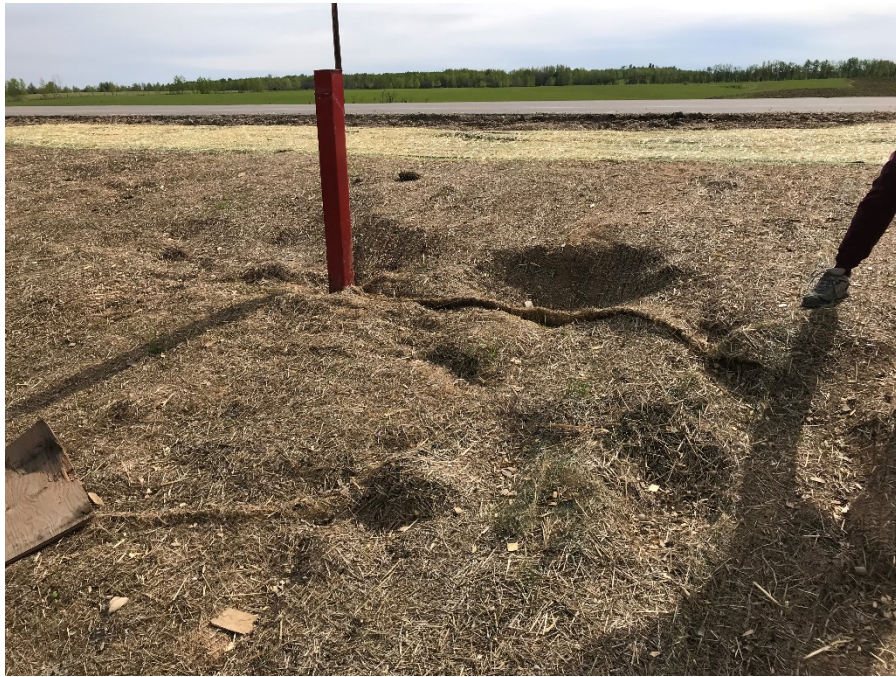
Photo 3: Depression at SI19-01. Looking east.

Recommendations	<p>Given that the site is still under warranty, the Contractor can backfill the depressions around the SI. The erosion matting at the culvert inlet can also be cut shorter to the edge of creek instead of draping it across the creek.</p> <p>Site inspections should continue to be completed annually. The instruments should be read semi-annually. The frequency of both inspections and instrumentation readings may be reduced following another year of monitoring, depending on the performance of the highway.</p>
------------------------	---

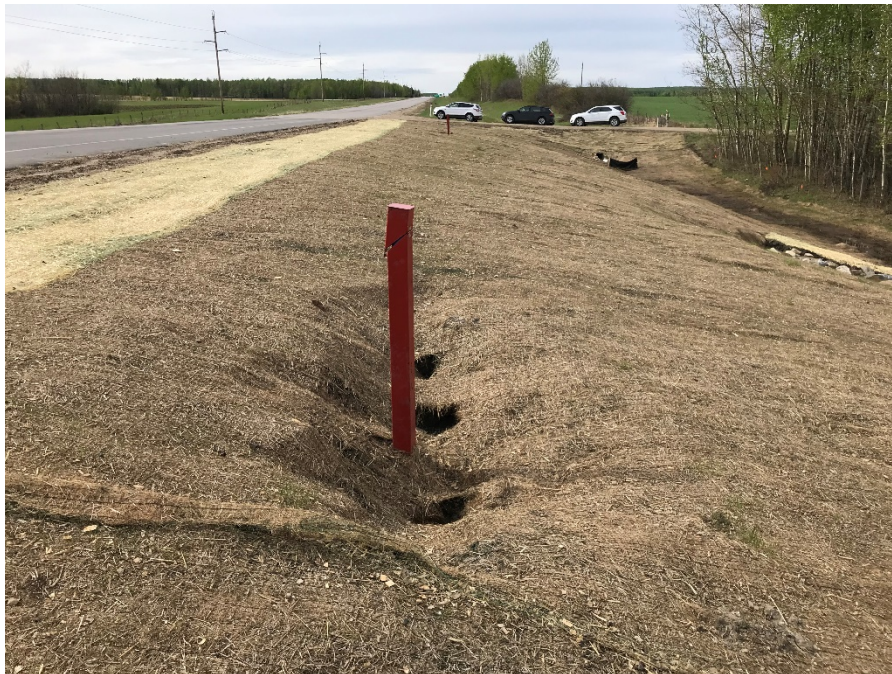
Photo 4: Depression at SI19-02. Looking south.

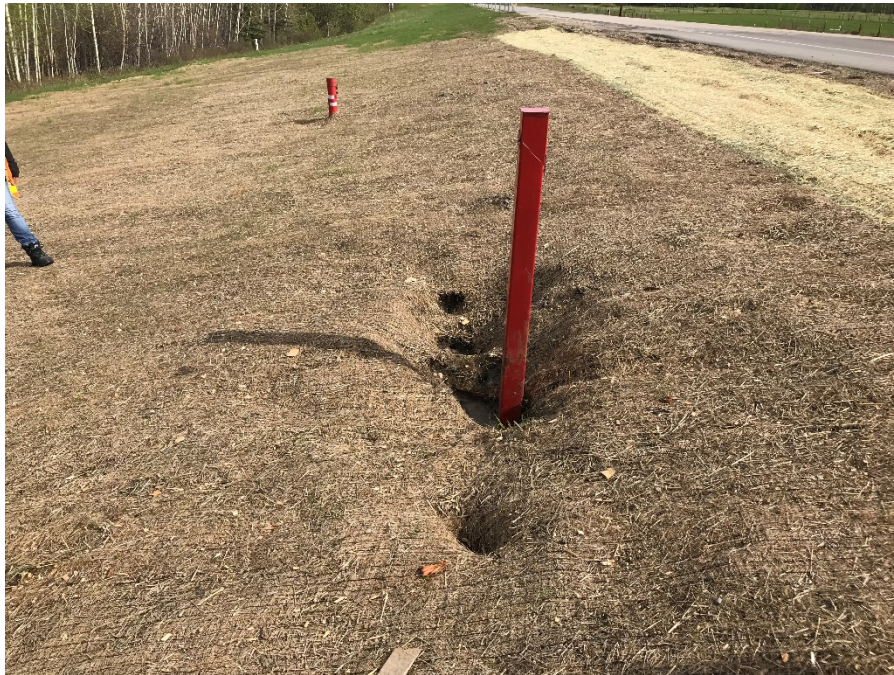
Photo 5: Depression at S119-03. Looking north.

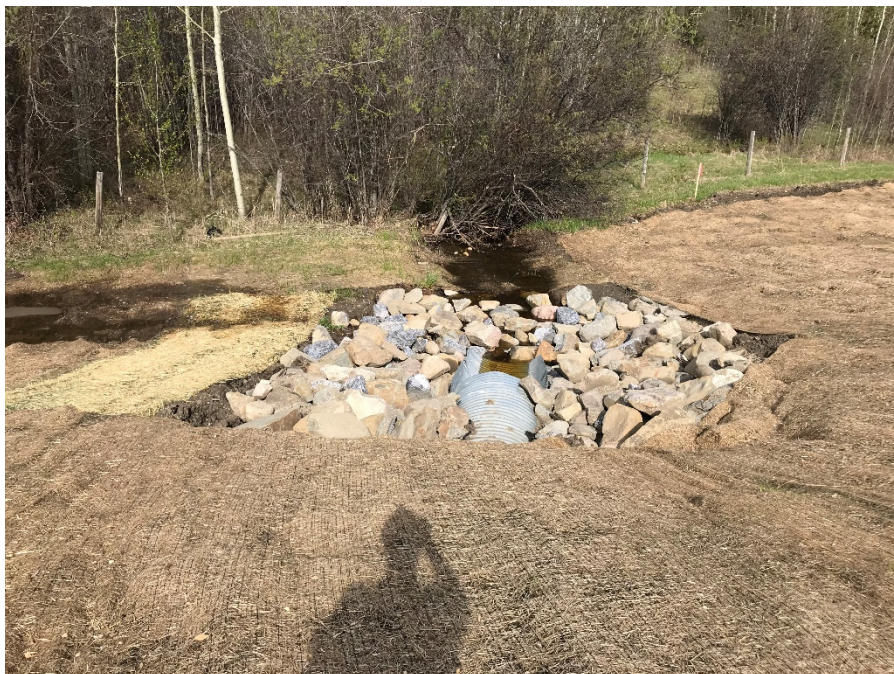
Photo 6: Culvert outlet. Looking northwest.

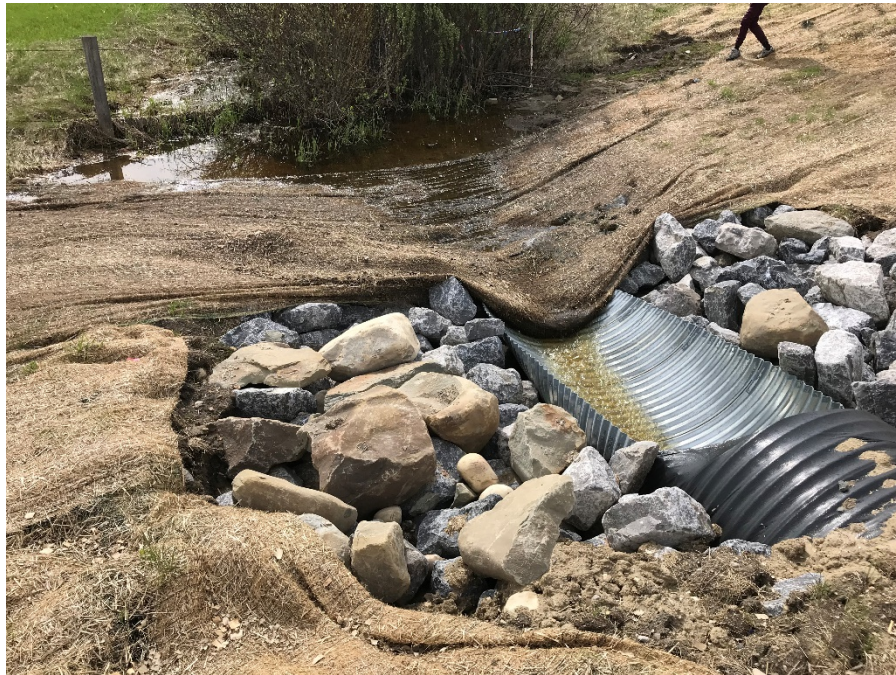
Photo 7: Erosion matting displaced at culvert inlet. Looking southeast.

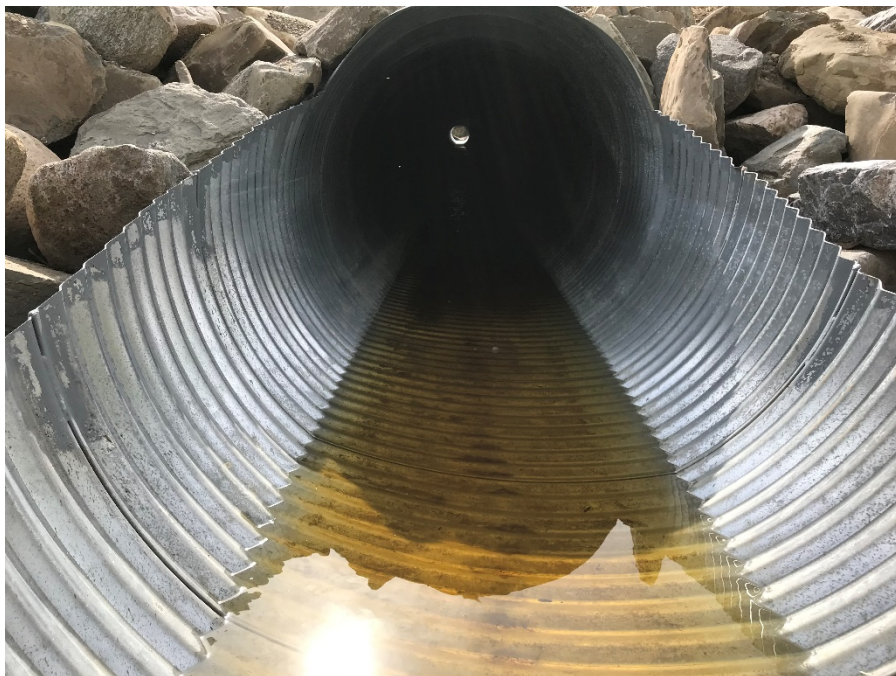
Photo 8: Culvert condition from outlet. Looking southeast.

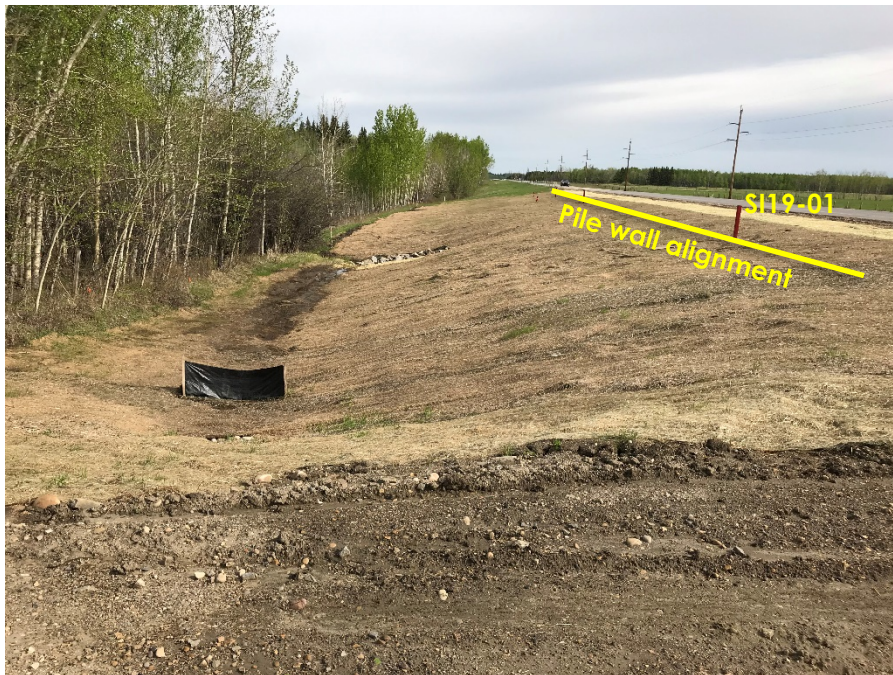
Photo 9: Overall repaired west embankment slope. Looking north.

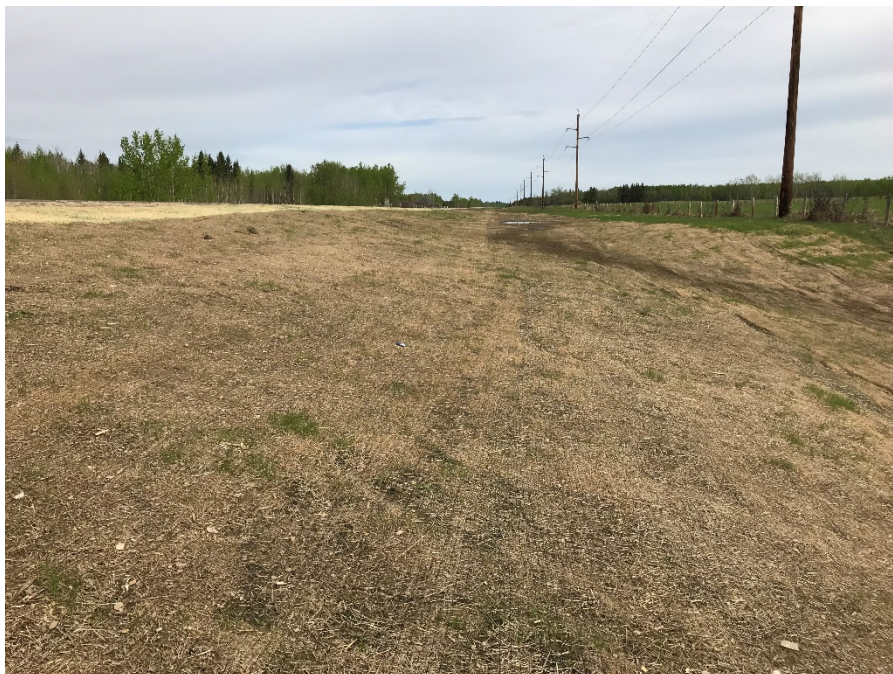
Photo 10: Overall east embankment slope. Looking north.
