| To: | Amy Driessen Alberta Transportation | From: | Leslie Cho and Carrie Murray Stantec Consulting Ltd. |
| File: | 123315222 | Date: | June 12, 2022 |

Reference: North Central Region, Edson, Site NC074 - Highway 22:30 South of Entwistle Slide, Spring 2022 Instrumentation Monitoring Report

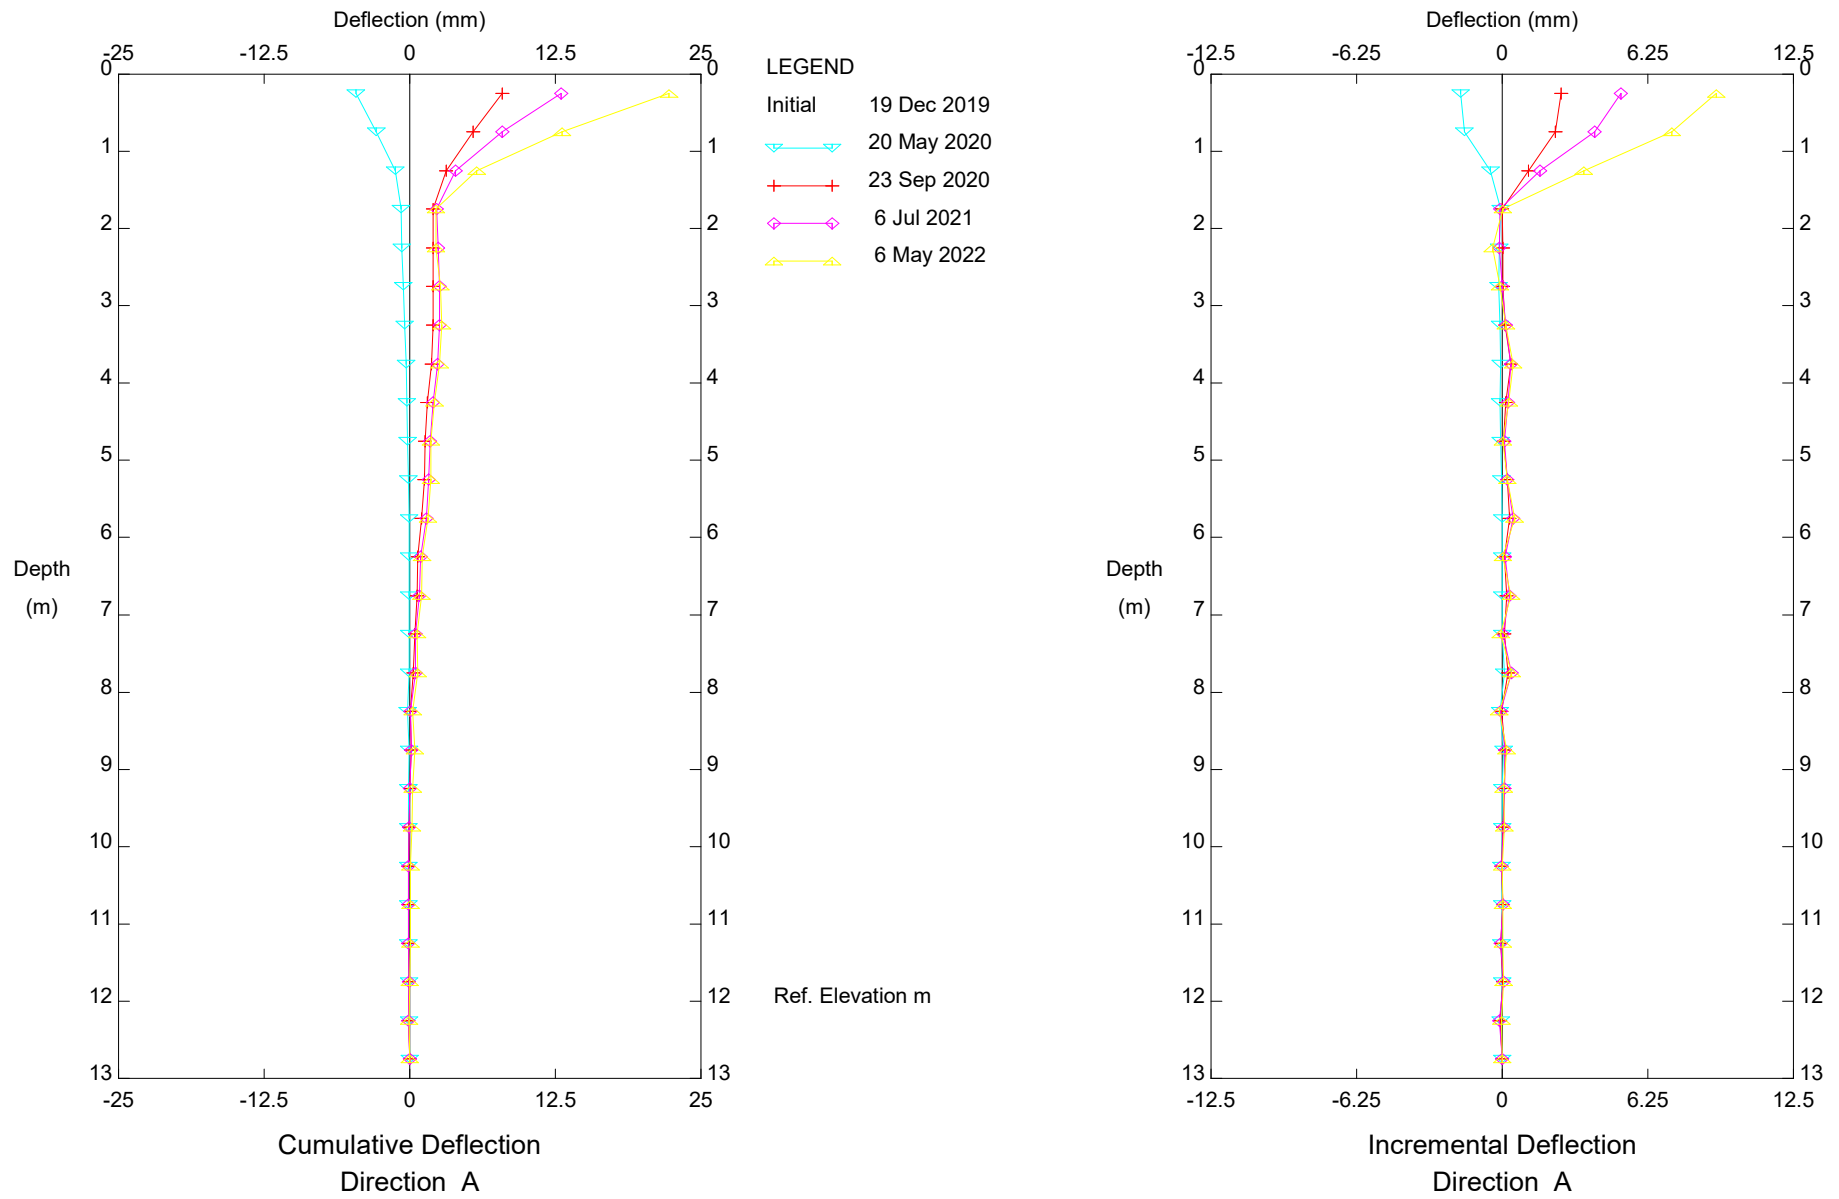
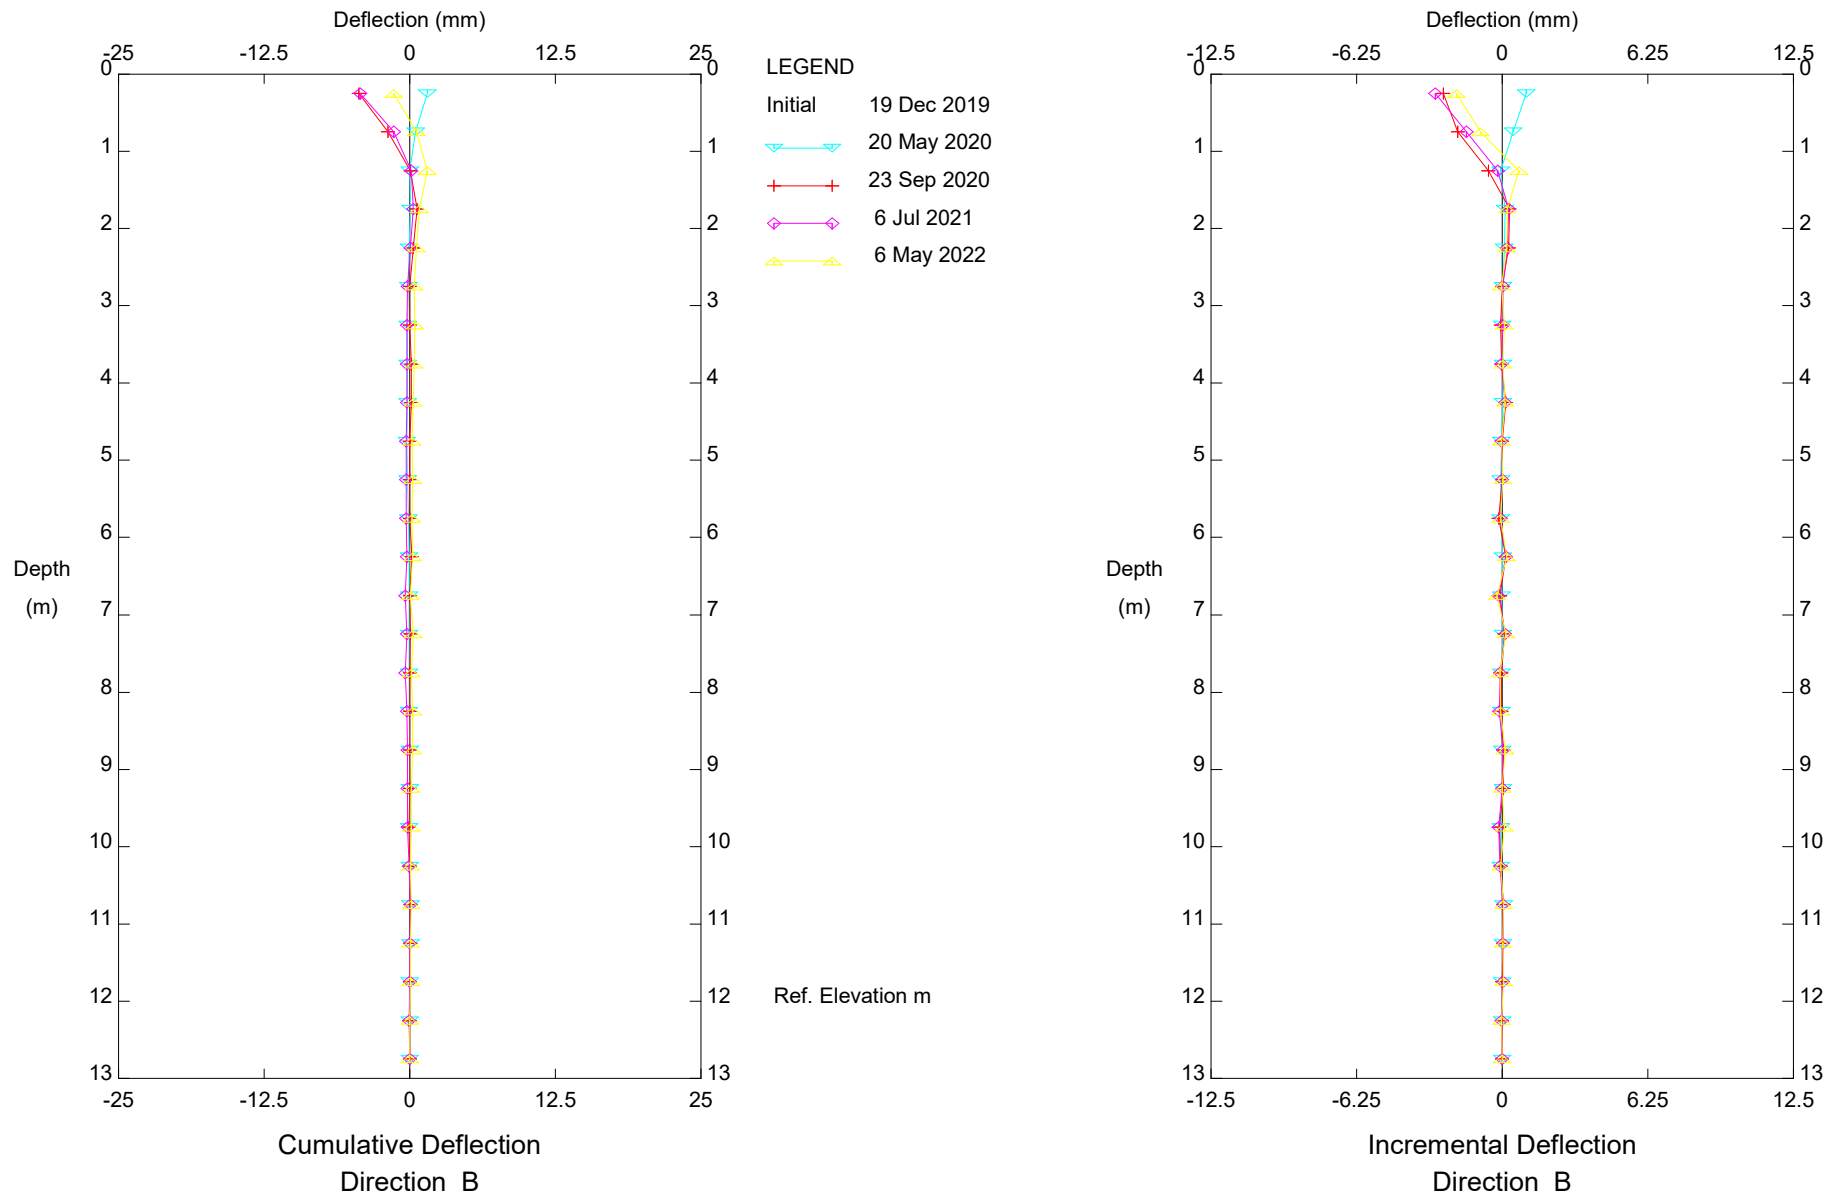
Hwy 22:30, South of Entwistle (NC074), Inclinometer SI19-01
 Alberta Transportation

No discernable zone of movement was observed; however, small movements were observed in all SI near the pile top. These movements may reflect deflection of the pile wall.

All SI were installed within the H-piles. **SI19-01** to **SI19-03** shows various magnitudes of deflection at the top of pile ranging from 25 mm to 103 mm. The observed deflection at the pile top is likely a result of deflection necessary to mobilize resistance against slope movements.

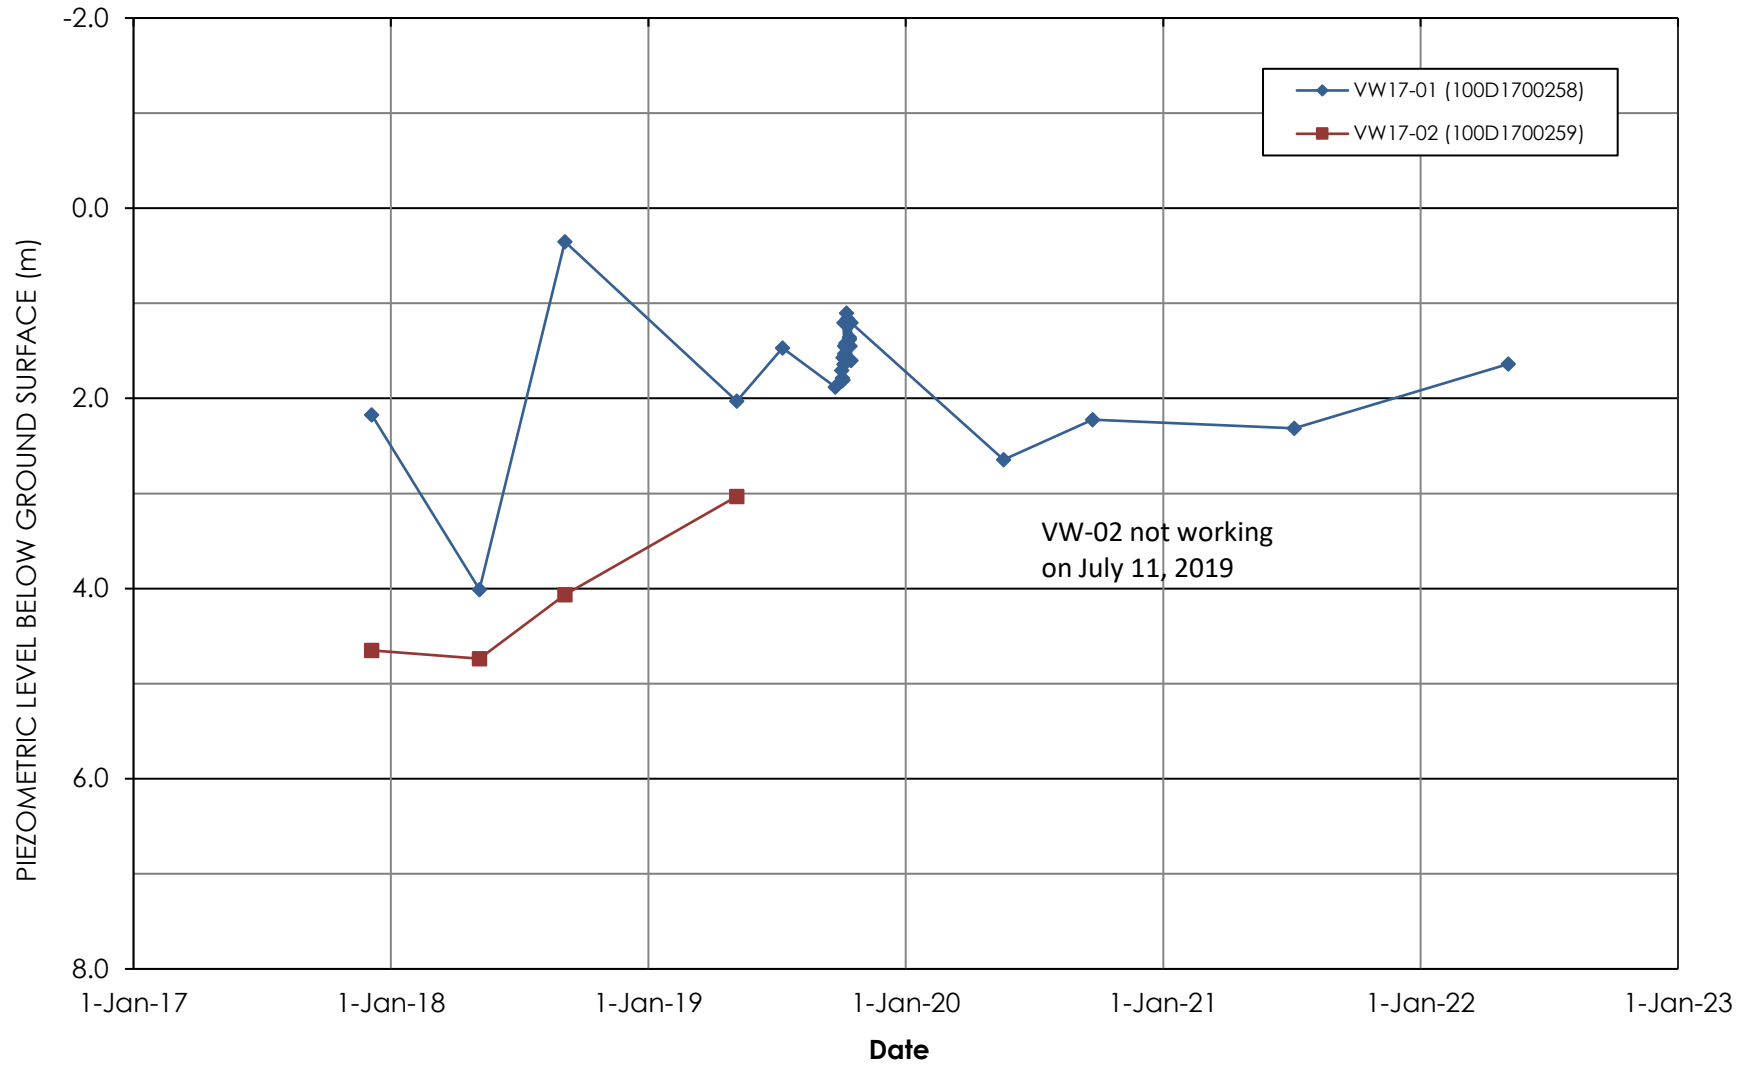
Piezometric Level Below Existing Ground Surface

The Spring 2022 readings indicate piezometric levels increased by 0.7 m (corresponding elevation of 786.0 m) since the previous reading cycle in Spring 2021. A trend of increasing piezometric levels is developing since Spring 2020.
