SITE NUMBER AND NAME: NC074 – South of Entwistle Slide	HIGHWAY AND KM: 22:30, km 44.2	PREVIOUS INSPECTION: May 25, 2020	CURRENT INSPECTION: June 14, 2023
LEGAL DESCRIPTION: SE 17 & SW 16-52-07-W5	NAD83 COORDINATES: UTM11U 5928504N, 633710E		RISK ASSESSMENT: PF: 3 CF: 5 Total: 15
AVERAGE ANNUAL DAILY TRAFFIC (AADT): 3,340 (2023)		CONTRACTOR MAINTENANCE AREA (CMA): 509

Client/Project
 Transportation and Economic Corridors
 Geohazard Monitoring Program
 NC74 Hwy 22:30 South of Entwistle Slide

2024 Site Inspection Photos at NC074

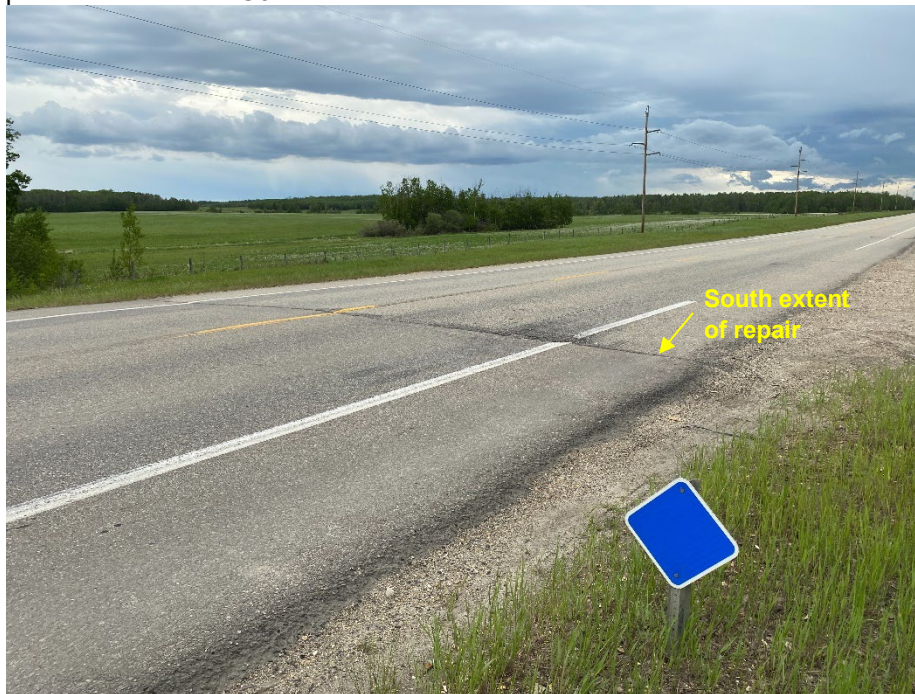
COMMENTS
<ul style="list-style-type: none"> Faint longitudinal cracks were observed within the remediated area of the highway. The cracks do not appear to be related to movement of the highway embankment (Photos 1 to 3). A bump is present in the SBL where the remediated pavement surface ends. A blue marker on the side of the highway warns of the bump (Photo 1). The highway embankments were observed to be well vegetated (Photo 4). Ground depressions of various dimensions around each of the slope inclinometers (SI) were observed to be generally unchanged since 2020, though the ground surface is now vegetated (Photo 5). These depressions are likely due to a combination of poor fill compaction during winter construction, and the Contractor being careful with compaction equipment around the SIs.

Photo 1: Bump at south extent of highway repair in SBL. Looking southeast.

- The highway surface should be monitored for pavement cracks, and cracks should be sealed to prevent water infiltrating the embankment.
- The depressions around the SIs on the west sideslope should be backfilled and seeded to prevent water from collecting and softening the surrounding soils.
- Site inspections should continue to be completed once per contract cycle.
- Instrumentation should continue to be read annually.

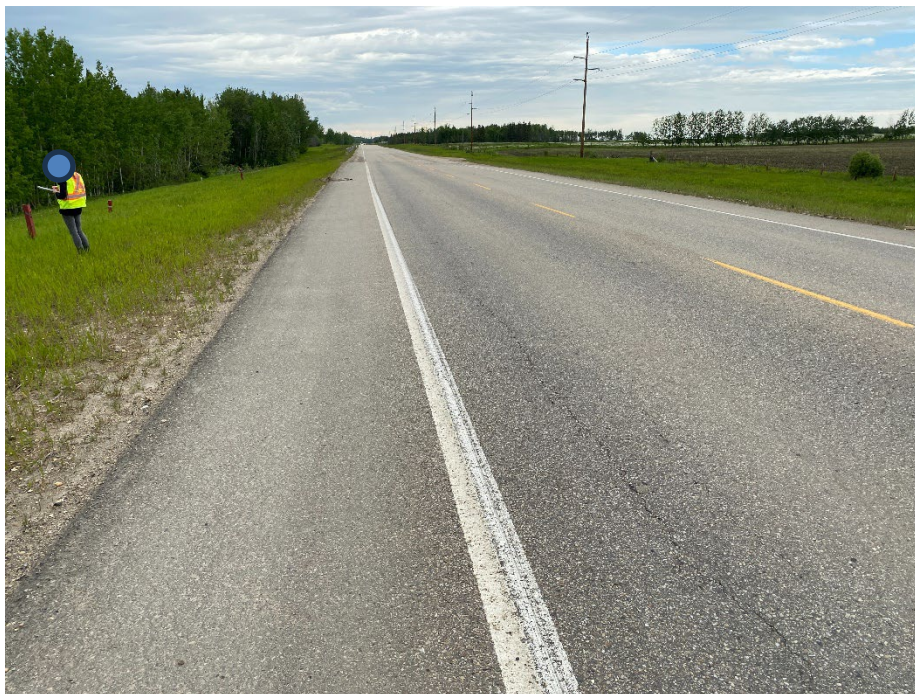
Photo 2: Highway condition within repair zone, looking north.

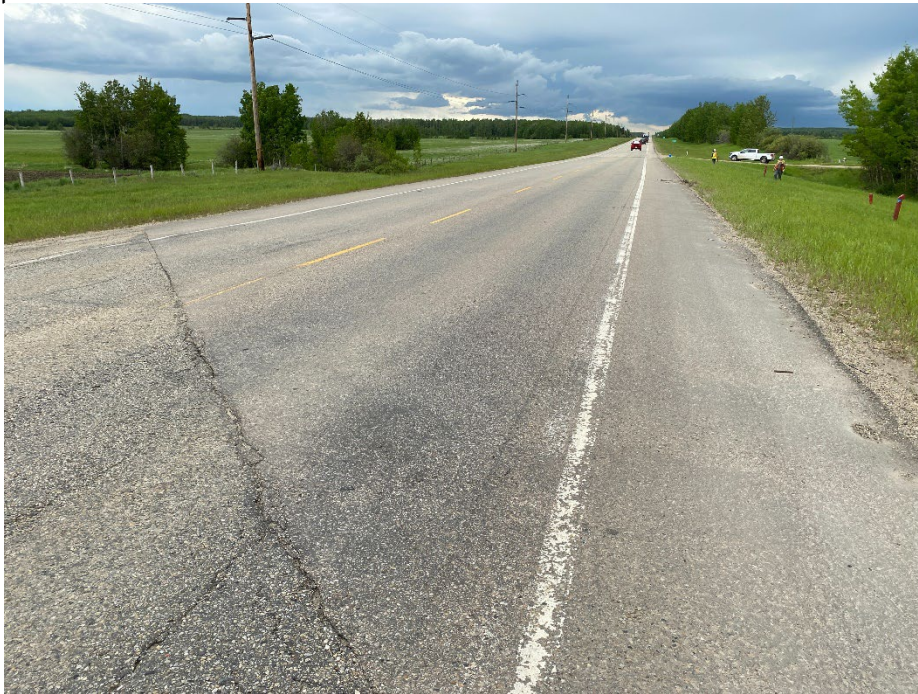
Photo 3: Pavement at north end of remediation limits. Looking south.

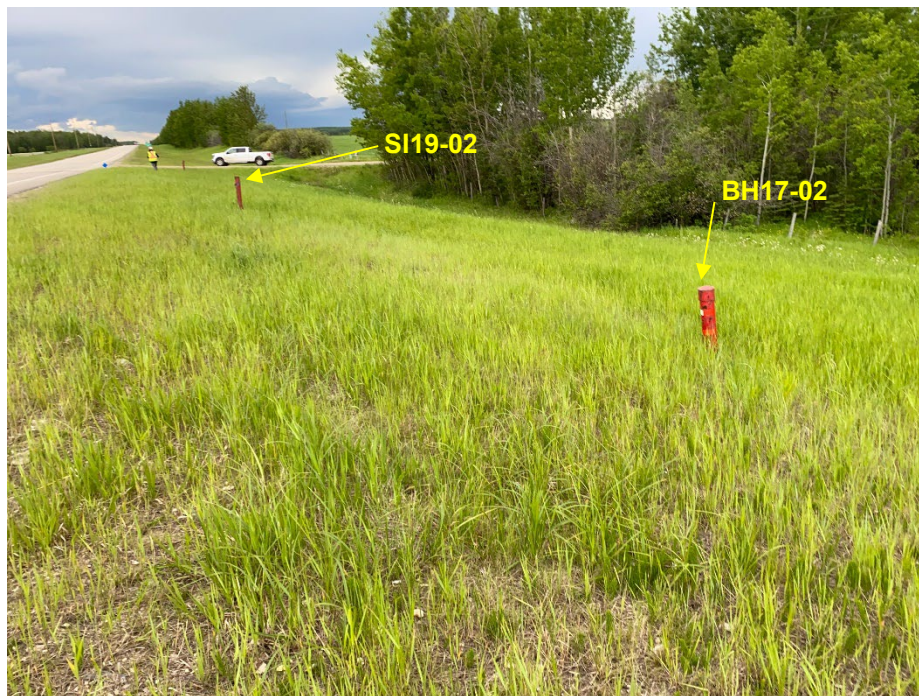
- All SIs are installed within the H-piles. The SIs showed deflection of the top pile ranging from 25 mm to 130 mm. Some regrading work was completed as warranty following construction of the pile wall which could have contributed to some of the observed deflection.

Photo 4: Slope inclinometers along pile wall on west embankment slope. Looking southwest.

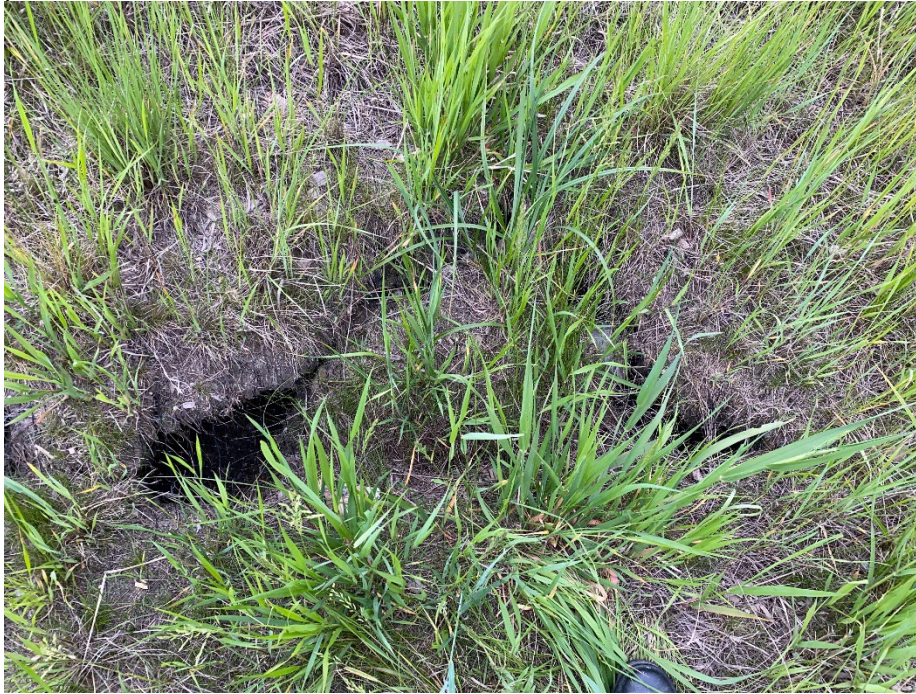
Photo 5: Depression in west embankment slope along pile wall alignment, near SI19-03. Looking east.

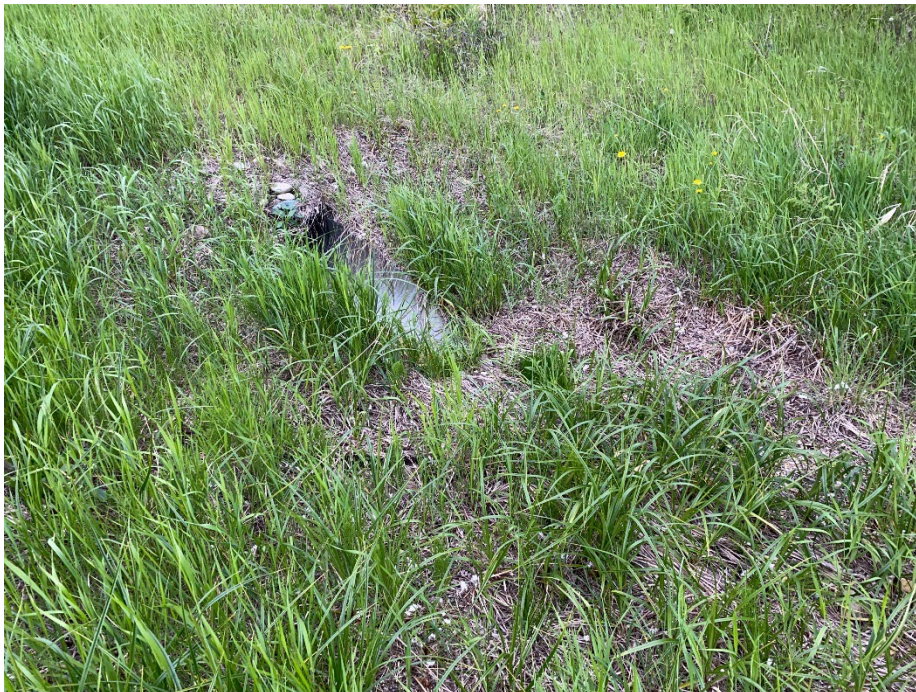
- The outlet of the culvert below the driveway on the west side of the highway is partially obscured by vegetation (Photo 6).
- The replaced culvert appeared to be performing well with no signs of distress. Water was flowing from the outlet, and algae is growing on the riprap below the outlet (Photo 7). The displaced erosion control blanket at the inlet has partially degraded and is unlikely to hinder water collection by the culvert (Photo 8).

Photo 6: Culvert below driveway on west side of highway, looking southwest.

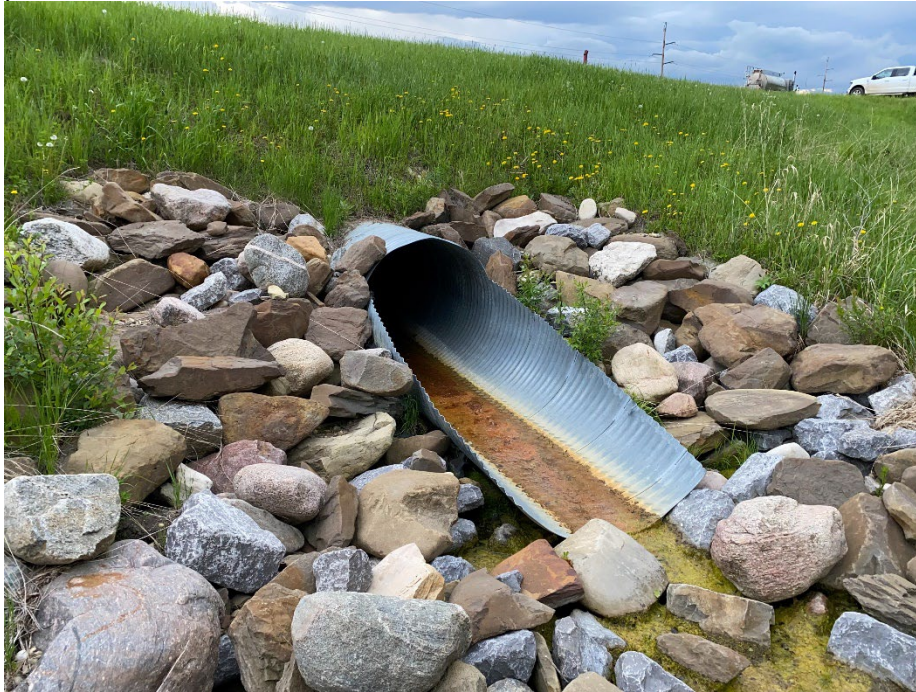
Photo 7: Culvert outlet on west side of highway. Looking southeast.

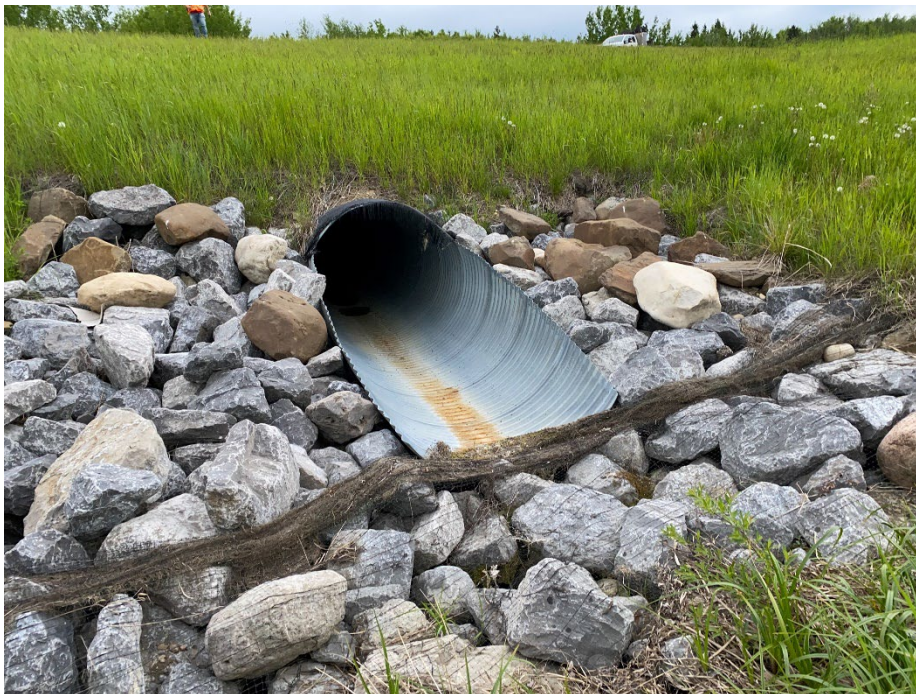
Photo 8: Culvert inlet on the east side of the highway. Looking northwest.

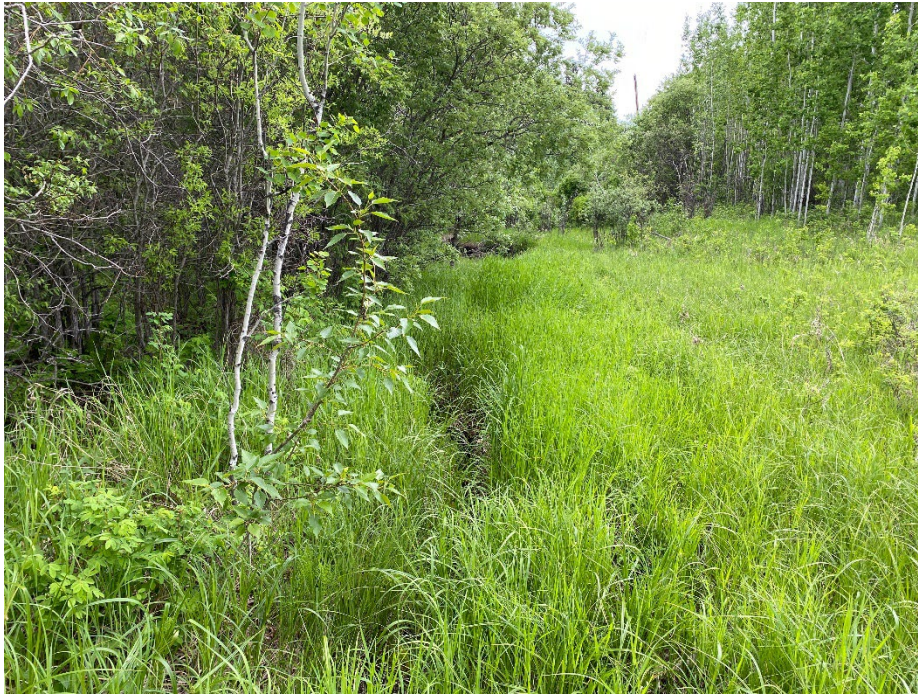
- Water flow from the culvert outlet appears to be incising the toe of the slope west of the fence line. A significant erosion channel was observed further downstream as shown in Photos 9 and 10.

Photo 9: Flow from culvert leading from culvert outlet to erosion area. Looking north.

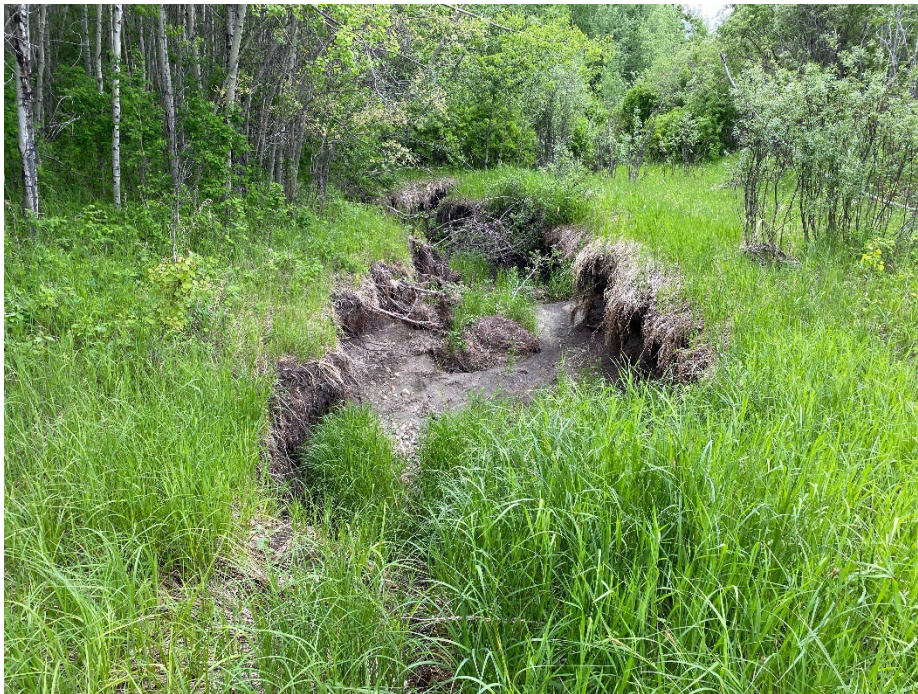
Photo 10: Significant erosion along creek channel. Looking north.
