To:	Amy Driessen	From:	Leslie Cho and Xiteng Liu
	Transportation and Economic Corridors		Stantec Consulting Ltd.
File:	123315222	Date:	June 18, 2024

Reference: North Central Region, Edson, Site NC074 - Highway 22:30 South of Entwistle Slide, Spring 2024 Instrumentation Monitoring Report

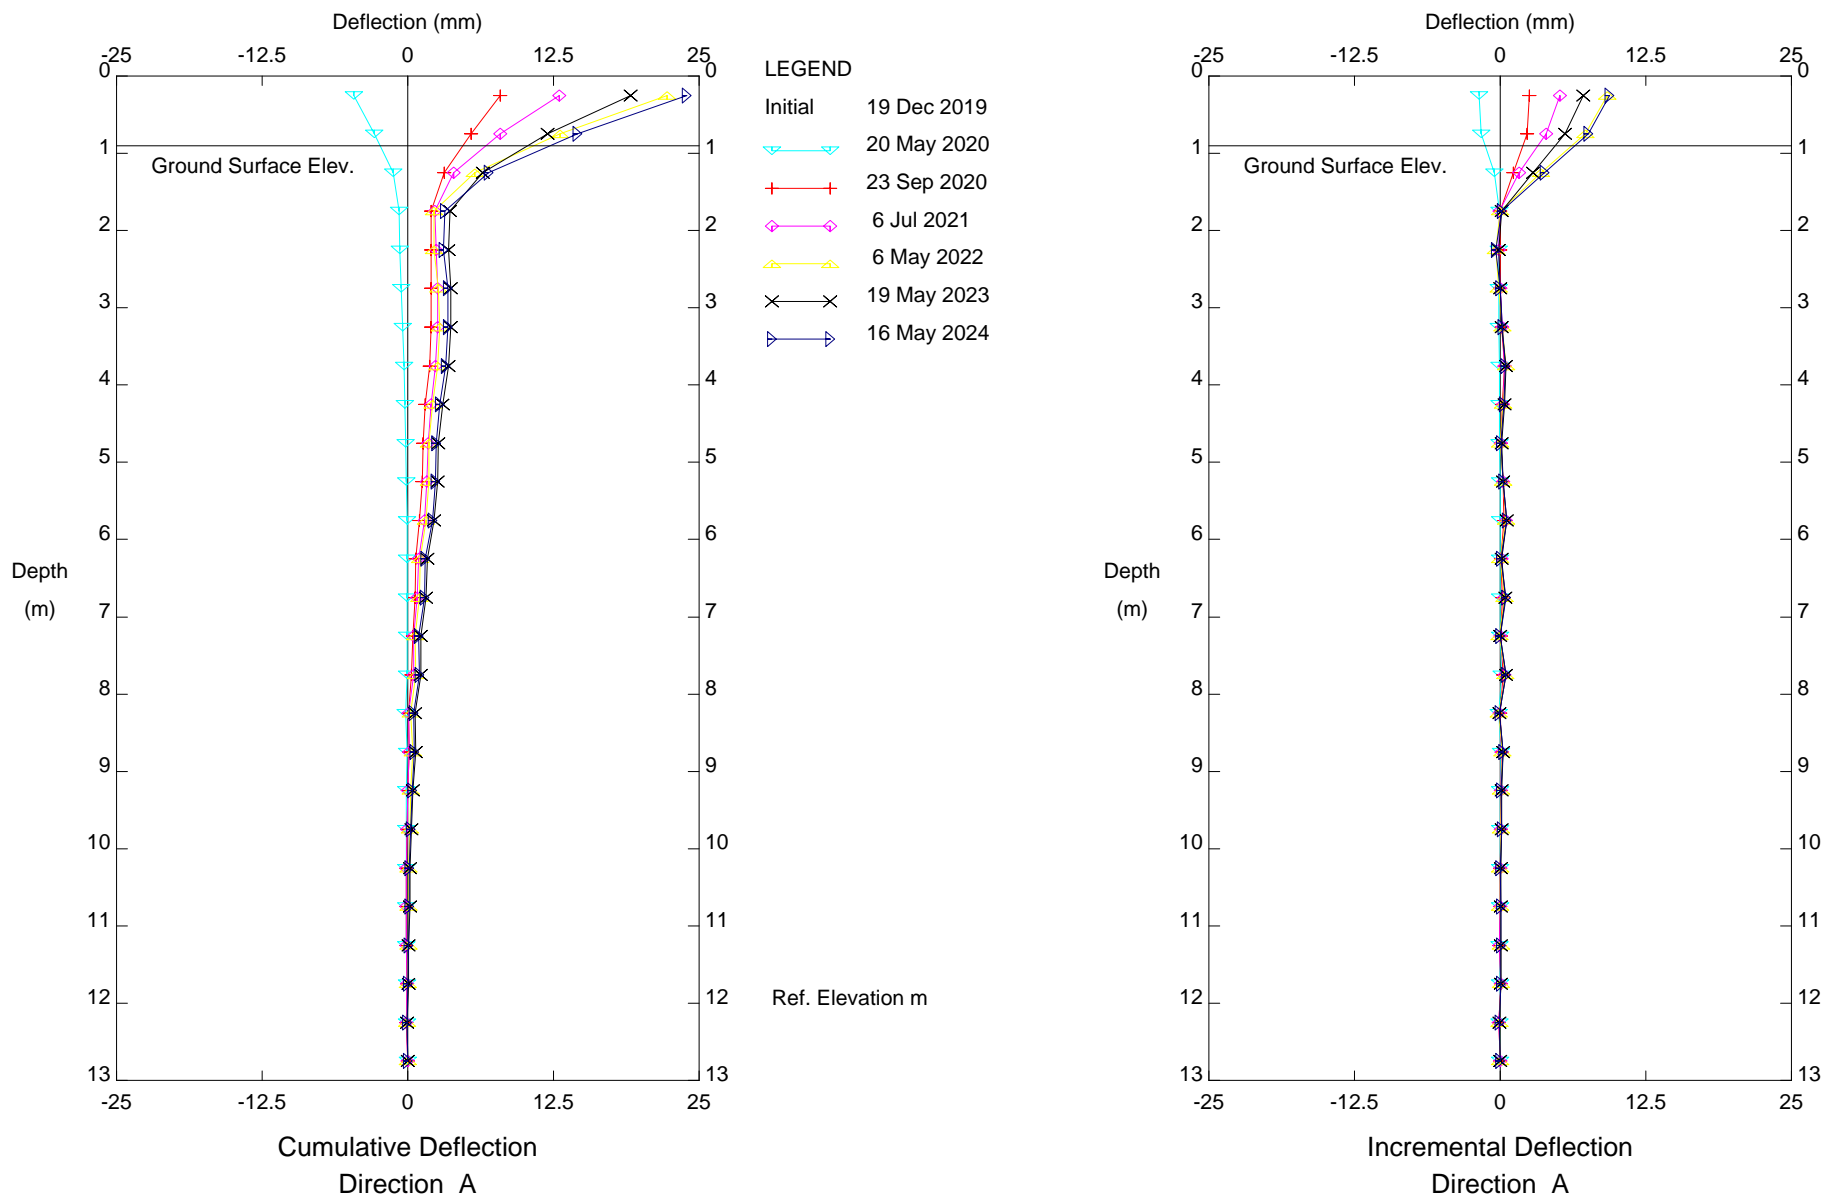
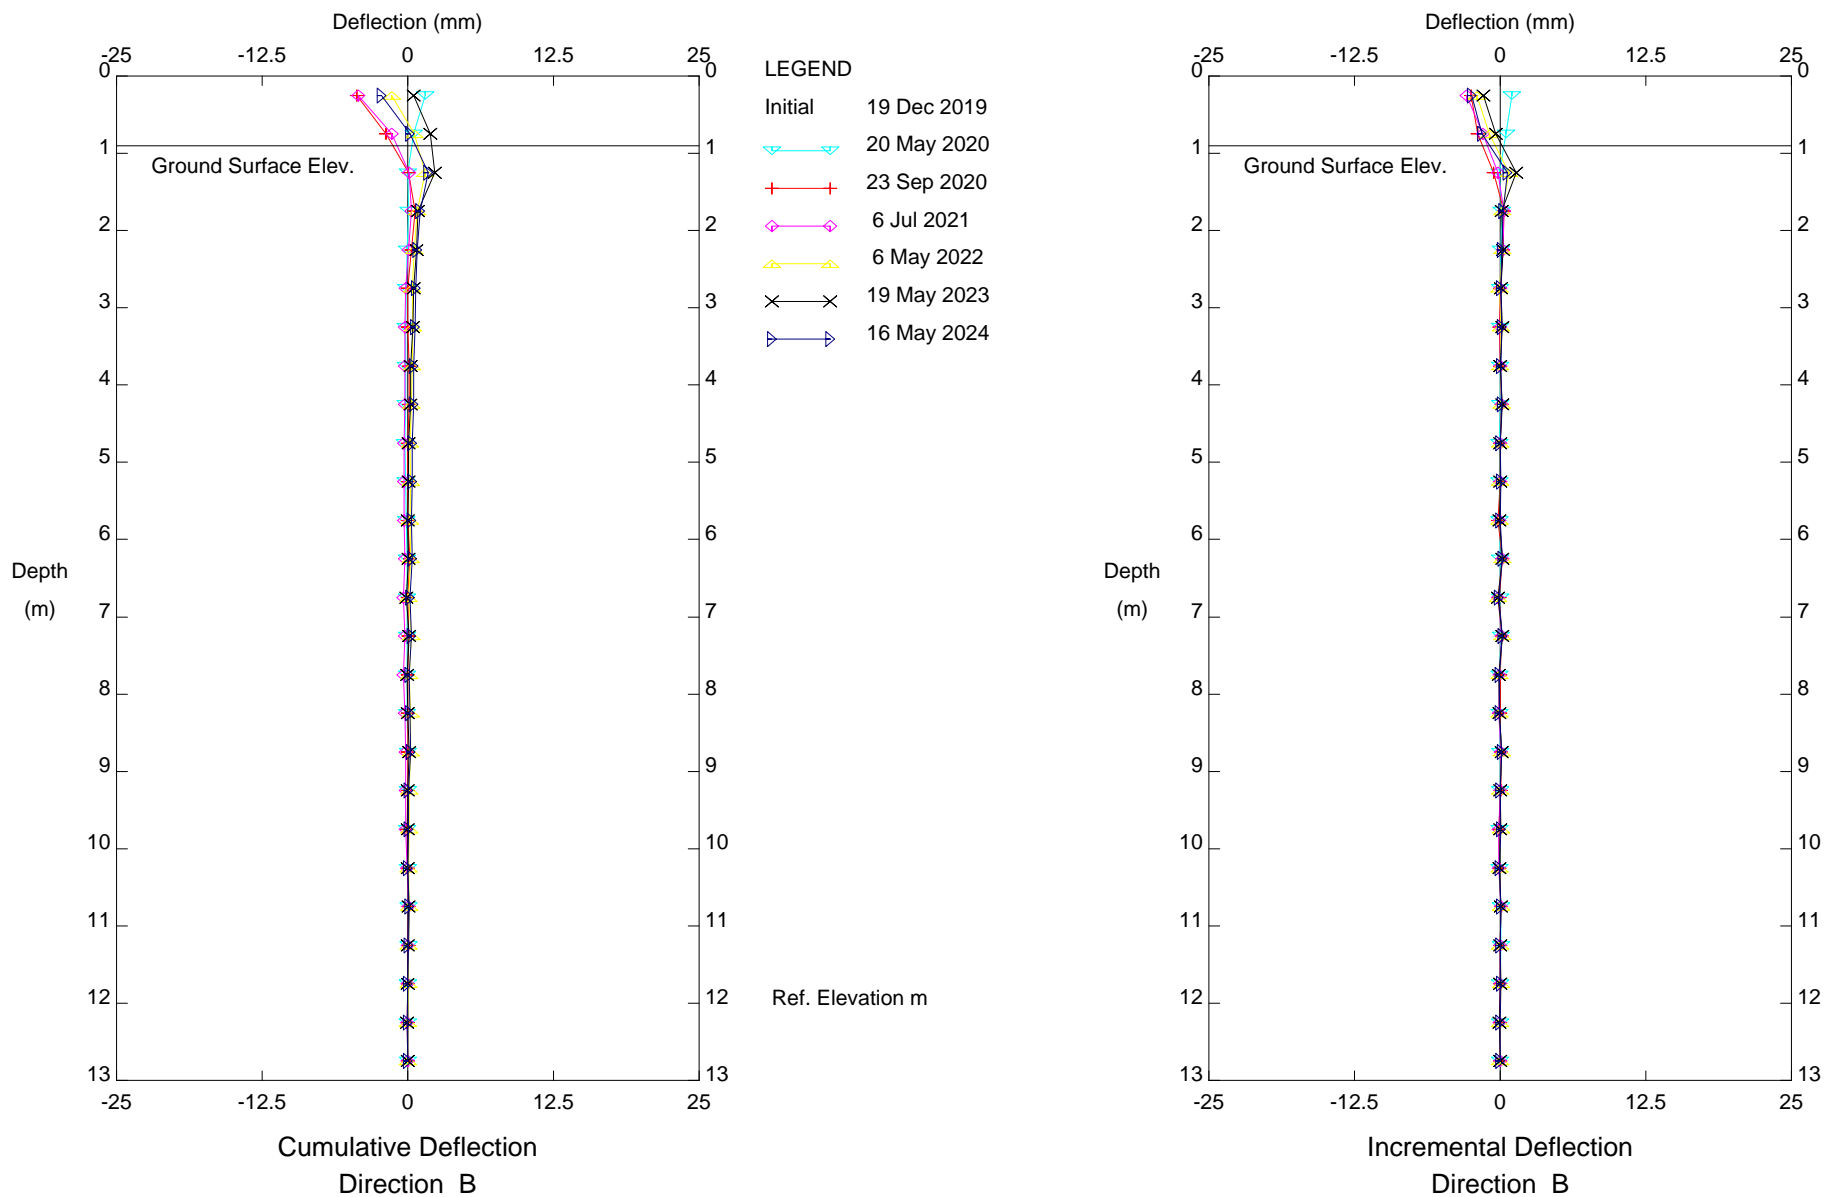
Hwy 22:30, South of Entwistle (NC74), Inclinometer SI19-01
 Transportation & Economic Corridors

All SI were installed within the H-piles. SI19-01 to SI19-03 shows various magnitudes of deflection at the top of pile ranging from 25 mm to 130 mm. Landslide remediation was completed in November 2019; however, relatively large ground depressions up to 0.8 m deep and 3 m wide around each SI were observed the following spring. The depressions were subsequently backfilled and recompacted. Furthermore, some

additional regrading was completed for reinstallation of the erosion control matting as part of warranty repairs in September 2020. Some observed deflection at the pile top is likely a result of construction disturbance post-initialization.

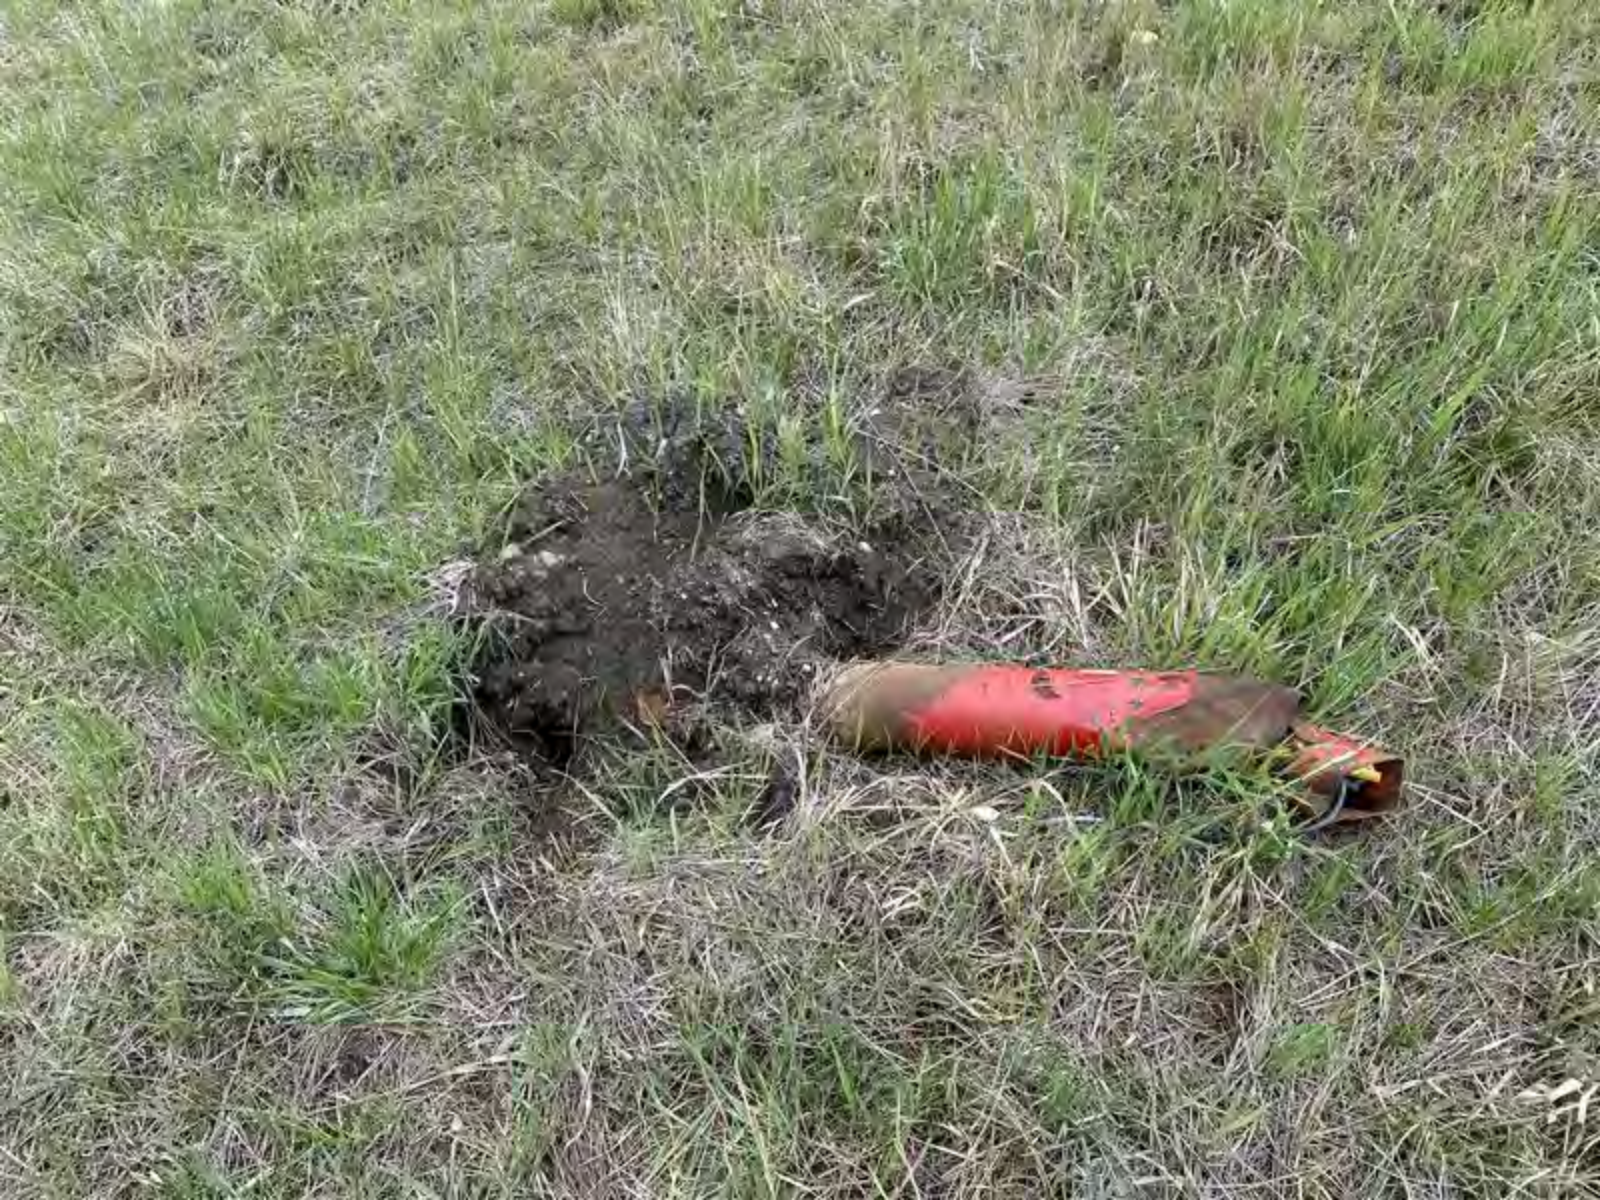
VW17-01 was found damaged in Spring 2024 as shown on the attached photo. Prior to this, the Spring 2023 readings had indicated that piezometric levels dropped by 1.2 m (corresponding elevation of 784.8 m) since the previous reading cycle in Spring 2022.

Since there are no operational piezometers on site, replacement piezometers could be considered to continue monitoring groundwater levels at the site.
