# ALBERTA TRANSPORTATION LANDSLIDE RISK ASSESSMENT

## SECTION A: GEOTECHNICAL FILE REVIEW

### SITE NC31: DEER LODGE

**ALBERTA TRANSPORTATION  
GEOHAZARD MONITORING PROGRAM  
NC31 HWY 22-32  
SITE PLAN**

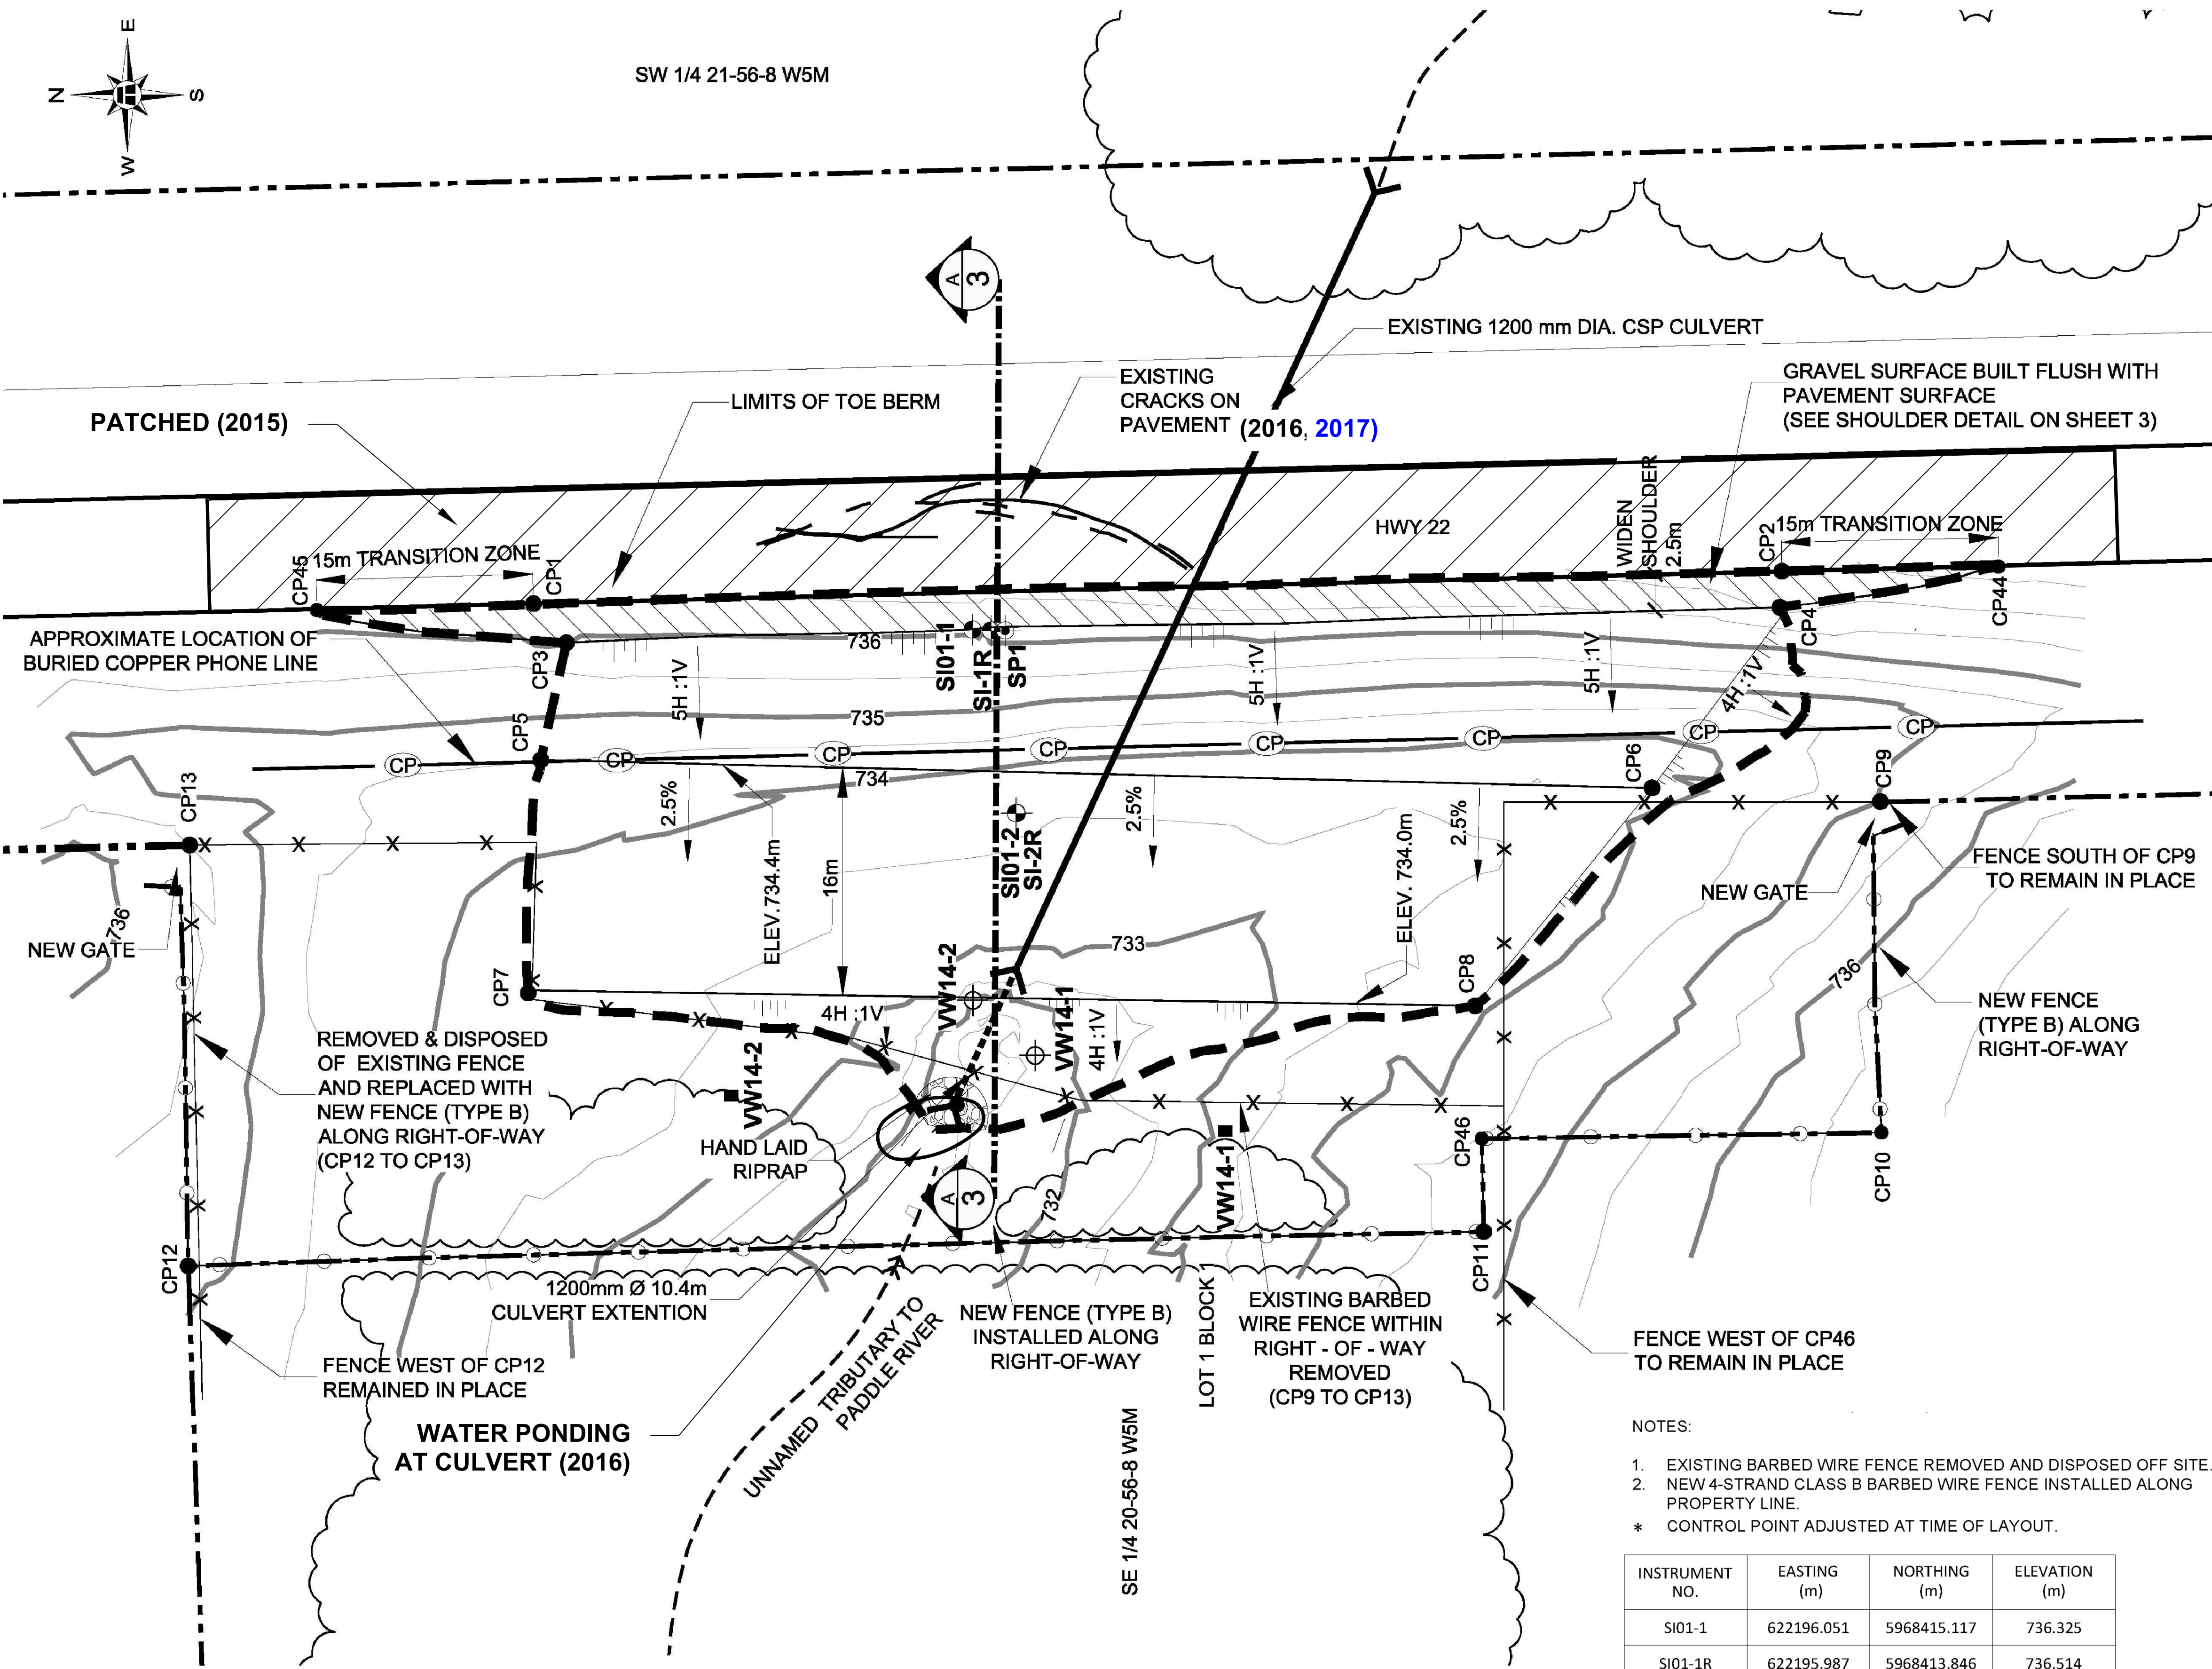
FIGURE - 1

Two slope inclinometers, two vibrating wire piezometers, and one standpipe piezometer were operational at the site to monitor ground movements and groundwater levels. The location of these instruments is shown on **Figure 1**.
